BRE Global Client Report

BS 8414-1:2015 + A1:2017 test referred to as DCLG test 3.

Prepared for: DCLG
Date: 3rd August 2017 (Issue 1.0)
12th September 2017 (Issue 1.2)
Report Number: B137611-1037 (DCLG test 3) **Issue: 1.2**

Prepared for:
Department for Communities and Local
Government
2 Marsham Street
London
SW1P 4DF

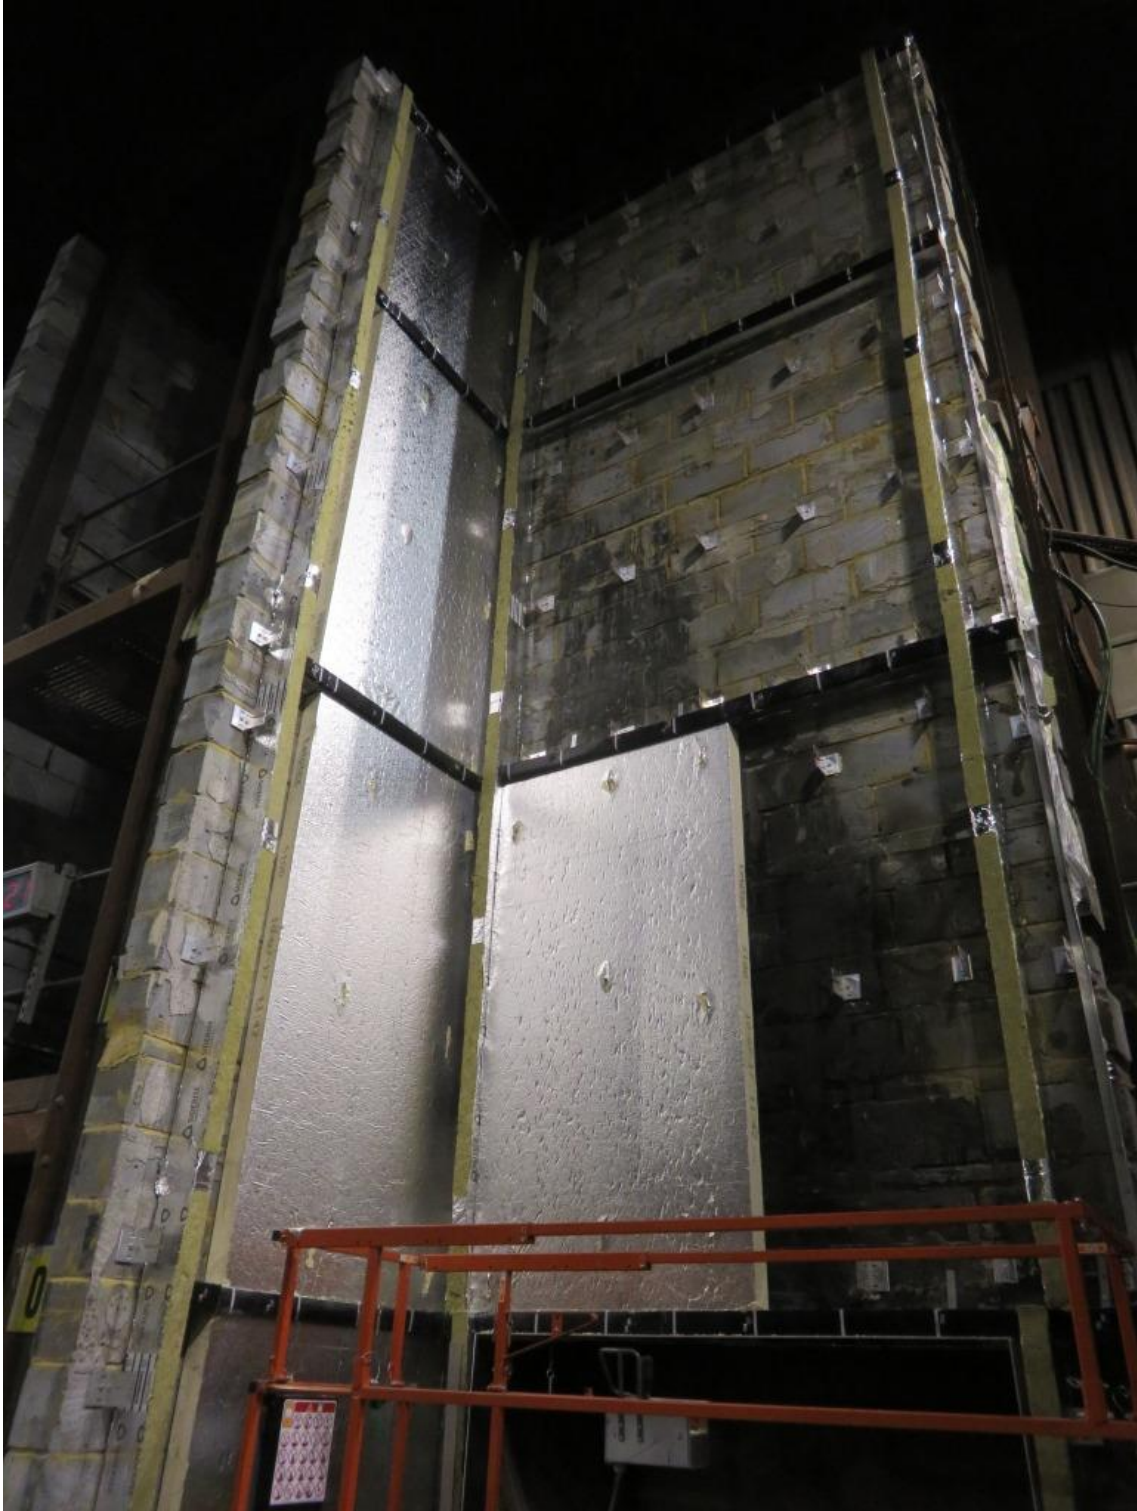
Onto the masonry support structure the 90mm-high × 64mm-wide × 113mm-deep × 4mm-thick aluminium 'L'-shaped brackets were fixed in position on low density polyethylene isolation pads (5mm-thick), with a single 90mm-long × ϕ 8mm stainless steel screw anchor and plastic plug. On the main face the horizontal spacing between the brackets varied between 340mm and 500mm. On the wing wall the horizontal spacing between the brackets was 645mm as specified in the manufacturer's details. The vertical spacing between the brackets was 960mm and where horizontal cavity barriers were present a spacing of 410mm was used - see *Figure 3&4*.

The system included vertical and horizontal cavity barriers. On the main face, two 75mm-wide × 160mm-deep stone wool vertical cavity barriers, with 10mm compression, were fixed in position with a clear distance of 2120mm between them. The vertical cavity barriers above the combustion chamber were installed with an offset towards the main wall edges of approximately 70mm – see *Figure 5*. The vertical cavity barriers were skewered to $\frac{3}{4}$ -depth on steel brackets fixed into the masonry wall with one 70mm-long × ϕ 4mm anchor. Two steel brackets were used for each length of 1200mm of stone wool cavity barrier – see *Figure 3&4*.

On the wing wall, one 75mm-wide × 160mm-deep stone wool vertical cavity barrier, with 10mm compression, was fixed in position at the edge of the system, approximately 1350mm from the external face of the main wall. Once installed in position the stone wool vertical cavity barriers were compressed by the ACM panels to fully close the 50mm ventilated cavity. *Figure 3&4* demonstrate the installed 'L' brackets and vertical cavity barriers.

Figure 3. Location of 'L' brackets (partially visible), cavity barriers and PIR insulation panels.

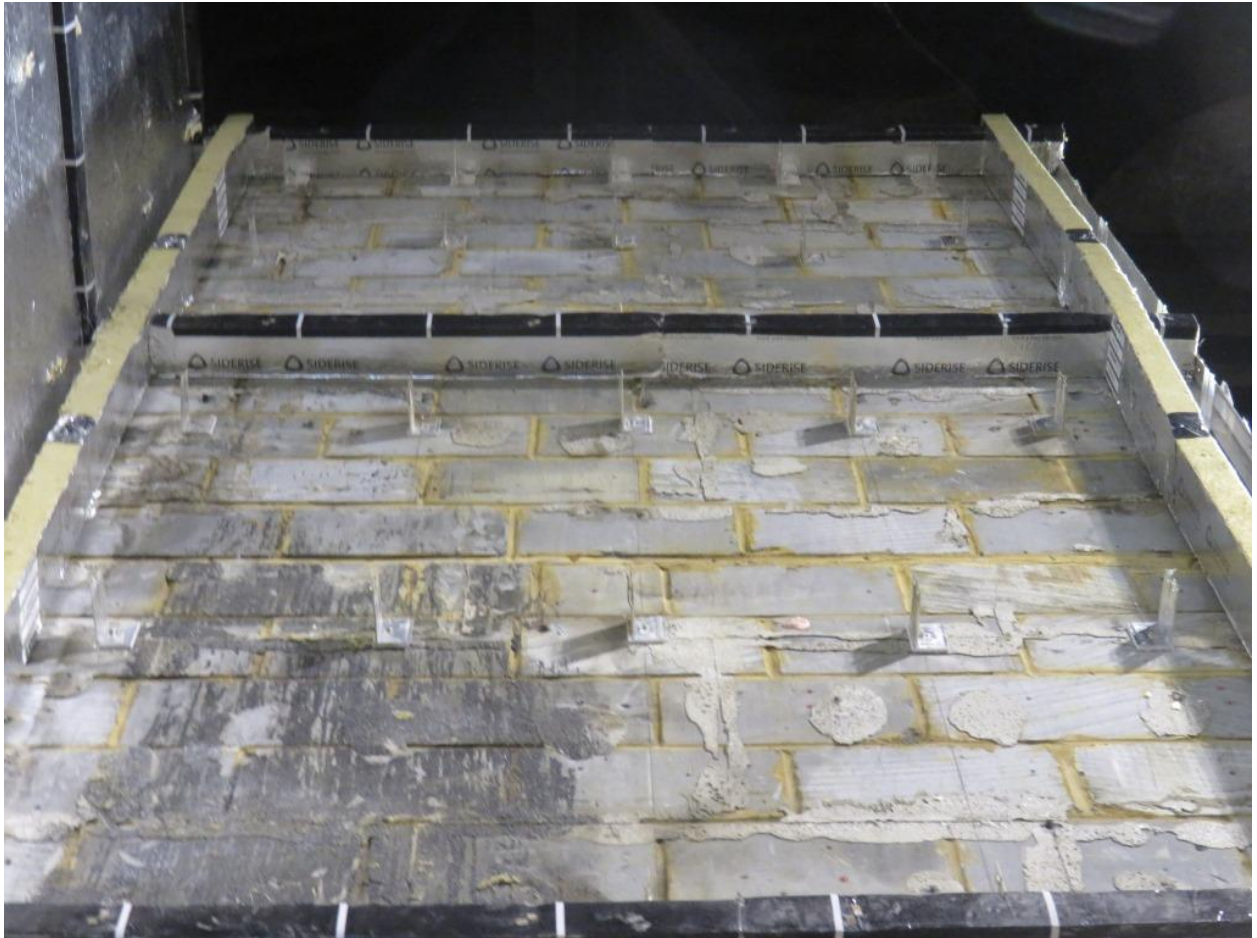
Figure 4. Horizontal intumescent cavity barriers fixed through the entire depth on face turned steel brackets, fitted between vertical cavity barriers.

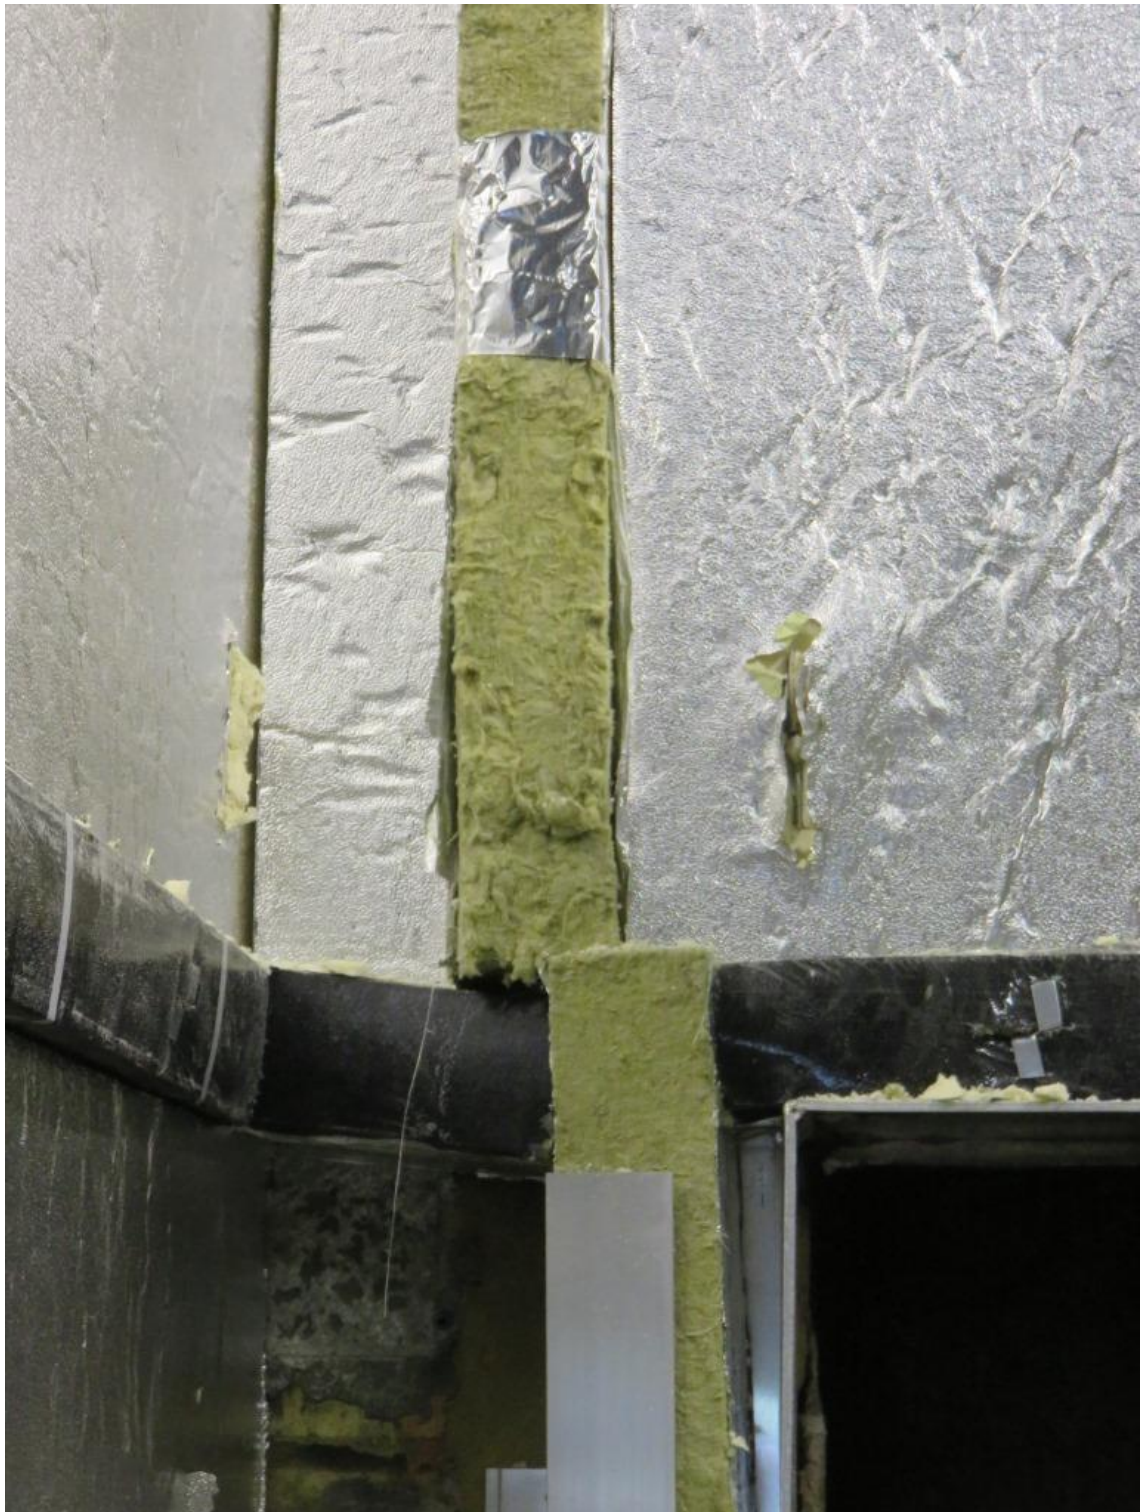
Figure 5. Vertical cavity barrier staggered at the height of the combustion chamber opening.

Note: The vertical cavity barriers above the combustion chamber were installed with an offset towards the main wall edges of approximately 70mm – see also Figure 5.

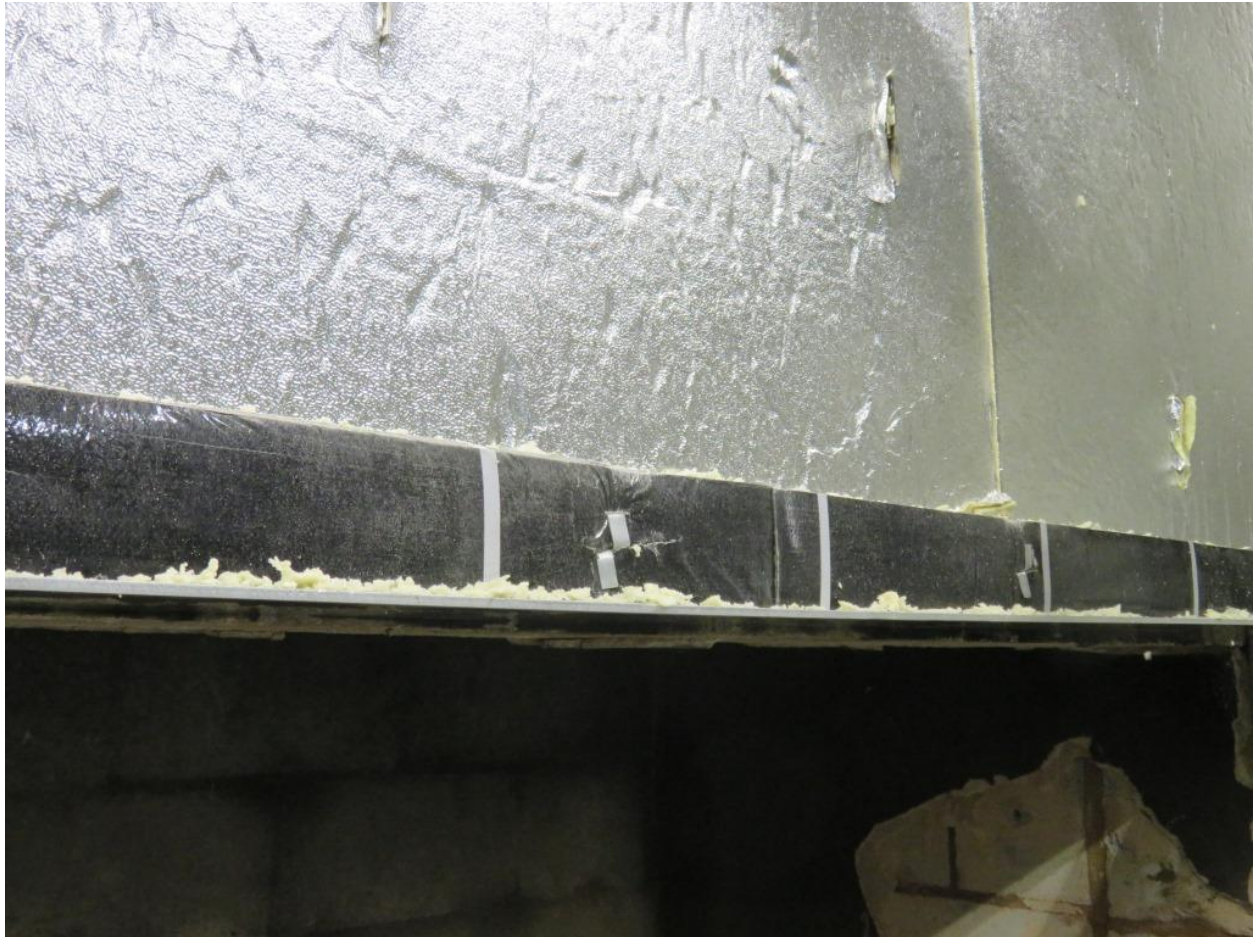
A pre-fabricated, welded window pod constructed from 5mm-thick aluminium was fixed onto the edge of the combustion chamber opening with eight (two on top, three on both vertical edges) 90mm-long × ϕ 8mm stainless steel screw anchor and plastic plugs – see *Figures 5&6*. The window pod extended 180mm perpendicular to the masonry wall so that it extended approximately 30mm beyond the front face of the finished cladding system.

Figure 6. Installed window pod lining combustion chamber.

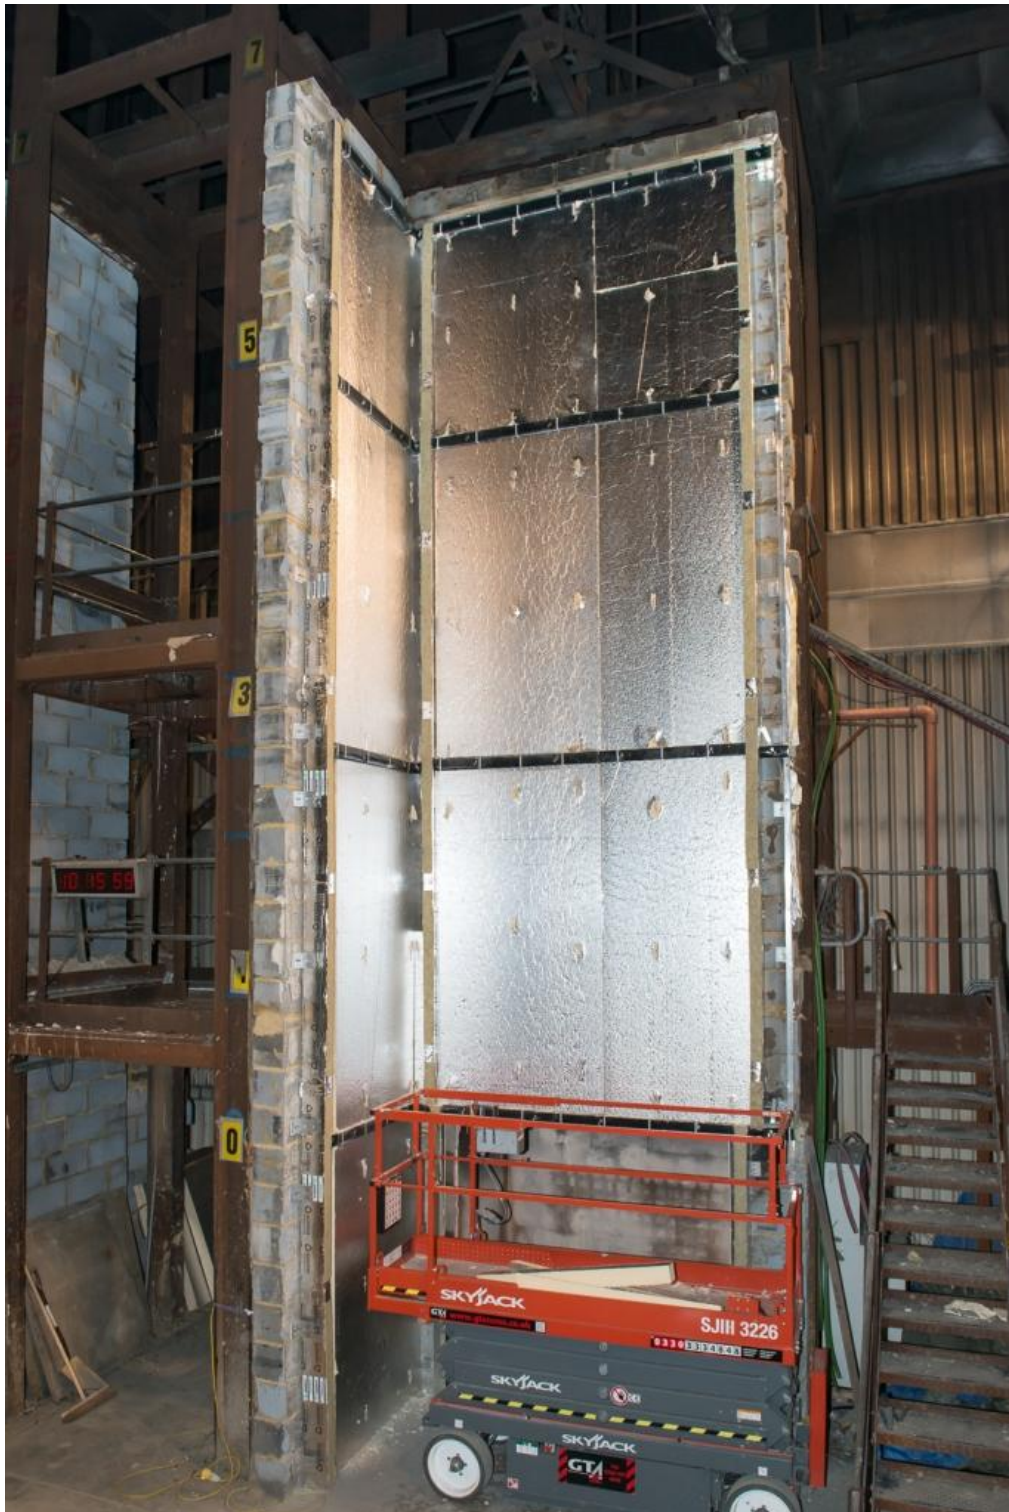
Figure 7. Installed cavity barriers. PIR insulation panels cut to fit and skewered onto 'L'-brackets.

Note: Insulation panels have not yet been fixed to masonry.

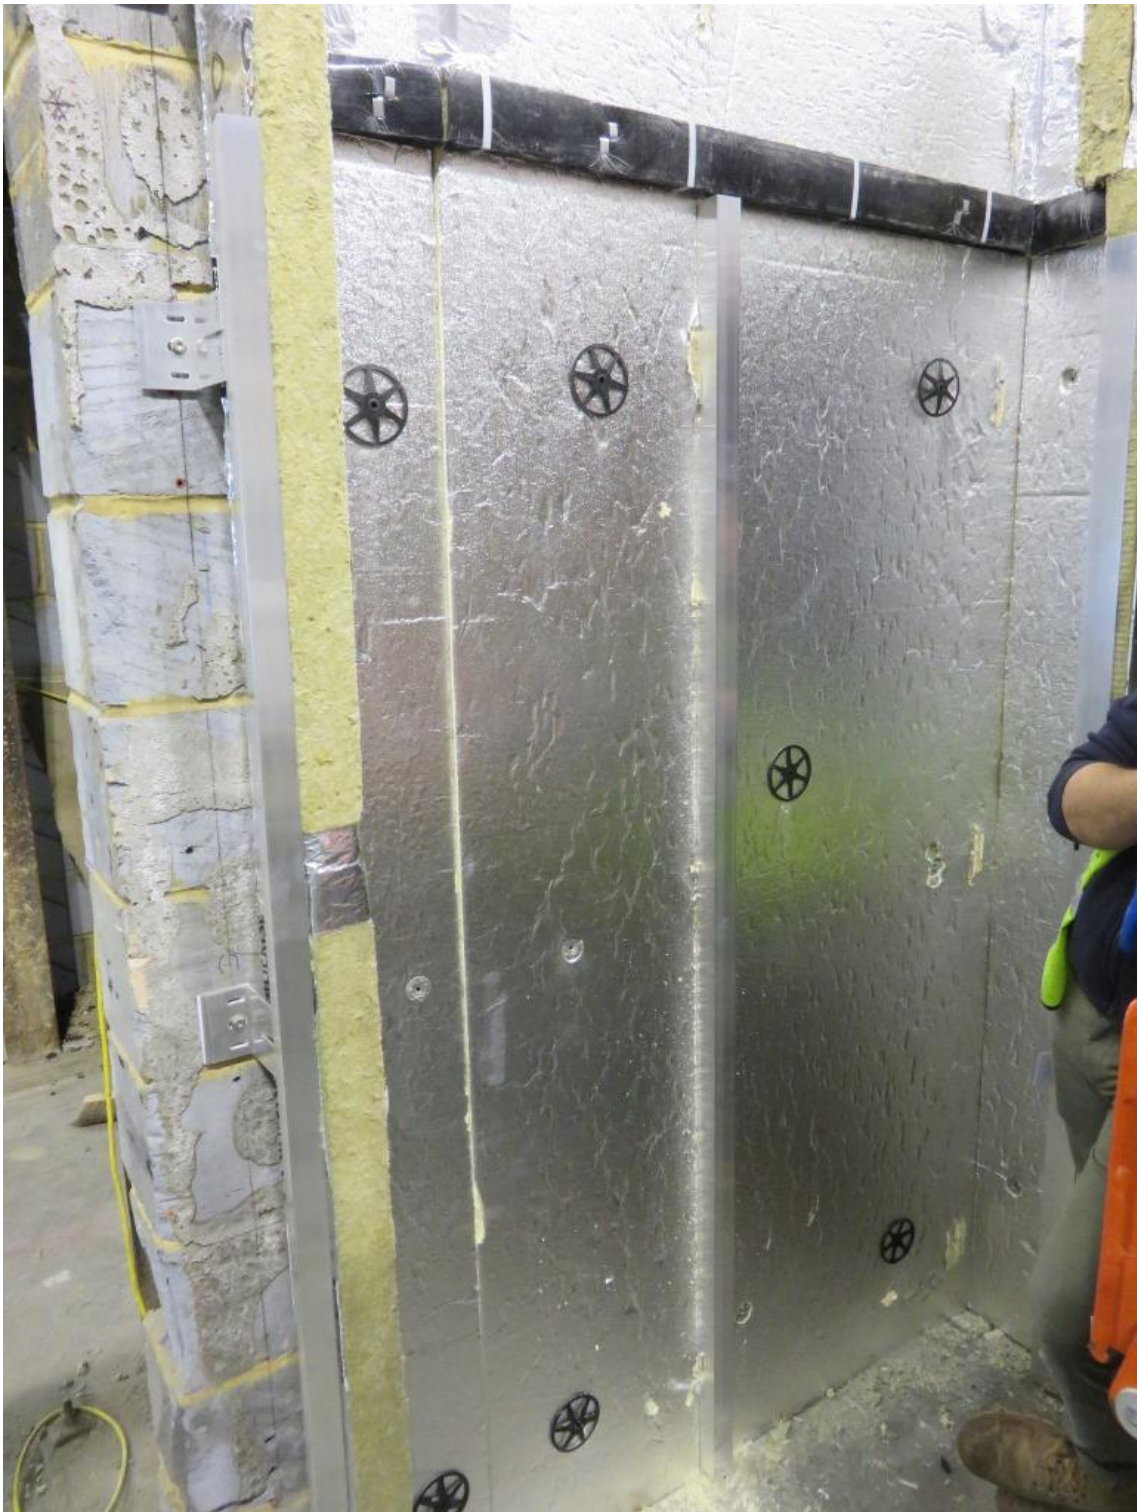
The horizontal cavity barriers were fixed through the entire depth on face turned steel brackets –see *Figures 5, 6 & 8*. Two steel brackets were used per length of 1200mm of stone wool cavity barrier, each fixed into the masonry wall with one 70mm-long × ϕ 4mm anchor, positioned above the cavity barrier. The horizontal intumescent cavity barriers were installed with a maximum gap of 25mm to the back face of the panel in accordance with the manufacturer's recommendation.

Figure 8. Insulation fixings applied and 'L'-rail embedded into panel.

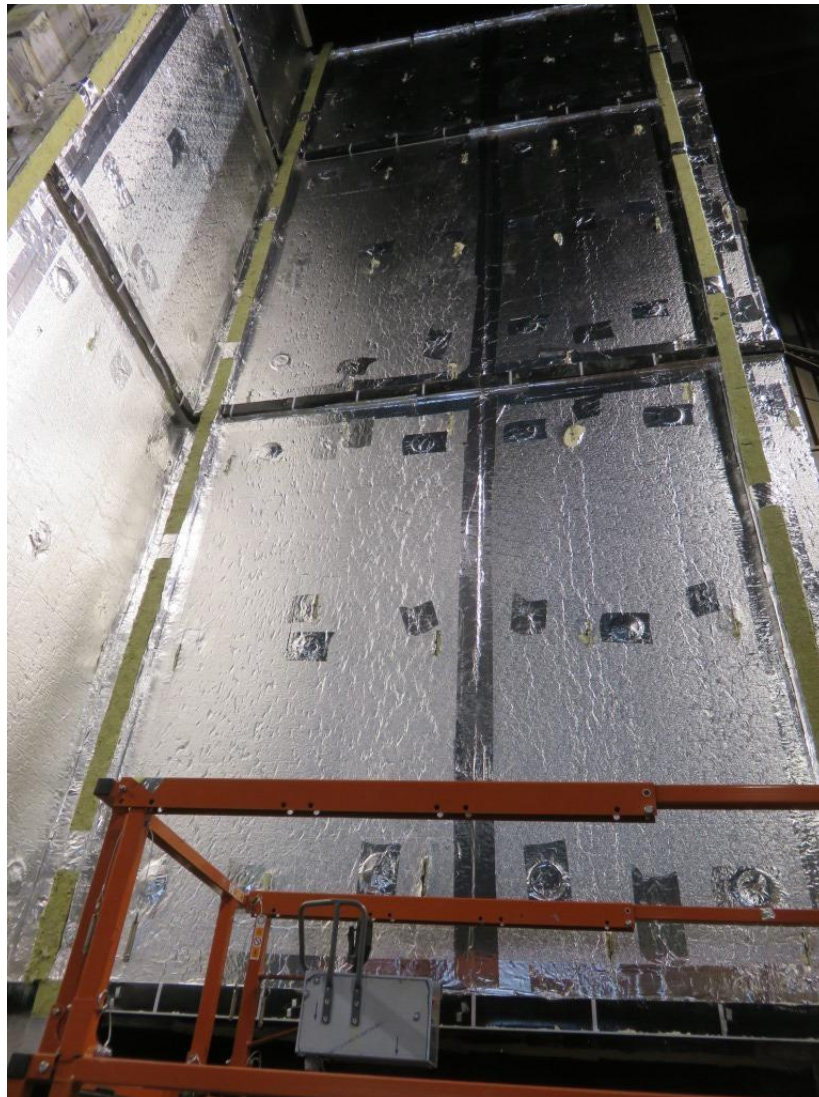
The 100mm-thick foil-faced PIR insulation panels (supplied in 2400mm × 1200mm panels and cut to fit) were installed in position through the substructure bracket fixing systems and fixed to the support structure (masonry wall) with five 125mm-long × ϕ 8mm plastic anchors and four 140mm-long × ϕ 8mm stainless steel anchors per full size panel - see *Figure 8*. The insulation panels were installed with the long edge orientated vertically - see *Figures 8&9*. All the gaps between the insulation panels and at the intersection with the cavity barriers or aluminium brackets were sealed with aluminium tape as recommended by the manufacturer - see *Figure 9*.

Figure 9. Joints and fixings covered with aluminium tape.

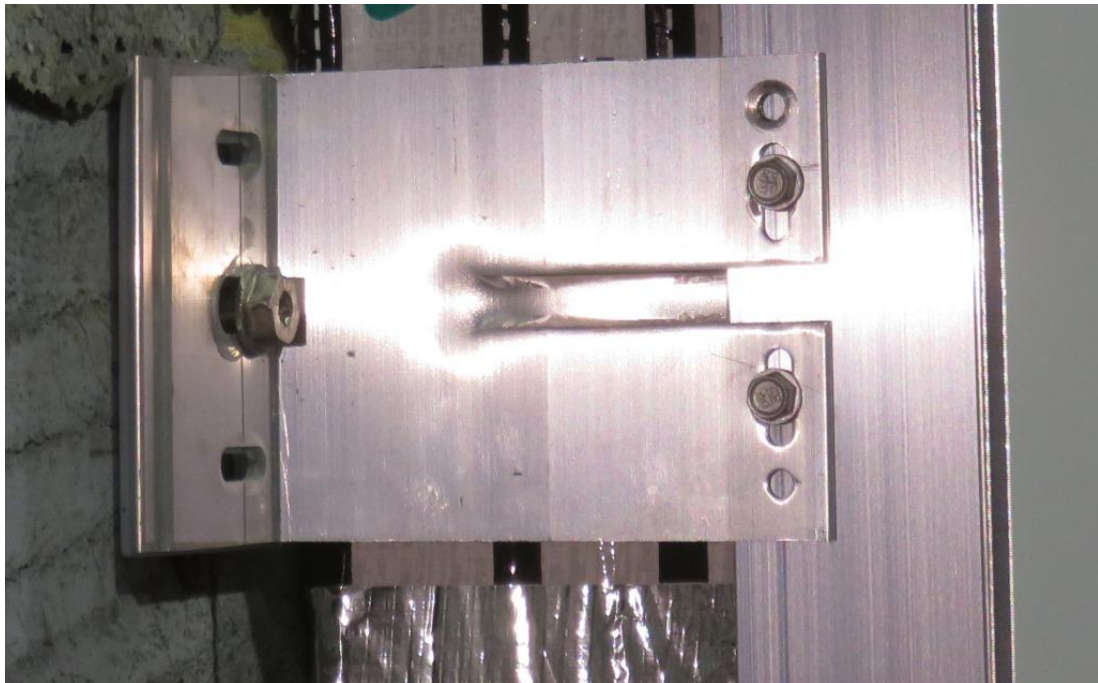
After the insulation was fixed in position, the 120mm-wide × 60mm-deep × 2mm-thick aluminium 'T'-section and 40mm-wide × 60mm-deep × 2mm-thick 'L'-section framing were installed at horizontal spacings of 480mm. The horizontal spacing between successive sections of aluminium 'T'-section or 'L'-section framing was 970mm as shown in *Figure 12*. The aluminium vertical rails, with a typical length of 2300mm, were positioned 10mm inside the thermal insulation with each rail fixed to the brackets with 2 × 4.8 × 16mm self-drilling, self-tapping, stainless steel screws. The aluminium rails were installed with a 30mm gap at the floor levels to allow for structural movement. Three brackets supported each section of rail: the middle bracket was fixed while the top and bottom brackets were connected with movement holes – see *Figures 10&11*.

Figure 10. Example of aluminium rail fixed to 'L' bracket through movement holes.

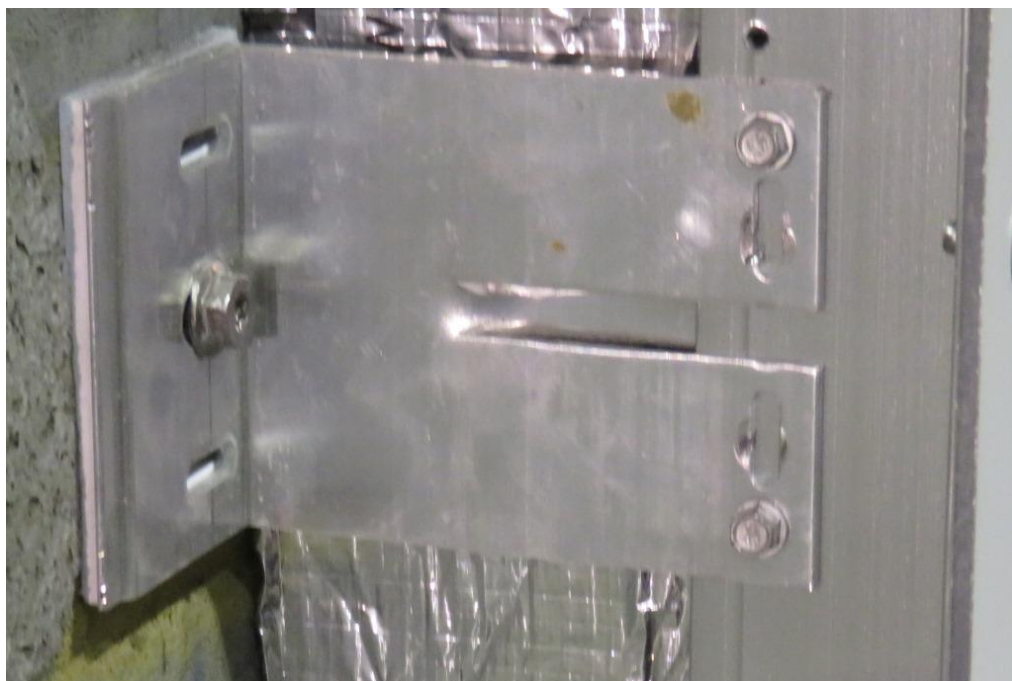
Figure 11. Example of aluminium rail fixed to 'L' bracket through fixed holes.

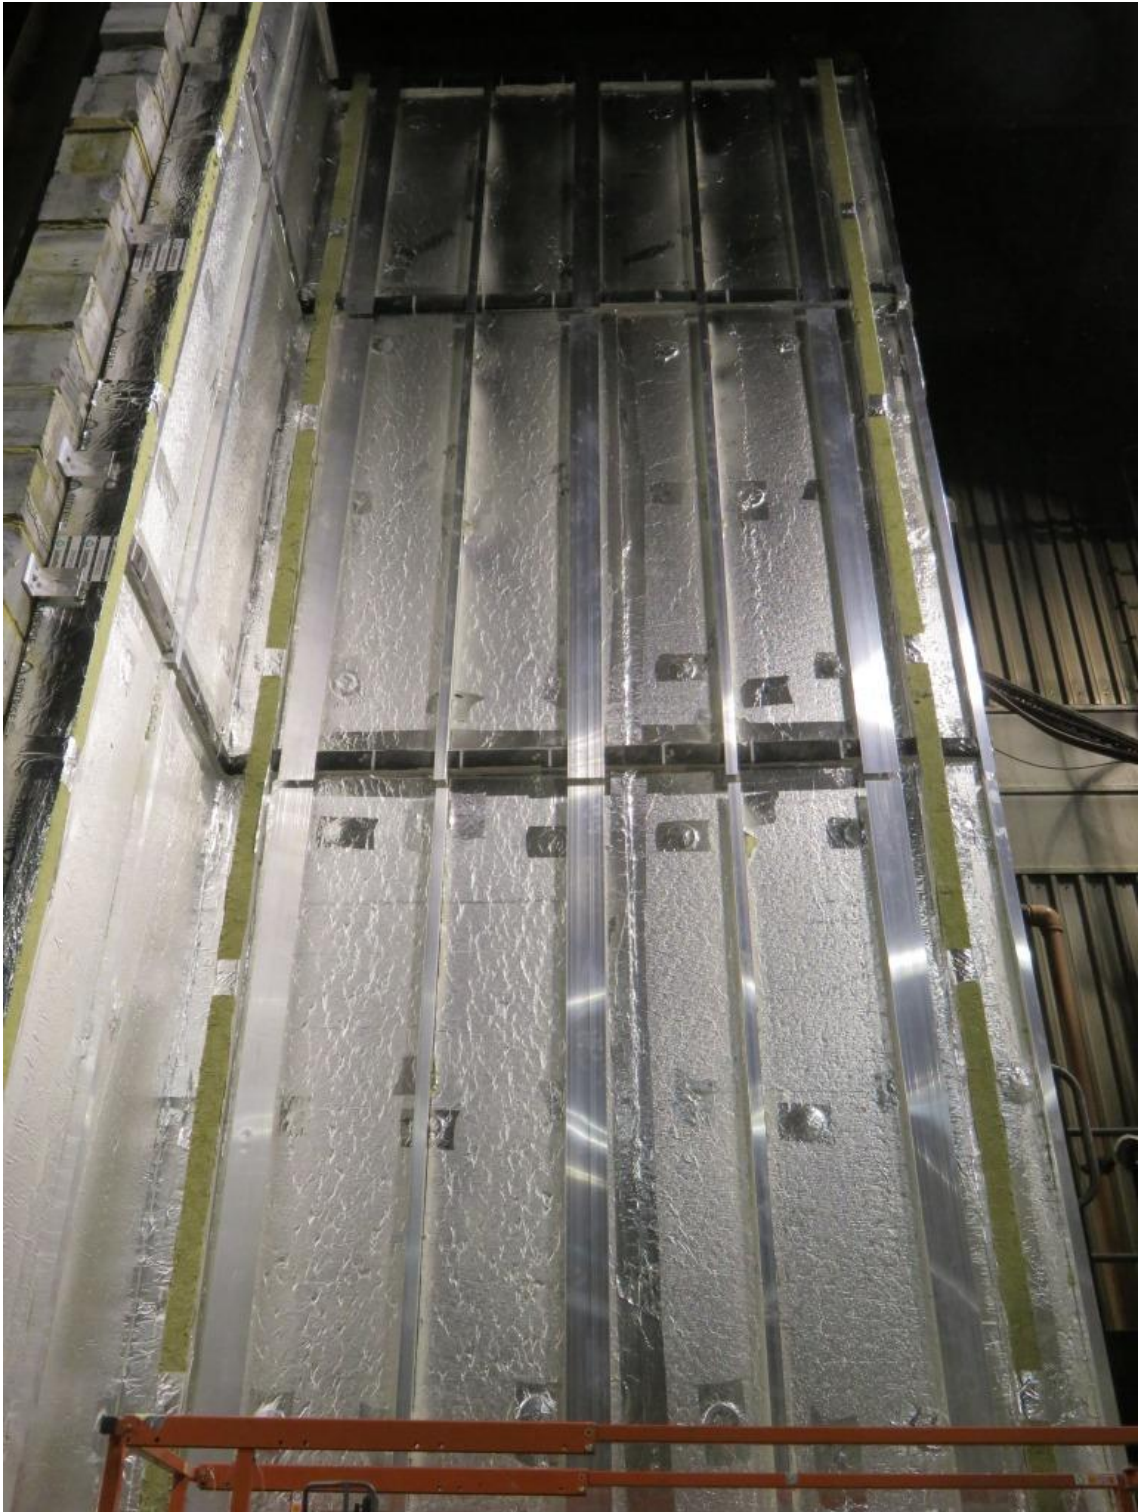
- 120mm-wide × 60mm-deep × 2mm-thick aluminum 'T'-section framing and 40mm-wide × 60mm-deep × 2mm-thick aluminum 'L'-section framing – see *Figure 12*;

Figure 12. Completed installation of railing substructure visible on main wall.

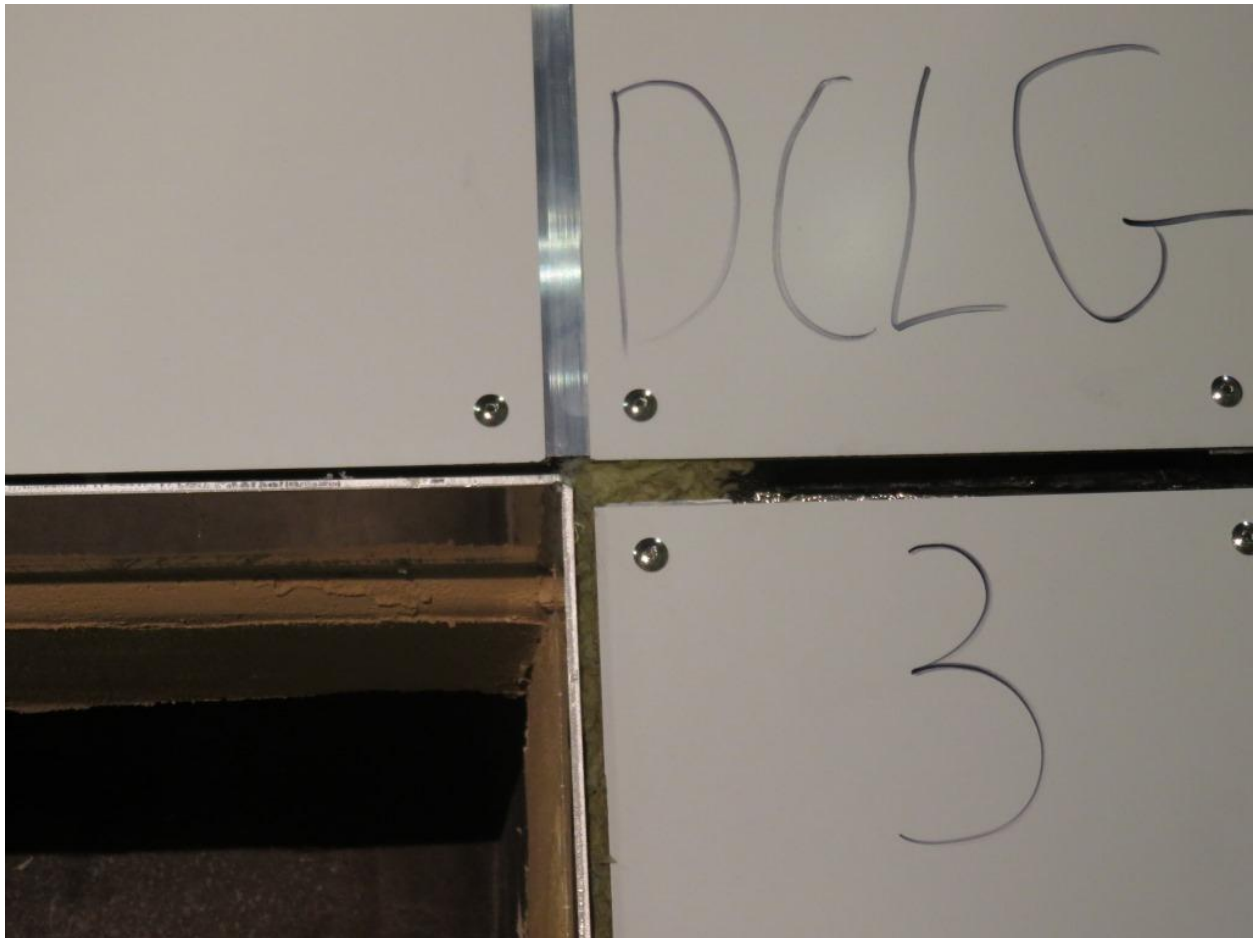
Figure 13. Detail at corner of combustion chamber opening. Panels riveted in place with nominal 20mm vertical gap for ventilation purposes.

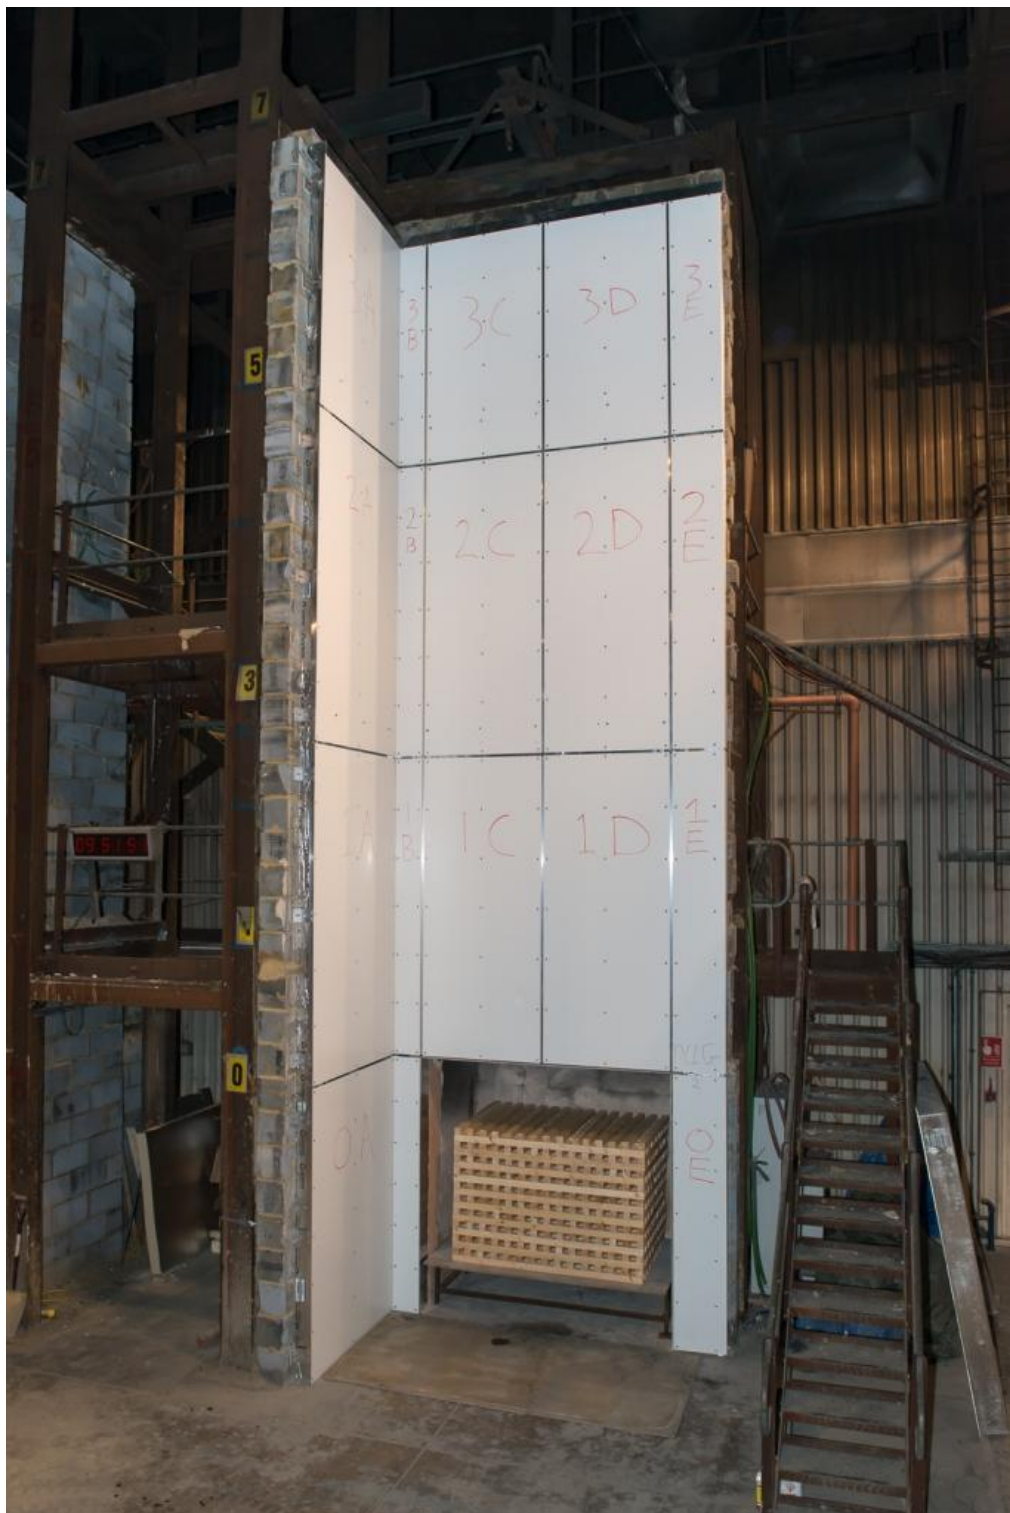
Figure 14. Completed installation prior to test.

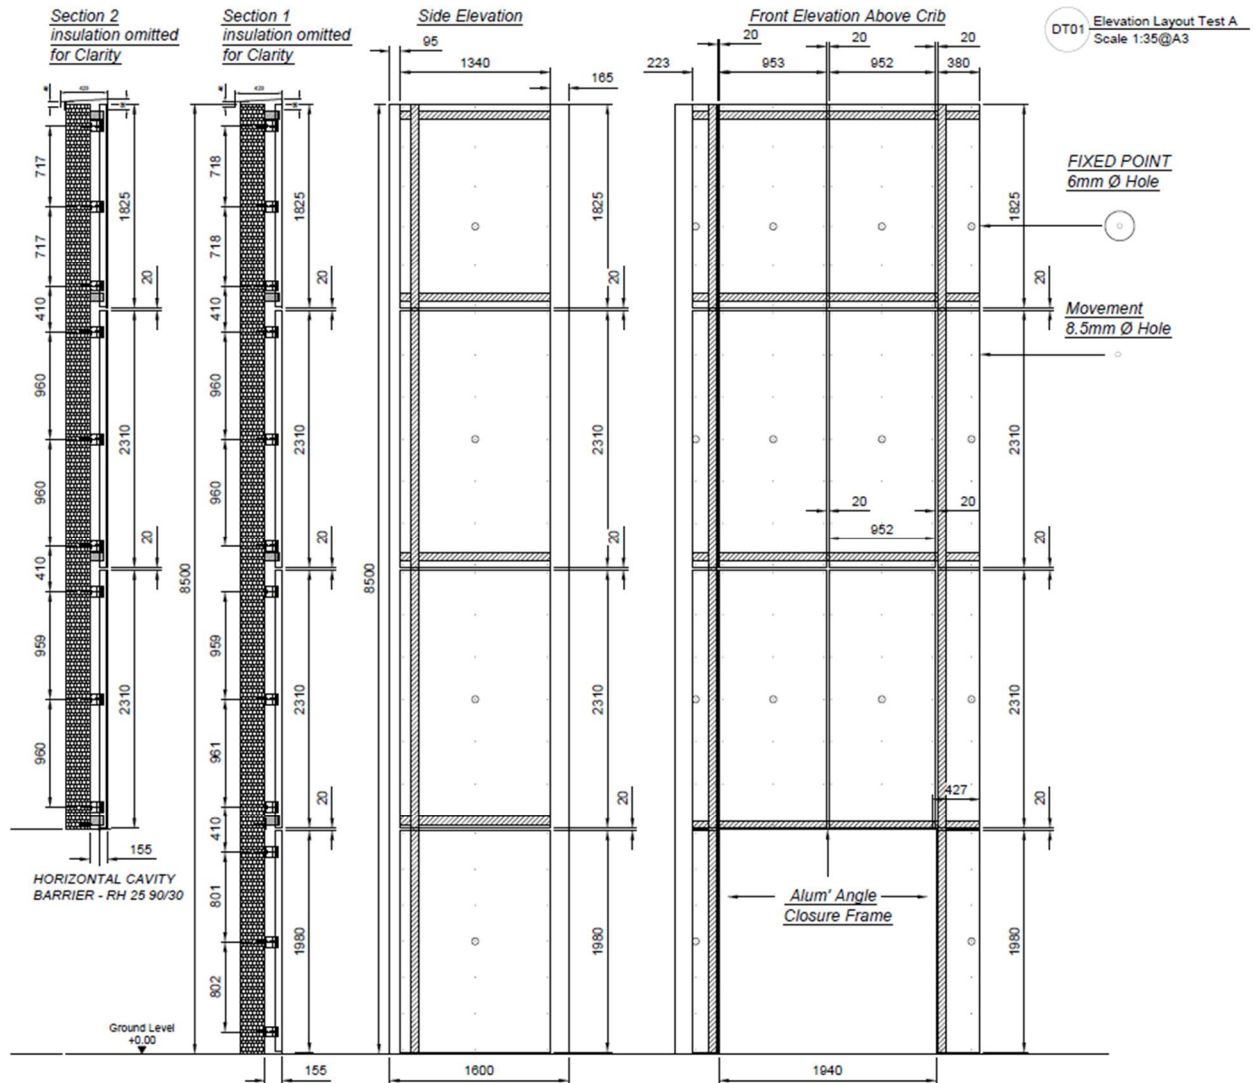
Figure 15. Front elevation, side elevation and vertical sections for the system (supplied by the Test Sponsor).

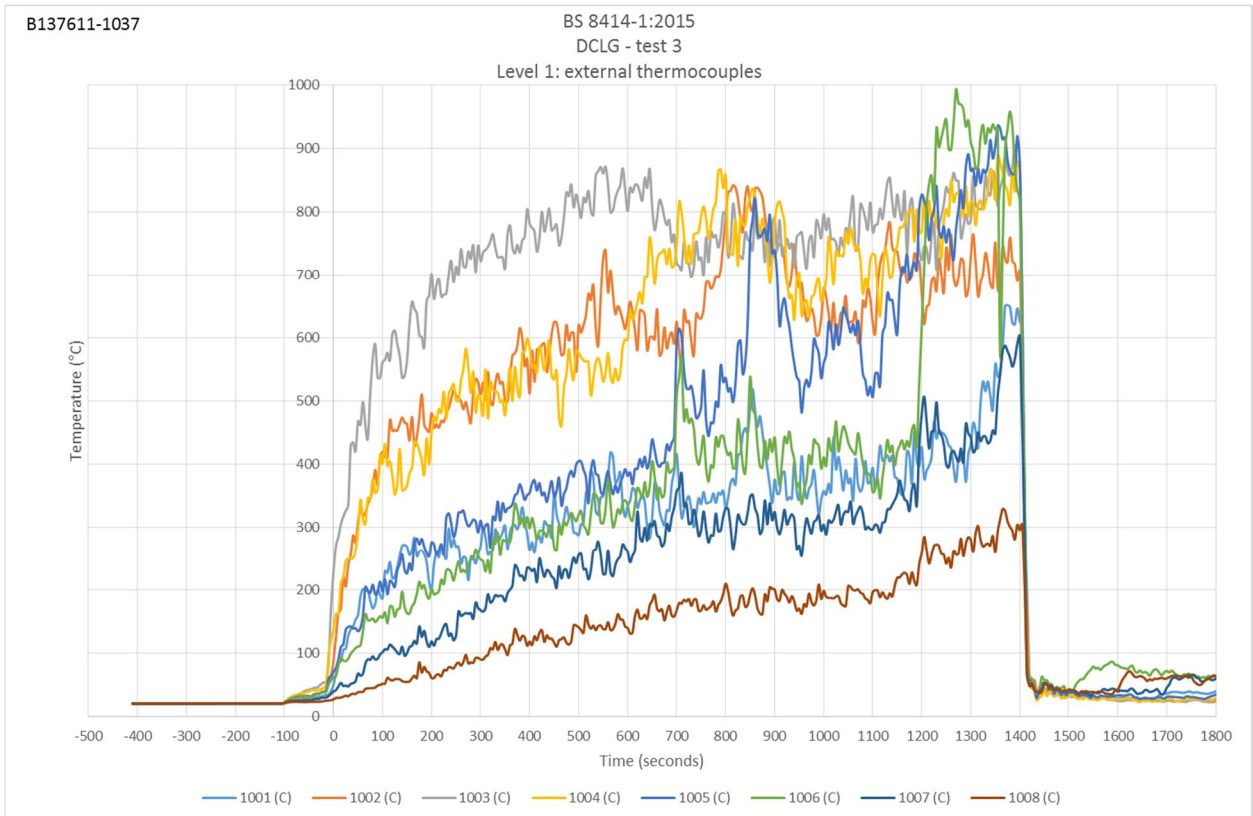
Figure 20. Level 1 external thermocouples.

$t_s=110s$ after ignition of the crib.

Note: Test terminated after 1402s.

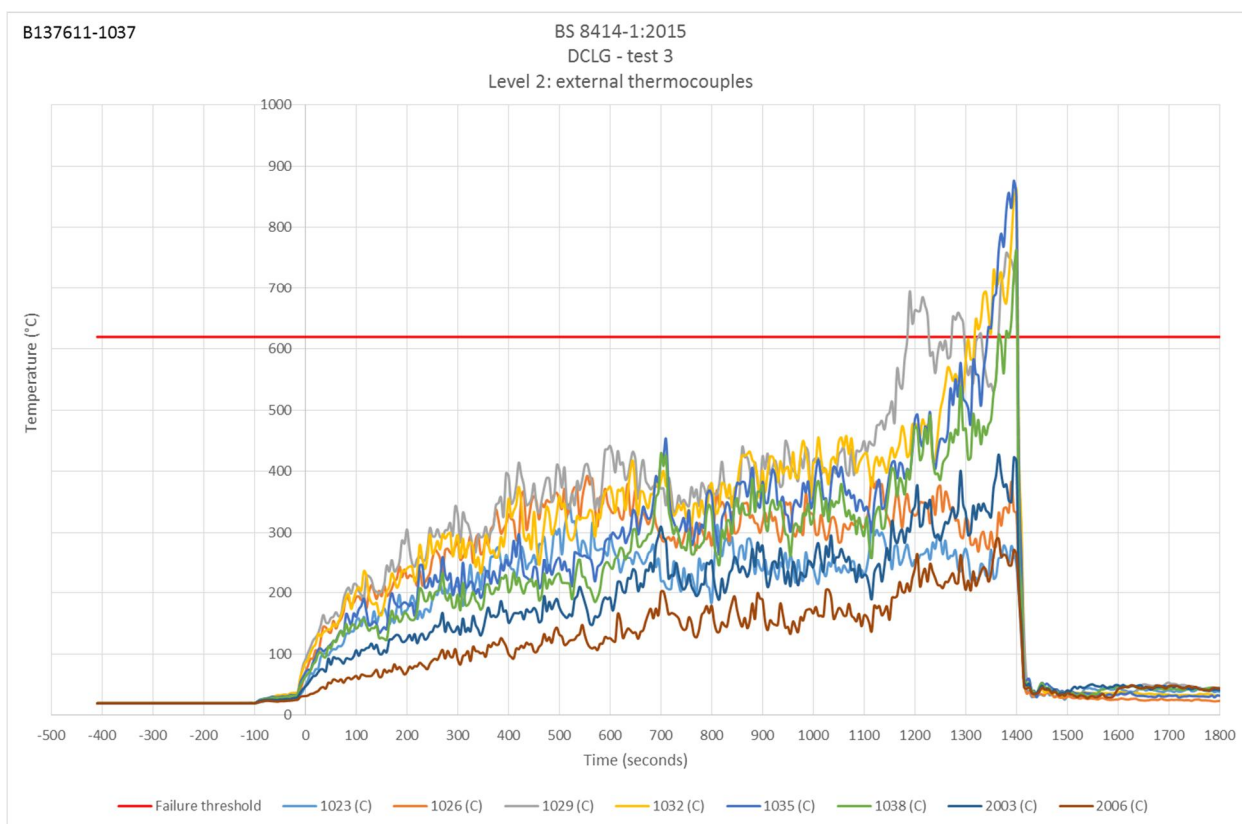
Figure 21. Level 2 external thermocouples.

$t_s=110s$ after ignition of the crib.

Note: Test terminated after 1402s.

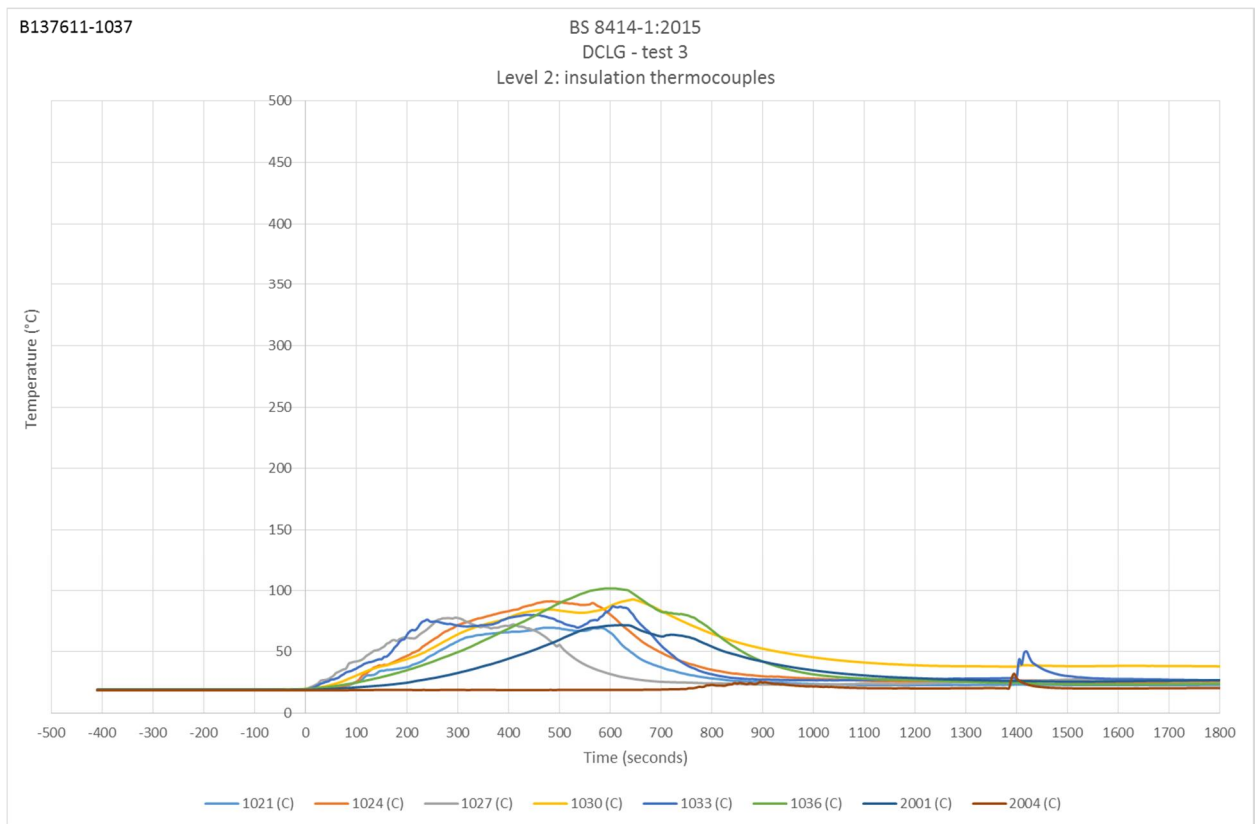
Figure 23. Level 2 insulation thermocouples.

$t_s=110s$ after ignition of the crib.
