FISHING ACCIDENT FLYER

VESSEL LOST FOLLOWING A FIRE

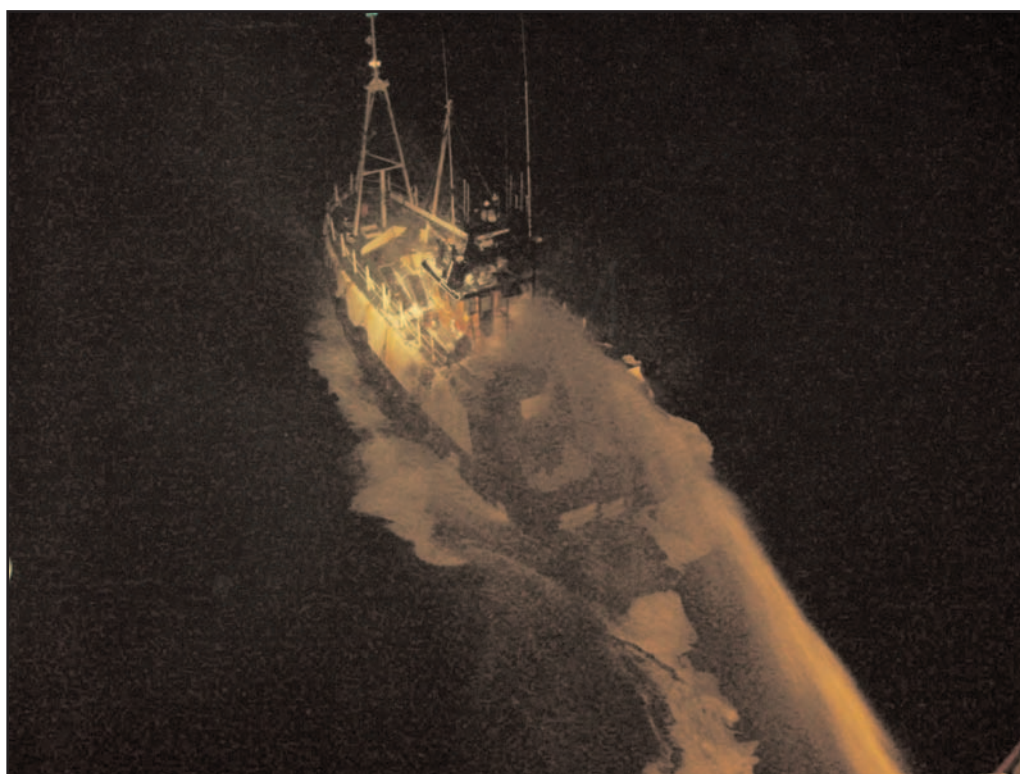
A 20m wooden fishing vessel suffered an engine room fire, thought to be caused by a fault in the electrical system. The emergency engine and fuel shut off systems did not operate correctly, and the engine had to be stopped by fouling the propeller with a rope. The fire was severe, and with dense smoke escaping from the engine room, the skipper sent a “Mayday” and evacuated his crew to the liferaft. They were all safely rescued by a nearby fishing vessel responding to the “Mayday” call.

Smoke from the wheelhouse had dispersed, and down below the galley appeared undamaged. The mate entered the cabin and saw where fire had damaged the starboard side. He went forward to the engine room door and cracked it open. Thick smoke and noxious gases escaped and the skipper pulled the mate clear. They waited on the upper deck for a few minutes and then returned to the engine room. The smoke had now cleared, enabling the mate to go into the engine room, where he heard a crackle and then saw a glow of fire in the far corner.

1. Electrical systems and insulation material should be checked carefully to minimise the risk of fire.
2. Emergency engine and fuel system shut down arrangements should be tested regularly and repaired if they do not operate correctly.
3. Engine rooms should be checked to ensure that they can be fully closed down in a fire situation to prevent smoke spreading and to give CO₂ drench systems the maximum chance of success.
4. Do not put yourself back into danger by returning to the scene of a fire too soon. Re-opening a compartment causes air to enter, which can then allow a fire to re-ignite. Engine room fires may require many hours to cool before re-entry can be safely made. Compartment re-entry should be attempted by properly trained firefighters with the correct fire-fighting equipment and breathing apparatus.
