Rail Accident Investigation Branch

Rail Accident Report

Overturning of a tram at Sandilands junction, Croydon 9 November 2016

Report 18/2017
v2.2 - October 2020

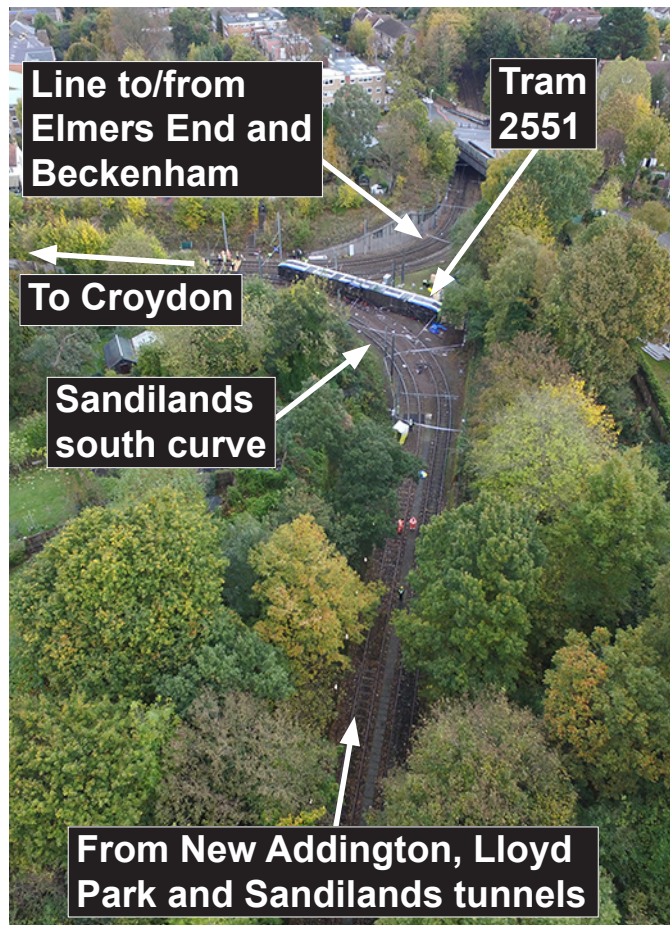
Figure S2: Final position of the tram

- S5 The passengers on the tram had no warning of what was to come. Some of them were standing, but most were seated, and as the tram began to tilt they were thrown across and around the vehicle. Some described it as “like being in a washing machine”. The windows on the right-hand side smashed as passengers were thrown against them, and as the tram hit the ground. Some of the doors on that side were torn off. People fell through the openings where the doors and windows had been, and were crushed under the tram as it slid to a stop, about three seconds after leaving the rails. The tram came to rest after travelling a distance of about 27 metres from the place where it left the rails (figure S2).

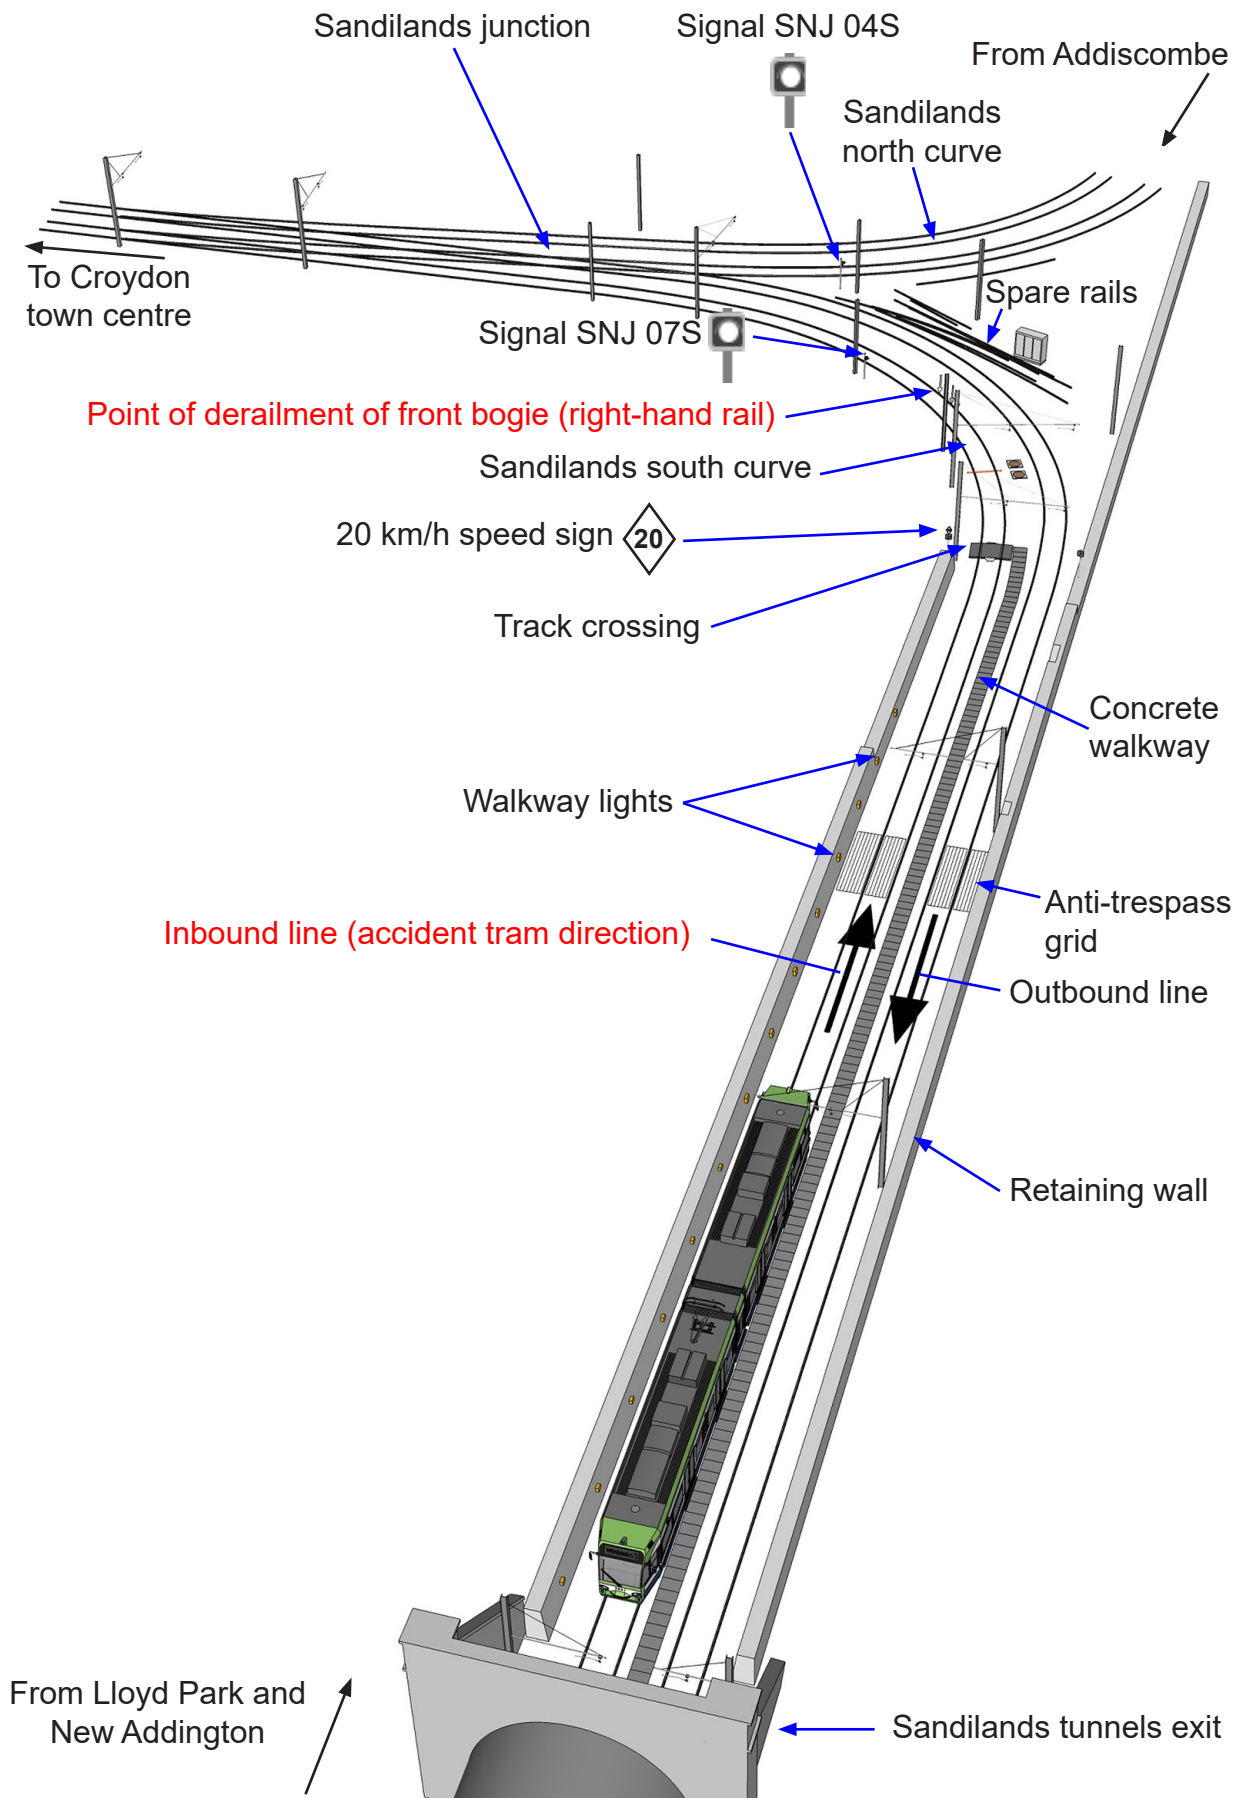
Figure 8: Accident site

- 23 On exiting from the Sandilands tunnels, trams travelling towards Sandilands junction emerge into a cutting and continue in a broadly straight line for a distance of about 94 metres until they reach the start of the left-hand curve on which the accident occurred (figures 8 and 9).

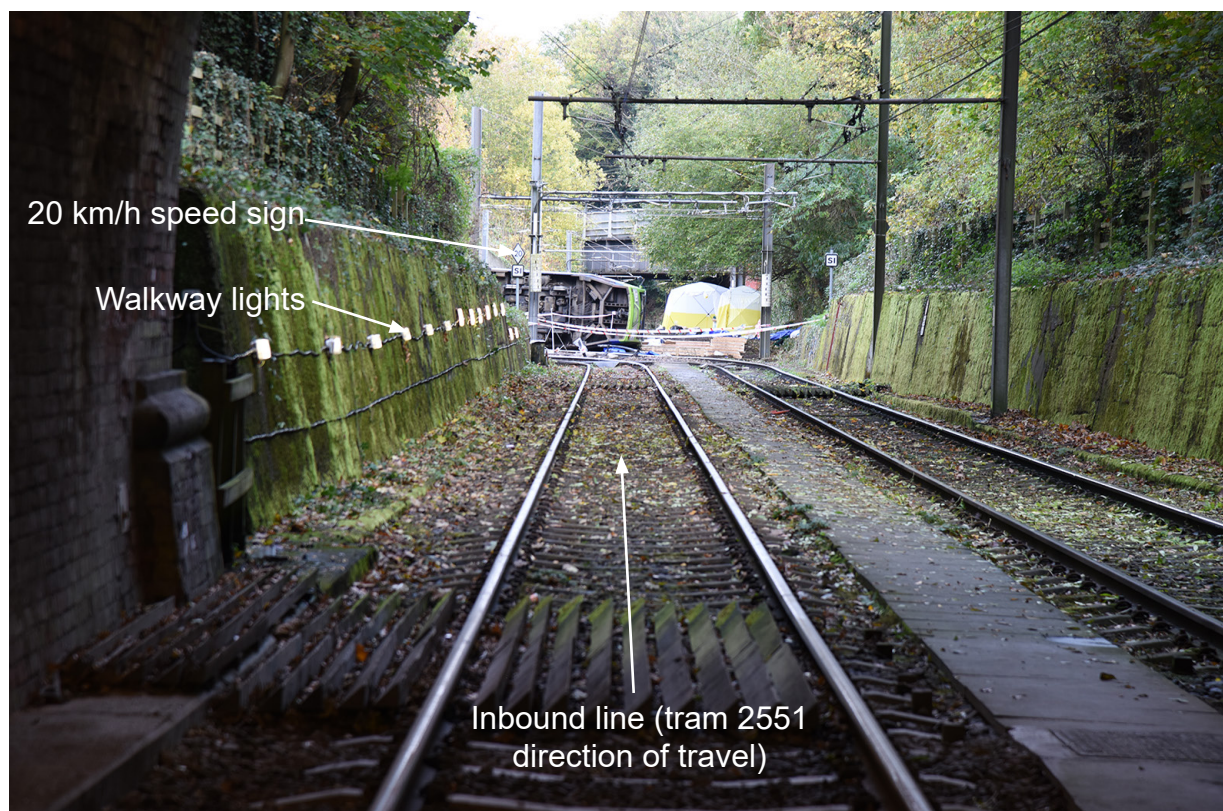
Figure 9: Approach to Sandilands south curve viewed from tunnel exit (overturned tram visible in distance)

- 24 Along this section of straight track, and starting seven metres beyond the tunnel exit, there is a row of walkway lights fitted to the cutting wall adjacent to the left side of the track. These are positioned approximately five metres apart for a distance of around 70 metres, and are between 0.8 and 1.3 metres above ground level. These lights were installed in 2013 to illuminate a walkway used by tram drivers when they needed to park trams at that location during engineering works (figure 9).

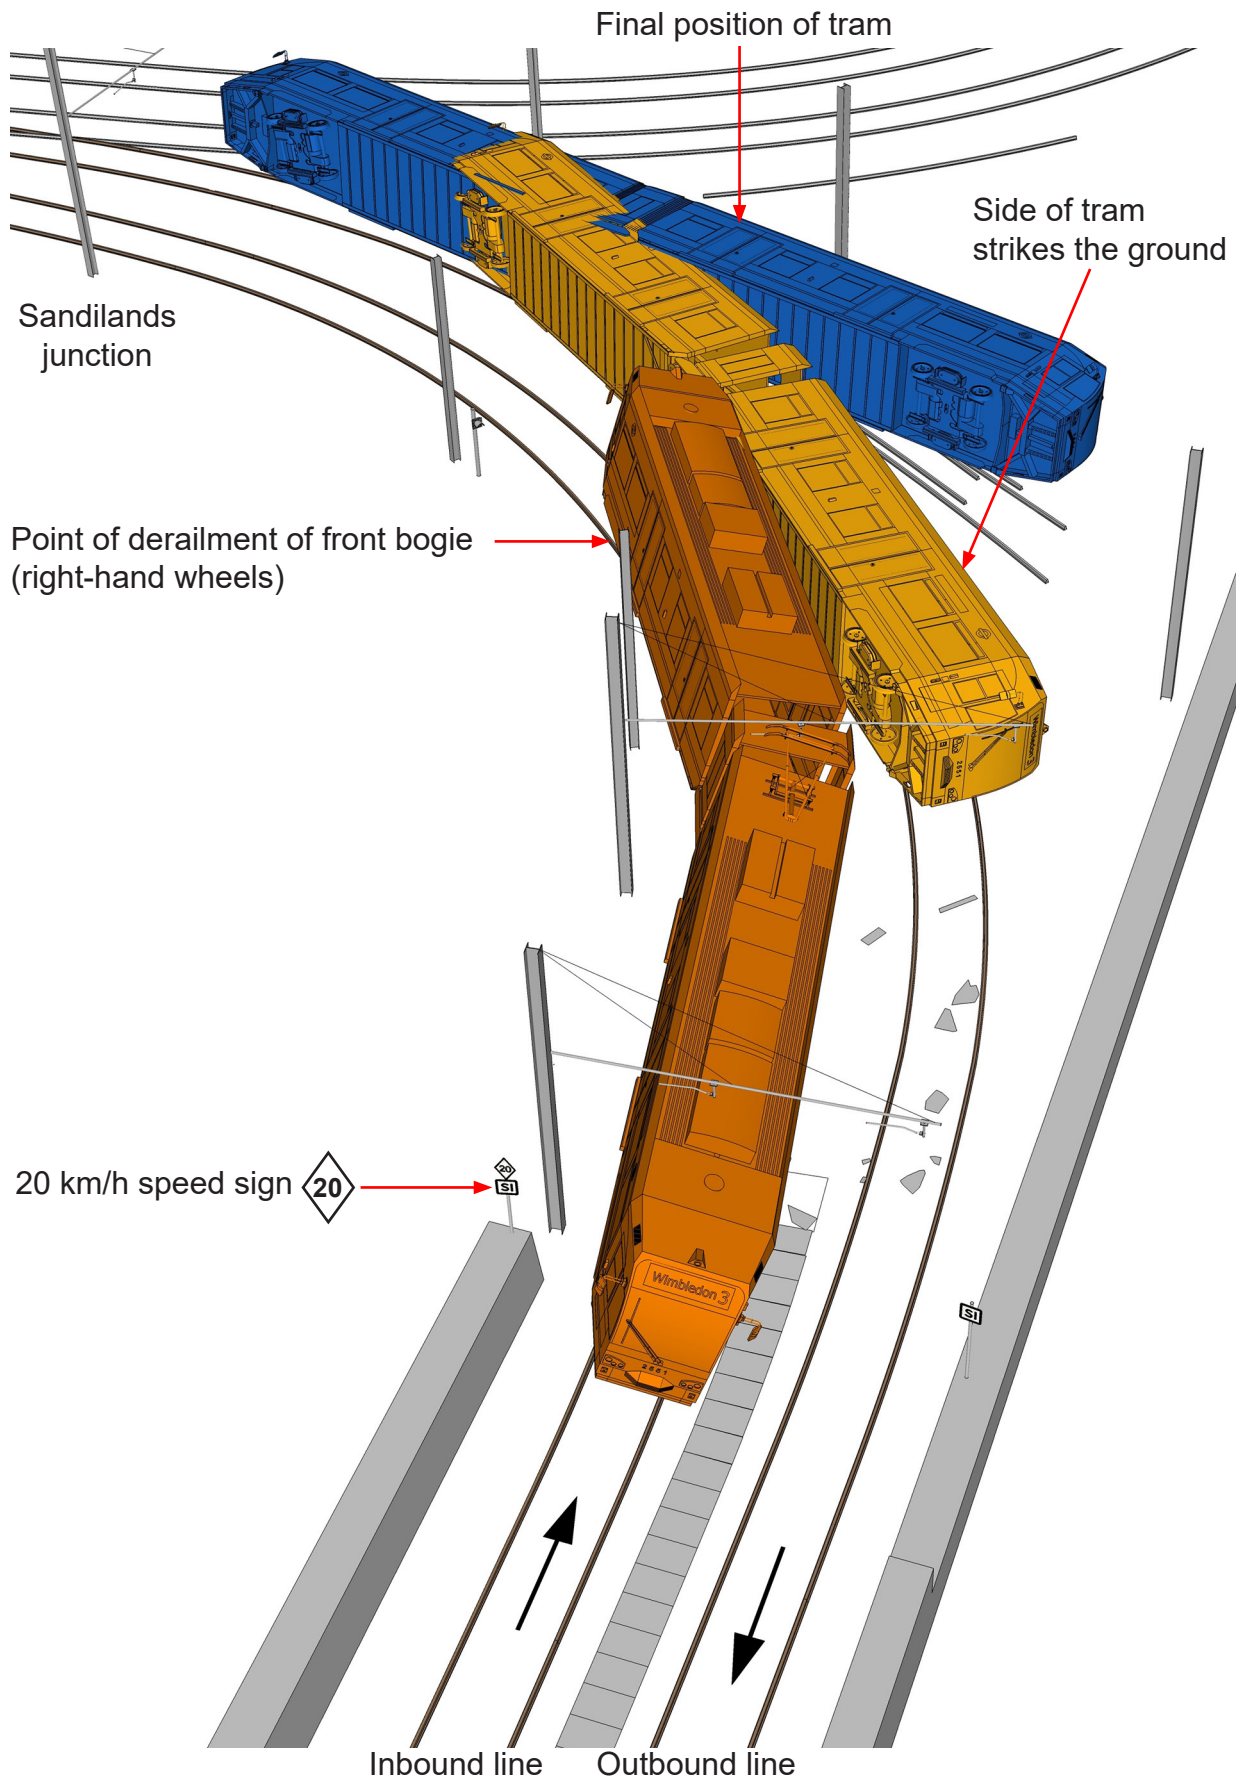
Figure 15: Accident sequence

- 55 The tram came to rest after travelling for about three seconds and covering a distance of about 27 metres from the place where it left the rails. Approximately 18 metres of this distance was while the tram was rolling onto its side. It then slid on its side for the remaining 9 metres (figure 15). It had struck various items of lineside equipment and was lying across the outbound curve to Lloyd Park and the inbound curve from Addiscombe (figure 4).

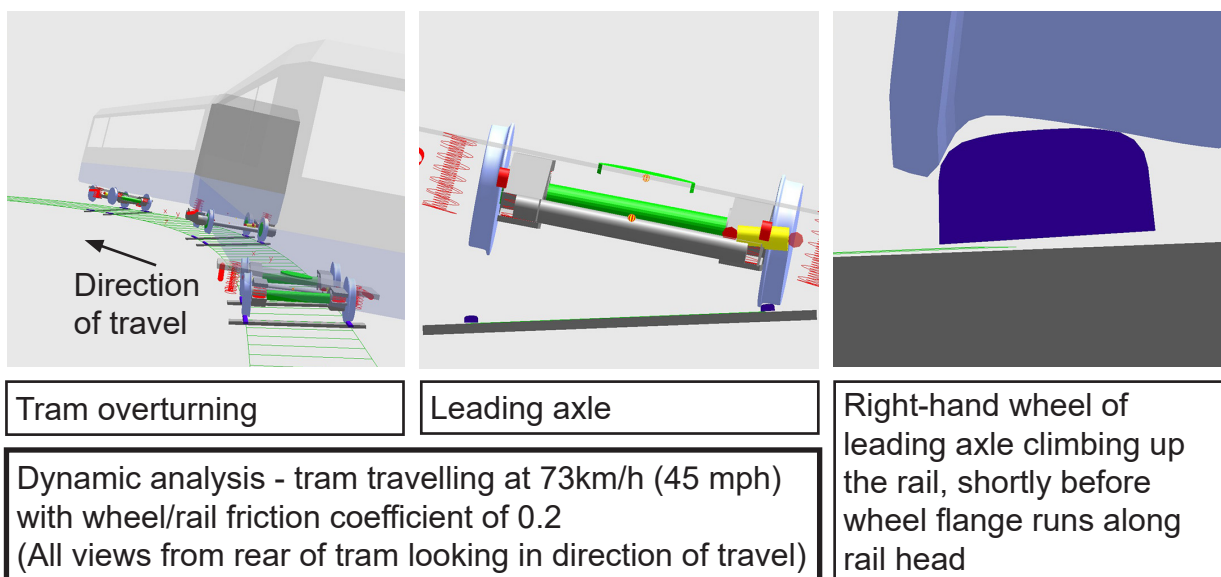
Figure 19: Tram overturning in dynamic simulation (images courtesy of Bombardier Transportation)

110 Figure 19 shows a pictorial representation of the output of the simulation in which the tram overturns when travelling at 73 km/h (45 mph) with a friction coefficient of 0.2. As the tram enters the curve, the lateral acceleration increases and induces roll on the vehicles. At the point shown in figure 19, the roll angle on the leading wheelset is approximately 13 degrees and the roll angle for the leading vehicle is similar. As the leading vehicle rolls, the intermediate and trailing vehicles follow it into roll. The simulation stops as the right-hand wheel starts sliding on the top of the right-hand rail.

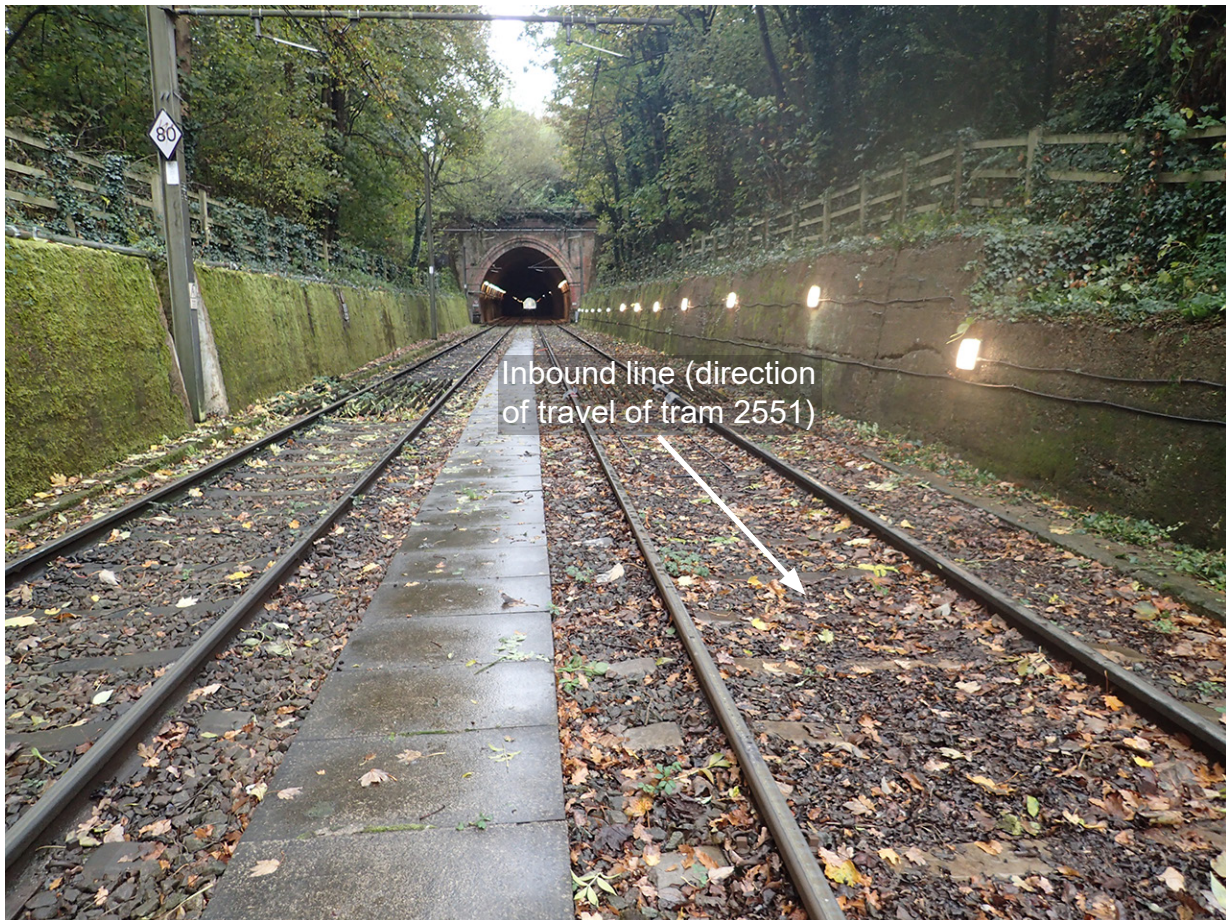
- 108 The heavy rain meant that rails outside the tunnels would have been wet and this would have reduced the available adhesion (friction) at the rail-wheel interface. There is no evidence that leaves affected adhesion. No significant leaf contamination was observed when the RAIB inspected the rails (figure 20), and material swabbed from the rail head by the RAIB, when tested, was found to contain no leaf matter. Grease was being dispensed from a *flange lubricator* about 8 metres before the 20 km/h sign at the start of the curve, and then distributed along the curve by tram wheels, in order to reduce rail wear from contact between the *wheel flange* and the tightly curved rail. Evidence of reduced adhesion is supported by data from the OTDR, which showed that the tram's sanding system had been activated on the approach to the curve (paragraph 35), shortly before reaching the flange lubricator.

Figure 20: Inbound line between tunnels and speed sign six and a half hours after the accident. No evidence of significant leaf contamination on the rail head.

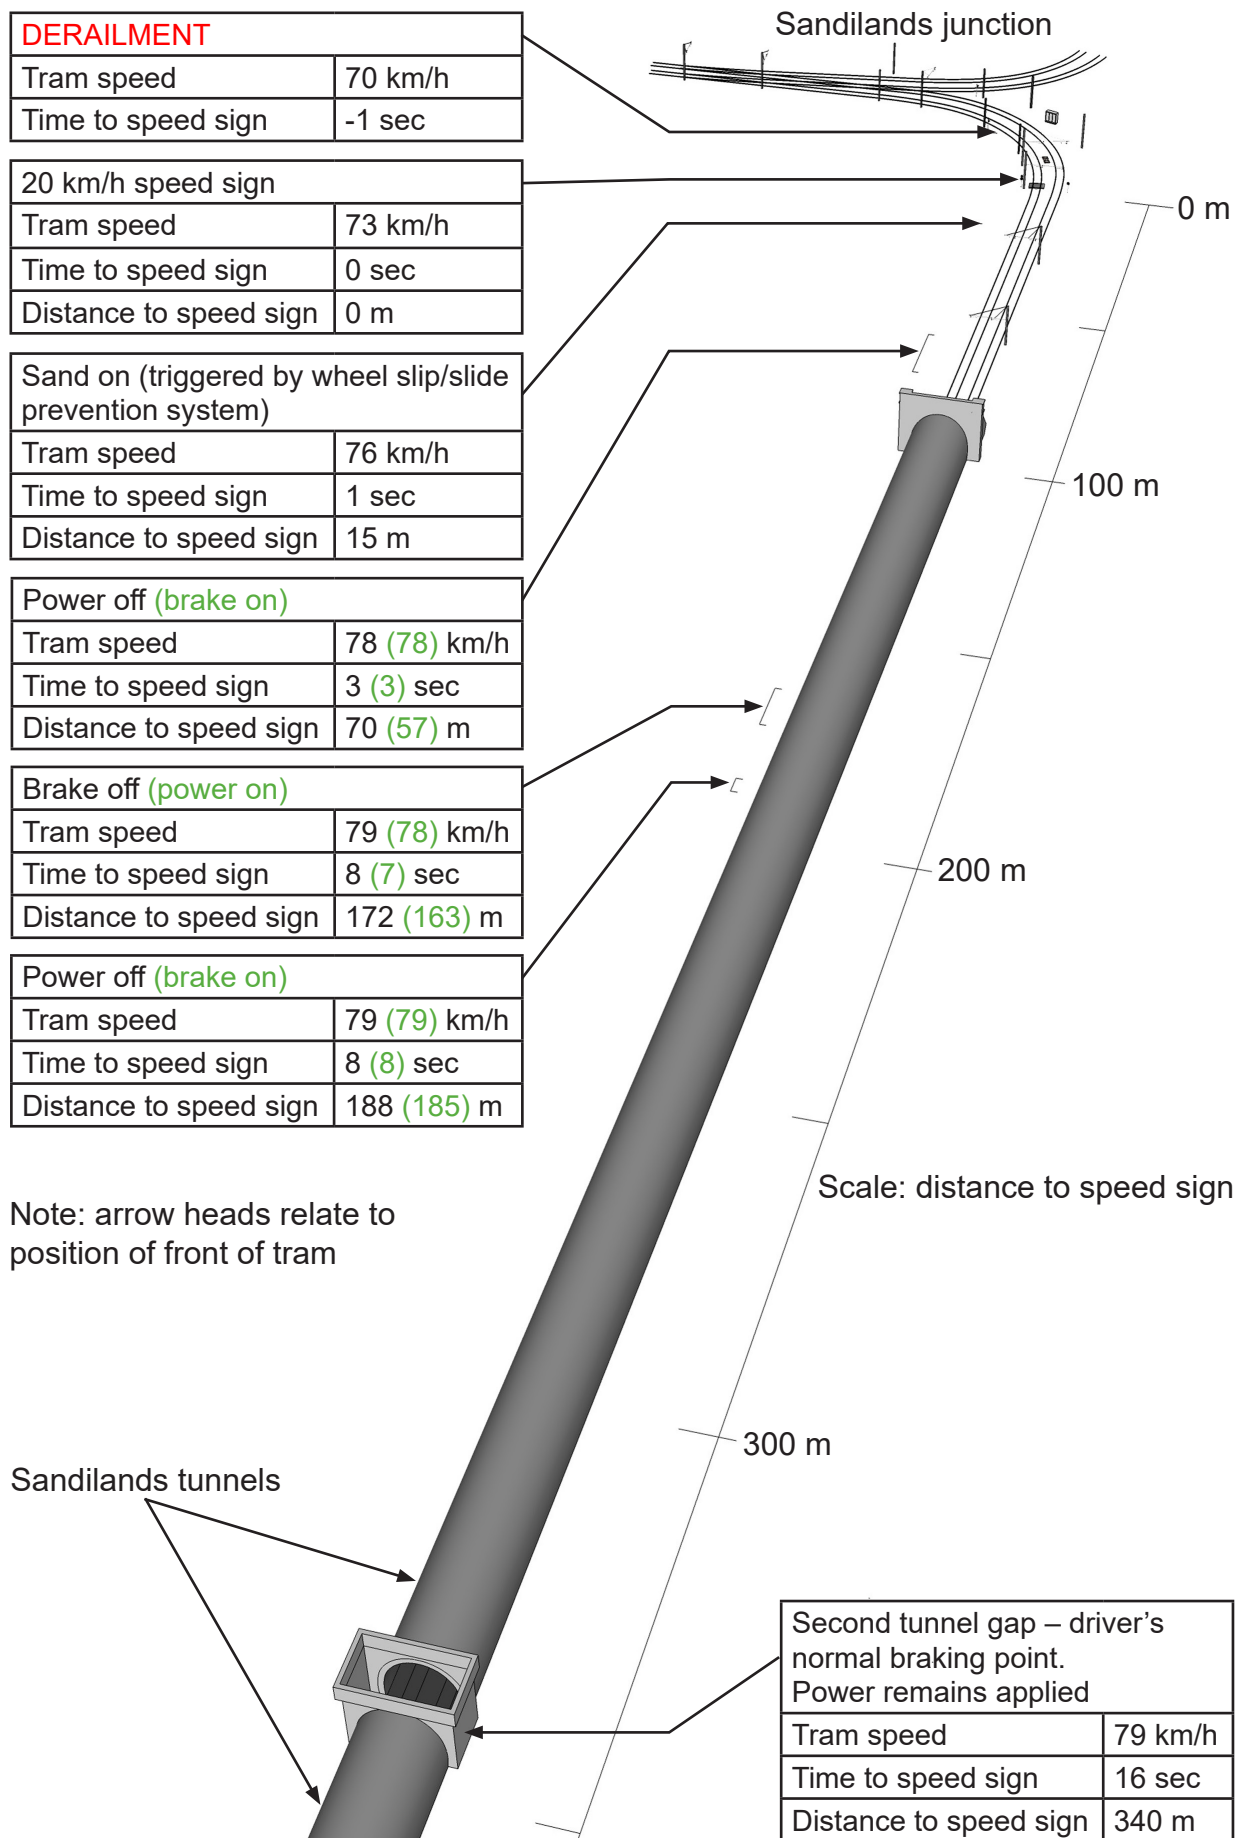
Figure 23: Information recorded by the OTDR as tram approached accident site

- 129 Information from the OTDR (figure 23) showed that when the tram passed the second tunnel gap, the TBC was in the drive position with the tram travelling at 79 km/h (49 mph). The TBC remained in drive for a further eight seconds. By then the tram was about 155 metres beyond the driver's normal braking point. At this point, about 185 metres from the 20 km/h speed sign, the driver then made a brief brake application of less than one second (paragraph 51). The driver stated that he realised that he had become disorientated at about the time that the tram passed the second tunnel gap. Although he cannot recall making this brake application, he believes that it may have been when he was reorienting himself (paragraph 153).

- 130 The driver's application of the service brake after exiting the Sandilands end of the tunnels took place about 57 metres, about three seconds, before reaching the 20 km/h speed sign at the start of the Sandilands south curve (figure 23). The driver was not able to recall why he had applied the brakes at this point but stated that this brake application was not because he now realised the tram was approaching the curve at Sandilands junction.

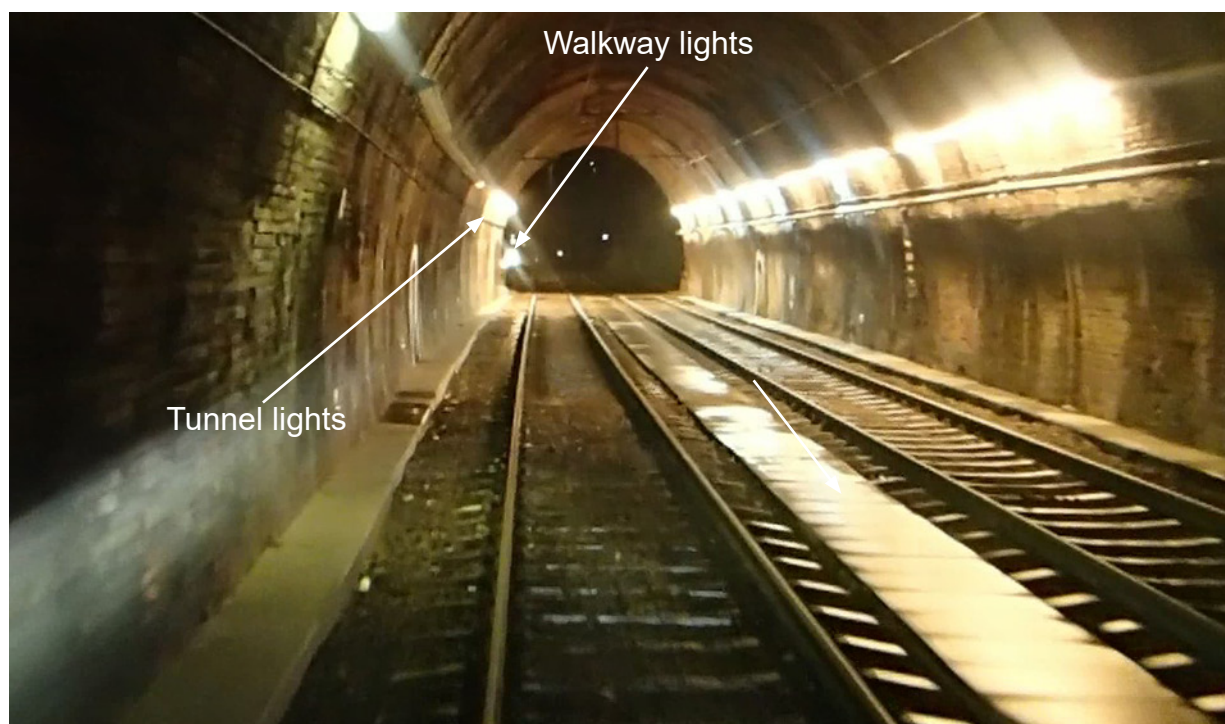
Figure 25: Walkway lights viewed approaching Sandilands west curve, about 80 metres from tunnel exit

168 The walkway lights adjacent to the left-hand side of the track on the exit from the tunnel were probably the strongest cue that the tram was exiting the Sandilands junction end of the tunnels. Similar lights are not provided when exiting towards Lloyd Park. The walkway lights start seven metres outside the tunnel mouth and continue at intervals of about five metres for a distance of 70 metres (until about 18 metres from the speed sign at the start of the curve). Testing by the RAIB and TRL showed that, when travelling towards Sandilands, these lights were visible about 250 metres before exiting the tunnel but are not distinguishable from the tunnel lighting until around 80 metres from the tunnel end (figure 25). At a distance of 50 metres from the tunnel exit, about seven seconds before reaching the 20 km/h speed sign, these lights would have been clear and distinct. Tram 2551 passed the last of the walkway lights less than a second before reaching the 20 km/h speed sign. Although it was raining heavily, visual perception of the lights is unlikely to have been affected by the rain.

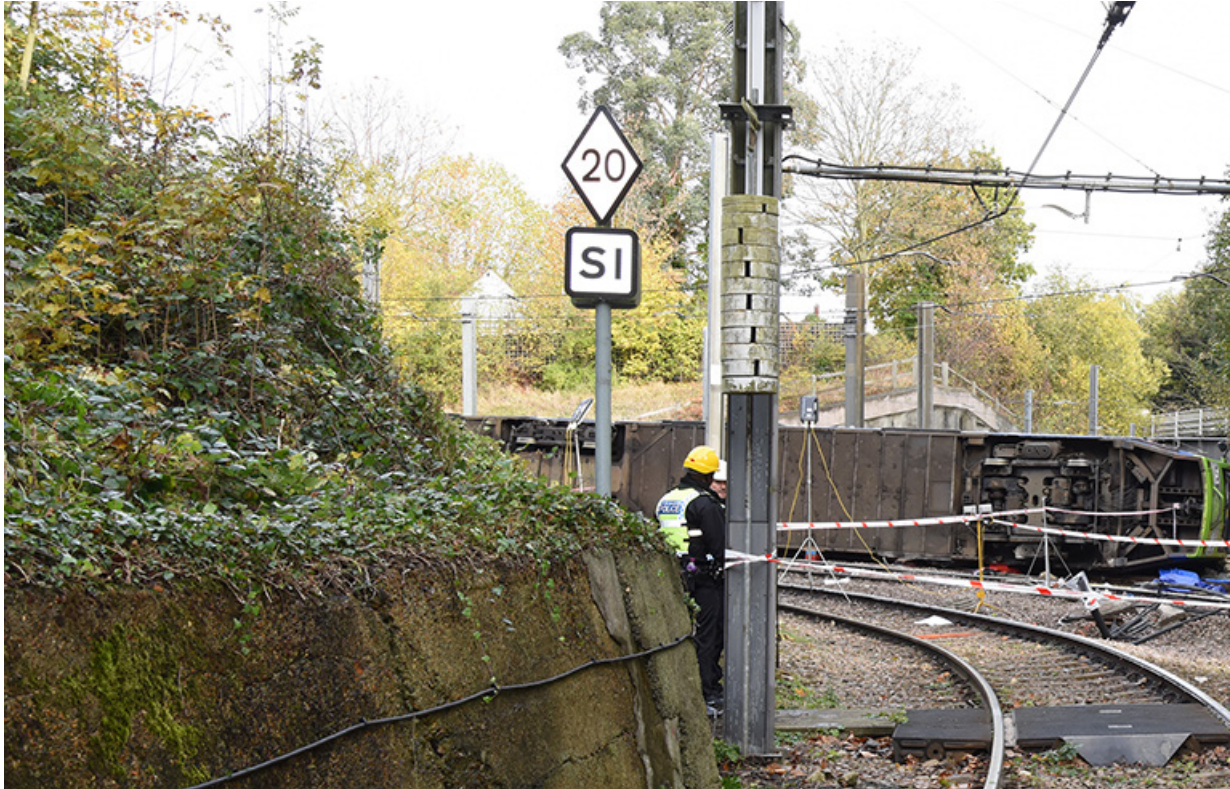
Figure 26: 20 km/h speed sign and 'SI' sign at the start of the west curve

169 The 20 km/h speed sign (figure 26), and sighting of the curve itself (figure 10), were both potential cues to the driver that he was approaching Sandilands south curve. If not recognised as being at Sandilands south curve, they provided information about the need to slow the tram rapidly. However, neither of these cues alerted the driver to apply the braking needed to avoid the accident and neither resulted in the driver applying the hazard brake.

170 Post-accident testing found that the 20 km/h speed sign¹⁵ at the bend was readable at night from about 90 metres when the tram's headlamps were set to main beam, and about 60 metres when set to dipped beam. The testing also found that the left-hand curve was first visible at the same time as the speed restriction sign.

171 The testing was carried out in dry conditions, so these distances would have been reduced on the morning of the accident because of the heavy rain. The driver was unable to remember whether he was using main or dipped beam headlamps when approaching Sandilands junction on the day of the accident, but stated that he often used main beam to supplement the tunnel lighting when transiting the tunnel, switching to dipped beam as the tram passed around the curve. The headlamp setting is not recorded by the OTDR so the RAIB has not been able to establish which setting the driver was using as the tram approached the curve.

- The presence of an SI sign (figure 26) immediately beneath the speed sign which reduced the conspicuity of the speed restriction sign. Testing by TRL found that from 90 metres the speed restriction sign and SI sign reflected about the same amount of light, and that from 60 metres the SI sign reflected more light than the speed restriction sign. This was true of both main and dipped beam headlamp settings.

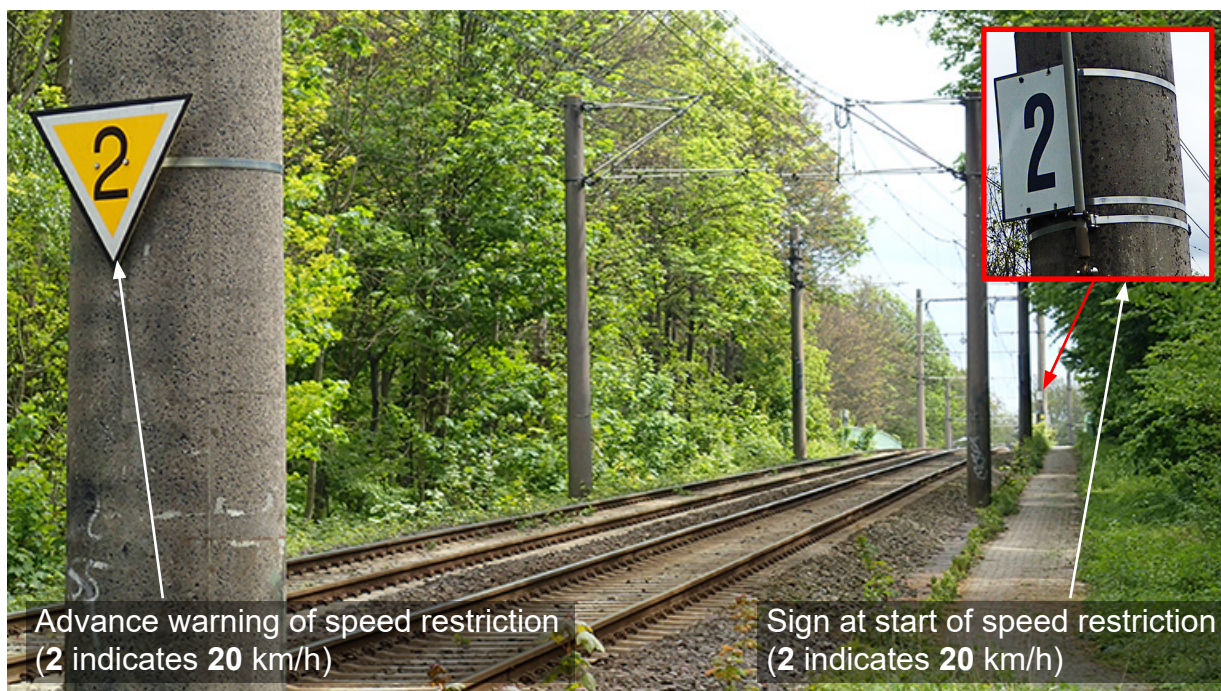
Figure 29: BOStrab advance warning of speed restriction on the Cologne tramway

261 The German BOStrab²⁸ standard requires the speed sign at the start of the restriction to be supplemented by an advance warning sign where local conditions mean that the sign at the start of the restriction cannot be seen from a sufficient distance. Examples from the Cologne tramway (figure 29) are used by TÜV Rheinland to demonstrate the provision of advance warning signs on German tramways where line-of-sight driving is used at a location where the maximum permitted speed reduces from 70 km/h (43 mph) to 20 km/h (12 mph).

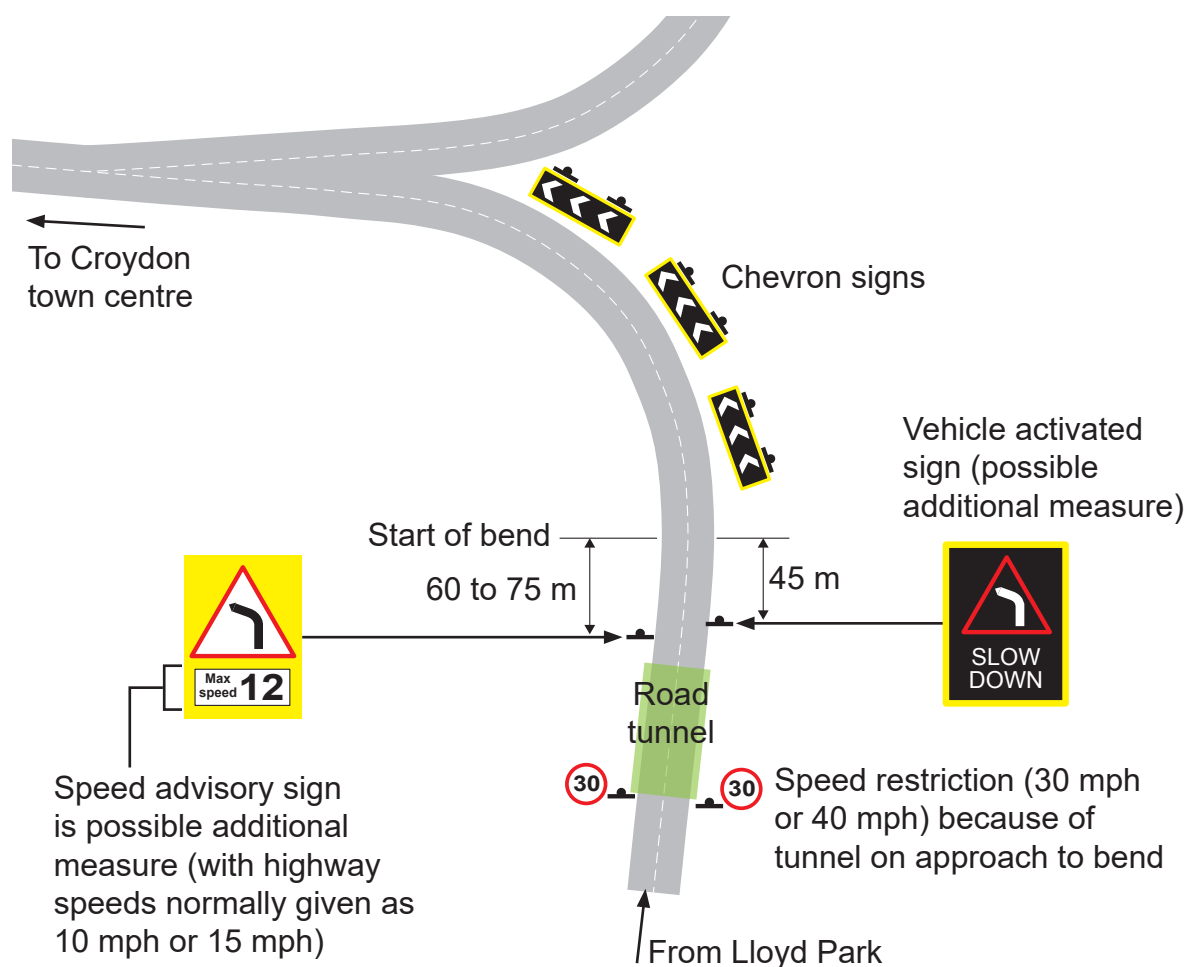
Figure 30: Normal and additional optional signing for similar road bend (additional signage required if junction equipped with traffic lights)

- 269 The RAIB commissioned TRL to identify the road signs and warnings²⁹ which would be considered good practice on a theoretical road similar to the tramway location at which the accident occurred. The theoretical road had a speed limit of 80 km/h (50 mph) and a tunnel on the approach to a tight left-hand bend. TRL concluded that, as a minimum, a triangular 'bend ahead' warning sign 600 mm high would be located between 60 and 75 metres before the start of the bend, and chevron signs, 600 mm high (or possibly 800 mm high to improve conspicuity) would be provided to mark out the bend itself. To further improve conspicuity, the 'bend ahead' warning sign and chevrons signs would be mounted on reflective rectangular yellow backing boards (figure 30).

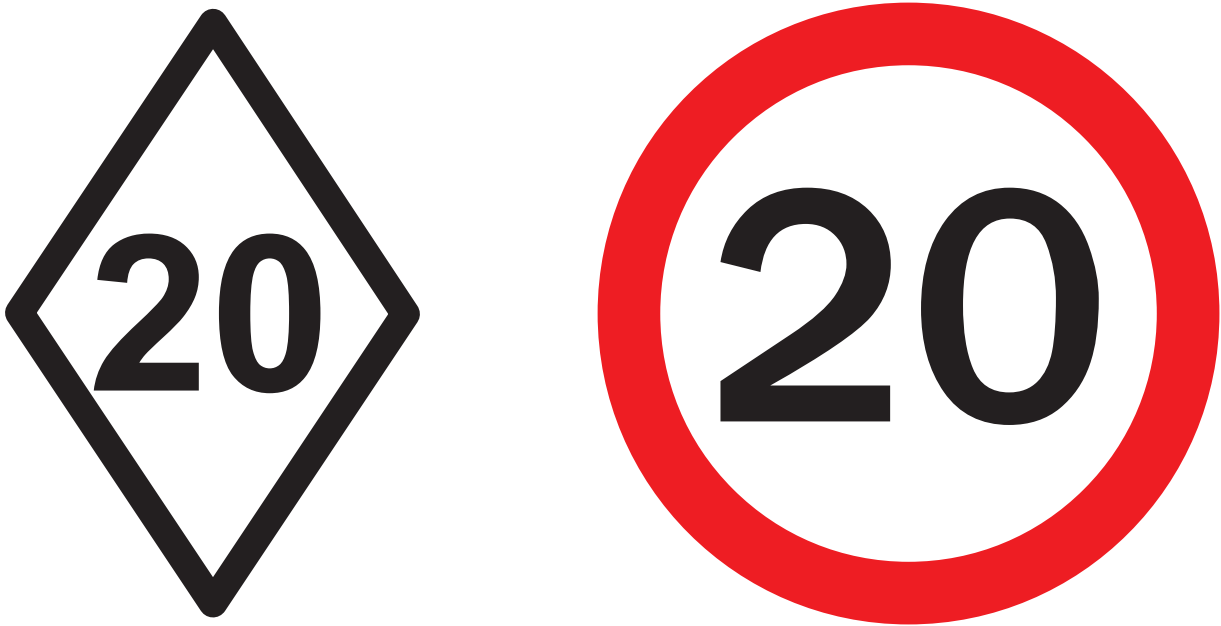
Figure 31: Maximum speed signs (to same scale) for trams (left image) and road vehicles (right image)

272 The speed limit signs for trams are different from those used for other road vehicles (figure 31) and both are described in The Traffic Signs Regulations and General Directions. TRL compared the surface area of the tramway speed sign from Sandilands with the equivalent road maximum speed sign that would be located on a road at which vehicles can approach at a maximum speed of 50 mph (80 km/h) (table 13). The tram speed restriction sign at Sandilands junction at the time of the accident had a surface area only 43% of that of an equivalent road speed limit sign. Therefore, the tram speed restriction sign will be less conspicuous than an equivalent road speed limit sign when installed in the same physical location with the same level of background lighting.

Sign intended for	Sign height	Sign width	Sign area
Tram at Sandilands south curve	603 mm	401 mm	0.121 m ²
Other vehicles on a public road	600 mm	600 mm	0.282 m ²

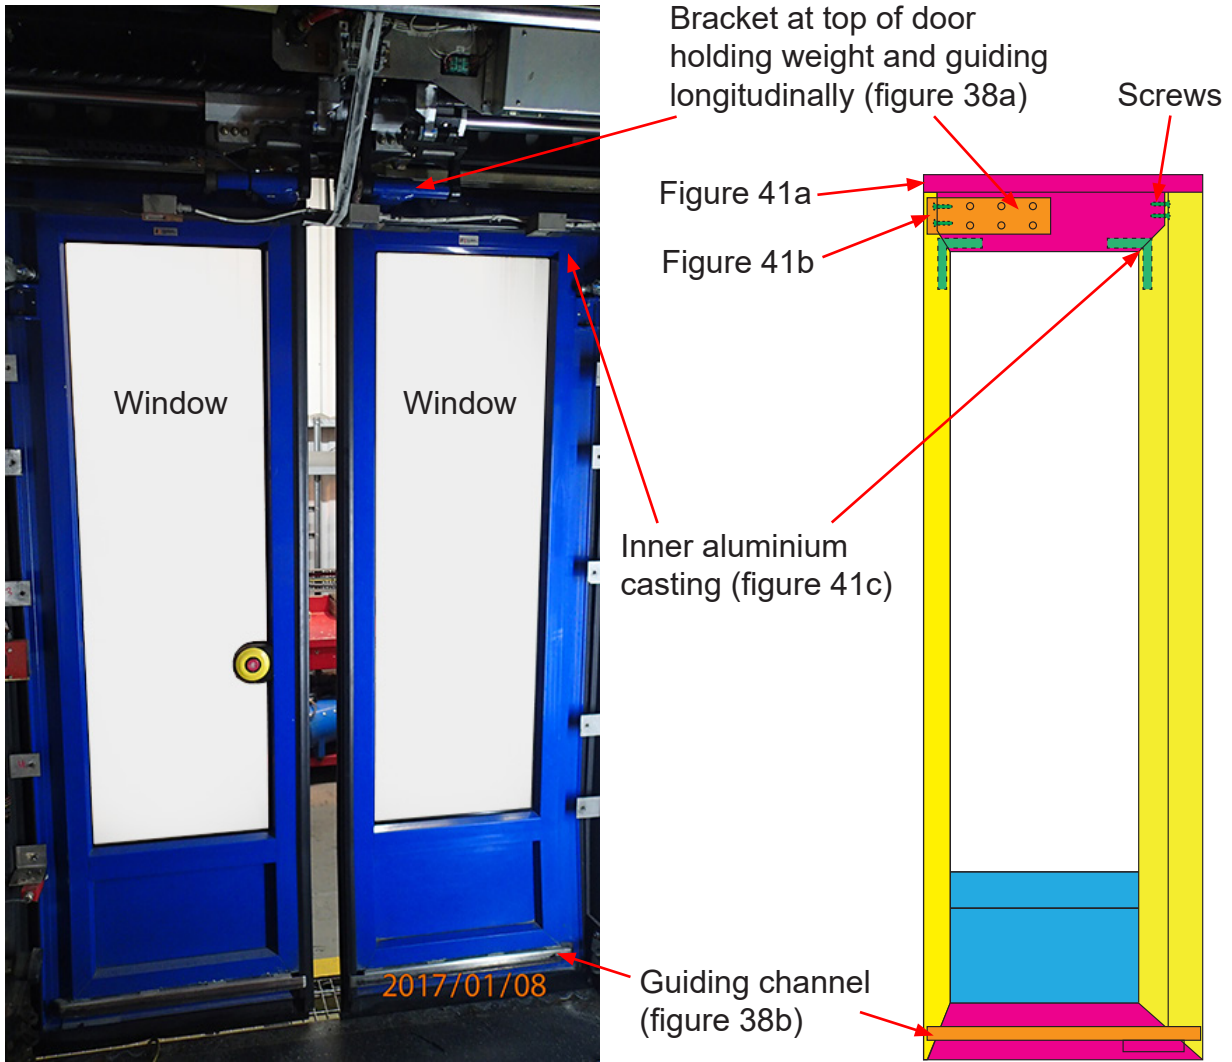
Figure 37: Photograph of door pair and diagram of a single leaf showing key features

- 292 There are four sets of double passenger doors on either side of a CR4000 tram. The doors are of a *plug type* and hence normally sit flush with the outer skin of the vehicle structure when fully closed. The door leaves (figure 37) are hung at the top from a bracket which carries the weight of the door and drives the doors along the longitudinal axis during door opening and closing operations (figure 38a). An arrangement consisting of an inverted U shaped channel and rollers along the bottom of the door (two rollers running inside the channel, and one outside the channel) provides the door with a degree of lateral restraint (figure 38b). Some doors on the tram are fitted with a metal bracket intended to prevent the roller being pulled out of the channel.

- 294 The door itself is constructed from aluminium extrusions which are connected with each other at the corners using an aluminium casting and two screws. The casting is bonded (glued) inside the extrusions. The typical failure mode was across the casting itself with the screws being pulled from the extrusions as they became overloaded (figure 41).

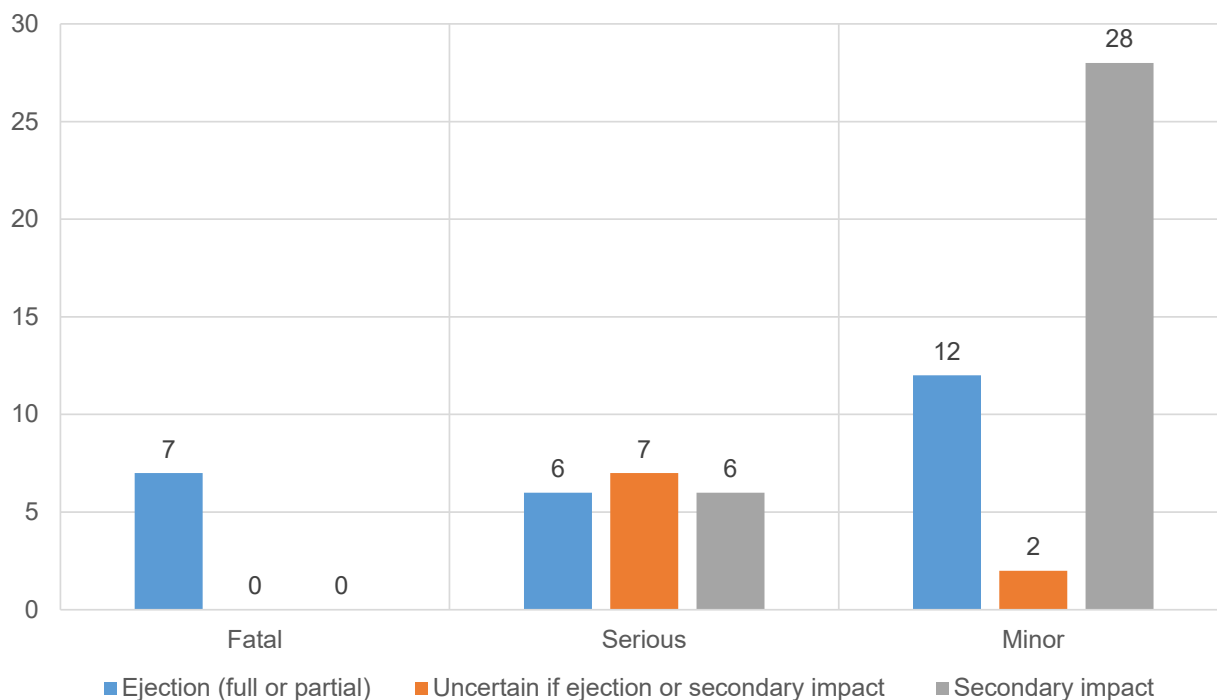
Figure 44: Primary cause of passenger injuries

305 The RAIB and its medical expert reviewed the accounts given by the passengers and the medical professionals who treated their injuries to determine what the main injury causation mechanisms were. The RAIB found that the only causes of significant injuries in this accident were ejection (full or partial) and secondary impacts. There is no evidence to suggest that any of the other injury causation mechanisms were encountered. Figure 44 shows the distribution of ejection and secondary impact injuries.

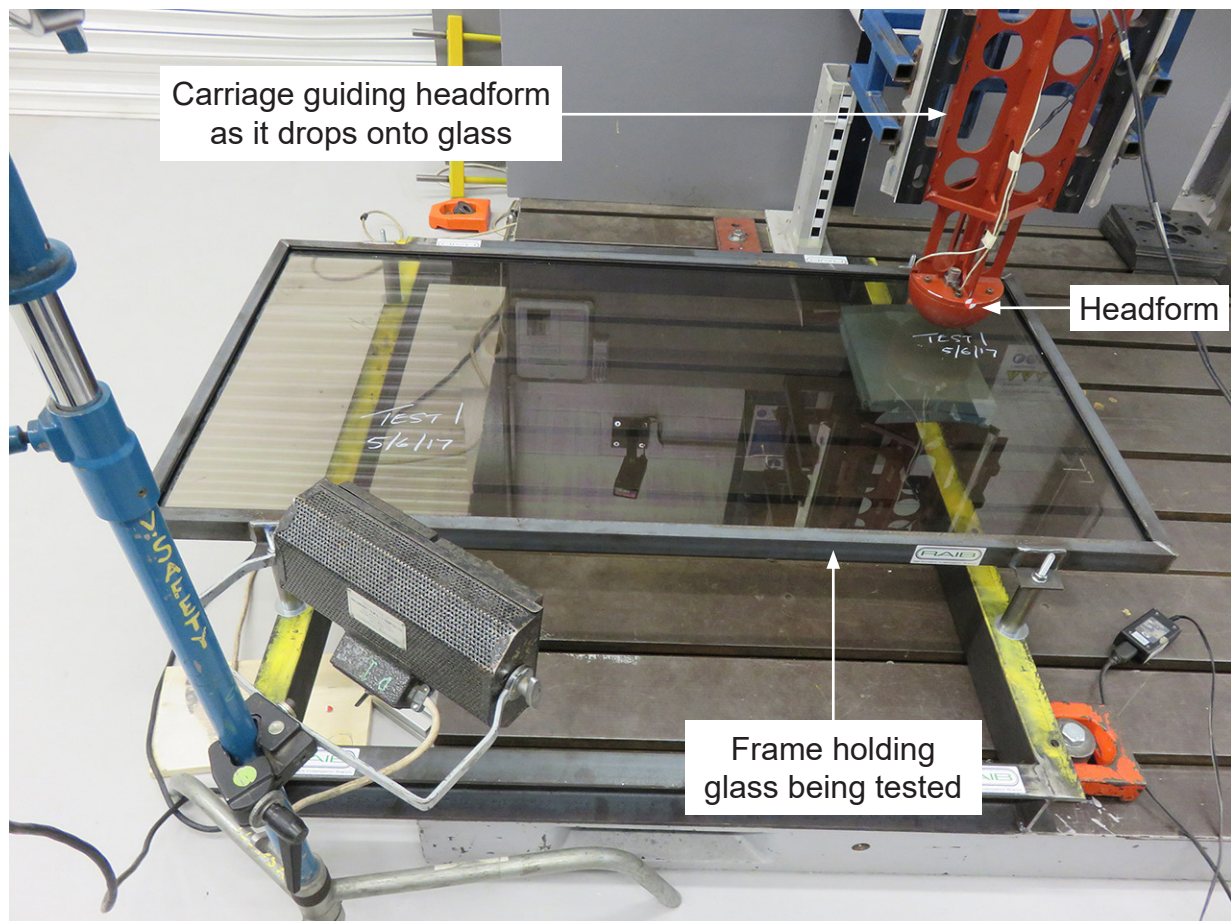
Figure 46: Window testing

325 In order to understand more about the mechanical strength of toughened glass, the RAIB conducted a series of tests on four intact windows from tram 2551 (the accident tram) and on another set of windows which had recently been removed from another CR4000 tram (both sets of windows were fitted with anti-vandal film, except one door window noted in table 16). The tests were carried out at Horiba MIRA³⁴, a UK-based testing facility for the automotive industry. They used a headform weighing 7 kg, dropped onto the windows from an increasing height, until the windows shattered. These tests were carried out on three types of window (window types 1, 2 and 3) and the headform was dropped in the corner or at the geometrical centre of the window. Figure 46 shows the window test setup.

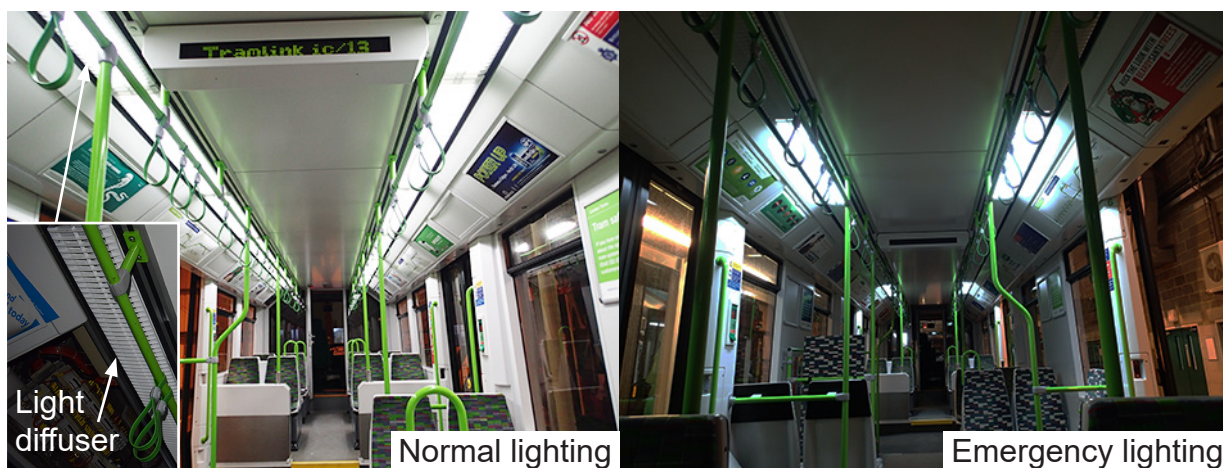
Figure 50: Lighting system

345 The tram's emergency lighting did not work once the tram had overturned.

346 The tram is provided with two rows of fluorescent tubes running along the length of the ceiling and fitted with light diffusers (figure 50). In the event of a loss of supply from the overhead power line, power is provided through roof-mounted batteries, but to a reduced number of tubes which are located around the doorways.

347 As the pantograph lost contact with the overhead power line (paragraph 116), the tram automatically switched to the battery supply for the lighting. The passengers noticed this as a flickering of the lights.
