Rail Accident Investigation Branch

Rail Accident Report

Overturning of a tram at Sandilands junction, Croydon 9 November 2016

Report 18/2017
v2.2 - October 2020

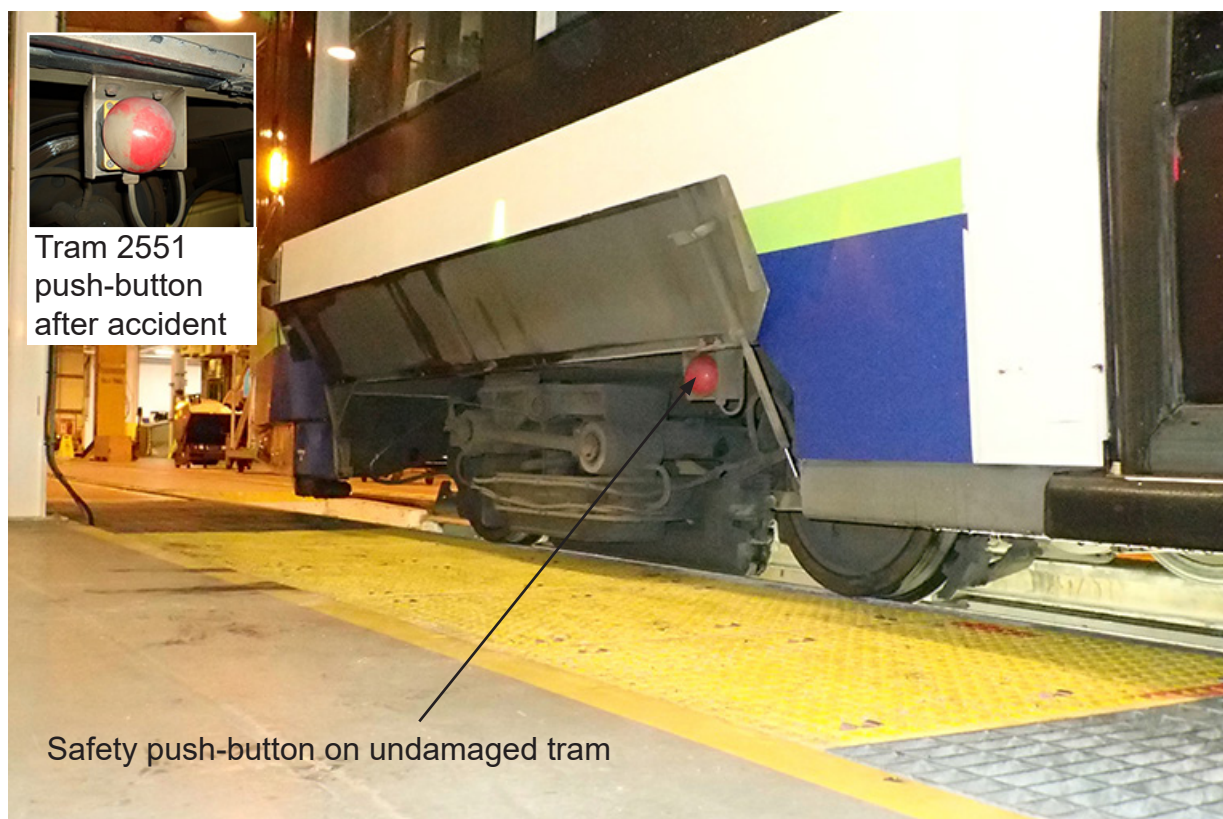
Figure 51: Safety push-button for tram's electrical system

348 As the tram overturned, the lighting system became completely disabled when a safety push-button (figure 51) was operated when the side of the tram came into contact with the ground. This cut off all power supplies, including the one from the batteries³⁵. This push-button is provided to allow the tram to be electrically disabled by the emergency services.

³⁵ All the roof-mounted batteries that supply the lighting system were damaged during the accident but two of the four batteries remained available to power the emergency lights.

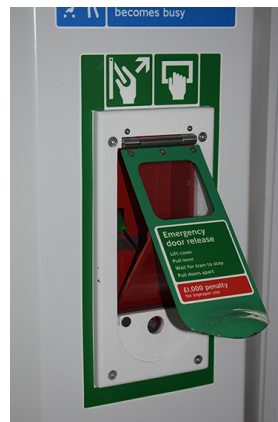
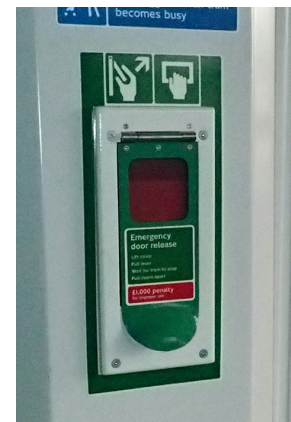
Figure 52: Emergency door release system

353 Each door is fitted with an emergency door release handle. Operation of the handle disengages the door driving mechanism and enables the user to manually push the door leaves open. Figure 52 shows the emergency door release handles and identifies the handles that had been pulled after the accident.

Release pulled

Release not pulled
(normal position in service)

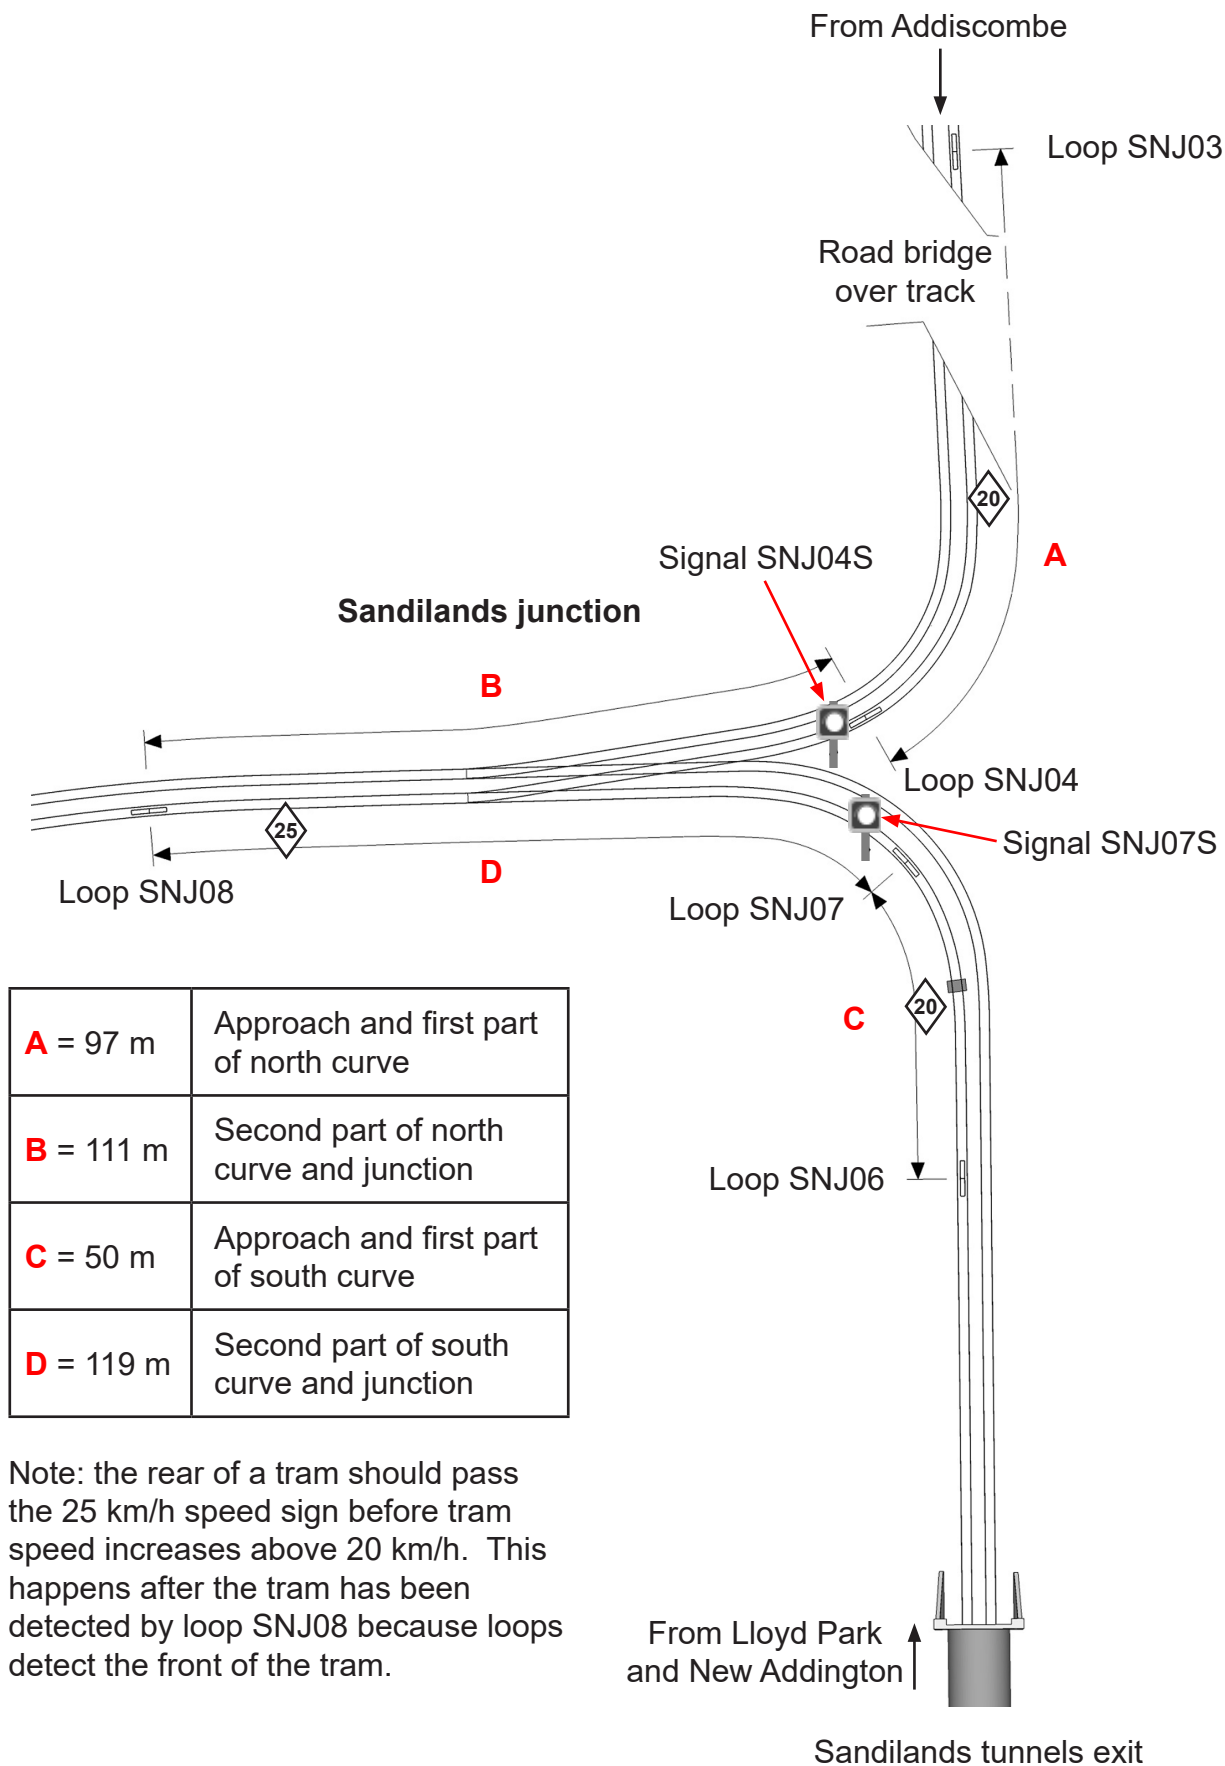
Figure 53: Position of loops used in the RAIB analysis

386 Loop data from 1 January 2015 to 21 December 2016 was analysed for pairs of loops on the Sandilands curves. This includes almost all tram transits in this period (a small proportion, less than 10%, were not analysed for reasons explained in Appendix D). Each loop pair is either the approach to a speed restriction plus part of that restriction or entirely within a speed restriction. The RAIB has calculated the maximum permitted average speed between each loop pair taking account of the higher speed permitted in the first part of some loop pairs (figure 53).

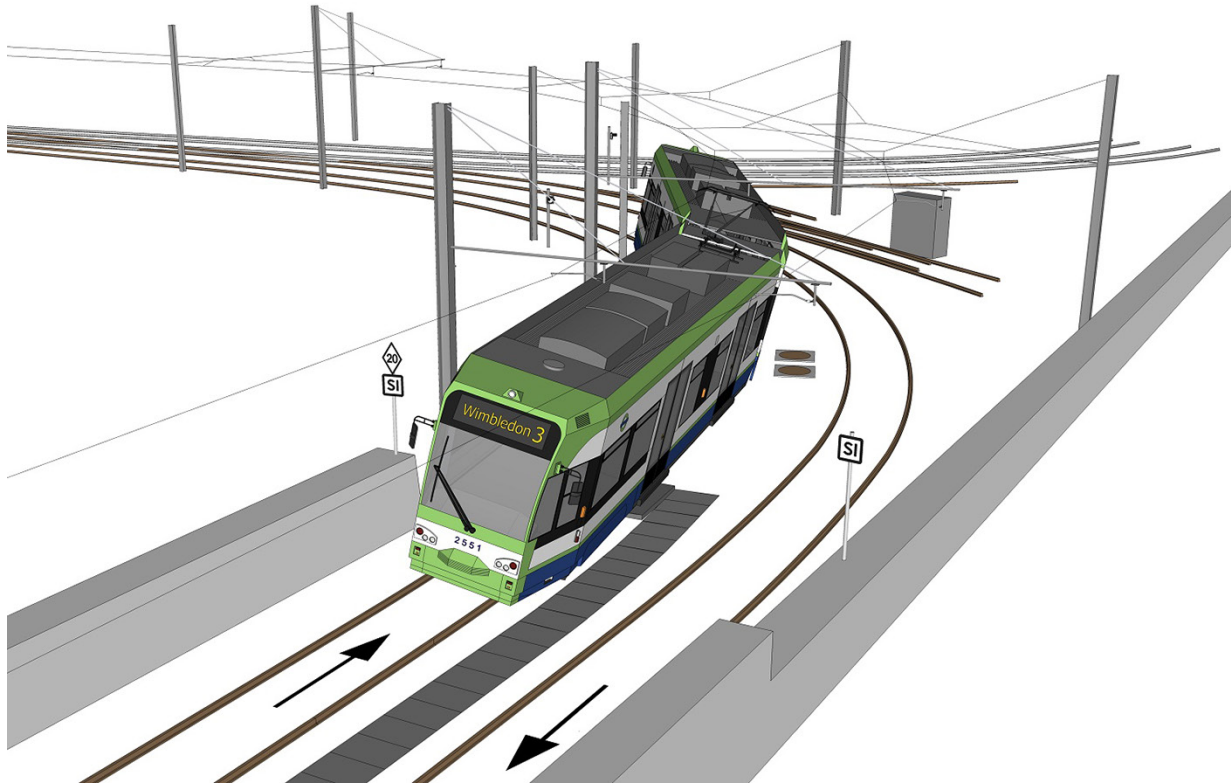
Figure G.1: Overview when front wheels become derailed (point of derailment). Tram is tilting over at about 10°. Note: the flexible connections between the sections of the tram are not shown for clarity.

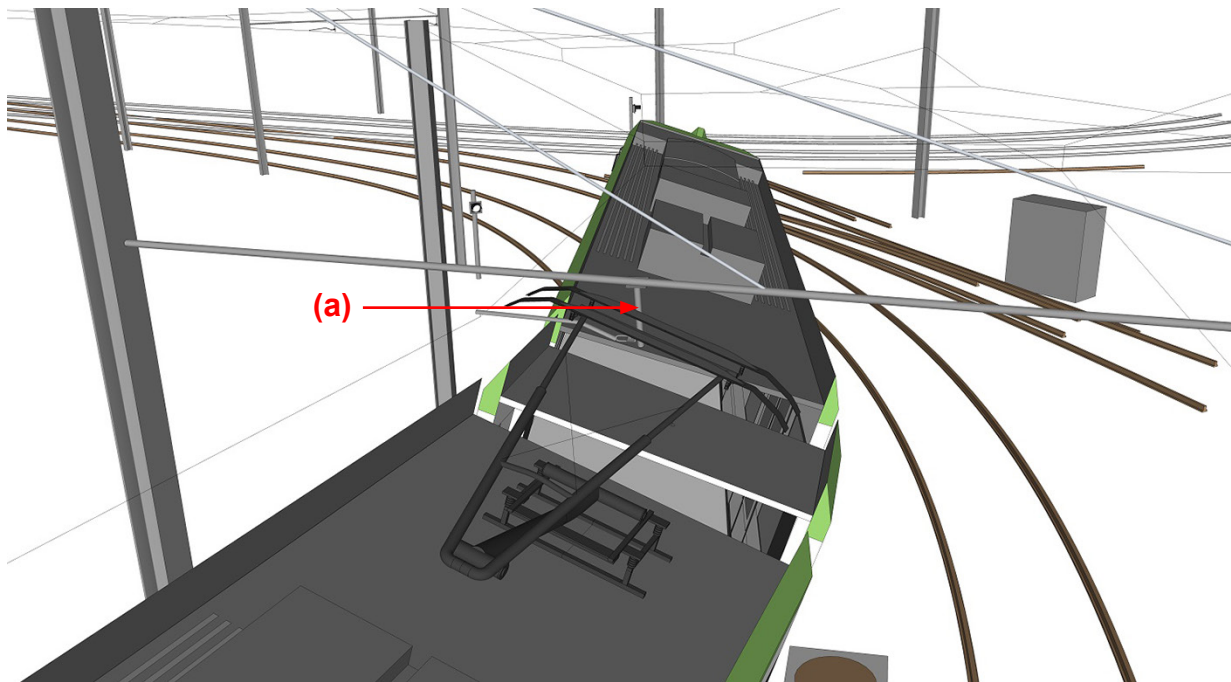
Figure G.2: As tram derails, pantograph strikes overhead line support tube (dropper) (a)

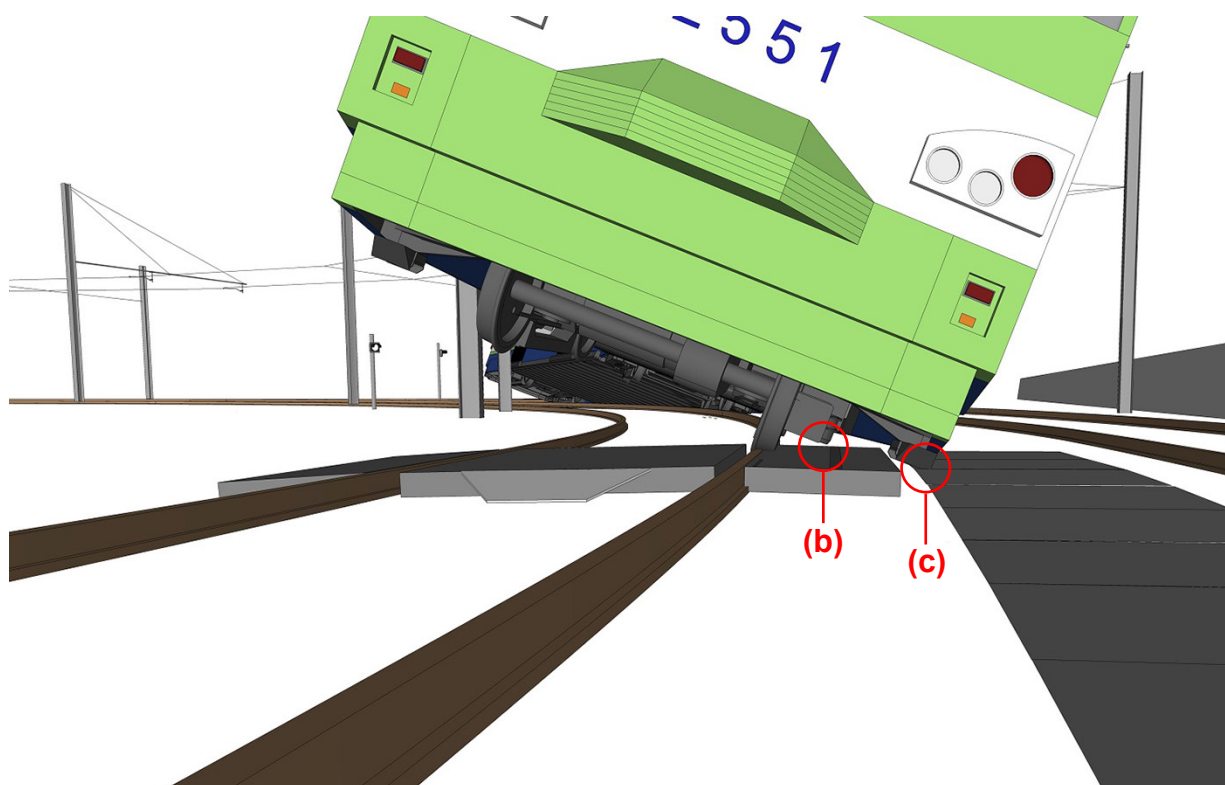
Figure G.3: Rear of tram suspension scuffs track crossing (b) and possibly, the jacking point damages walkway (c)

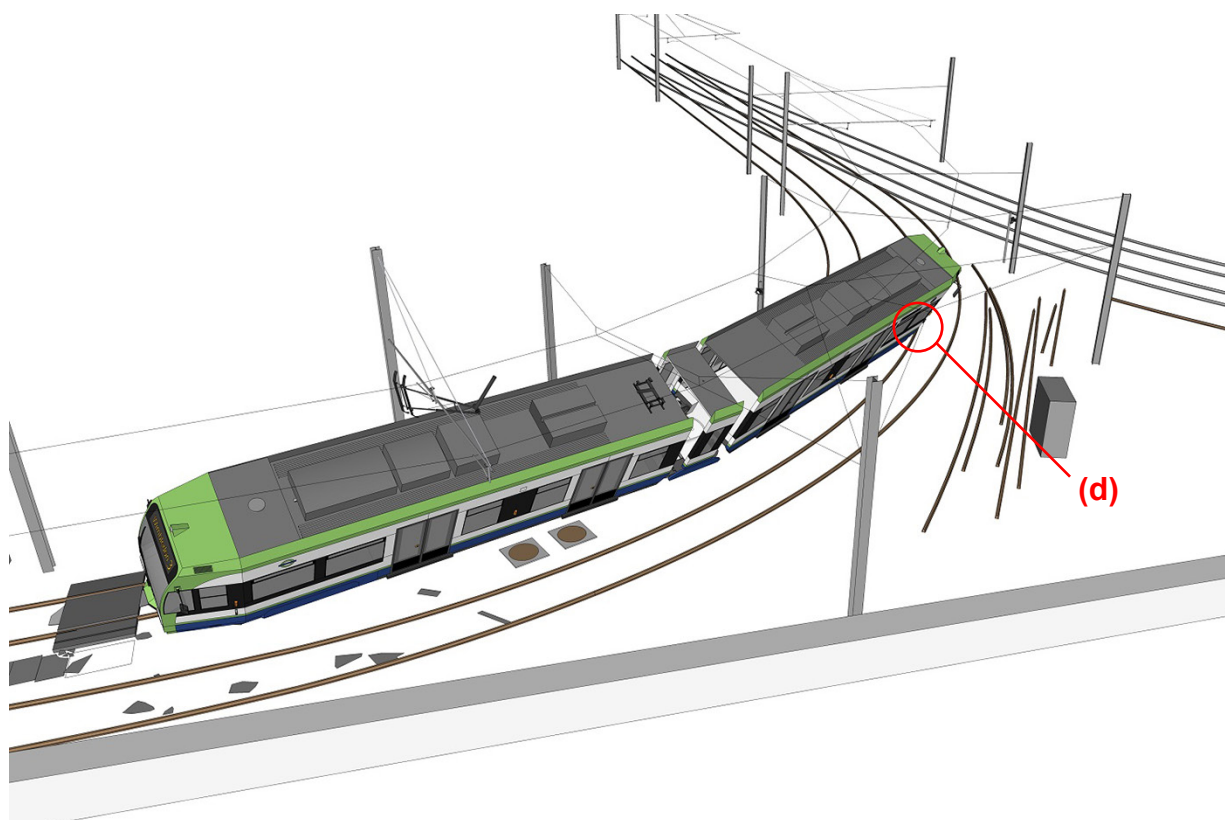
Figure G.4: Front of tram strikes and breaks six-foot rail of outbound line (d)

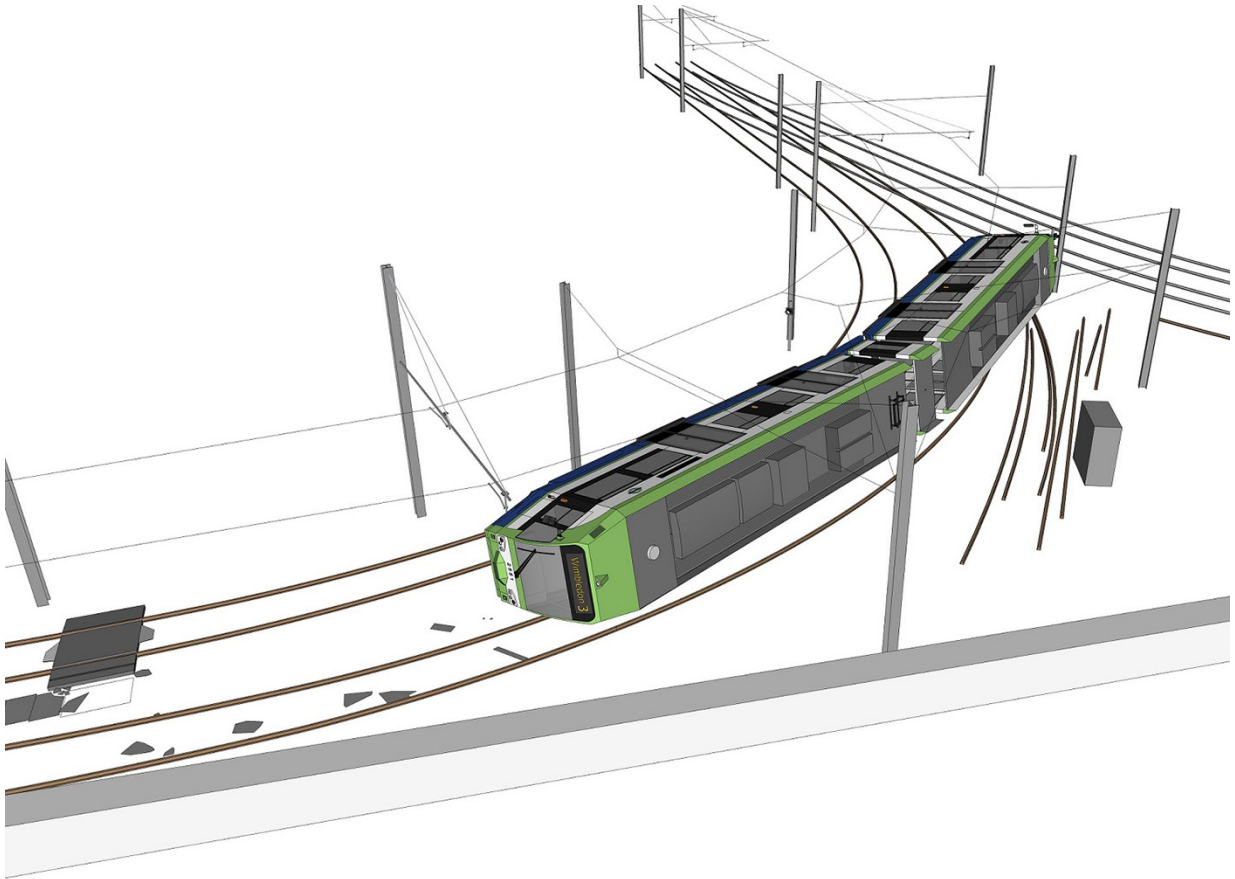
Figure G.5: Side of tram hits ground

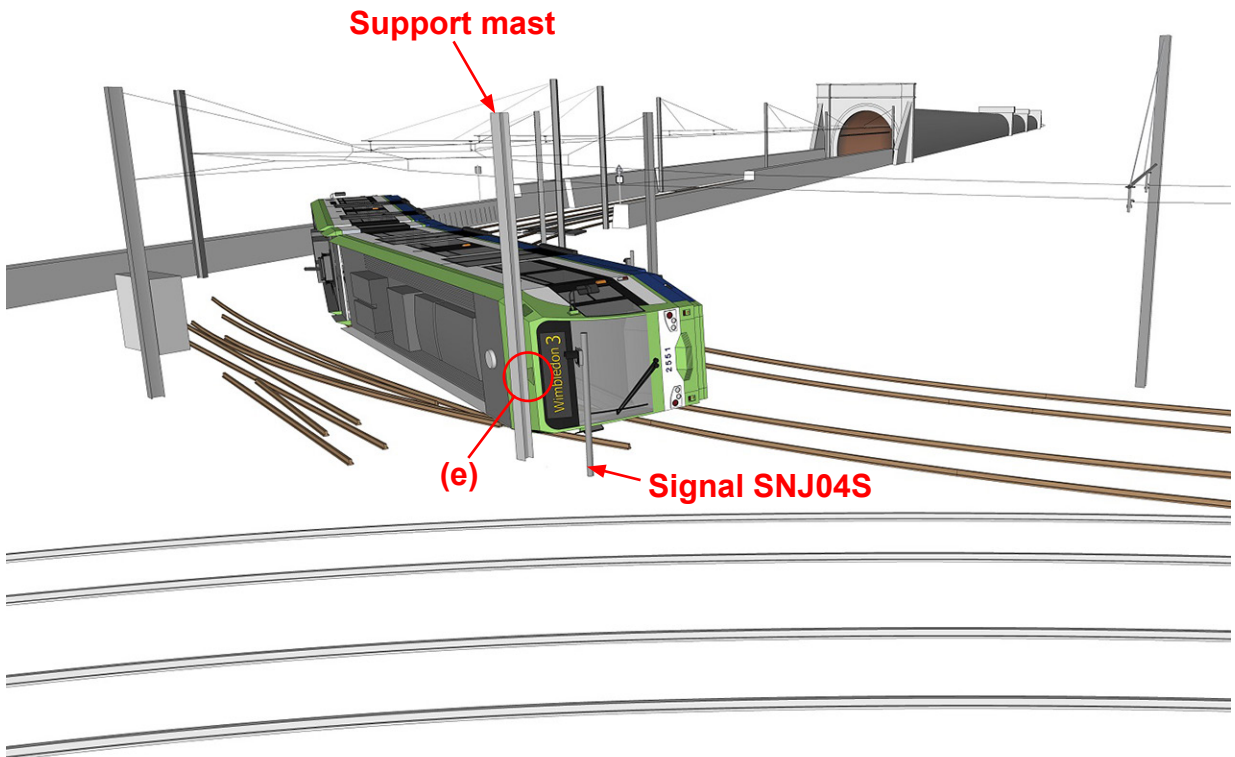
Figure G.6: Roof of tram hits overhead line support mast, displacing headlight from tram roof (e)

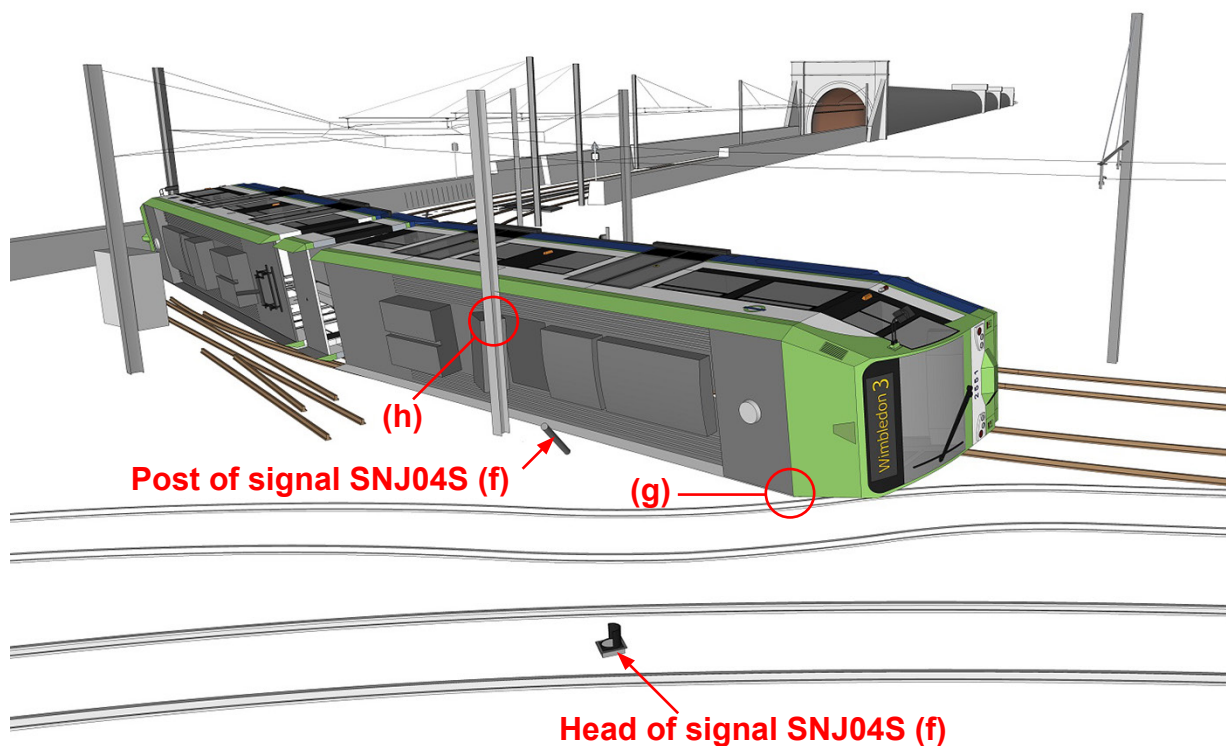
Figure G.7: Front of tram collides with signal (f), then track of inbound Addiscombe line (g). Roof equipment is displaced from tram as it slides against the overhead line support mast (h).

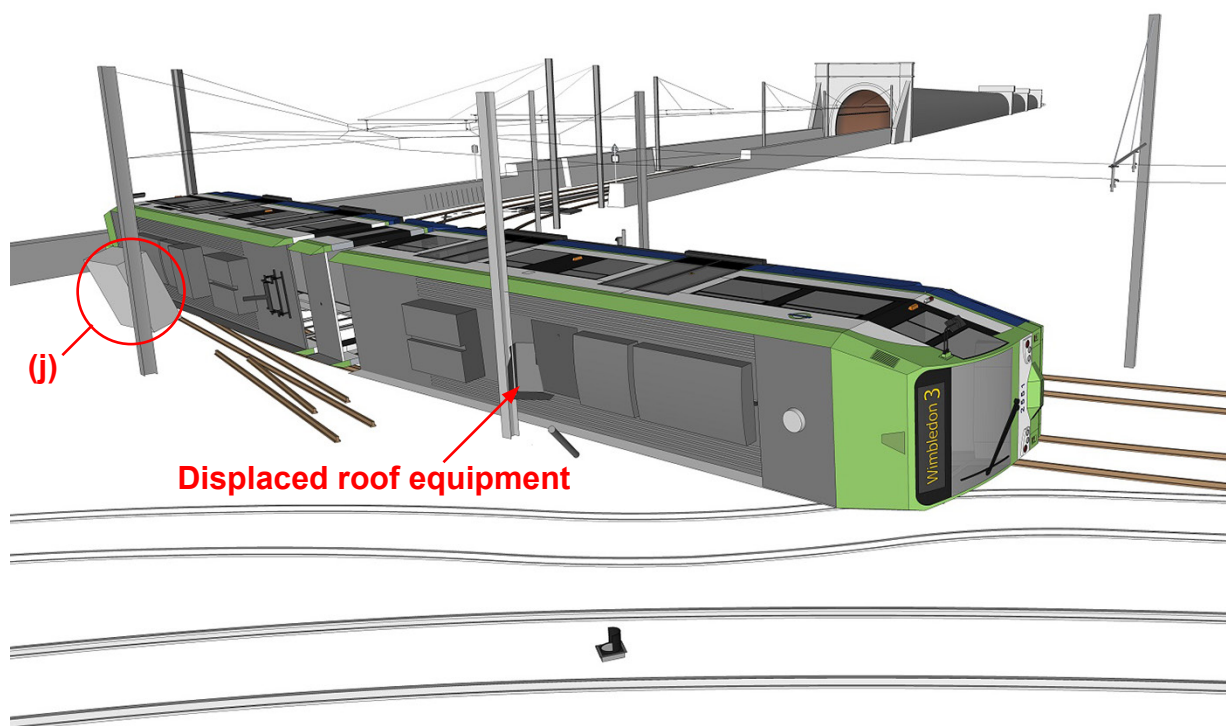
Figure G.8: Rear of tram collides with electrical equipment cabinet (j)

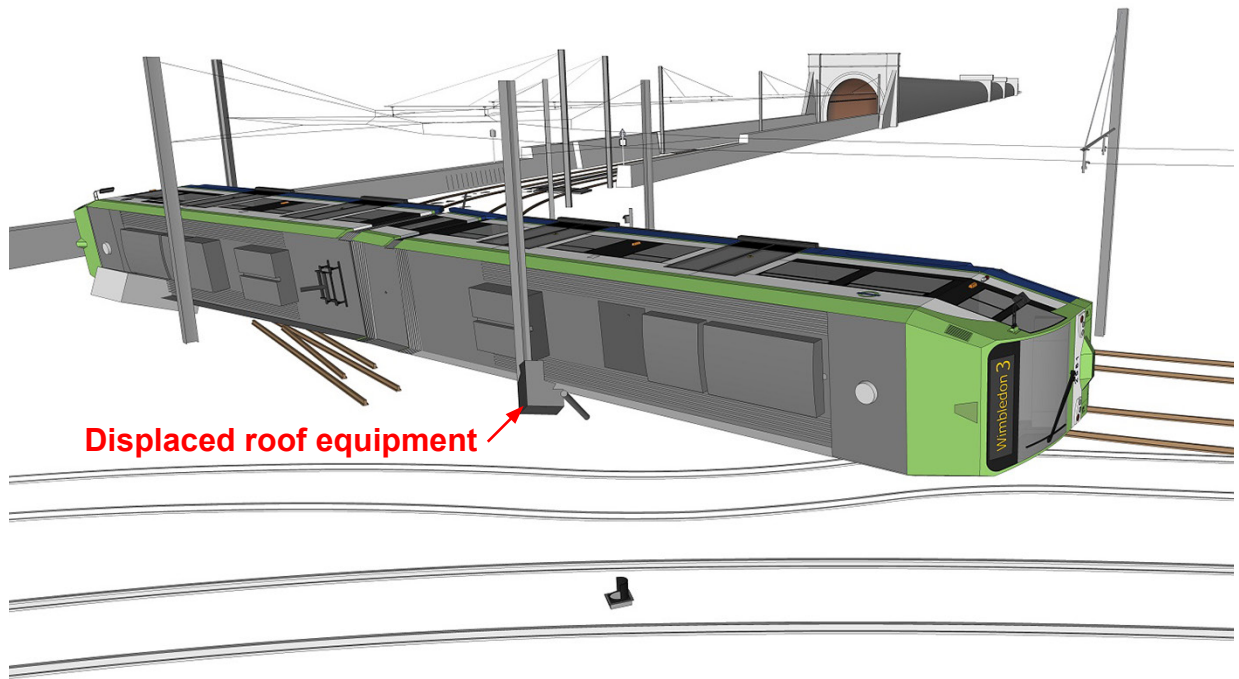
Displaced roof equipment

Figure G.9: Tram comes to rest
