# Rail Accident Investigation: Interim Report

**Collision near London Waterloo station,  
15 August 2017**

Report IR2/2017  
December 2017

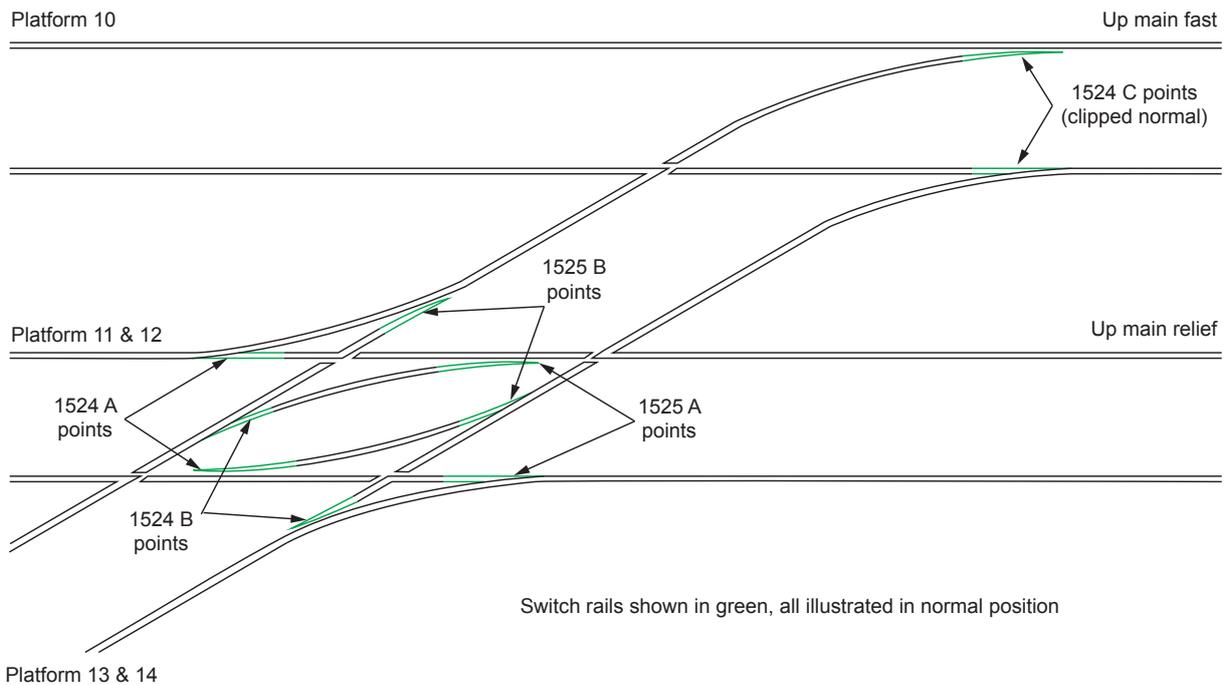
Figure 3: Detailed layout of accident location

- 3 The collision occurred because a set of *points*<sup>1</sup> was not in the correct position and directed the passenger train away from its intended route. When the train passed over them, the points were in this position because of a temporary modification to the points control system, which also caused the train driver and signaller to receive indications that the points were correctly set.

15 Routes from platforms 11 and 12 via 1524 points would lead to the up main relief line with 1524 points *normal* and the up main fast line with 1524 points *reverse*.
