Rail Accident Investigation Branch

Rail Accident Report

**Freight train derailment at Lewisham,
south-east London
24 January 2017**

Report 04/2018
February 2018

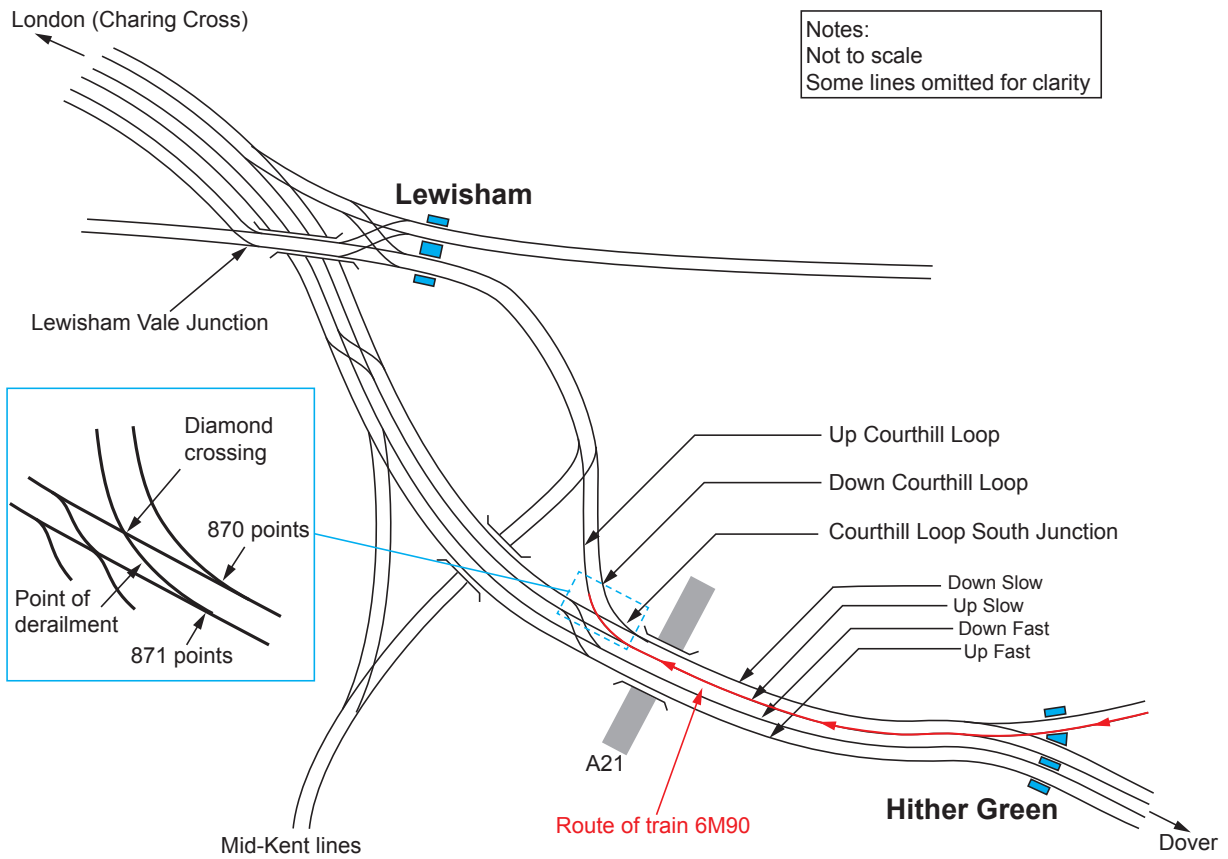
Figure 2: Track layout at Courthill Loop South Junction showing the route of train 6M90

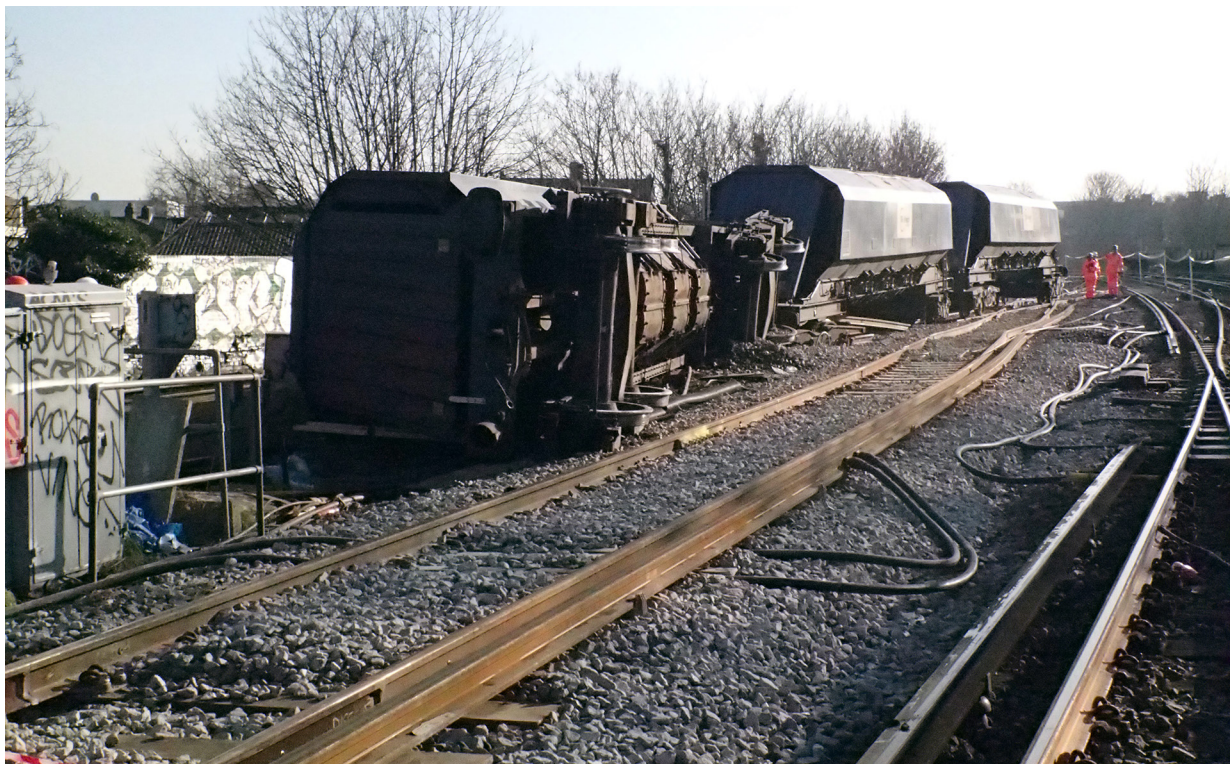
- 5 Train 6M90 had been routed from the Up Slow to the Up Courthill Loop line (figure 2), and it was travelling at around 20 mph (32 km/h). The 16th wagon on the train derailed to the left as it traversed the track between the points on the Up Slow (871 points) and the *diamond crossing* on the Down Slow. It was then pulled back towards the loop lines before overturning, separating from the wagon in front, and coming to rest. The 17th wagon derailed as a consequence, but remained upright. The brakes automatically applied and brought the forward part of the train to a stand after running a further 190 metres along the Up Courthill Loop line. All the wheels of the 18th wagon, the last in the train, remained on the track. Figure 3 shows the location of the last three wagons after the derailment.

Figure 3: Location of the last three wagons of train 6M90 after the derailment

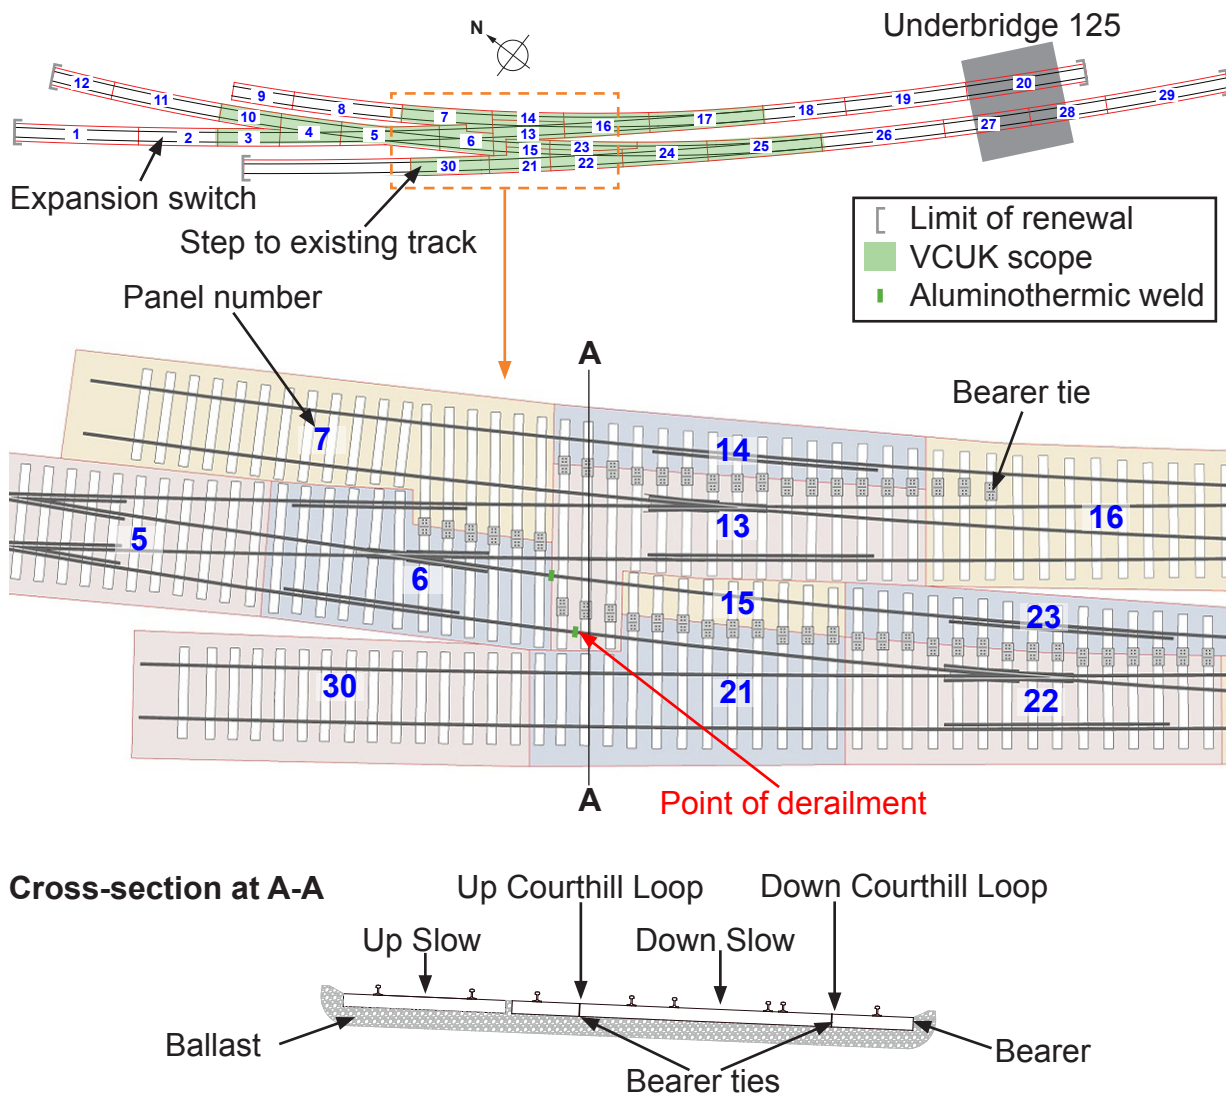
24 Figure 6 is a diagram of the new track layout showing the limits of the renewal, the way it was subdivided into (modular) S&C panels and the main elements that VCUK supplied. It includes a cross-section through the layout close to where the derailment occurred showing the common concrete bearer that supported the rails on the Up Courthill Loop, the Down Slow and the Down Courthill Loop lines and the concrete bearer that supported the rails on the Up Slow line.

Figure 6: The new track layout at Courthill Loop South Junction

106 The bearer closest to the point of derailment supports three lines. It has a bearer tie in the four-foot of the Up Courthill Loop line as well as in the four-foot of the Down Courthill Loop line. The bearer section supporting the Down Slow line is continuous in between (figure 6). The RAIB analysed the track measurement trolley recordings made during the follow-up work (paragraph 35) and the void measurements and track measurement trolley recordings made after the derailment (paragraph 47). With reference to figure 19, it found that, at the time of the follow-up work, the cant on the individual lines on the bearer varied: the static cant on the Up Courthill Loop line was less than that on the Down Slow line (in the middle of the bearer), and the static cant on the Down Courthill Loop line was more. The different amount of cant on each line is explained by the fact that the bearer ties were acting as hinges, which allowed the bearer sections to rotate relative to one another. By the time of the derailment, the static cant on the Up Courthill Loop line had reduced considerably further. The dynamic cant was even less, evidencing how vulnerable the short bearer section under the left-hand rail was to inadequate track bed support.
