AAIB Bulletin

3/2018

Published 8 March 2018

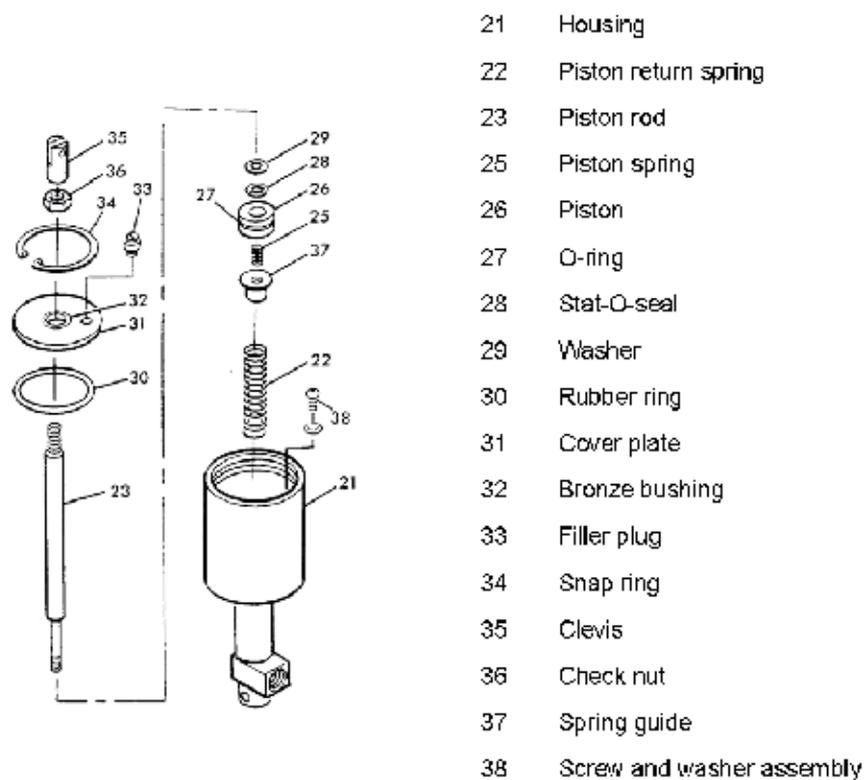
Damage on the identification plate obscured most of the details but the unit was manufactured by Cleveland in August 1994. Figure 3 is a schematic depicting the internal construction of a Cleveland master cylinder.

The filler plug was missing and the cover plate could be rotated using finger pressure. When the snap ring and cover plate were removed, it was apparent that the rubber ring was missing.

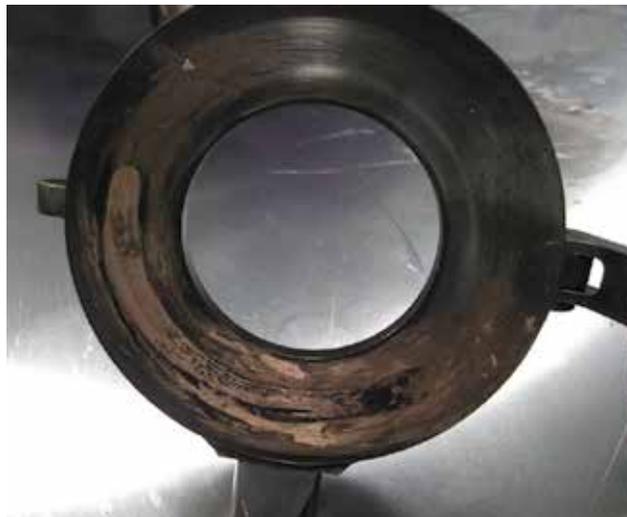
Figure 6

where they contacted the swashplate but were otherwise intact and correctly positioned in the synchronising plate. The servo piston was correctly attached to the swashplate and free to move. Figures 5 and 6 show the Green pump components.

Associated swashplate piston track marks

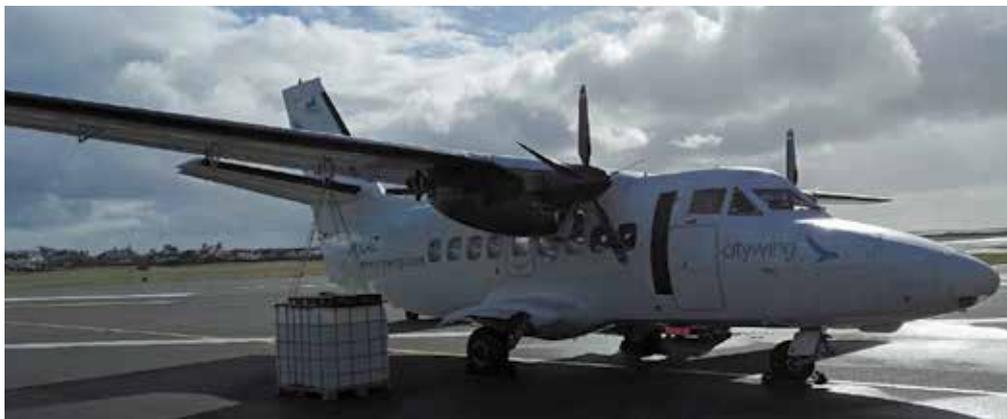
RFFS vehicles were positioned around the aircraft, to provide some screening from the wind, and a bus transferred the three uninjured passengers to the terminal building. The aircraft was later tied down until the wind subsided, (Figure 1).

Figure 1
Aircraft tied down at IOM

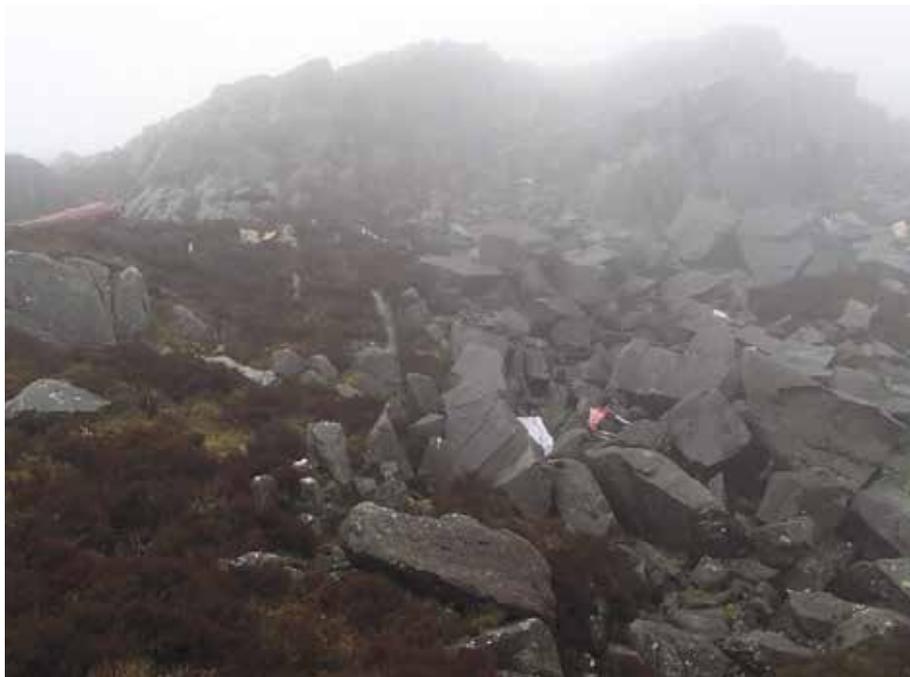
Figure 4

The accident site was located on the south-east face of Rhinog Fawr in southern Snowdonia, at an elevation of 2,060 ft amsl, approximately 300 ft below the summit shown in Figure 3. The helicopter had struck a rock outcrop (Figure 4), completely destroying the cabin section and depositing wreckage along a trail 150 m in length, oriented on a heading of 280°M. The helicopter's main rotor, gearbox and engines had separated from the fuselage and continued over the rock outcrop, coming to rest 140 m from the initial impact. The degree of disintegration of the cabin indicated that the helicopter had been flying at cruising speed immediately prior to impact. Witness marks made by the cabin, right skid and right horizontal stabiliser on the rock outcrop showed that the helicopter was in an approximately level pitch and roll attitude at impact.

Section of the accident site wreckage trial

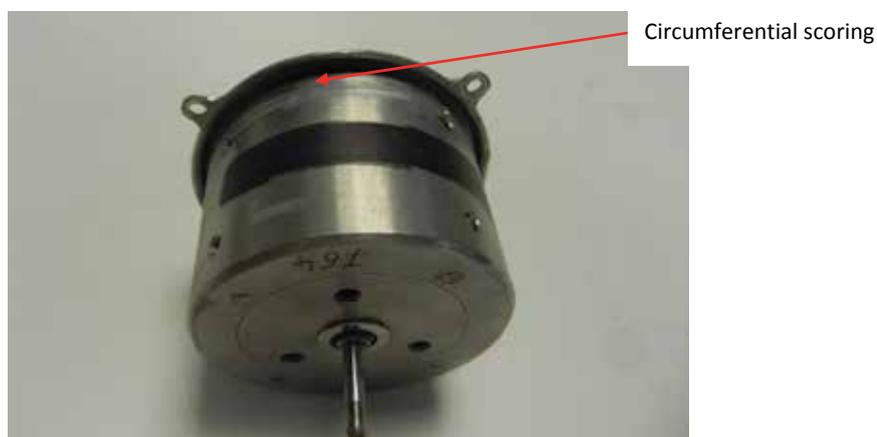
Figure 5

All the helicopter's flight instruments had been severely damaged during the impact sequence. The pilot's artificial horizon and the standby artificial horizon were disassembled and examined in detail. Both units had suffered from significant internal damage. Circumferential scoring was identified on the gyroscope of the pilot's artificial horizon and rotational damage was observed on the cooling fins of the standby artificial horizon gyroscope wheel (Figure 5), indicating they were both operational at the time of impact.

Pilot's artificial horizon gyroscope exhibiting circumferential scoring

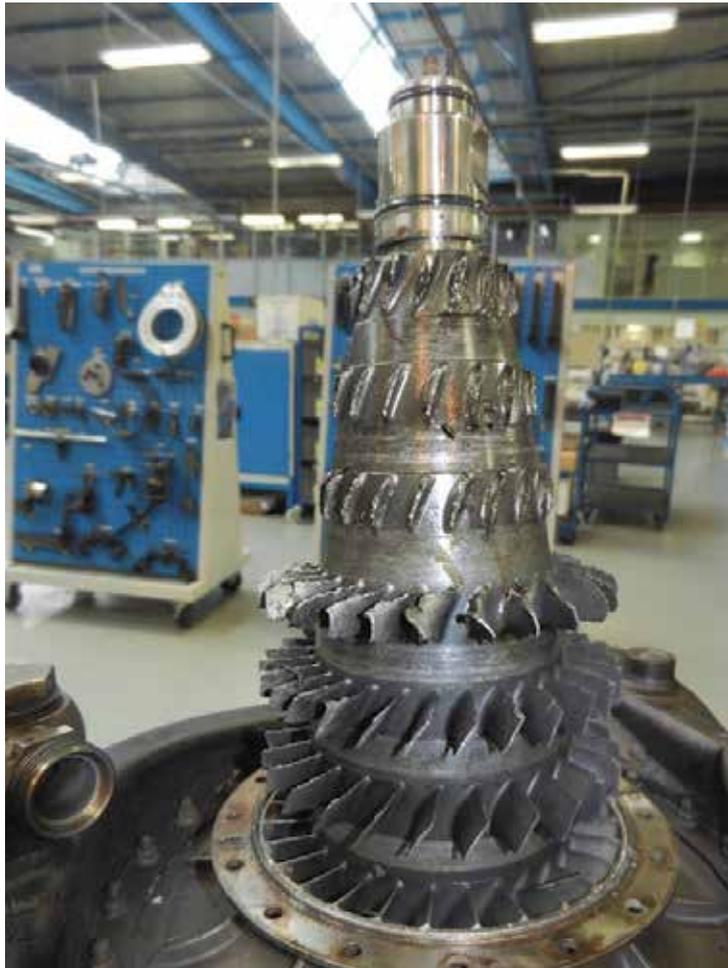
The compressor spool was heavily damaged, all the first three stages of compressor blades had been released, and the blades on the fourth stage exhibited significant impact damage (Figure 11). The impeller and impeller shroud also showed signs of rubbing. Small particles of vegetation were also found within the impeller.

Figure 11
Right engine axial compressor

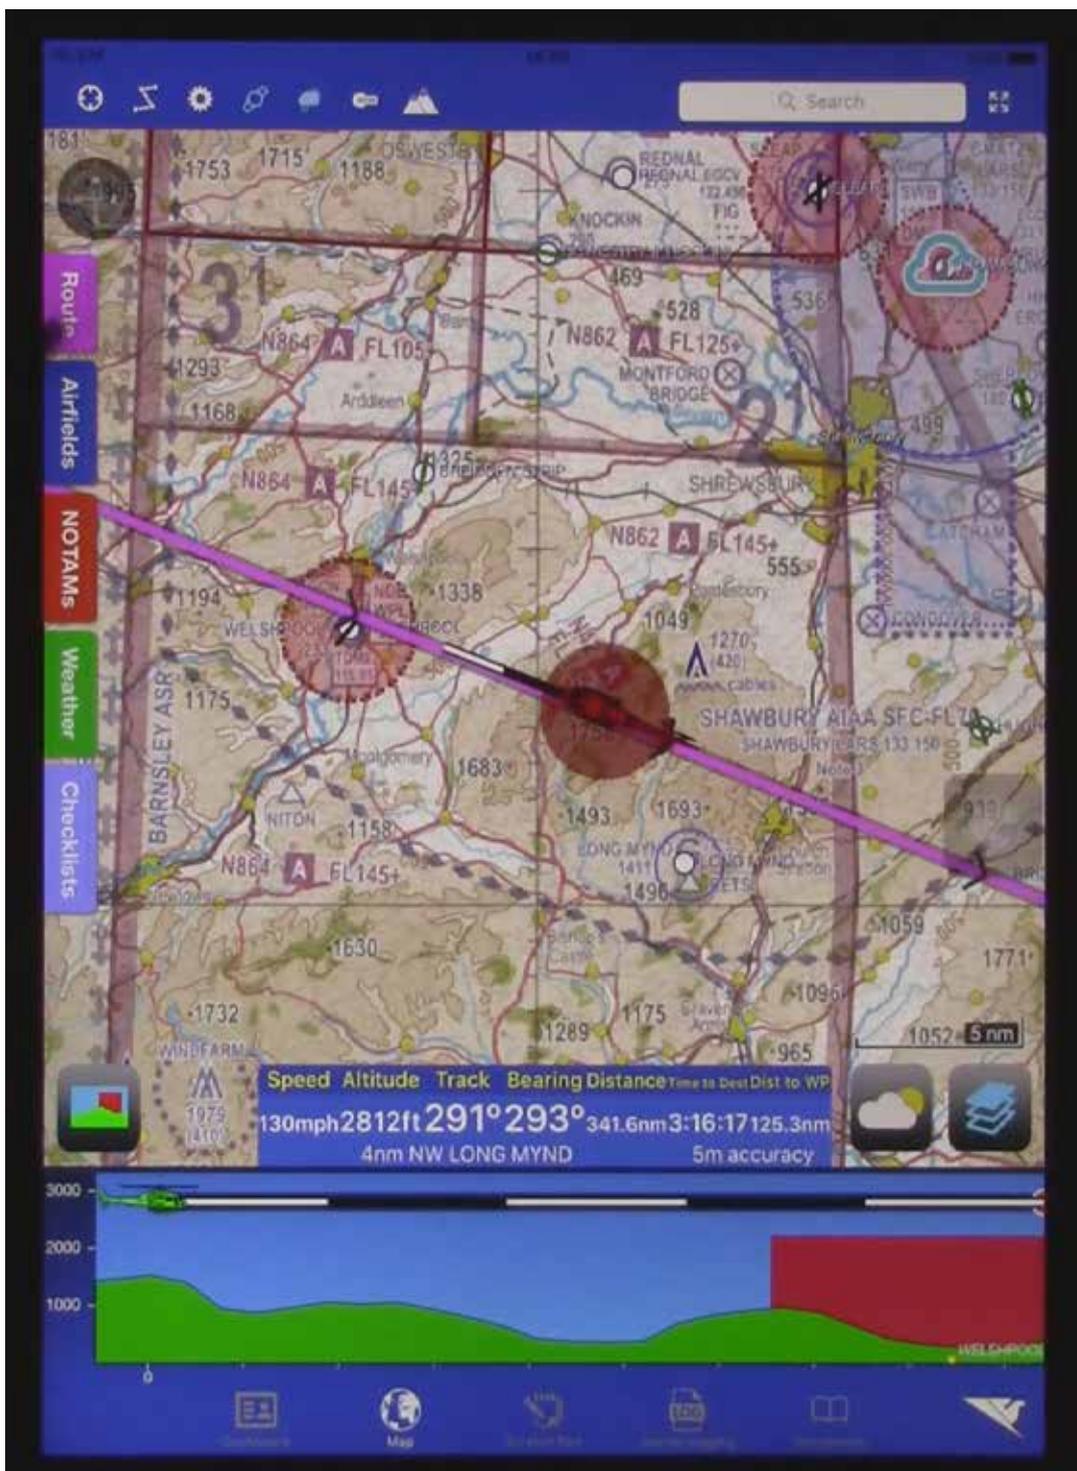
Figure 13

Both of the screenshots for RunwayHD (Figure 13) and SkyDemon (Figure 14) show the position of the helicopter as 8 nm east of Welshpool Airport (33 nm from the accident site, at 2,280 ft amsl with 112 kt groundspeed), implying that SkyDemon had been selected prior to this point (no information available as to how long for) and that RunwayHD was then selected and remained selected until the accident⁵.

Stored screenshot of the selected app (Runway HD) running at the time of the accident

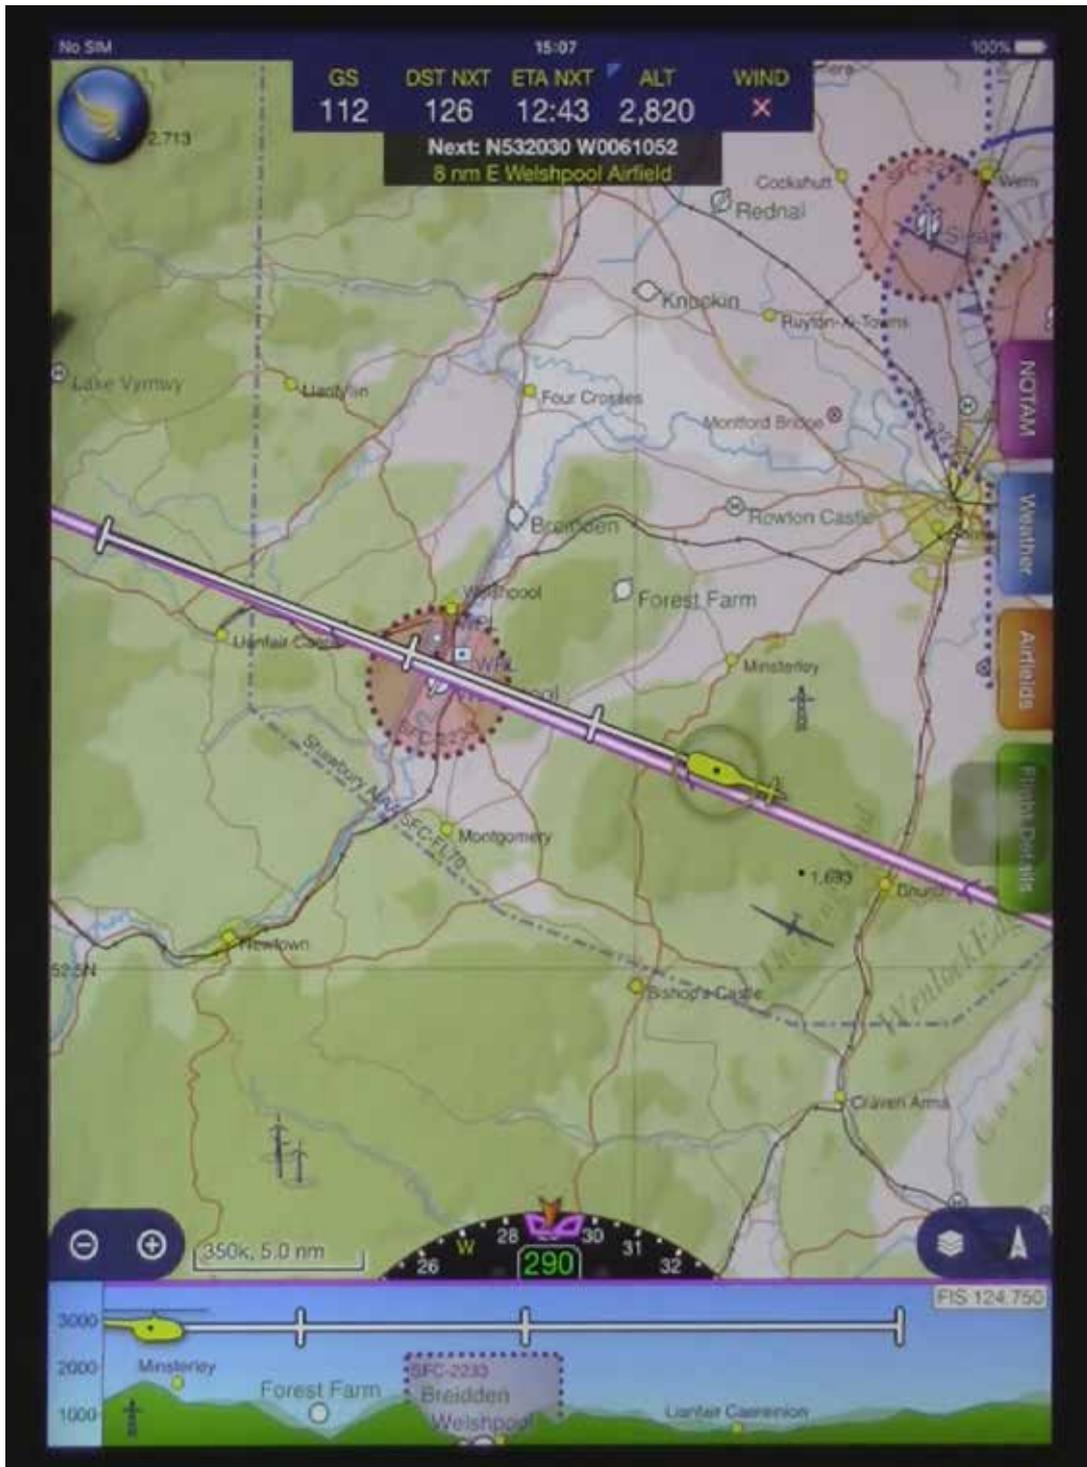
Figure 14

Stored screenshot of app (SkyDemon) running in the background at the time of the accident

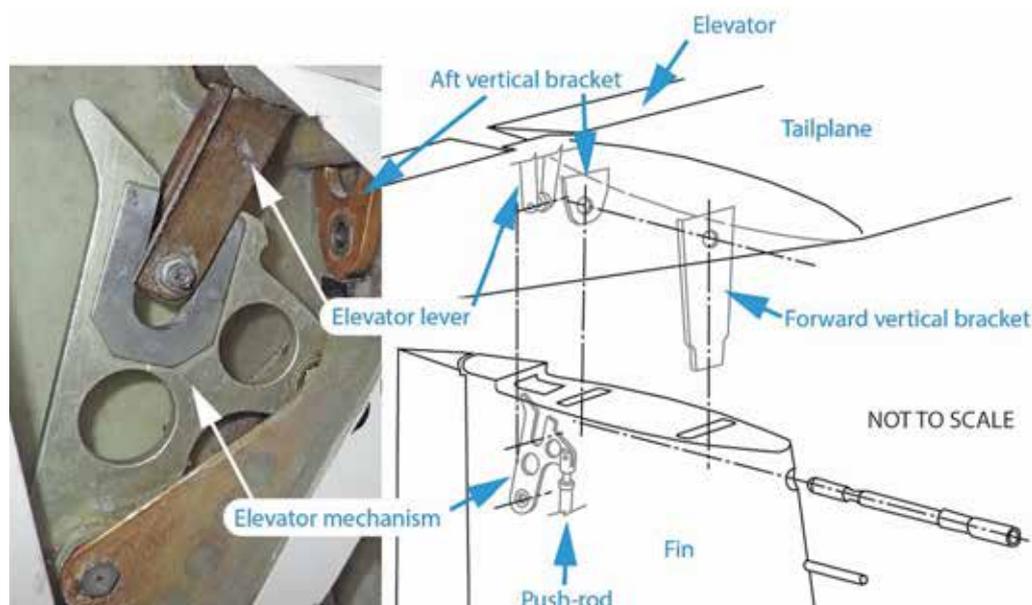
Figure 4

Normal connection of elevator lever and elevator mechanism on SZD-55-1

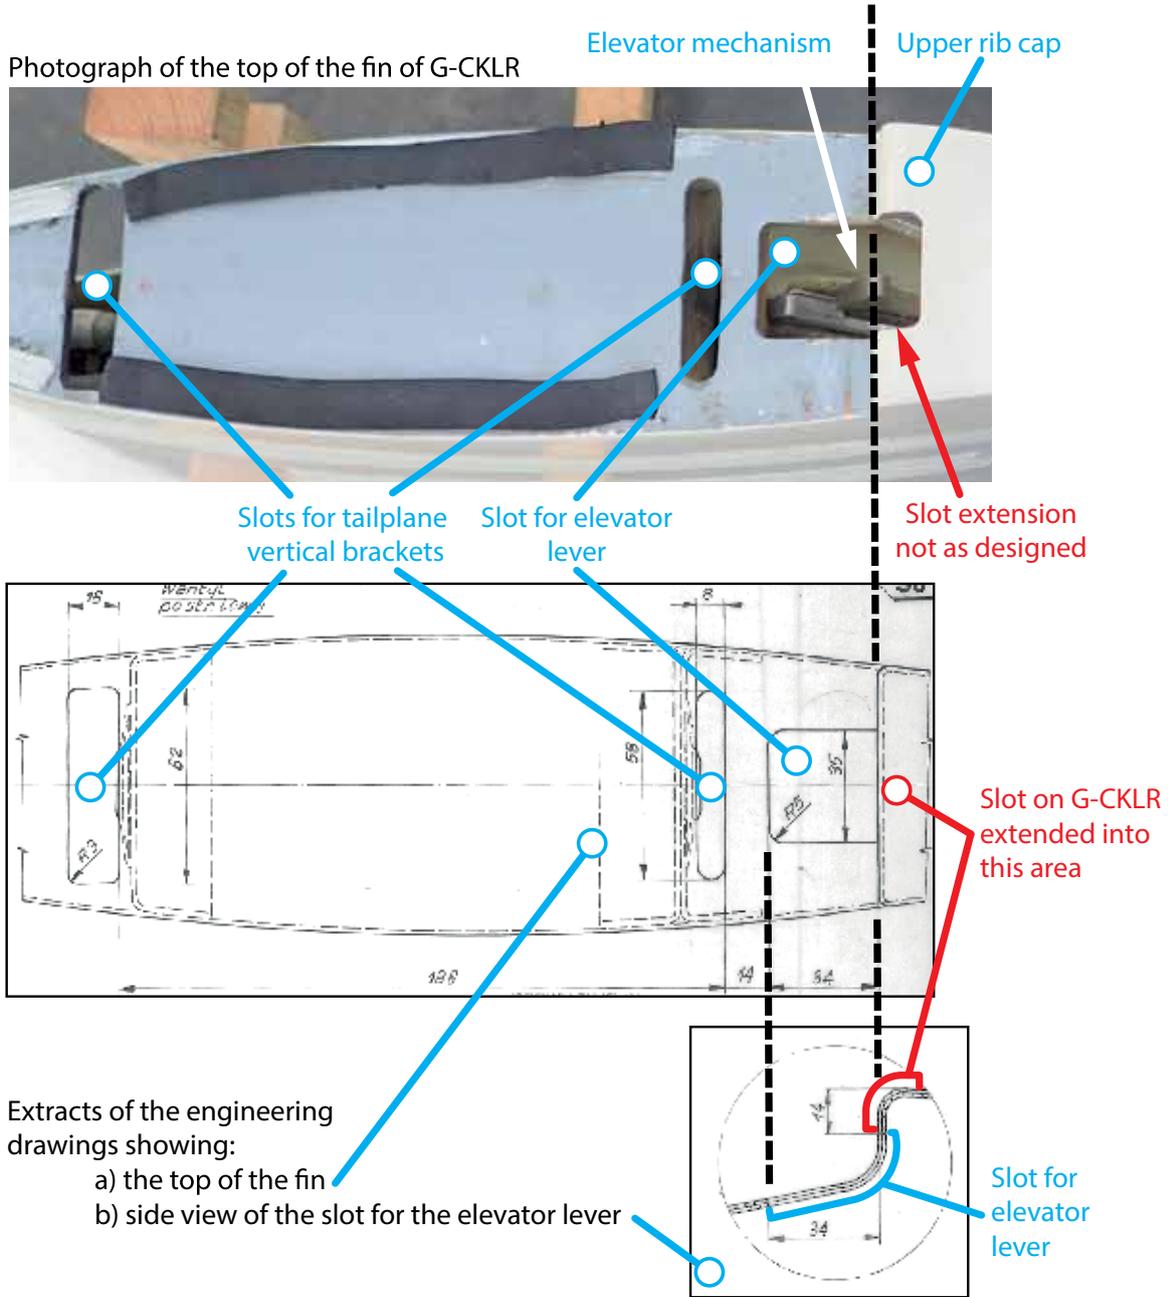
Figure 7 shows a plan view of the horizontal rib from the tail fin of G-CKLR compared with extracts from an engineering drawing provided by the manufacturer.

A number of trial tailplane riggings were conducted, in various configurations, to understand how the presence of the enlarged slot on G-CKLR may have affected the rigging process.

It was noted that when the tailplane was held in a way that did not involve touching the elevator, the elevator surface would droop under its own weight and the elevator lever would hang vertically downwards. This put the elevator in the best orientation to align with the elevator mechanism. When offered up to the fin in this manner, even with the elevator mechanism in the fully forward position, it was possible to rig the elevator controls correctly.

G-CKLR tail fin horizontal rib comparison with extracts from engineering drawing showing design dimensions

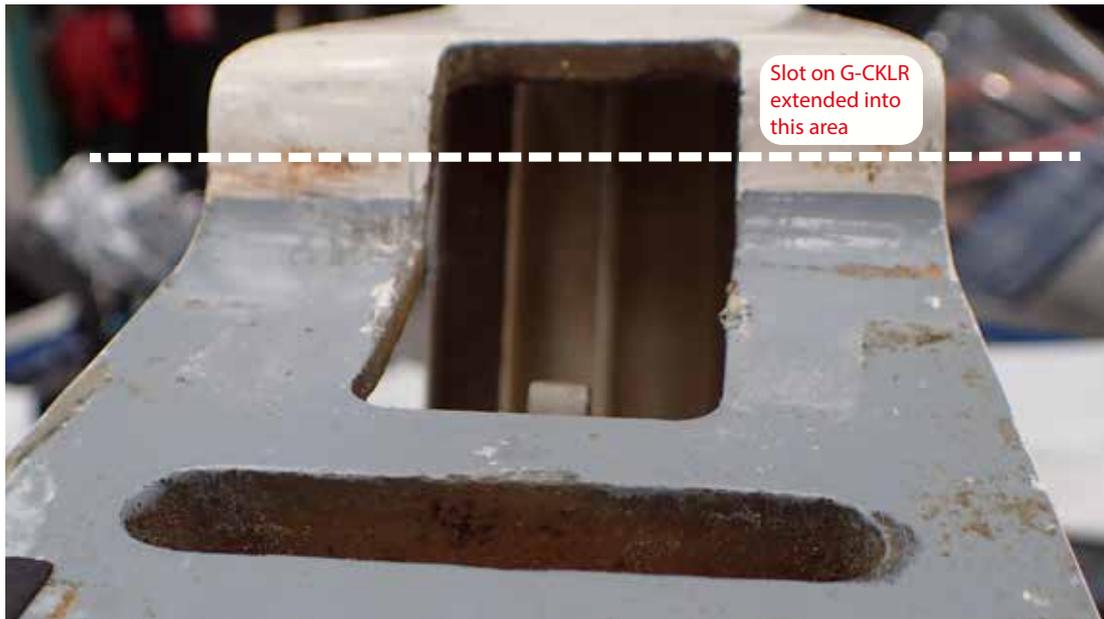
The design dimensions of the elevator slot in the horizontal rib of the tail fin should be 34 mm x 35 mm. The horizontal rib exhibits an approximately vertical step-change in profile towards its aft end. The design drawings indicate that the elevator lever slot should extend only partially up this vertical step, to a position which is approximately indicated by the dashed line in Figure 8. However, on G-CKLR this slot extends up the entirety of the vertical step and onto the upper rib cap.

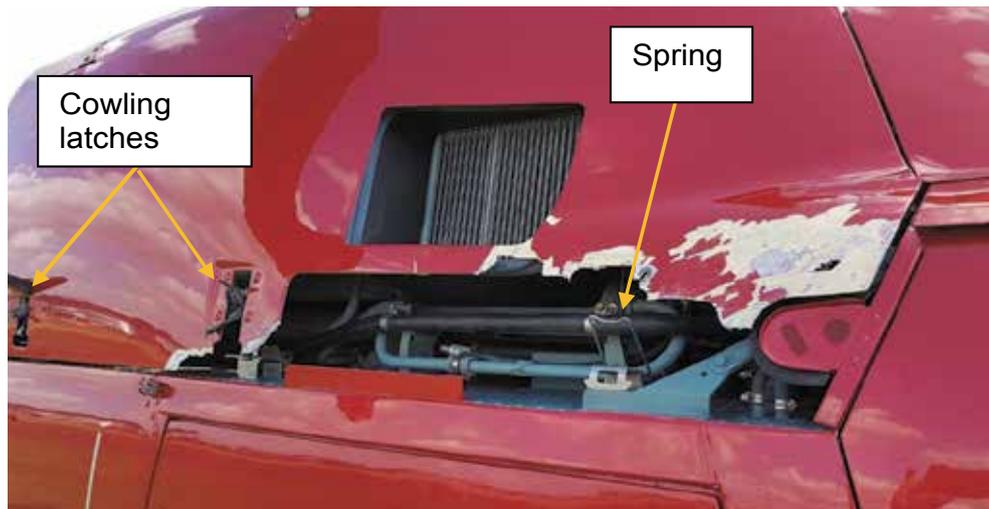
Figure 1

After flying for approximately one hour the pilot returned to land. During the flare he became aware of an unusual noise and landed immediately. Examination of the helicopter showed that the lower forward edge of the right engine cowling was damaged, the forward cowl latch assembly was missing and the centre latch had been damaged (Figure 1). Damage was also observed on the inboard sections of all the main rotor blades.

G-SWNG right engine cowling

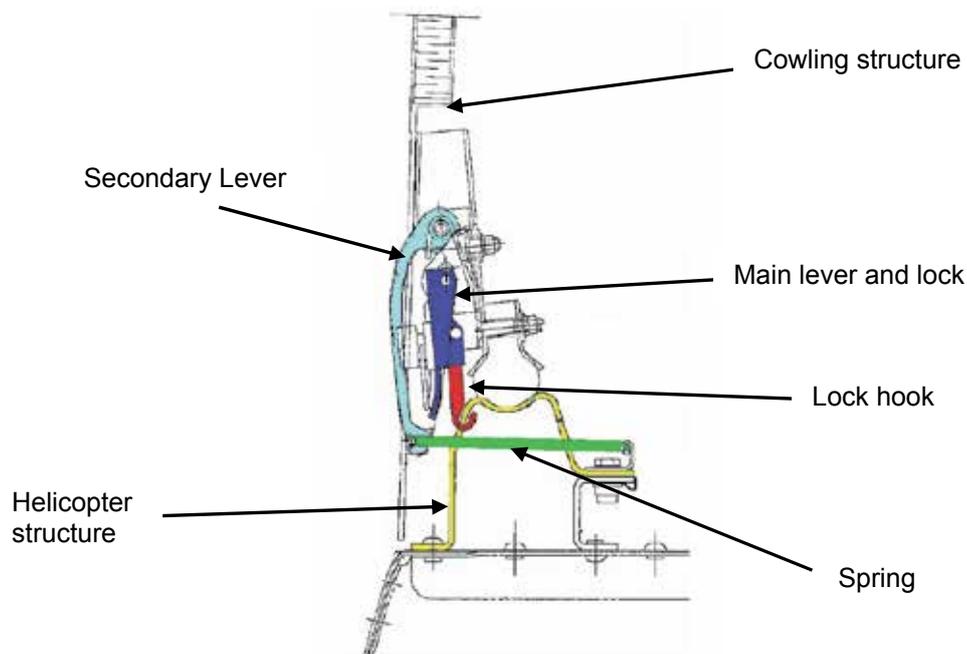
Figure 2

The engine cowlings on the EC120B are hinged to open upwards. Each cowling is held in the closed position by three hooked latches which engage with fixings on the helicopter structure (Figure 2). Closing the main lever of each latch places the latch hook under tension, securing the cowling to the structure and locks the main lever in the closed position. The secondary lever will not close if the main lever is not in the locked position, providing a positive indication of an unlocked latch. When the secondary lever is closed a spring can then be moved over the tip of the secondary lever to prevent it from opening.

Engine cowling latch diagram (courtesy of Airbus Helicopters)
