AAIB Bulletin

5/2018

Published 10 May 2018

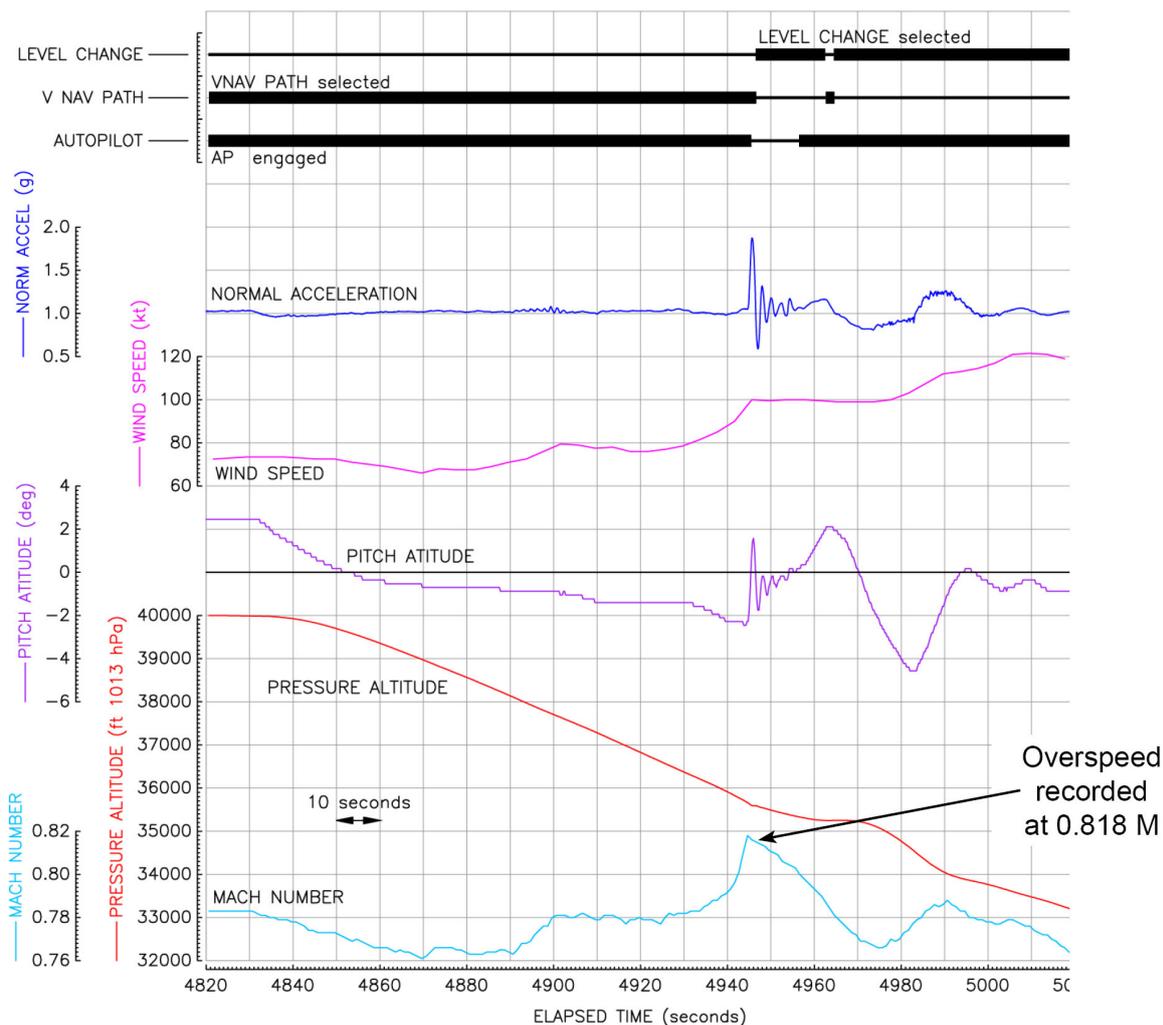
Figure 2
Recorded information

Parameters relevant to autopilot disconnection for this accident were recorded. The sample rate was such that the timing of disconnection could be determined within a window of 0.3 s. The column force exerted by the commander rose above the autopilot disconnect threshold of 21 lb during such an interval of 0.3 s. Accordingly, it was not possible to determine whether autopilot disengagement was caused by force override or by the commander's use of the autopilot disengage button.

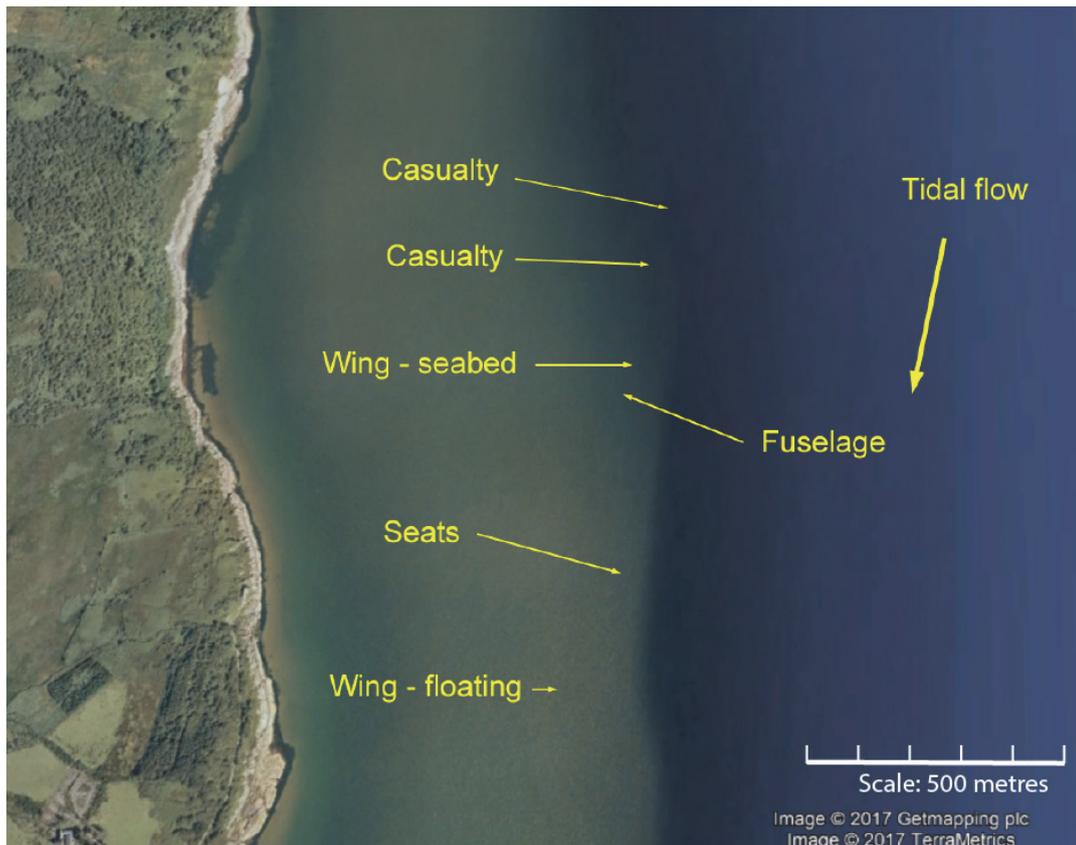
Figure 1

The locations of the casualties and wreckage extended over an area 800 m long and are plotted in Figure 1. It is possible that in the 12 days between the accident occurring and the underwater search beginning, some items of wreckage might have moved as a result of the extensive bottom trawling that is carried out in this area.

At the time of the accident, the wind was calm and the predicted tidal flow was 0.2 kt to the south; therefore, the floating section of wing could not have been the same section of wing found on the seabed. Given the tidal flow, it is likely that the floating wreckage may have settled in an area south of the accident site where submerged cables between Skipness Point and Arran are routed along the seabed; an underwater search could not be conducted in this area. The wreckage might also have remained afloat for some considerable time and moved further down the Firth of Clyde.

Reported position of casualties and wreckage

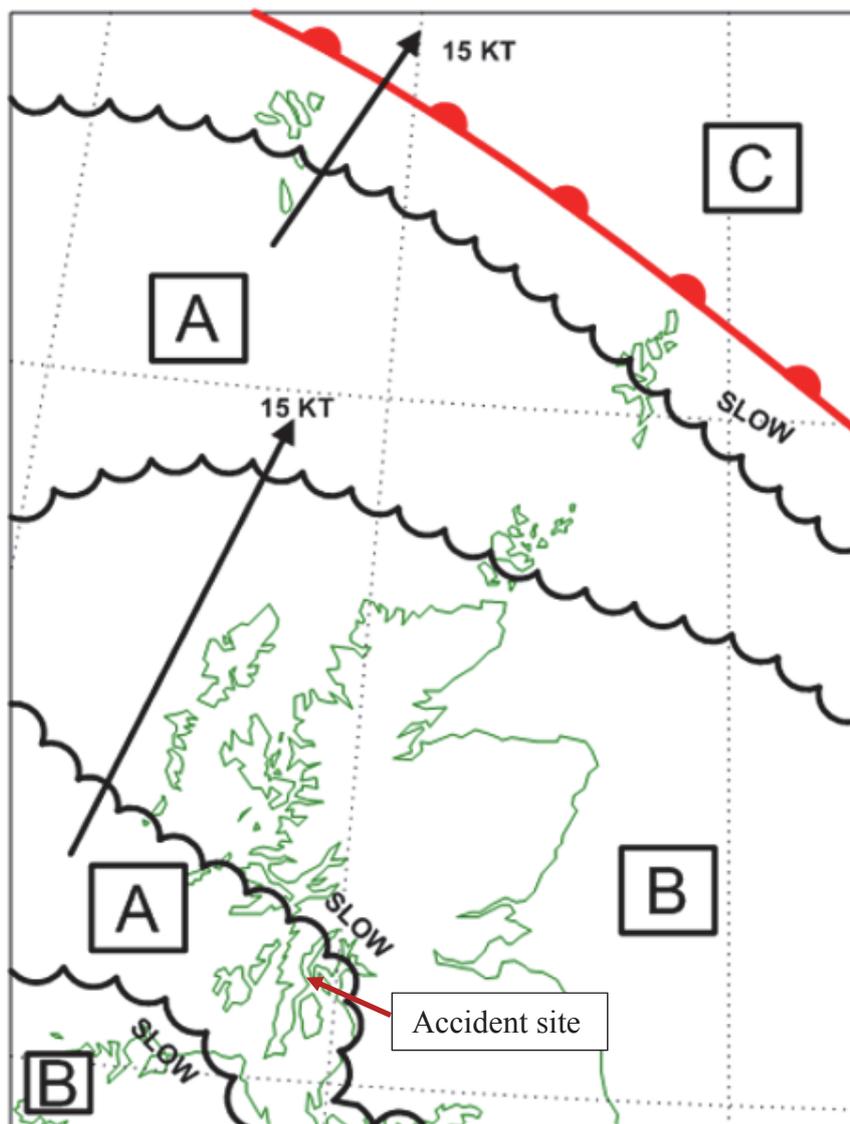
The Met Office forecast (below 10,000 ft), which was valid from 0800 hrs until 1700 hrs on 25 May 2017, reported extensive areas of poor visibility extending from the Irish Sea into Loch Fyne. The wind at 1,000 ft in the area of Skipness was forecast to be from the south at approximately 12 kt. The synopsis map is at Figure 2 and the accident occurred in Zone A. The Met Office text relating to Zone A reported:

Widespread 3000 M in mist and occasional 200 M in fog, along with widespread hill fog. Isolated moderate turbulence was forecast near the fog until 1100 UTC. Cloud structure (all heights AMSL) was expected to be widespread stratus with bases 200-600 FT with tops 1500 FT, bases on the surface were allowed for in fog. Above this stratus, isolated areas of broken stratocumulus were expected in the far N.'

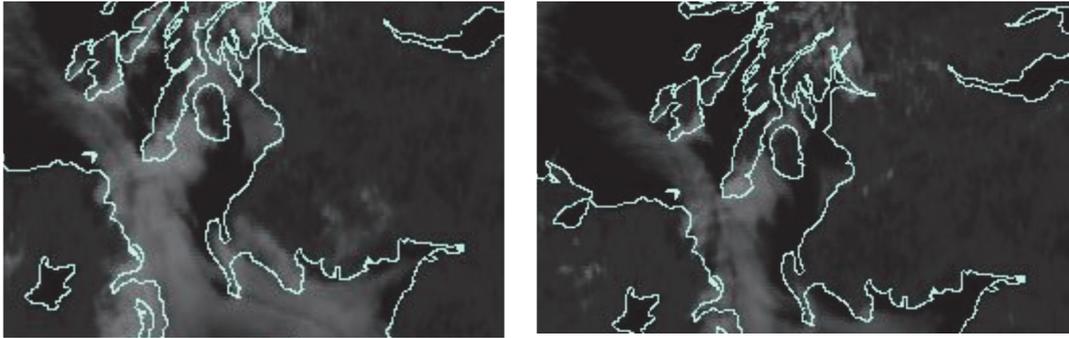
Figure 3

The Met Office high resolution visible satellite images taken at 1000 hrs and 1100 hrs on 25 May 2017 show areas of stratus or fog extending into Loch Fyne, with clear areas to the lee of high ground (Figure 3).

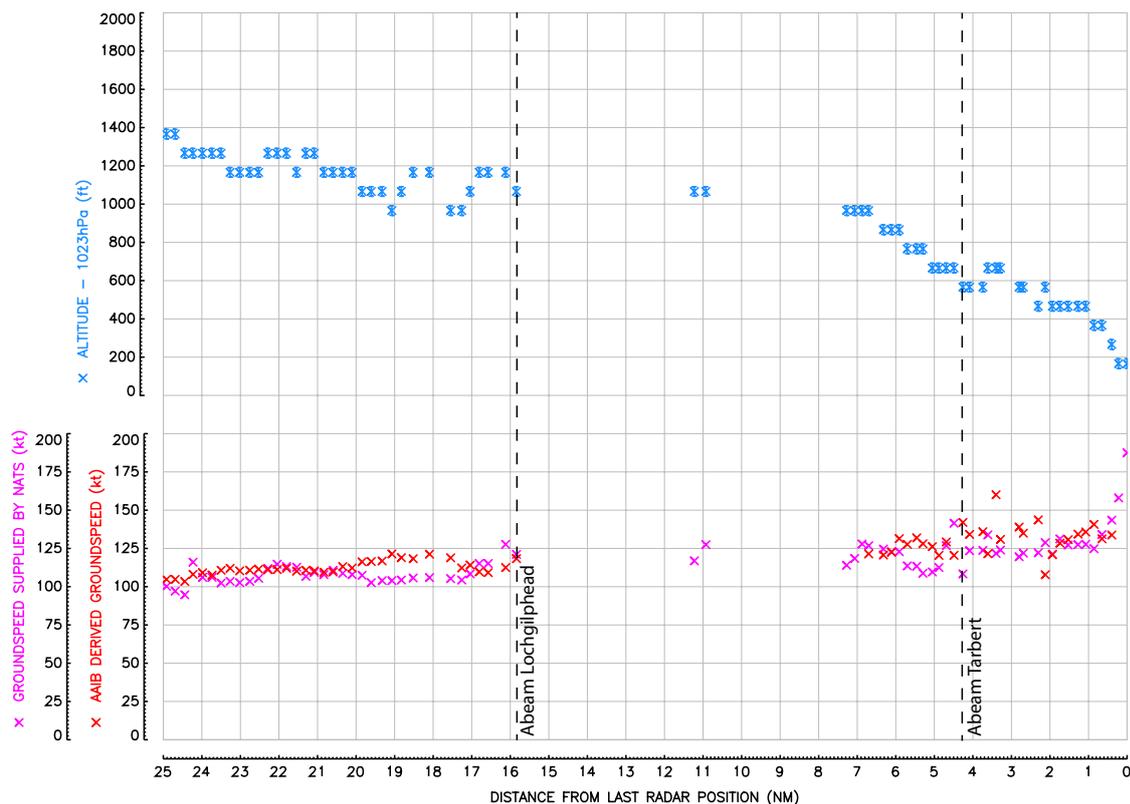
From the radar data, the AAIB was able to derive the aircraft's approximate groundspeed using a moving average calculation, which has been plotted, along with the altitude, at Figure 5 against the distance from the last radar return. There is a gap in the radar data as the aircraft passed Lochgilphead and before it was picked up by the second radar head.

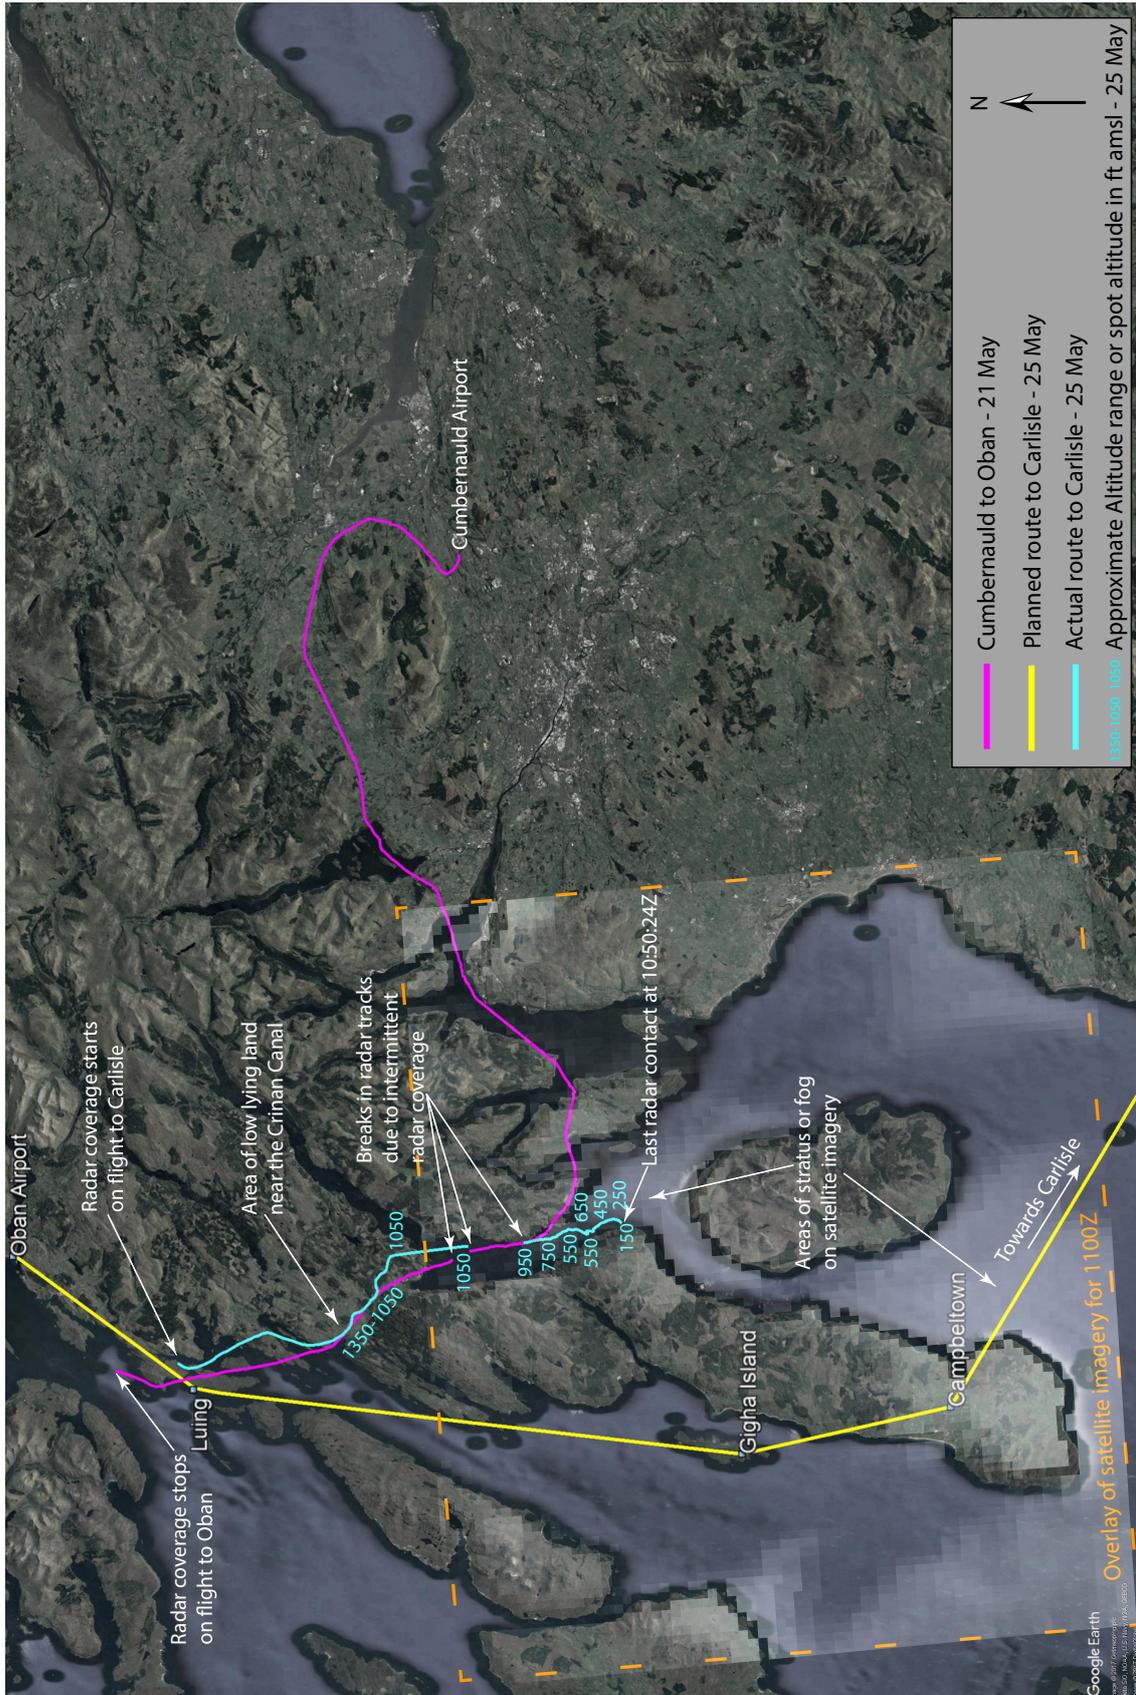
On 25 May 2017, G-CEOF initially followed the planned route from Oban to the island of Luing, but then deviated inland flying along the Crinan Canal towards Lochgilphead, before heading south down Loch Fyne towards the Isle of Arran. The radar data showed that G-CEOF was abeam Lochgilphead at 1042:41 hrs at a height of 1,050 ft and then flew for a further 15 nm down Loch Fyne with the last radar return occurring 7 minutes 43 seconds later when it was at a height of 150 ft. During the first 10.1 nm from Lochgilphead, the aircraft descended approximately 300 ft until it was at a height of 750 ft abeam Tarbert. During the next 4.9 nm, there was an increase in the rate of descent which was estimated to be approximately 500 ft/min towards the end of the flight.

Plotted at Figure 6 are the radar tracks for the flights from Cumbernauld Airport to Oban on 21 May 2017, the accident flight, and the planned route to Carlisle stored on the company’s servers. The tracks are overlaid with the Met Office satellite imagery taken at 1100 hrs on 25 May 2017.

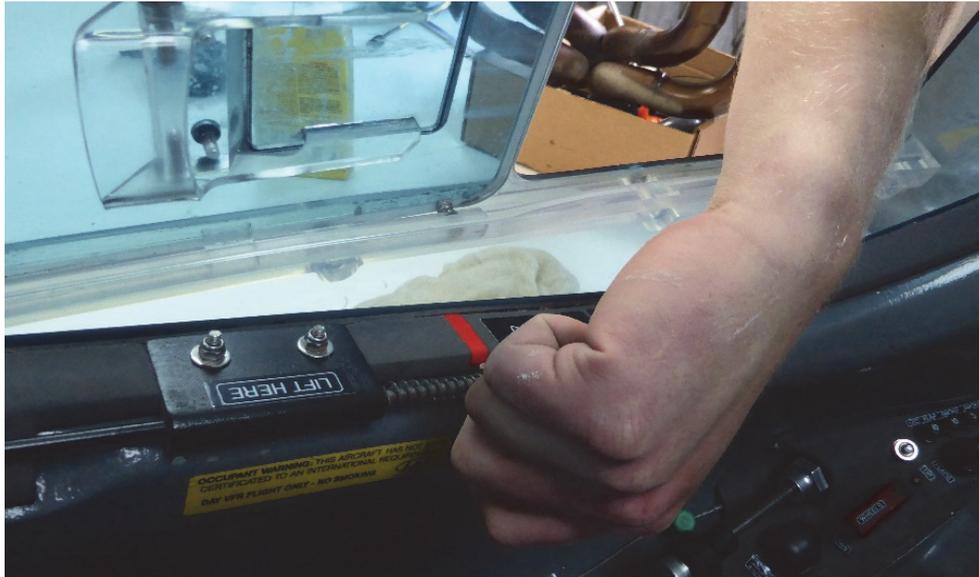
Figure 5

There are no canopy opening or jettison handles on the outside of the cockpit; however, it can be unlatched by reaching through the small ventilation window and operating the white handle (Figure 5). There were no instructions visible from outside the cockpit explaining how the canopy is opened.

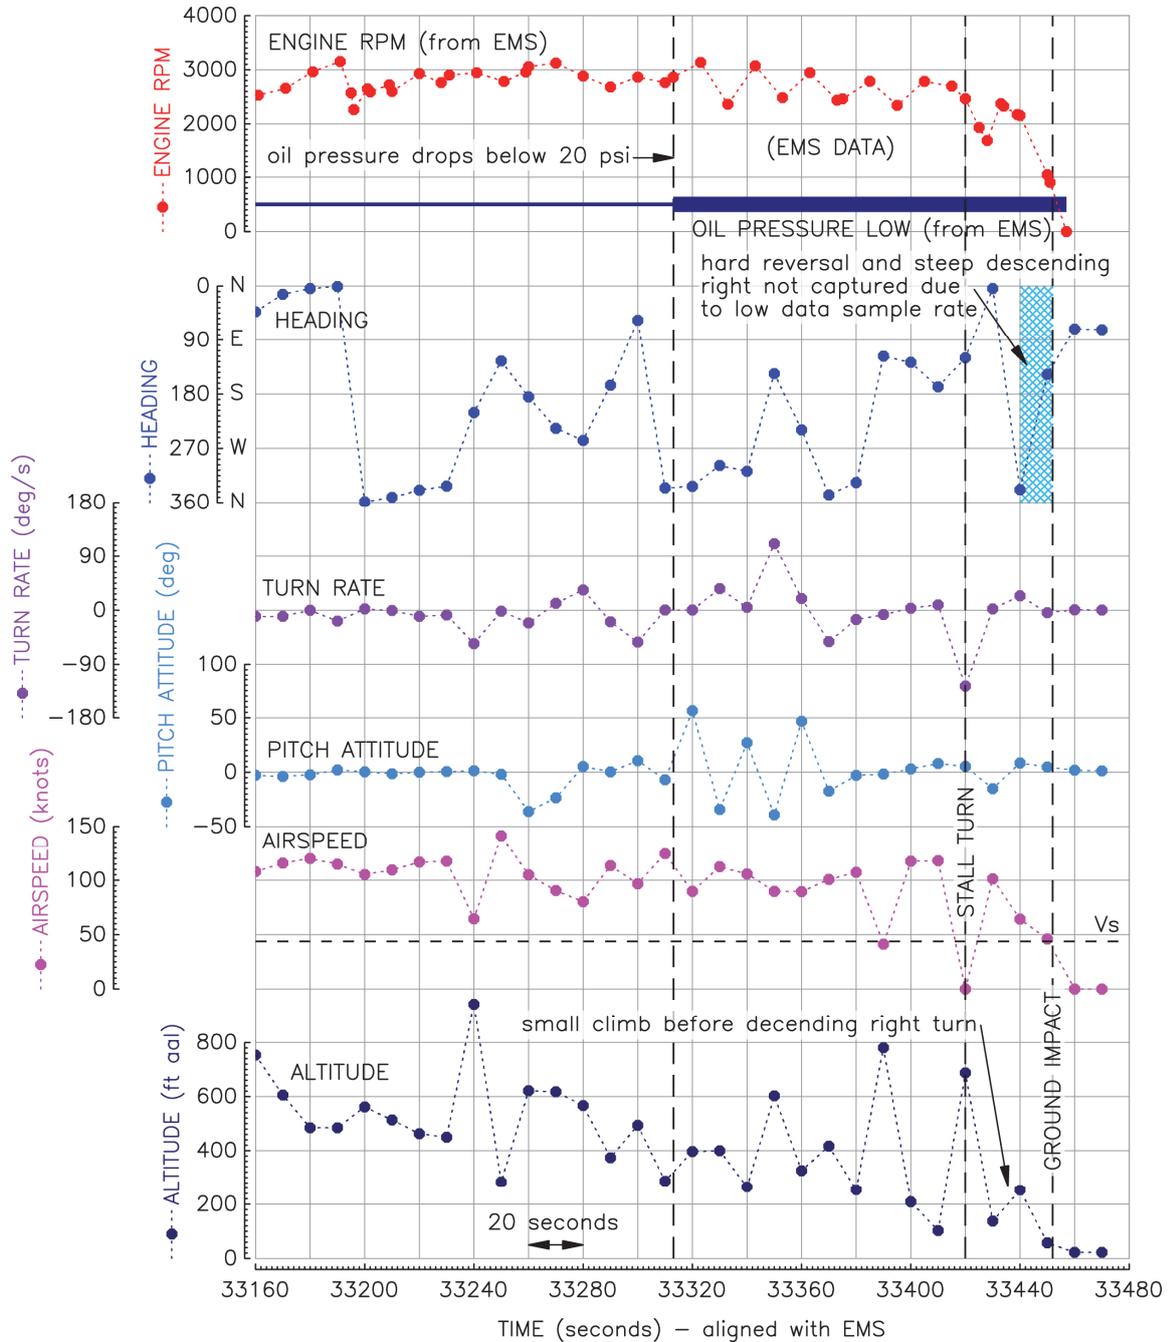
Figure 8
EFIS recorded flight data – accident flight

Figure 8 shows flight data from the EFIS starting as the aircraft descended to the start the display sequence and ending with the aircraft on the ground. EFIS times have been adjusted to align them with EMS. Figure 8 shows when the oil pressure dropped below 20 psi (generating an EMS low pressure warning – also plotted with engine rpm from EMS), the point in the flight where G-JINX performs a stall turn and when (based on timing from video evidence) it struck the ground 32 seconds later.

From video evidence, the right turn and descent to ground impact took 12 seconds, so are not evident in the EFIS data because of the low data sampling rate. However, the turn was through about 180° initially at 65 kt airspeed at about 250 ft aal. During the first half of the turn the bank angle was held at about 45° without significant height loss. The aircraft then began to descend as the bank angle increased and the nose dropped (Figure 9). At just under 60 ft aal the airspeed had reduced to 46 kt, after which the wings were levelled and the nose was raised to a slightly nose-down attitude at impact.

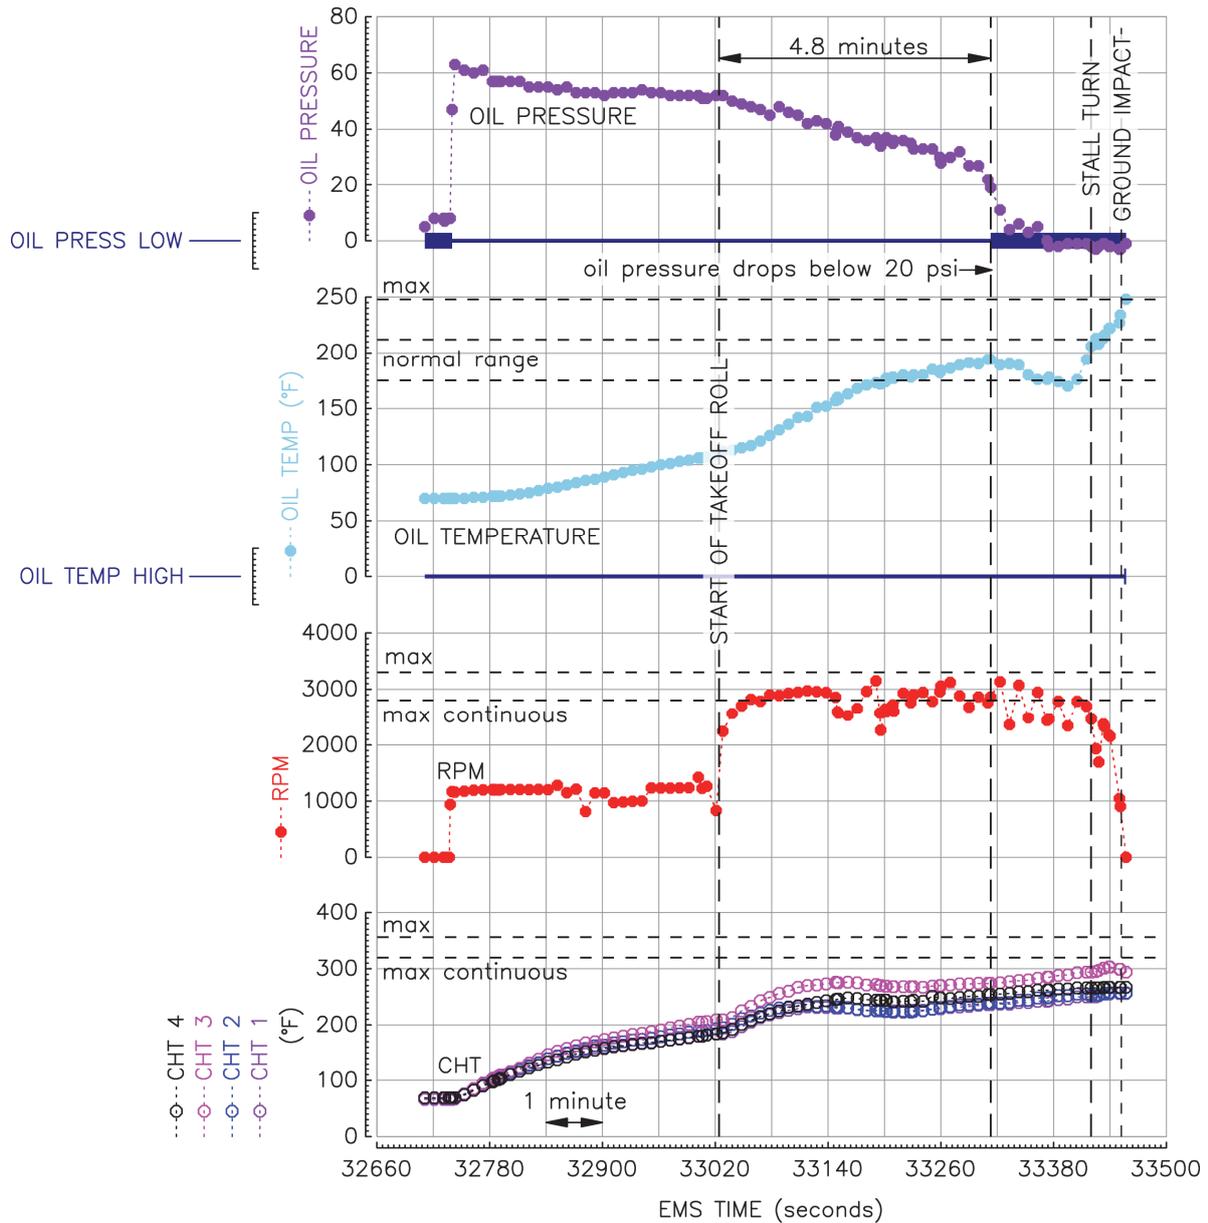
Figure 10
EMS recorded engine data - accident flight

The investigation found that the engine seized following the loss of its oil during the accident flight.

Figure 10 shows relevant engine data from the EMS. It indicates that the time between the increase in engine speed (time 33030, which corresponded to the start of the takeoff roll), and the low oil pressure warning was 4.8 minutes. During this period, as the oil temperature increased and the oil pressure decreased, engine rpm varied around 2,800 rpm (maximum continuous) and peaked briefly at 3,151 rpm. The CHTs also increased with the No 3 cylinder operating between 20 and 30°F hotter than the hottest of the other three cylinders (cylinder No 4). After approximately 4 minutes, the oil pressure had decreased to 30 psi. It then continued to decrease below 20 psi, generating the low pressure warning and reaching zero one minute later. The engine continued to rotate for a further 1.5 minutes.

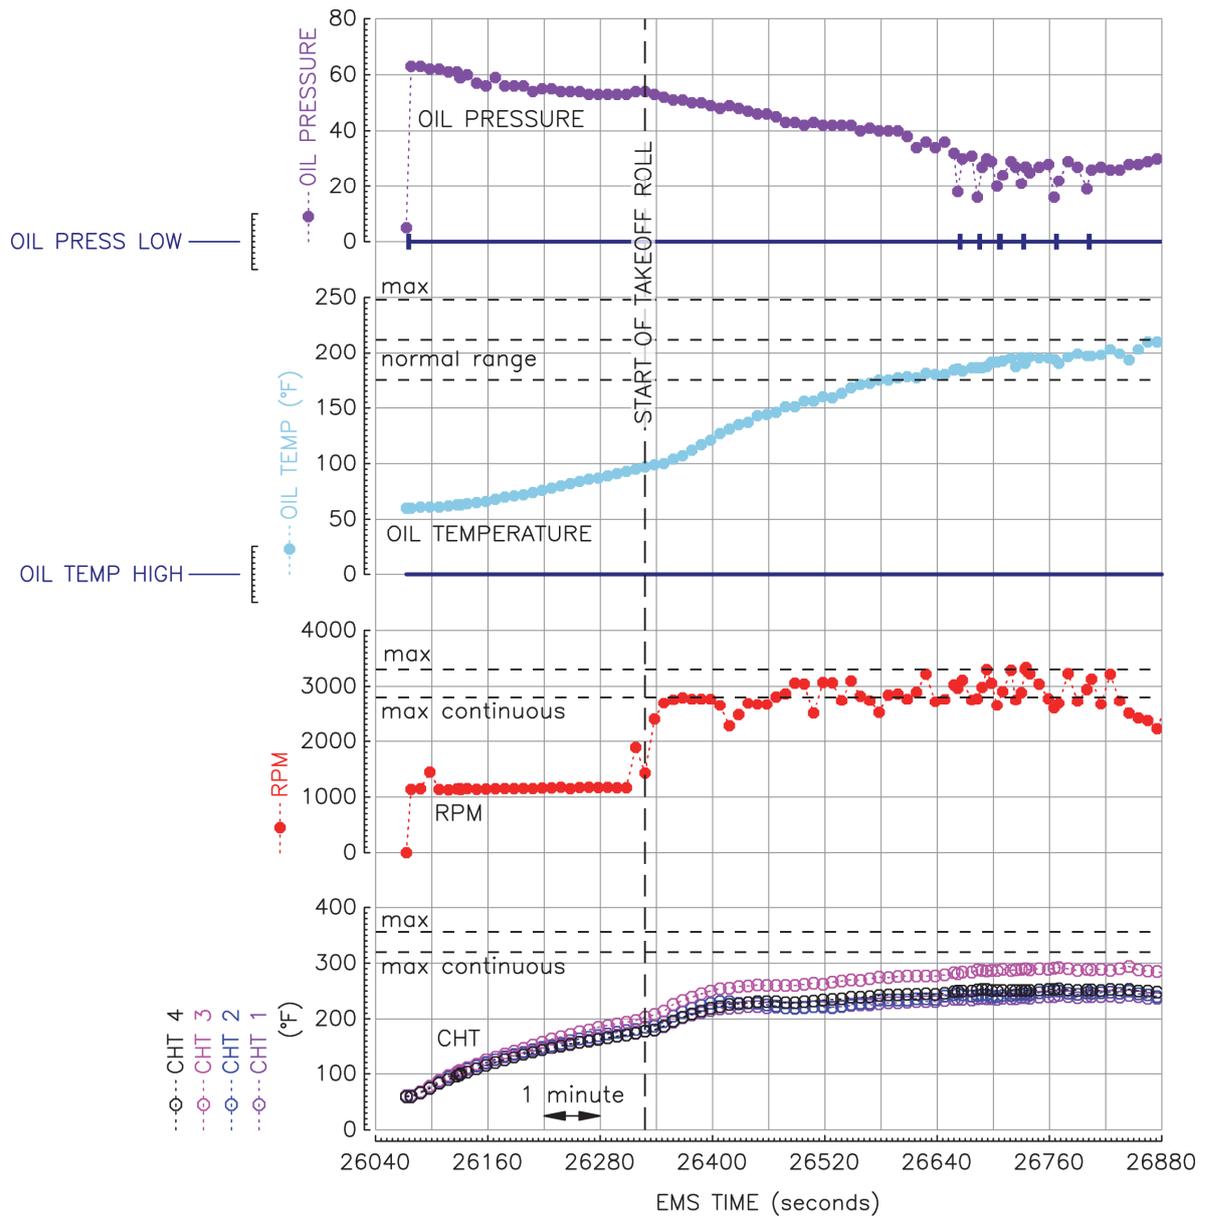
Figure 11

Data from the accident flight was compared with data from a previous flight during which the aircraft flew the same display routine (Figure 11). The engine rpm, oil pressure, oil temperature and CHT profiles (including the hotter running No 3 cylinder) were similar on both flights until five minutes after the start of the takeoff roll, when both oil pressures decreased to below 30 psi. During the earlier display flight there was then a 2.5 minute period in which the oil pressure fluctuated between 16 and 30 psi, causing the low oil pressure warning to activate six times.

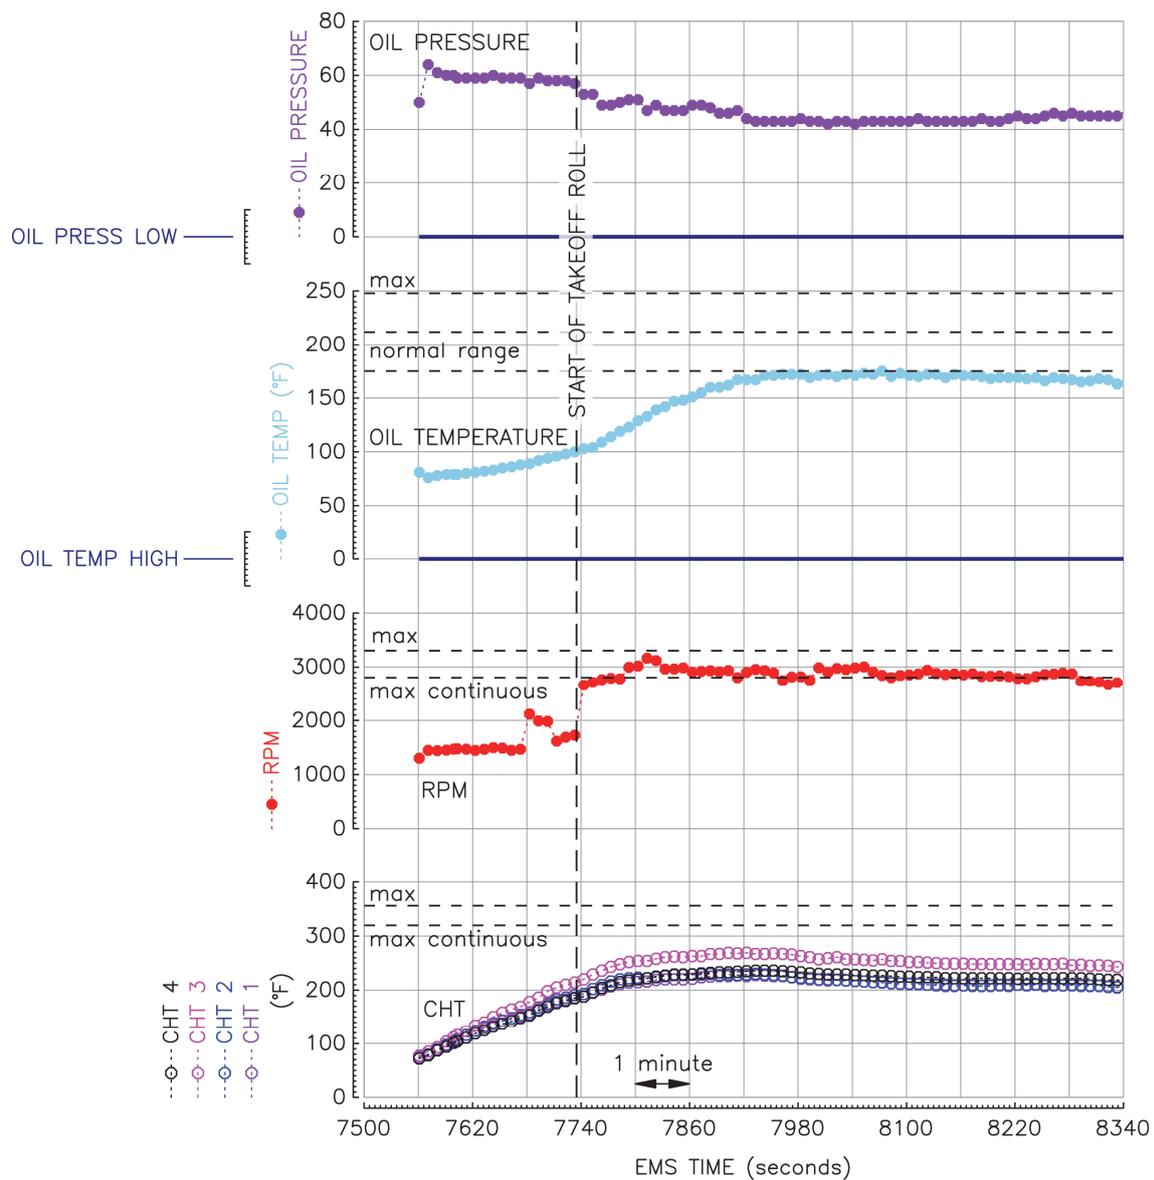
Figure 12
EMS recorded engine data - earlier cruise flight

Engine data from the display flights was also compared with data from the aircraft when it was in cruising flight (Figure 12), during which oil pressure was 43(±2) psi and the oil temperature was stable at 175° F (the lower end of the normal range). The CHTs were also approximately 30° F cooler, with the No 3 cylinder again running hotter by about 20° F.
