# Rail Accident Report

## **Passengers struck by a flying cable at Abergavenny (Y Fenni) station 28 July 2017**

Report 06/2018  
May 2018

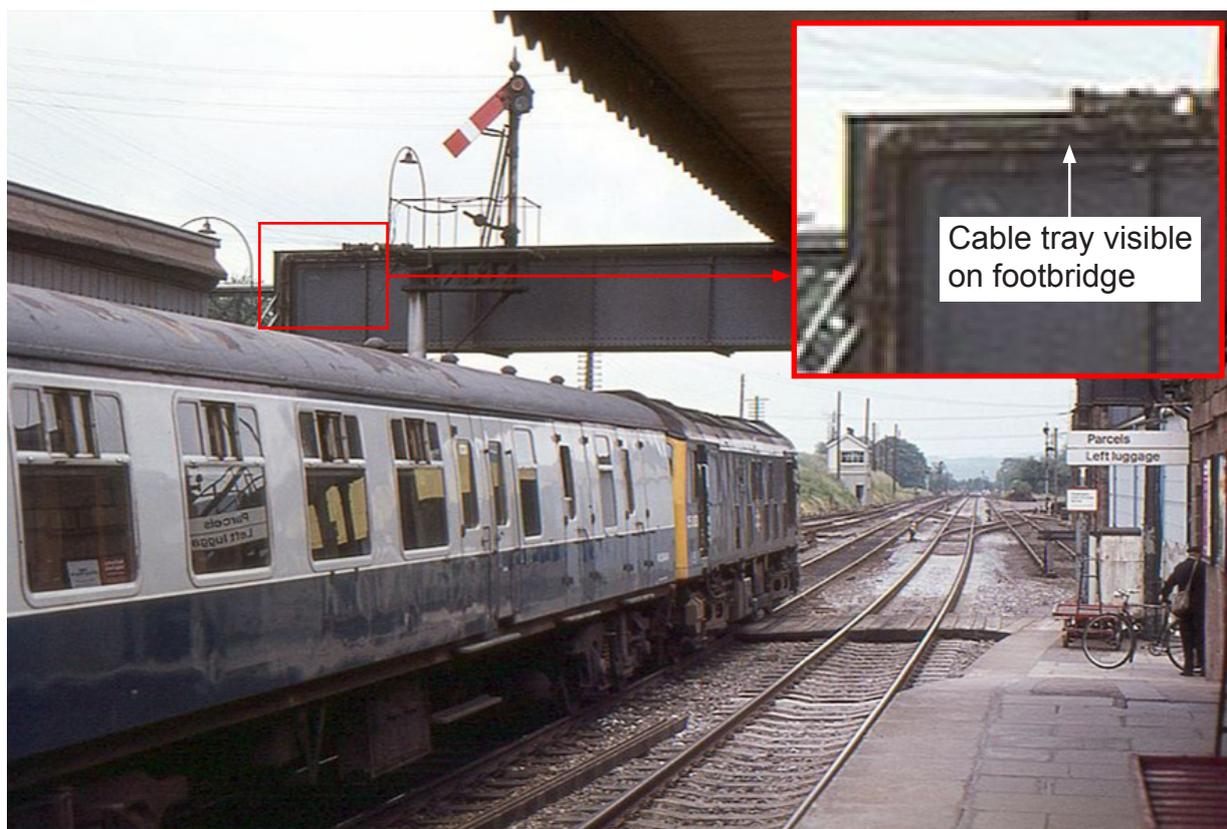
- 13 Historic photographs of the footbridge at Abergavenny station show that the original lattice footbridge span was replaced during the 1950s with a plate girder bridge. A photograph from 1977 (figure 5) shows a cable tray running over the footbridge in the same position as at the time of the accident. It is possible that the cable tray was replaced in the early 1990s as a photograph from 1992 (figure 6) shows a brighter silver coloured cable tray standing out against the footbridge background.

Figure 5: Abergavenny station and footbridge in 1977 (image courtesy of Mark Carter)

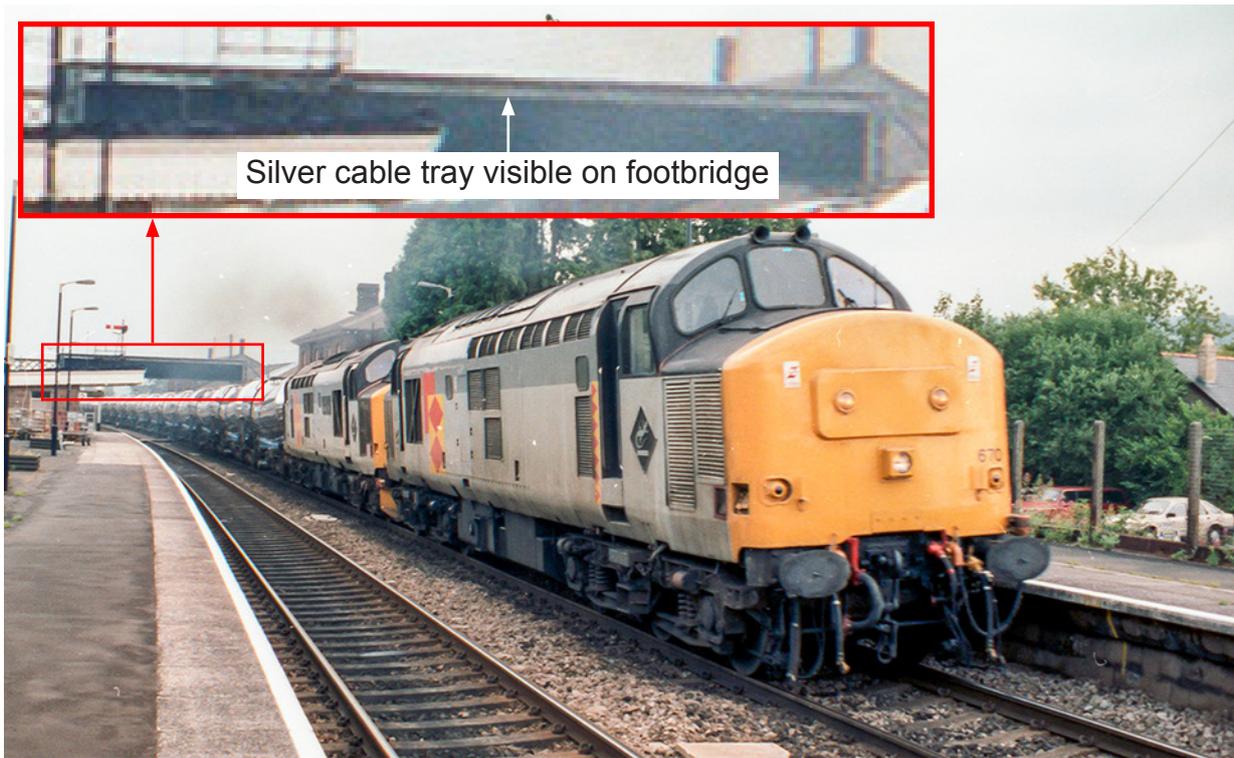
Figure 6: Abergavenny station and footbridge in 1992 (image courtesy of Brian Tucker)

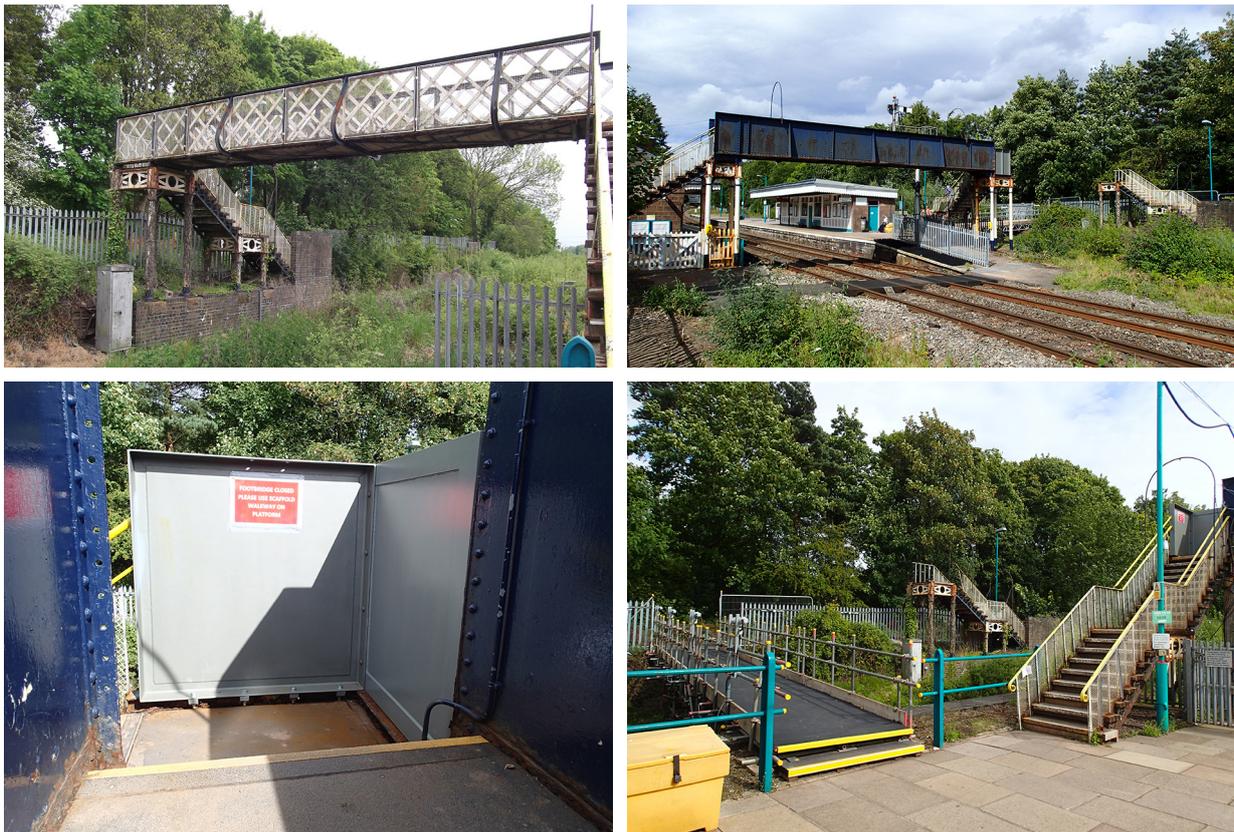
- 15 The footbridge comprised two spans: a girder span over the operational railway and a lattice span over a disused track bed (figure 8). Network Rail had identified that the lattice span was in a poor condition and required attention so it contracted Centregreat Engineering to remove the lattice span so it could be examined and refurbished. The contract also included installing a corner section at the top of the centre footbridge stairs and building a temporary walkway from platform 2 over the disused track bed to the bottom of the far set of footbridge stairs (figure 8), to maintain the public right of way. This work was scoped during December 2016 and planned to take place during the first half of 2017.

- 16 The lattice span was lifted out during the night of 15-16 July. Photographs of the footbridge taken before and after this work show that the cable's position had not changed (figure 7). Further work took place during the night of 27-28 July to correct minor issues that had been reported. The only work carried out on the footbridge was to extend the handrails at the top of the central flight of stairs so that they could be attached to the new corner section. The RAIB found no evidence that this work affected the cable tray or the cables attached to it.

Figure 8: From top left clockwise: The footbridge lattice span, the footbridge after the lattice span had been removed, the temporary walkway to platform 2 over the disused lines and the footbridge corner section (top left image courtesy of Network Rail)

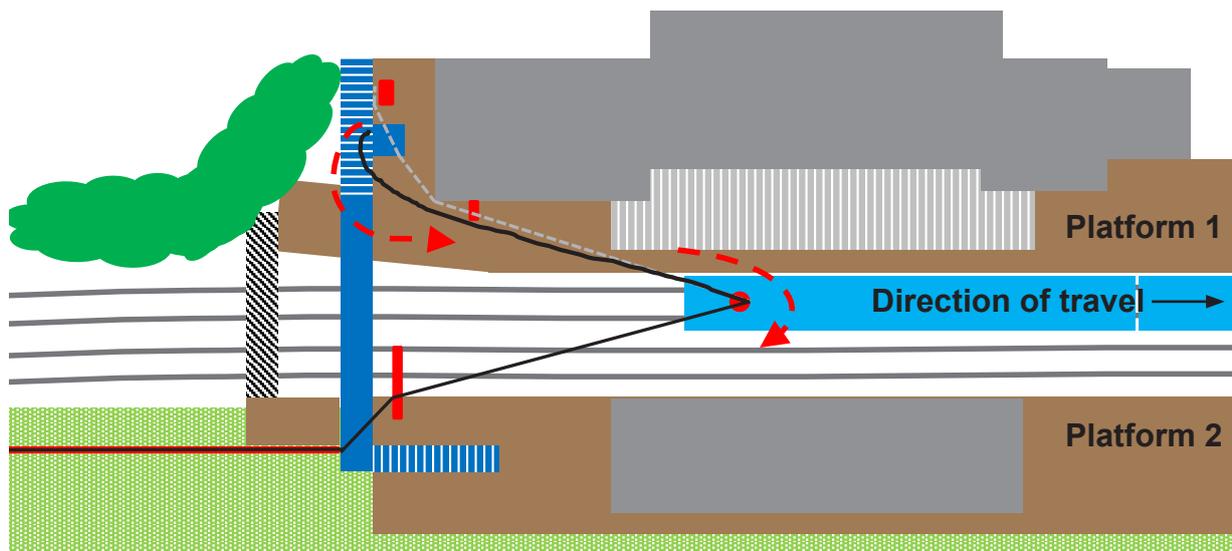
20 The electrical supply cable was pulled until no further movement was possible, at which point the end of the cable that was terminated within a distribution cabinet at the foot of the footbridge stairs broke free. Once loose, the free end of this cable whipped round and struck a group of passengers on the footbridge stairs (figure 11) causing minor injuries to three of the group. There were no injuries to anyone on the platforms although a member of station staff was nearly struck (paragraph 4). The cable came to rest on the Down Main line next to the train, with its end resting on platform 2 (figure 12). The telecommunications cable snapped during the accident, with a length of it also coming to rest on the Down Main line. This cable is not reported to have injured anyone.

Figure 11: Diagram showing the position of the electrical supply cable once it broke free

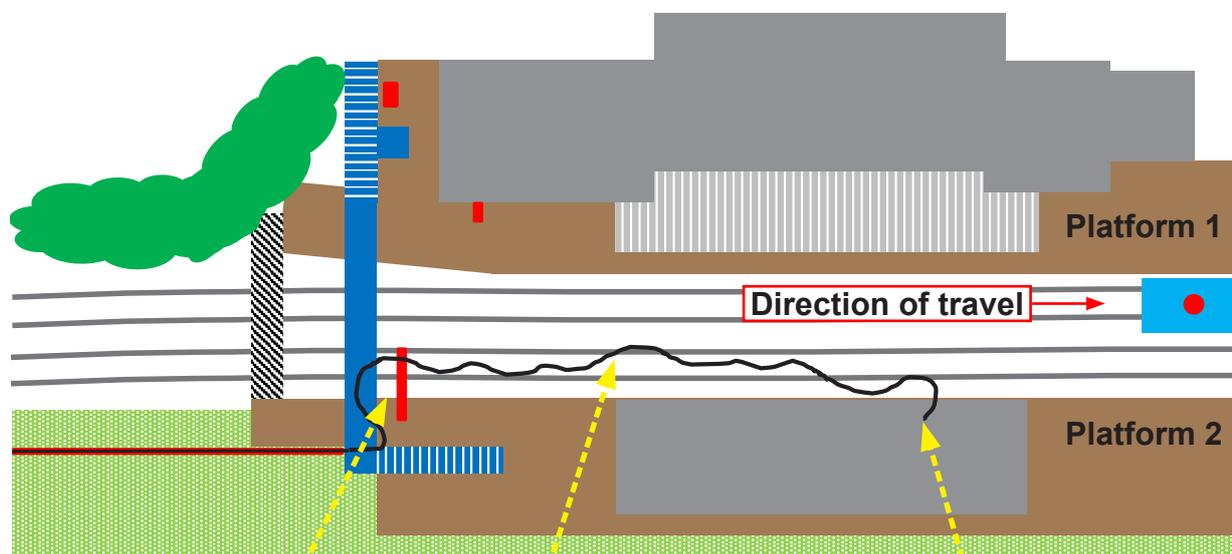
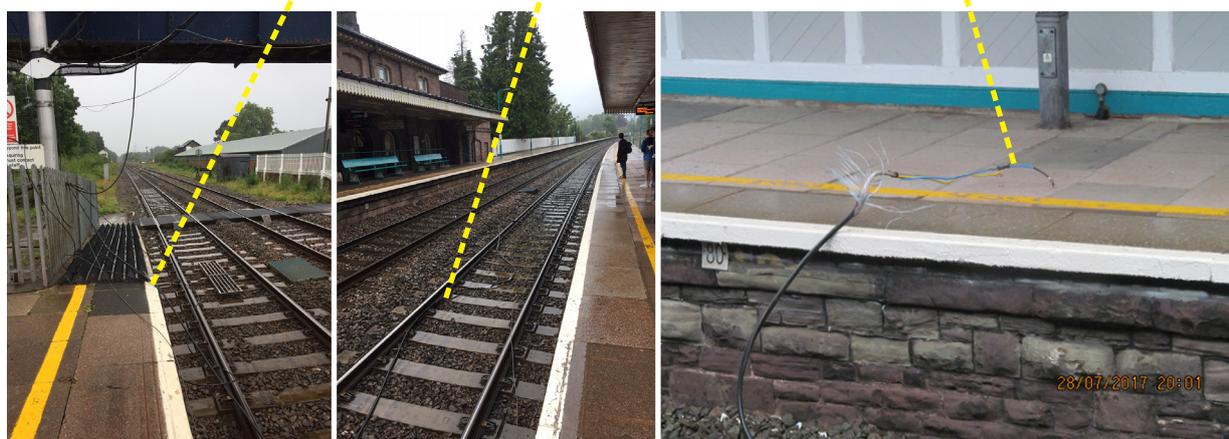
Figure 12: Diagram and photographs showing the position of the electrical supply cable after it came to rest (left and middle images courtesy of Network Rail, right image courtesy of British Transport Police)

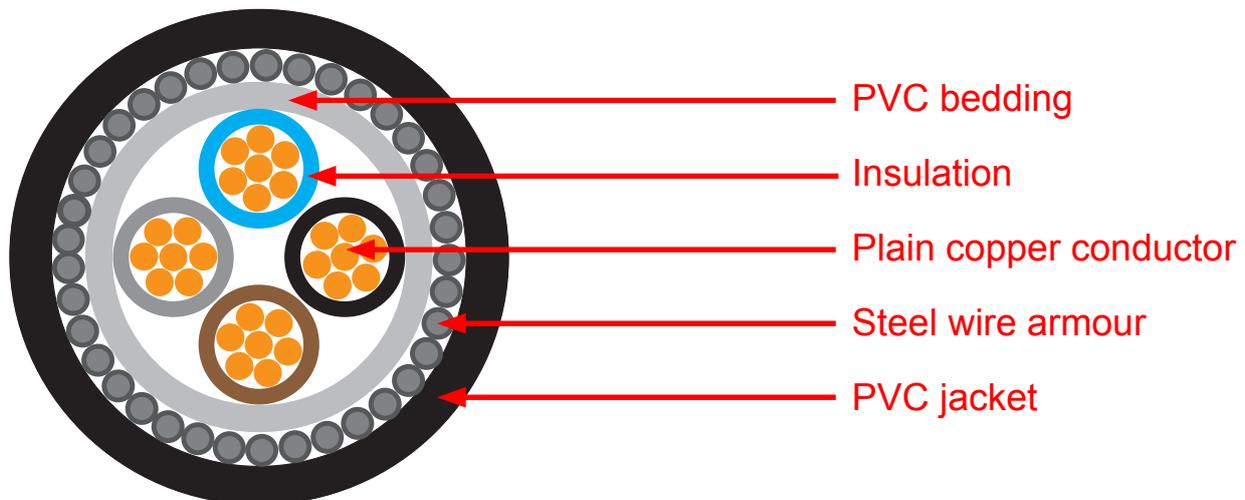
- 30 The electrical supply cable ran from the distribution cabinet at the station, over the footbridge, to the signal box. It was a four core steel wire armoured cable (figure 13), rated for 600/1000 V, with a diameter of about 25 mm. A cable of this construction and diameter typically weighs about 1.3 kg per metre length. Its manufacturer estimates it has a breaking load of about 30 kN (about 3 tonnes), which made it more likely that the cable would break at its termination point rather than breaking along its length, when it was pulled.

Figure 13: Diagram showing the construction of a steel wired armour cable

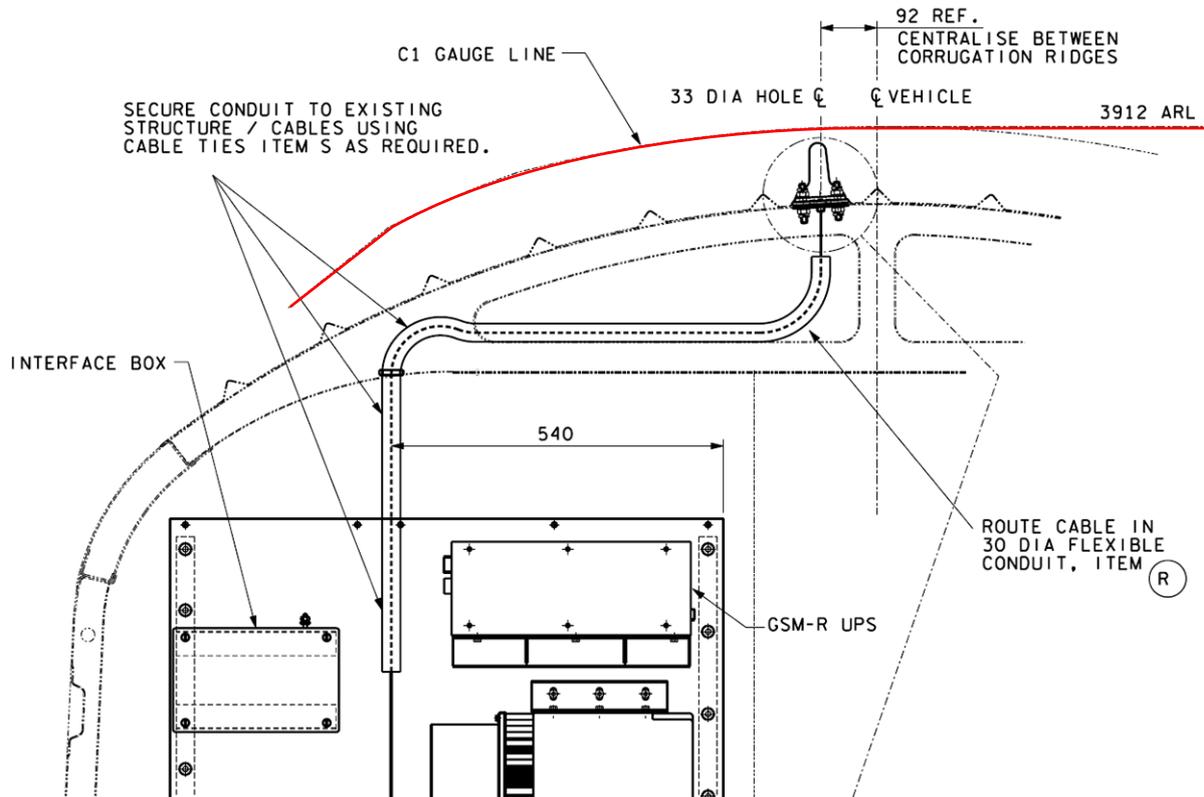
- 35 The installation drawing for the modifications made to the DVT when its radio equipment was installed shows the top of the antenna is within the limits of the relevant profile by about 25 mm (figure 15). The height of the antenna was assumed by the designer of the installation to be at the maximum ride height for the vehicle, ie when in tare condition and with new wheels (ie maximum wheel diameter). Therefore the height of the radio antenna was compliant with the requirements of GE/RT8073 and in a normal position relative to the railway's infrastructure.

Figure 15: Extract from the drawing for installing the radio antenna to the DVT (drawing courtesy of Network Rail)

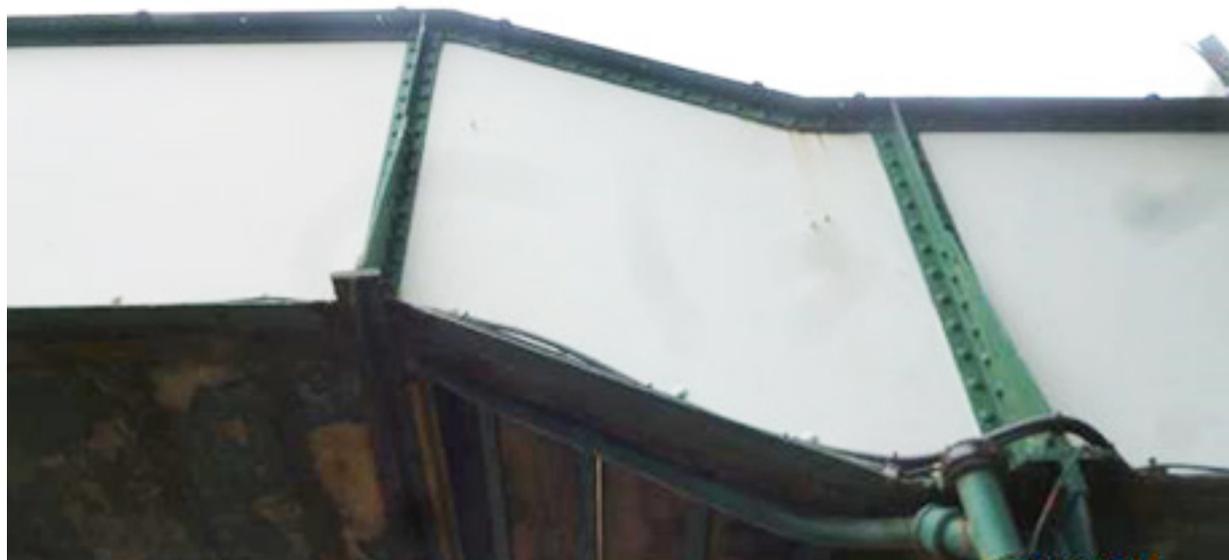
- 84 As a result of the accident, Network Rail Wales Route carried out a review of cable and cable containment running over its station footbridges. It reviewed its inspection photographs for 85 station footbridges and identified that 55 of these had cables running over them. Of these, nine had cables attached to the external structure of the footbridge; in eight of these cases the cable routing was contained within the footbridge structure such that the cable could not droop significantly if any fixings broke. The only example found of a cable with the potential to droop was the footbridge at Helsby station (figure 24). Network Rail has reported to the RAIB that work is underway to refurbish this footbridge and that the cables will be rerouted during this work.

Figure 24: Cables routed on the outside of the footbridge at Helsby station (image courtesy of Network Rail)
