Rail Accident Investigation Branch

Rail Accident Report

Collision at Stainforth Road level crossing, 11 January 2018

Report 08/2018
July 2018

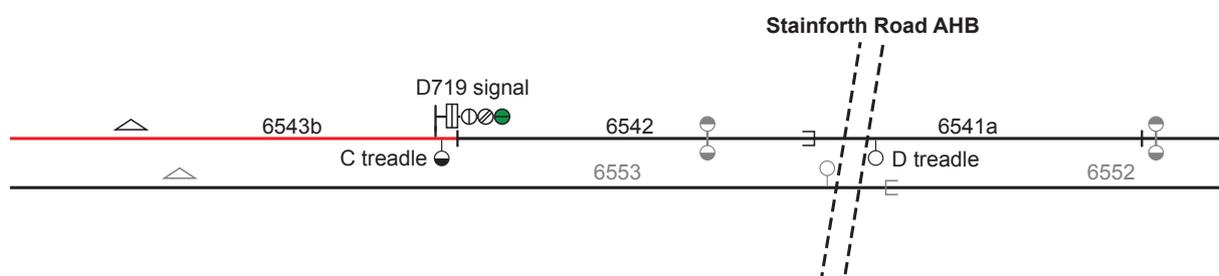
Figure 8: A train approaching on the Down Skellow line occupies track circuit 6543b

27 With D719 signal showing a green (proceed) or yellow (caution) aspect, trains approaching Stainforth Road AHB on the Down Skellow line will ‘strike-in’⁴ when they occupy track circuit⁵ 6543b, which is located on approach to the signal (figure 8). ‘Striking-in’ will cause the crossing’s control circuits to initiate the road closure sequence. This means that the road traffic lights and audible alarms will activate and the half-barriers will drop (paragraph 9). Just beyond D719 signal, the wheels of an approaching train will operate treadle⁶ ‘C’ (figure 9). This will register the presence of the train at this location within the level crossing’s controls.

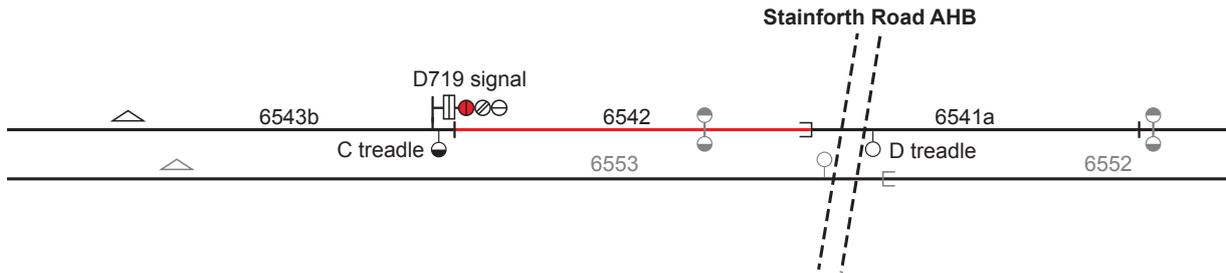
Figure 10: A train approaching on the Down Skellow line clears track circuit 6543b and occupies track circuit 6542

28 As the train continues to approach the crossing, track circuit 6542 will become occupied and track circuit 6543b will clear (figure 10). Occupying track circuit 6542 or operating treadle ‘C’ will also activate the road closure sequence if track circuit 6543b has not already done so (this would be the case if D719 signal is passed while showing a red (danger) aspect).

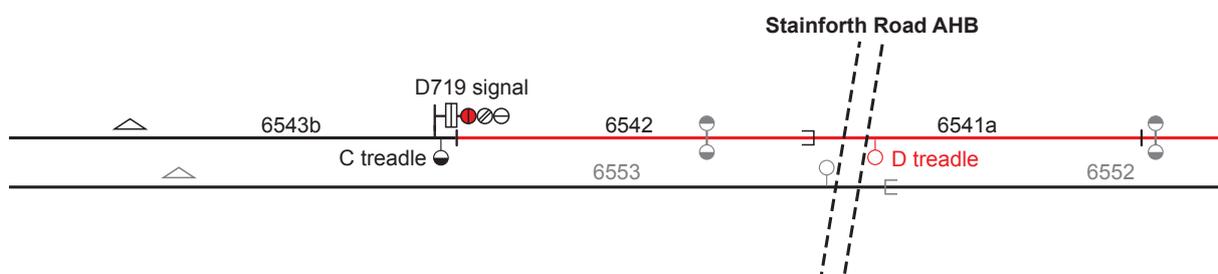
Figure 12: A train on the Down Skellow line operates Treadle D as it exits the crossing

- 31 Having entered track circuit 6541a, the front of the train passes over and leaves the crossing surface. About 4 metres beyond the crossing, the train's wheels will operate treadle 'D' (figure 12). Providing the control circuitry of the crossing has previously stored the operation of treadle C and can confirm that the road closure has been called and that the barriers remain down, the operation of treadle 'D' signifies to the controls that the crossing function and direction of the train has been proved. This information will again be stored by the control circuits.

- 32 The rear of the train will then clear track circuit 6542. Providing the crossing function and direction of the train has been stored, the clearance of this track circuit will cause the crossing re-opening sequence to start.

- 33 Stainforth Road AHB will therefore start to re-open to road traffic when the rearmost axle of an approaching train passes a point around 17 metres on approach to the crossing. Allowing a nominal 3 metres for the overhang of a wagon's body, and taking into account the 11 metre width of the crossing's surface, trains on the Down Skellow line will therefore have to travel around 31 metres after the crossing's re-opening sequence has started, before they completely clear the crossing's surface. For a train travelling at the maximum permitted linespeed of 50 mph (80 km/h) this will take about 1.4 seconds.
