AAIB Bulletin

8/2018

Aircraft Type and Registration:	Piper PA-28RT-201 Cherokee Arrow IV, G-BHAY	
No & Type of Engines:	1 Lycoming IO-360-C1C6 piston engine	
Year of Manufacture:	1979 (Serial no: 28R-7918213)	
Date & Time (UTC):	11 September 2017 at 0956 hrs	
Location:	Wolferton, Norfolk	
Type of Flight:	Private	
Persons on Board:	Crew - 1	Passengers - 1
Injuries:	Crew - 1 (Fatal)	Passengers - 1 (Fatal)
Nature of Damage:	Engine front fuselage, wings and landing gear severely disrupted	
Commander's Licence:	Private Pilot's Licence	
Commander's Age:	58 years	
Commander's Flying Experience:	1,129 hours (of which 406 were on type) Last 90 days - 15 hours Last 28 days - 10 hours	
Information Source:	AAIB Field Investigation

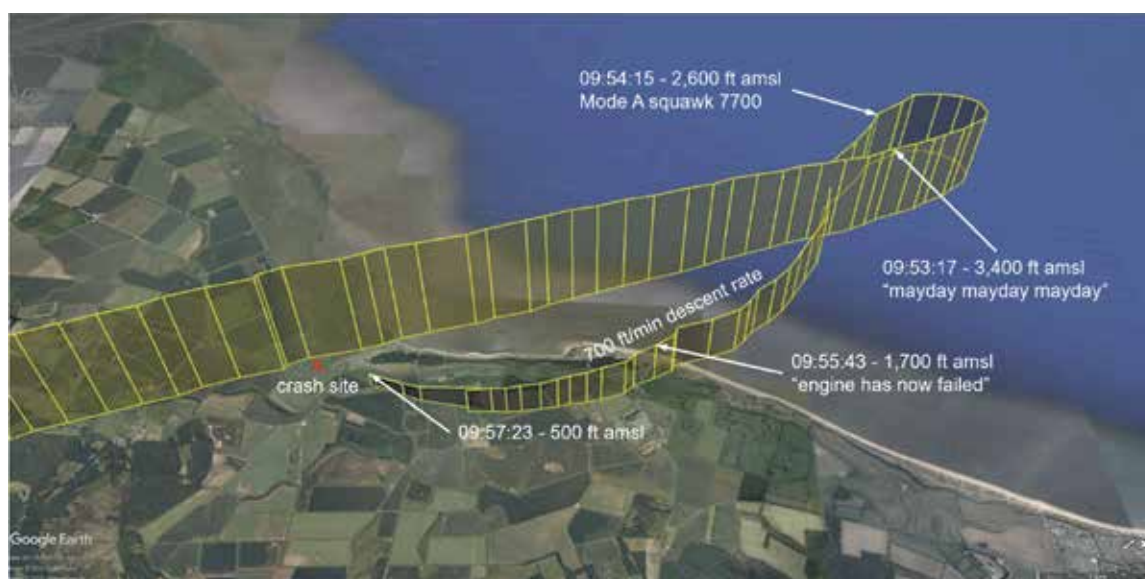
Figure 1

View looking to the west of last seven minutes of the radar track
(altitudes are Mode C \pm 50 ft, corrected to the QNH 988 hPa)

The aircraft crossed the coastline at 0951:30 hrs and started to descend 30 seconds later. After a further 1 minute 17 seconds (about 3 nm from the coastline crossing) the pilot made the MAYDAY radio transmission (RTF) to D&D (Figure 1).

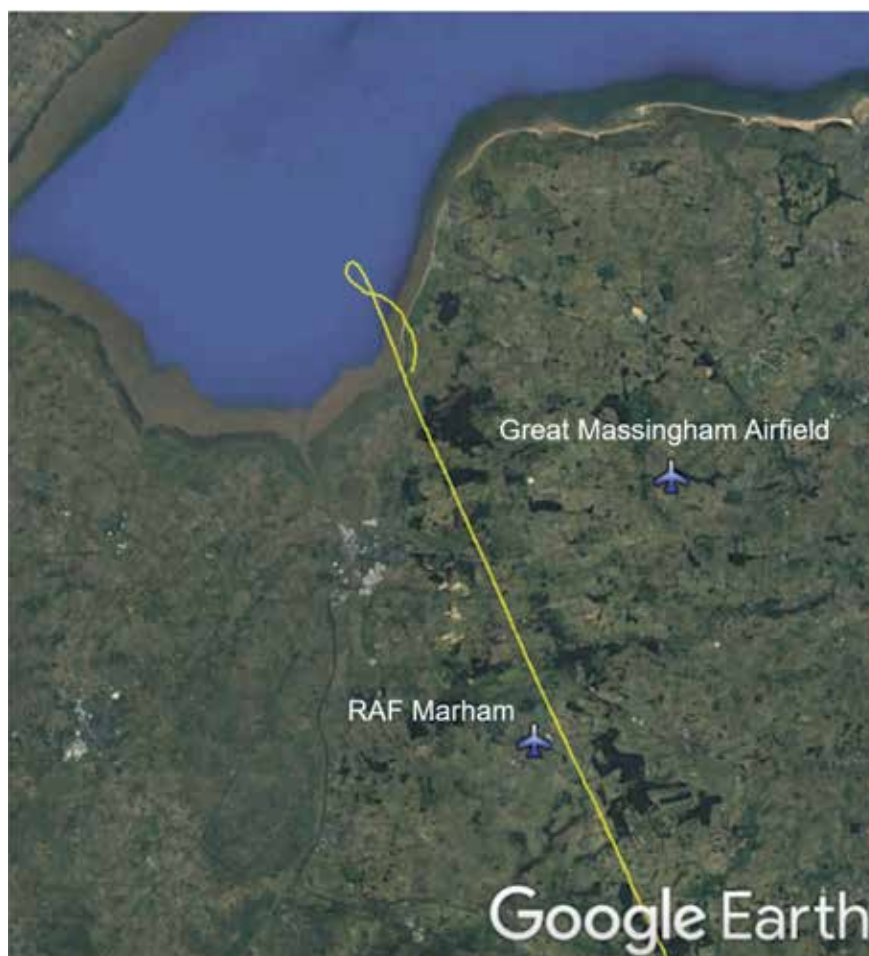
Figure 2

Portion of radar track of G-BHAY – final 17 minutes

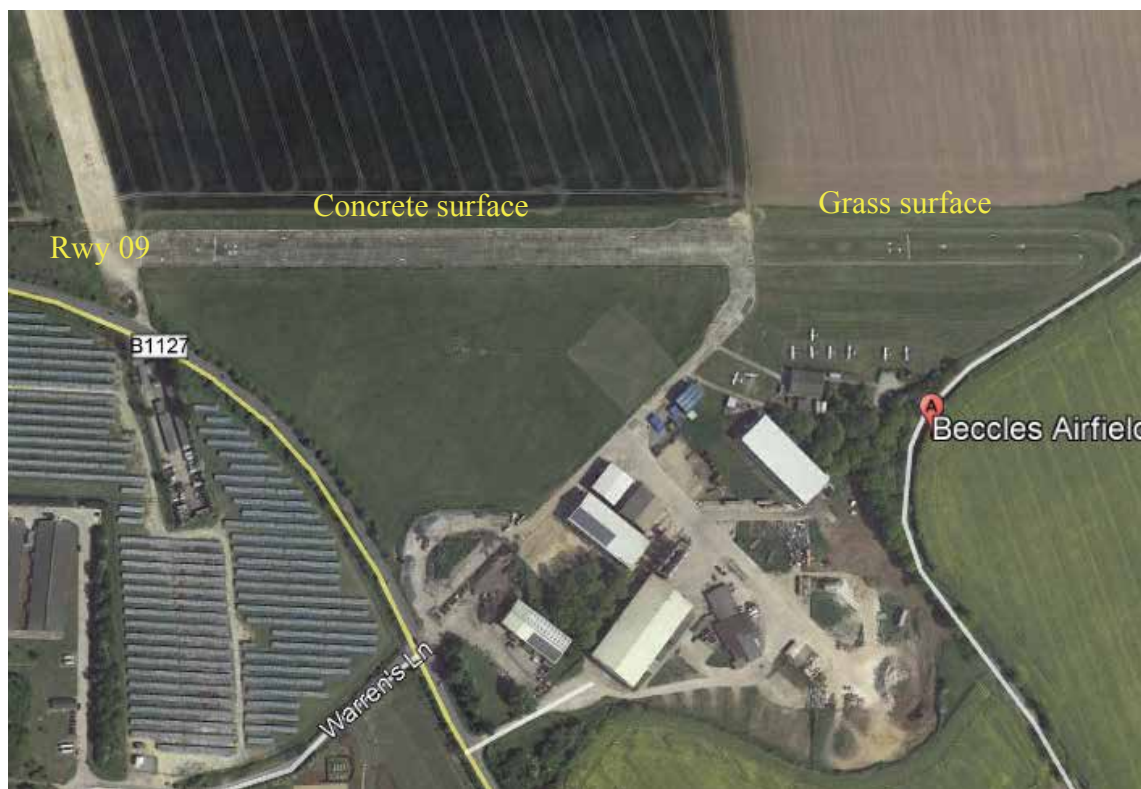
Beccles Airfield has one runway, aligned 09/27. The surface of the first 500 m of Runway 09 is concrete and the remaining 250 m is covered in grass. The LDA is 624 m. A Google Earth image of the airfield is at Figure 2.

Figure 2
Beccles Airfield
