Derailment of a passenger train near Clogwyn y Gwin South foot crossing, Welsh Highland Railway, 10 June 2018

Summary of the accident

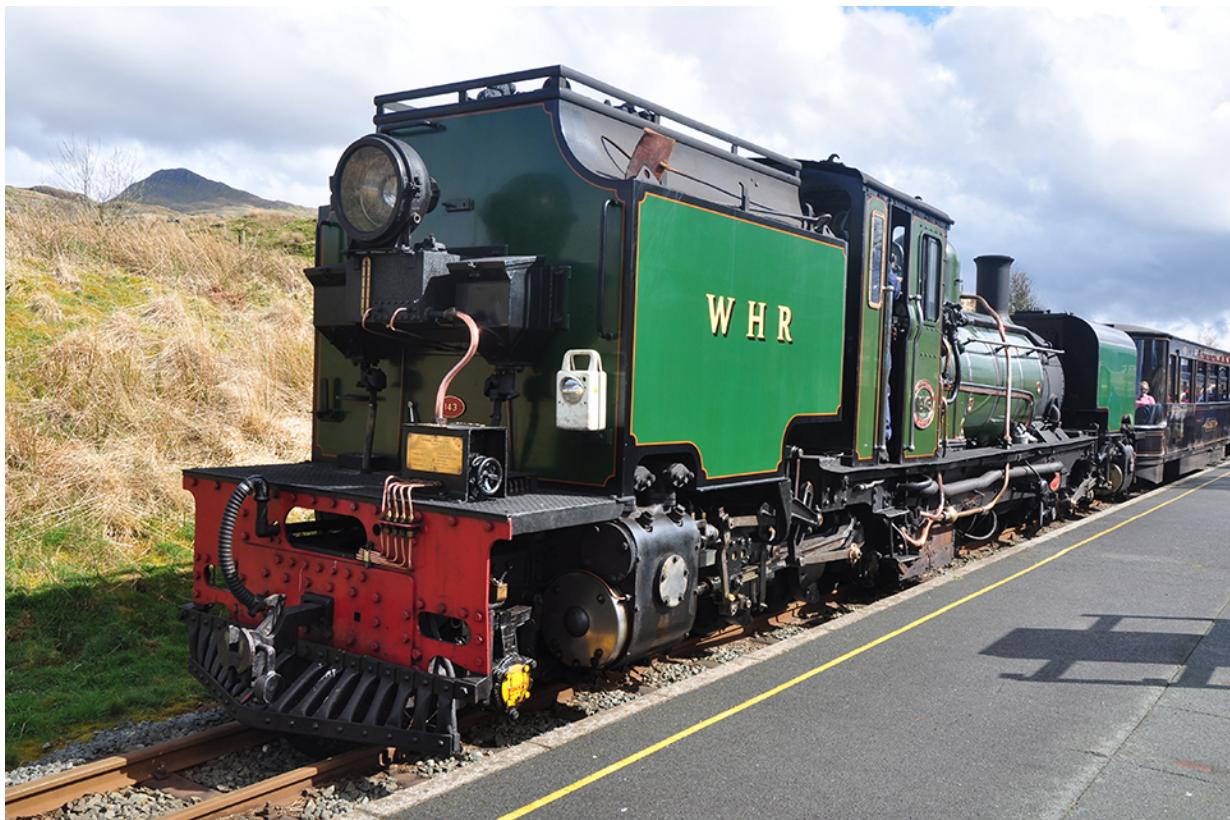
Locomotive 143 at Rhyd Ddu station travelling in same direction (right to left of photograph) as at the time of derailment
