Rail Accident Investigation Branch

Rail Accident Report

Pushchair trapped in tram doors and dragged, Nottingham 15 December 2017

Report 15/2018
September 2018

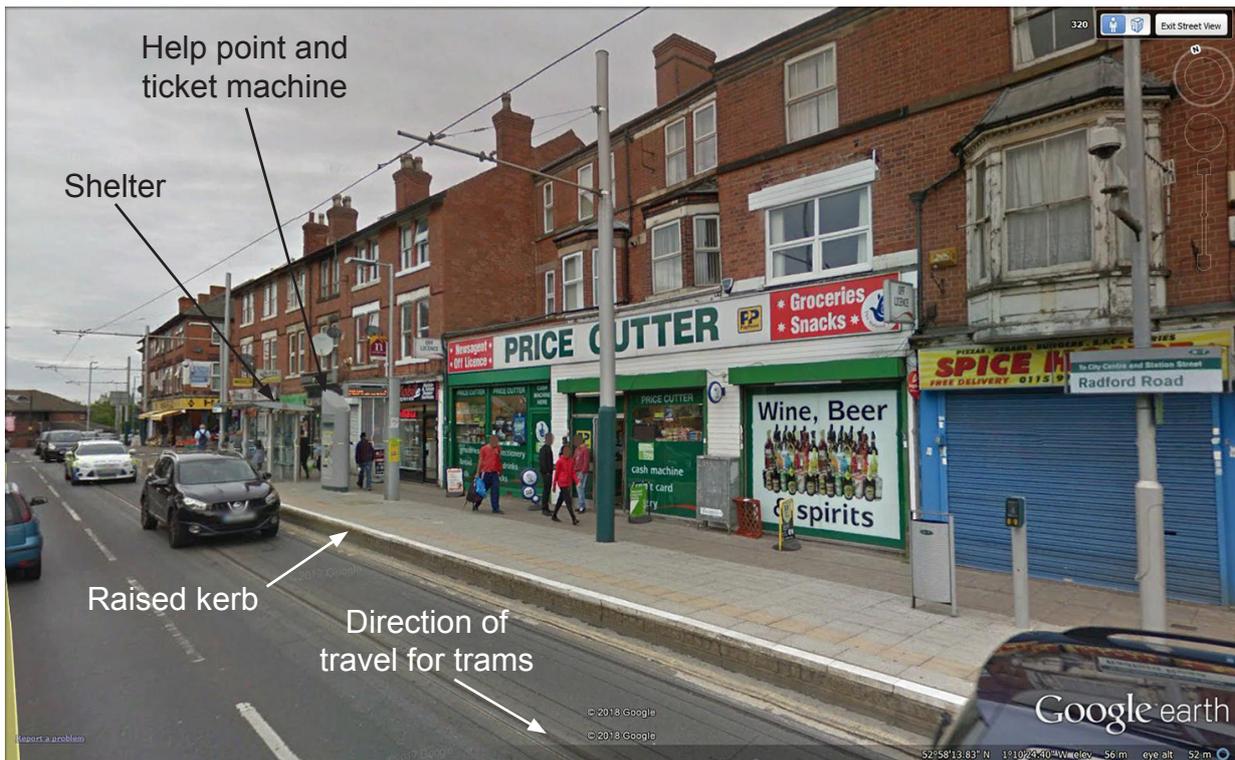
Figure 5: Radford Road tram stop

- 5 The tram stop has a raised kerb to make the pavement level with tram floors. The tram stop includes a shelter, and a combined ticket machine and help point (figure 5) which is connected to Nottingham Trams' control centre located at Wilkinson Street depot. Images from closed-circuit television system (CCTV) cameras at the tram stop are transmitted to the control centre for continuous recording and for live viewing if necessary.

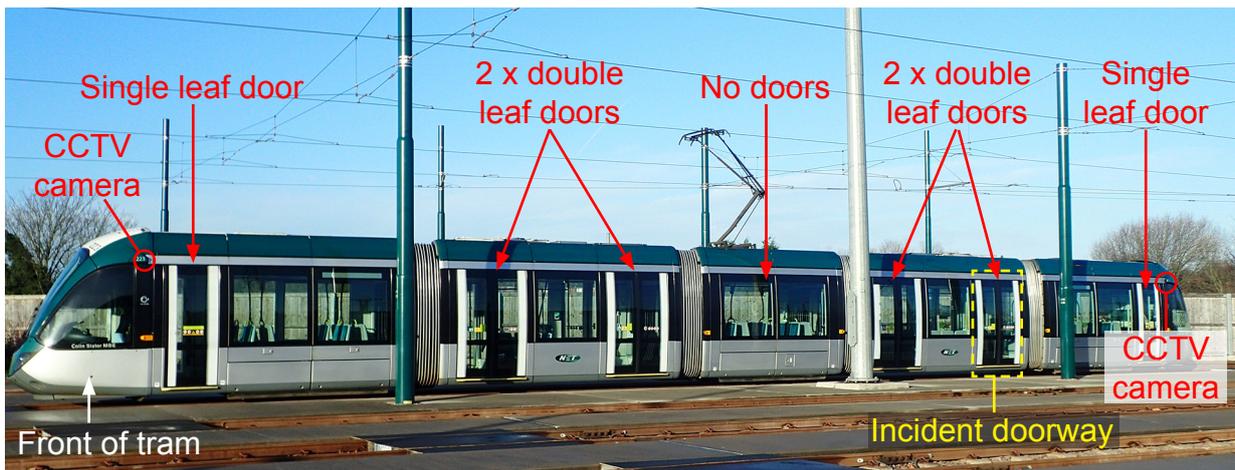
Figure 6: A Citadis type tram used on the Nottingham tramway

9 The Citadis trams are formed of five modules. The driving cab modules at each end of the tram have a single sliding passenger door on each side, the centre module has no doors, and the two intermediate modules each have two double sliding doors on each side (figure 6). The door arrangement includes a system for detecting objects if they are trapped between closing doors. If no obstacles are detected as the doors close, they lock and an electrical interlock circuit is made (the interlock circuit permits the driver to take traction power to move the tram).

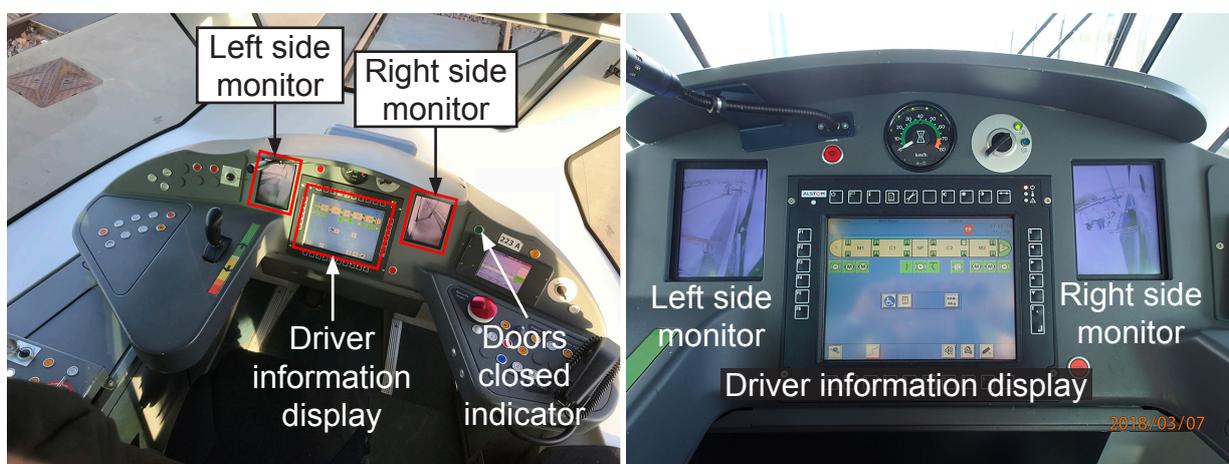
Figure 7: Driving cab monitors

- 10 Operation of the passenger doors is enabled by the driver, using push-buttons in the driving cab, so the doors can then be opened as required by passengers using push-buttons on the doors¹. When preparing to depart, the driver operates a push-button in the driving cab which closes and locks all doors. When the doors are closed and locked with nothing detected trapped between them, the following happen simultaneously:
- a chime sounds in the driving cab;
 - a green light illuminates on the drivers control panel in the driving cab;
 - the colour of the doors shown on the drivers graphical information display changes from white to green (figure 7); and
 - the images displayed on the CCTV monitors in the driving cab change (paragraphs 13 and 14).

- 11 The tram is fitted with three types of CCTV system: forward and rear-facing CCTV, internal CCTV, and bodyside CCTV. The body side mounted cameras fitted at each end of the tram (looking towards the opposite end of the tram, figure 6) are linked to two monitors in each driving cab, one to the left, and one to the right of the driver, and normally show the images from the bodyside mounted cameras (figure 7).

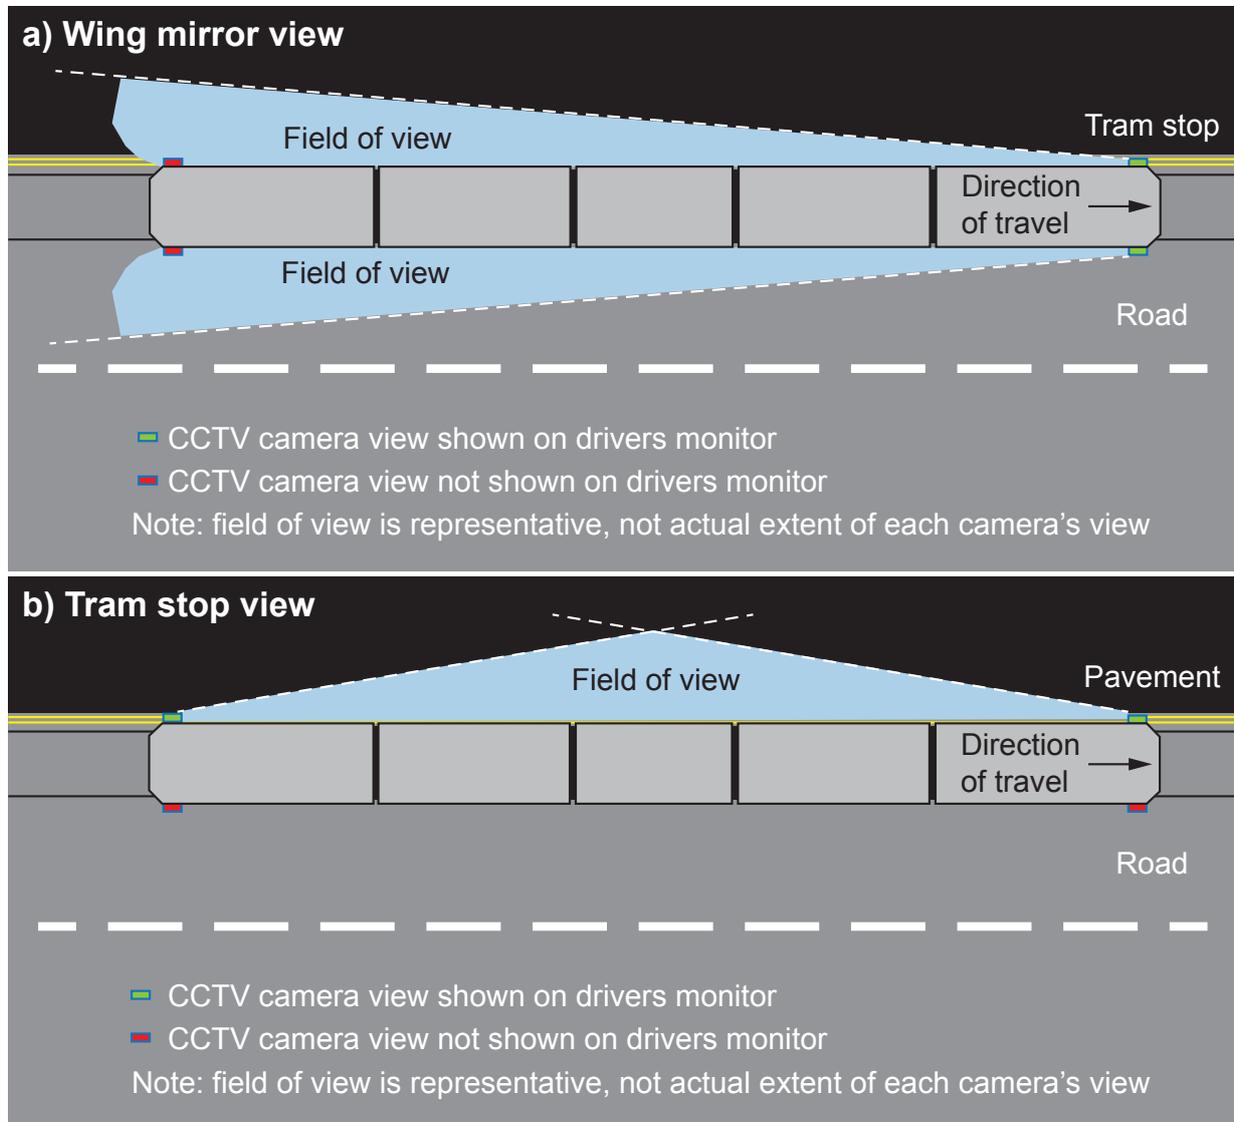
Figures 8a and 8b: Tram body side CCTV

- 12 The trams are not fitted with traditional road vehicle wing mirrors (paragraph 66) so, in order to see what is happening alongside and behind them, tram drivers use images from bodyside CCTV cameras (figure 8a). In this configuration, the front left CCTV camera is linked to the left-hand monitor in the drivers cab, and the front right CCTV camera is linked to the right-hand monitor in the drivers cab.

- 13 When a tram reaches a tram stop and the passenger doors are opened, the monitor adjacent to the tram stop continues to show that side of the tram using images from the front CCTV camera. The images on the monitor furthest from the tram stop change to show the side of the tram adjacent to the tram stop viewed from the rear CCTV camera on that side of the tram (figure 8b).

- 14 When the doors are detected as closed and locked, the monitor views immediately change automatically to show the 'wing mirror' view required before the tram can move off (figure 8a). Although only two camera views are shown to the driver at one time, images from both front and both rear CCTV cameras were recorded at all times and were available for the RAIB investigation.
