Rail Accident Investigation Branch

Rail Accident Report

Detrainment of passengers onto electrically live track near Peckham Rye station 7 November 2017

Report 16/2018
October 2018

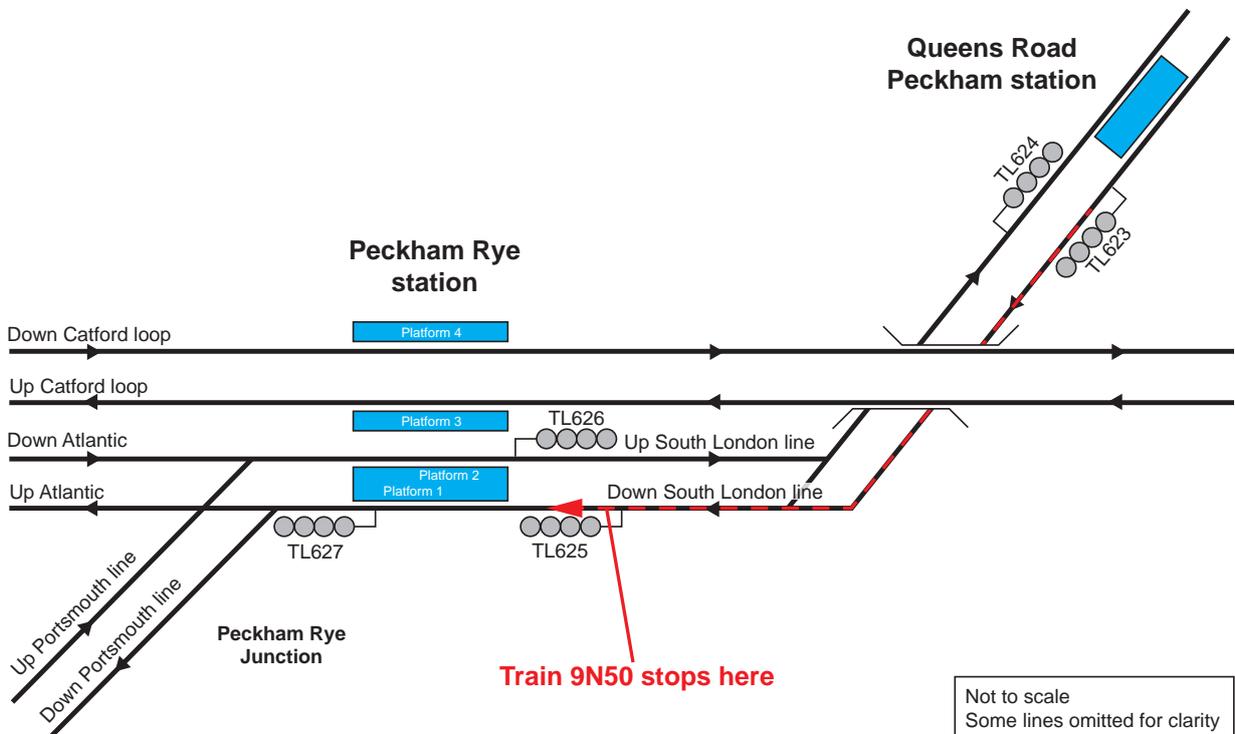
- 6 The train came to a stand on the Down South London line, approximately 30 metres away from the east end of platform one on the approach to Peckham Rye station. This part of the station consists of an island platform situated between the Up and Down South London lines (figures 2 and 3).

Figure 2: Track layout showing the location of the incident

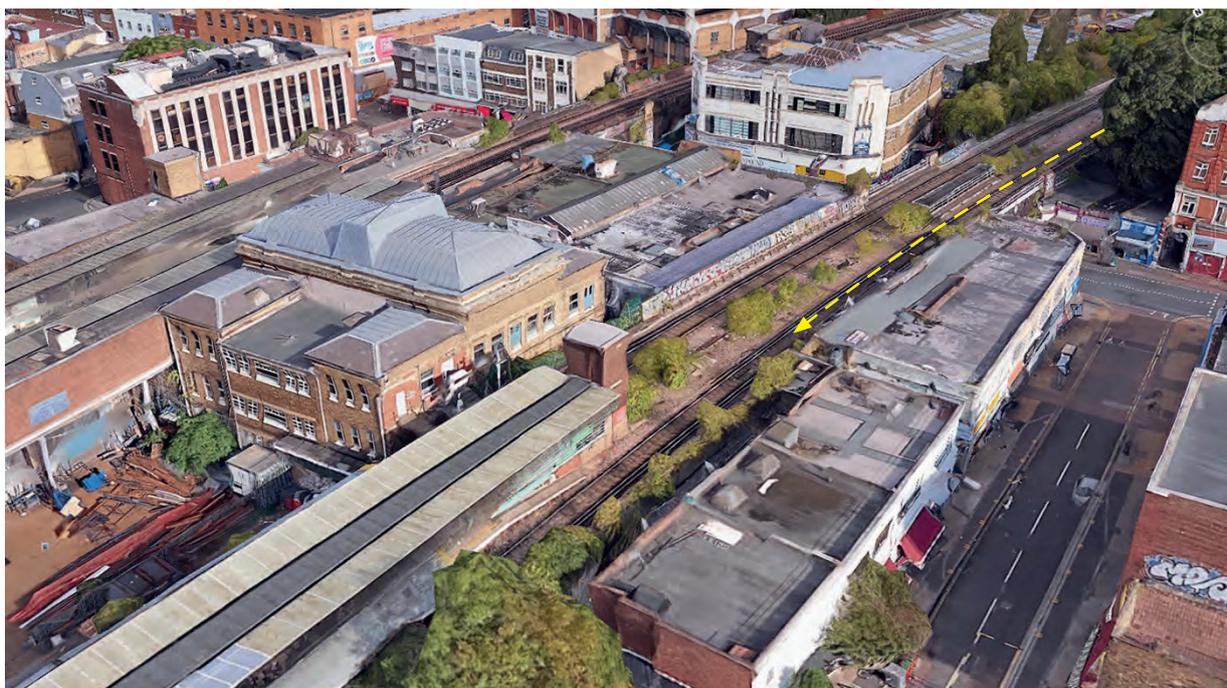
Figure 3: Peckham Rye station, with the South London line platforms bottom left (image courtesy of Network Rail)

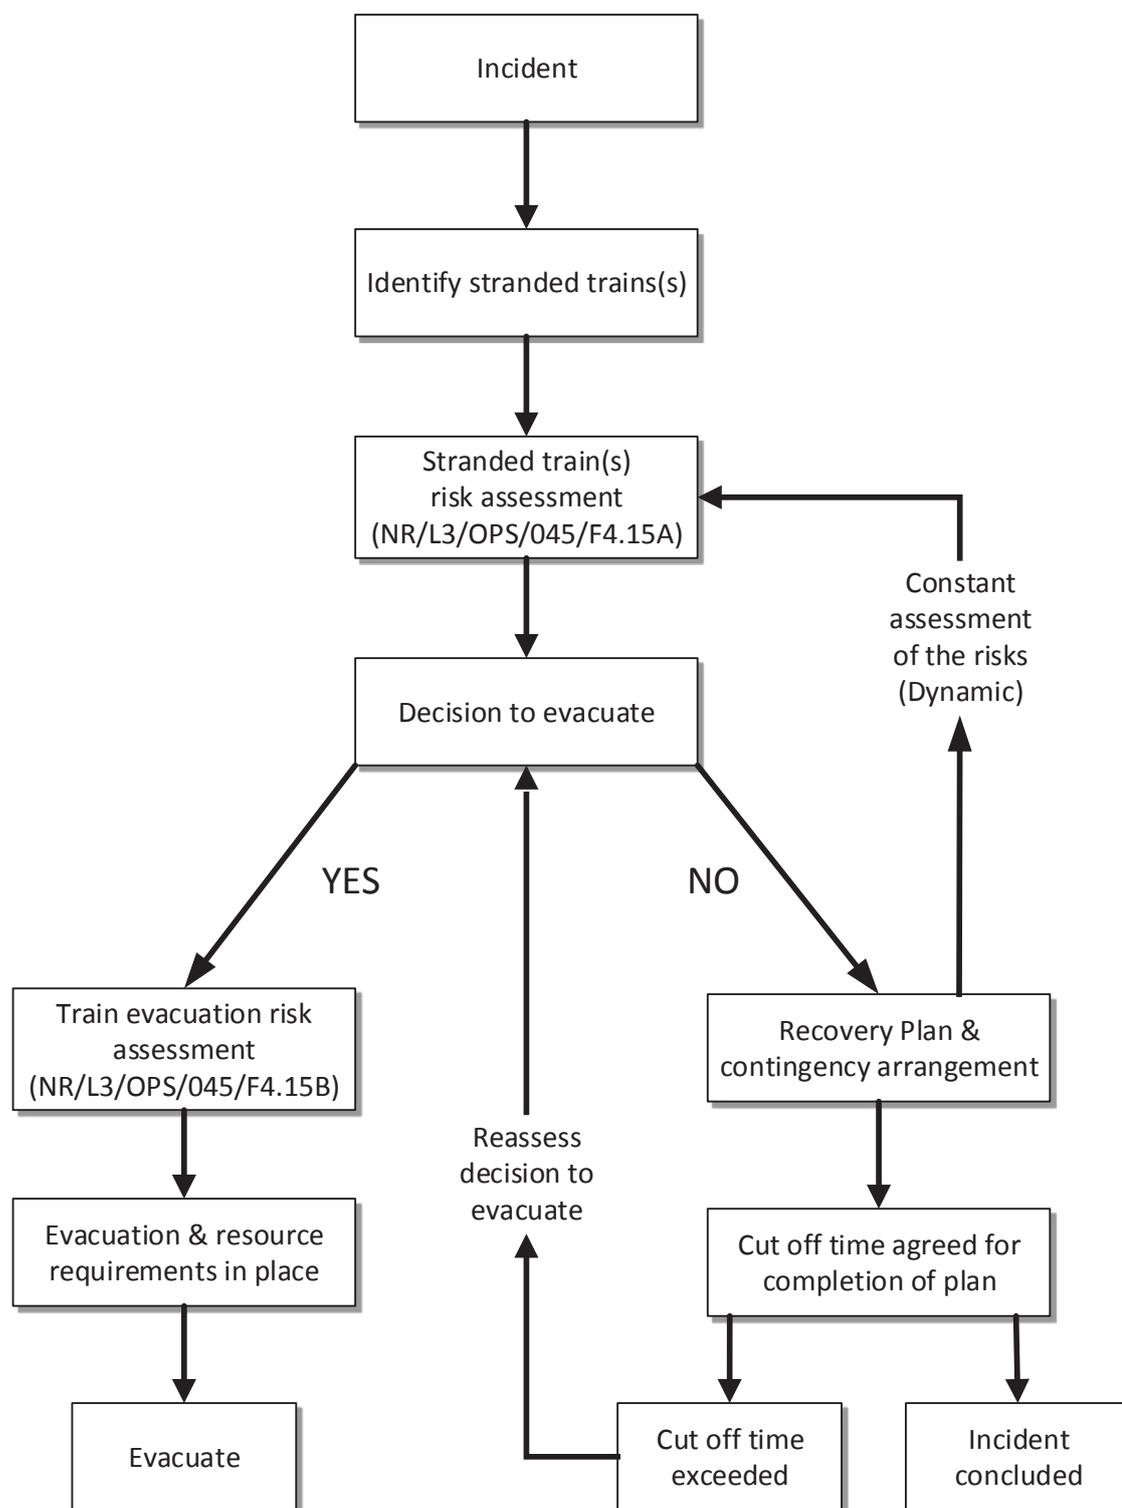
- 60 The railway industry has issued a number of standards and guidance documents relating to the strategic management of incidents (such as Network Rail (National emergency plan NR/L2/OPS/250), RSSB (Incident response planning and management, RIS-3118-TOM) and RDG/Network Rail jointly (Meeting the needs of passengers when trains are stranded, ATOC NR/GN SP01)). These define high level requirements for emergency planning and the principles of emergency response. In addition, Network Rail has issued a national operating procedure entitled 'Managing stranded trains and train evacuation' (NOP 4.15: issue 1, dated September 2017). This covers the required actions by route operations controllers and the train operating company prior to starting an evacuation and reflects the principles outlined in the joint Network Rail / RDG guidance. National operating procedure 4.15 establishes the principle that evacuation onto the track is a last resort due to the associated inherent risks, and should be a cooperative venture between Network Rail and the relevant train operating companies. The procedures to be followed in such cases are outlined in figure 9.

Figure 9: Railway industry procedure following an incident which results in a single train or multiple trains being stranded (diagram courtesy of Network Rail, ref. NOP 4.15 fig 1)
