Rail Accident Investigation Branch

# Rail Accident Report

## **Landslip and derailment at Loch Eilt, north-west Scotland 22 January 2018**

Report 10/2018  
August 2018

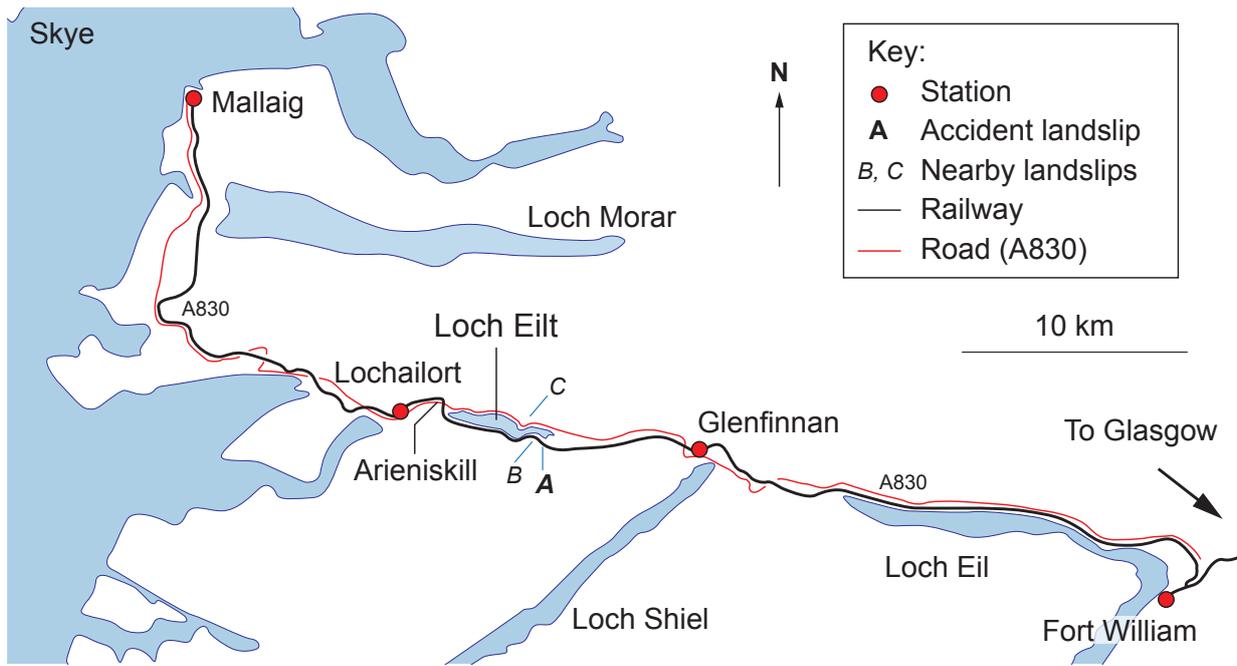
Figure 2: Map showing railway between Mallaig and Fort William and location of recent landslips. Sites marked 'B' and 'C' are referred to in paragraphs 54 and 41 respectively. Some intermediate stations have been omitted for clarity.

- 41 Network Rail geotechnical staff attending the accident site on 23 January observed that another landslip had occurred, 1 km to the north-west (marked 'C' in figure 2 and in background of figure 3), and believe this occurred at a similar time. This affected a natural hillside above the A830 on the opposite side of Loch Eilt. Although debris did not reach the road, two landslips in relatively close proximity demonstrates that slopes in this area were particularly vulnerable to the effect of the climatic conditions prevailing at that time.

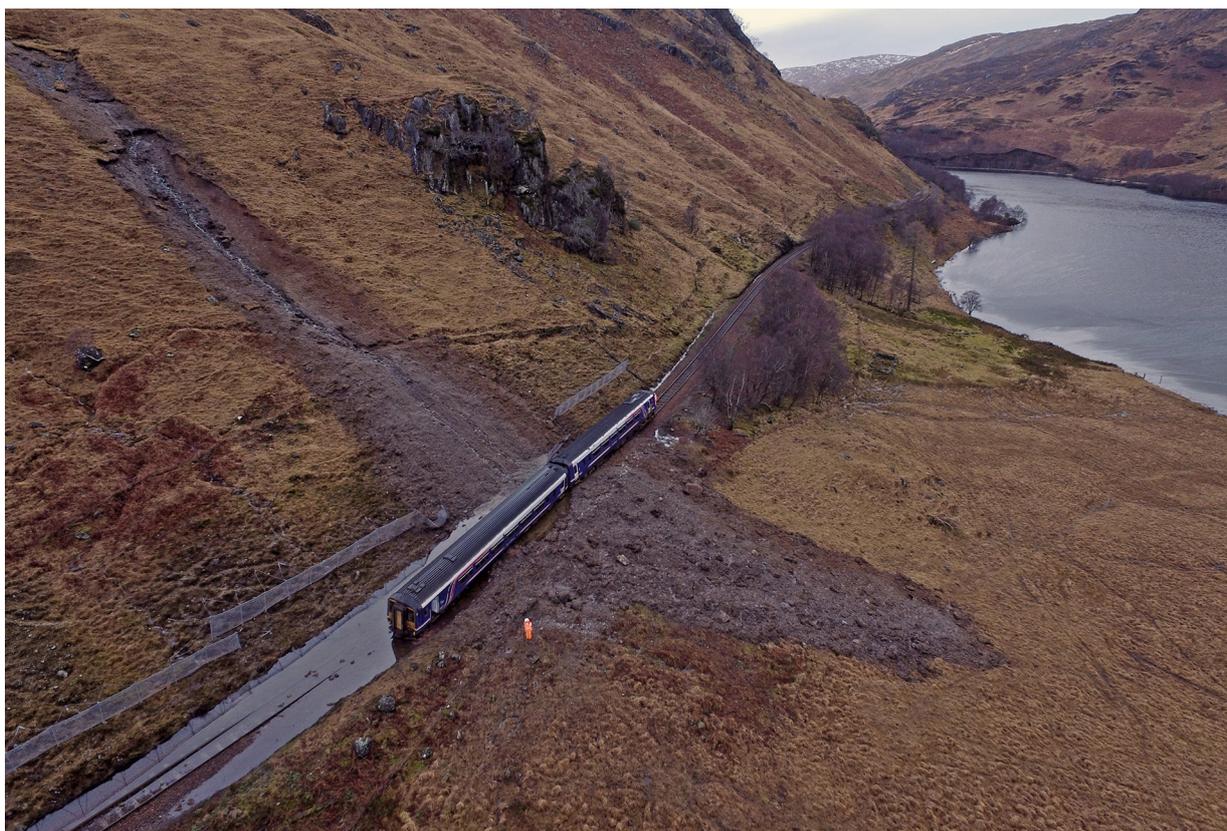
- 7 The accident occurred at about 19 miles 200 yards<sup>1</sup> on a right-hand bend on a remote section of single line about five miles west of Glenfinnan. The railway at this location is in a shallow cutting on sloping ground, and runs along the south shore of Loch Eilt at an elevation of approximately 50 metres above sea level (figure 5). The route forms part of the West Highland line between Glasgow and Mallaig in the Scottish Highlands.

Figure 5: Aerial view showing proximity of the accident site to Loch Eilt

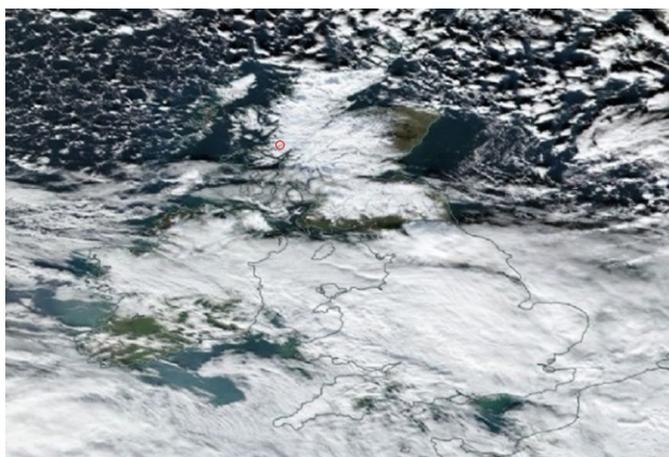
- 36 The RAIB has confirmed that snow cover extended over north-west Scotland by 20 January using satellite imagery (figure 7). Confirmation that this extended over the north slope of Sgùrr na Paite, to below track level, is provided by a witness report provided to the RAIB by a member of railway staff who arrived at the site a few hours after the accident.

Figure 7: Satellite photograph showing snow cover across north-west Scotland on 20 January 2018. Note that England and Wales are covered in cloud (image copyright NASA Worldview)

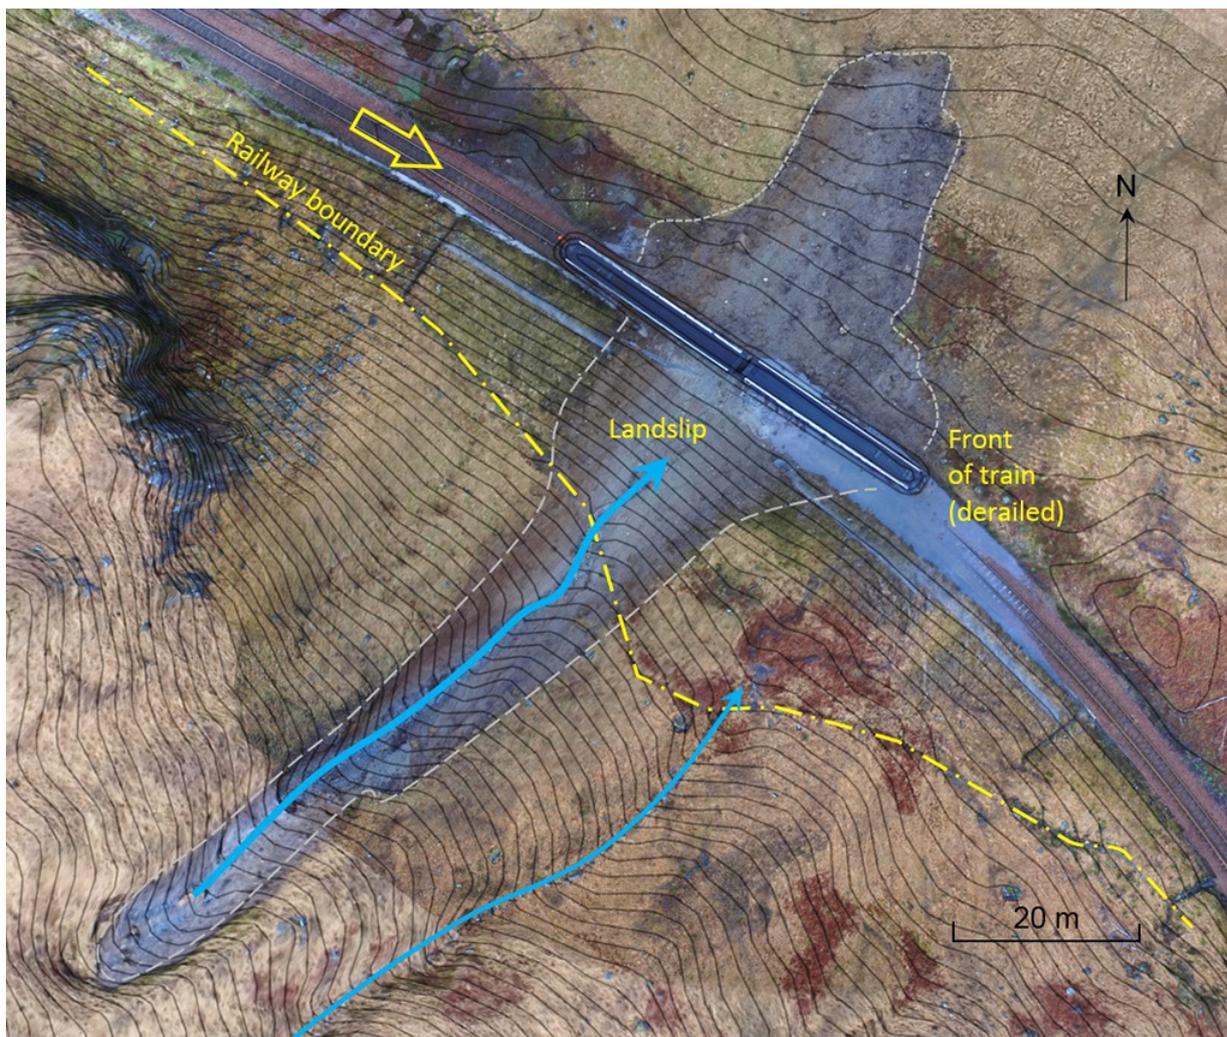
- 44 As the leading edge of the sliding debris approached the railway, it destroyed part of the catch-fence which had been installed in 2017 to trap falling rocks. It then spread out as a debris plume, 40 metres long below the level of the railway (figures 11 and 12). The displaced material included several large boulders, and a significant volume of water.

Figure 12: Landslip site showing railway boundary and post-accident contours at one metre intervals. The railway boundary on the uphill side is shown. Note: this 'orthomosaic' map is derived from multiple overlapping aerial photographs, and has been automatically adjusted for topographic relief, lens distortion, and camera tilt.
