Rail Accident Report

Runaway of a road-rail vehicle at Bradford Interchange 8 June 2018

Report 01/2019
March 2019

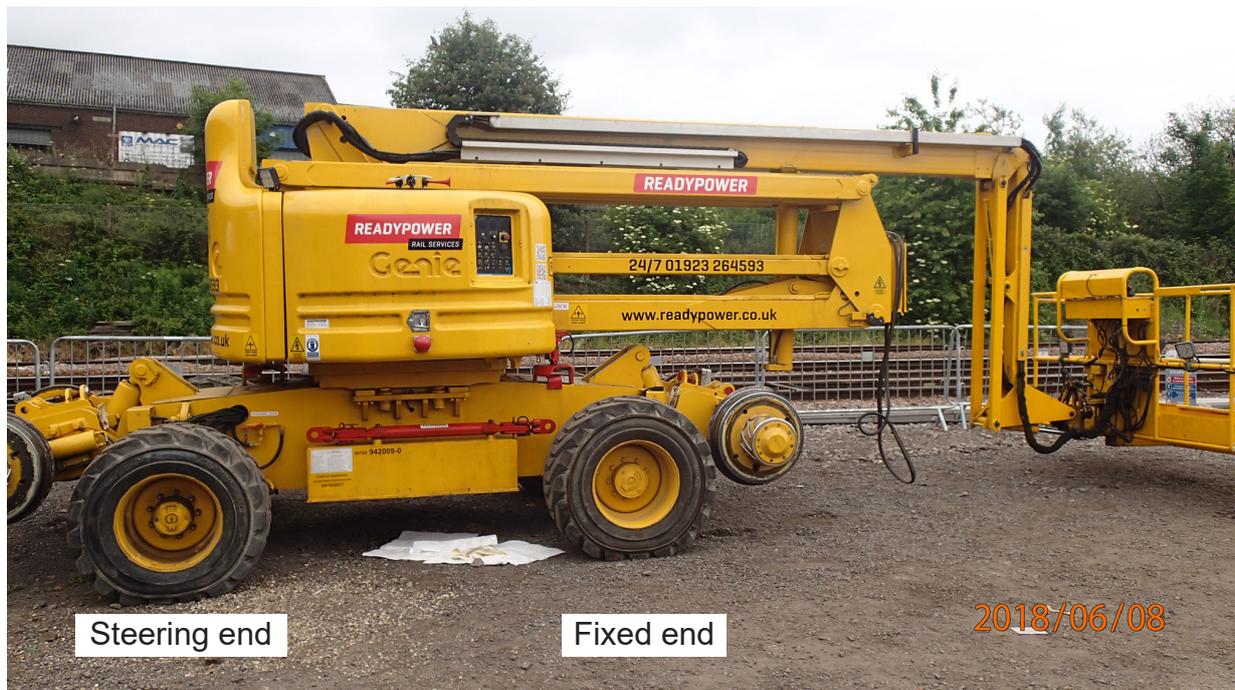
Figure 2: The RRV involved in the incident

- 4 The RRV was a Genie Z60/34 Mobile Elevating Work Platform (MEWP), which was owned and operated by Readypower Rail Services Ltd (referred to as Readypower in the rest of this report) (figure 2). It weighed 17.5 tonnes. There were two members of Readypower's staff with the MEWP at the time of the on-tracking operation, a machine operator and a machine controller. Unable to stop the runaway, they both were able to keep up with the silent and unlit machine as it ran towards the station, and they warned others of its approach.

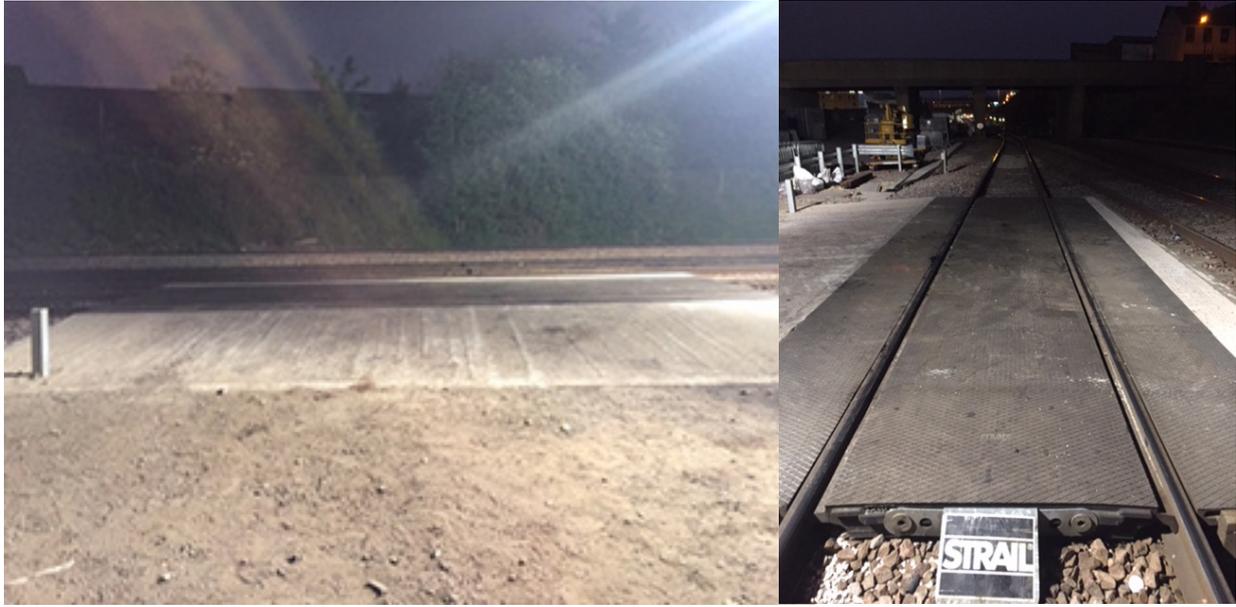
Figure 9: Britannia Street RRAP on night of the incident (courtesy of Network Rail)

- 18 It was a dry, mild night with a temperature of 10°C recorded at a nearby weather station in Bradford at the time of the incident. It was dark, but ample artificial light was provided at the RRAP by temporary flood lights (figure 9).

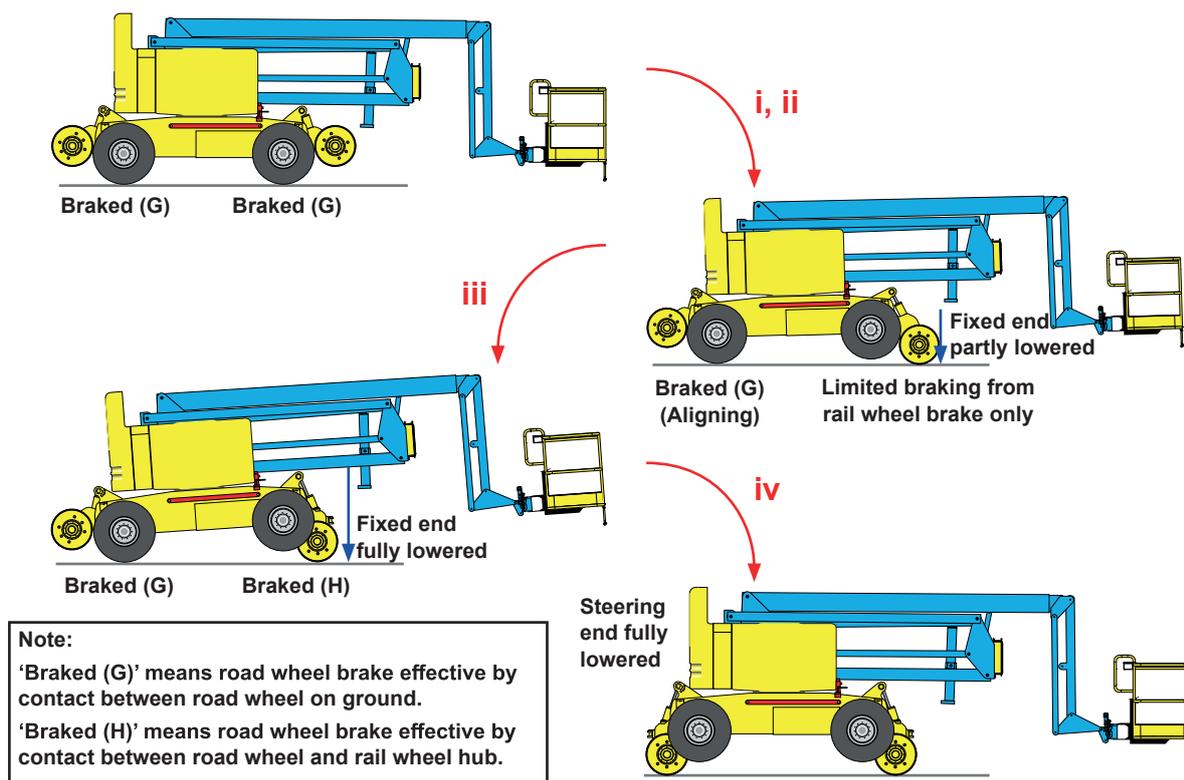
Figure 14: On-tracking in accordance with trained procedure

- 48 Since the introduction of the DRWB systems in 2014, interlocks of this type are no longer fitted to RRVs and the risk of runaway is mitigated by the presence of the DRWB system. As part of their training, machine operators are still warned about the risks of a runaway and taught not to start deploying the second rail axle until the first one is fully deployed. But there is now no interlock preventing a machine operator from deploying the rail wheels the way it was done on the night (figure 13).

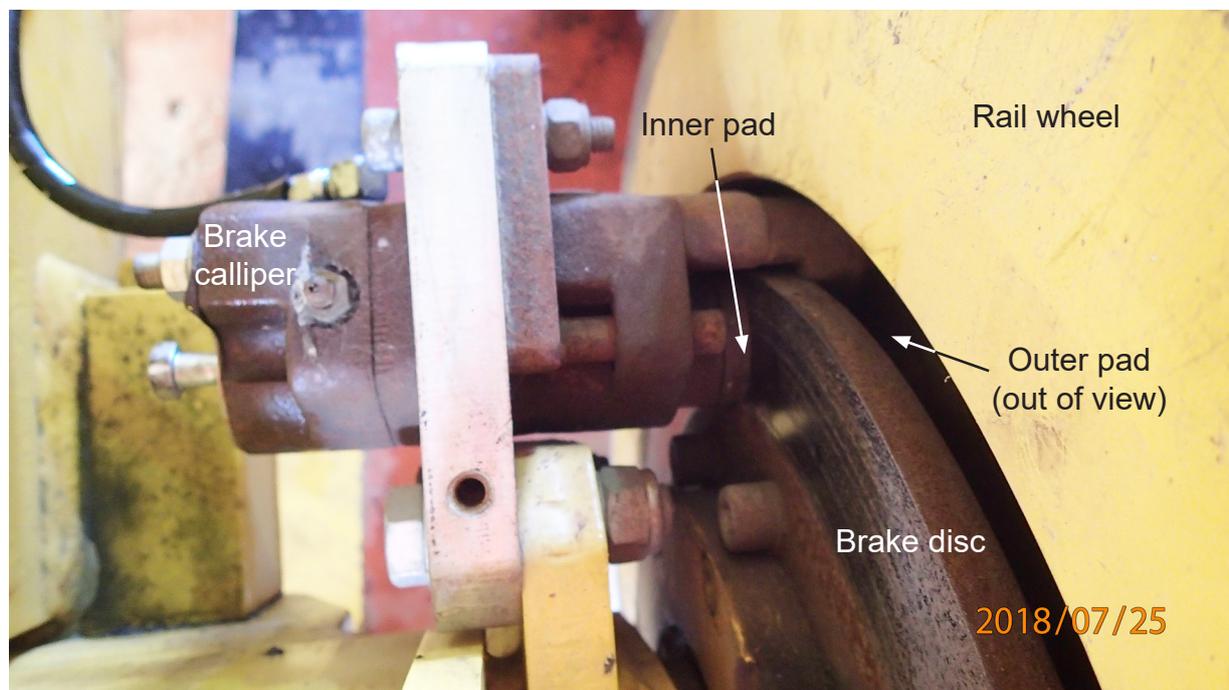
Figure 17: Hargreaves DRWB arrangement

- 66 This causal factor arose due to a combination of the following:
- The brake pads were worn (paragraph 67).
 - The brake callipers had not been adjusted to compensate for brake pad wear (paragraph 71).

68 Figure 17 shows the DRWB system fitted to the incident MEWP and figure 18 shows a cross-section of the calliper. The Hargreaves design uses a single acting calliper installed on a floating mount to accommodate a fixed brake disc. This design is replicated at every wheel. The clamping load (applying the brake) is provided by a spring made of Belleville washers¹⁰ in compression. In order to release the brakes, hydraulic pressure is provided to the calliper to further compress the spring. The calliper is fail-safe as a loss of hydraulic pressure results in the brakes being applied.

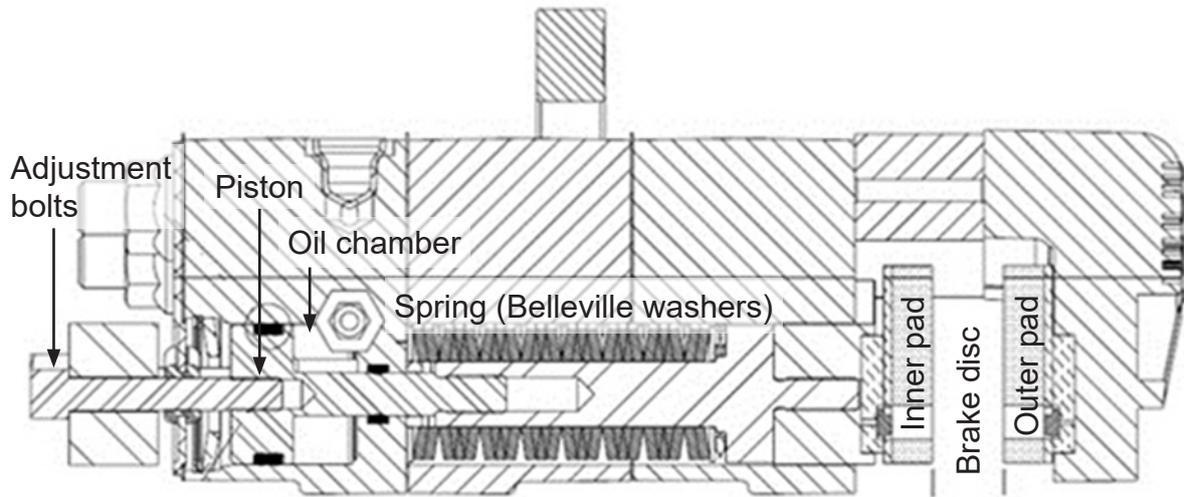
Figure 18: Calliper cross-section

69 When the brakes are applied to slow a vehicle, the brake discs are clamped between the pads (inner and outer) and the pads wear as a result. This is a normal condition. As the pads wear, the load in the spring reduces which lowers the clamping load. In order to compensate for wear, the calliper needs to be manually adjusted by operating the adjustment bolts which results in a gap opening between the spring holder and the compensator plate (figure 19). This has the effect of compressing the spring which reinstates the required clamping load. If this operation is not carried out and the pads are allowed to wear, the clamping load will continue to decrease. According to the calliper manufacturer's datasheet, a combined wear of 11.7 mm on the pads, if unadjusted, will lead to all the clamping load being lost.

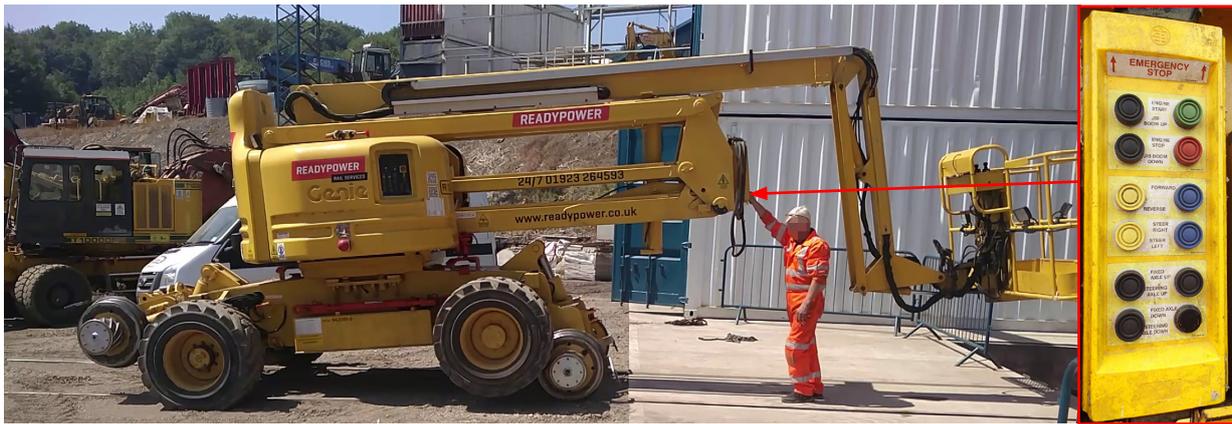
Figure 21: Operator pressing the rail axle deployment button at bottom of pendant

- 99 As the MEWP started to roll away, the machine operator and machine controller stated that they started to panic. The engine had stopped either because of an engine fault or because the emergency stop button had been pressed, and it needed to be restarted before the deployment of one of the rail axles could be completed. However, having elected to leave the pendant in its housing, the machine operator was now unable to press the 'engine start' button which was located at the top of the pendant, out of reach¹⁵ (figure 21). He was also unaware that the emergency stop button had been pressed; it needed to be reset before the engine could be restarted.

¹⁵ The buttons to raise and lower the rail axles are at the bottom of the pendant.
