Derailment of a rail head treatment train near Dunkeld & Birnam, 29 October 2018

Summary of the accident

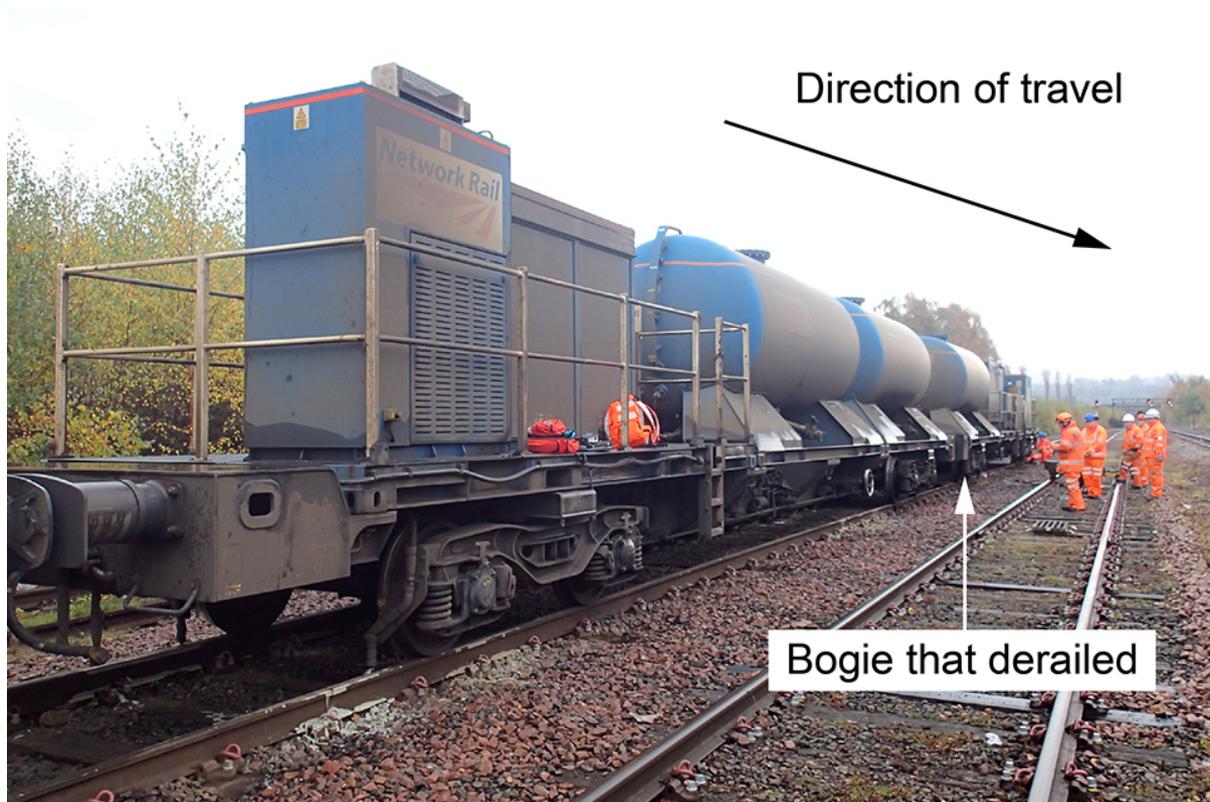
The RHTT wagons involved

Each wagon wheel has a single brake block. When the train brakes are applied, the geometry of mechanical links in the brake system cause the brake blocks on the wheels closest to the centre of the wagon (the inboard wheels) to touch first, closely followed by the brake blocks against the outboard wheels. Each wagon also has a mechanical handbrake which applies the brake blocks to one of the wagon's bogie. The handbrake is activated and released by turning a wheel.
