## **Service Inquiry**

Loss of Watchkeeper  
(WK042) Unmanned Air  
Vehicle over Cardigan Bay  
in West Wales

3 Feb 17

**SERVICE INQUIRY INTO AN ACCIDENT INVOLVING A WATCHKEEPER UNMANNED  
AIRCRAFT (UA) WK042 THAT OCCURRED NORTH OF WEST WALES AIRPORT ON 3 FEB 17**

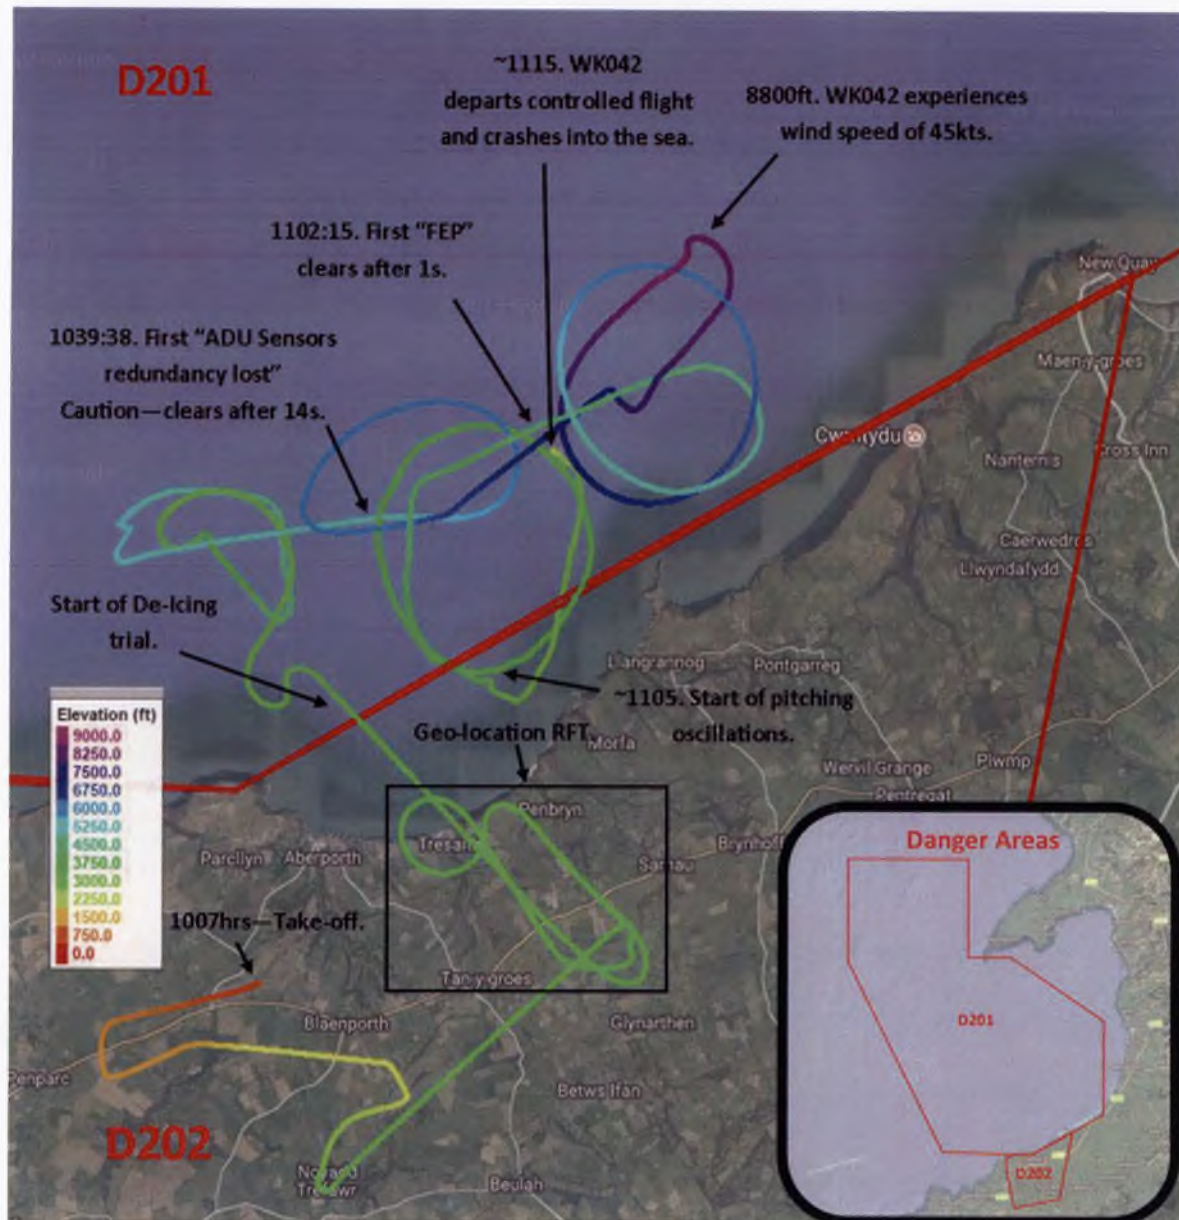
Figure 1.4.2.2 – Flight 593 overview

1.4.2.11. The first FEP manoeuvre occurred just after 1100hrs and just above 4000ft. Following the FEP the UA pitched up and climbed nearly 300ft before it then pitched down and continued with the descent. At 3360ft the UA commenced a set of pitching oscillations. Each oscillation lasted on average 27s, during which time the UA gained and lost approximately 200ft of height. During this time the crew were unable to get the UA to descend any further, but they were able to keep it flying over the sea within the D201 and D202 Danger Areas, as shown in Figure 1.4.2.2, by using a series of fly to coordinate commands. Due to the FEP manoeuvres, which take priority over new commands, the number of commands issued and the non-recovery of the UA Vehicle Management System Computer (VMSC), it is unclear which commands were accepted and actioned by the UA, however, lateral control does appear to have been maintained. The Panel concluded that the decision of the crew to remain over the sea in the D201 Danger Area was the safest and most suitable course of action.

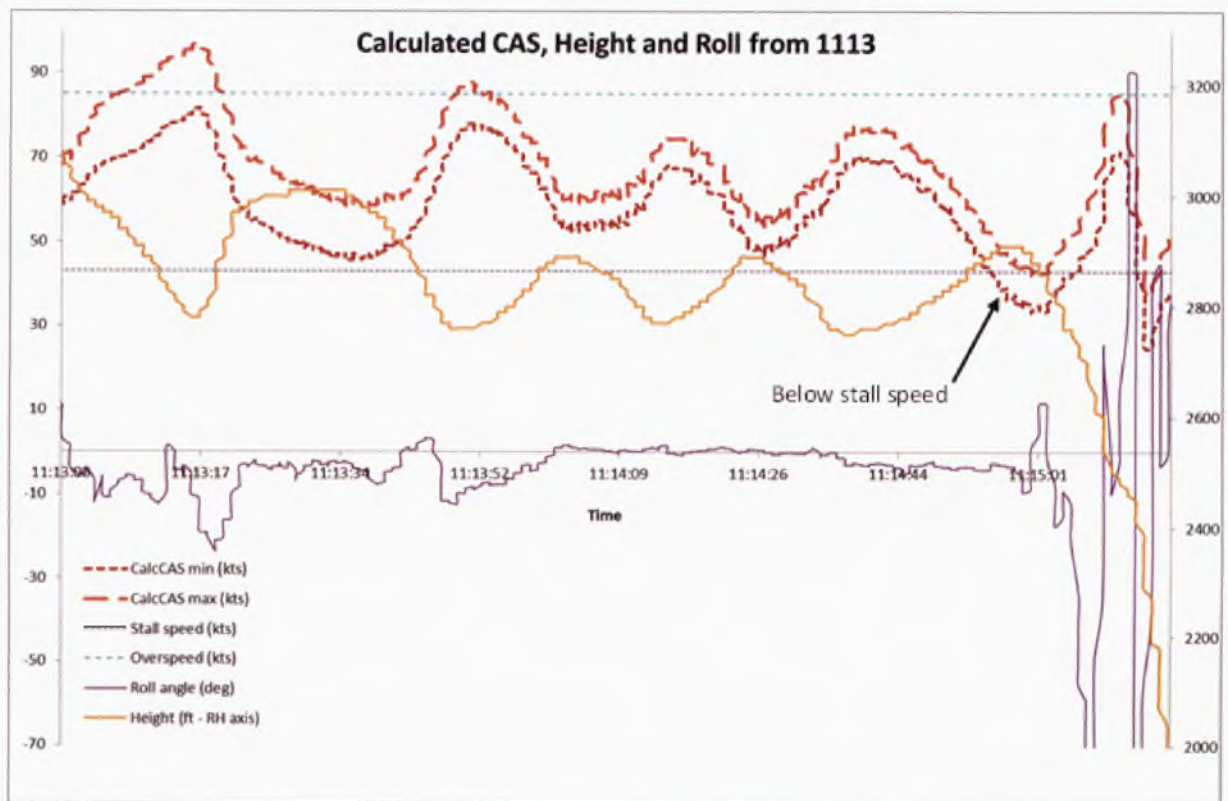
Figure 1.4.3.6 – Calculated CAS range, roll and height from 1113hrs

1.4.3.18. **Effect of pitot blockage.** As previously concluded, CAS was erroneous during the pitching oscillations, which the Panel determined is very likely to have been caused by moisture blocking the pitot tube total pressure feed. As CAS is based on the dynamic pressure, which is the total pressure minus the static pressure, relatively modest changes in altitude can have an effect on the CAS reading of a blocked total pressure feed. This is because static pressure reduces as altitude increases, increasing the relative pressure of air trapped behind a blockage on the total pressure side. The opposite is true when altitude decreases. A well-documented symptom<sup>25</sup> of a blocked pitot tube is an observed increase in instrumented airspeed in a climb and a decrease in a descent. This is illustrated in Figure 1.4.3.10. It is also possible that due to changes in AOA changing the total pressure ahead of the blockage, that pitch may also have an effect. Due to the pressure differential changing over the blockage, the weight and viscosity of the water, the blockage may temporarily clear, move and reform as illustrated in Figure 1.4.3.11. Changes in pitch are also often associated with changes in altitude and hence static pressure, will of course also change as illustrated.

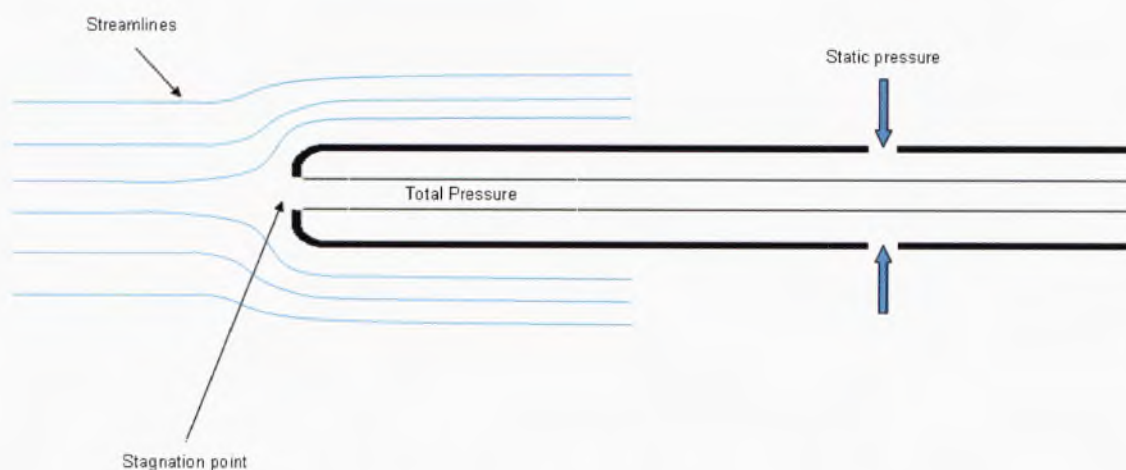
Figure 1.4.3.8 – Air flow around a pitot probe

The Panel believe that whilst the heaters are very likely to have been effective at evaporating any water entering the probe, it is possible that this would have increased the relative humidity inside the tube, with condensation forming at cooler points. WK042 was flying for an extended period in cloud and during its descent in sleet and then rain after having been cold soaked at a higher altitude below freezing point. It is therefore very likely that the blockages in the later part of the flight were caused by a combination of precipitation droplet ingress and condensation. It is also very likely that the velocity sensor redundancy loss caution seen briefly earlier in the flight was a result of precipitation ingress, which was quickly cleared by the heaters.

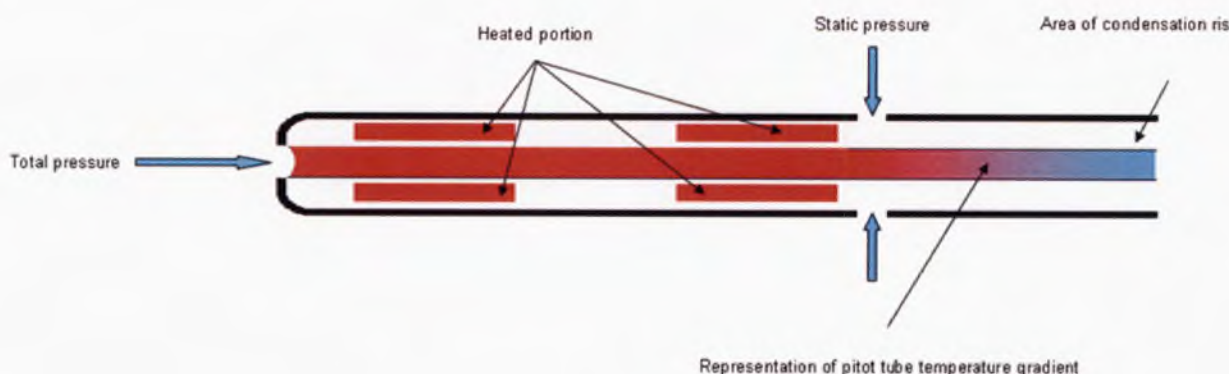
Figure 1.4.3.9 – Typical heated pitot probe

temperature gradient along the tube and a condensation risk in any cold spots. Accumulation of the condensate could then block the tubes further back in the system. It is common on rotary wing platforms for pitot systems to be fitted with moisture traps, which are drained periodically as a maintenance activity.

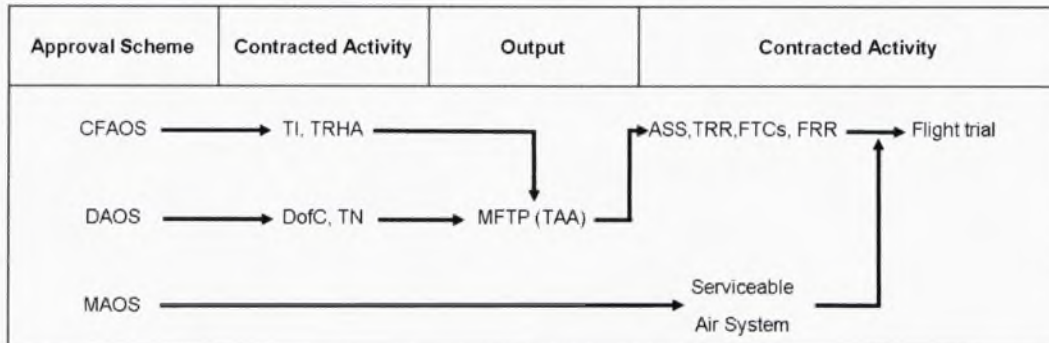
**Figure 1.4.4.1 – Application approval schemes for WK flying at WWA**

**1.4.4.4 Analysis.** Figure 1.4.4.1 summarises how the MAA approvals schemes were applied to the contracted T&E flying of WK. Whilst it was clear that the TAA had an input into the airworthiness aspects, the Panel noted that there was not any mandated MOD operator input into the contracted T&E activity at WWA. The impact of this is discussed in the Section 1.4.6.
