Passenger train derailment at Penryn, 28 January 2019

Summary of the accident

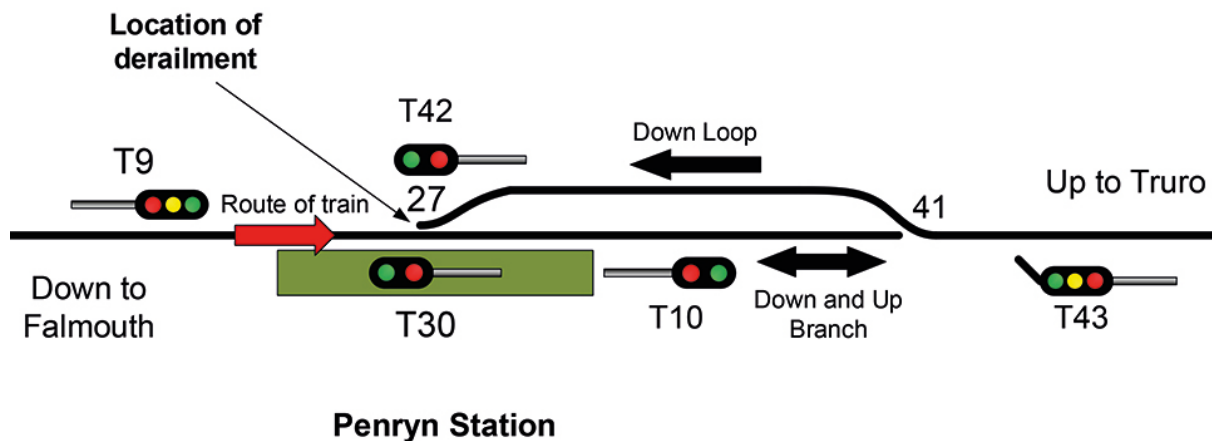
Figure 1: Track diagram showing signalling layout. The points are shown in the 'normal' position

Penryn station (figure 1) is the intermediate passing point on the single track Falmouth branch line. The passing loop was constructed in 2009, for the introduction of a half-hourly service on the line. A single platform serves trains travelling in both directions, and loop points 27 are located near the centre of the platform, so that trains travelling towards Truro can enter the station before being passed by trains going in the opposite direction, which call at the Falmouth end of the platform. The maximum permitted speed for trains passing over the points is 25 mph (40 km/h).
