Maritime &  
Coastguard  
Agency

## SS Richard Montgomery Survey Report 2017

Maritime and Coastguard Agency  
January 2019

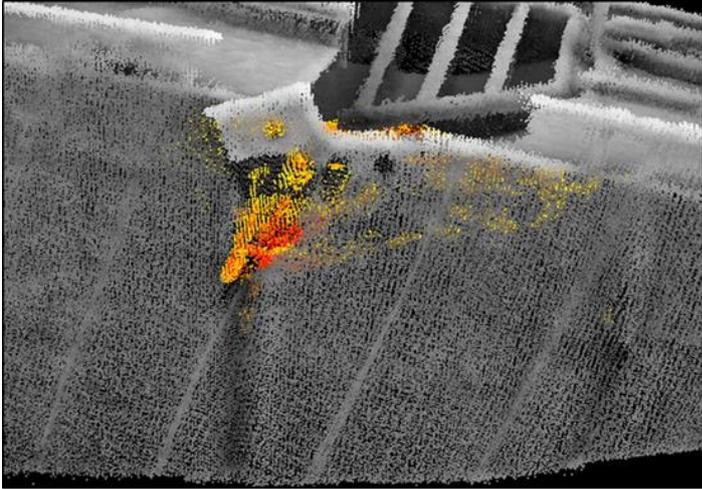
4.11.1 Although the focus of the multibeam survey is the structure of the hull rather than the cargo, at a number of points in the wreck it has been possible in previous surveys to visualise material inside the holds. In some cases this may represent cargo and in others it may represent sediment build-up. For the 2017 there was good coverage of the contents of Hold 2 as far as they are visible through the crack in the hull on the port side and the collapsing deck plating. Taking cross-sections through the data and comparing

them with previous datasets, similarities in the positions of the ensonified contents suggest that no movement has taken place since the previous survey. Some improvement in the density of the data was achieved and this translates as better definition of the features. Structures with rounded forms are present within the hold, possibly representing the munitions cargo.

Fig. 33 Yellow/red data showing data points inside of the hull visualised through the holes in the hull and collapsing deck plating.

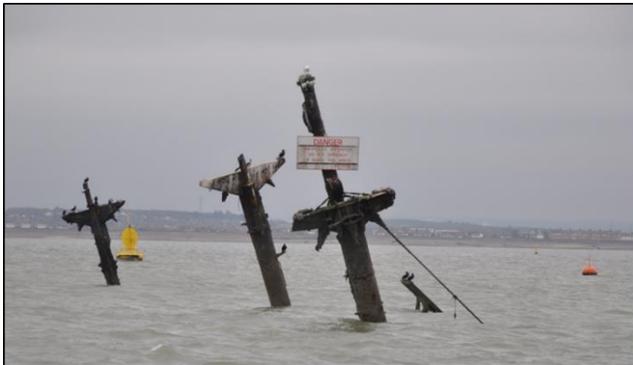
4.12.2 The multibeam data, laser data and photographs all demonstrate that, aside from the loss of a small section of frame (see above), the forward, main and mizzen masts have all remained stable since the last survey.

Fig. 35 Photograph of features visible above the waterline.

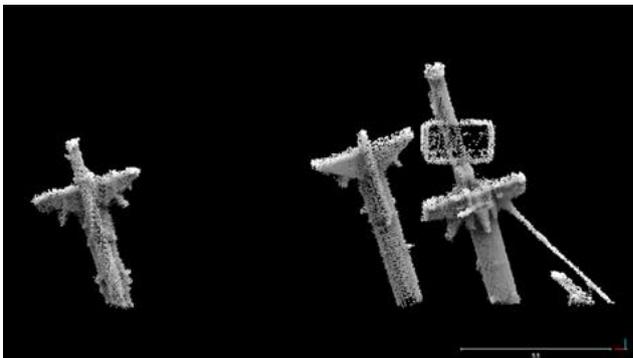
Fig. 36 Laser scanning data of features visible above the waterline.

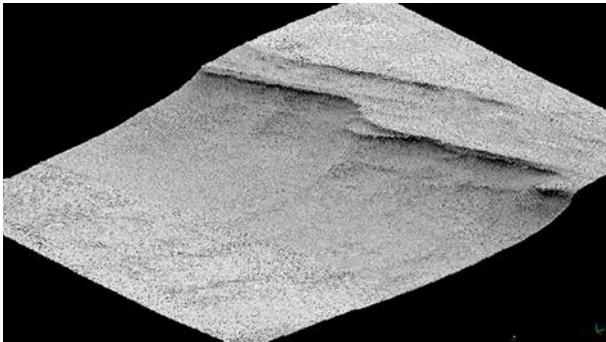
5.6.1 Surface difference analysis was used to identify any changes in the area of the Medway Approach Channel. Within the channel, there has been a widespread erosional trend with depth changes typically between -0.2m and -0.6m. The greatest difference is in the far southeast corner with a change of -0.8m. Towards the western end of the survey area a maximum depth change of -1.6m was seen in the survey data. This depth change relates to a scour that has developed on the northern side of a smooth protrusion of the seabed. The scour does not appear to have formed around a piece of debris.

Fig. 39 Seabed results 2016

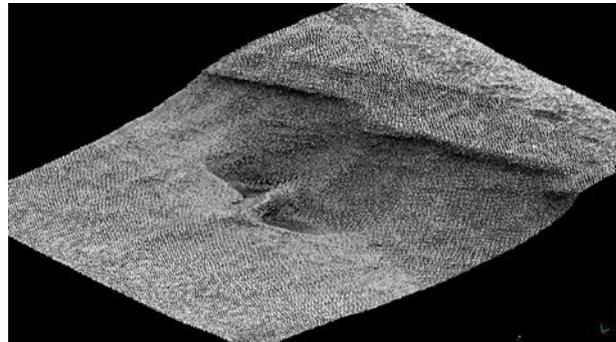
Fig. 40 The same area of seabed in 2017

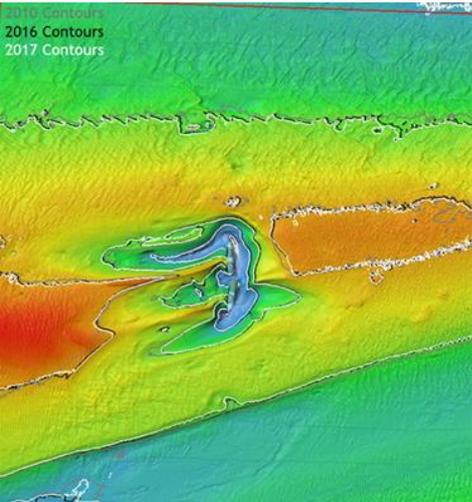
5.9.1 Contours were generated from the 2017 dataset and compared with those from 2016 and 2010 in Fledermaus. The 2010 set of contours is used as a baseline dataset against which longer term trends could be identified. Seabed contours for the 2010, 2016 and 2017 surveys were generated at 5m intervals. The contours between the 2016 and 2017 surveys show a close alignment across the survey area with only minor differences compared to the 2010 baseline dataset. This suggests that the scour bedforms are in equilibrium with the tidal regime in the Thames Estuary.

5.9.2 Seabed contours from the 2017 and 2016 surveys generated at 2m intervals in the area of the scours around the wreck demonstrate a close alignment between the contours from the two datasets. This is especially true on the eastern side of the wreck. To the west the differences in the positions of the contours are most varied around the pear-shaped scour within the central scour. However, as the surface difference results indicate, the survey site has remained generally stable since the last survey. Along the slope of the Medway Approach Channel the 10m and 12m contours from 2017 and 2016 are very closely aligned which indicates little change between the two surveys.

Fig. 42 Comparisons of seabed contours between the 2017, 2016 and 2010 surveys. Contours generated at 5m intervals. White = 2017, black = 2016 and grey = 2010.

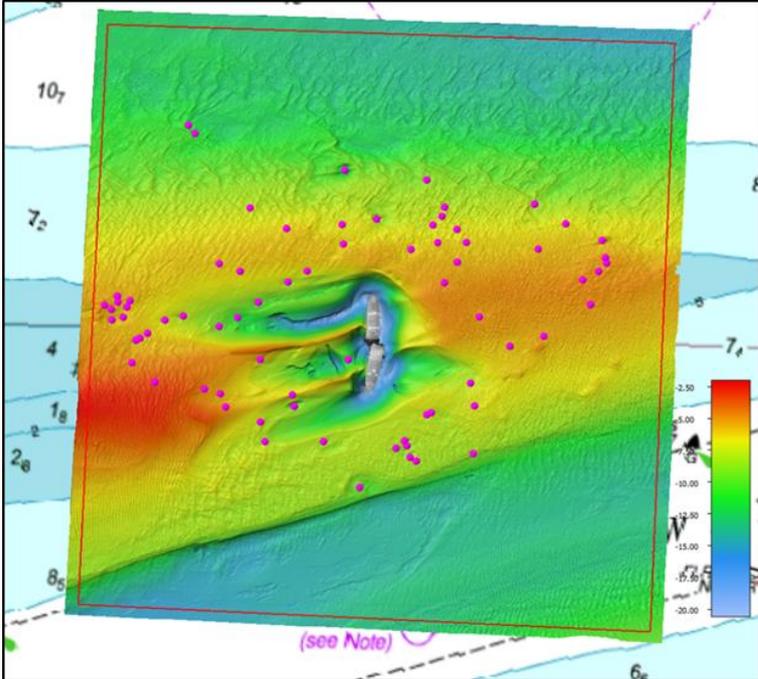
located objects are reported on. In 2016 this list contained 66 objects and the number has increased to 72 in the 2017 report. This increase is due to close scrutiny of the backscatter data combined with the bathymetry. Below is an image showing the location of these targets within the survey area. It can be seen that the majority are not directly adjacent to the wreck and the approximately diamond shape that they make around the wreck is due to many of the targets being part of current or previous sinkers and chains for the buoys around the wreck. The one object that is on the seabed close to the wreck may represent one of the two current meters that were lost in 2013.

Fig. 43 Seabed targets

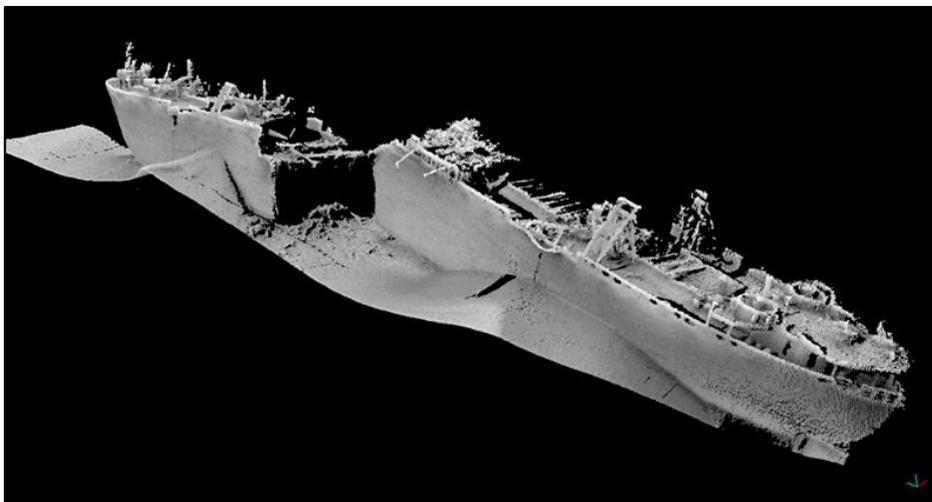
6.3 A qualitative evaluation of the ultra-high resolution dataset suggests that edges of features are well defined and it would be possible to create a point cloud model of sufficient quality to perform a comparative analysis of the wreck. The data from the R2 Sonic has a very close beam spacing and, in the benign conditions experienced during the survey, generated data with very high density ideal for capturing the features of the wreck.

Fig. 45 Point Cloud showing the coverage using the 700kHz mode

6.4 Although this initial trial wasn't completely successful, the collection of ultra-high resolution data has the potential to improve the clarity of the point cloud model. If it is trialed again in the future, it is recommended that it is from a different vessel, possibly a smaller one that is capable of surveying directly over the wreck and that this ultra-high resolution surveying takes place on a different day to the normal wreck survey as the period of slack water is too short to have two survey vessels trying to survey the wreck at the same time.
