Rail Accident Investigation Branch

Rail Accident Report

Near miss between a train and a track worker at Peterborough 20 July 2018

Report 04/2019
June 2019

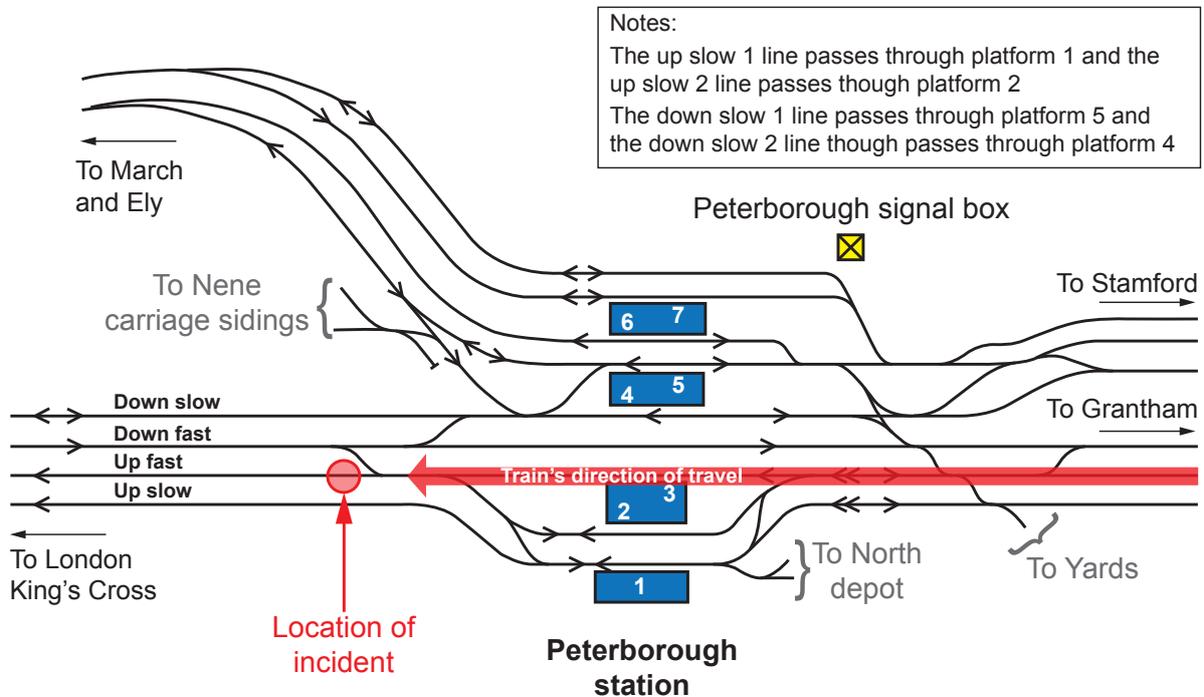
Figure 2: Schematic of track layout at Peterborough station

- 8 The track workers were working on the up slow and up fast lines (figure 2). The up fast line passes through platform 3 and has a maximum permitted speed of 105 mph (169 km/h). The up slow line passes through platform 1 and has a maximum permitted speed of 50 mph (80 km/h).
- 9 The approach on both lines is initially straight, leading into a left-hand curve (in the train's direction of travel) of about 2000 metres radius. This curve starts towards the southern end of the platforms and ends as the track straightens out after passing under the road bridge for Thorpe Road (figure 3).
- 10 Signalling in the area is controlled from Peterborough signal box. Most lines through the station, including the up fast line through platform 3, are electrified with 25kV AC overhead line equipment.

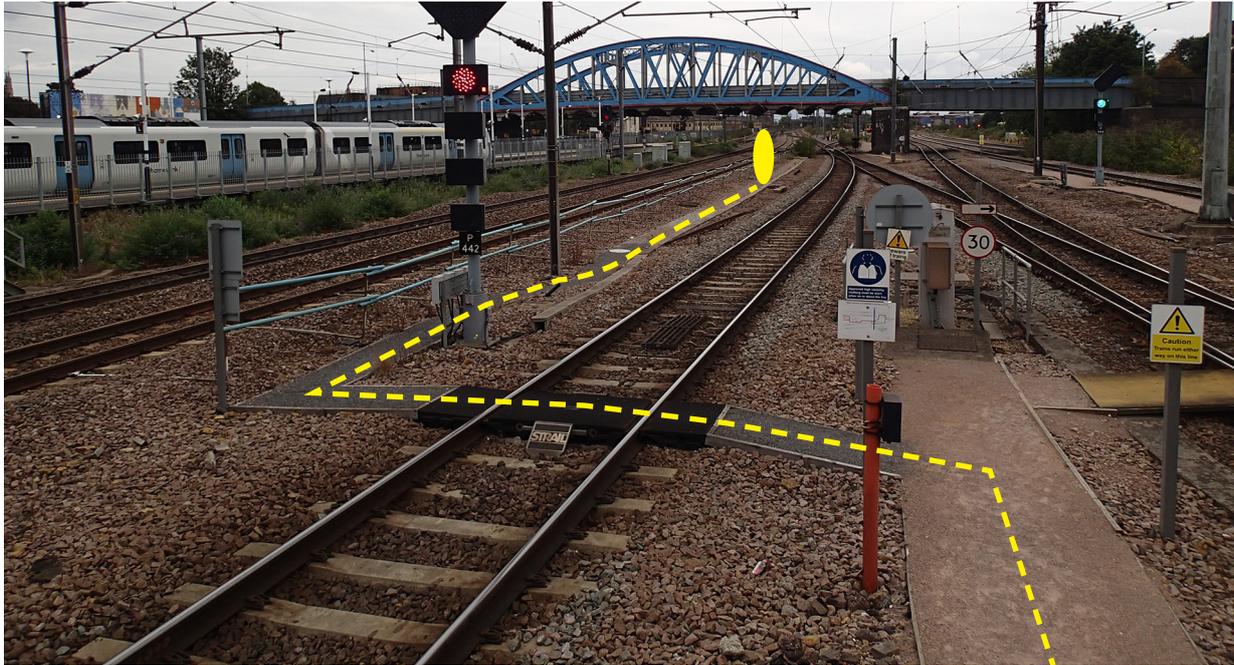
Figure 5: The authorised walkway off the end of platforms 4 and 5

81 The walkway off the end of platforms 4 and 5 is a popular place for distant lookouts to stand (figure 5). It gives good sighting of trains approaching from the north for work taking place to the south of the station. Similarly, it gives good sighting of trains approaching from the south for work taking place to the north of the station. That morning, three maintenance teams with lookouts from Network Rail's Peterborough depot, were working around the station, and each wanted to place its distant lookout at that location.

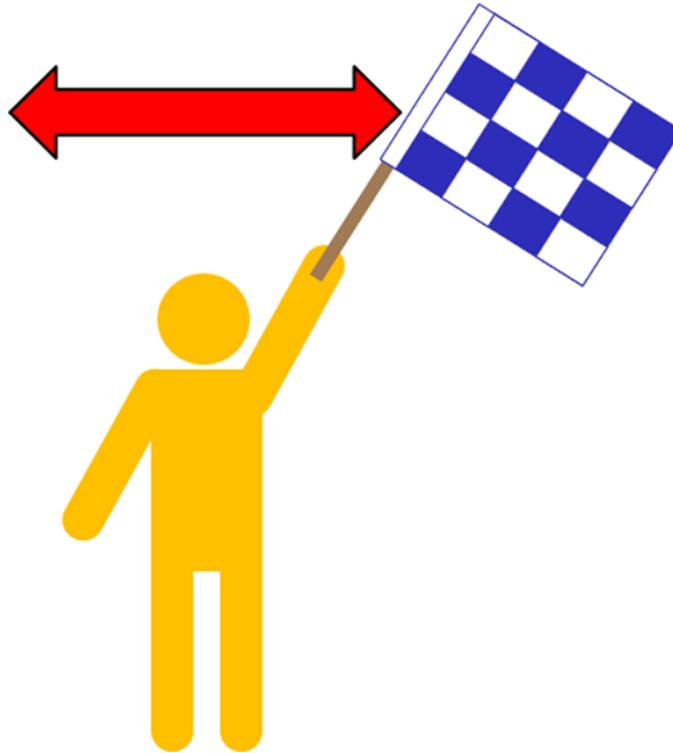
Figure 11: Lookout flag signal to give a warning

- 71 Only one lookout flag signal is described in the Rule Book (Handbook 3), to be used by the distant lookout to give a warning for an approaching train. A distant lookout waves the lookout flag from side to side above the head as shown in figure 11. When a site lookout sees this, he/she should warn the group at the site of work. Once everyone in the group has acknowledged the lookout's warning (by raising one arm above their head) and moved to a position of safety, the site lookout should return the same flag signal to acknowledge the distant lookout's warning. Both lookouts should then stop waving their lookout flags.

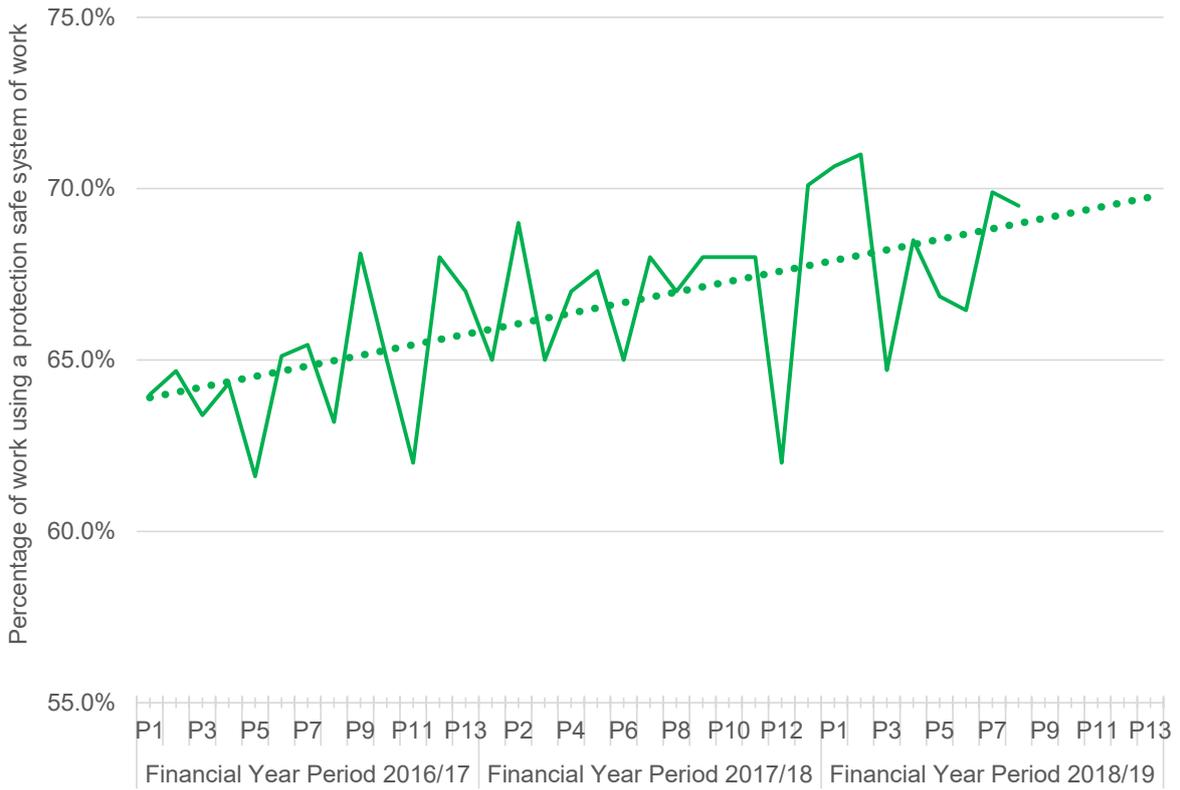
- 100 The S&EW project is monitoring the amount of work taking place using protection safe systems of work and reports it has seen a steady increase in this type of working by the four maintenance delivery units that cover the southern end of the ECML from London King's Cross to Doncaster (figure 14). Data obtained by the project also shows that the rail testing and lubrication section within the Peterborough delivery unit is the section that carries out the least proportion of work using protection safe systems of work (figure 15).

Figure 14: Graph showing the increase in the amount of work carried out using protection safe systems of work by the four maintenance delivery units that cover the southern end of the ECML from London King's Cross to Doncaster

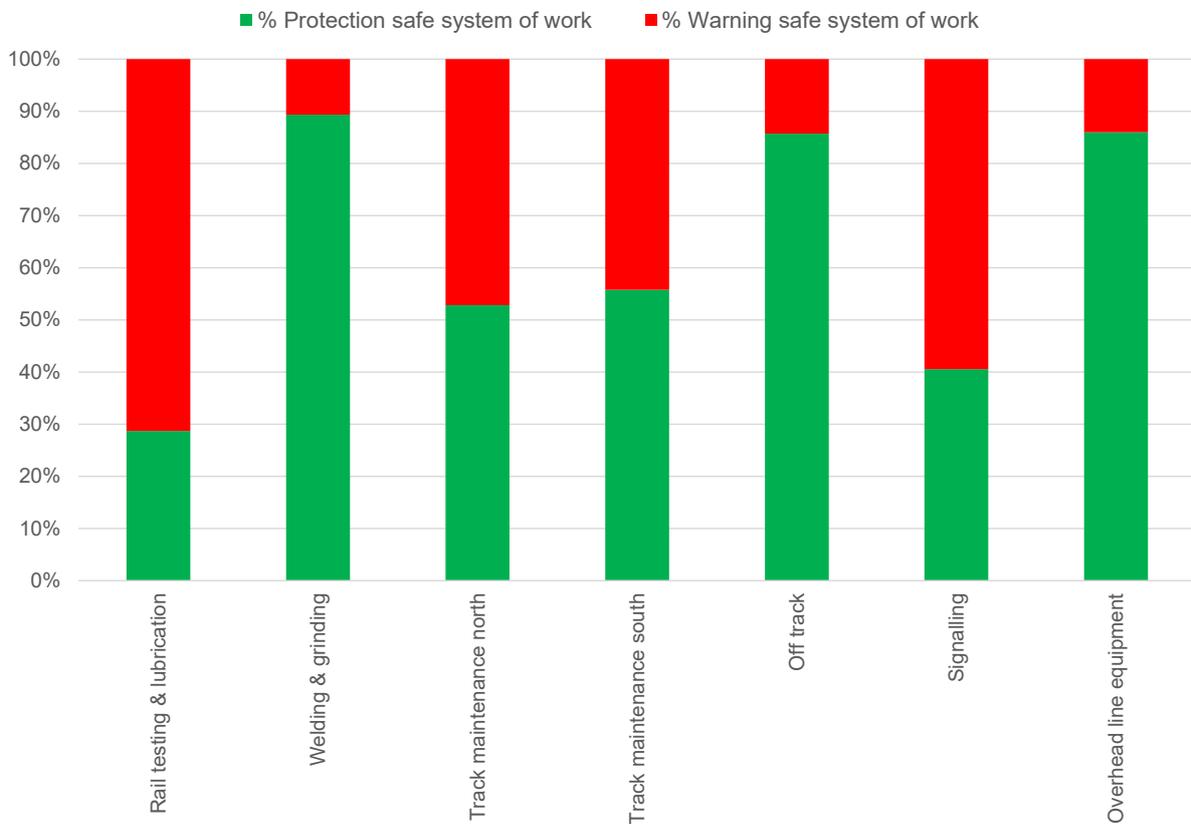
- 101 At the time of the incident, the Peterborough rail testing and lubrication section was carrying out about 70% of its work using a warning safe system of work, primarily using lookouts rather than equipment (figure 15). A large proportion of this section's work is responding to suspected rail defects within a specified timescale, so this rail testing work often cannot be planned into engineering possessions or line blockages. However, this is not the case for the work of the lubrication team, as almost all of its work consists of cyclic inspections.

Figure 15: Graph showing the amount of work carried out using protection safe systems of work by each maintenance section within Peterborough delivery unit
