Rail Accident Investigation Branch

Rail Accident Report

**Train travelling with doors open on the Jubilee line
1 September 2018**

Report 06/2019
July 2019

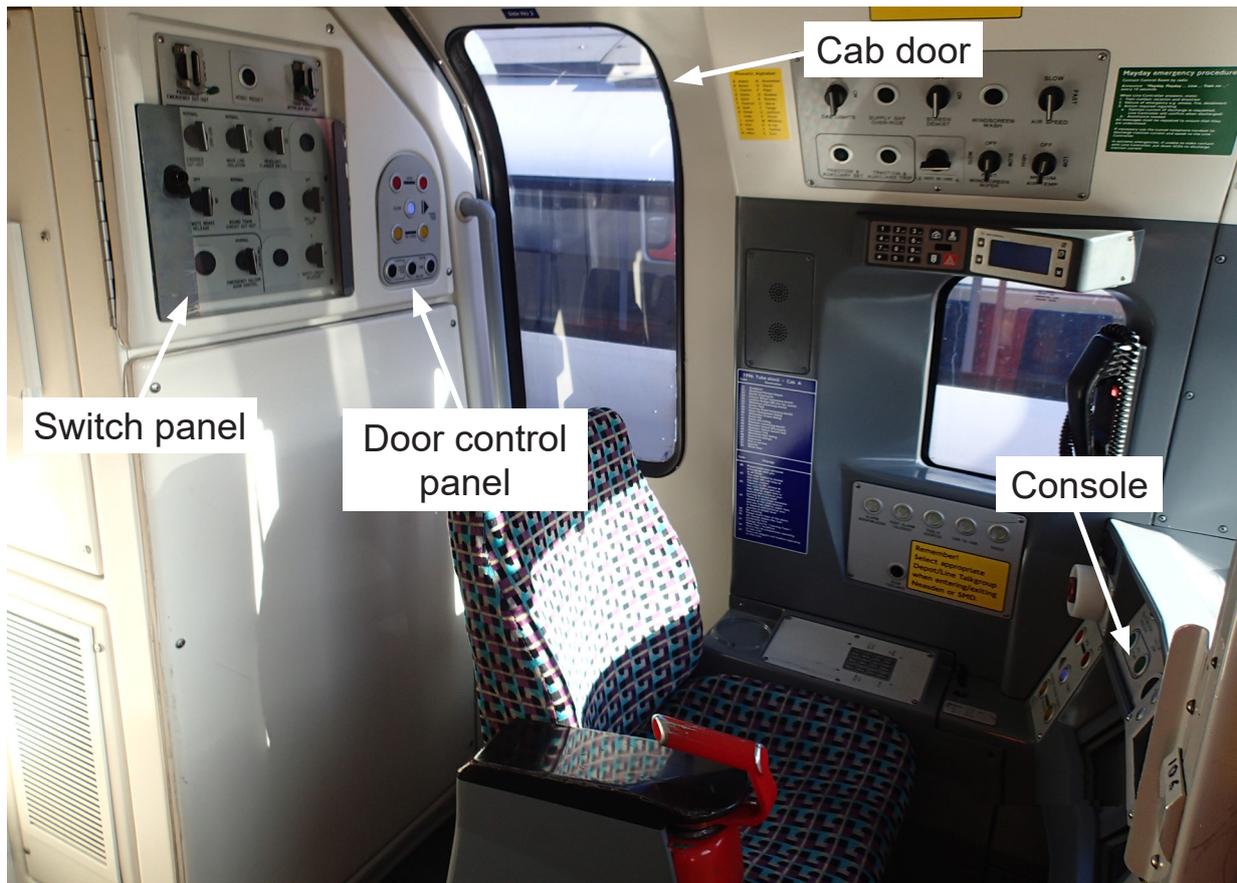
Figure 5: Driving cab

- 61 Both the ESDC and TDIC switches are part of the cut-out switch bank on the back wall of the driving cab, near the cab door which was adjacent to the platform (figures 5 and 10). However, there are significant differences between these switches; the TDIC switch is at a higher level and nearer the cab door than the ESDC switch. The TDIC switch is fitted with a flap and a seal in the form of a plastic tag which must be broken before the switch can be operated. The flap covers only the TDIC switch and must be lifted before the switch can be turned. The ESDC has no seal or individual flap. However, it can only be operated after opening a plastic door which covers most of the switch bank, but not the TDIC switch. This plastic door opens towards the driving cab door, which makes operating the ESDC switch from the doorway difficult.

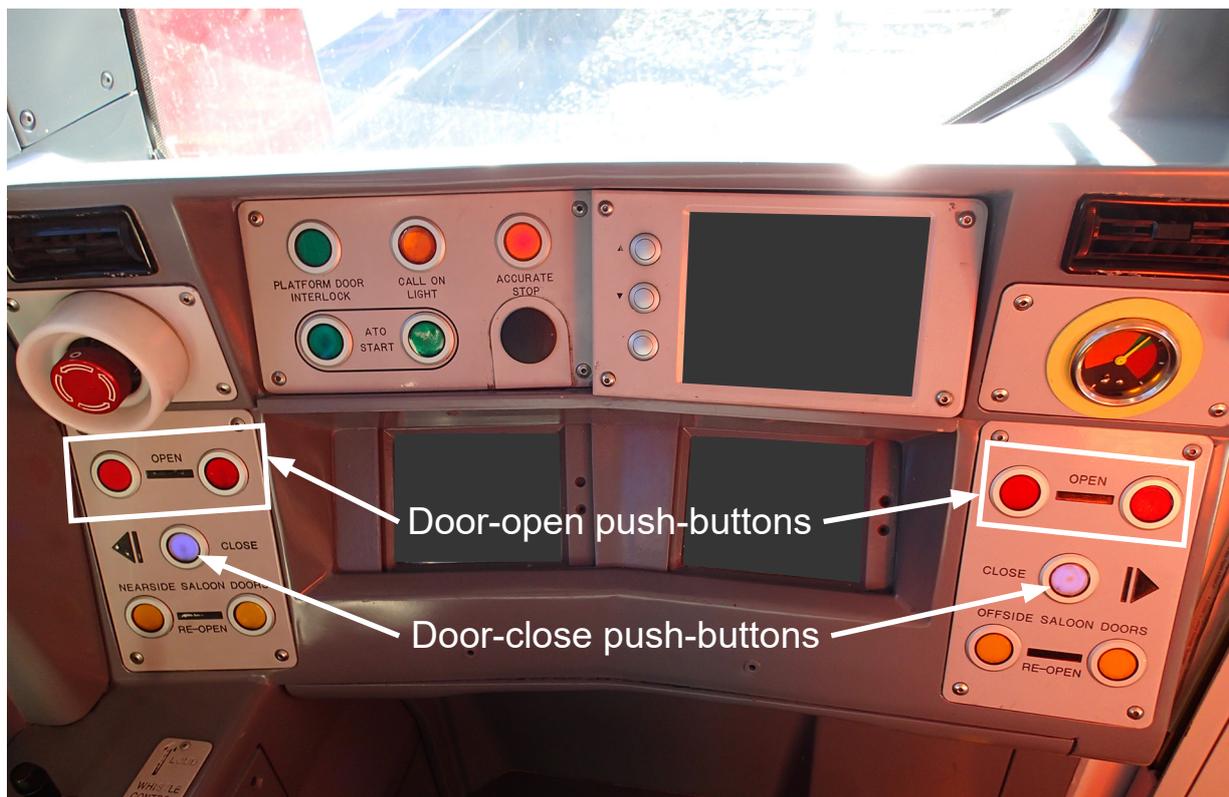
Figure 6: Train operator's passenger door-open and close buttons

68 Before starting a train, train operators are required to check the DCV lights are illuminated as confirmation that all doors are fully closed (figure 6 and paragraph 41). The train operator could not recall whether he checked the DCV lights before departing from Finchley Road, but stated that if he had seen they were not illuminated he would not have started the train. He also stated that he would have stopped the train if had he noticed that the DCV lights were not lit during the journey to West Hampstead.

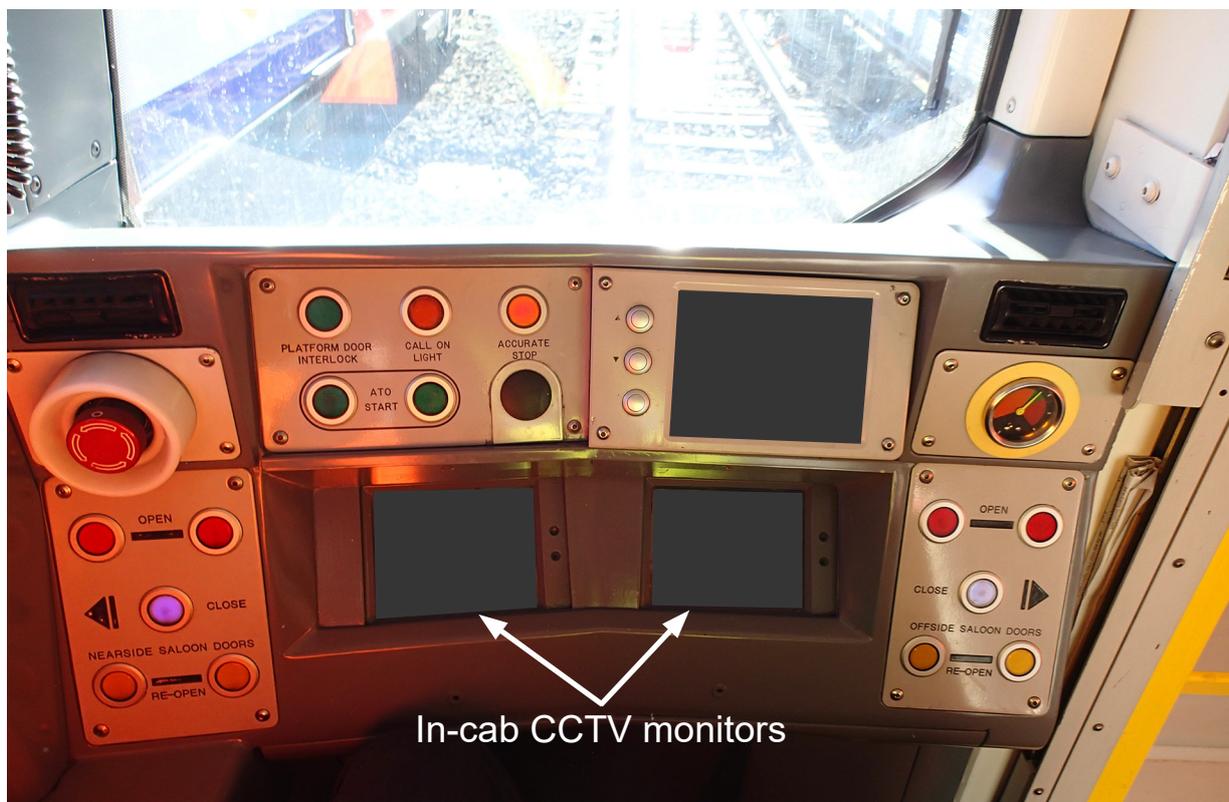
Figure 7: CCTV monitors on console

72 The train operator recalled having to use his hands to shield the in-cab CCTV monitors from sunlight when checking if it was safe to start the train, and during the time the train was leaving the platform (paragraph 14). Post-incident observations by the RAIB at a similar time of day to that of the incident showed that sun glare made it difficult to see the side of the train on the CCTV monitors (figure 15).

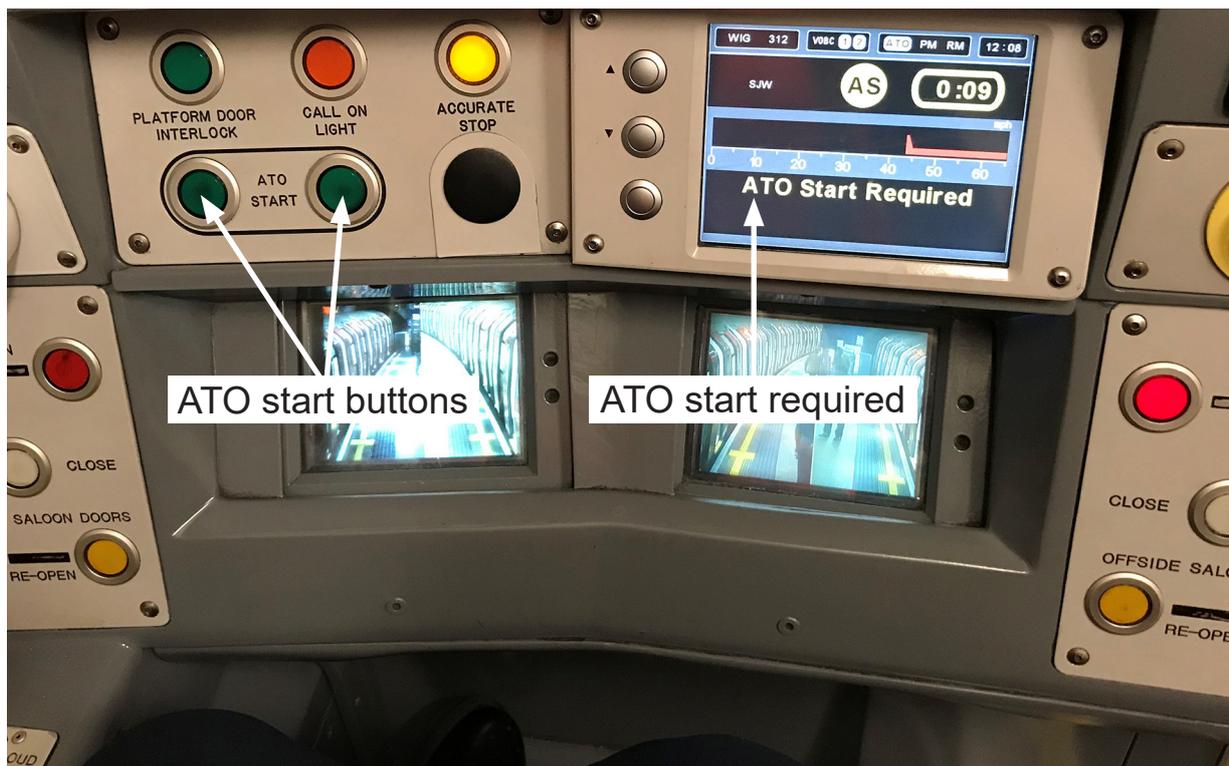
- 15 The ATO system is intended to optimise the interval between successive trains based on real-time train running information. The system calculates the optimum dwell time (the length of time a train is stationary at a platform stop) and presents this to the train operator on an in-cab countdown display showing the number of seconds before the desired departure time. When there are approximately 10 seconds of calculated dwell time remaining a warning tone sounds in the driving cab. The display then shows 'ATO Start Required' after the calculated optimum departure time has passed (figure 9).

- 16 When the train is ready to depart from a station, the train operator presses two ATO start buttons simultaneously on the console (figure 9). This action removes the 'ATO Start Required' display and, around 4 seconds later, the train will start to move.

Figure 9: ATO display showing ATO start required and ATO start buttons

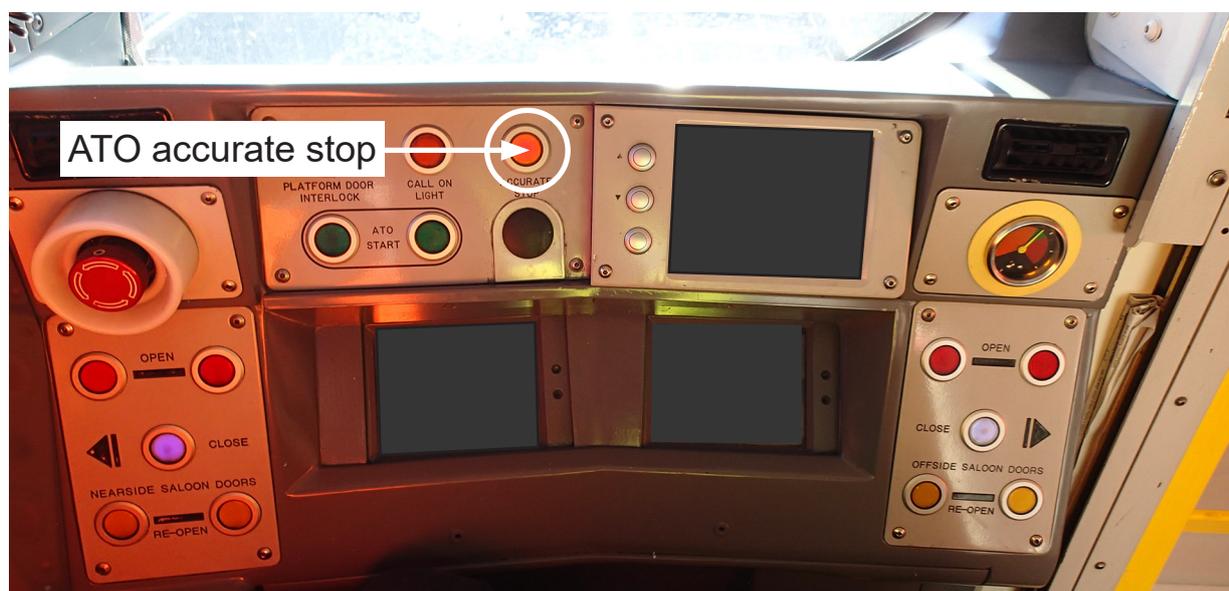
- 37 In normal ATO operation, the train stops automatically at the correct location, and this is confirmed by an accurate stop detection system, consisting of equipment fitted to the train and on the track, which causes a yellow 'accurate stop' light to illuminate on the train operator's console (figure 13). The train operator then opens the passenger doors on the appropriate side of the train.

- 39 In some instances trains do not stop accurately and the yellow light will not illuminate. LUL stated that this happens at about 0.017% of station stops. In these circumstances train operators are trained to open the cab door to check whether the train has stopped with all passenger doors alongside a part of the platform where they can be used safely by passengers.

Figure 13: ATO accurate stop indicator

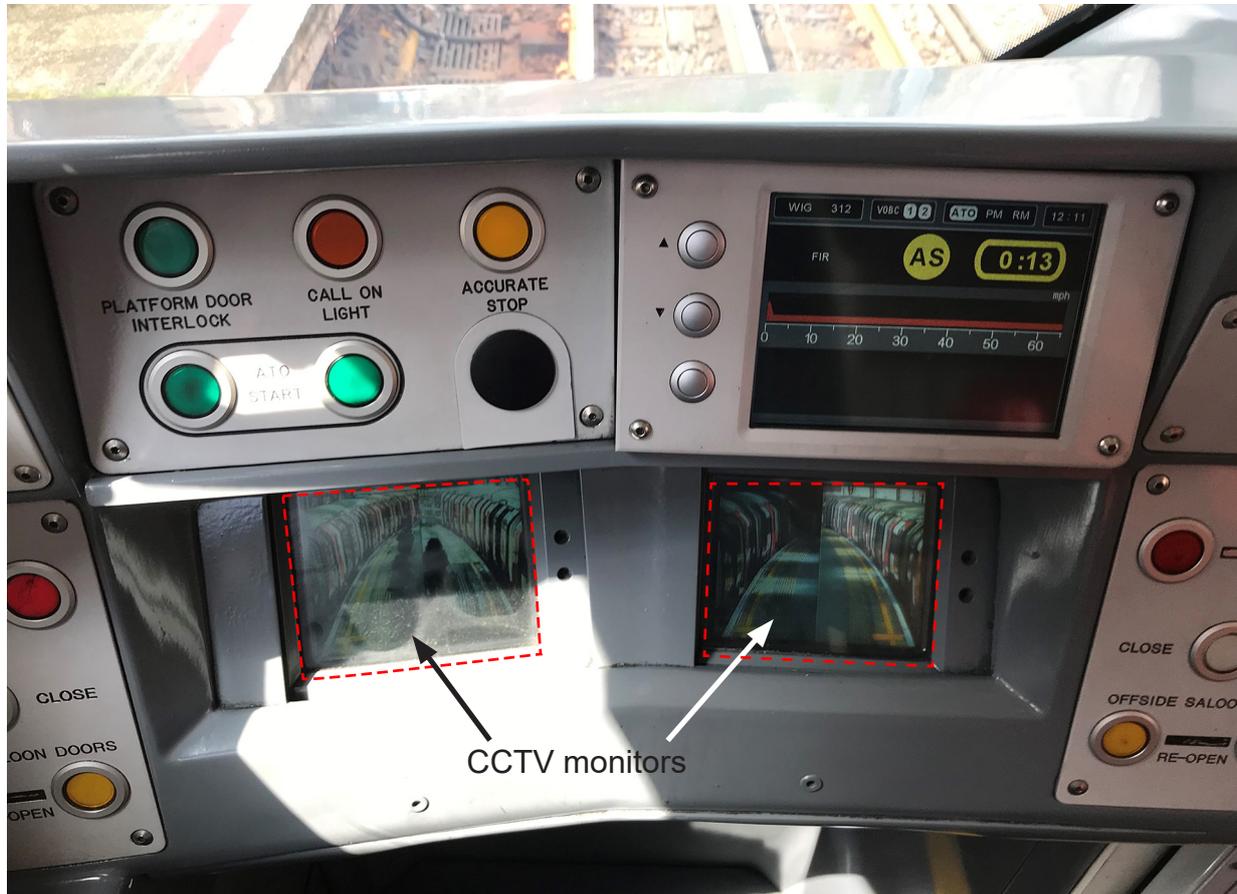
- 73 The CCTV cameras are positioned to provide the best view along the side of the train (figure 16) so that the train operator can see if anyone is trapped in a door or in an unsafe position relative to the side of the train. There is no requirement for CCTV cameras to be aligned to directly facilitate seeing whether train doors are open.

Figure 16: In-cab CCTV monitors showing longitudinal images of the side of a train

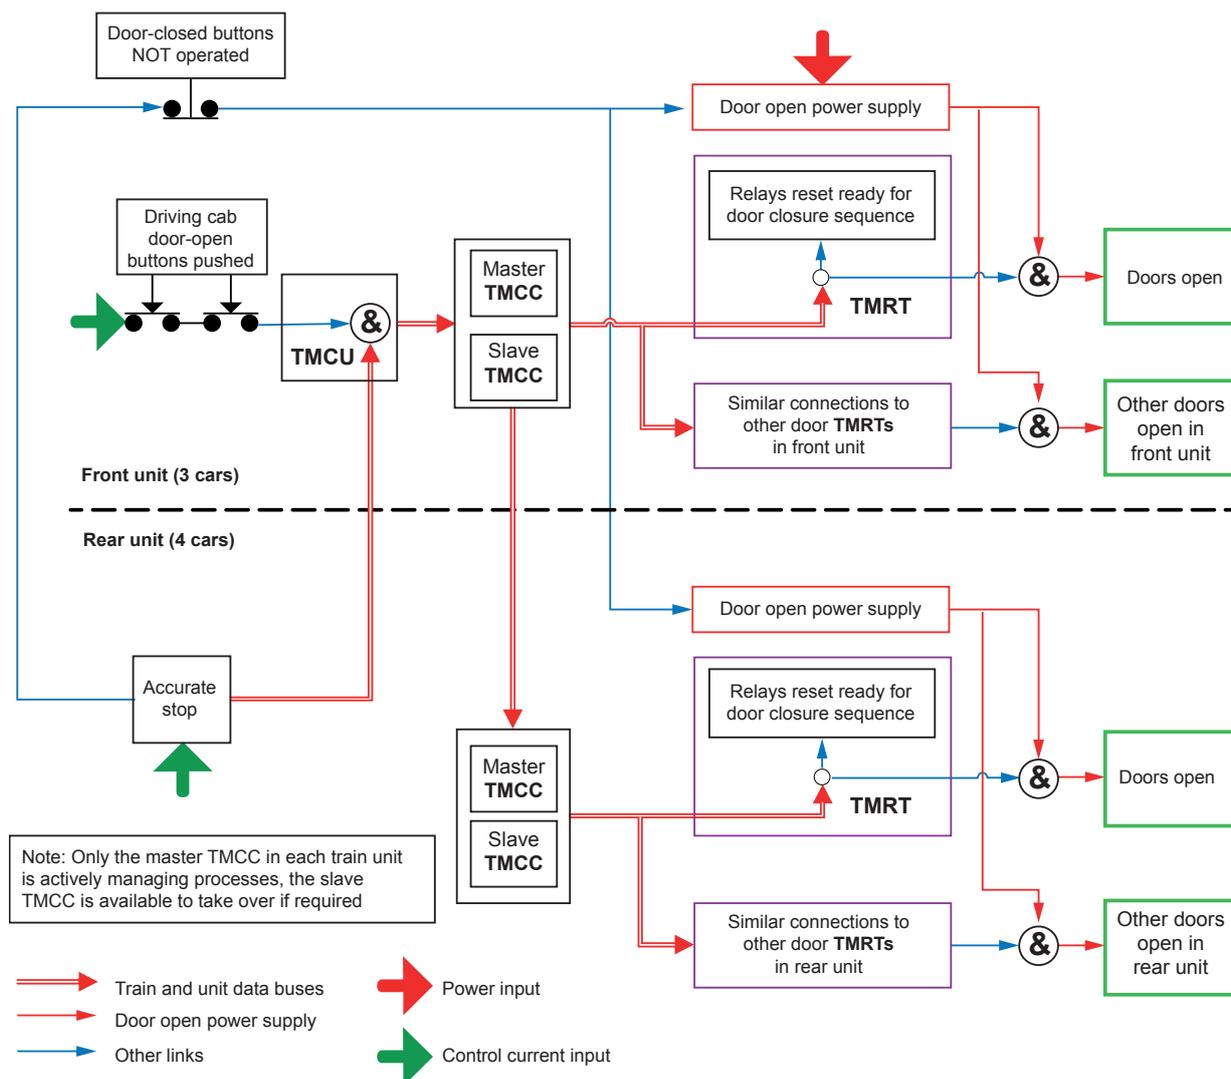
- C24 LUL has been unable to recreate the exact status of the control equipment during the Finchley Road incident, and so was unable to establish with certainty the effect of correctly following the procedures, including operation of the ESDC switch, intended to be applied by train operators dealing with doors not opening and closing when expected.

- C25 Post incident testing by LUL found that some local door-open buttons were defective. Some button defects had the same effect as keeping a button permanently pushed. Other faults meant that the intended effect of pushing a button was not achieved. In default passenger mode, the first of these defects would cause the associated doors to open as soon as power was available to open them. The second type of defect meant that passengers pressing a button would not open the associated doors.

Figure C1: Door opening system, normal operation with train stopped accurately (simplified)
