Rail Accident Report

Collision between two road-rail vehicles at Cholmondeston, Cheshire 19 September 2018

Report 08/2019
July 2019

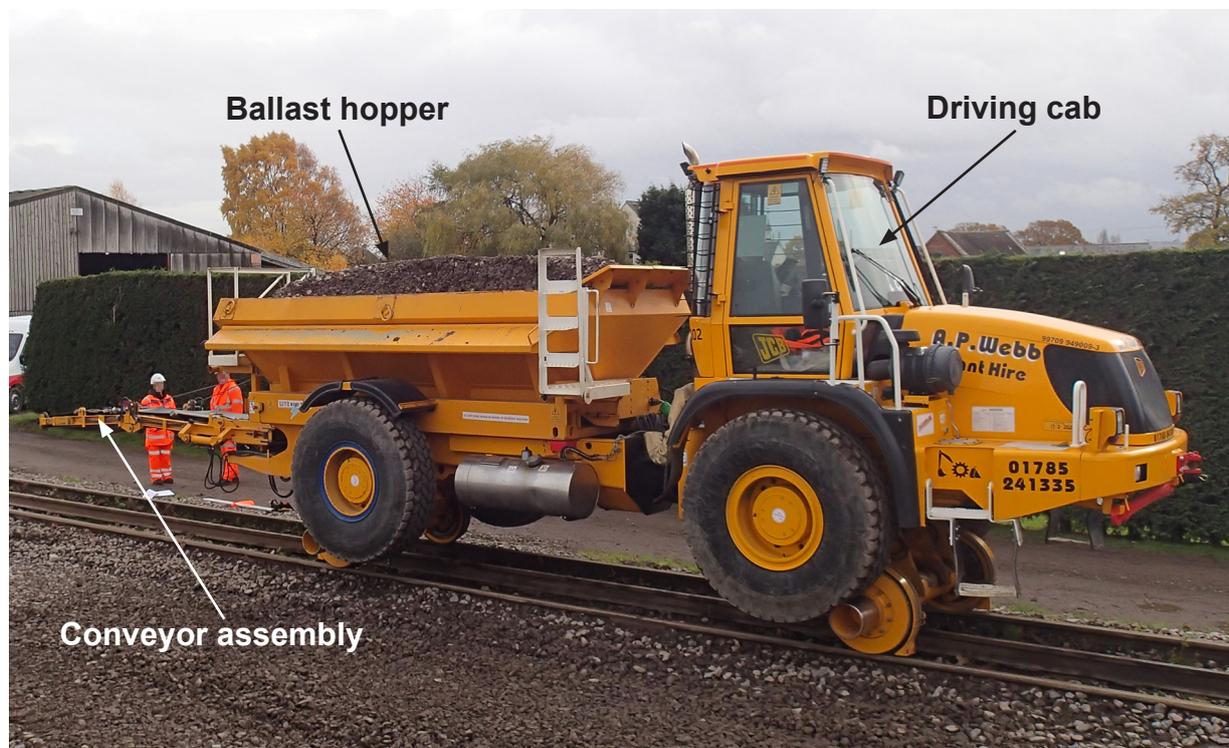
Figure 3: The ballast distributor road-rail vehicle

- 13 The ballast distributor RRV (figure 3) is a road based dumper truck, manufactured by JCB, and converted for use on the UK rail network by Railability in 2005. After conversion, the cab of the RRV remained unidirectional, with the operator's seat facing forwards away from the hopper. There is no evidence that JCB played any part in the factors relating to the accident.

- 14 The vehicle is fitted with a ballast hopper module that has a conveyor belt in the bottom. This conveyor belt extends to the rear of the vehicle and can swing laterally to allow the ballast to be deposited where required on, or beside, the track. The hopper can carry up to 10 tonnes of ballast.

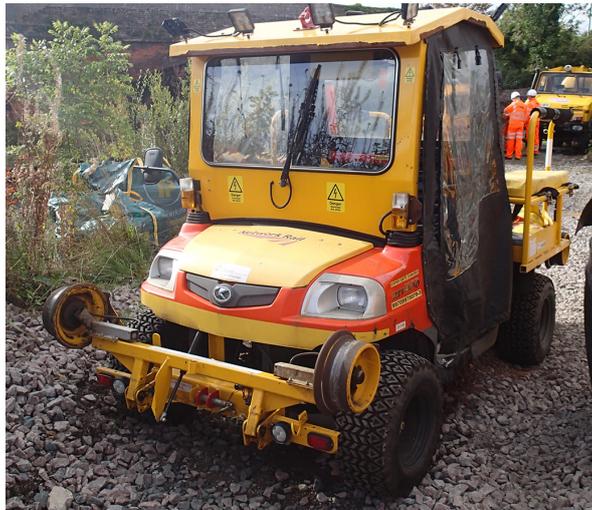
Figure 4: A 'kubota' personnel carrier RRV, similar to that involved in the accident

- 16 The personnel carrier RRV was a Permaquip Kubota (figure 4). This is a four-wheeled Kubota all-terrain vehicle that had been converted for use on rail by Permaquip. When on the track, the rail wheels are lowered to provide guidance. The road wheels remain in contact with the rail, taking the weight and providing traction and braking (type 9C⁷).

- 17 The kubota has seating for two people, including the driver, in the front, as well as space for up to four people and/or equipment in the rear. There is no evidence that the design, construction or conversion of the vehicle for rail use played any part in the cause of the collision.

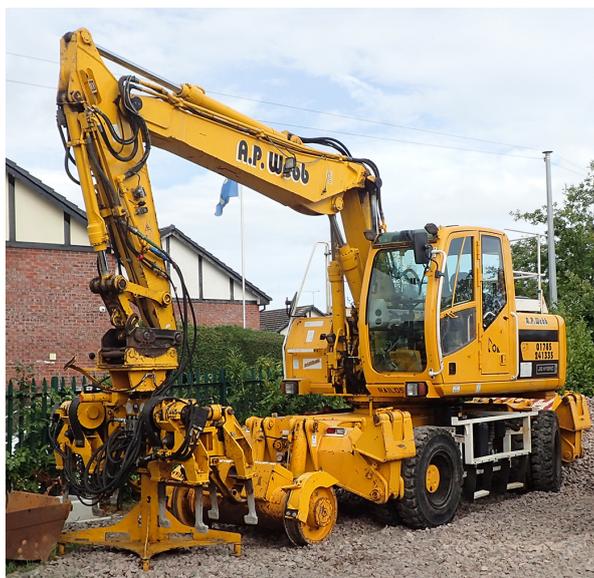
Figure 6: The tamper bank RRV

- 34 The track maintenance team then on-tracked their kubota on the down line at the RRAP, followed by a 360 degree excavator type RRV that was fitted with a tamper bank attachment¹³ instead of a bucket (henceforth referred to as the tamper bank RRV - figure 6). The five members of the team then travelled to 162 miles 1450 yards, with the two RRVs, where they were intending to repair a track geometry fault by lifting and tamping the track.
