Rail Accident Investigation Branch

Rail Accident Report

Overspeed at Sandy South Junction, Bedfordshire 19 October 2018

Report 10/2019
August 2019

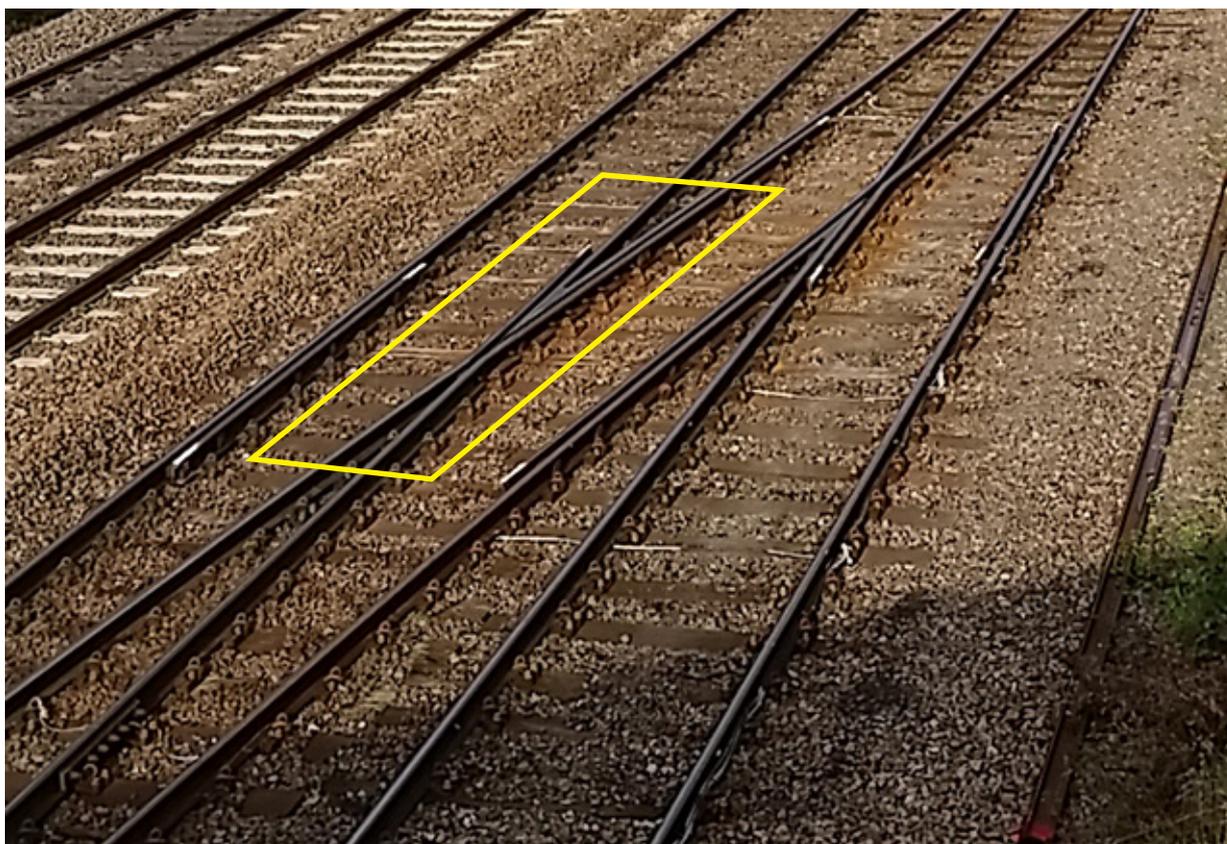
Figure 3: Photograph of a crossing within a set of points

- 23 On 18 October 2018 at around 10:00 hrs, a Network Rail patroller carrying out a basic visual inspection of the track identified a crack estimated to measure 60 mm long in the crossing of 1100A points at Sandy South Junction.

- 24 Network Rail's maintenance delivery unit sent out a team to implement a 40/70² mph speed restriction, in accordance with the Network Rail company standard governing such situations. Around 13:30 hrs a member of this team measured the crack at 85 mm in length.

- 25 Due to the length of the crack, the 40/70 mph emergency speed restriction was no longer appropriate and, in accordance with Network Rail standard, NR/L2/TRK/1054, a 20 mph (32 km/h) emergency speed restriction was imposed. Hourly line blockages were also imposed to enable an inspection of the crack, and a watchman was appointed to keep a watch on the crossing and the trains traversing the points.

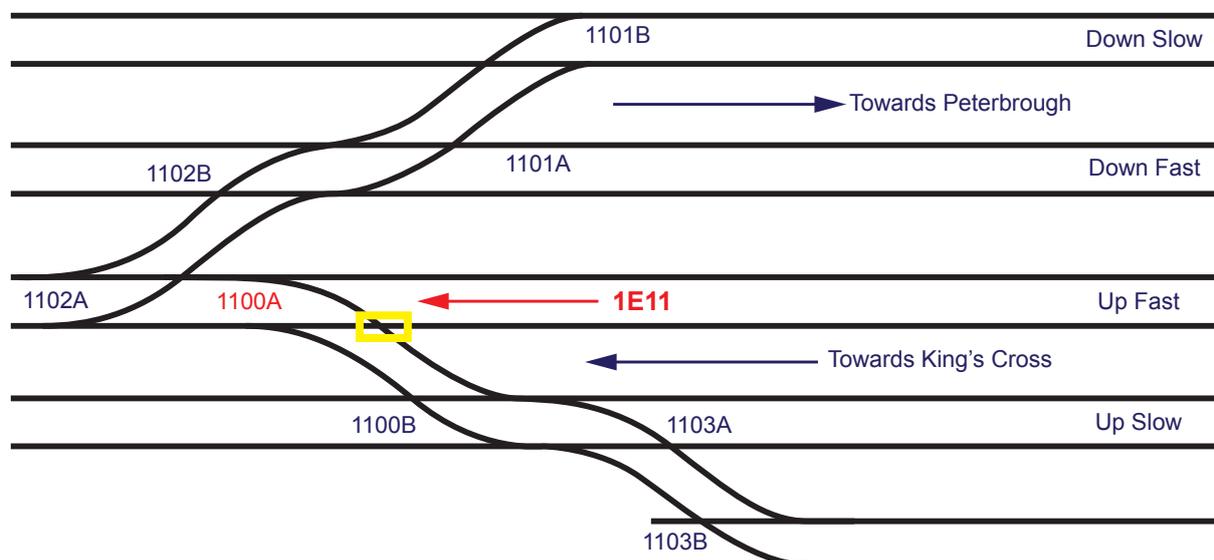
Figure 4: Sandy South Junction, with yellow box around the relevant crossing

- 6 Sandy South Junction is on the East Coast Main Line to the south of Sandy station, which is about 44 miles (71 km) from London King's Cross (see figure 4).
- 7 Points 1100A, where the crack in the crossing was found, are located in the up fast line, at 43 miles and 61 chains (380 m south of Sandy station), and are part of a crossover which allows trains to pass from the up slow line on to the up fast line.
