# Derailment of a freight wagon at Carpenters Road North Junction, near Stratford in East London, 11 June 2019

## Summary of the accident

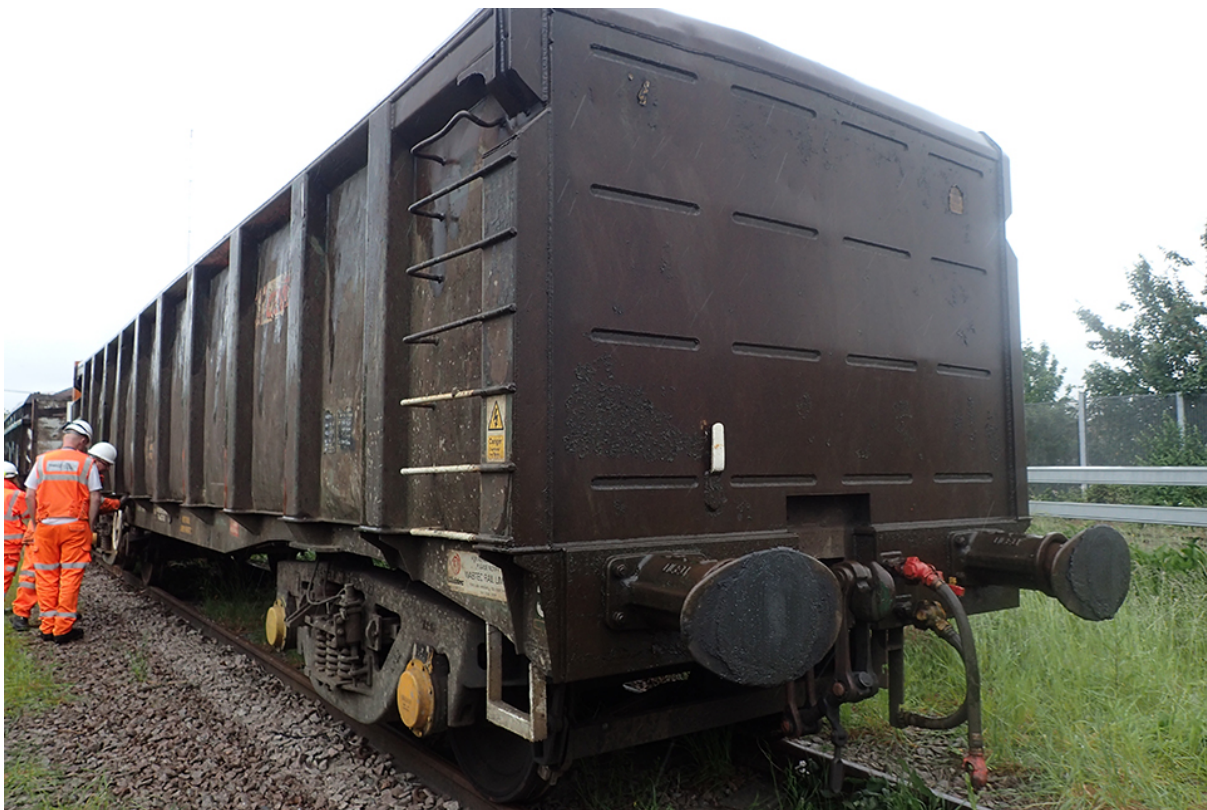
**Figure 3: Wagon involved in the accident**

Shortly after the train restarted its journey, a component of the braking system on the seventh wagon became partially detached and began bouncing along the track. Shortly after, as the wagon passed through Carpenters Road North Junction, a substantial part of the wagon's braking system detached. This equipment fell onto the track, where a trailing wheel on the leading bogie ran over it and derailed.

The wagon ran derailed, damaging sleepers and signalling equipment, and breaking a rail, before it re-railed at Carpenters Road South Junction and continued to Bow sidings, a short distance beyond Carpenters Road South Junction. Neither the train driver, nor a manager in the driving cab, noticed anything unusual during the derailment.

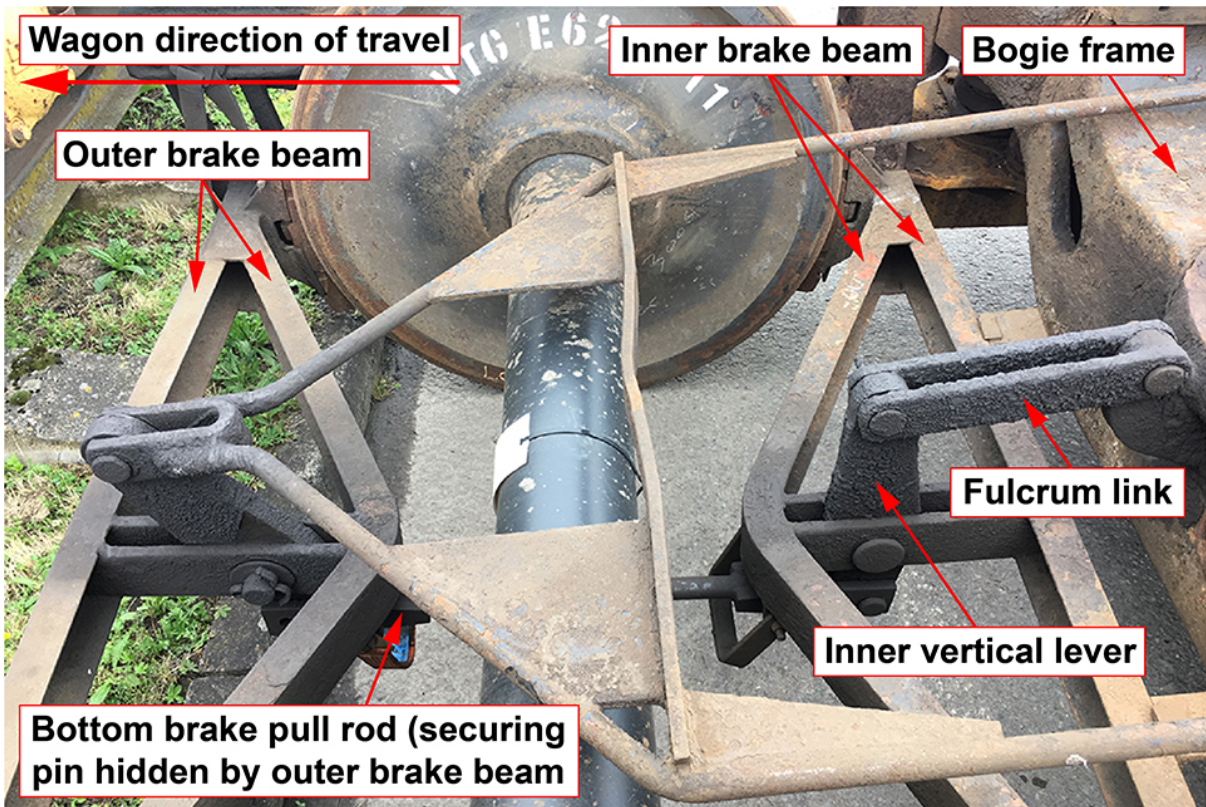
Figure 4: Wagon brake components (viewed from above a similar bogie without a wagon body)

The braking system comprises a system of rods, beams, levers and links (figures 4 and 5) which are connected by securing pins and which transfer force from the brake cylinder onto brake blocks, causing them to be pulled against the wagon wheels when braking is required. Some securing pins require a split pin to be inserted at one end to prevent the securing pin falling out.
