Rail Accident Investigation Branch

Rail Accident Report

**Near miss with a track worker near Gatwick
Airport station
2 December 2018**

Report 12/2019
September 2019

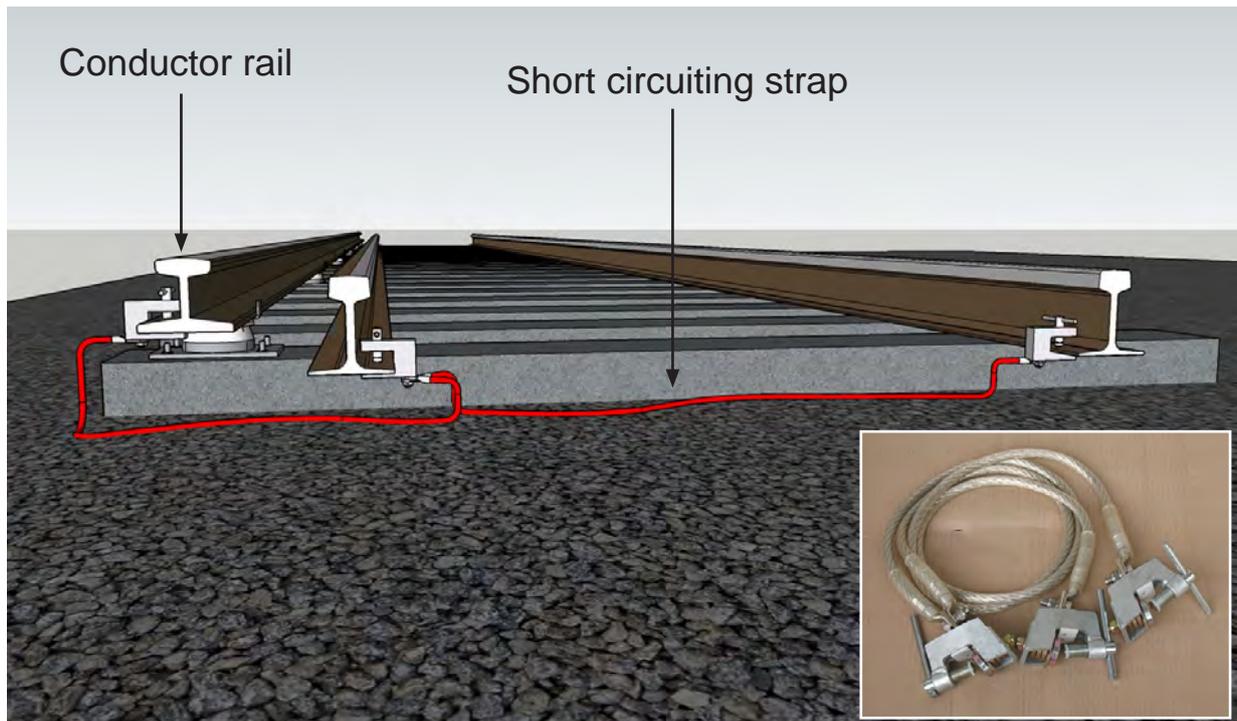
Figure 4: Short circuiting strap (inset photograph of strap (courtesy of Unipart Rail))

21 When engineering work is carried out on or near conductor rails, it is necessary to isolate these rails. This involves disconnecting the electrical feed and fitting short circuiting straps to temporarily connect the conductor rails to the rails which carry train wheels (figure 4). Connecting these rails causes circuit breakers to trip if power is accidentally restored to the conductor rail. This could occur if a mistake were made in a control room or if, contrary to the intended operation of trains in these circumstances, an electric train moves across the gap between a live and an isolated conductor rail allowing the electrically connected power pick up shoes at each end of a coach to touch both conductor rails simultaneously.

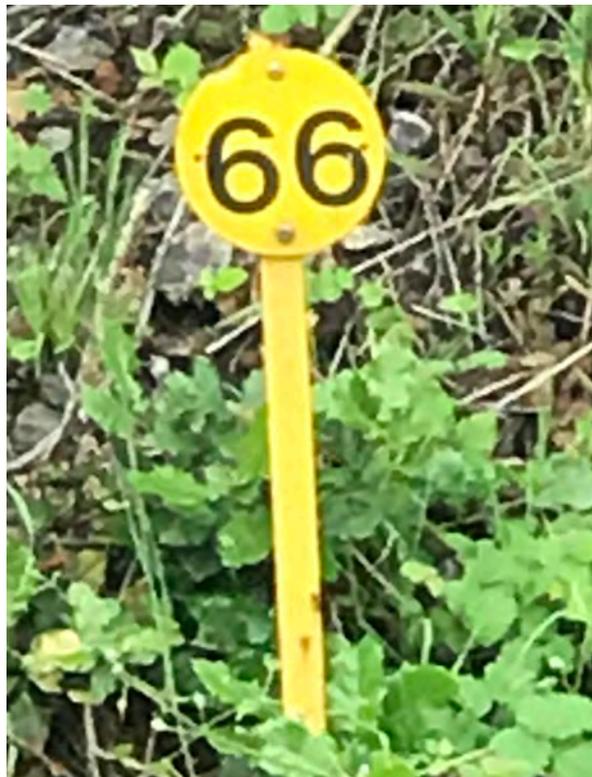
Figure 9: Typical chain marker, not at incident site

50 The SSOW pack for installing and removing short circuiting straps at 1703A and 1704A points was prepared by BAM Nuttall's SSOW planners based on information contained on a form (the B2 form) prepared by Network Rail's isolation planners. This form described the position of the straps as '26 miles 22 chains – 1703 points & 26 miles 30 chains – 1704 points'. It did not specify whether strapping at the A or B end points was required but the chainages correspond to 1703A and 1704A points on the down slow line. These positions could be identified at the site of work because there are lineside markers provided at almost every chain (figure 9). Although the 22 chain marker was missing, those for 21 chains and 23 chains were present.
