# Door open in traffic between Shenfield and Hockley stations, 22 August 2019

## Summary of the incident

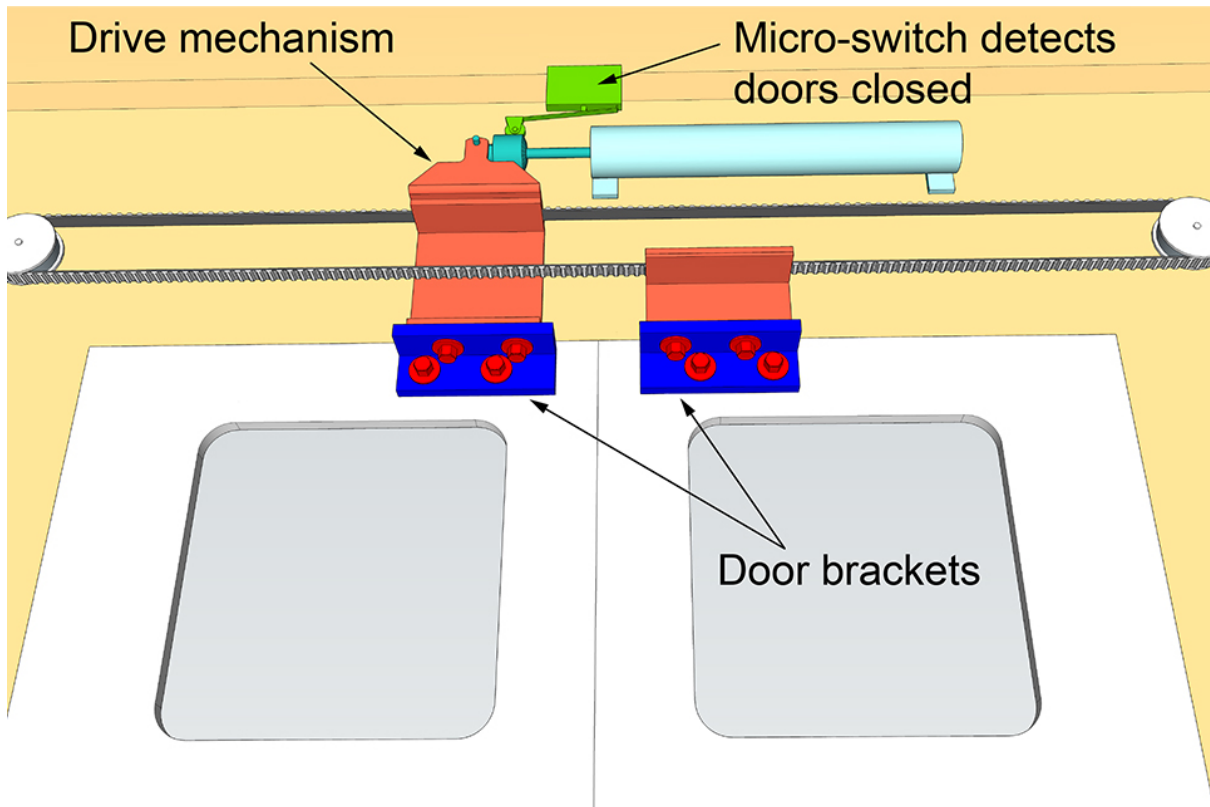
The passenger doorways of a class 321 unit comprise a double-leaf door which is opened and closed by a drive belt powered by a pneumatic piston. The connection between each door leaf and the belt includes a bracket fixed to the leaf by two screws and secured to the drive mechanism by a further two screws.

**Schematic of door mechanism in the normal condition with doors closed (only relevant components shown, not to scale)**

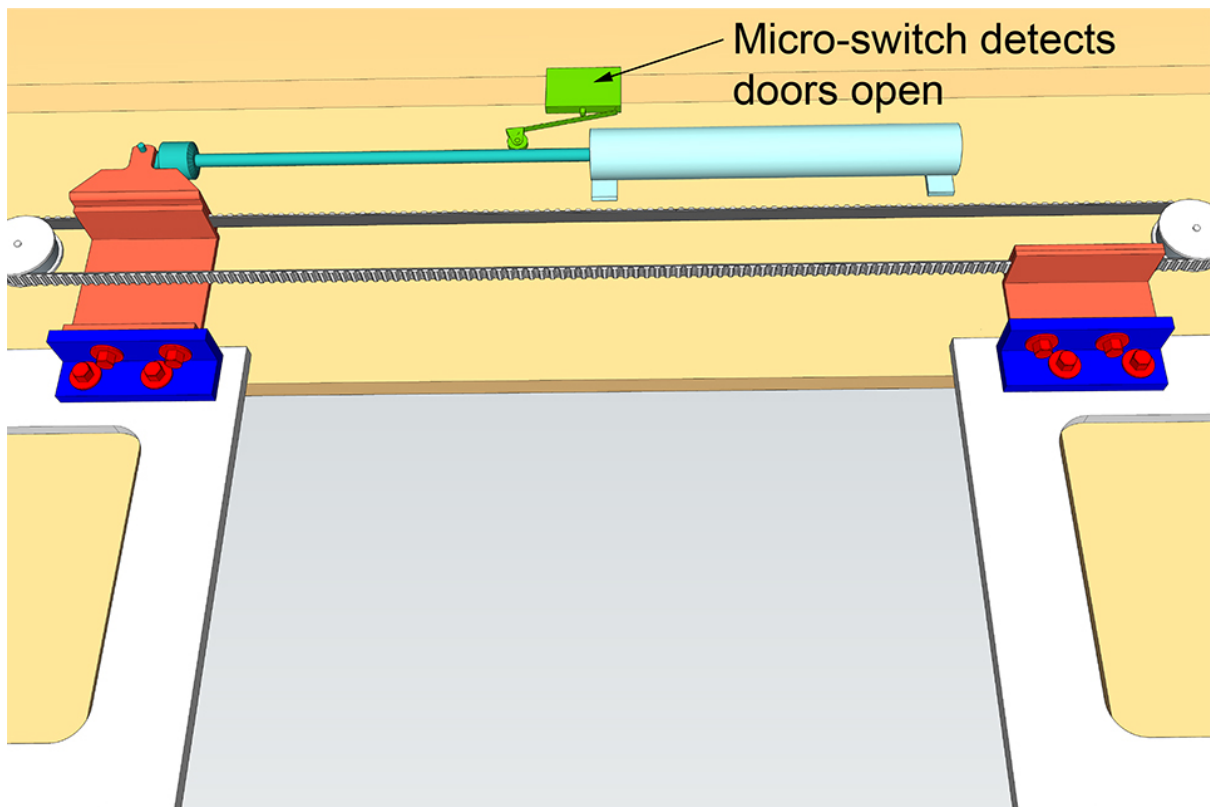
**Schematic of door mechanism in the normal condition with doors open (only relevant components shown, not to scale)**

The door leaf which remained open between Shenfield and Hockley had become detached from the drive mechanism because the two screws fixing its bracket to the drive mechanism had worked loose and fallen from the bracket. The two screws and the associated four wedge lock washers were found by the driver, while at Hockley, when he opened a panel giving access to the door equipment. With the screws fallen from the bracket, the door leaf did not respond to movement of the drive belt and was free to open and close in response to the train's motion.
