Marine Accident Investigation Branch (MAIB) - Safety Digest 2/2004

This Safety Digest draws the attention of the marine community to some of the lessons arising from investigations into recent accidents. It contains facts which have been determined up to the time of issue.

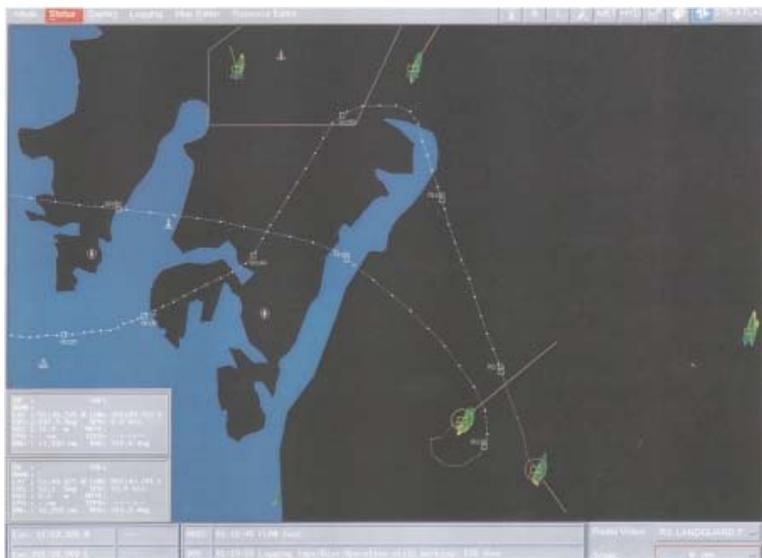
VTS still

A passenger/freight ferry had left Harwich at about the same time, and was heading on a course of 100° at a speed of 14 knots. Her bridge complement was a second officer and a lookout. The ferry's OOW tracked the bulk carrier by radar as she headed in the north-north-easterly direction, and as she crossed ahead of the ferry at a distance of 3 miles. The bulk carrier's subsequent alteration of course to 160° meant that a close quarters situation now existed between the two vessels. The ferry's OOW believed the bulk carrier had then switched on the three red lights. He called the local VTS to ask them about the bulk carrier's intentions. The VTS advised him to call the other vessel to ascertain the information. On doing so, and requesting that the bulk carrier alter her course to starboard, the OOW on the bulk carrier replied that he intended to hold his course because he had another ship to port and shallow water to starboard (see figure).

The ferry's OOW asked the bulk carrier on two further occasions to alter to starboard. However, the bulk carrier took no action. The OOW on the ferry notified the VTS he was going to take a round turn to starboard to alleviate the situation.

He then carried out the manoeuvre, which resulted in the ferry paralleling the bulk carrier's course at 0.5 miles and then passing safely astern and clear of her. It was noticed that during this manoeuvre the bulk carrier reduced her speed.

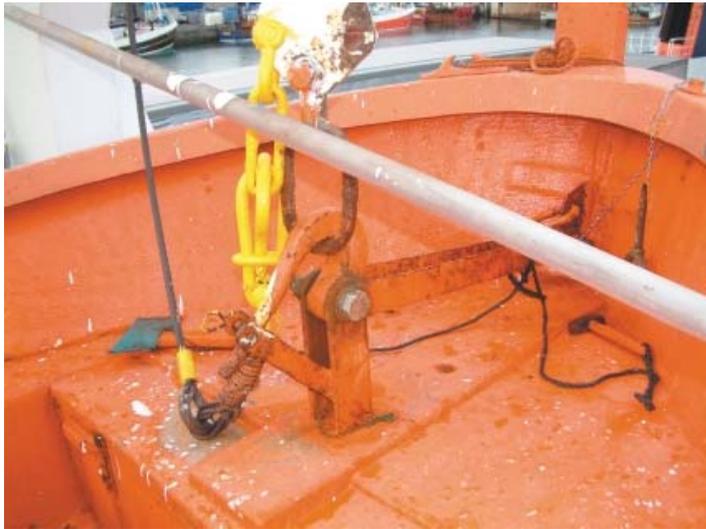
Figure 1 Lifting hook showing fall block chain ring correctly secured

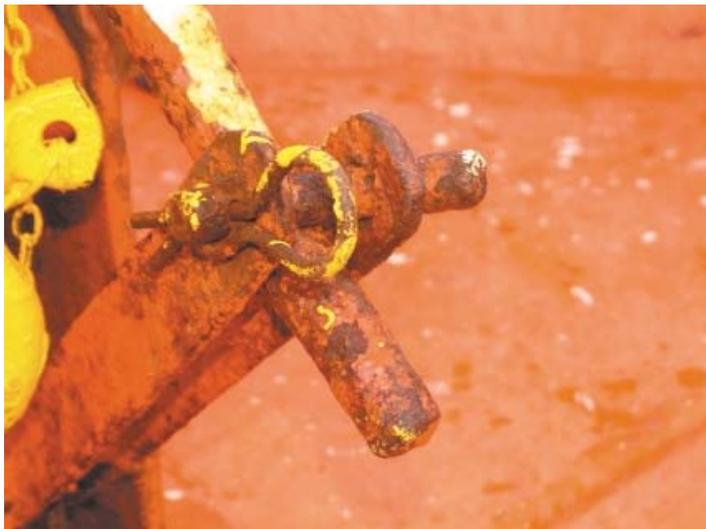
Figure 2 Detail showing hook in the secure position with the safety pin and 'R' clip in place

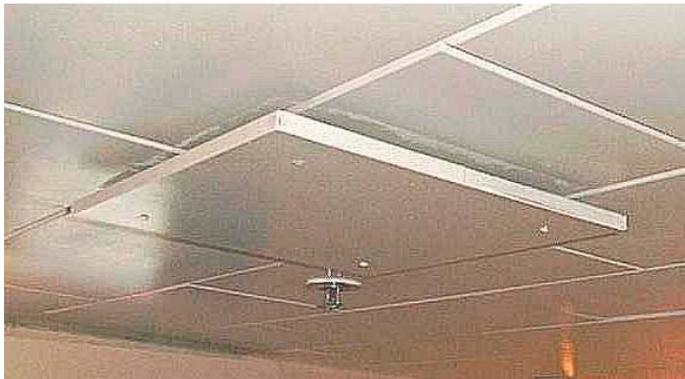
The thermostat was connected to an electrical heating element within the vent. By turning the thermostat to fully on, this, in turn, switched the heating element fully on and ensured that it stayed on. At that stage, the towel, which had been stuffed into the diffuser area some time ago, caught fire.

Sprinkler head

The vent heaters were in addition to central air conditioning heaters. They were fitted to allow a degree of local control to the temperature of the air entering the cabin. As a result of this incident, the company has decommissioned all the vent heaters on board the vessel.

- 1. Never restrict the flow of any ventilation, other than by using the available controls. This incident could have had a far more serious outcome if the crew member had been asleep in the cabin, or had not returned to the cabin when he did.**
- 2. Let the engineers on board fix problems of a technical nature. That is what they are there for. There any number of reasons why a cabin vent might be blowing out too much hot or cold air. If there are no accessible controls, or they do not appear to work, then report the problem.**
- 3. When adjusting any temperature controller, it is good practice to wait to see the effect this will have before leaving the space.**
- 4. Where thermostats, or any other heating controls, are made available, the operating instructions for them should be provided in the cabin, or stuck to the bulkhead beside the controller.**

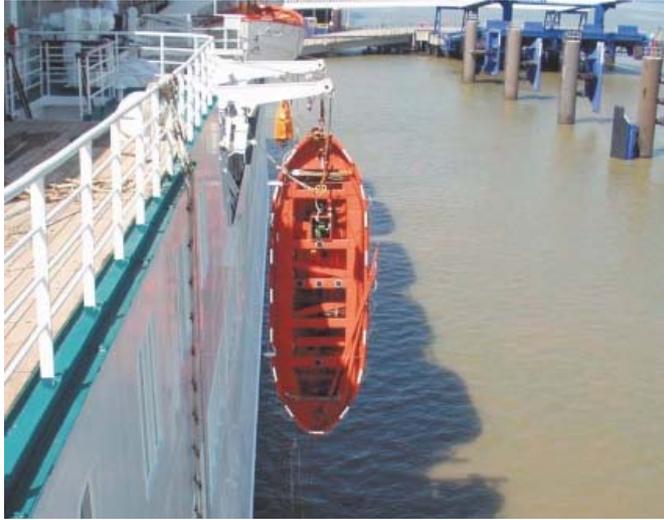
Lifeboat being released

- 2. Figure 2 shows a lifeboat rigged in such a way that this problem could occur. When the gripe is removed, the tricing pendant will drop down under the suspension hook balance weight. When the boat is lowered, the tricing pendant will tighten and lift the weight.**

- 4. If unguarded balance weights are fitted, they should be observed while the lifeboat is being lowered, to ensure they are not lifted accidentally. If crew are in the boat when this happens, a serious accident could result!**

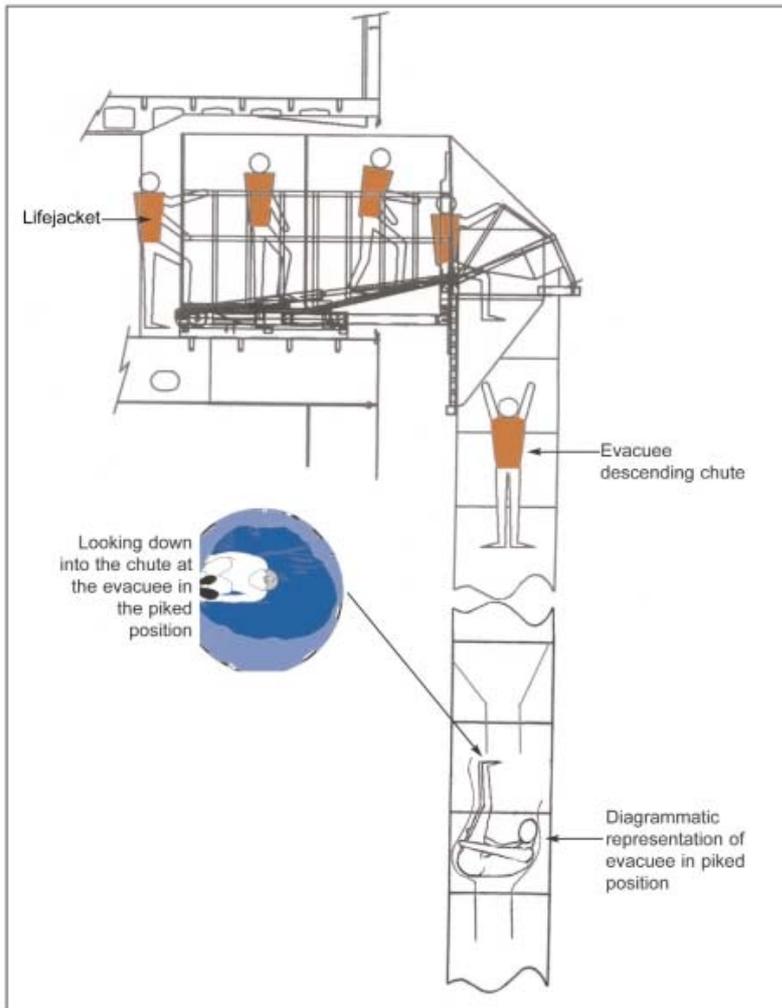
There were no witnesses to the evacuee's descent, so it is impossible to determine exactly how she assumed the position in which she was found. However, she probably became stuck when her lifejacket rode up over her head and then, in the ensuing struggle to free herself, caught her feet so that her legs became raised in such a way that she assumed a piked position in the next tube.

Lifejacket having ridden up

- 5. The initial cause of this accident was the lady's lifejacket riding up. It is essential to ensure that lifejackets for use in vertical chutes cannot ride up.**

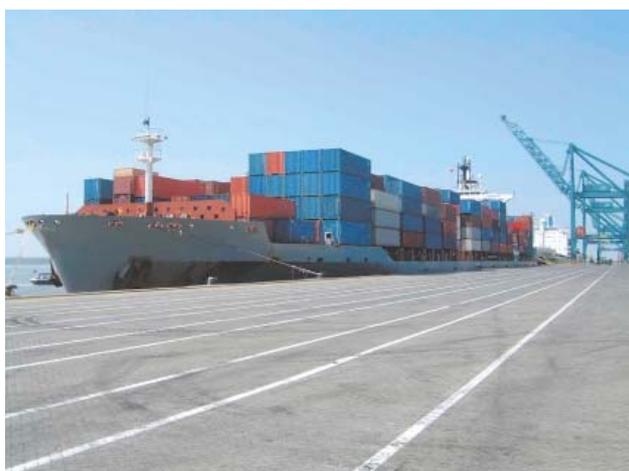
Container ship

The watchkeeper of the fishing vessel did not keep a close eye on the closing container ship, and just before 1300 the two vessels collided. Initial contact was made several metres aft of the container ship's port bow, before the fishing vessel scraped down her port side. Almost immediately, the fishing vessel started to go down by her head, indicating that she had been holed below the waterline forward. A "Mayday" call was sent via VHF channel 16, requesting the ship that she had collided with to turn back and assist. The crew then abandoned ship using the vessel's two liferafts.

At the time of the collision, the container ship's OOW was at the chart table completing the hourly entries into the deck log. He felt the impact of the fishing vessel, but considered this to have been caused by a large wave. Although he checked along the port side, the containers on deck obscured the fishing vessel. Shortly afterwards, the OOW heard the "Mayday" sent by the fishing vessel and, after seeing the fishing vessel about 4 miles astern, called the master to the bridge. The master immediately turned the container ship towards the stricken fishing vessel. As the liferafts were drifting apart, a lifeboat was launched to assist in their recovery.

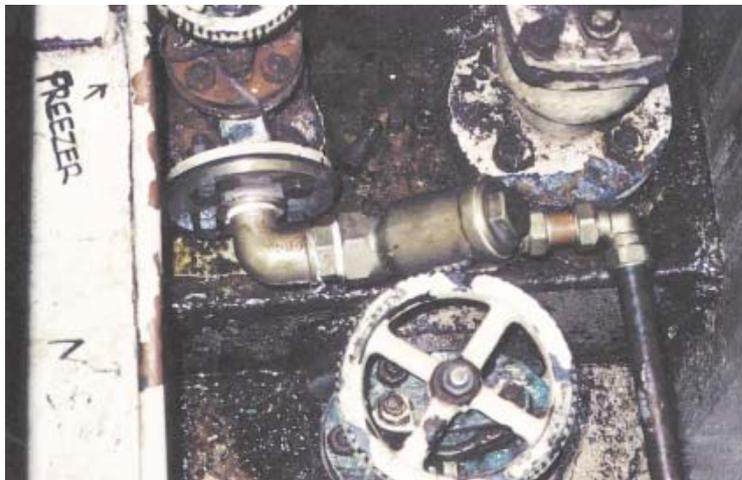
With the floodwater evacuated, the engineer was able to inspect the pipework below the floor plates. The source of the flooding was found to be a fractured pipe in the refrigeration system serving the fish room. The seacock for the refrigeration system (figure 1) was kept closed while the others were opened. The vessel was then able to sail back to port under her own power.

The fracture occurred at a screwed joint between steel and brass piping; the problem was probably caused by galvanic action (figure 2).
