MARINE ACCIDENT
INVESTIGATION BRANCH

SAFETY DIGEST

**Lessons from Marine
Accident Reports
1/2006**

No 1/2006

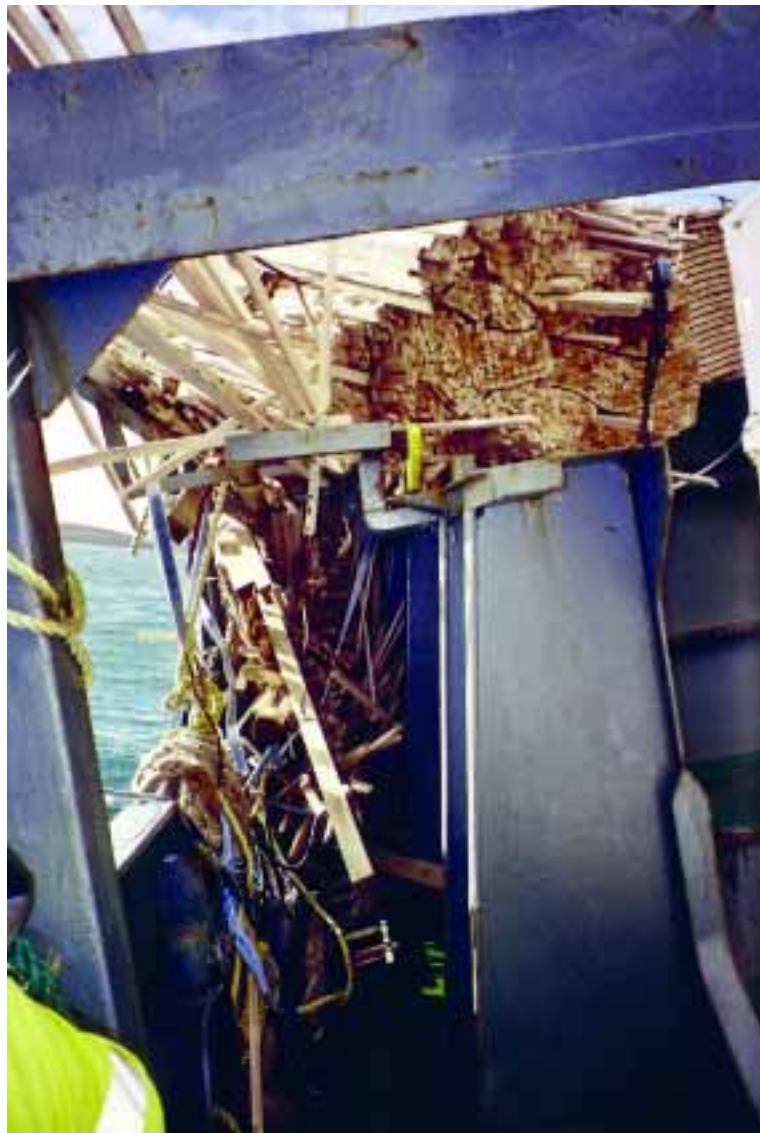
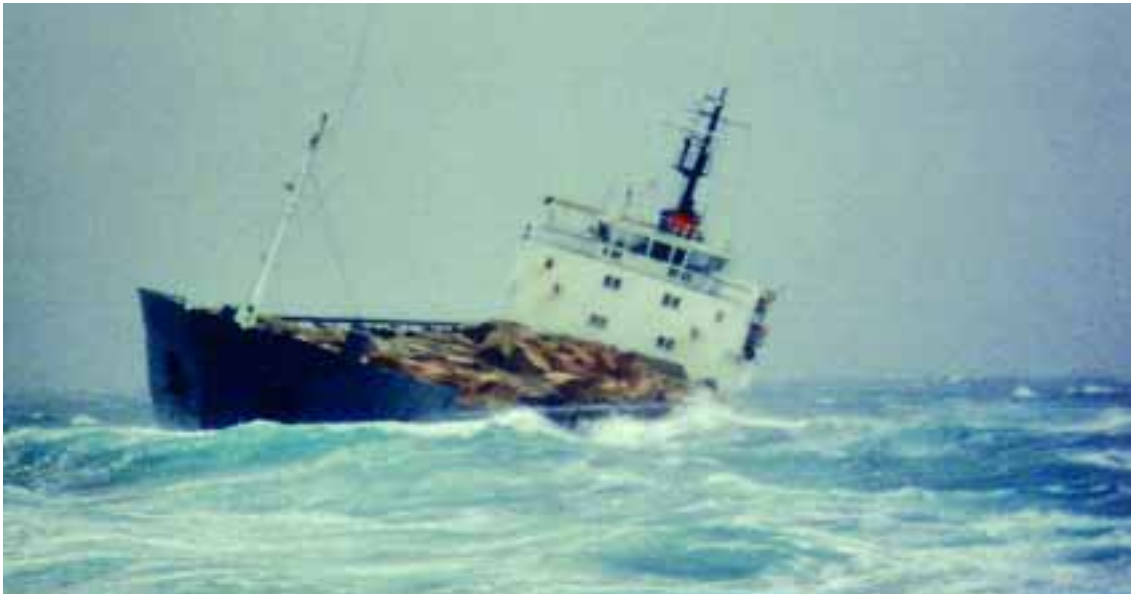
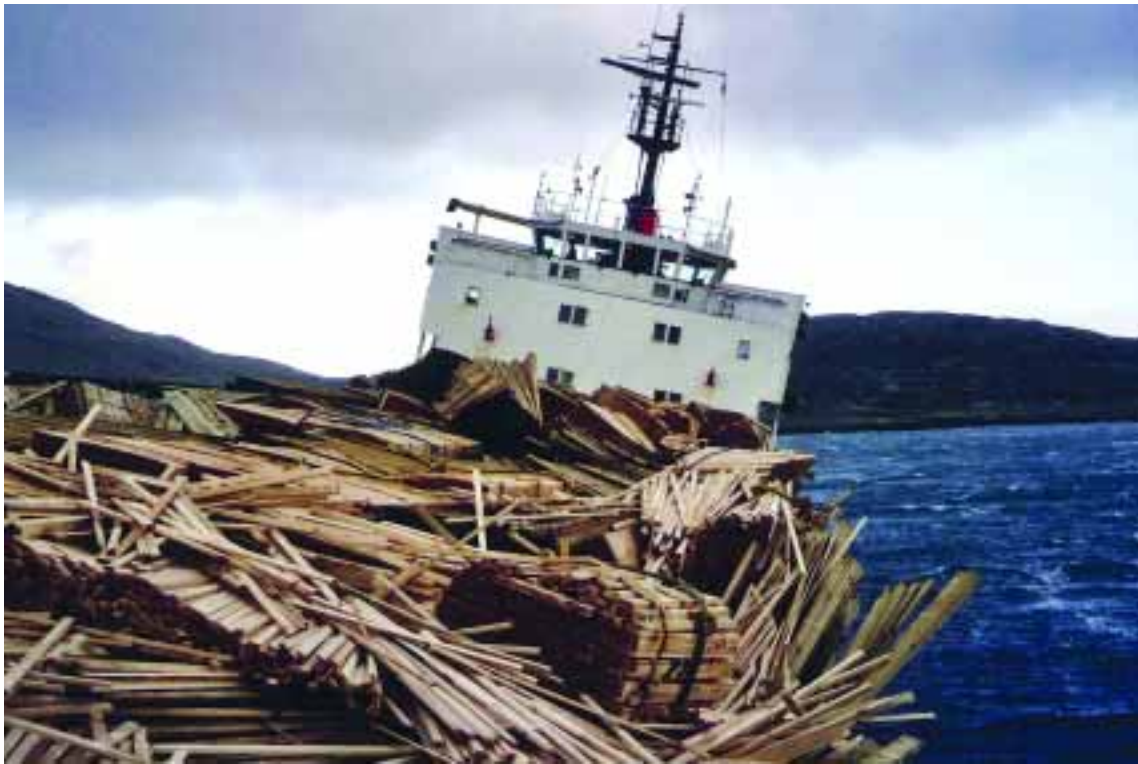
A general cargo vessel carrying 210m³ of packaged timber cargo on deck encountered a very large wave on her starboard beam. The wave caused some of the webbing lashings and package banding to part and the cargo to shift. The vessel was passing close to the coast in strong south-westerly gale conditions, and it was winter. Although the conditions were not good, just prior to the accident the vessel had been making a steady 7.5 knots with only moderate pitching and rolling. The general poor weather conditions during the voyage

The master rang emergency stations before attempting to slowly bring the vessel around to head north and put the weather on the port side. It was estimated that about 40 or 50 of the original 300 packs on deck had been lost, and about half of the lashings had failed. The remaining timber packages had moved to port, but were prevented from falling overboard by structure, at the ship's side, which was designed for the carriage of containers, and

which caused the loose timber to jam between it and the hatch. Crew members were assigned to cut the remaining lashings in an attempt to jettison the rest of the packages and reduce the list. However, this was mostly unsuccessful.

The vessel managed to make her way to a safe anchorage, where the deck cargo could be removed and complete packages eventually re-stowed. Fortunately, no injuries to the crew or serious structural damage to the vessel occurred.

2. Webbing or synthetic lashings have become more prevalent for securing deck cargoes in recent years, but are not mentioned in the IMO Code of Practice. They are quick and easy to use, they do not rot and are easy to store. They are, however, vulnerable to abrasion and are not suitable for really heavy-duty work. Regular and close inspection of the webbing material should be carried out, and worn lashings replaced. Consideration should also be given to using additional, alternative types of lashing to supplement the webbing lashings during winter or if heavy weather is predicted.

3. Due to the low value of the timber cargo, plastic wrappings or tarpaulins were not used on this vessel. The use of protective coverings would have assisted in reducing the amount of water absorption in the timber and consequent reduction in stability. It might also have reduced the possibility of packages being broken or distorted as a result of wave impact or heavy rolling.

4. The hatch covers were of smooth painted steel. This is not an effective non-slip coating, and when wet it has a particularly low coefficient of friction. One of the easiest methods to help prevent movement of a deck cargo, is to ensure that hatch tops are painted with a high friction coating. This reduces the effective loading on the lashing arrangement and reduces the possibility of lashing failure.

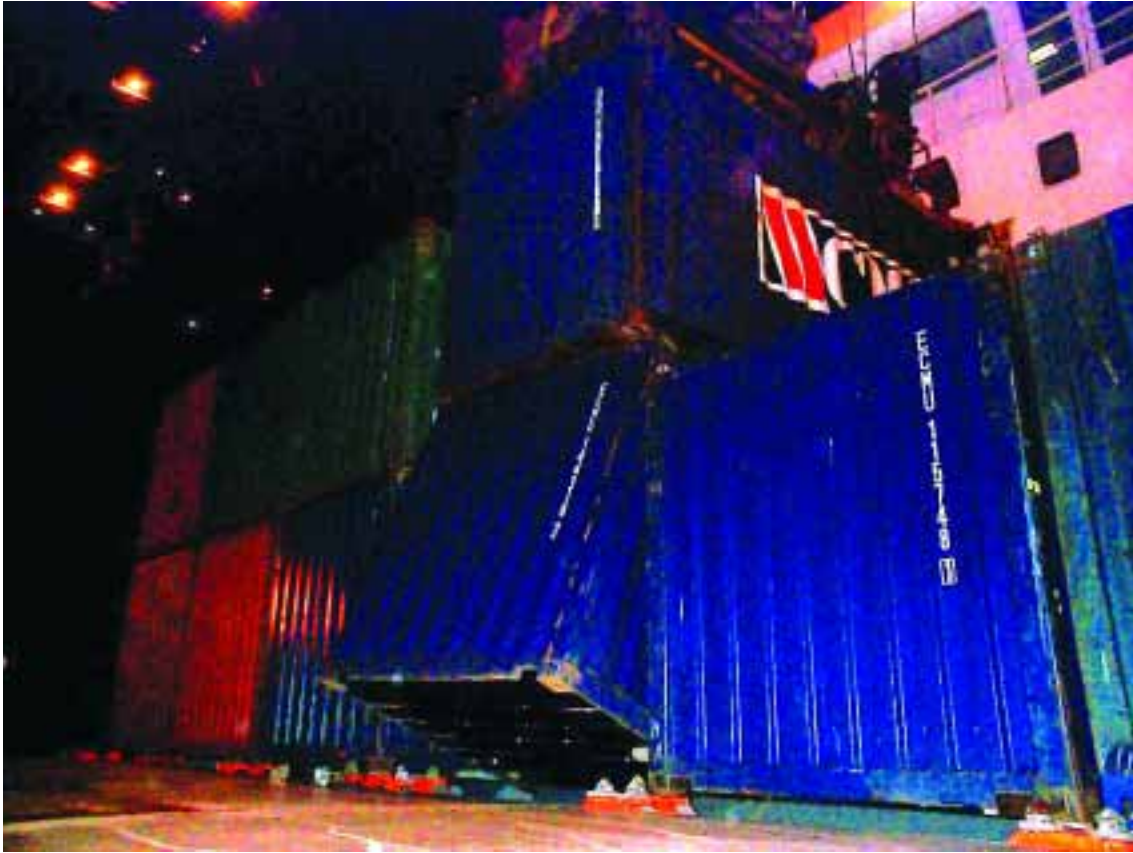
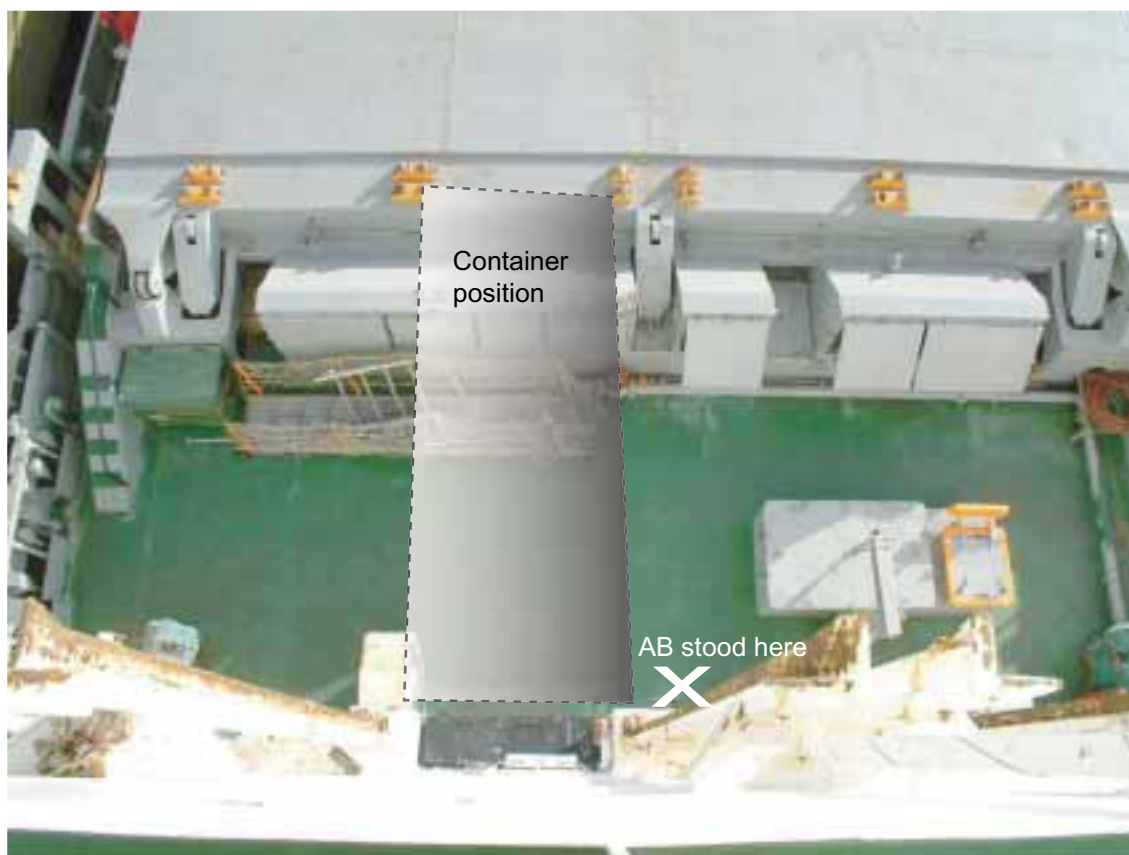
The final inboard containers on the port side were being discharged when one of the twist locks at the forward end failed to release. The combined weight of the two containers was not enough to set off the crane overload alarm; the crane continued to lift. This partially lifted the lower container by its forward end, and pitched the after end into the well. The top after edge of the container struck the AB, crushing him between the container and the ladder. The paramedics were called, but the AB was pronounced dead at the scene.

1. This is a hazardous operation, particularly in the feeder trade, where lean manning does not allow constant supervision. It is essential that people are routinely briefed on safety issues.
2. The company safety posters state that, when removing twist locks, crew should stand at least one container away from the one being worked. This tragic accident clearly demonstrates why.
3. There were no written instructions available for cargo work. Instruction relied on briefing and on-the-job training. The AB had been working on this ship for 6 years, and his work pattern was well established. It is possible that his perception of the risk had reduced, and that this unsafe shortcut had become his normal routine.

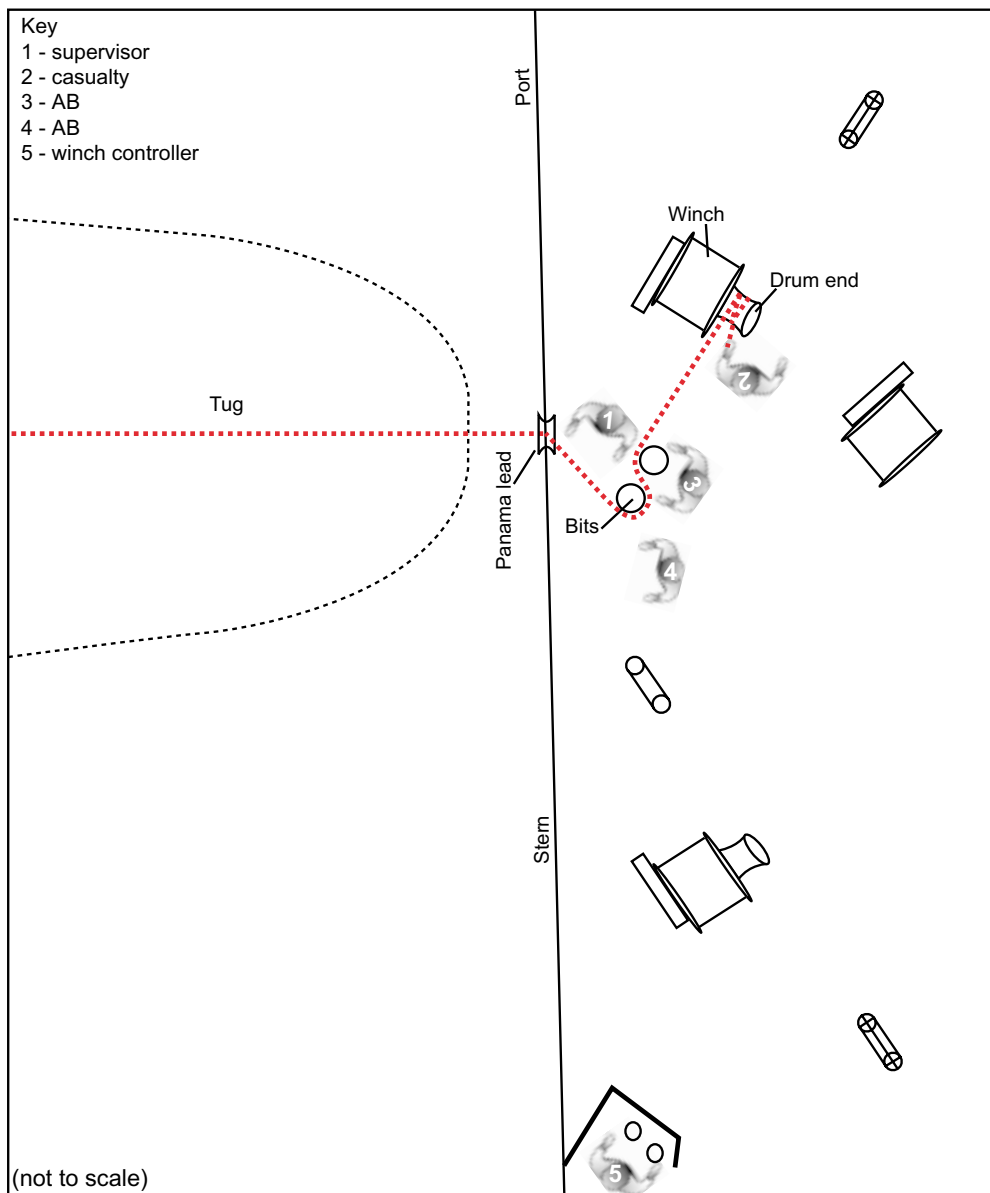
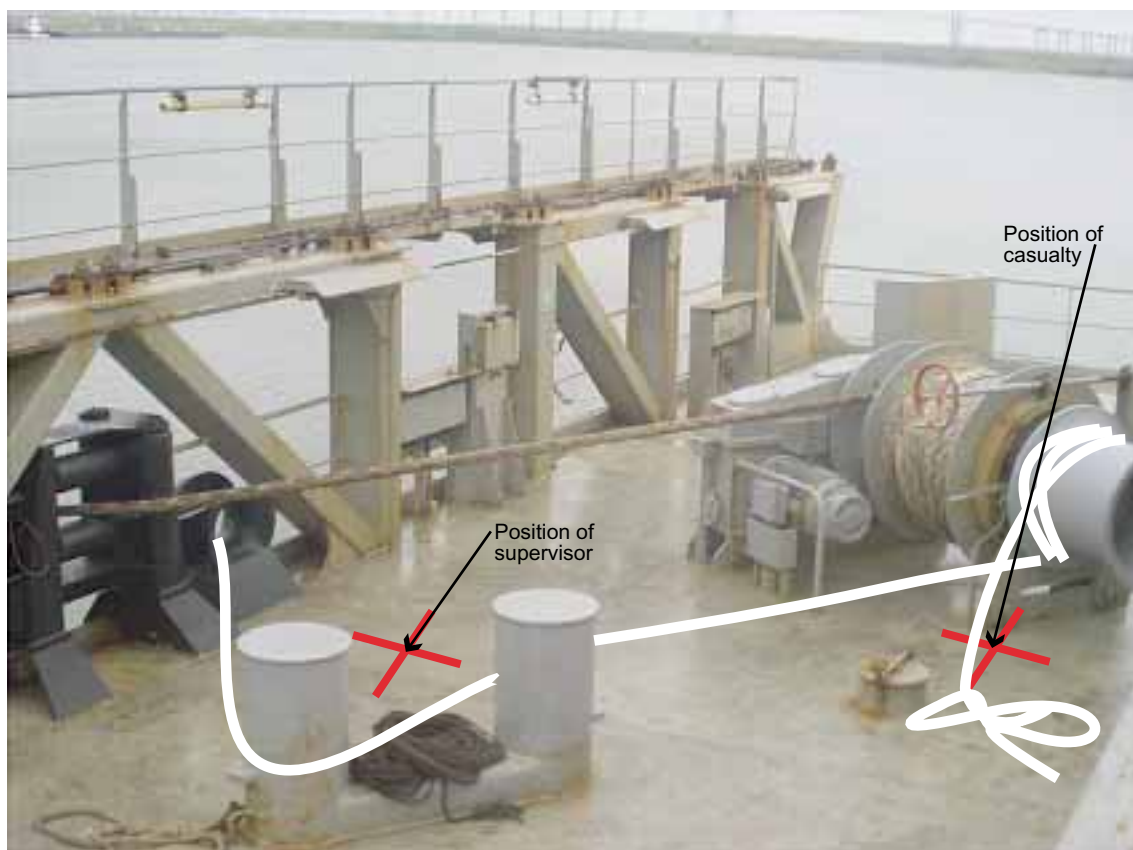
Messenger rope arrangement

Unfortunately the tug was not paying out slack at a controlled speed and, feeling the strain of the jerking motion, the drum end seaman attempted to apply more turns to the whipping drum. During this process, the messenger rope snapped back, and the whiplash of the working part connected with, and broke, the drum end seaman's arm.

1. Stand facing the danger: always put the winch between the operative and the potential danger zone. This, in itself, creates a safety barrier, allows full visual contact with the mooring team and surroundings, allows controlled surging on the drum end and keeps the operative clear of the working part.
2. Be aware of the dangers of sharp nips – these cause excess strain on machinery, fittings and ropes – and use fair leads wherever possible.
3. During our first day at sea, most of us were made aware of the dangers of standing in bights of rope; a brief lapse of attention to this ordinary practice can so easily cause grief.
4. Watch out for shipmates and their work practices. Ships operate on efficient team-working, part of which involves looking out for our shipmates and recognising potential dangers to them. It is so much easier to stop bad habits than to patch up broken bodies.

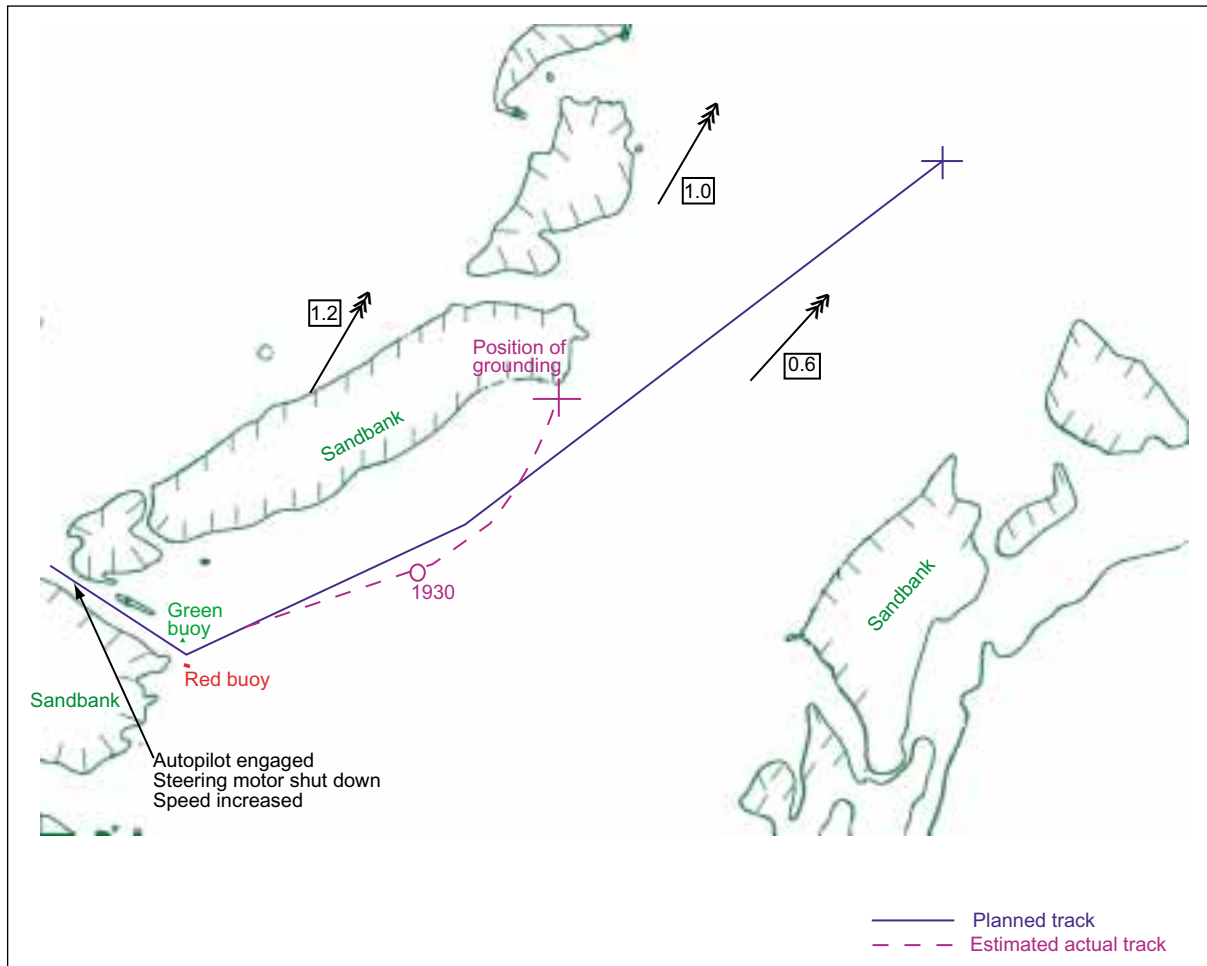
Shortly after, the master noticed that the ship's heading was drifting to port. He saw that the heading by gyro was now 040°. A large alteration to starboard was applied using the autopilot, but the ship kept turning. Breaking waves were then seen directly ahead. The master put the engine to stop, started the second steering motor, changed to hand steering, and applied maximum starboard helm. He then put the engine to full astern,

but the vessel was felt to ground moments later on a gyro heading of 330°. The ship suffered substantial damage to her rudder.

5. The use of autopilots is widespread, and is indeed essential on ships with limited crew. But they are fallible, and do occasionally malfunction. In open water, such a malfunction is likely to be detected and dealt with without any adverse consequences. However, when in close proximity to navigational dangers, or other shipping, the time available to react is far more limited and the potential outcome is therefore more serious. Manual steering is the safer option in many situations.

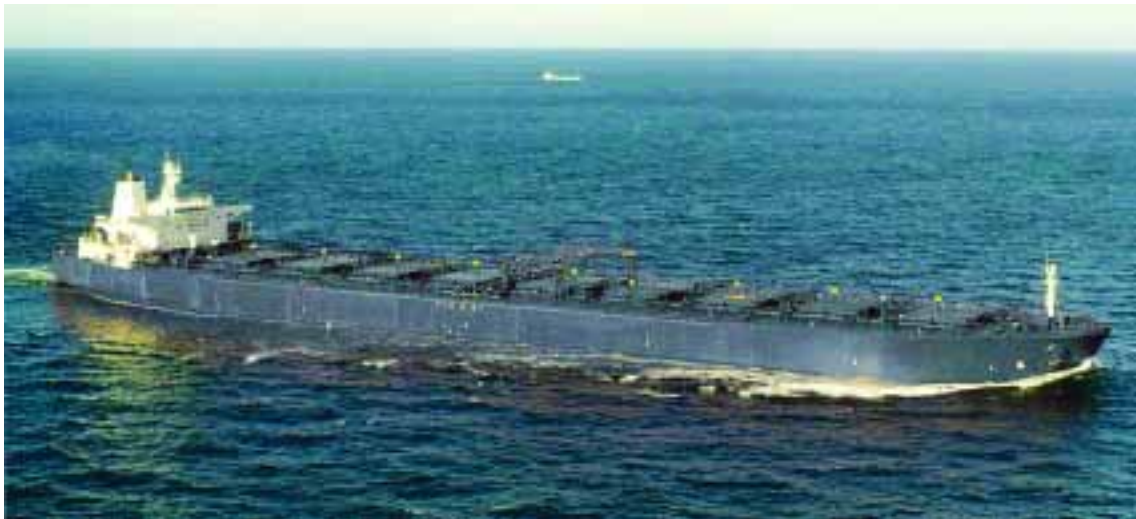
Figure 2

About 30 minutes before the incident, a large oil bulk ore (OBO) vessel (Figure 2) raised her anchor and began to move in preparation for picking up a pilot. The vessel's movement was disguised by two other vessels, which had their deck lights on.

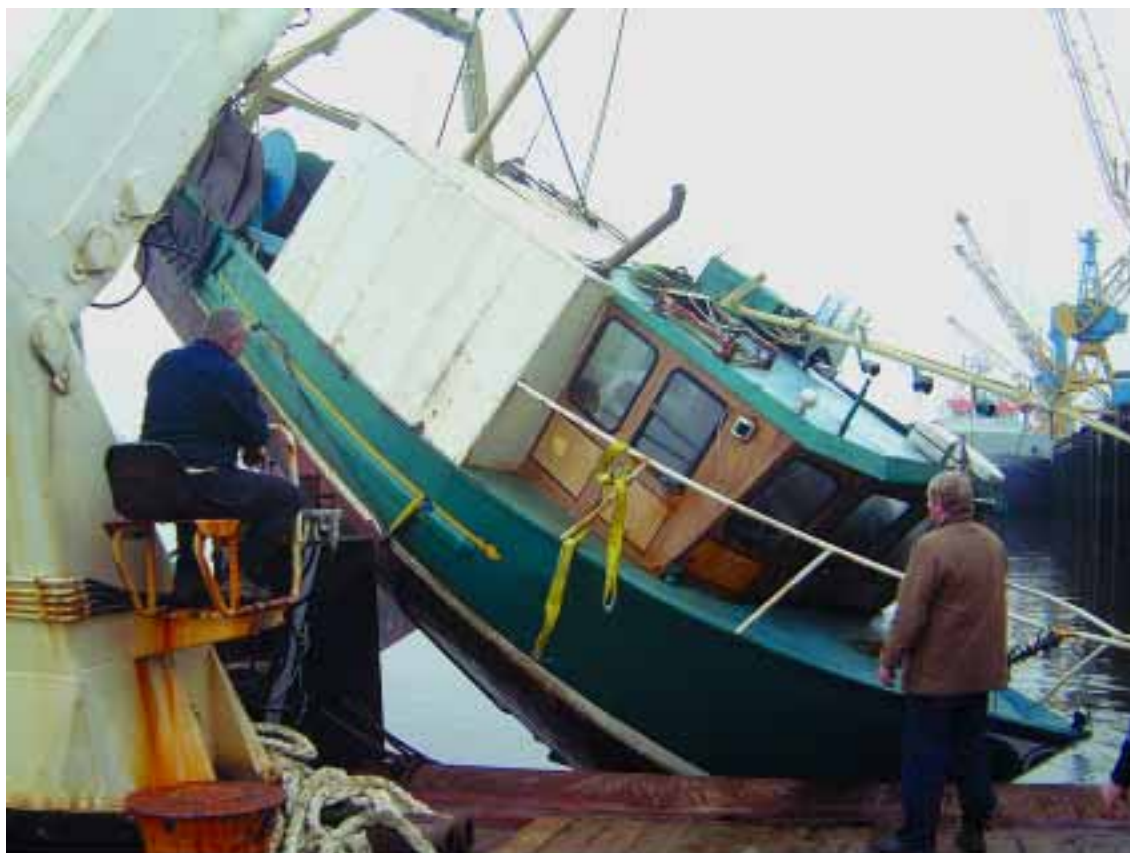
Figure 1: Salvage

Subsequent events included a search for the wreck. The wreck was located, and an underwater survey was carried out, during which the liferaft was found on the seabed and damage to the radar dome noted. The trawler was salvaged (Figure 1) to enable a more detailed structural survey, metallurgical examination of the hull plating and stability tests to be conducted. Neither of the brothers' bodies was found on board.

The investigation found the vessel to be in a poor structural condition. There were splits and holes to her upper deck, hull shell plating and steering gear compartment forward watertight bulkhead (Figures 2, 3 and 4). In addition, the rudder stock gland was leaking, the engine room high level bilge alarm float switch had been disconnected, and one of her bilge pumps was not operational. It was also found that the vessel's inherent stability was marginal, making her unsuitable for offshore fishing; this was a major factor in her loss.

2. Structural maintenance is an essential element in ensuring a vessel's watertight integrity. Although expensive, it is of comparatively little cost for a potentially great return: preventing the possible loss of a vessel. Hull repairs should be given the highest priority if downflooding and internal flooding is to be prevented.

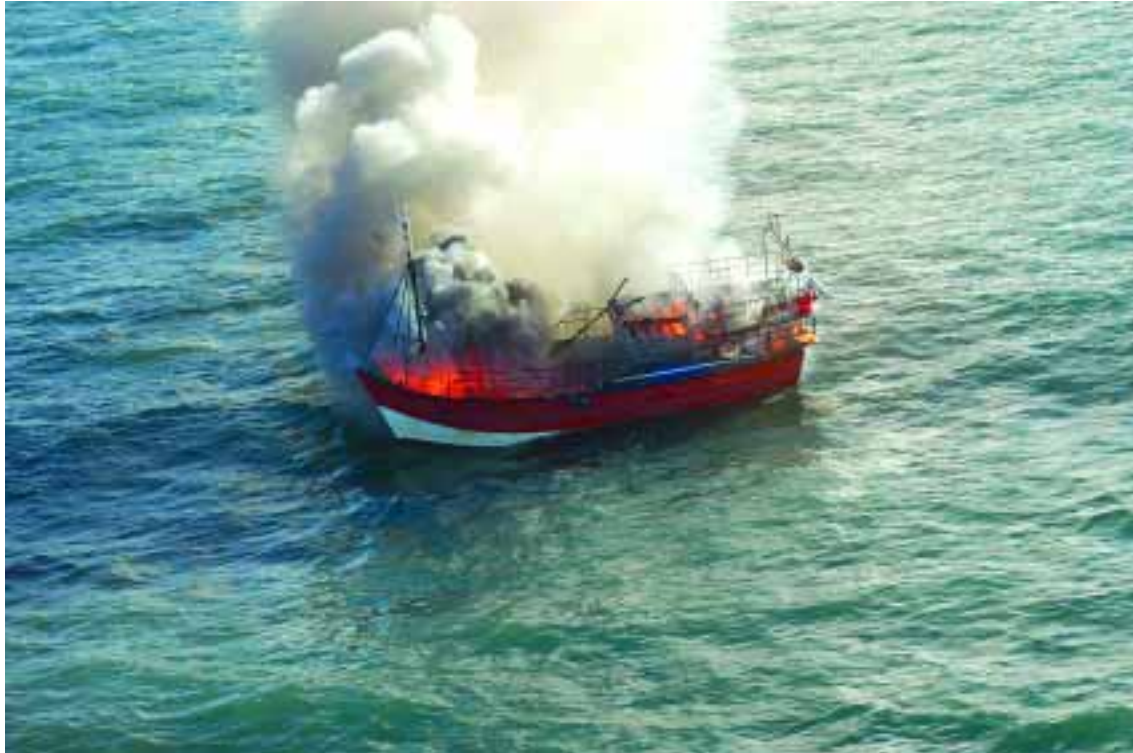
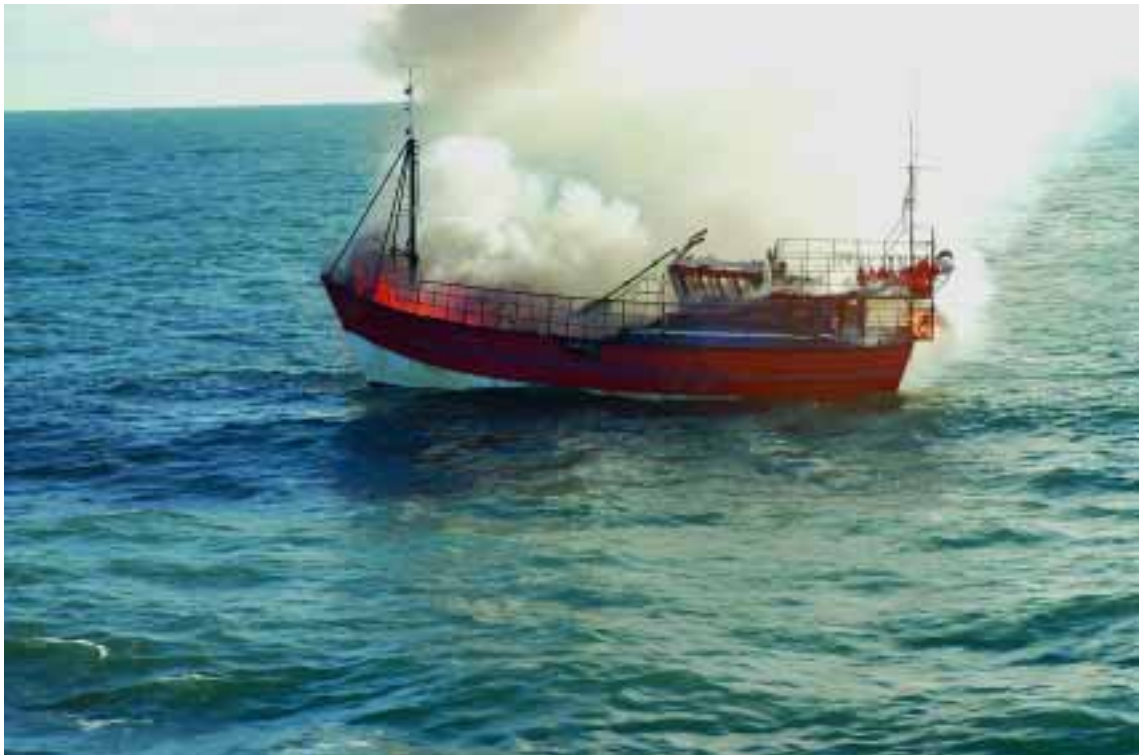
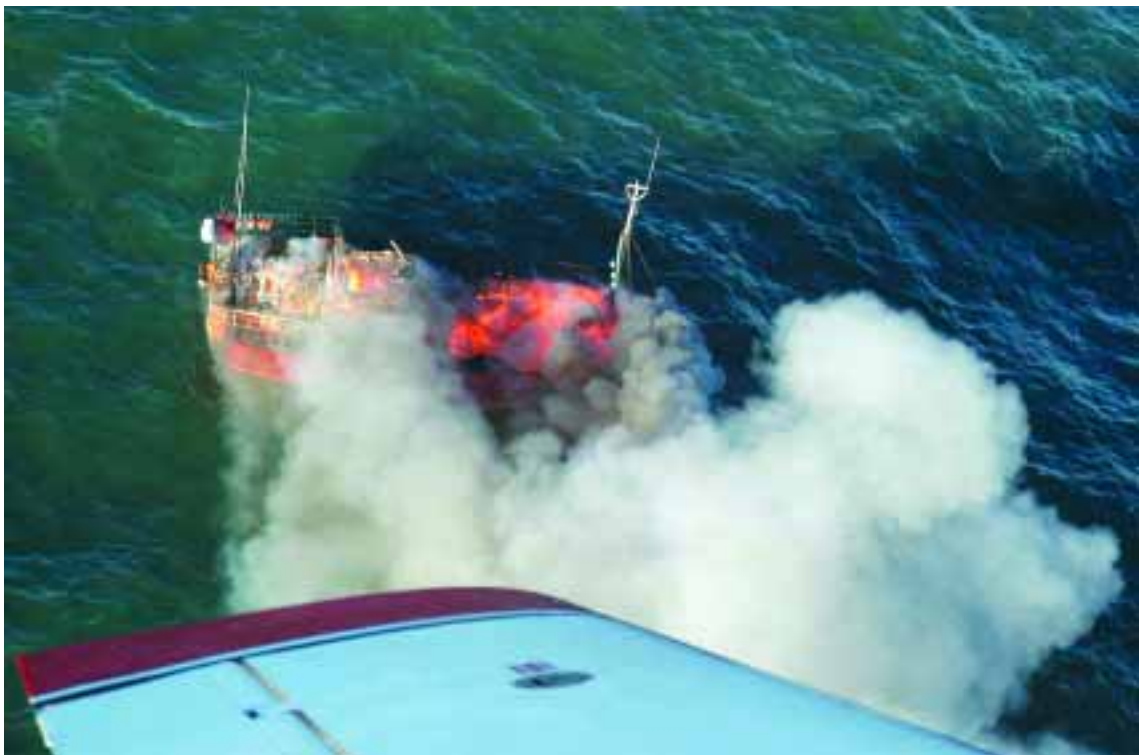
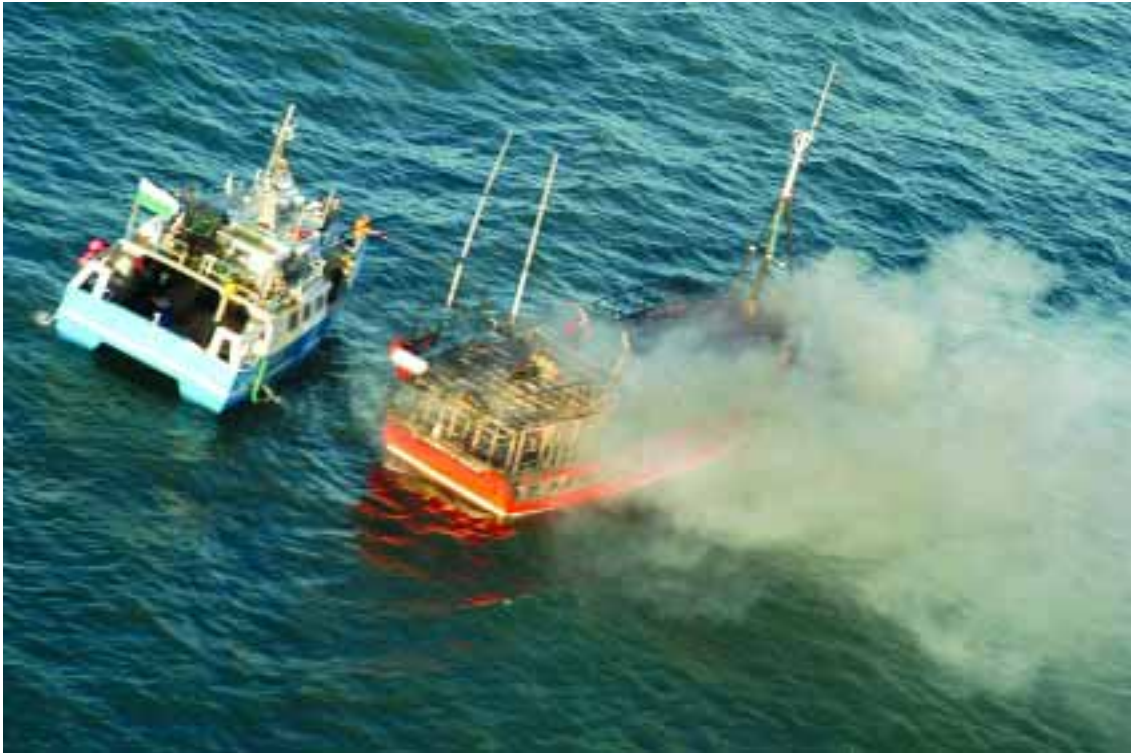
He went back to the wheelhouse and tried to call the coastguard again, but found that the VHF radio would not transmit or receive. He looked in the compartment under the wheelhouse deck where the emergency batteries were fitted, and saw smoke emanating from it. He then tried to use the hand-held VHF set, but the battery was flat.

The fishing vessel remained afloat and on fire until later that afternoon, at which time the fuel tanks exploded and the vessel foundered.

1. The fishing vessel was not fitted with a fire detection system in either her forward auxiliary generator hold or her engine room. Had one been fitted, this would have alerted the crew at a much earlier stage and would have given them a chance to fight the fire before it had time to take hold.
2. The electrical fault, which was probably the cause of the fire, also affected the charging of the emergency batteries and, in turn, the power to the radio sets. Therefore, it is essential to ensure that backup hand-held VHF sets are fully charged at all times.
3. The crew member who attempted to extinguish the fire used correct fire-fighting techniques, such as touching hot spots with the back of his hand and sealing a space which is on fire to starve it of oxygen. He clearly demonstrated the value of having attended a fire-fighting course.

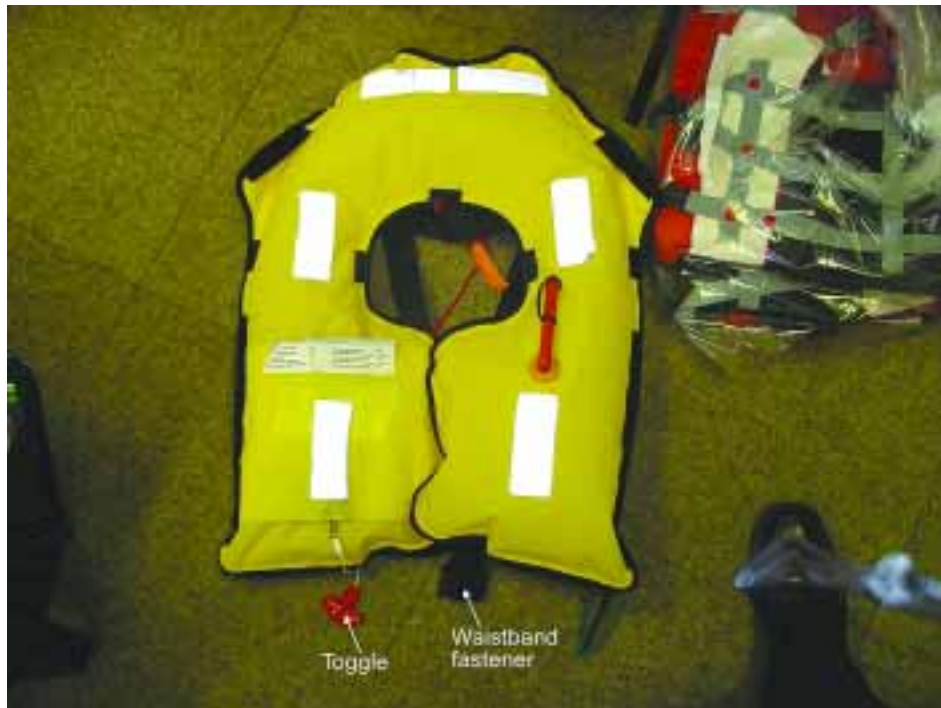
Figure 1: Owner's lifejacket

When on a short coastal passage, a 4m sailing dinghy capsized 7 cables from the nearest point of land. On board were its owner, an adult crewman and two children. All were dressed in shorts and "T" shirts. The owner was wearing a lifejacket, and the remainder of the crew wore buoyancy aids. Following capsizing, two attempts were made to right the dinghy, which had fully inverted. Despite the wind being between force 5 and 6, and waves at a height of about 1.5m, the boat was rotated to an upright position on both occasions, but quickly capsized and inverted again.

2. When putting on a lifejacket, take a few seconds to ensure it is worn correctly. If it is not, the jacket will tend to ride up when inflated, and will be more of a hindrance than assistance. This will decrease, rather than increase, an individual's chances of survival.

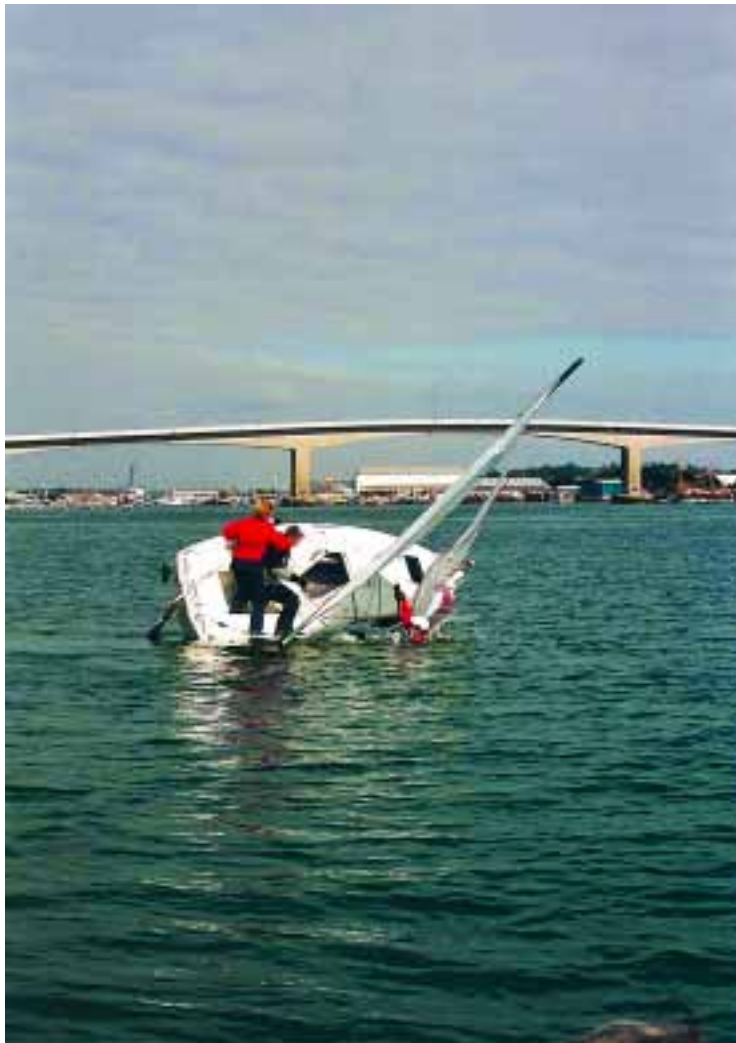
Test report photograph – dinghy being capsized

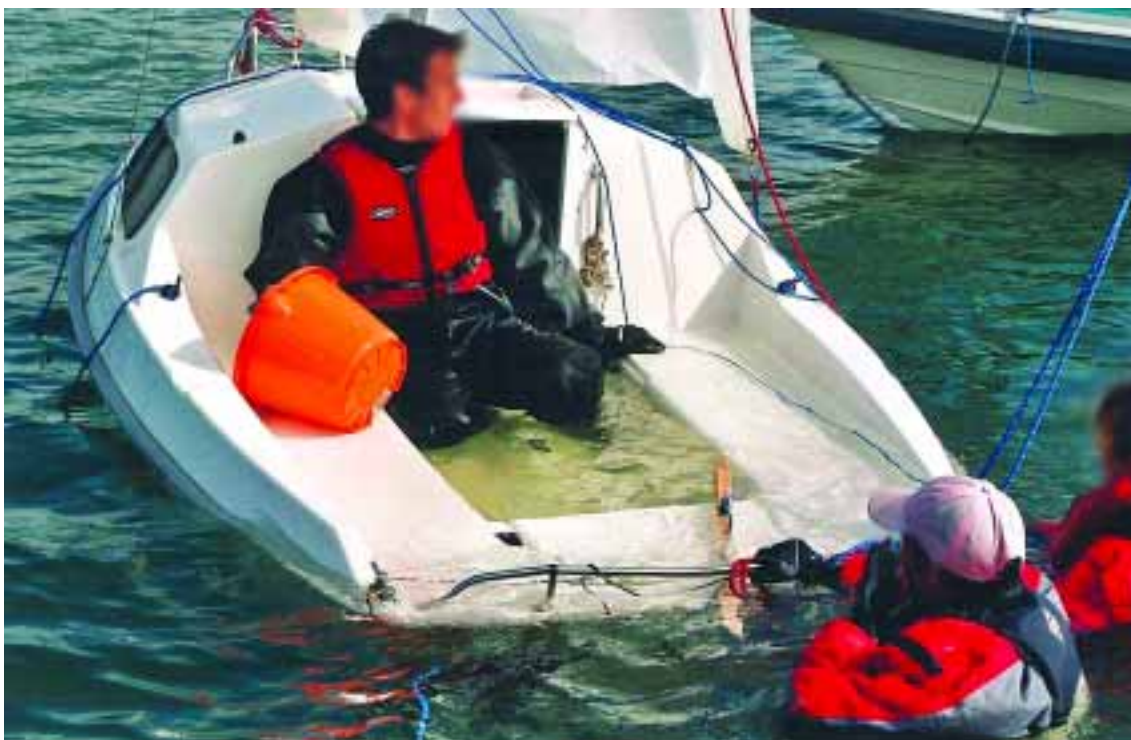
Test report photograph – cockpit fully swamped

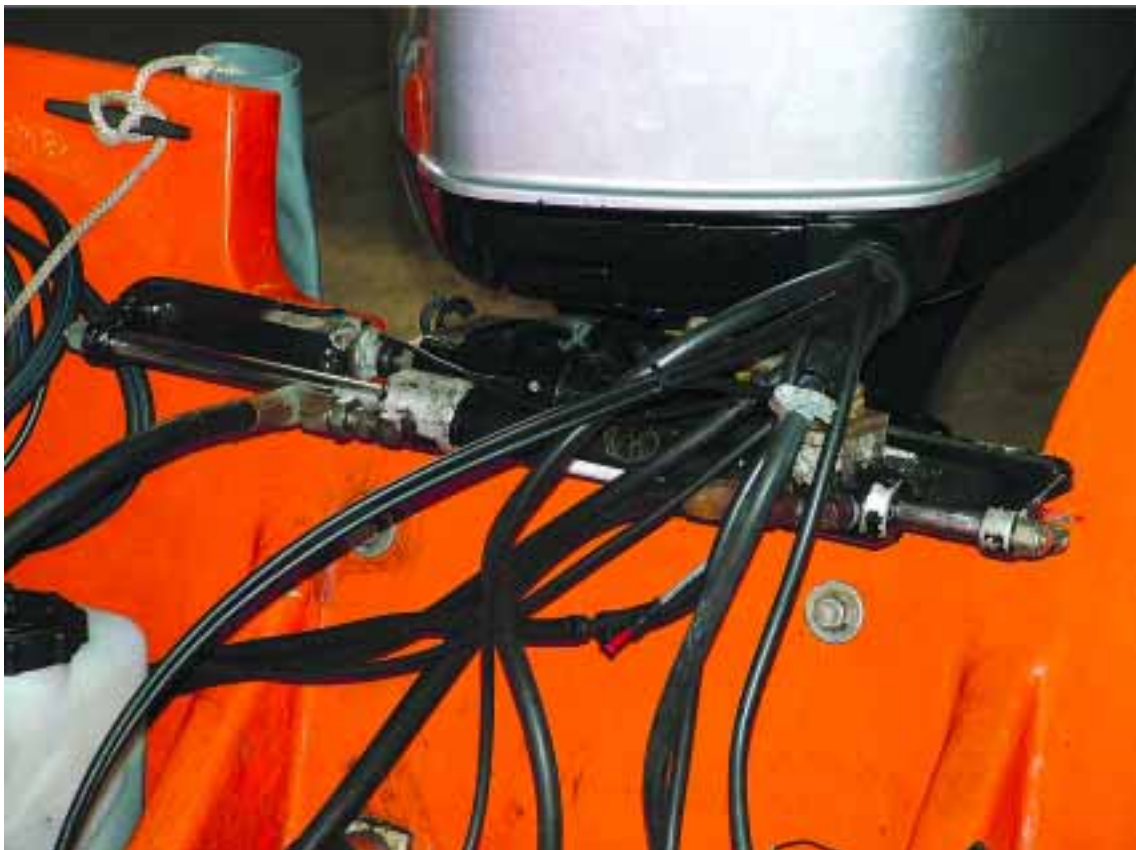
Figure 2: Steering system

All the evidence points towards a mechanical failure of the RIB's steering system (Figure 2) causing it to lurch uncontrollably. It was found that the system had non-standard components fitted, and that the hydraulic oil level was low, due to oil leakage from the helm/shaft pump boss (Figure 3). This allowed air and moisture to enter the system, causing intermittent steering control, and water ingress causing corrosion to internal components.

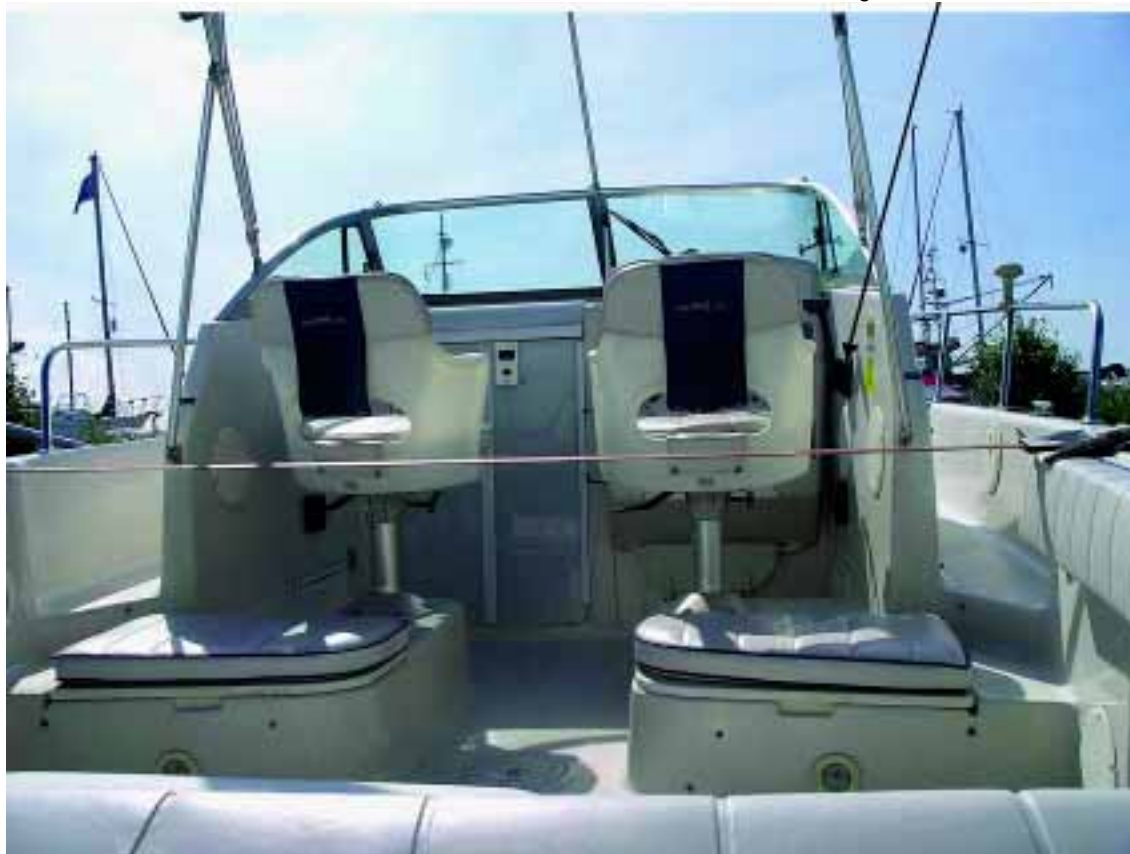
A view looking forward from the stern of the cockpit area

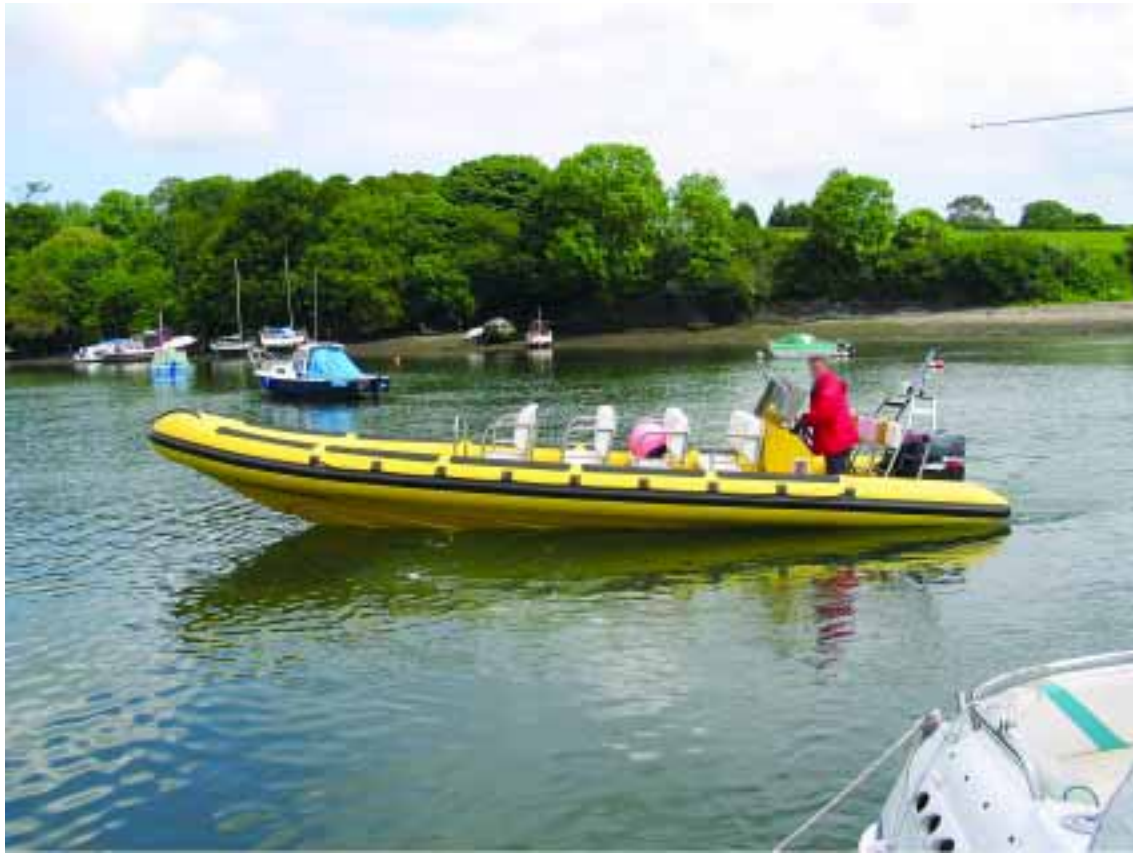
Figure 1: Broad on, port perspective

The skipper felt the RIB's handling characteristics change. The deck heaved slightly, there was a loud crack and the forward part of the hull momentarily adopted an angle of about 45 degrees from the horizontal. The front bench seat was torn from its deck mountings, plunging two of the children into the water (Figure 2). One female passenger also trapped her legs between the split sections of the marine ply deck before being pulled back by her husband. In the meantime, the skipper ran forward, the engines stopped as the kill cord was activated, and he dropped both his anchors and launched the lifeboat, although he was unsure how to do this. The RIB, although still afloat, had its bow section fully open to the sea, with port and starboard splits to the hull extending to over half the RIB's length (Figure 3).

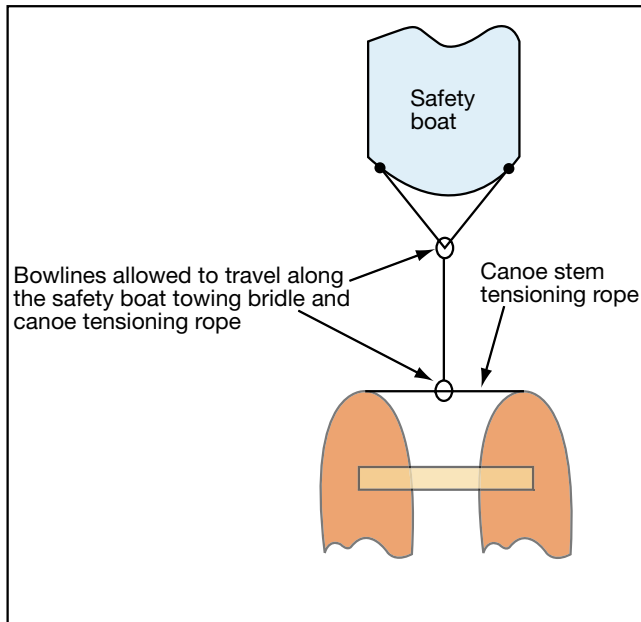
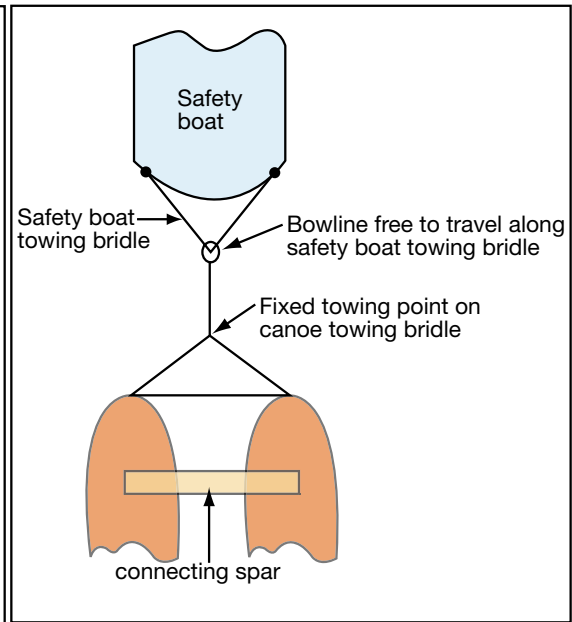
Figure 2

TOWING ARRANGEMENT

ALTERNATIVE TOWING ARRANGEMENT

the group continued with the open water crossing. About 30 minutes later, the group became very tired, and made little headway, having lost the lee of the land. It was decided to take them in tow, although no thought had been given to the best towing method. The canoes yawed badly and became quickly swamped (Figure 2).

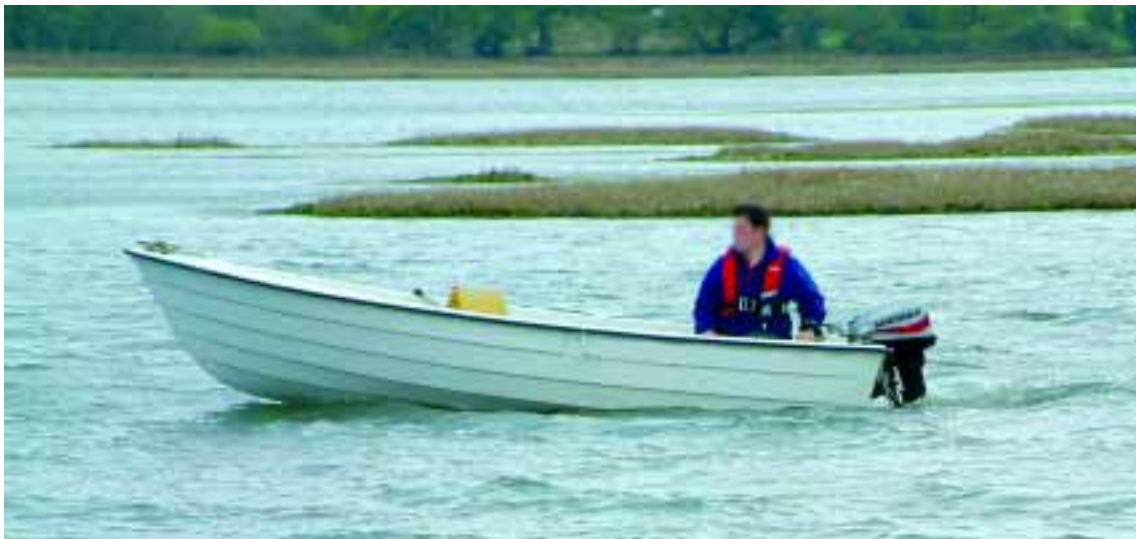
Figure 3: Safety boat

In an effort to warm up the course members, the instructors decided to put the entire group into the 4-man capacity safety boat (Figure 3). As the last person was pulled on board, the safety boat became swamped and all 10 people were, once again, plunged back into the cold water. The boat capsized.
