MARINE ACCIDENT
INVESTIGATION BRANCH

SAFETY DIGEST

**Lessons from Marine
Accident Reports
3/2007**

No 3/2007

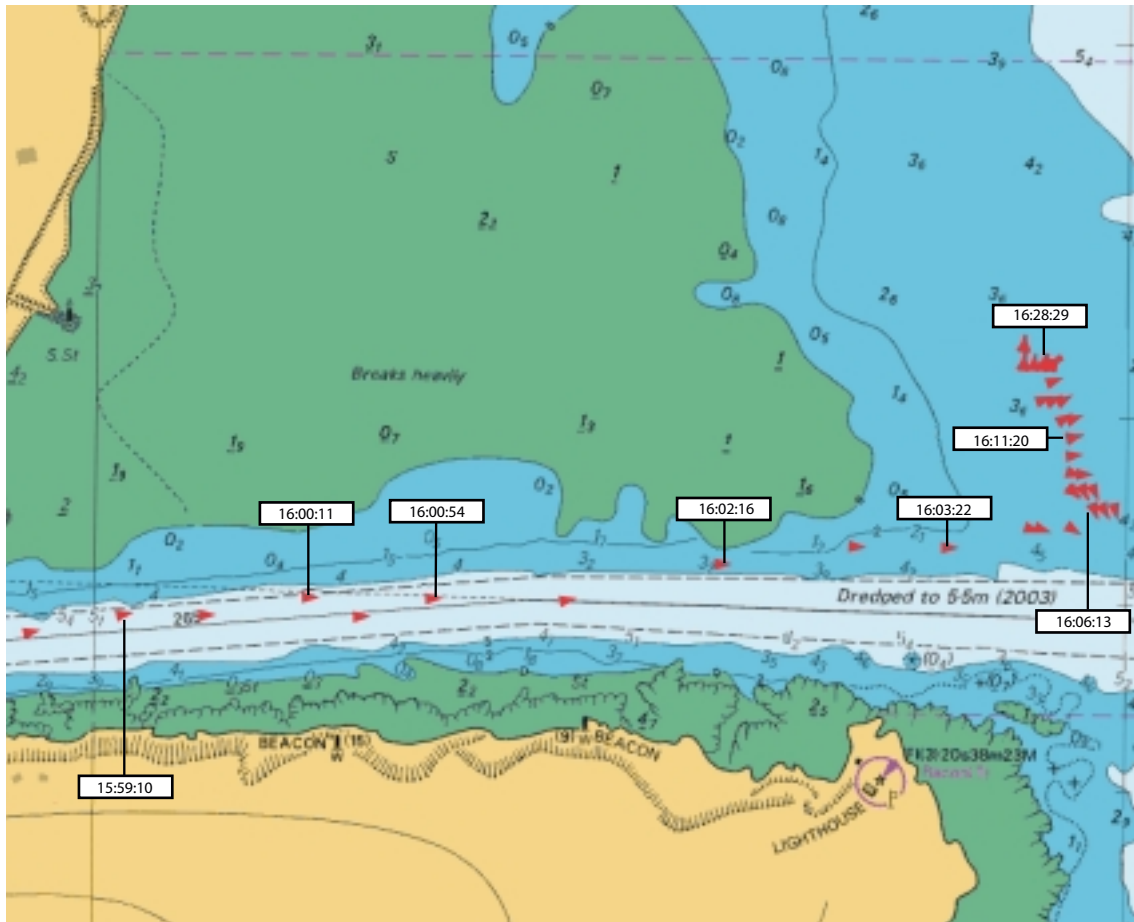
Figure 2

The ship's ground track from leaving her berth until 1630 is at Figure 2. She remained aground for 6 days, and was only refloated after her bunkers and some of her cargo were removed.

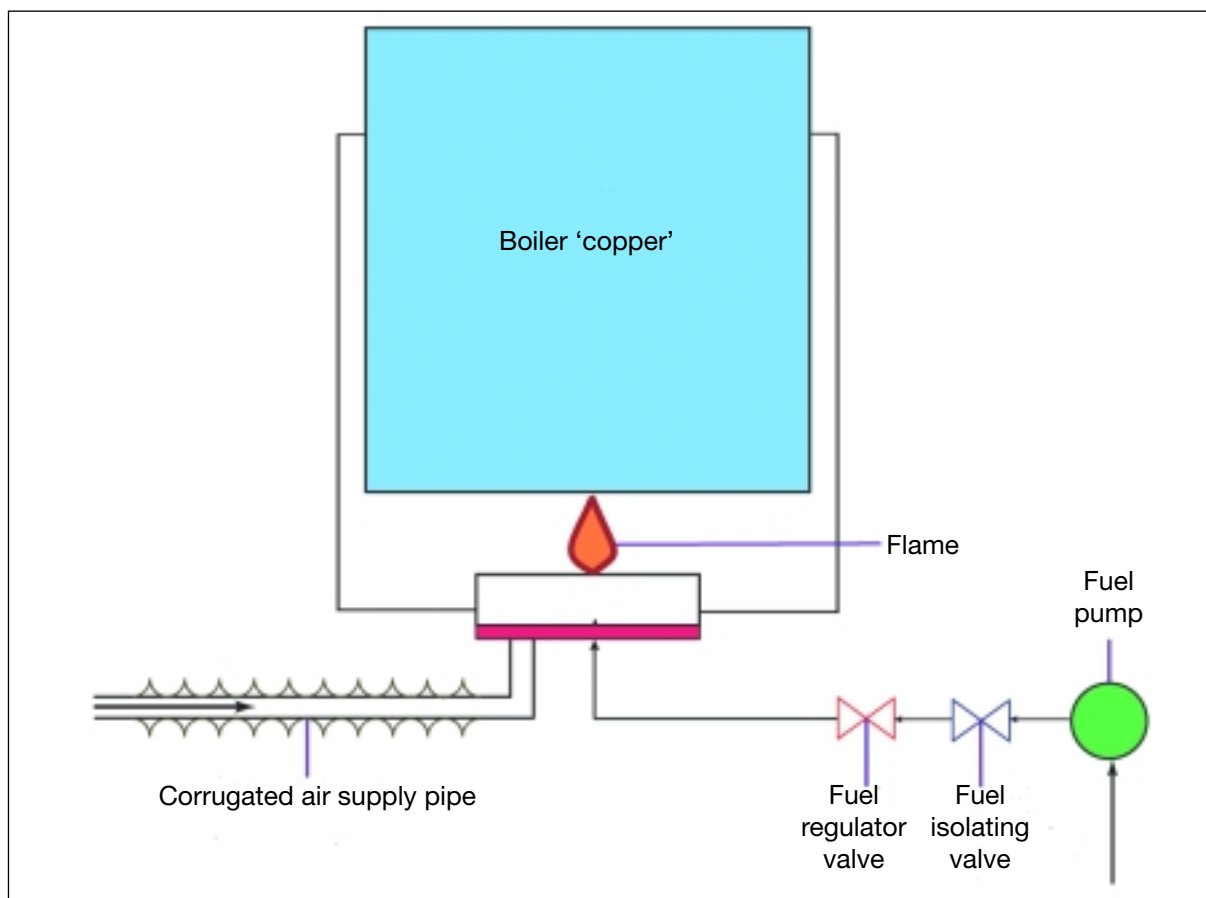
Figure 1

It was a very basic boiler: an electrically driven blower supplied air through a flexible, plastic corrugated hose, and a small pump delivered the diesel fuel (Figure 1). Both the blower and fuel pump were located in the engine room and were switched on from the wheelhouse by

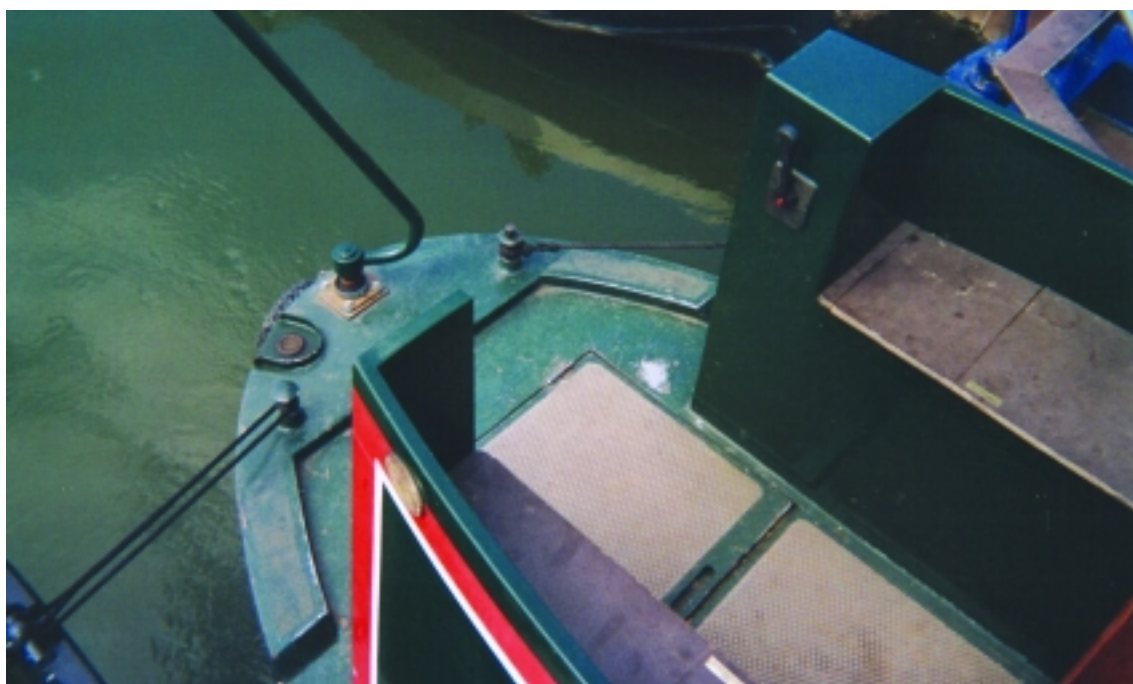
Aft section of the narrowboat

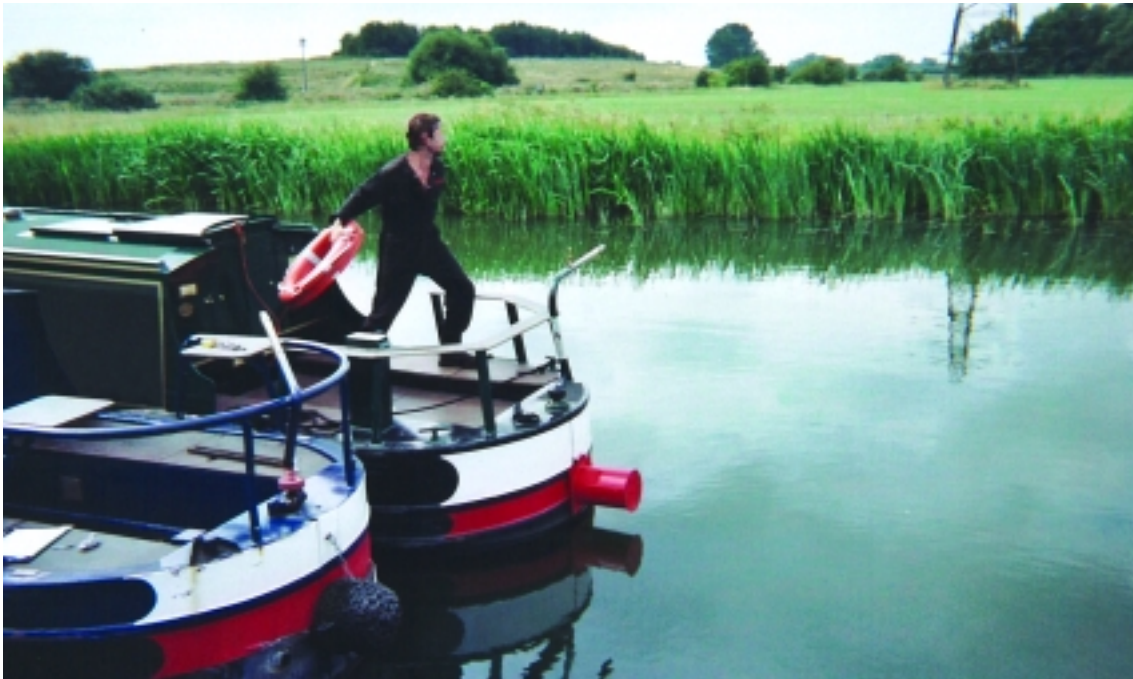
The boat entered a particularly sharp right-hand turn, and it became apparent that they were not going to get round in one go. Astern thrust was applied, but at the same time the wind caught the bow and the boat gently bumped into the left-hand bank of the river. The stern, pushed by the current, edged closer to the right-hand bank. At some point, the gentleman on the tiller lost his footing and fell off the right-hand side of the boat, into the river, and drifted downstream. There was a cry of 'man overboard', and the lady who had been down below divered into the river to help. She swam to the casualty and attempted to keep his head above water. Meanwhile, another gentleman climbed on top of the canal boat to deploy the life-ring. The lanyard for the life-ring was wrapped around it like a yo-yo. Unfortunately, the life-ring lanyard didn't unravel as it was thrown, resulting in the life-

Demonstrating use of the life-ring

1. Make sure you have a manoverboard procedure and that you know how to use the safety equipment on your hire boat. Throwing the life-ring correctly might have ensured vital seconds were saved while those in the water were trying to remain afloat. It was very lucky, in this case, that the rescuer who dived in did not also perish.
2. Lifejackets, although often seen as unnecessary on a canal boat, are really essential if there are any non-swimmers or physically impaired members in your party. Diving into a river to assist a weak or non swimmer can put you at great risk.
3. Ensure you hire a canal boat that is suitable for your party. For example, you may wish to consider:
 - a cruiser stern, which includes a rail around the stern
 - easier access steps into cabin
 - other child-friendly safety features if travelling with children.

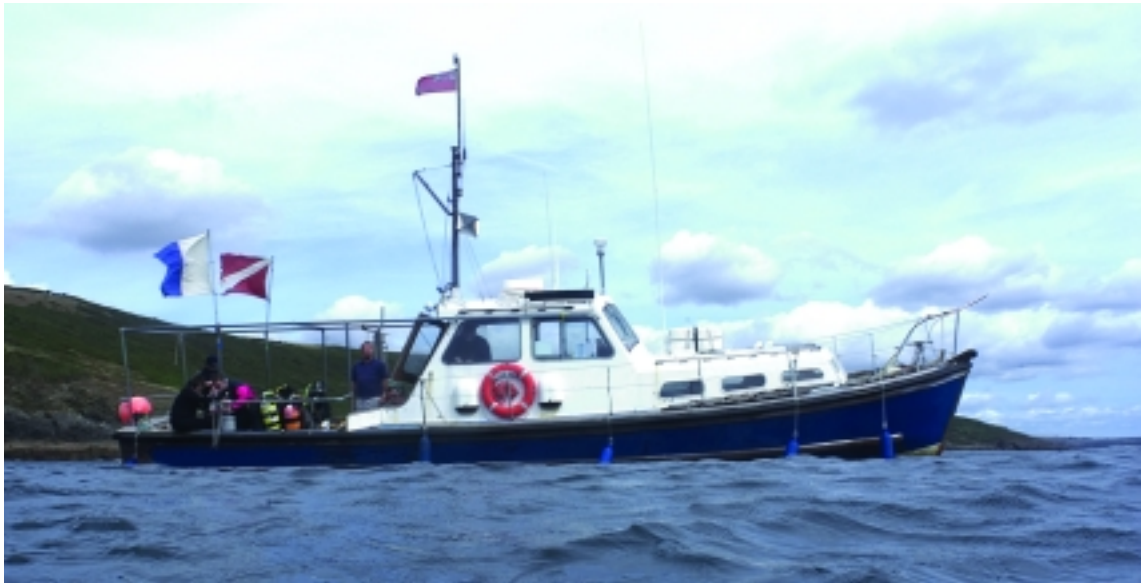
Dive vessel displaying the Alpha flag and the American Territories flag
