MARINE ACCIDENT  
INVESTIGATION BRANCH

# SAFETY DIGEST

**Lessons from Marine  
Accident Reports  
1/2009**

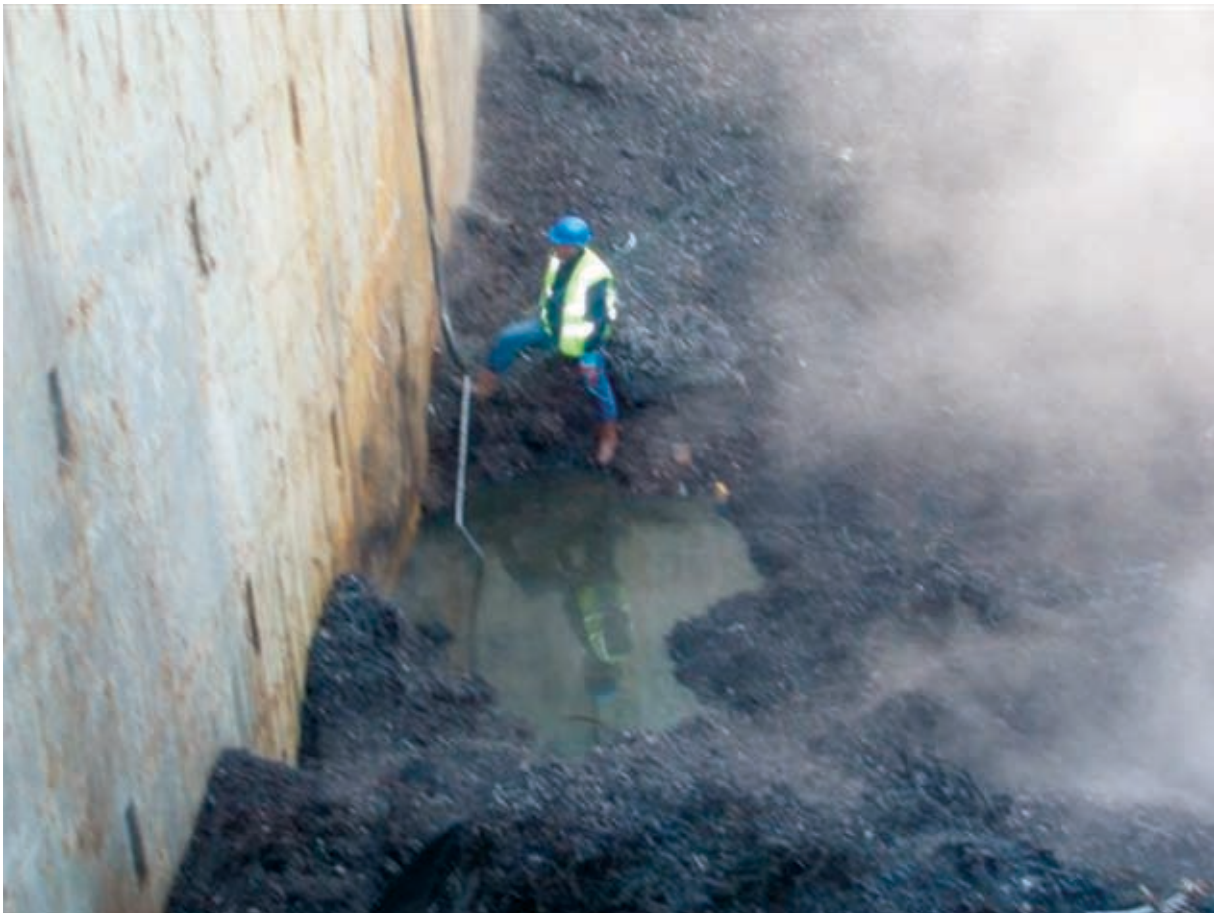
Figure 1

At about 0235, the duty AB detected a small fire in the open hold. He alerted the crew, who attempted to extinguish the fire. However, this was unsuccessful. At 0308 the local fire and rescue service attended the vessel and began to douse the cargo with water (Figure 1). The ship's master and harbour authorities advised against using large amounts of water because of potential stability concerns. At about 0330 the fire was declared to be under control, and three out of the five fire tenders providing assistance were released.

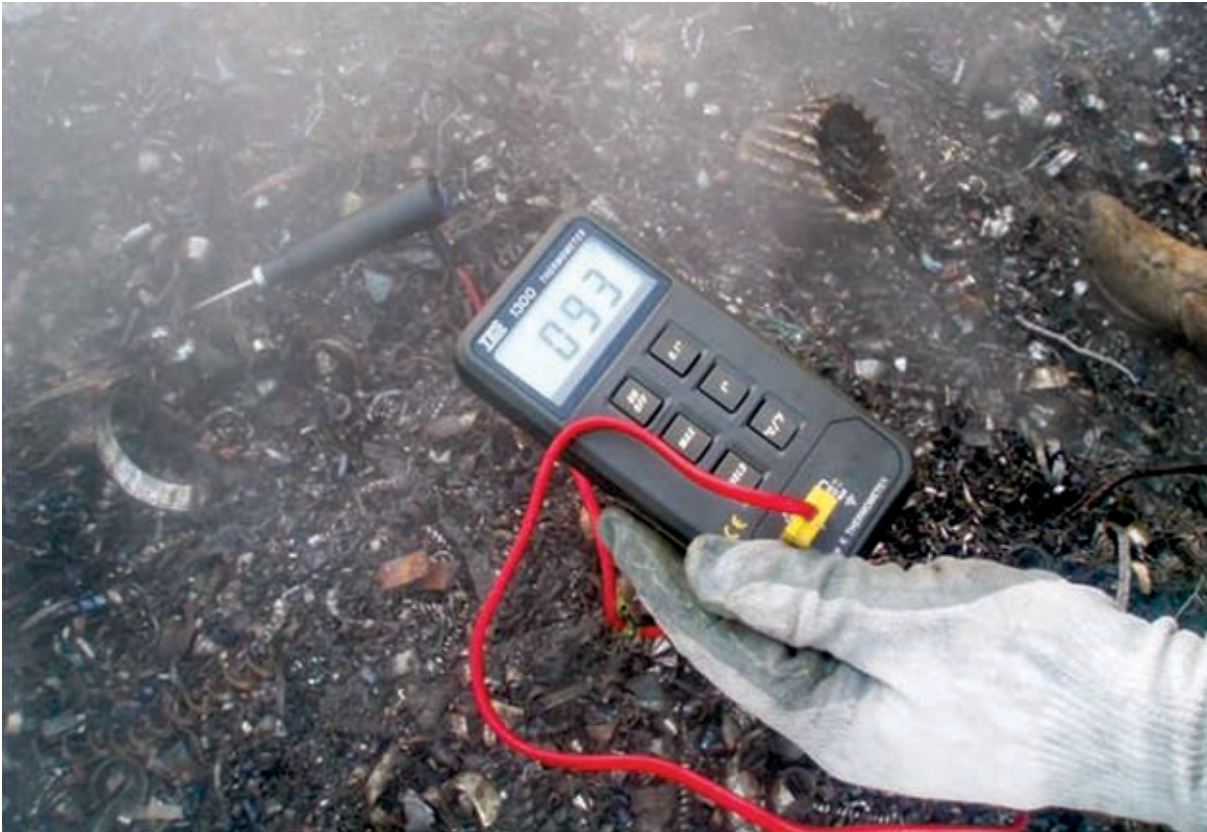
Figure 2

At 0530 the cargo loading crane driver arrived, and an hour later he started to remove the smoking cargo to the dockside, where it was cooled down once more. The temperature of the hold cargo was constantly monitored; it reached a maximum of 93°C (Figure 2). The cargo and hold water removal, and cargo re-load took a further 60 hours.

1. The temperature of UN 2793 cargoes should be recorded by the waste management contractor. Prior to loading, the temperature taken from between 200-350mm into the pile should not exceed 55°C.
2. If the cargo temperature exceeds 90°C during loading, operations should be stopped until the temperature has fallen below 85°C.
3. A vessel should not depart unless the temperature is below 65°C and has shown a steady downward trend for at least 8 hours.
4. Cargo loading should be suspended during wet conditions, and the hold hatches should be closed when the holds are not being worked.

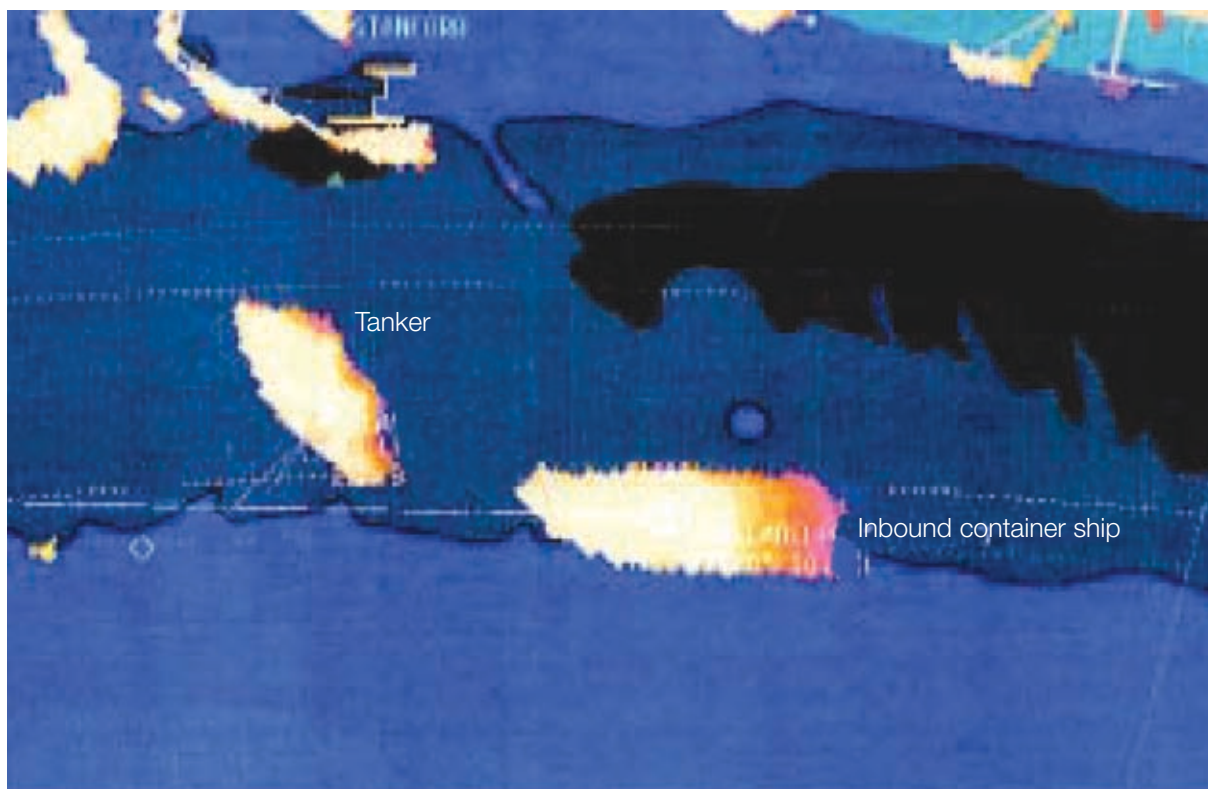
Screen shot from VTS radar of incident

1. The tanker was equipped with ground stabilised radar, log and GPS, all of which indicated that she was making sternway. However, because the berthing pilot had positioned himself on the port bridge wing, he was unable to monitor the instrumentation. He was therefore estimating the vessel's movement by eye, a particularly difficult task at night with few visual clues. The master, OOW and sea pilot were all in the wheelhouse, and were in a position to advise the berthing pilot of the vessel's movement and of the proximity of the container ship. Yet they failed to do so.

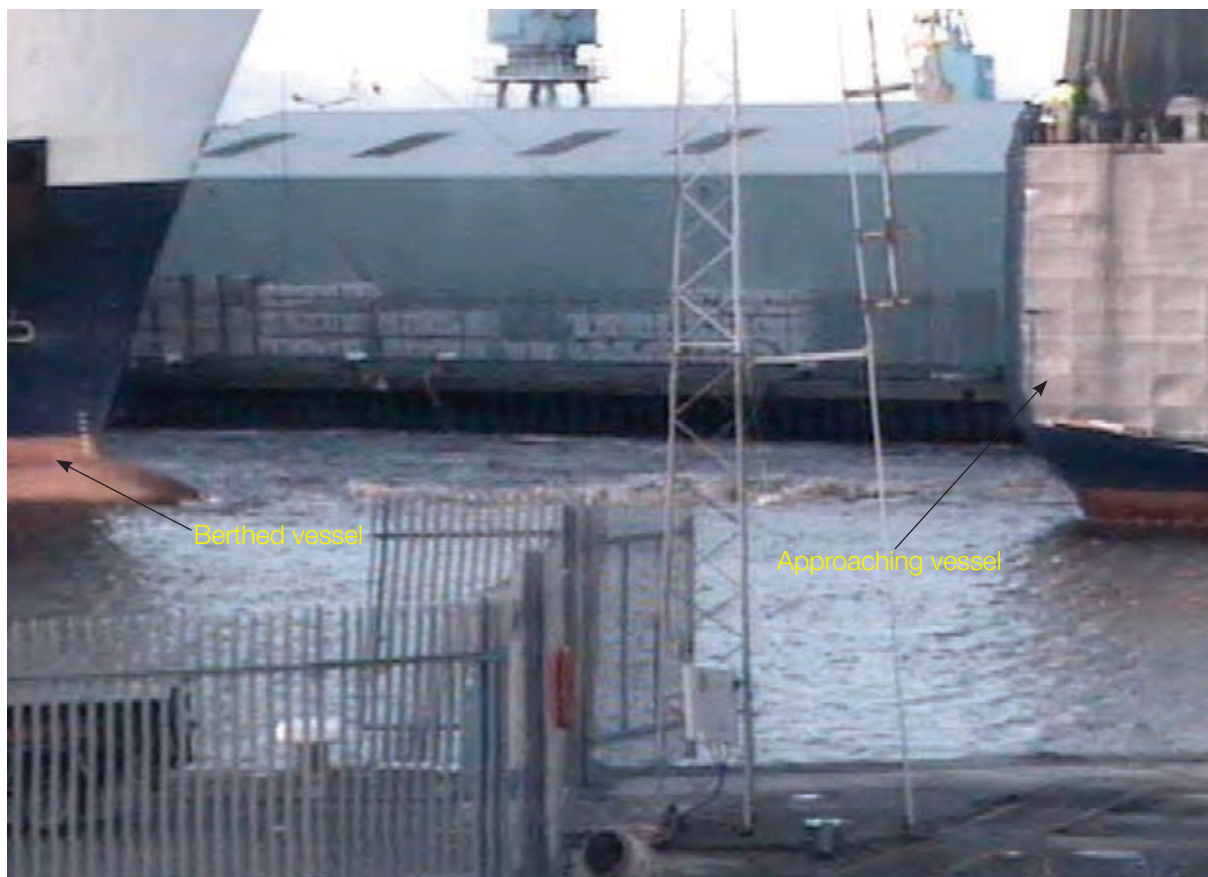
CCTV footage of vessel approaching occupied berth

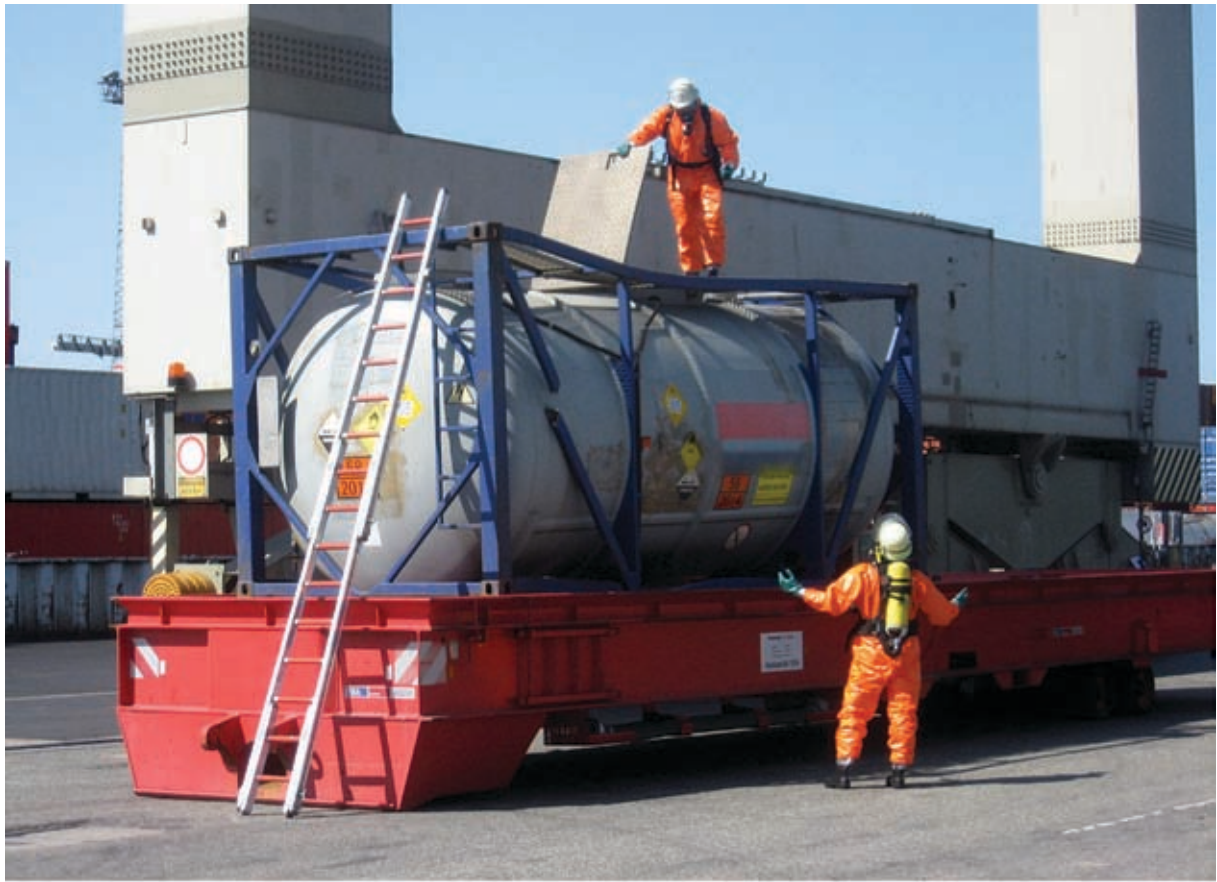
container was lifted between 30cm and 50cm before it dropped back to deck. The impact caused the tank frame to buckle and resulted in the release of a small quantity of the tank's contents (Figure 1). The crew immediately plugged the deck scuppers and spread sawdust over the deck to absorb the spilled liquid.

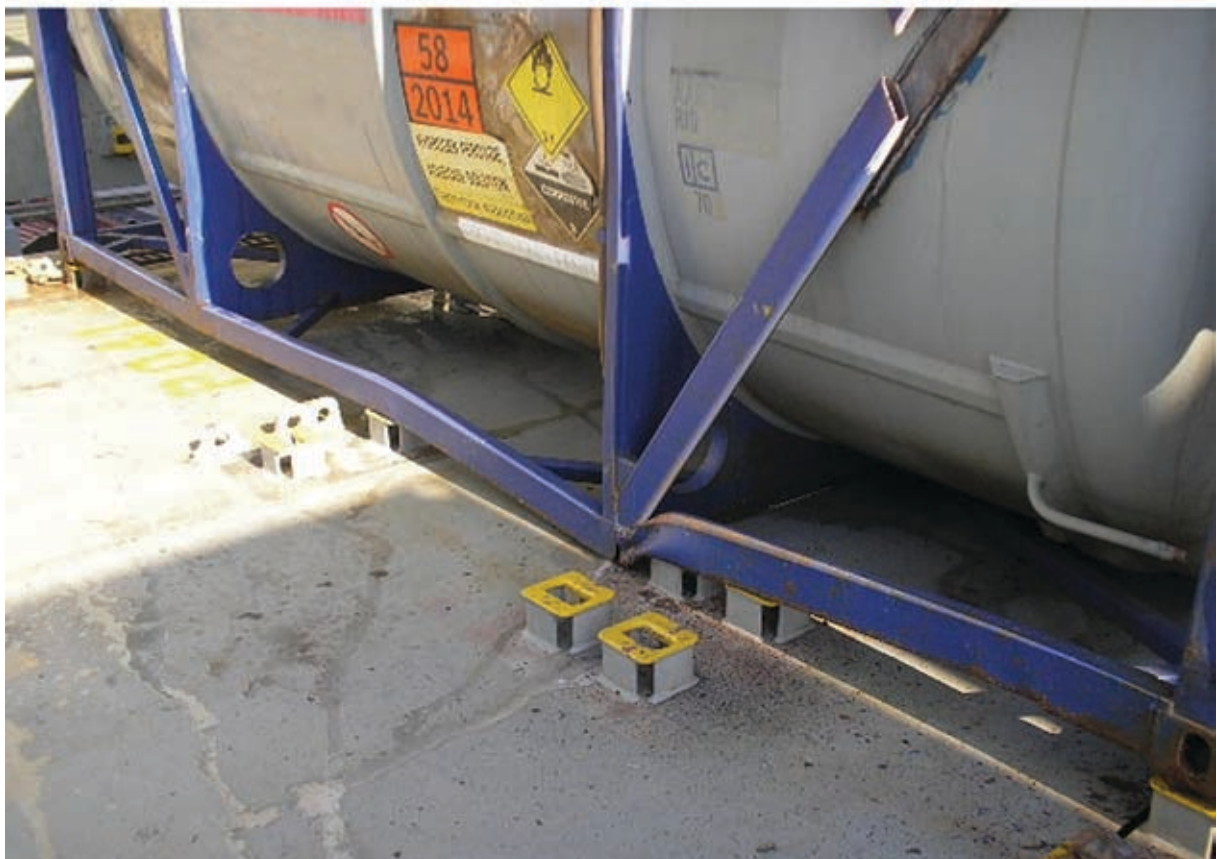
Figure 2

Following inspection, the tank was transferred ashore (Figure 2) and, shortly afterwards, the

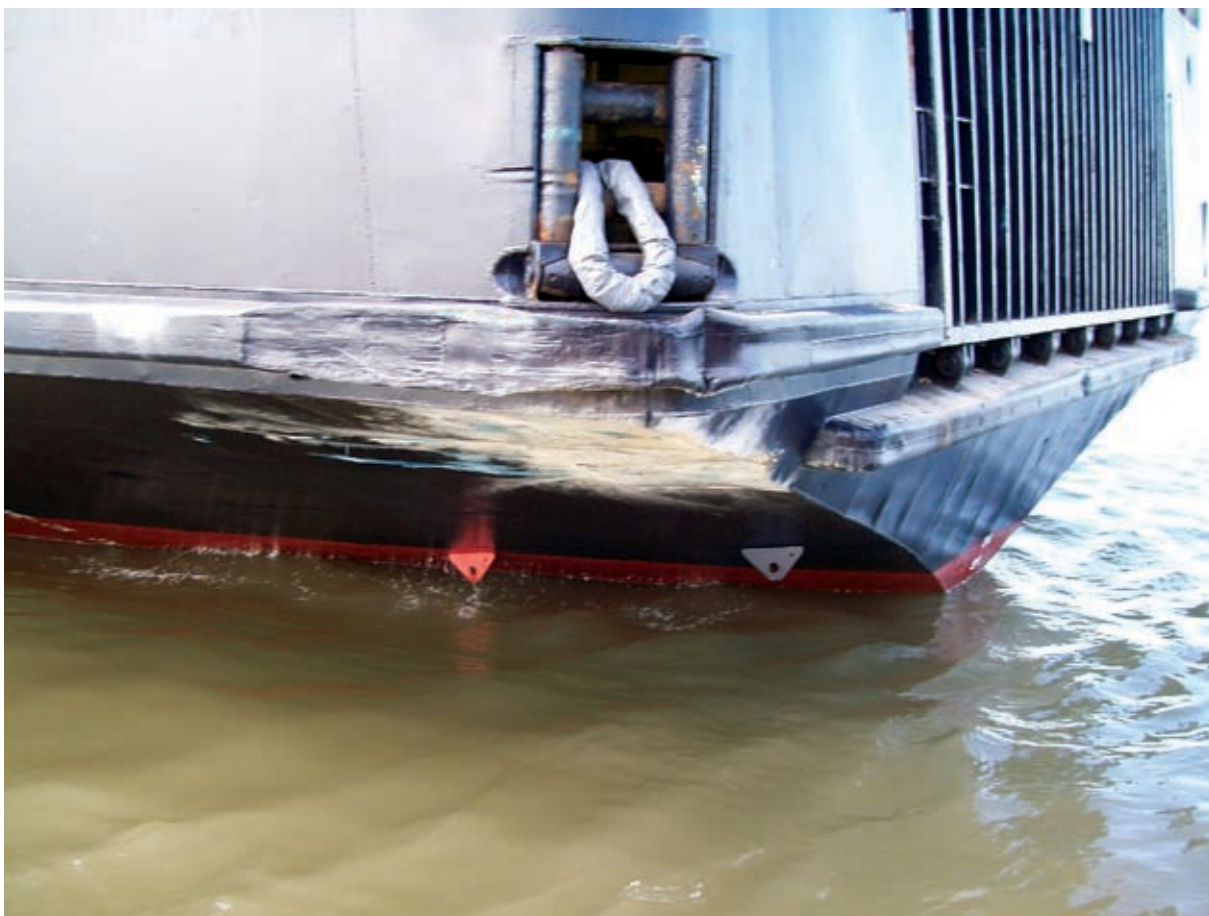
Figure 1: The port quarter

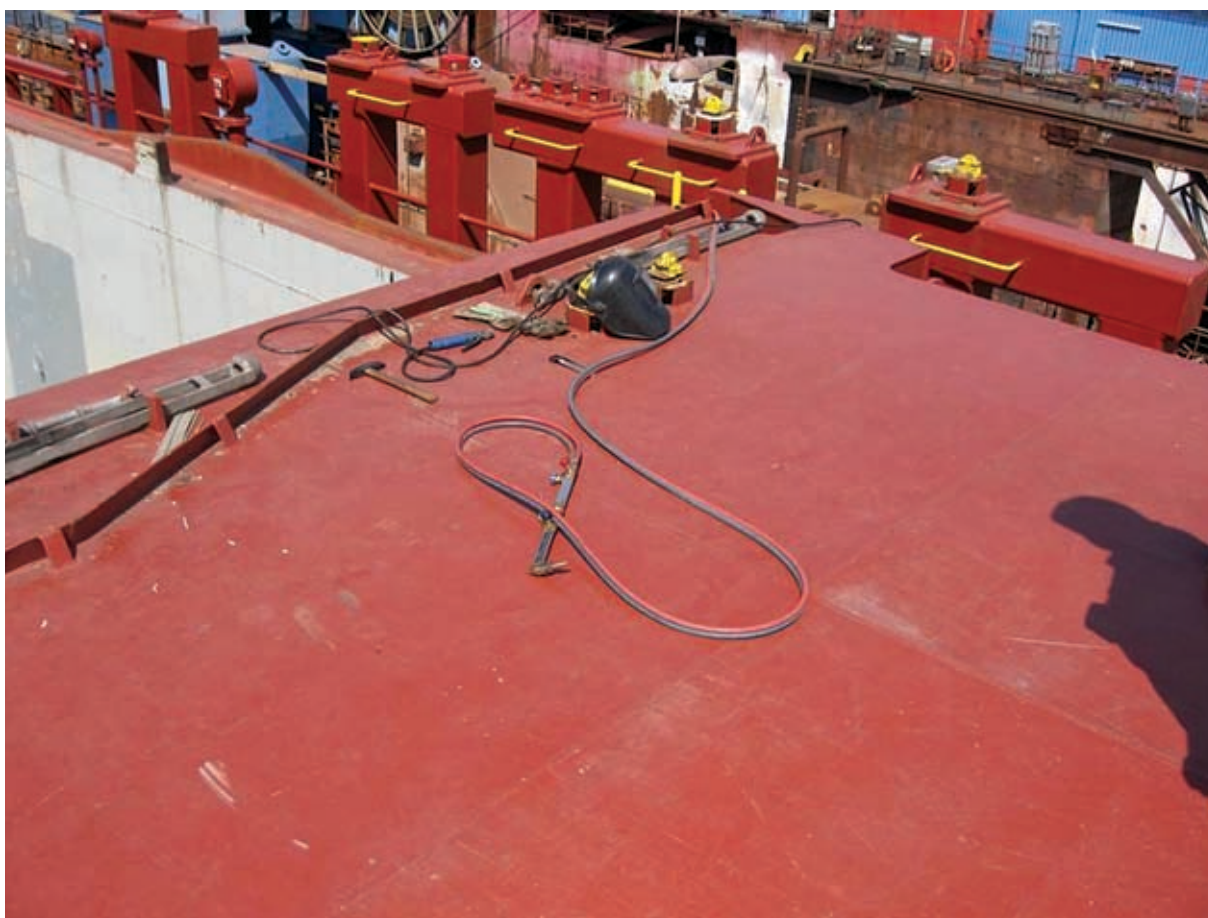
Despite a requirement under the vessel's SMS procedures for hot work to be supervised, this particular hatch top work was not monitored, and after completing several hot work tasks the fitter left his tools on the hatch cover while he took his lunch break. Meanwhile, the chief officer opened the after half of the hatch cover on which the fitter had been working to allow light into the hold to help the crew who were cleaning in the ballast tank below. Before opening the hatch cover he moved the fitter's tools, leaving them close to the unguarded edge of the adjoining forward hatch cover. When the fitter returned from lunch he found

The tools used by the fitter

The controls required by the work permit would have prevented this accident.

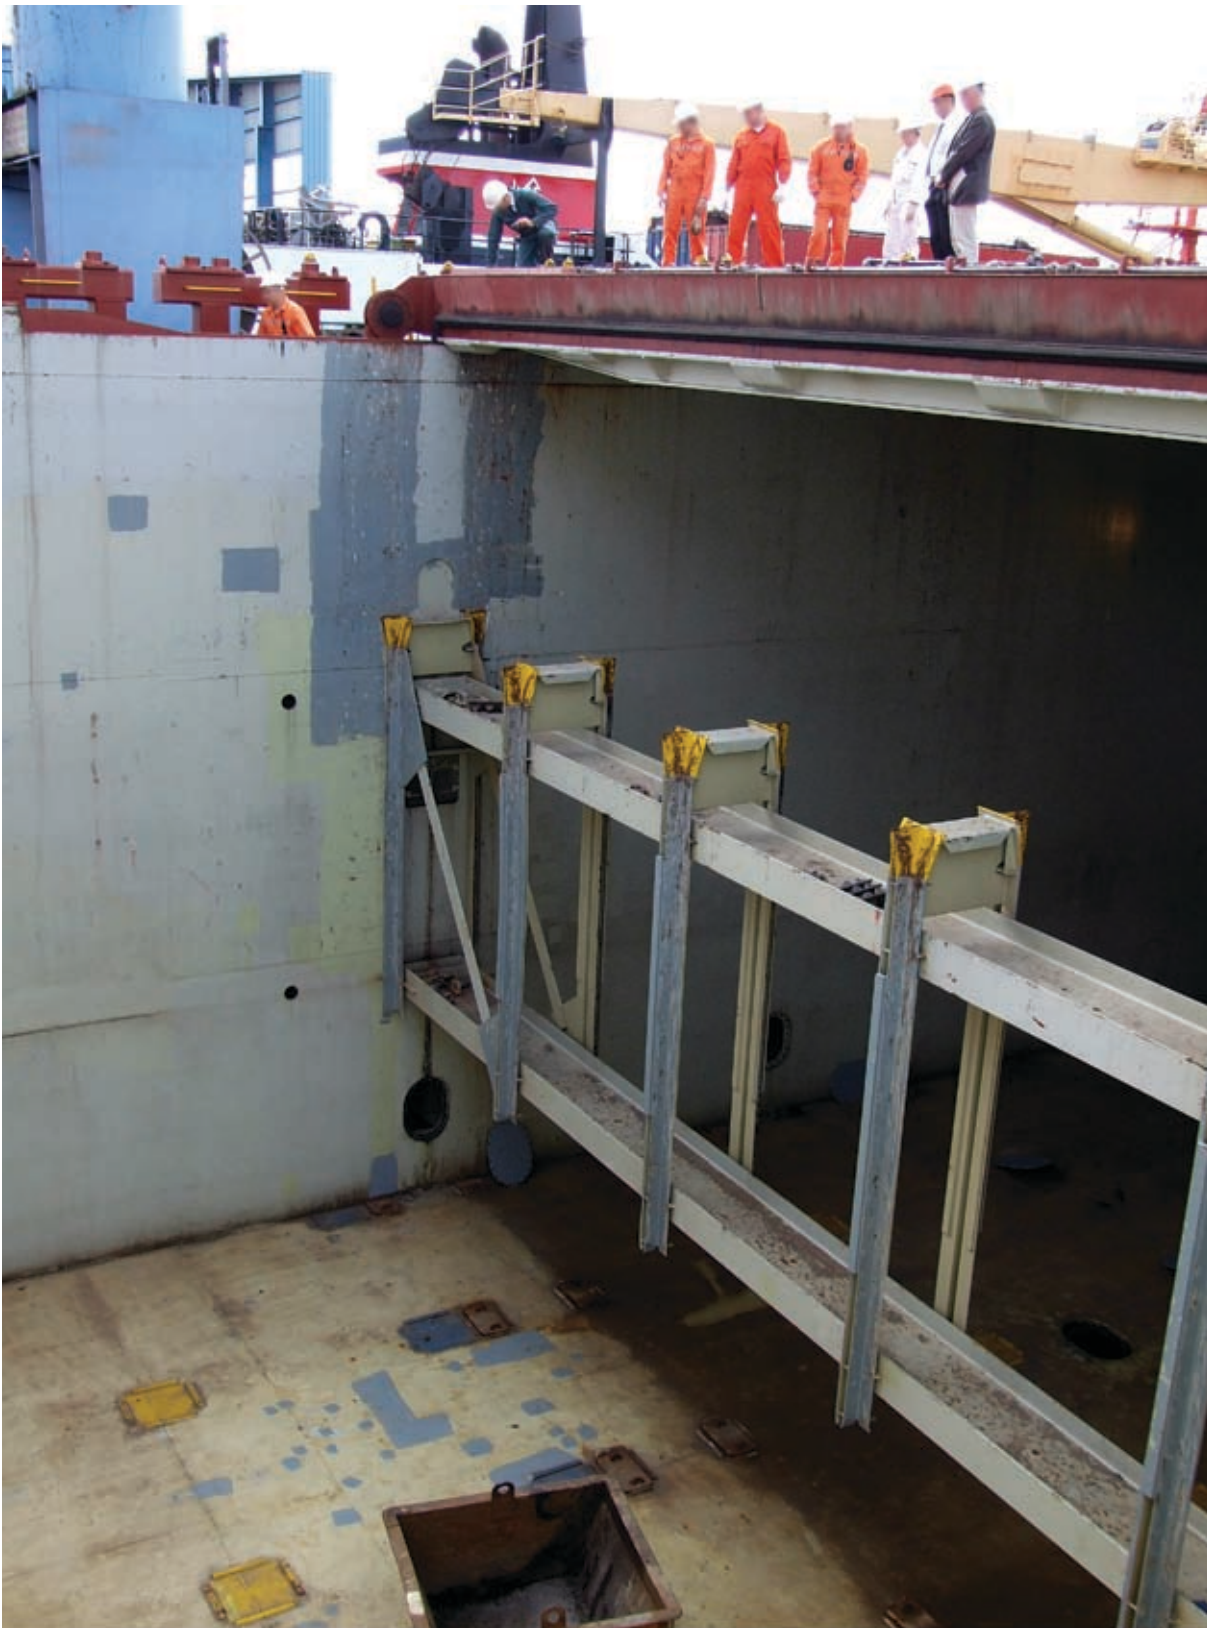
Vessel's cargo hold

the after section of the hatch cover open and his tools moved forward. He then continued his work close to the edge of the forward hatch cover some 10 metres above the unprotected open hold.

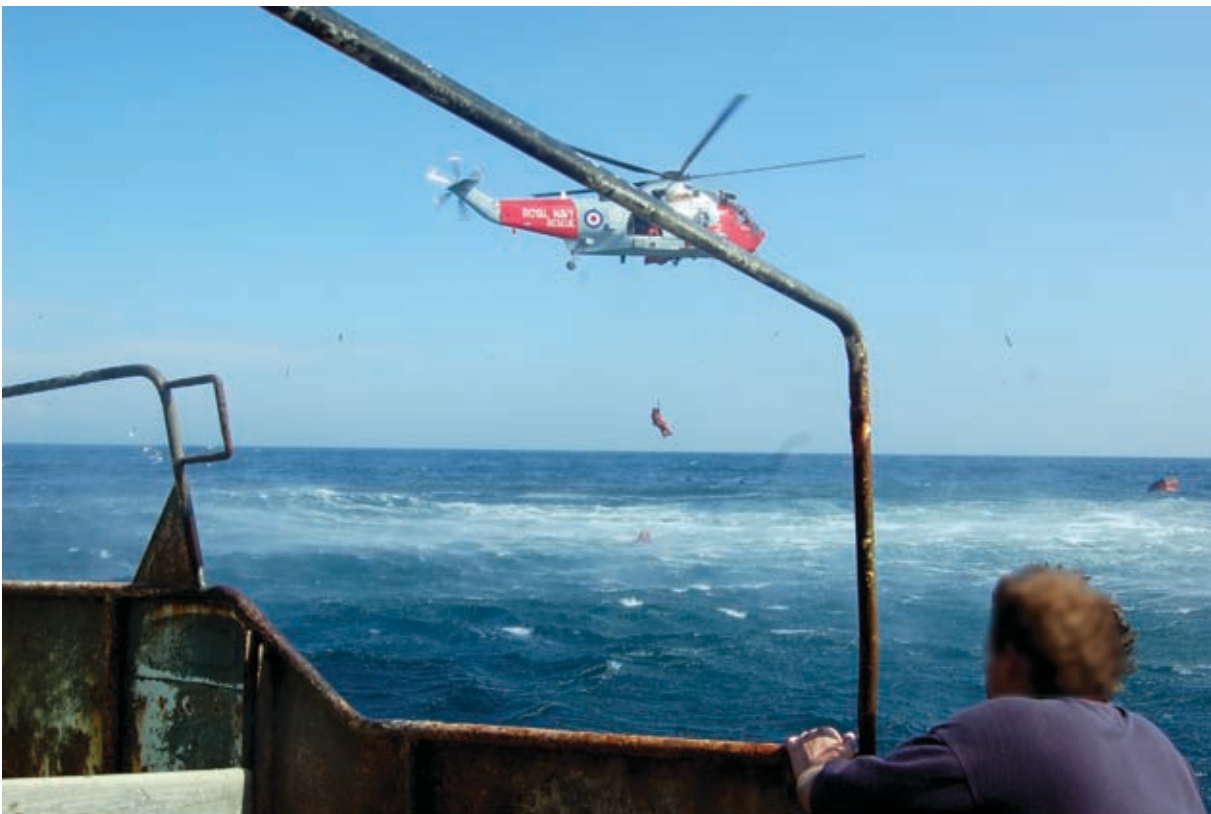
Figure 2

The skipper checked the accommodation area and found that the cabin deck was just under water. Sensibly, he did not enter the compartment because at about the same time the vessel made a sudden lurch and began to roll to starboard. The skipper immediately instructed the crew to jump into the water. They had insufficient time to right the still

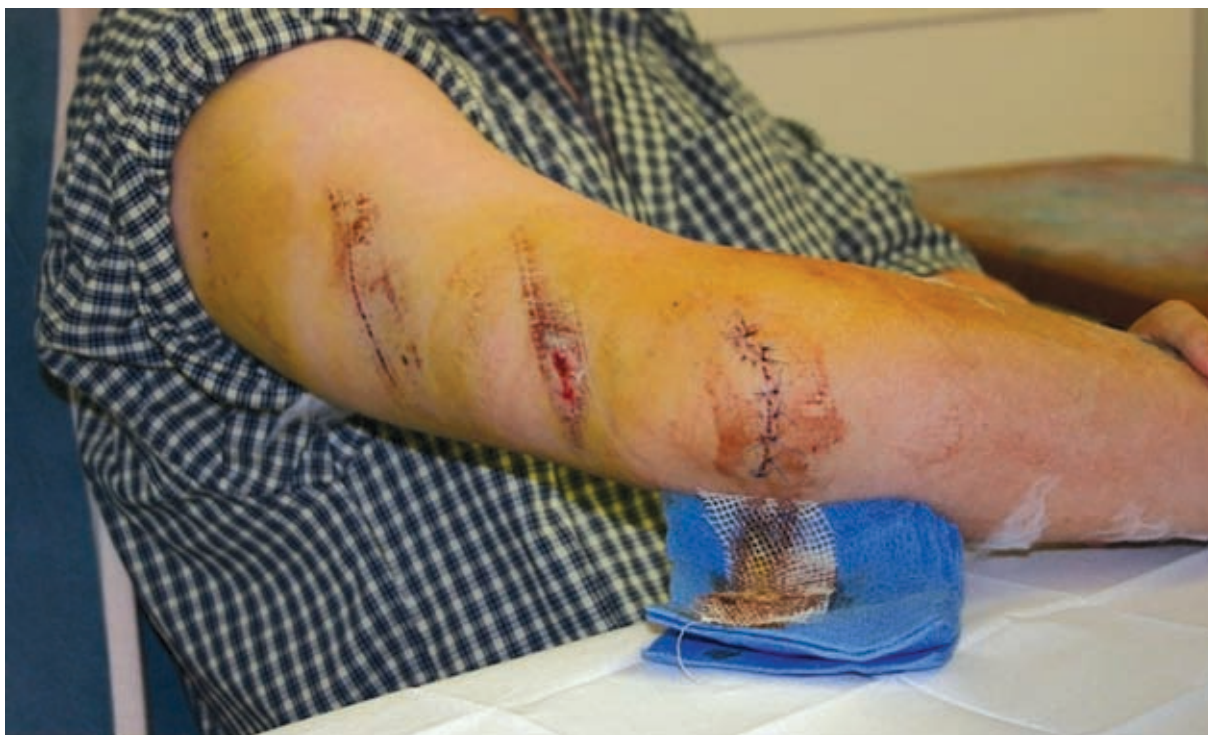
Figure 1

The instructor immediately took over the helm and manoeuvred the RIB to recover the trainees from the water. He quickly realised that the teenage boy was injured and headed back to the training base at best speed, calling the emergency services en route. The injured trainee was landed and taken to hospital by ambulance where he was found to have suffered a fracture, lacerations and bruising to his right arm (Figure 1).

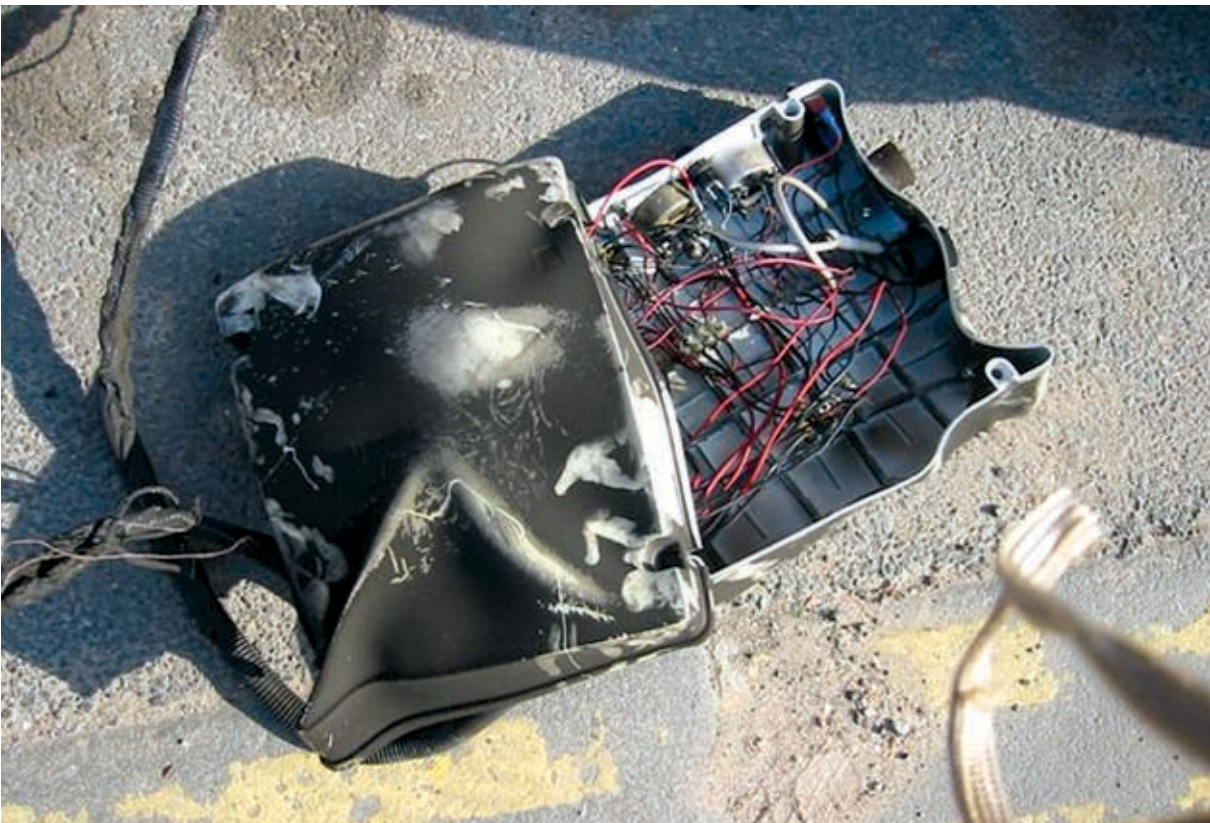
Figure 2

On investigation, it appeared that the television was left in the stand-by condition because power had not been isolated to the boat's electrical circuits. It is likely that the television's capacitor broke down, igniting the television's plastic casing. The flames from the television then damaged the engine monitoring plastic panel, burning the cable insulation outside the panel (Figure 2). This, in turn, shorted out the engine start circuit, causing the engine to start. Fortunately the wheelhouse was reasonably airtight, and the fire was short-lived.
