MARINE ACCIDENT  
INVESTIGATION BRANCH

# SAFETY DIGEST

**Lessons from Marine  
Accident Reports  
2/2009**

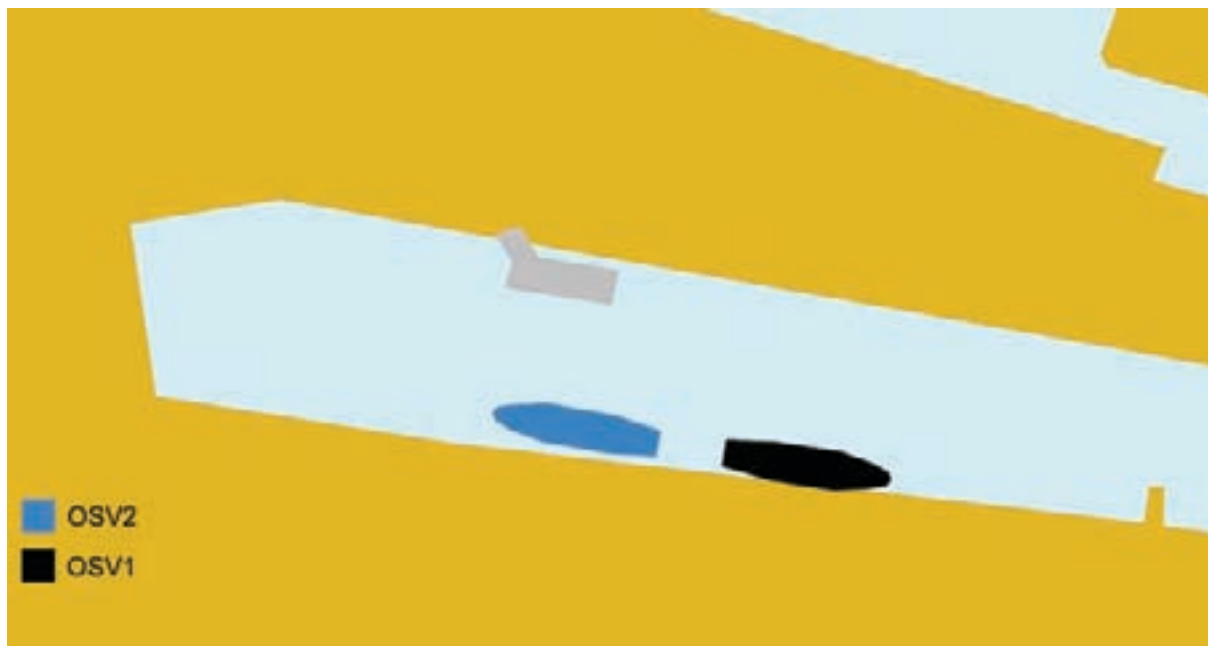
Figure 1

An offshore supply vessel (OSV1) and a sister vessel (OSV2) moored stern to stern alongside the south side of a tidal basin (Figure 1), were instructed to exchange berths by the port control. Each vessel was

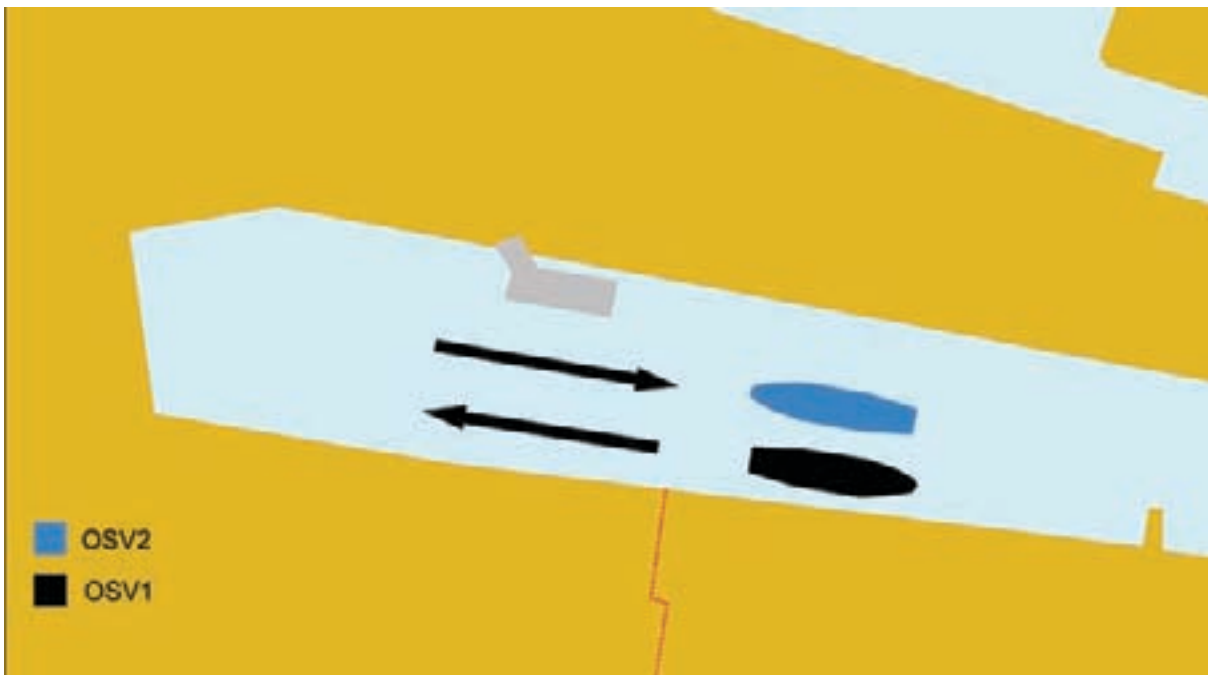
Figure 2

OSV2 slipped, manoeuvred into the centre of the basin, and then proceeded astern. During this manoeuvre, OSV1 also let go all ropes, and as soon as OSV2 was on the port beam, went astern (Figure 2). At this point the master of OSV1 was controlling the vessel's propulsion from the aft-facing control station. He was accompanied on the bridge by the chief officer,

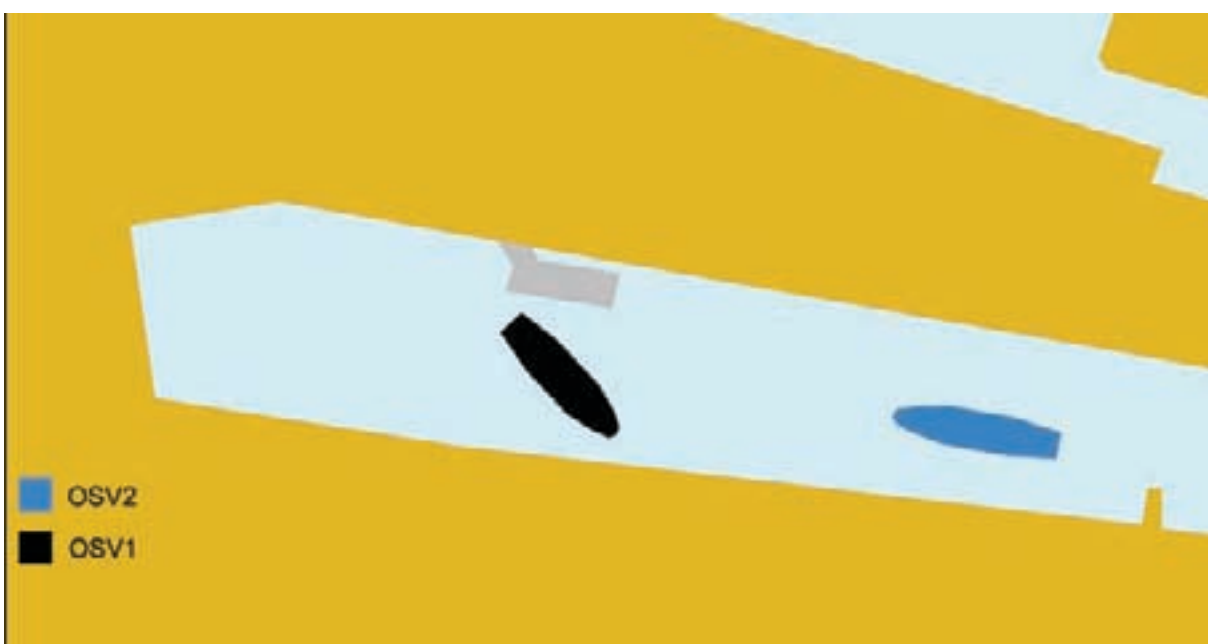
Figure 3

The bow moved back towards the quay, but the vessel's stern then started to swing rapidly towards a number of small pleasure craft moored alongside a ro-ro link span on the north side of the basin (Figure 3). Alerted by the chief officer, the master again moved to the aft control station and adjusted the azimuth units to arrest this

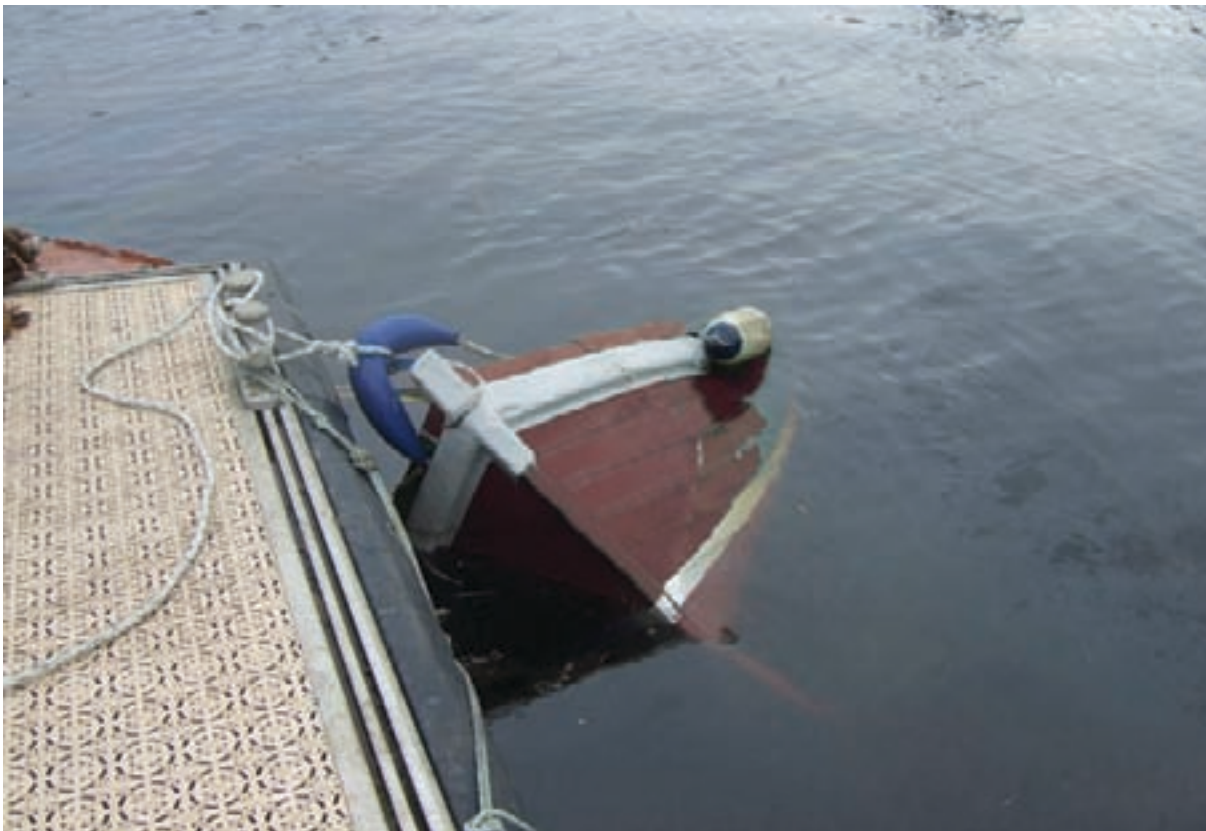
Figure 4

movement. However, the vessel did not respond as expected, and OSV2 was too distant to assist. As a result, the port quarter of OSV1 made contact with the small pleasure craft and the link span. Three pleasure craft sank (Figure 4) and three others were damaged. The link span was put out of action for several weeks.

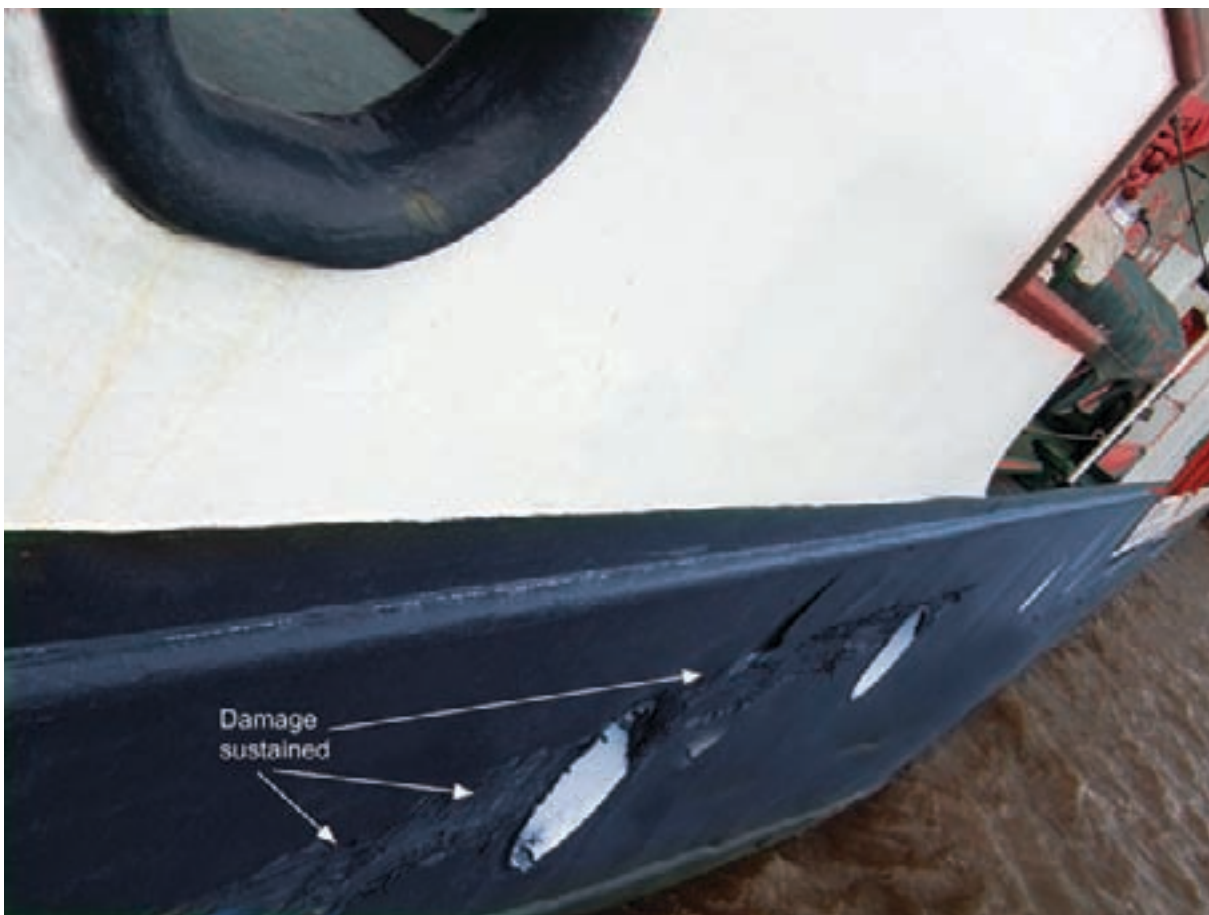
View from starboard quarter

The passage upriver was uneventful, with the pilot steering at the centre console. The weather was calm, with good visibility, it was dark and the tide was on neaps. As the vessel was negotiating the long bend before the bridge, the pilot, at the master's suggestion, moved the starboard console to obtain a better view down the side of the ship. When the ship's bow was half-way through the bridge transit, the master, standing at the centre console, sensed that the ship was being set to starboard and onto the buttress. He asked the pilot what he intended to do; the pilot applied hard to starboard helm and full ahead on the engine. However, the ship's starboard quarter made a glancing contact with the buttress's steelwork, causing damage to the ship's side plating.

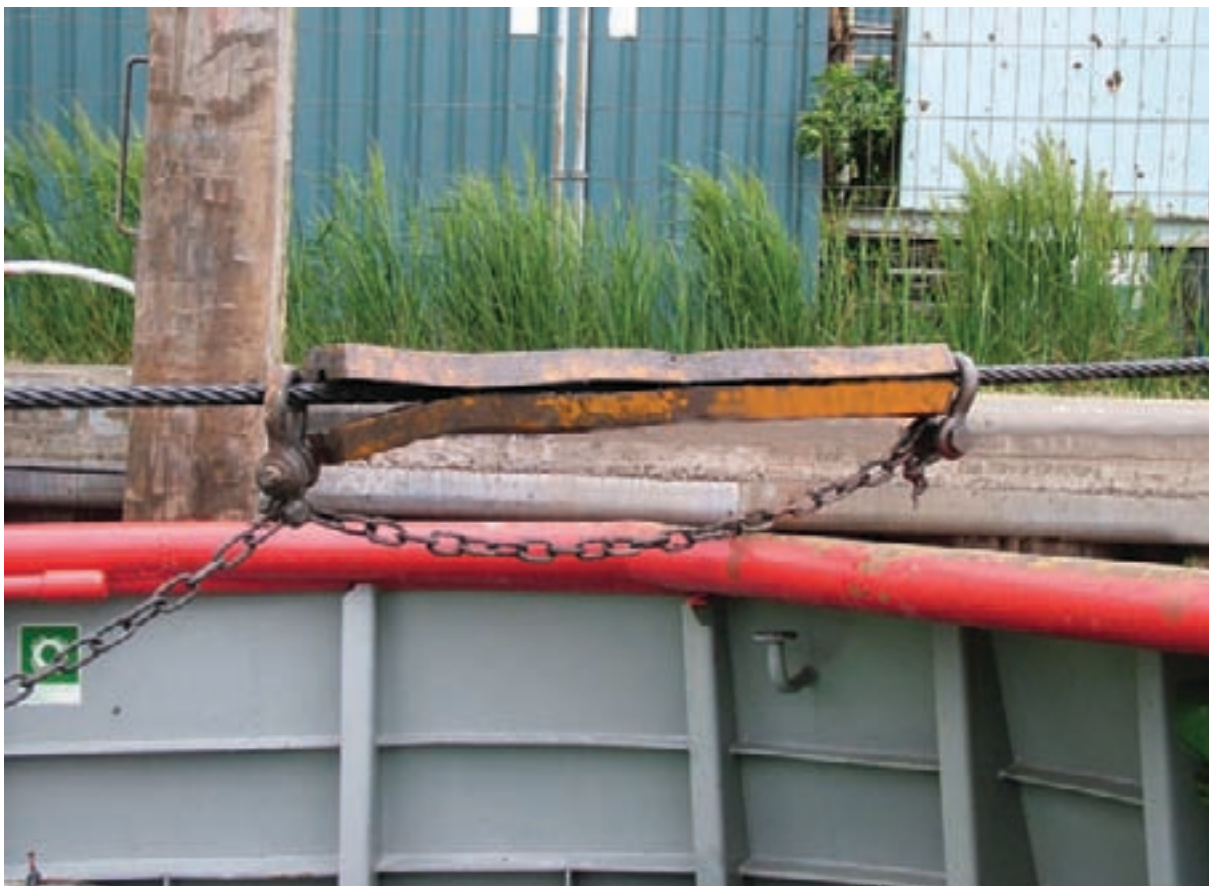
In the early hours of the morning, the “chafer” had slipped outboard as the cargo vessel continued to shear, so the tug’s bosun went out alone onto the working deck to re-position it back onto the bulwark rail. Although he was able to pull the “chafer” back on board, it came too far inboard of the rail. The tug was therefore again manoeuvred to position the tow wire on the starboard quarter so that the quarter could then be dipped to allow the “chafer” to be pushed back into position. However, as the tow wire and “chafer” moved

Figure 1: Chafer arrangement raised above bulwark rail

5. As often is the case, a robust risk assessment should have identified most of these issues and resulted in mitigating solutions being developed to reduce the risks, such as re-designing the bracket or moving the wire reel. The assessment was generic rather than vessel specific, and did not consider, in detail, different towing and deck operations. Although “toolbox talks” were regularly conducted on board, and are valuable, meaningful risk assessments are also essential in ensuring safe operations, and should not be overlooked.

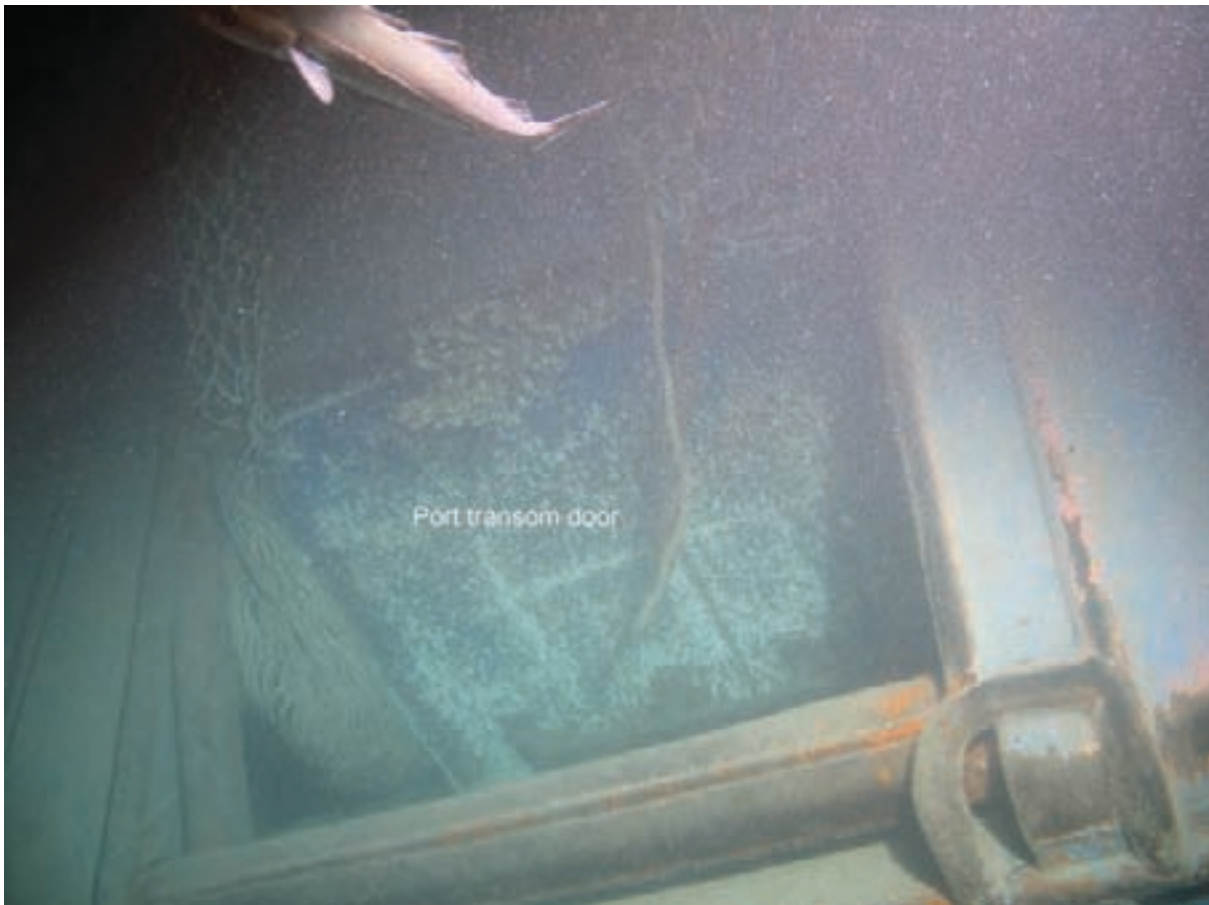
Given the proximity of the wreck to pipelines, the oil company undertook a video and side scan sonar survey of the seabed. These concluded that the bridle and tickler chains on the trawl gear had snagged on large mounds of boulder clay, probably created when the plough being used to back-fill the trench and cover the pipeline, had either stalled or jumped.

Figure 1: Port transom door open on wreck

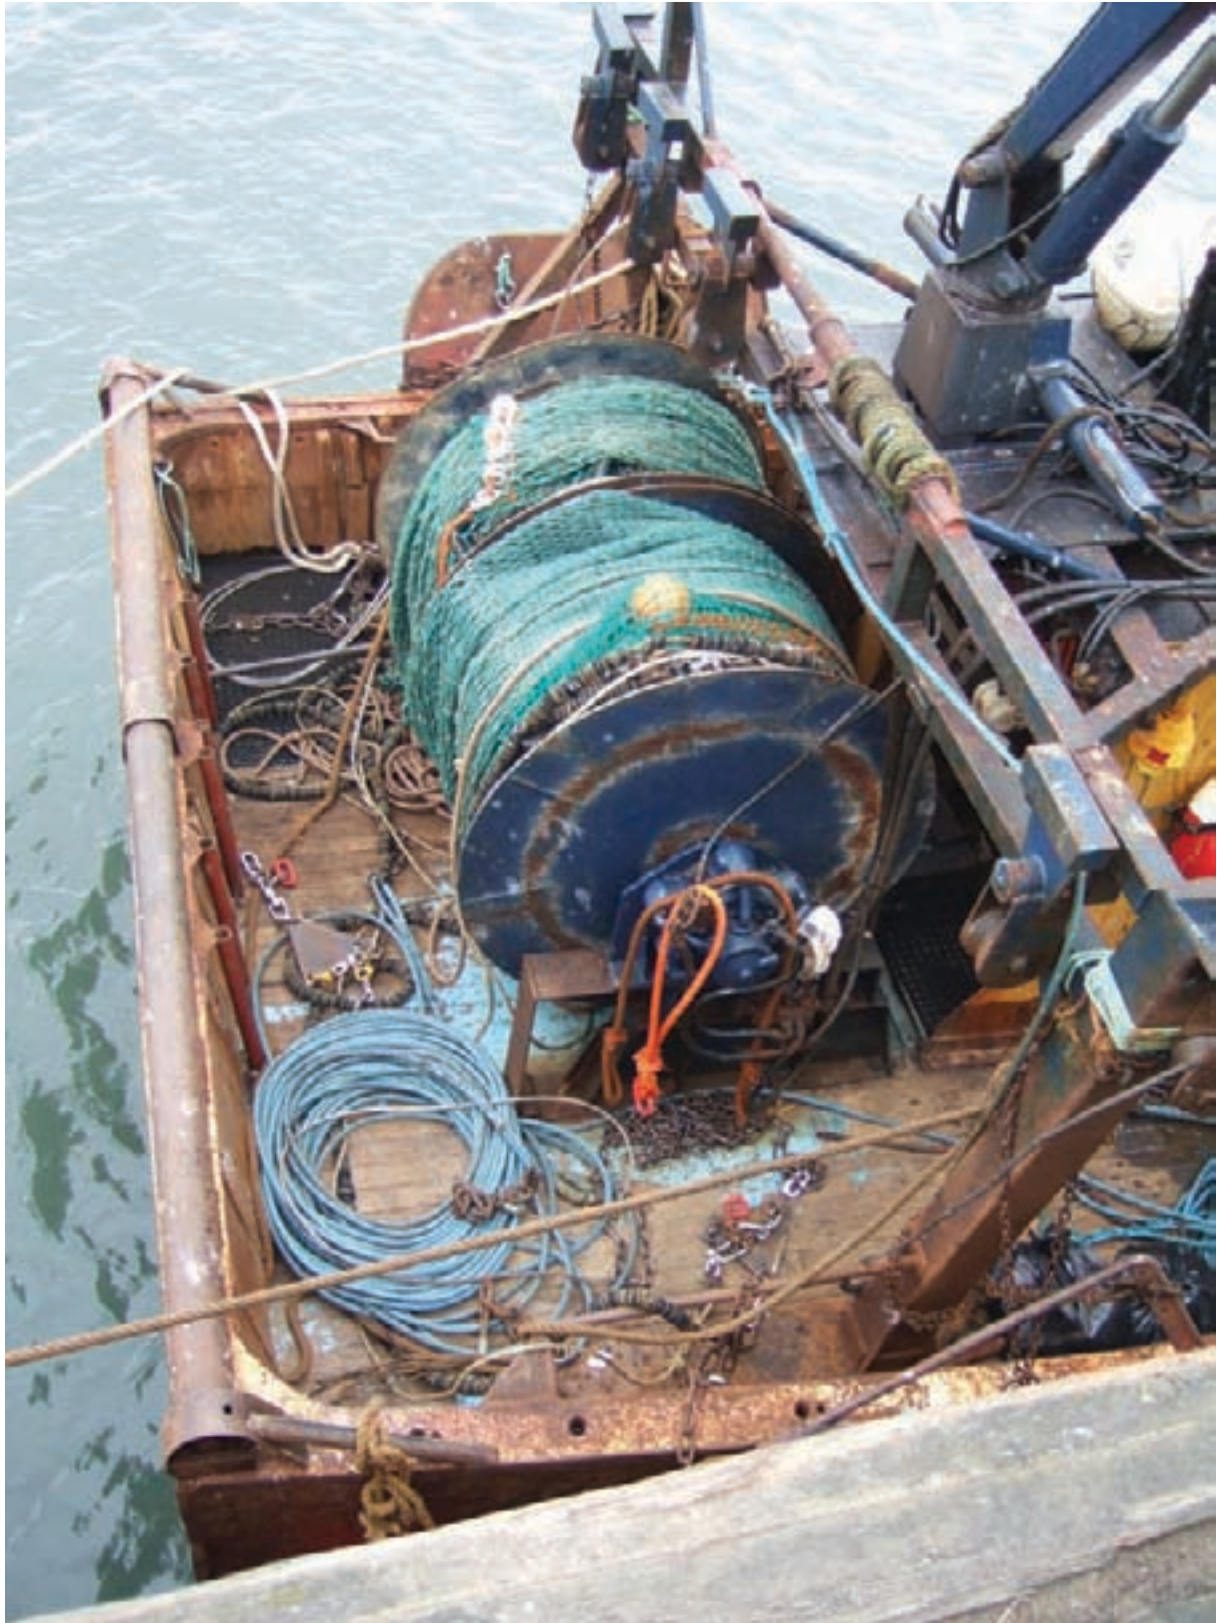
As the weight came on the wire, both stoppers parted and the crewman in the bight of wire was lifted off his feet and thrown overboard. He was not wearing a lifejacket or buoyancy aid.

Figure 1: Vessel's net drum and aft working area

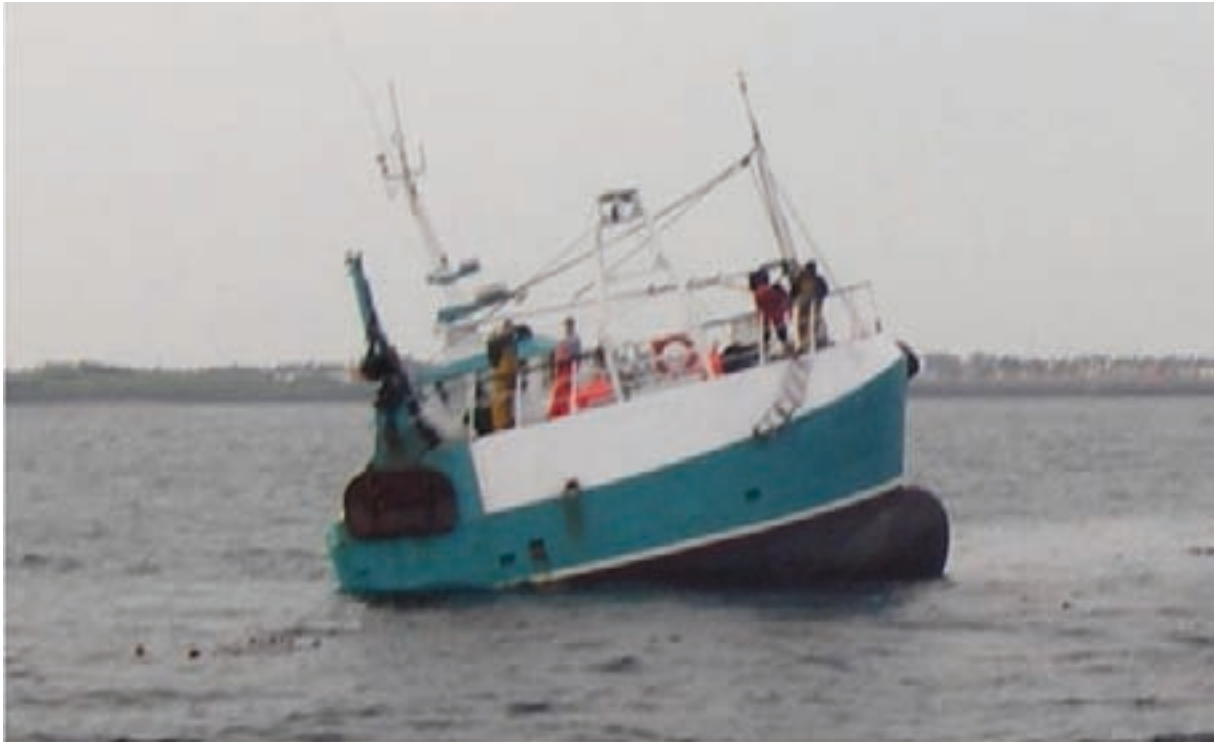
The vessel aground 0.5 mile from port

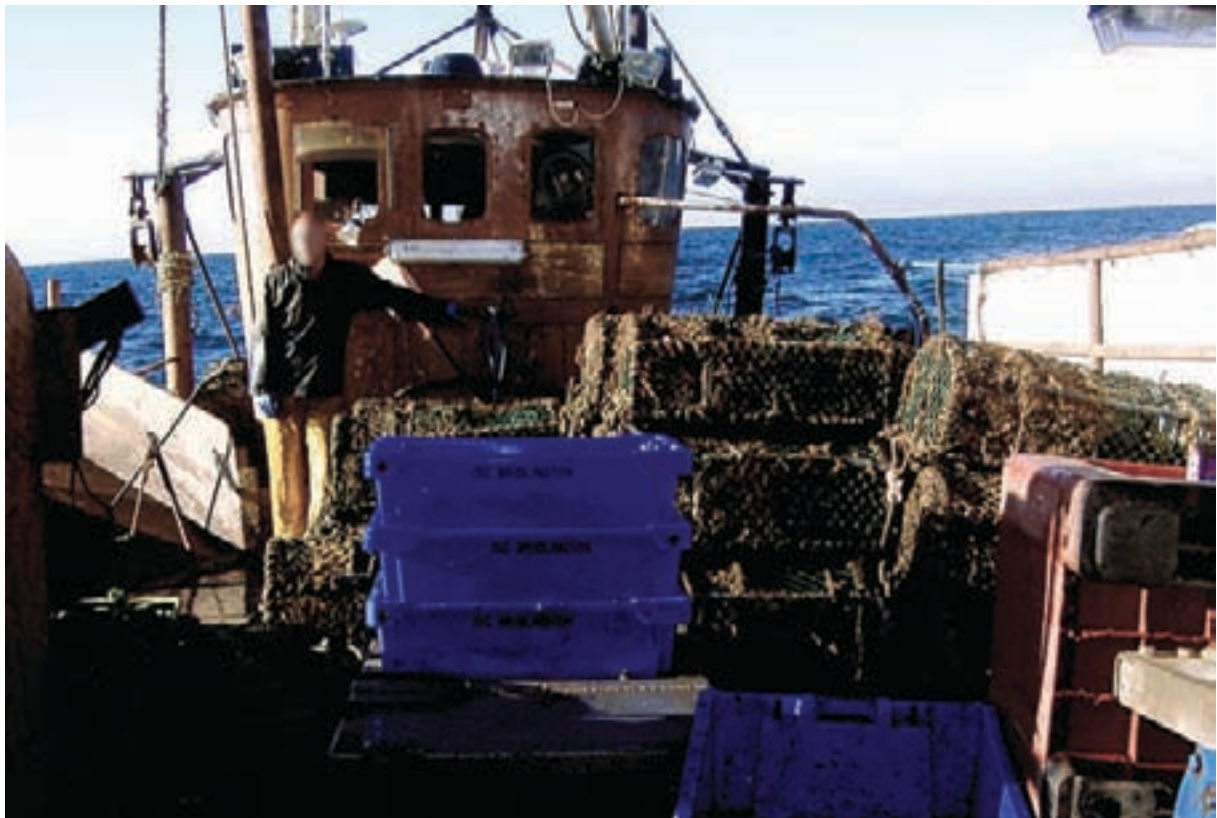
The second crewman was able to free his colleague's foot from the bight as the skipper manoeuvred the boat to keep the weight off the pot rope. The man's foot was very badly bruised as a result of the accident, and he had to be airlifted off the boat to receive medical attention.

Figure 1: Position of casualty at time of accident

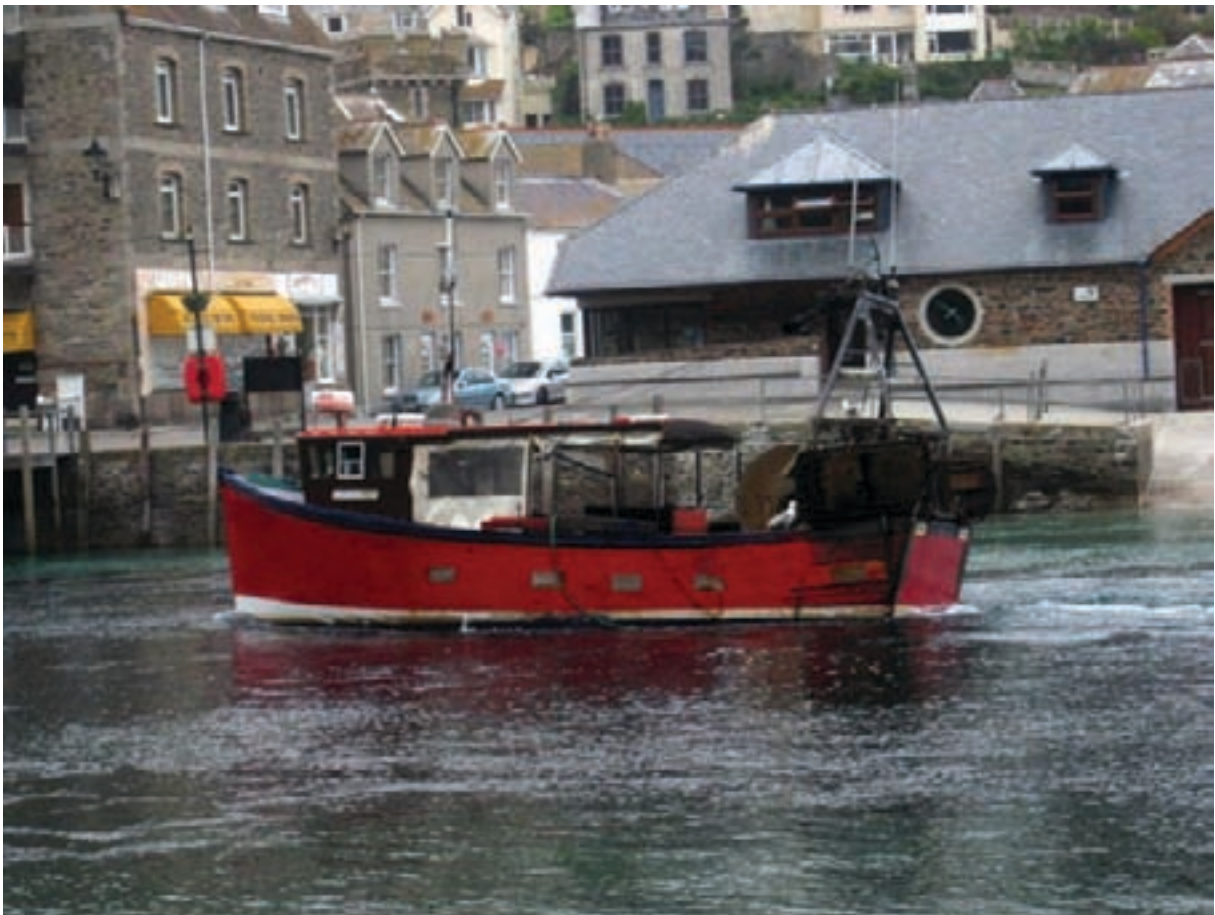
Figure 1

At about 1500, having made little progress, the skipper decided to make another attempt to remove the fastener. He hauled the gear until, once again, the trawl wires were "up and down". Keeping the engine in gear and running ahead, he applied the port trawl wire brake, disengaged the port dog clutch and heaved on the starboard trawl wire. The port wire suddenly slipped, transferring all of the weight to the starboard wire. Under the combined effect of this increased tension in the starboard trawl wire, the wind and tide also acting on the starboard side, and the engine running ahead, the vessel started to capsize to starboard very rapidly.

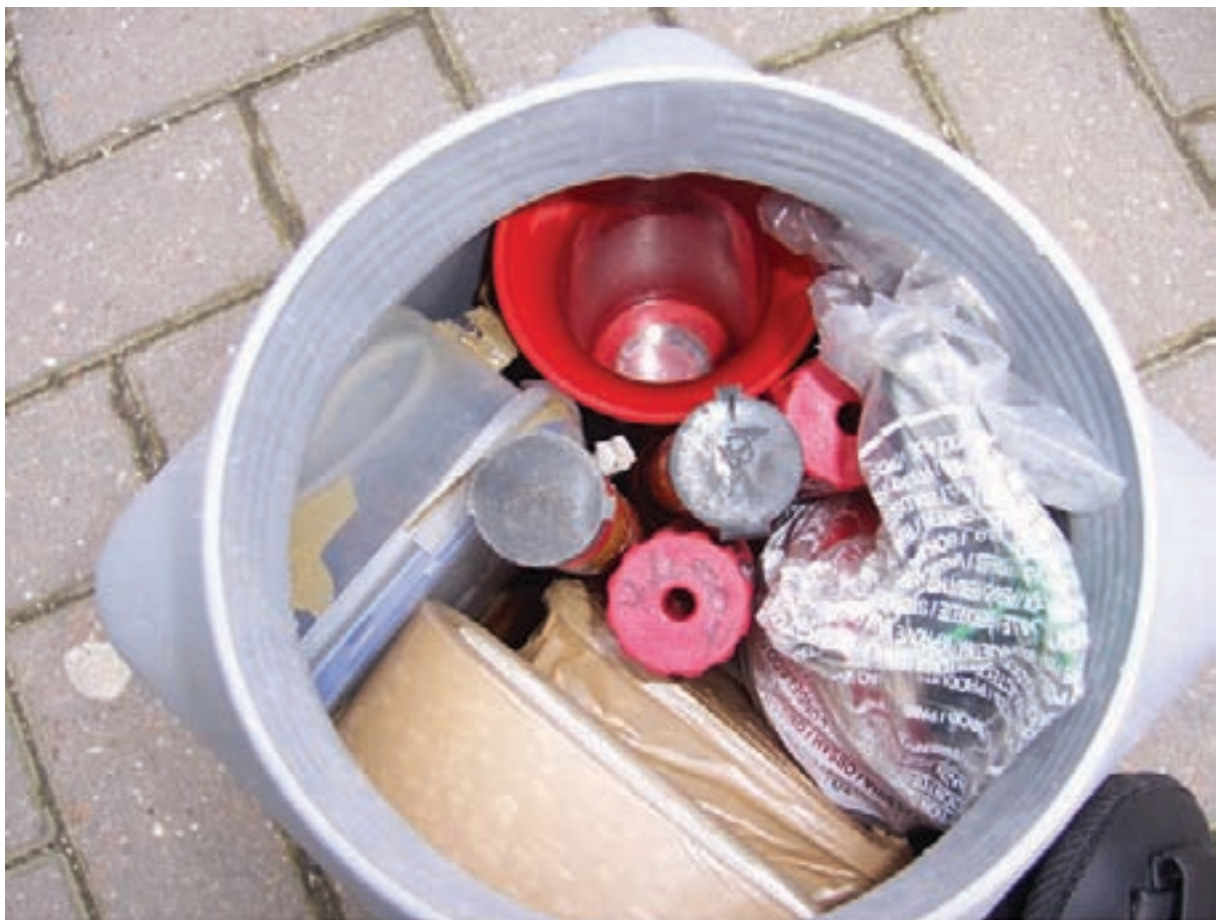
Figure 1

As the "safety box" was put onto the boat it was dropped onto the deck. The coxswain then heard a "fizzing" sound from the box; it was clear to him that one of the flares had detonated. The plastic box started to melt and orange smoke issued from it. The box then ignited and the fire spread to the RIB's inflatable tubes, badly scorching them. The coxswain raised the alarm and took an extinguisher from a nearby boat and tackled the fire. To his credit, the coxswain

On investigation, it was discovered that the coxswain did not carry out the required checks to ensure the flares were in the “safe” condition. It was most probable that the flare was not in the fully safe position, and that when the heavy “safety box” was dropped onto the deck of the RIB, the resultant upward force was sufficient to detonate the flare.

1. Induction procedure checks for new crew should ensure that all aspects of the procedures are covered; checklists and counter signatures may be helpful in this respect.
2. Flares should be regularly checked to ensure that they are in the fully safe position so that the risk of unintended detonation and risk of fire is as low as possible.
3. Do not make any modifications to the firing mechanism of flares. This can cause confusion when they are needed in an emergency; they may mistakenly be thought to be defective and, in the worst case, prevent a rescue from being initiated.
4. If there are concerns about the reliability or functionality of safety equipment, report these to the equipment manufacturer without delay.

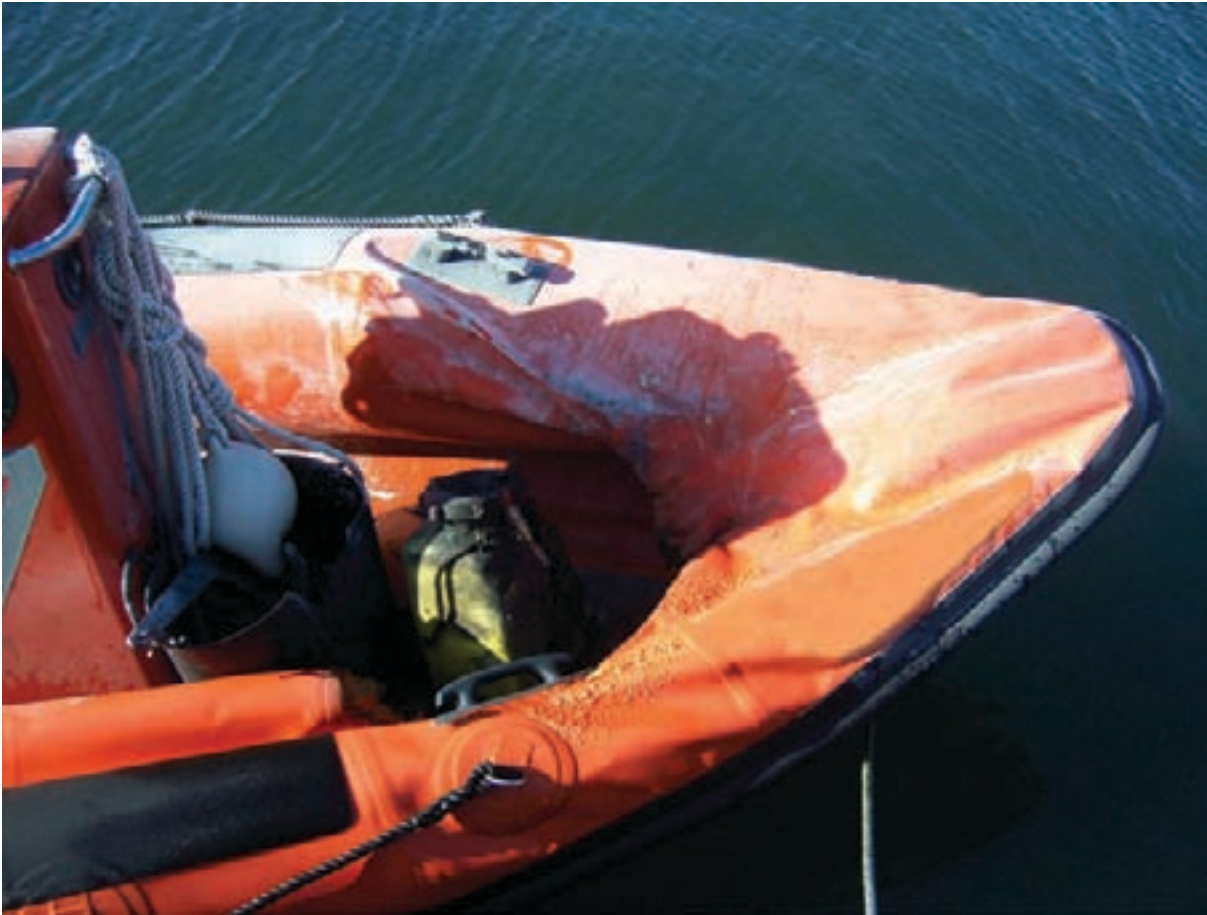
Figure 2

extinguished the fire, but not before the RIB's tubes were destroyed and the GRP deck damaged (Figure 2). The remaining flares were later destroyed by the Ministry of Defence's local bomb disposal team.

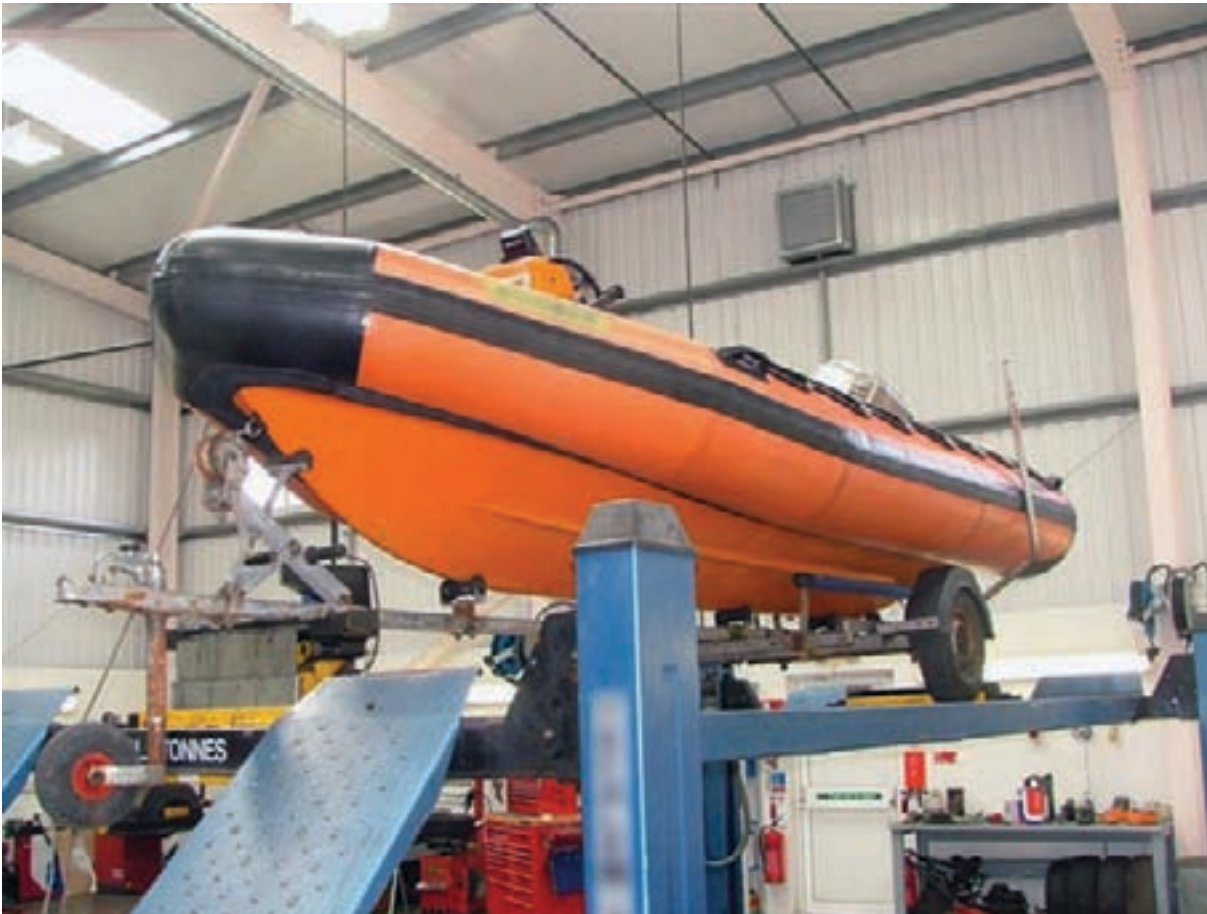
Figure 1: 6m RIB

A family and a friend were holidaying on the south coast. The friend, who had 6 years boat handling experience, had brought his well maintained, 6m RIB with him (Figure 1). The boat was fitted with a 90 HP engine, and there were two 150N lifejackets and a buoyancy aid carried in a kitbag. There were no flares or VHF radio on board and, although there was anecdotal evidence that a kill cord was occasionally used, it was not found.

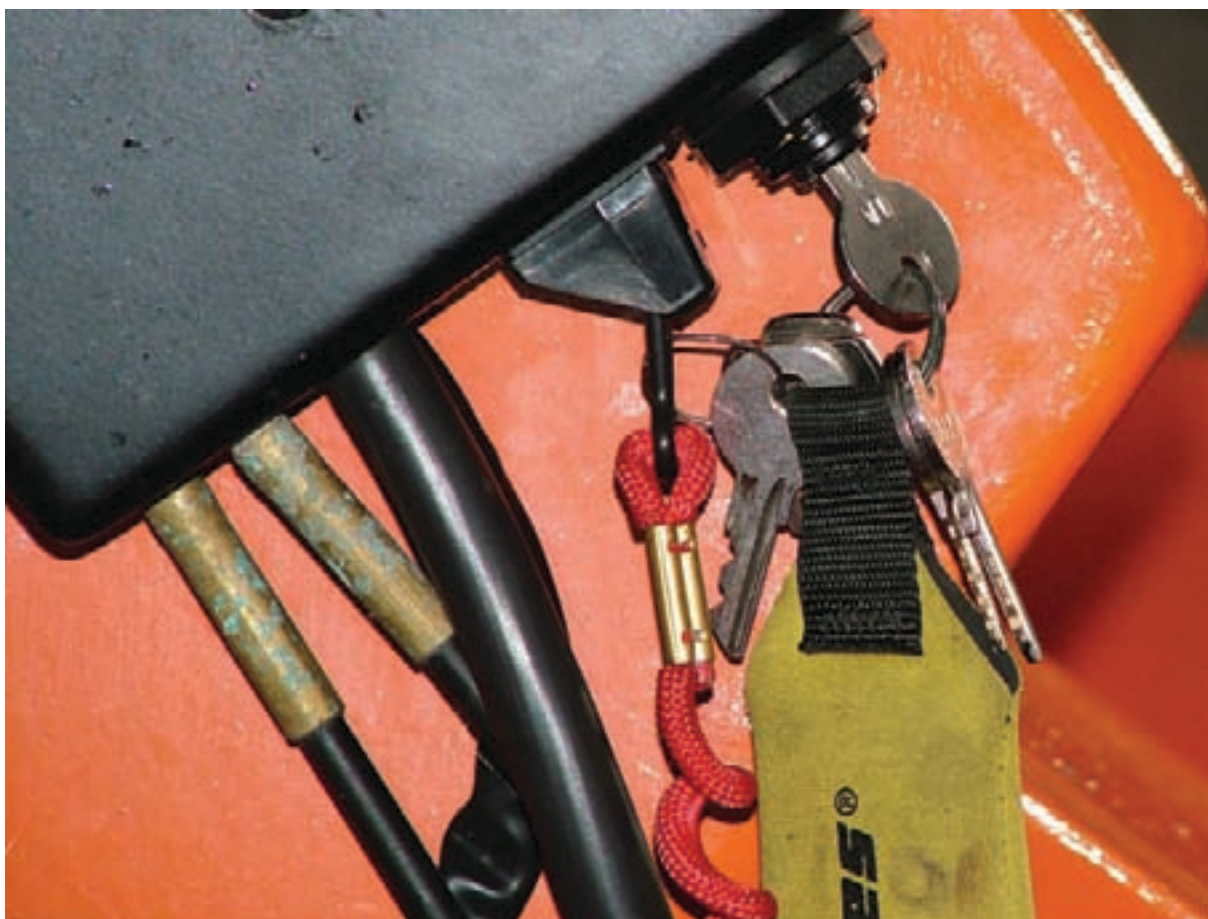
been connected to the engine stop toggle switch, and fitted to one of those on board, the engine shutdown circuit would have operated as the person was thrown overboard.

Figure 2: Kill cord toggle-type switch

1. Had the kill cord been used, the boat would have remained in the vicinity with its engine stopped, significantly improving the chances of survival. There are many configurations for fitting kill cords. Some operate a toggle type switch (Figure 2) and others hold off a spring-loaded engine circuit isolating switch. Whichever system you have, do check that your kill cord is free from abrasions and that the crimps securing the loops are tight. Always use the kill cord and make sure that it functions and that it is securely fitted to your body or to equipment that you are wearing. An example is at Figure 3.

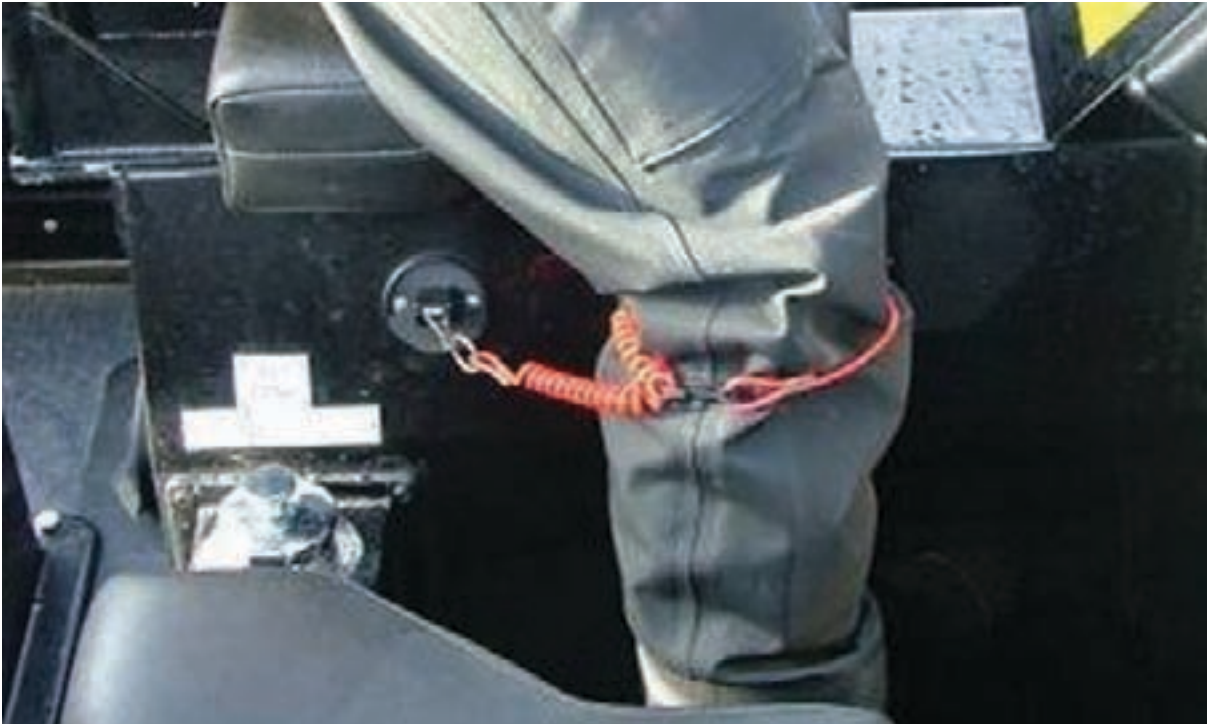
Figure 3: Example of fitting of the kill cord
