MARINE ACCIDENT INVESTIGATION BRANCH

1/2011

SAFETY DIGEST Lessons from Marine Accidents No 1/2011

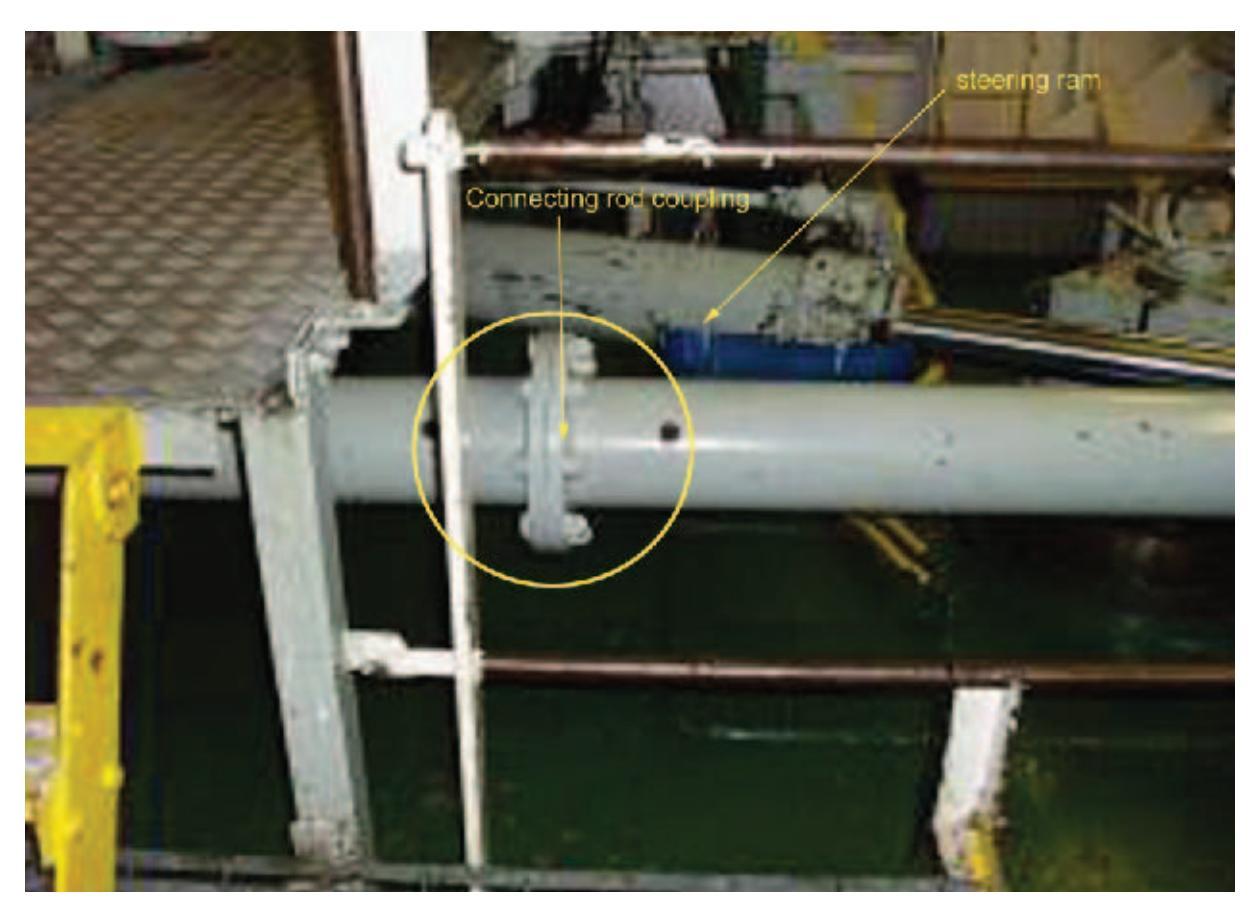
Figure 2

- On this vessel, the railings around the steering gear were not sufficient to protect anyone from inadvertently being dragged into a dangerous position. Areas around moving machinery should be securely guarded to prevent such accidents.

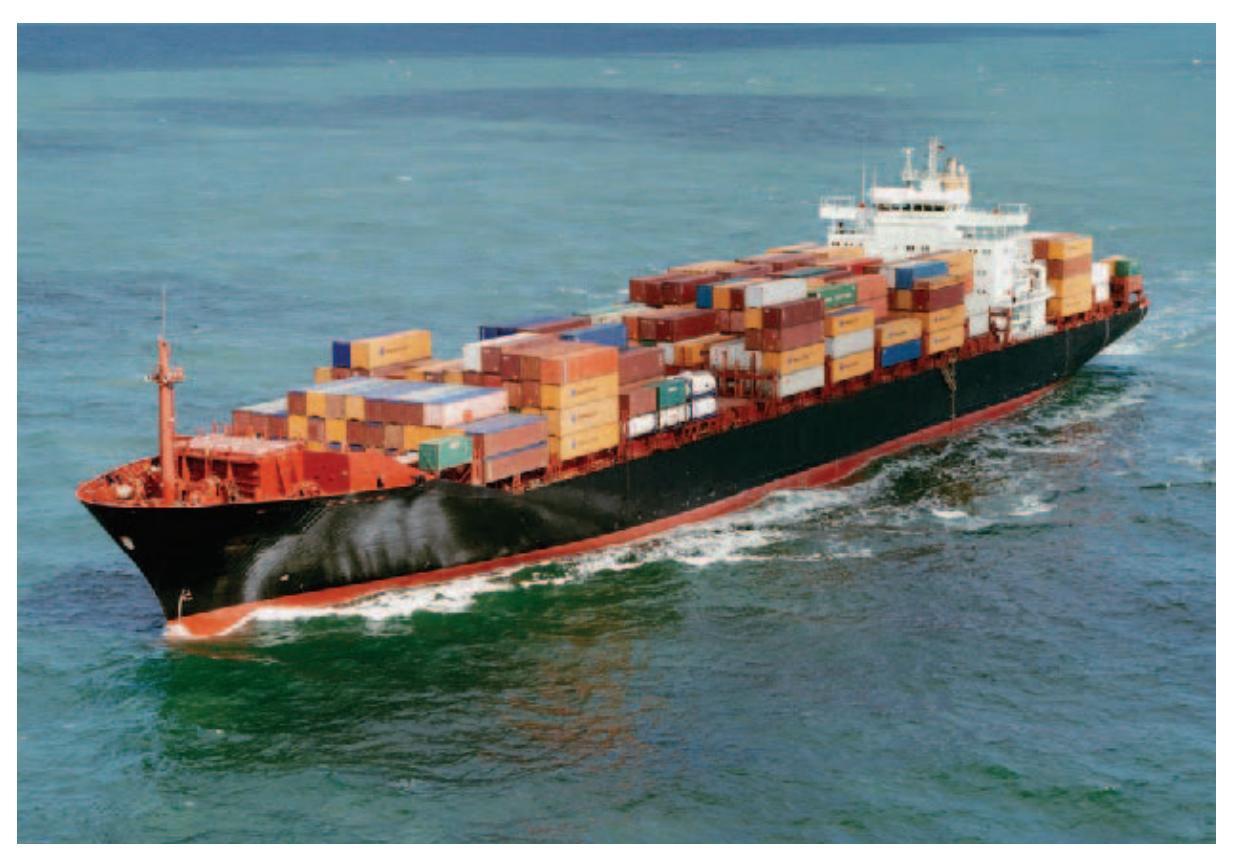
Figure 1: The vessel involved in the accident

A 235m container ship (Figure 1), fitted with a single, right-handed fixed pitch propeller was unmooring from a riverside container terminal. A pilot was embarked and two tugs were assisting: a 53 tonne bollard pull Voith Schneider tug was made fast on the centre lead forward and a 66 tonne bollard pull ASD tug was secured on the centre lead aft. The aft tug was slower to secure than usual as her secondary towing gear was being used due to her primary gear being defective.

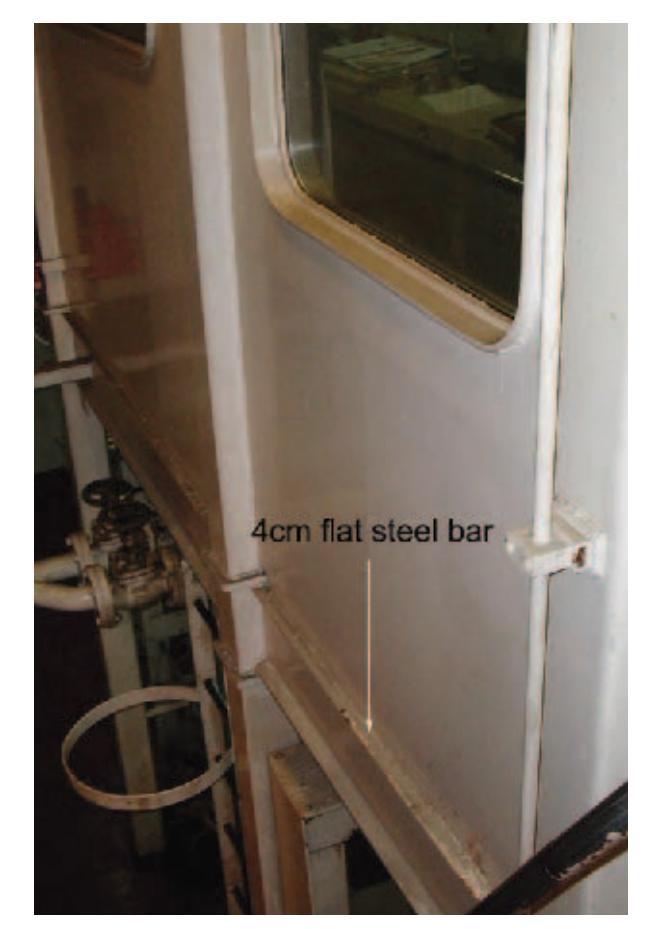
A dredger was on her routine passage to the dredging grounds. There was a chop to the sea and the wind was about force 5 as the third engineer went to the engine control room to take the 0400-1200 engine room watch on his own. He was a little annoyed at the smears on the control room windows which gave visibility into the engine room (Figure 1).

Figure 1: Door to the control room

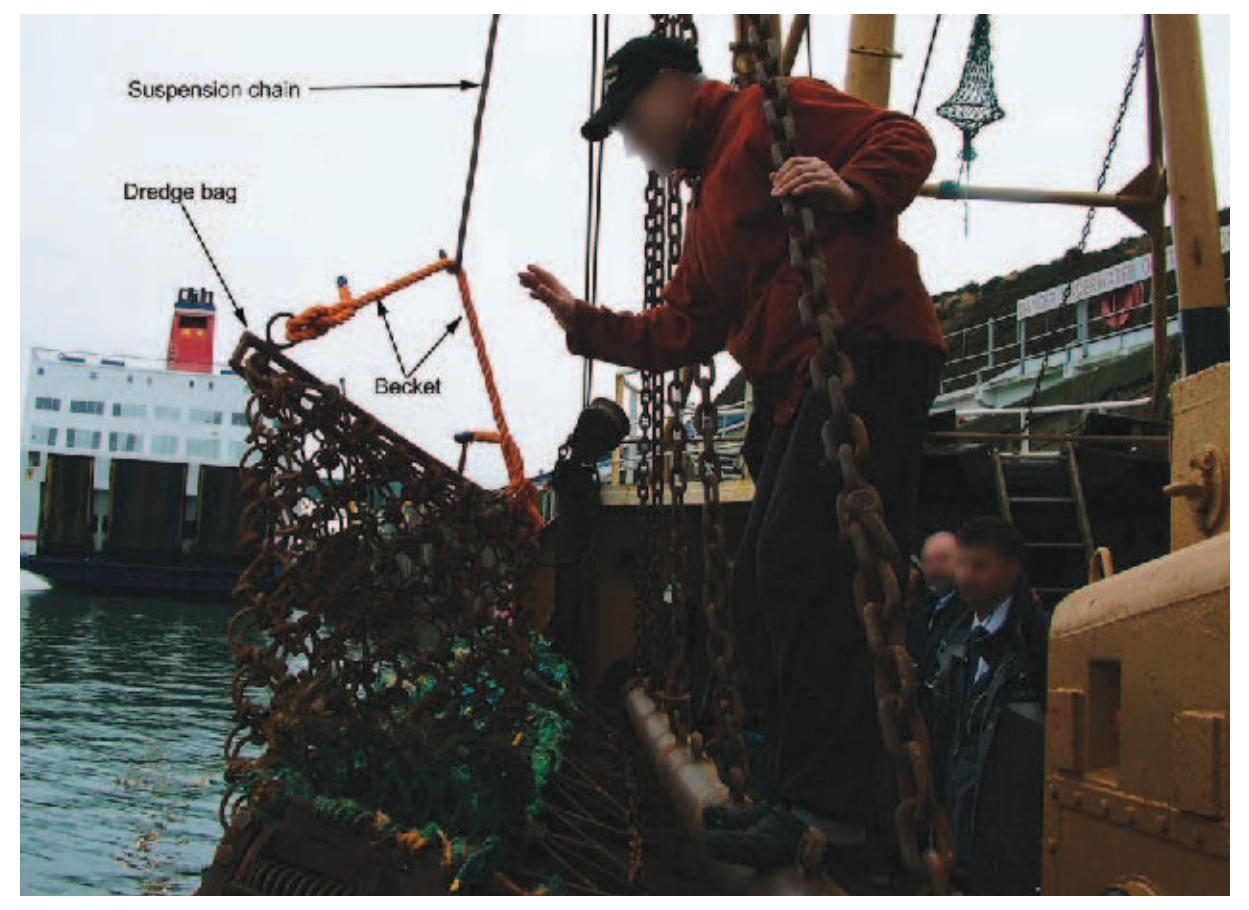
The deckhand was a seasoned fisherman but was new to scallop dredging and had worked on board for only 5 weeks. He had signed the Seafish Fishing Vessel Safety Folder to confirm that he had received a safety induction from the skipper, which included maintaining a secure hold of a suspension chain while attending to the dredge bags. However, he had not attended a safety awareness course and the risk assessment form neither identified any significant risk nor recorded any control measures against falling overboard. The deckhand was not wearing a personal flotation device or a safety harness when he stepped onto the elevated dredge beam, and it was not the practice for deckhands to do so. On this occasion, he let go of the suspension chain (Figure 1) to facilitate the emptying of one of the dredge bags. As he grasped the dredge bag with both hands, the lifting becket parted, causing him to fall forward and, with no protection from the bulwark, to continue to fall overboard.

A demonstration of where the crewman was standing immediately prior to the accident

- 1. The lifting becket parted at a point of attachment to the dredge bag which was prone to wear. A robust inspection and maintenance regime for the working gear might have identified the wear and have prevented the failure. Ensure you have a regime that does so.

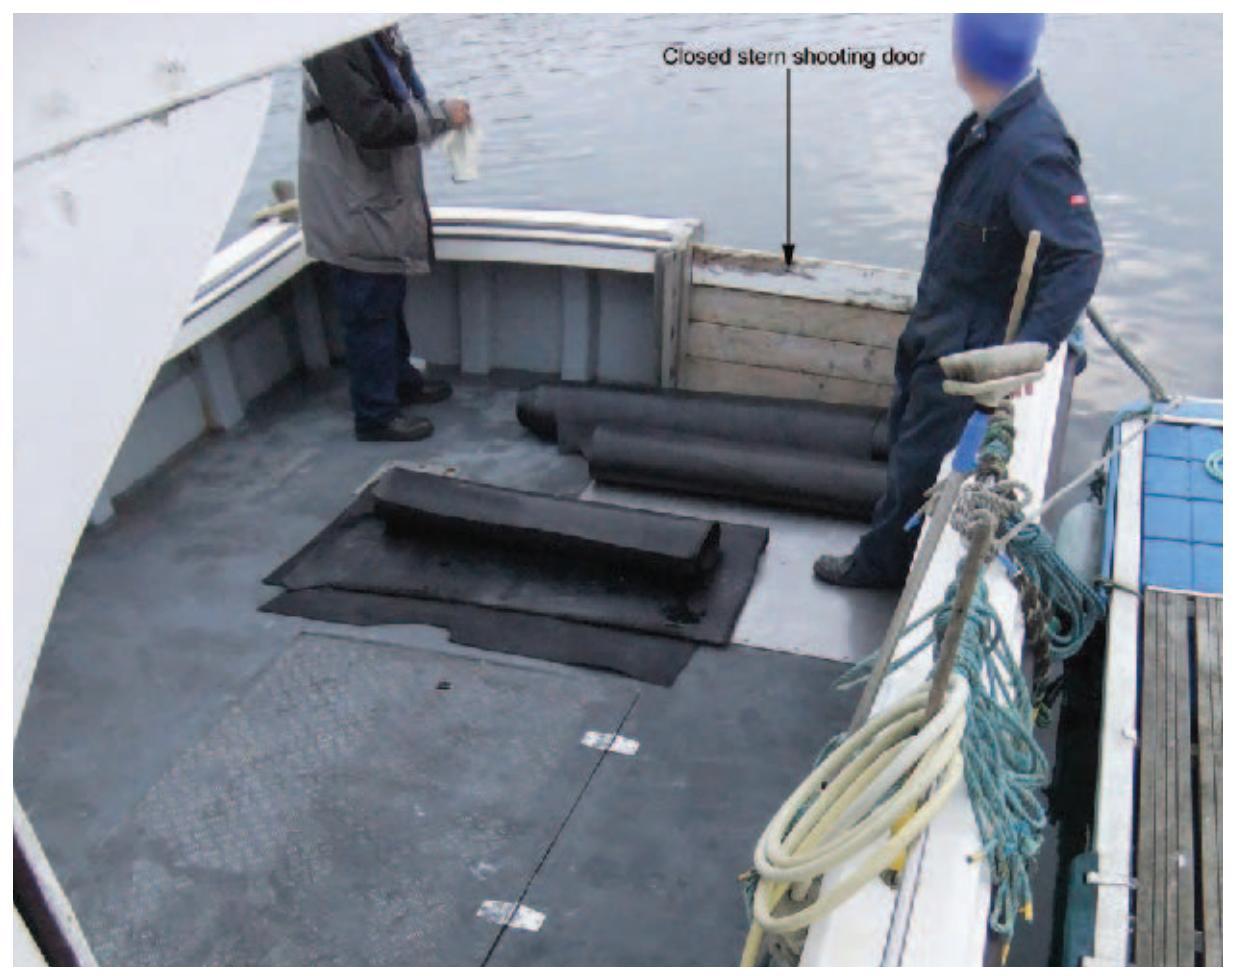
The potter was fitted with a stern shooting door that enabled a single set of pots to be shot over the stern with the crew safe in the wheelhouse. When more than one set was carried, such as when moving gear, the stern door was closed and the more traditional, and riskier, method of lifting the pots overboard was employed. As one of the last pots was being lifted overboard, the crewman in the wheelhouse heard the owner shout; he turned round and saw the owner standing at the stern, with the backrope caught around his leg. The owner did not have a knife to hand and the crewman threw the engine control full astern. Unfortunately, the weight on the backline was too great and the owner was pulled overboard.

Figure 1: Stern view of potter

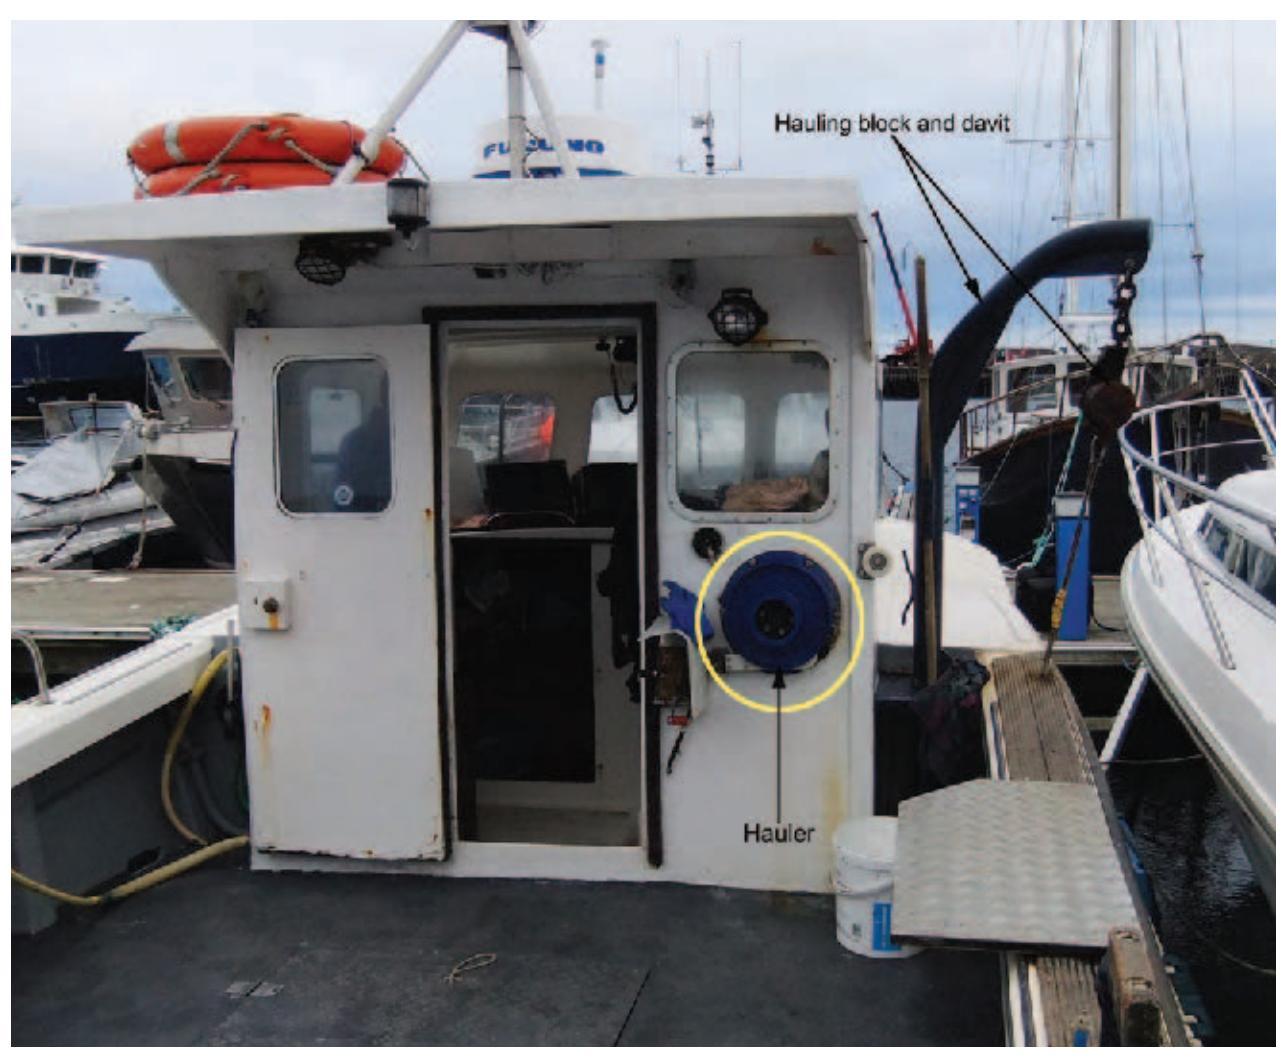
Figure 2: Forward view of potter

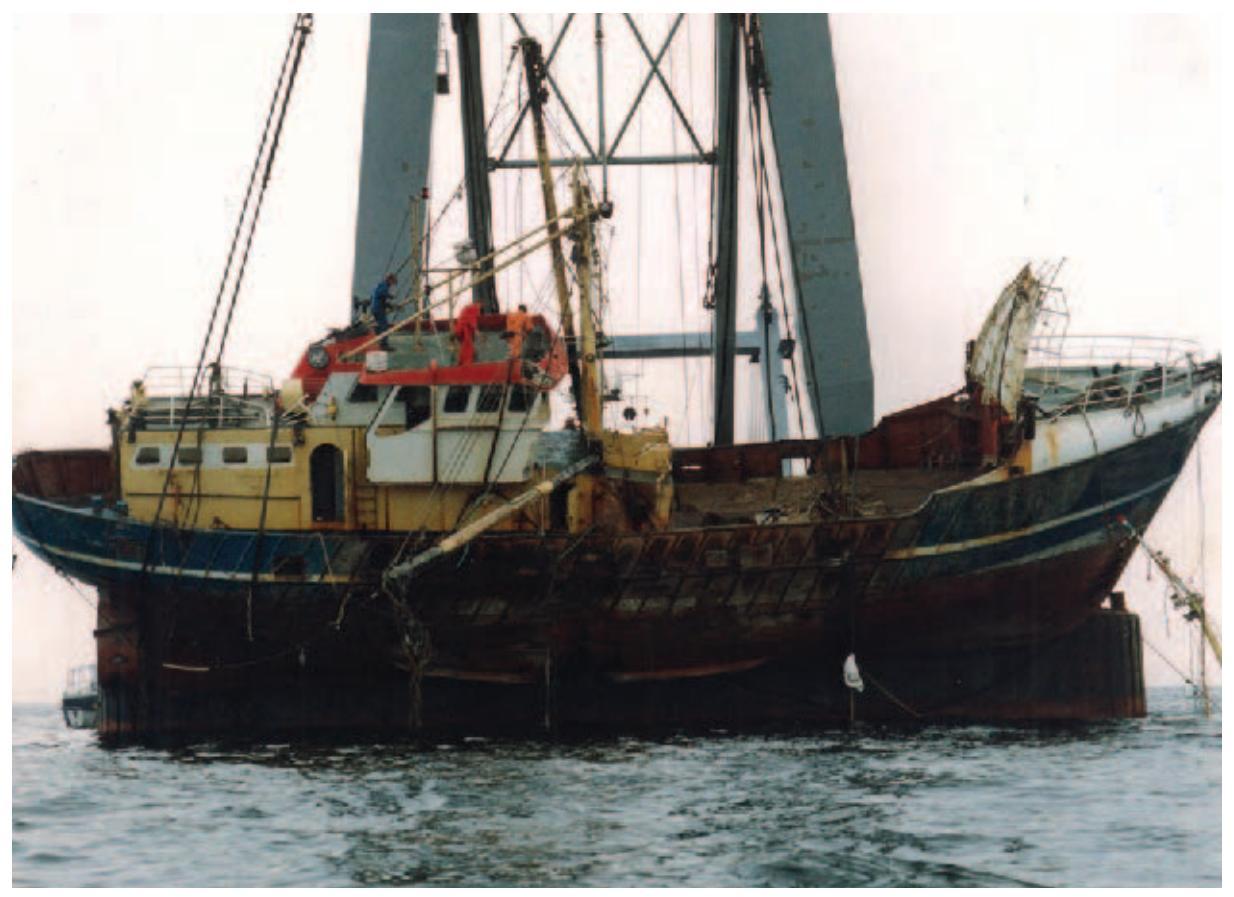
Although the trawler had both of her radars in operation (one on 6-miles range and the other on 12-miles range), her skipper was focused on other radar echoes in the vicinity and did not detect the gill netter until she appeared out of the fog on his starboard bow. By that time, the vessel was so close that the skipper decided to apply full astern propulsion rather than attempt to alter course.

The action taken by both skippers was insufficient to prevent the vessels colliding. The gill netter sustained significant damage and had to be escorted back to her home port.

This beam trawler sank affer a collision in dense fog - all of the trawler's crew were lost

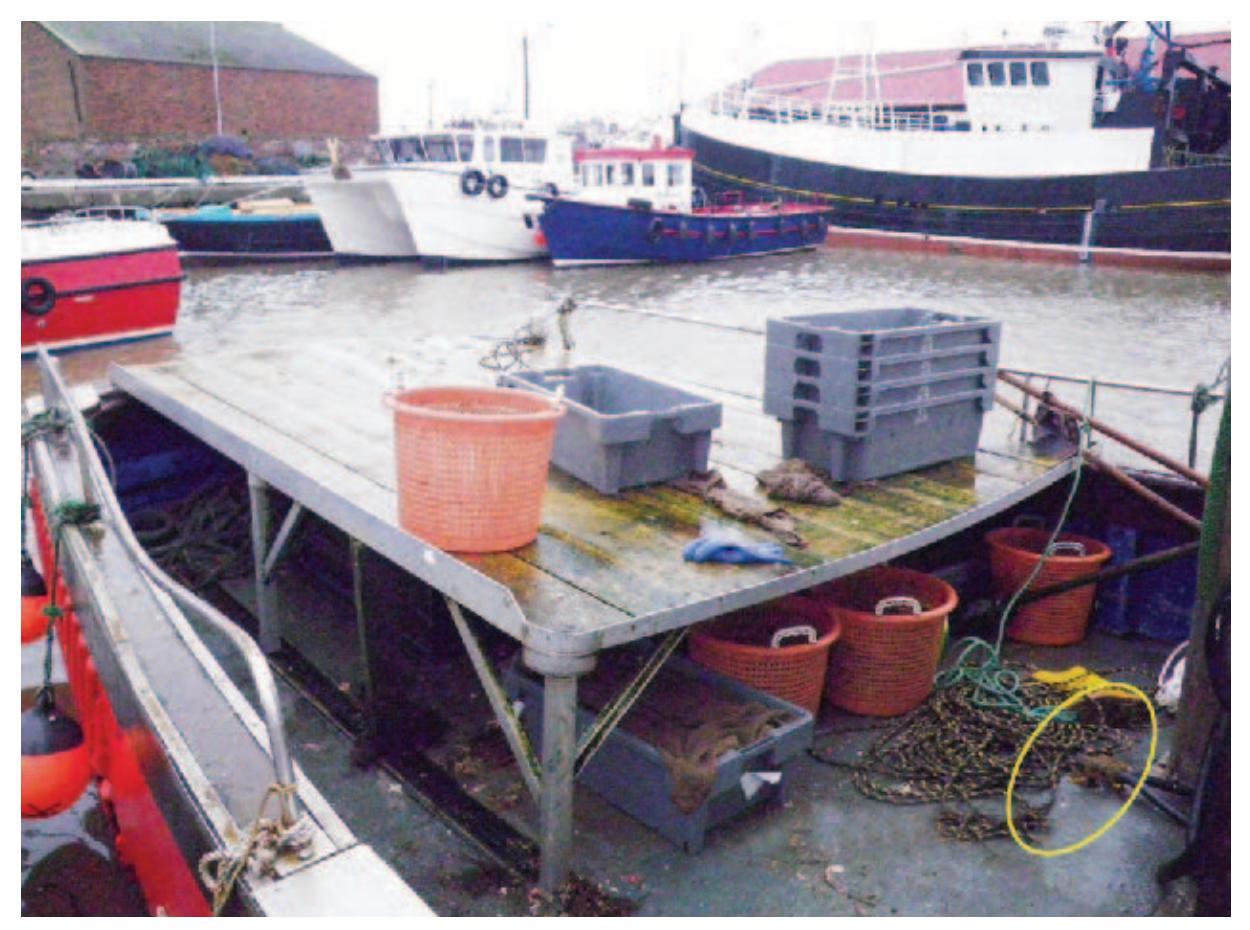
Figure 1: The position of where the crewman was standing before he was dragged overboard

- The accident happened during a normal creel shooting operation which, despite having been carried out routinely for several years, had not been properly evaluated to make the operation as safe as possible. The shooting operation required the casualty to work in close proximity to unguarded ropes strewn on deck. A simple dividing barrier separating crew from ropes could have prevented this entanglement and should be considered on all static gear vessels.
- 2. Had the casualty been able to free his leg from the rope, a flotation device might have assisted him to the surface and therefore increased his chances of survival.
- Never give up on apparently lifeless casualties unless advised to do so by medical experts. Seemingly deceased hypothermic and drowned casualties have been known to be resuscitated, despite them showing no visible signs of life for a prolonged period.

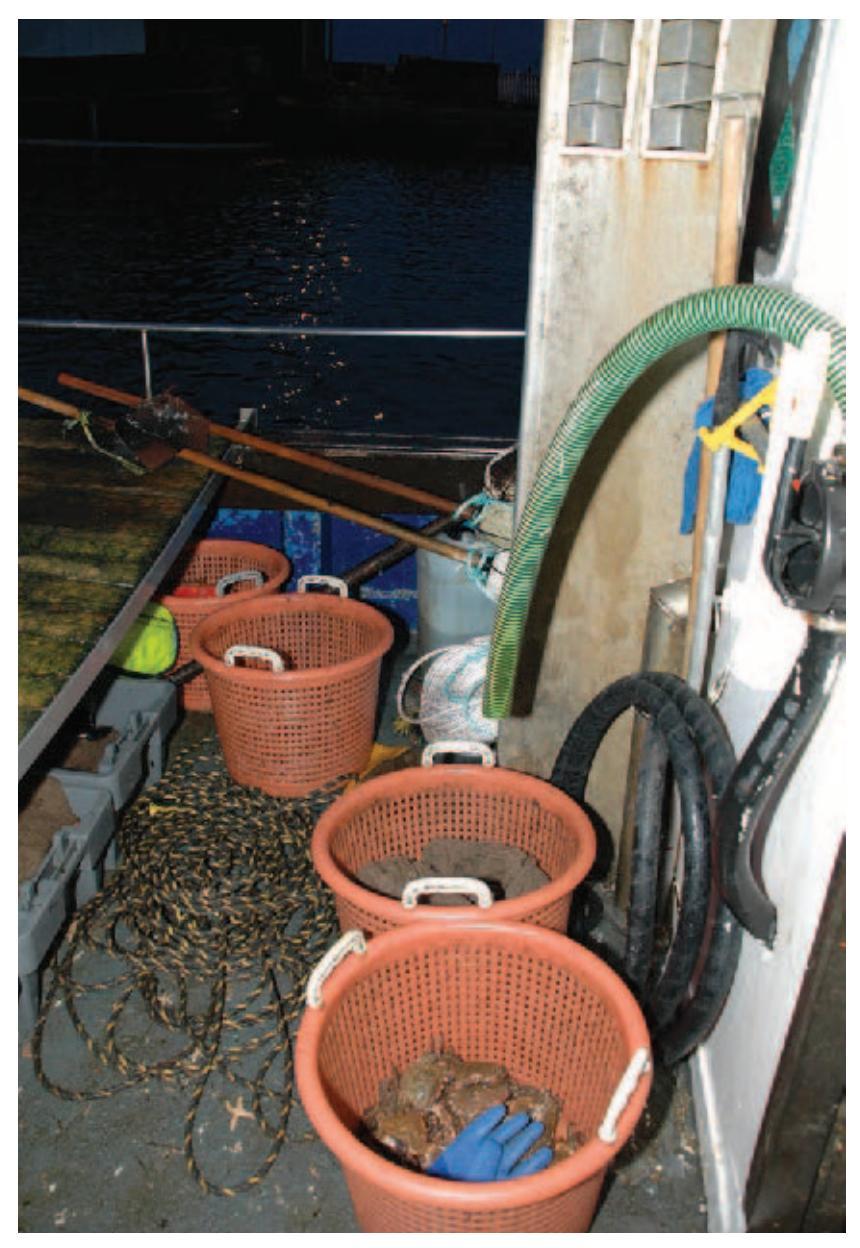
Figure 2: Onboard working area

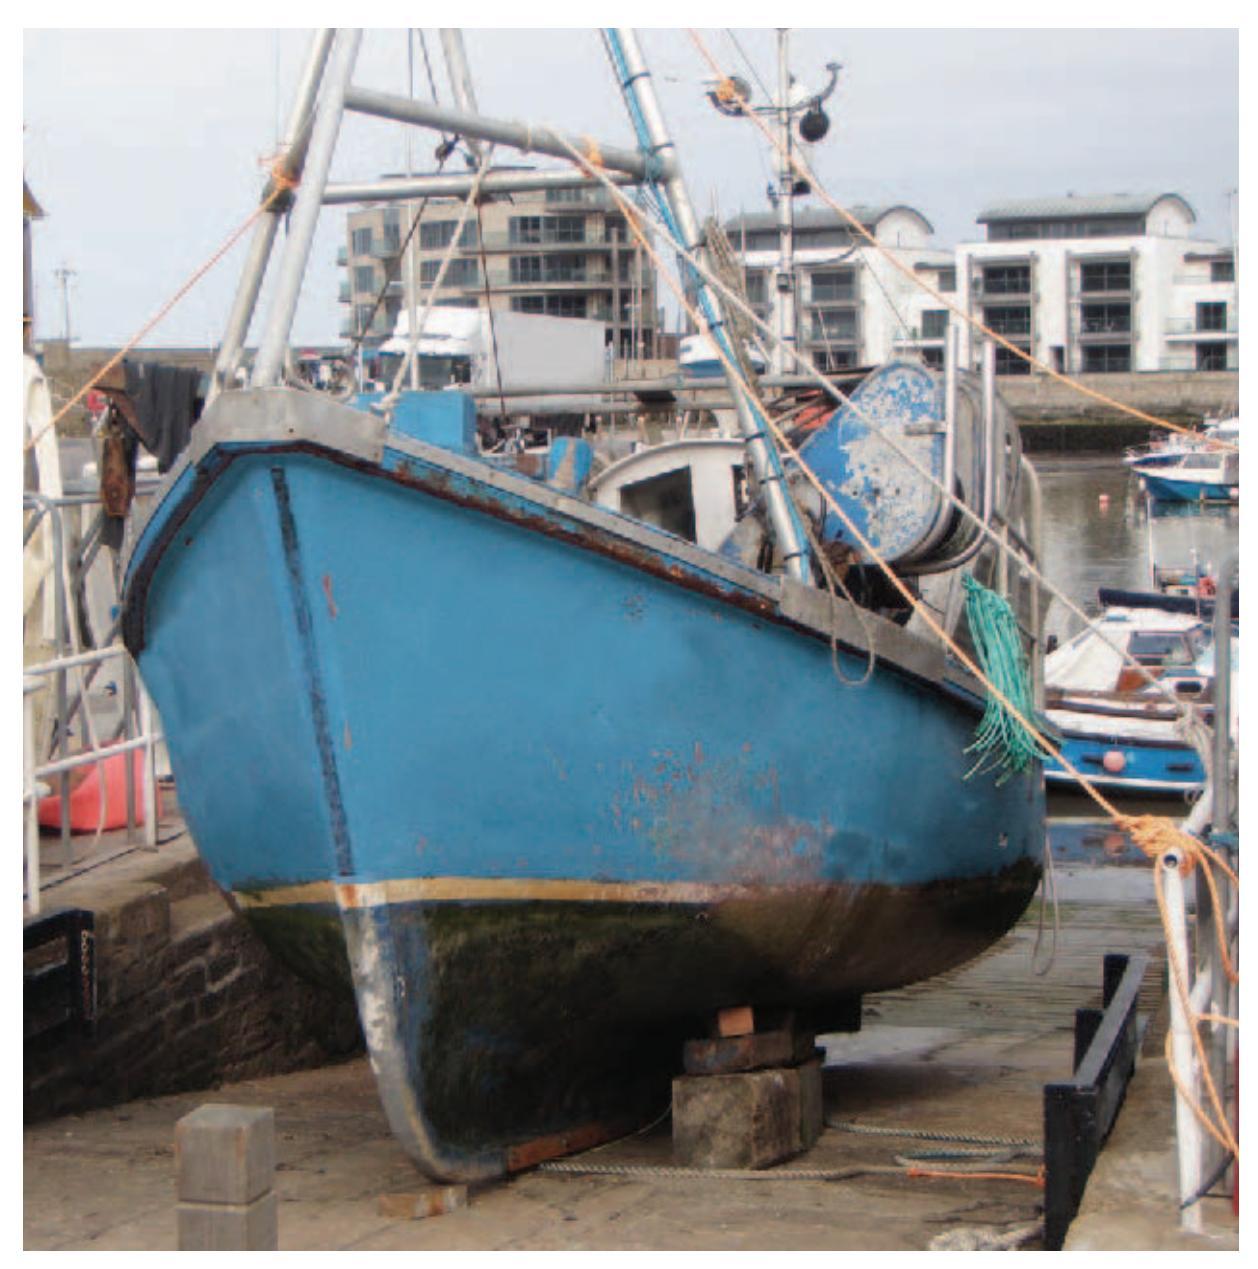
Vessel on slipway after recovery

without lifejackets and without having
 the time to transmit a "Mayday". Once
 again, the importance of wearing lifejackets
 when working on deck is clearly
 demonstrated.
- 3. Music playing via a loudspeaker meant that the crew were unable to monitor audible alarms or their VHF radio while they were on deck. This was not a safe way of operating the vessel, and it is notable that, later, when installing a new engine and rewiring the boat, the owner ensured that the *bilge alarm* and not the *music channel* was connected to the deck loudspeaker.

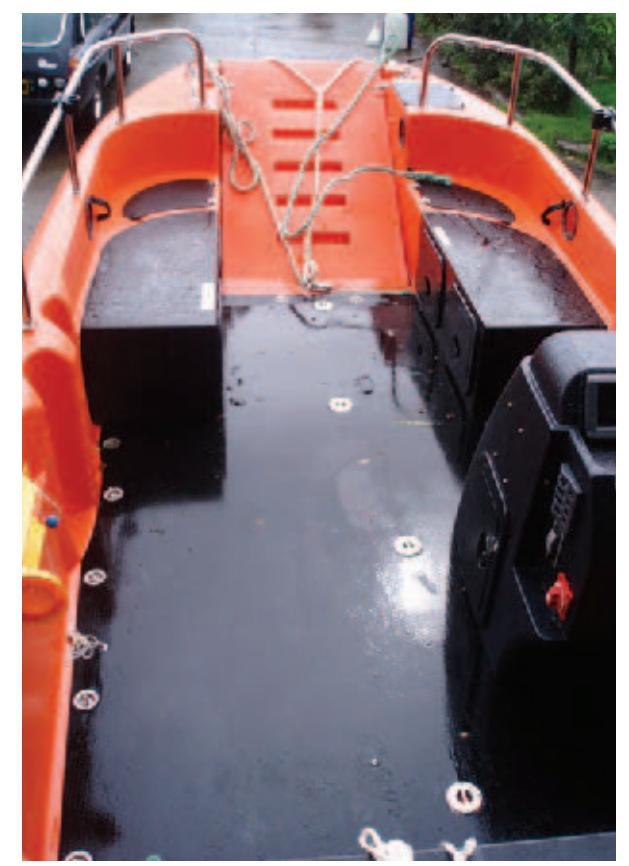
Figure 1: Deck layout post-incident

they were very well equipped with lifesaving equipment, VHF radios and bilge pumps. The owner was particularly happy with the boats' stability which, together with the bow ramp access, made them suitable for hirers with disabilities (Figure 1).
