# SAFETY DIGEST

**Lessons from Marine  
Accident Reports  
2/2011**

**SAFETY DIGEST**  
**Lessons from Marine Accidents**  
**No 2/2011**

October 2011

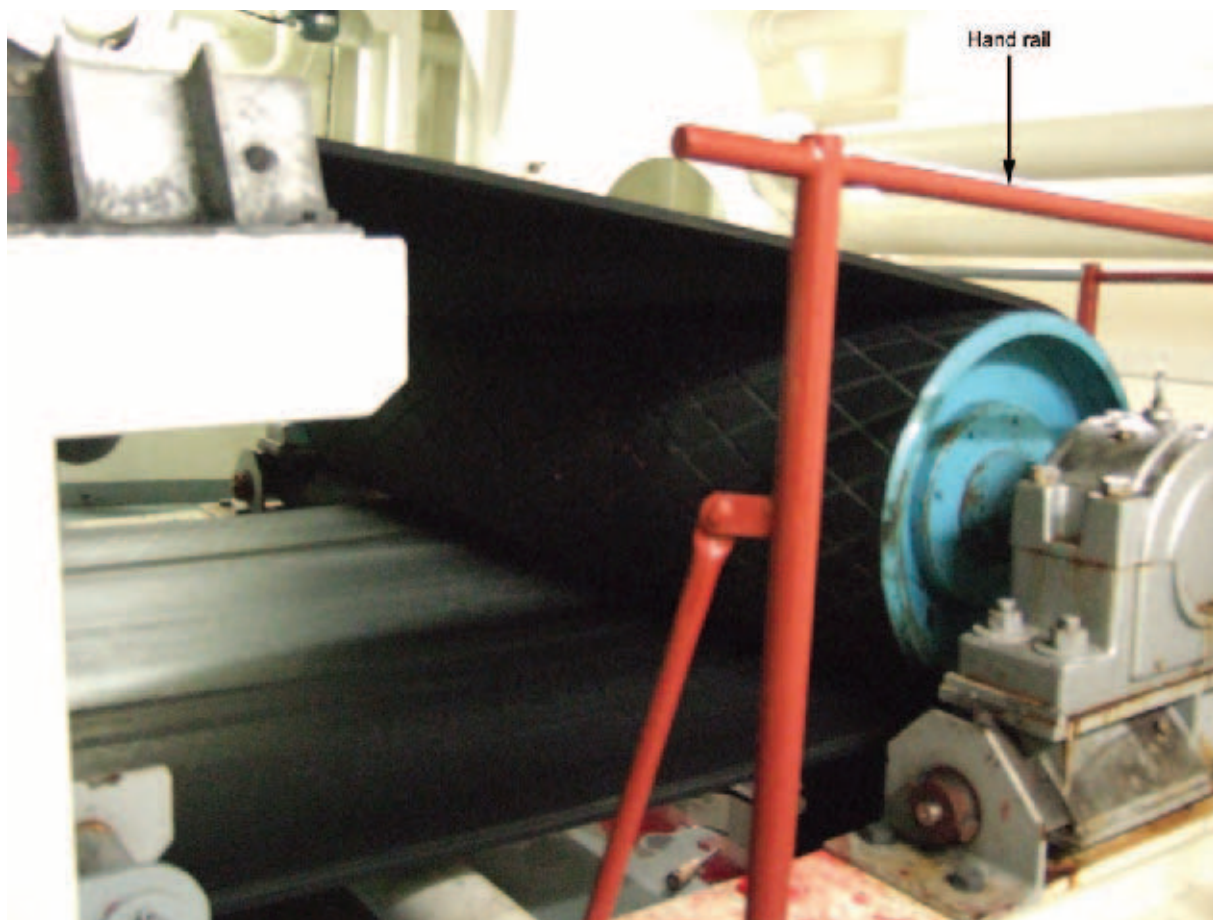
About 45 minutes later, the chief officer went down to the tunnels to carry out routine rounds of the self-discharging system. When he reached the after end of the port side conveyor belt, he found the wiper's body between the conveyor belt roller and a supporting beam. The chief officer activated the emergency conveyor belt stop system and called for help.

The wiper had not been required to carry out any maintenance work on watch and no mechanical faults were found in the self-discharging machinery.

The reason for the wiper becoming caught in the system is unknown. There were no witnesses.

The conveyor belt system

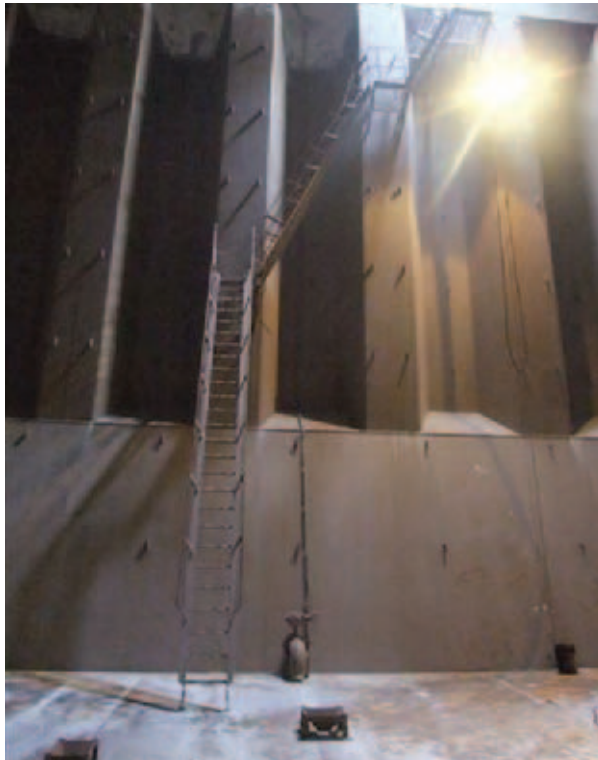
his colleague had fallen. The casualty was found at the bottom of the tank directly in line with the top resting platform and vertical ladder to the main deck. He was removed from the tank by the local emergency services. They declined the use of the ship's own casualty recovery equipment because of its unsuitability.

Figure 1: Cargo hold

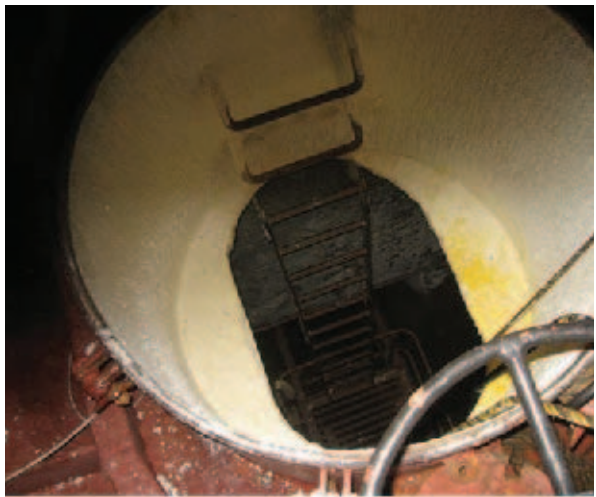
The post mortem toxicology report identified that the casualty's blood contained a cocktail of prescription and illegal drugs, which would have caused severe impairment. All the evidence suggests that he fell from the vertical ladder (Figure 2) and passed over the top resting platform's upper guardrail. His heavily cargo-contaminated gloves (Figure 3) could easily have caused him to lose his hand grip on the slippery surface of the ladder rungs. This was further exacerbated by his impaired physical condition.

Figure 2: An aerial view of the vertical ladder

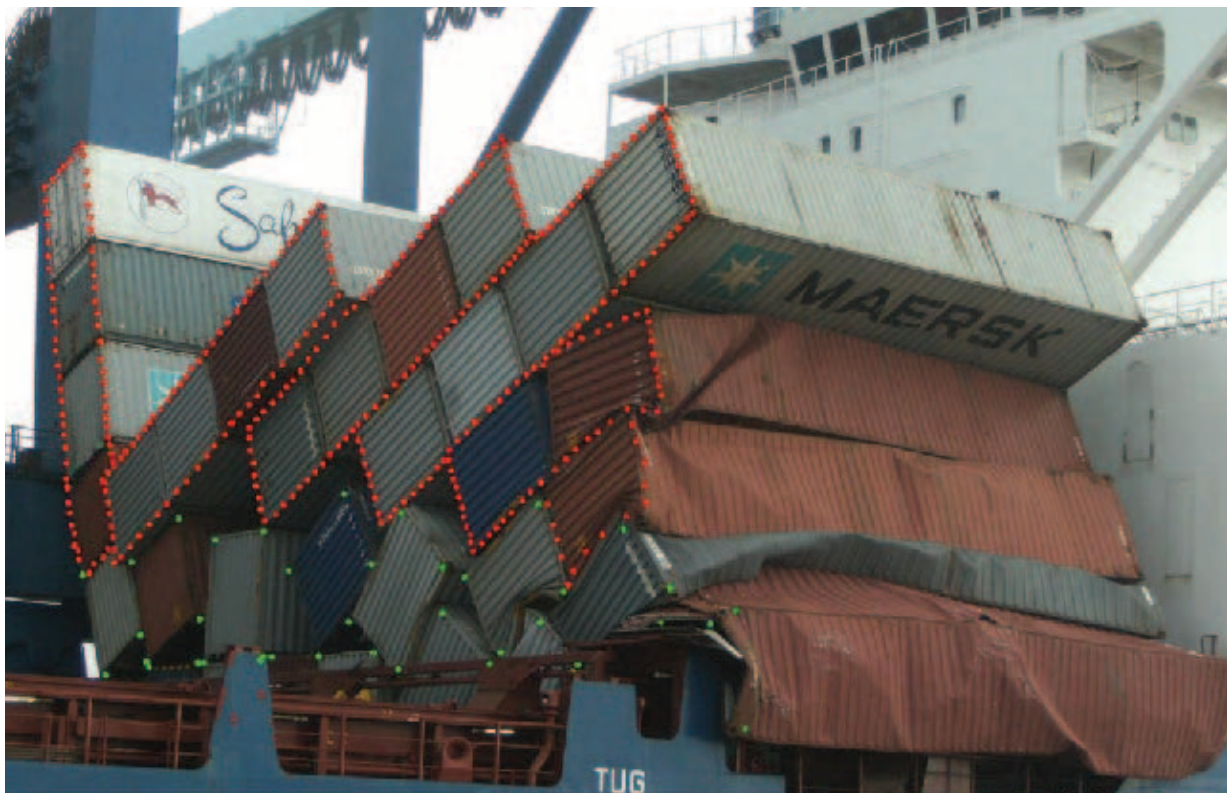
It was later found that the top containers in seven out of nine stacks, which had been declared as empty on the loading plan, each contained cargo of up to 30 tonnes weight. With the top four containers in each stack still connected by twist locks, these single units were very top heavy and liable to topple easily when exposed to a suitable trigger.

Container twist locks

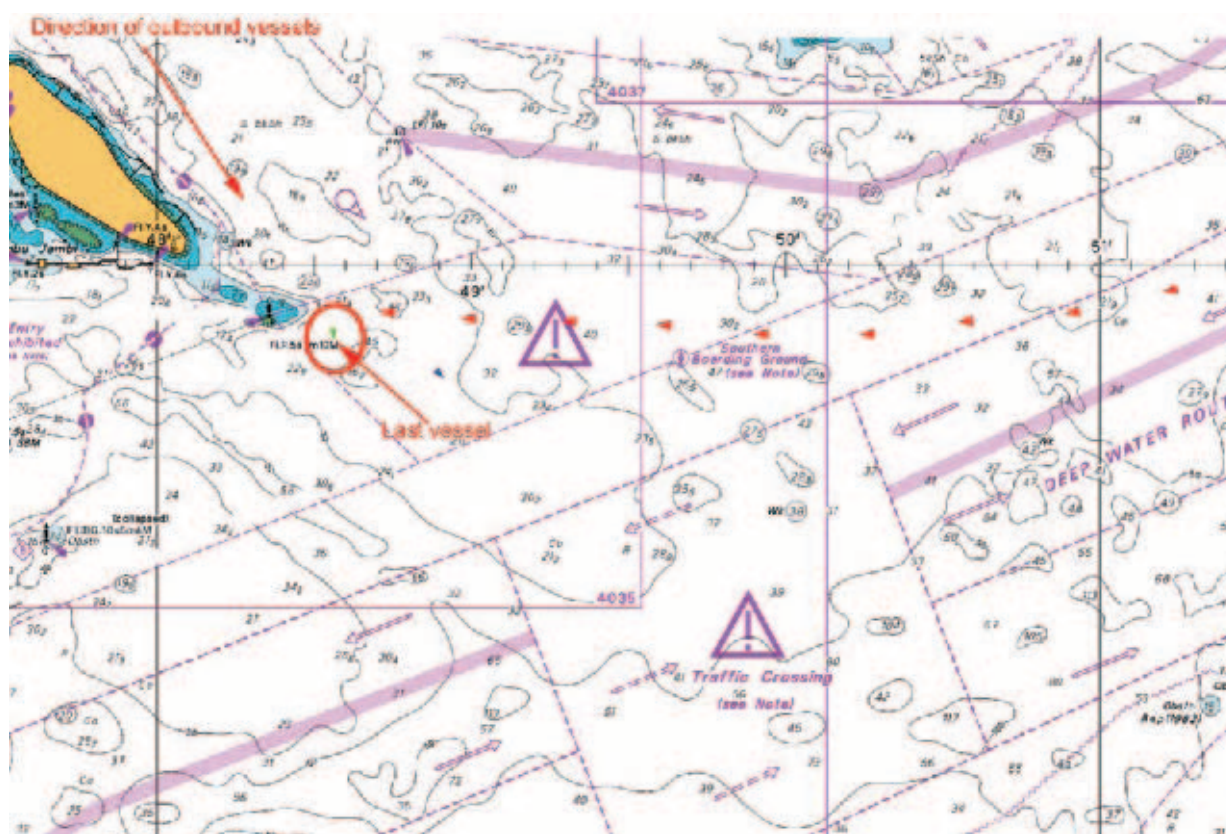
On clearing what the master thought to be the first of the three vessels referred to, he was contacted by VTS, who advised him again to slow down. He acknowledged by confirming that he had reduced speed and planned to pass around the stern of the next two vessels.

VTS, however, responded by informing him that the second of the two vessels, which was now almost right ahead, was not outbound. This was acknowledged by the OOW and,

Figure 1: AIS plot of vessel

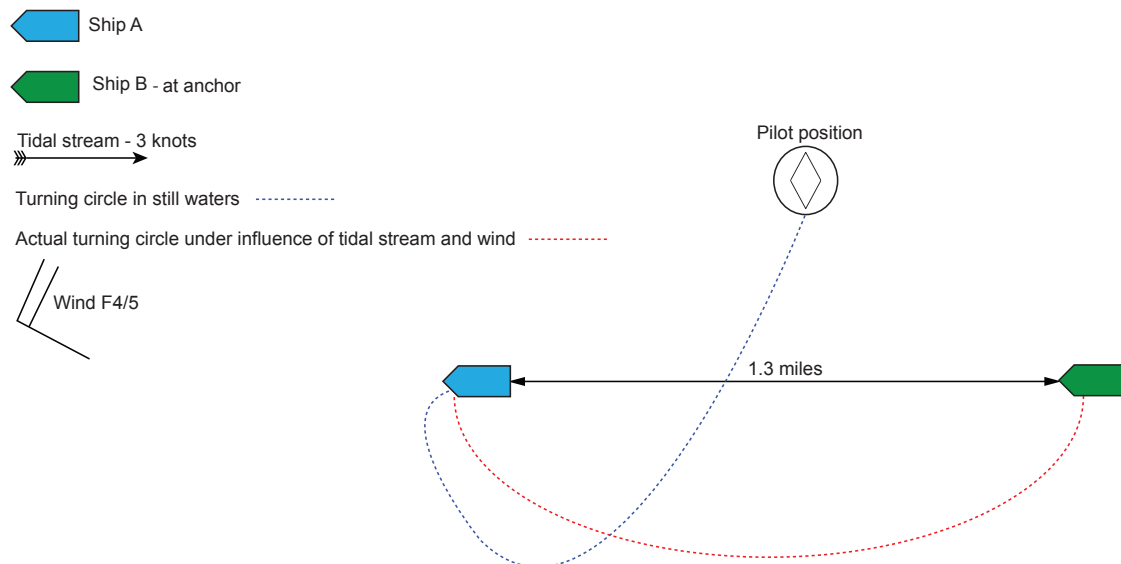
The bridge team began to discuss the current, and over the next 7 minutes the master gradually increased his vessel's engine speed through slow ahead, half ahead and full ahead to the maximum available. However, the master's efforts were too late, and the bulk carrier collided with the anchored vessel, causing structural damage above the waterline to both vessels and the anchored vessel to part its cable just below the hawse pipe. Both vessels assessed damage, ensured the safety of their crew and checked that there was no risk of pollution before safely re-anchoring. Guidance for this on board the vessel that was manoeuvring was not easily accessible in the SMS, and the master did not refer to it.

Plan showing intended and actual track of ship A

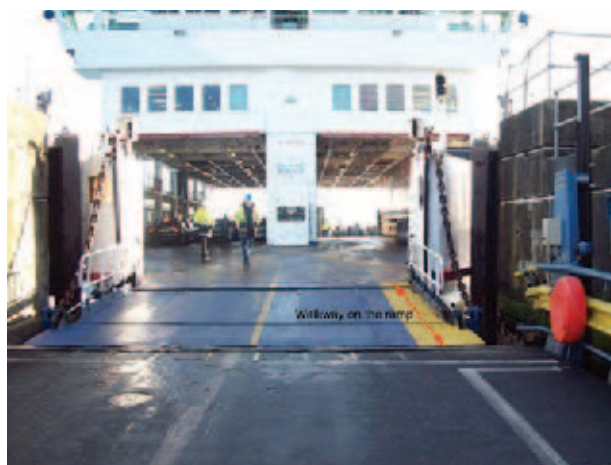
Figure 1: The walkway onto the vessel

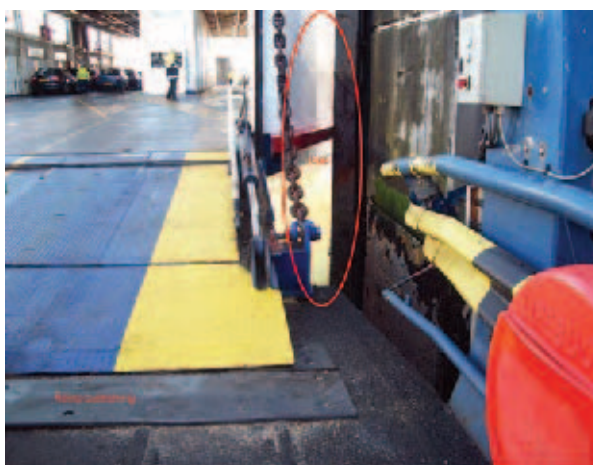
As she made her way towards the ferry ramp she kept her head down against the driving rain. Unfortunately, instead of moving towards the yellow painted footpath on the ramp, the lady veered off towards the right. She believes she might have tripped on the linkspan rubber cushioning before stumbling between the ramp and the linkspan wall (Figure 2) and then falling into the cold water.

The position where the passenger fell

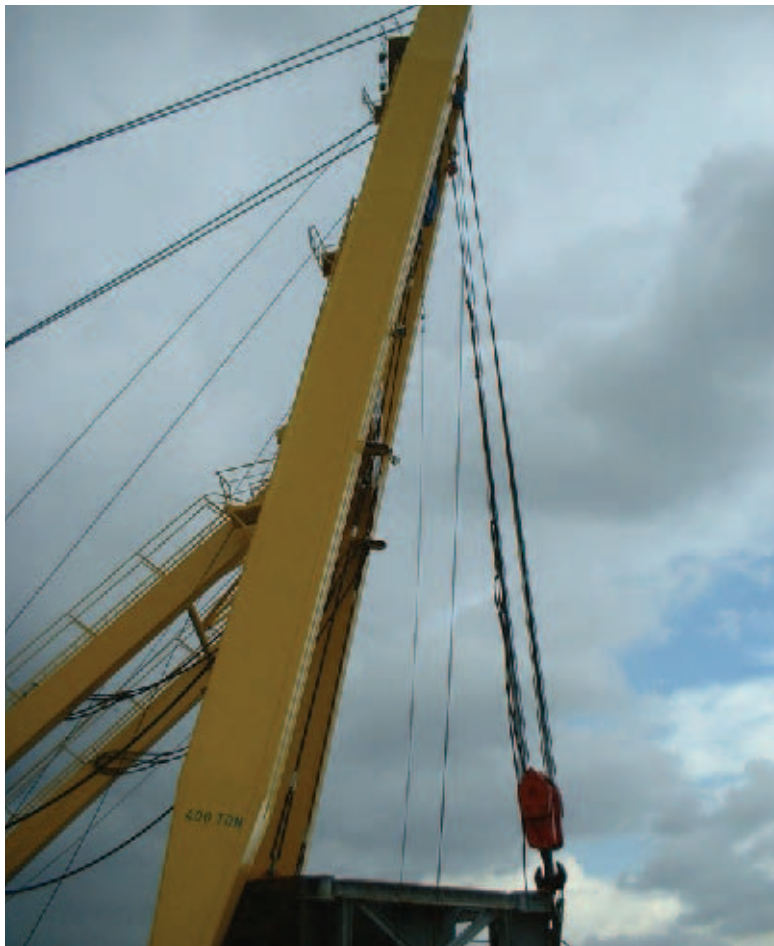
The raising of the 'A' frame was a fairly slow process, but after about 45 minutes it was upright (Figure 1). This was a critical phase of the rigging operation where the weight of the 'A' frame transferred from the heaving to the luffing winches.

At this point, the vessel's commercial agent boarded. The master stopped both sets of winches and gave the agent the information he required. The rigging operation was then resumed. However, a lack of co-ordination in the use of the hoisting and luffing winches caused the crane's deck pad eye fittings (Figure 2) to become overloaded. As a result, the deck pad eyes failed and the 80 tonne 'A' frame fell backwards onto the wheelhouse and the main deck. Although substantial damage to the deck and wheelhouse resulted (Figure 3), thankfully no one was injured.

Figure 1: The A-frame in the upright position

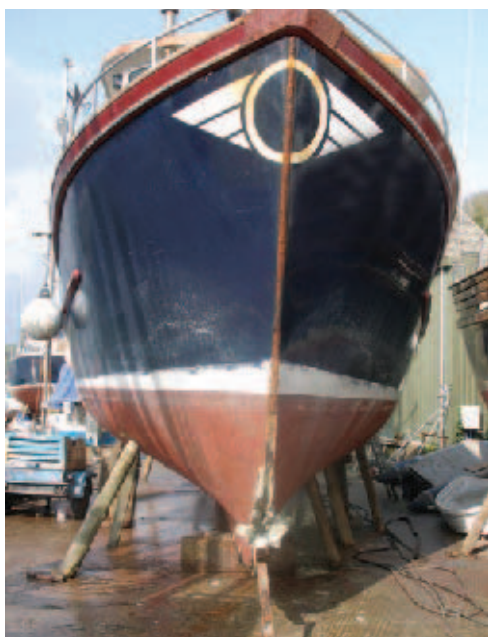
An RNLI lifeboat was dispatched to escort the trawler, and upon its arrival replaced the fire brigade's pump with a lifeboat salvage pump. This pump countered the flooding without difficulty while they lay alongside the pier. Escorted by the lifeboat, the trawler then set sail for the repair yard. As the trawler built up speed, sea was forced into the foc'sle through the hole in the damaged fore foot, requiring the salvage pump to be driven harder to cope with the water ingress. Without warning, the trawler's engine overheated and had to be stopped to enable a blocked sea inlet to be cleared. With the vessel slowed in the water the ingress reduced again. Unfortunately the speed of the salvage pump was not reduced to match the decreased water ingress. As a result, the salvage pump quickly emptied the foc'sle space and air locked, allowing uncontrolled flooding to ensue.

The escorting lifeboat quickly lashed alongside the trawler while attempts were made to prime the disabled salvage pump. A few minutes later the pump was re-activated, enabling the water to be pumped out again. The lifeboat then towed the trawler alongside until they reached port safely, where a waiting crane hoisted the damaged trawler ashore for repair.

Figure 1: The vessel awaiting repair

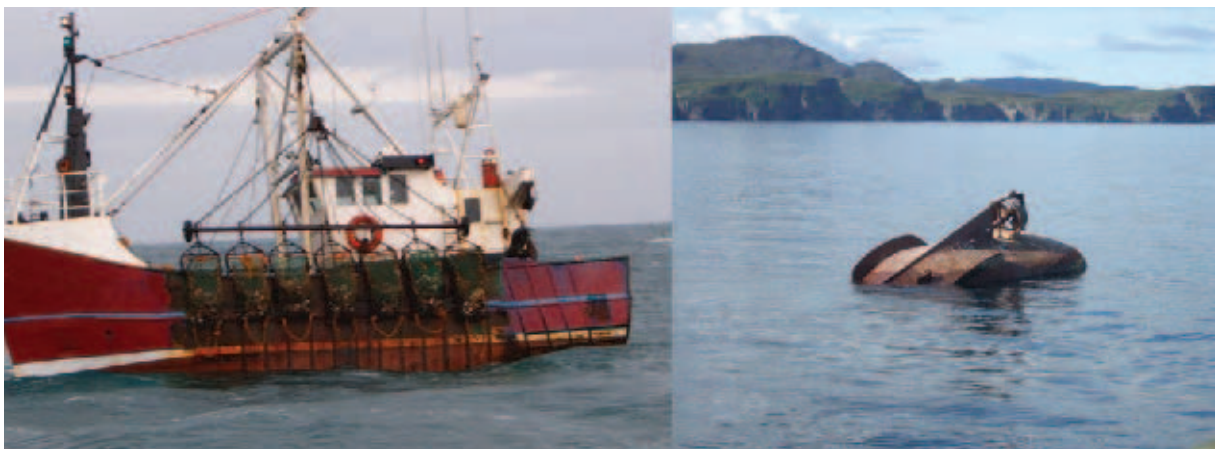
At the time of the accident the vessel had been towing her gear in following seas. When her warp became snagged, the resultant downward forces combined with the buoyant forces of the waves, proved sufficient to overcome the vessel.

The vessel had a registered length of less than 12m. At the time of her build, although not a statutory requirement, she had met the stability requirements for larger fishing vessels. When the vessel was salvaged, however, an analysis of her stability found that, due to the installation of additional ballast and fishing equipment, her operational displacement had increased by over 30% since new. Due to these modifications, the vessel would no longer have met these stability standards.

The fishing vessel before and after the accident

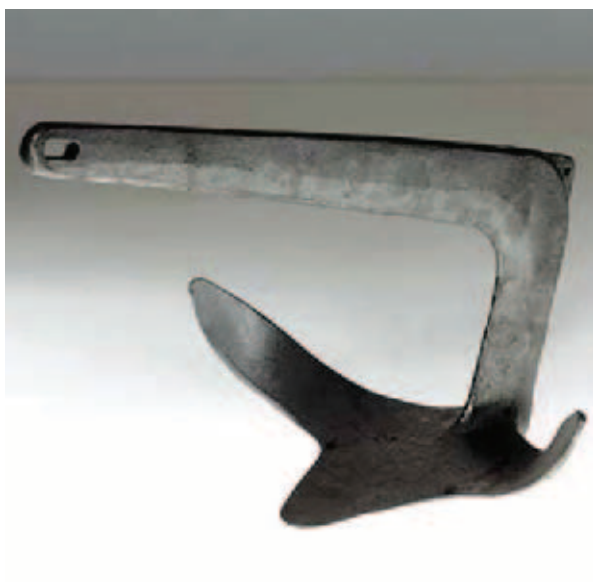
Thirty minutes later, the skipper heard the chain rumbling across the seabed and got up, to discover the vessel was almost aground. He promptly raised the rest of the crew and hauled in on the anchor chain; only the anchor shank was on the end of it. They picked up the trip buoy, and on hauling in the line found the remainder of the anchor attached.

Figure 1: "Look-alike" Bruce anchor

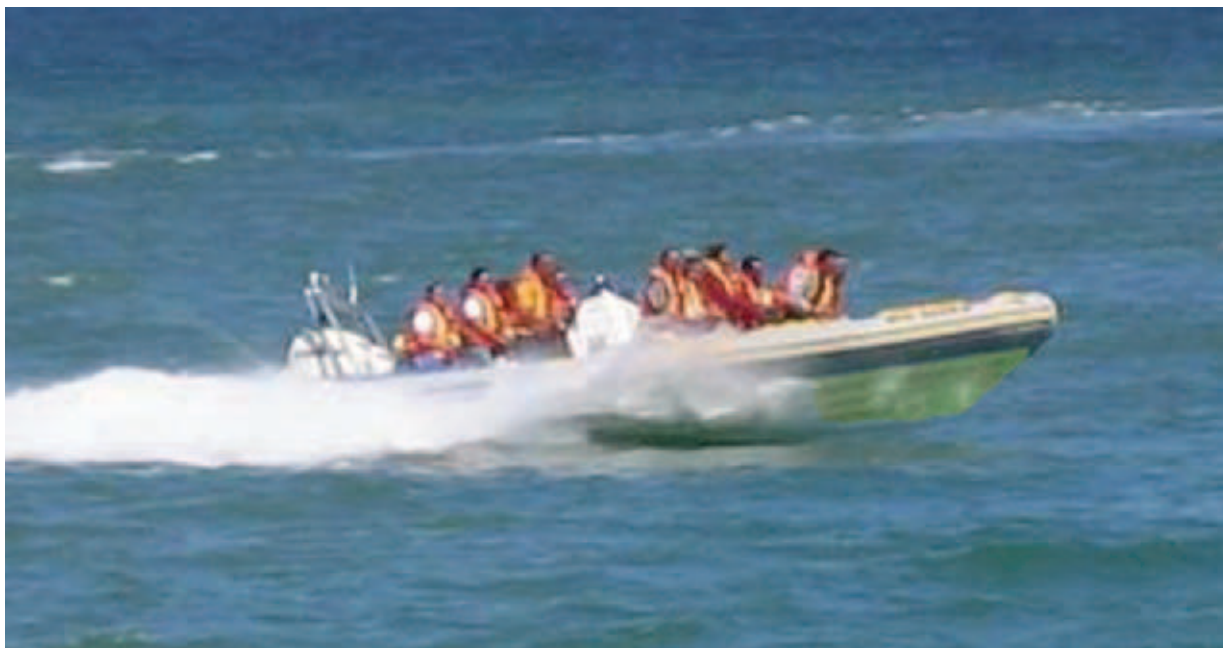
There were six passenger seats ahead of the helmsman and four behind him. The mother felt some trepidation, justifiably so as it turned out, and her family group opted to take the seats behind the helmsman because they felt more secure there (see figure).

Seating configuration

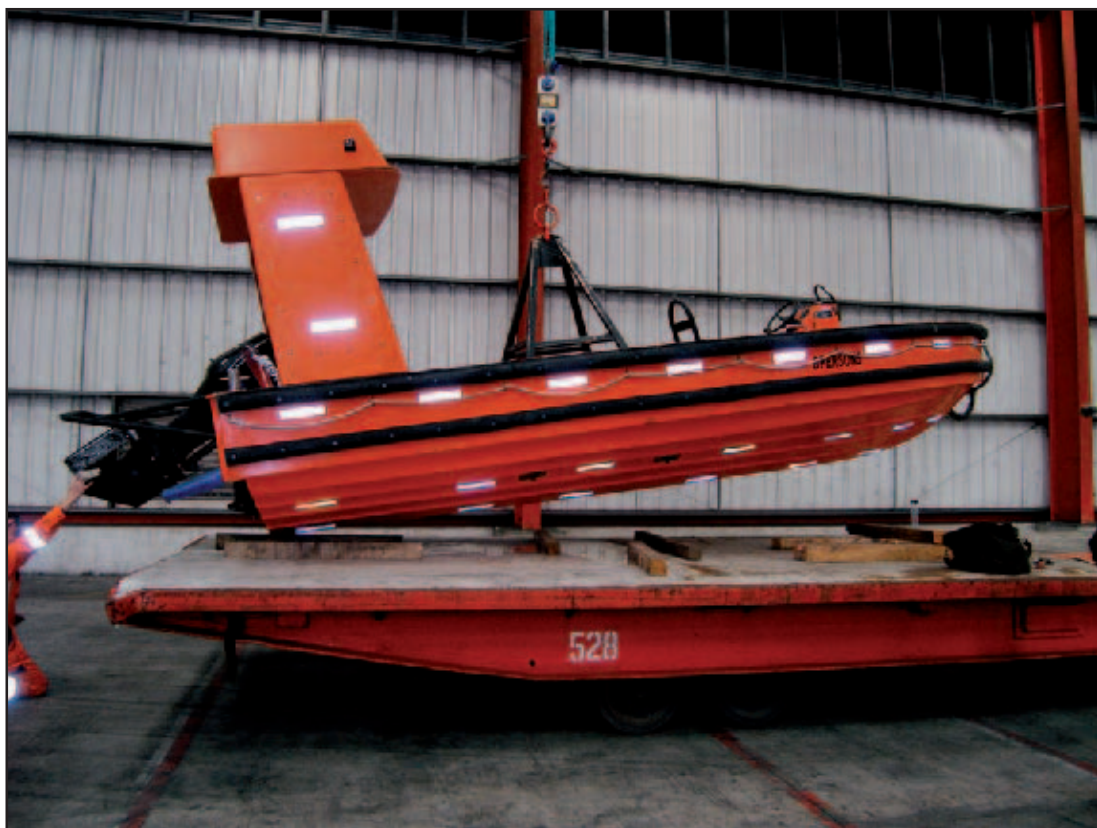
Figure 1

However, the weight of *Tombarra*'s rescue boat by itself should not have resulted in the failure of its fall wire due to the safety margins in place. Investigation into the failure of the wire remains ongoing and it is anticipated that a further safety bulletin will be published shortly.

Weighing of the rescue boat

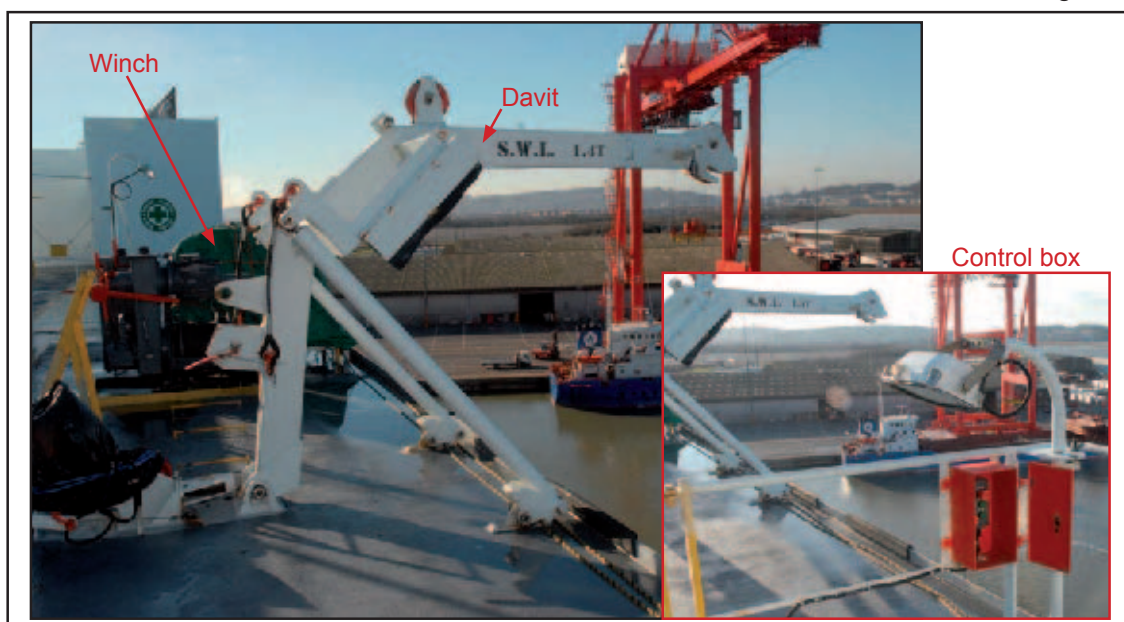
Figure 2

The 12mm diameter fall wire had a certified minimum breaking load of 141kN. Its safe working load (SWL) was 23.5kN based on a factor of safety of six. The wire was fitted to a single-arm davit (SA 1.5) (**Figure 2**), manufactured by Umoe Schat-Harding Equipment AS (Schat-Harding). The davit system was powered by a Schat-Harding W50 two-speed electric winch with a nominal pull of 50kN.

Davit system

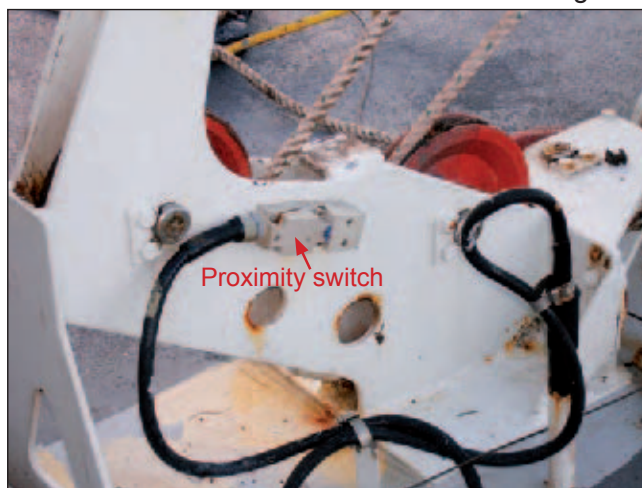
Figure 3

The winch was operated by a control panel sited forward of the davit. The boat was hoisted using the buttons on the control panel until the davit was near the stowed position. It was then intended that hoisting be completed manually by the use of a winch handle adjacent to the winch motor. To prevent the inadvertent operation of the winch when the rescue boat was in its stowed position, an inductive proximity sensor/switch (Telemecanique XS7-C40FP260) was fitted on the davit (**Figure 3**). The switch was intended to cut off power to the winch when the davit closed to within approximately 12mm of the sensor.

Proximity switch on davit
