**MARINE ACCIDENT  
INVESTIGATION BRANCH**

# **SAFETY DIGEST**

**Lessons from Marine  
Accident Reports  
1/2012**

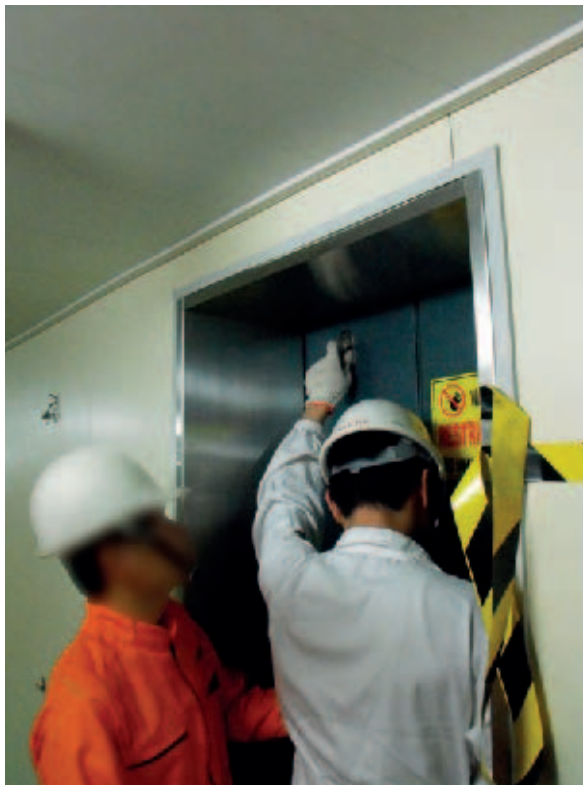
Figure 1: Lift shaft door being released

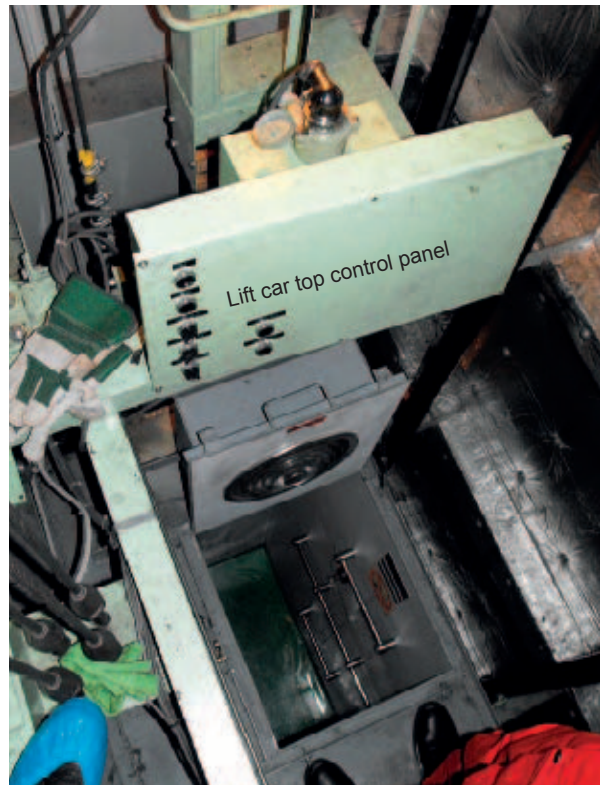
The duty engineer followed the chief engineer into the lift car and incorrectly assumed that, as the hatch was closed, the chief engineer had taken control of the lift from the controls on the lift car top (Figure 2). The duty engineer operated the spring-loaded reset for the lift car emergency stop using the reset key that was attached to the door opening key (Figure 3). The lift was now reset to its automatic operating mode.

Figure 2: Escape hatch and lift car top control panel

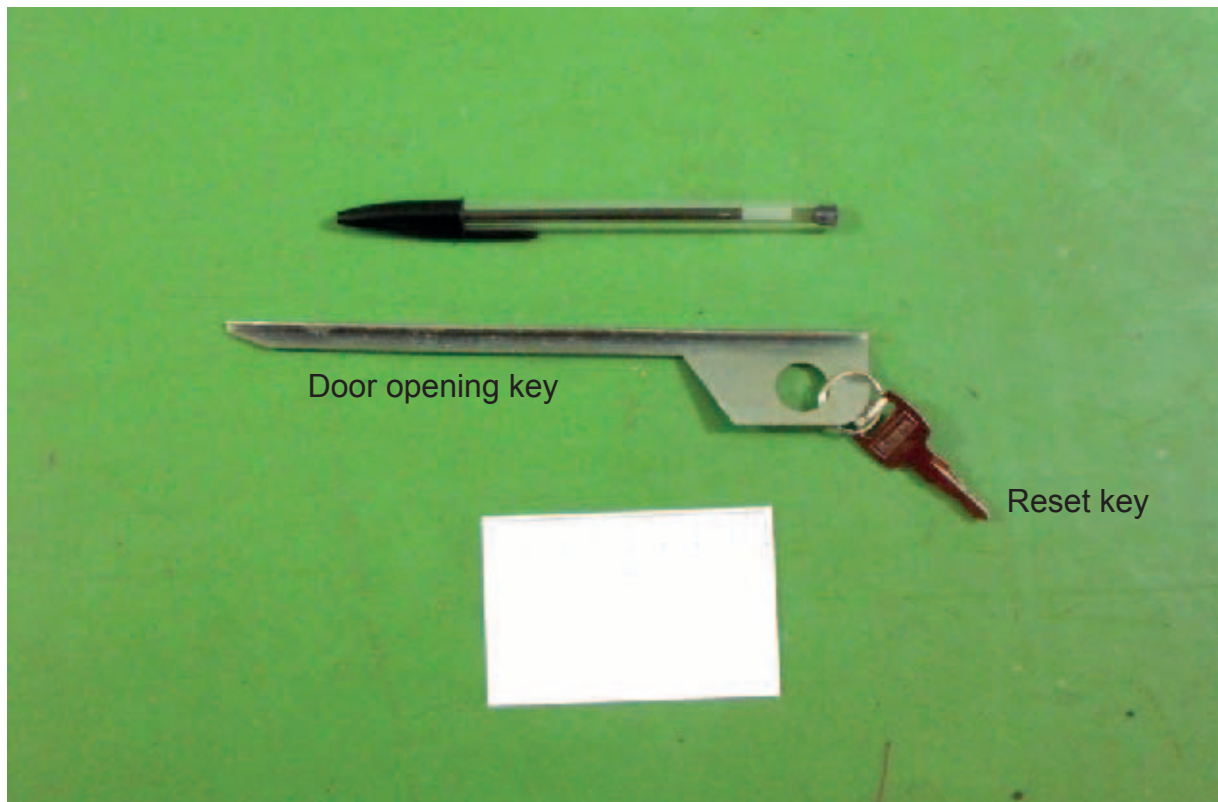
Figure 3: Lift door opening key and lift reset key

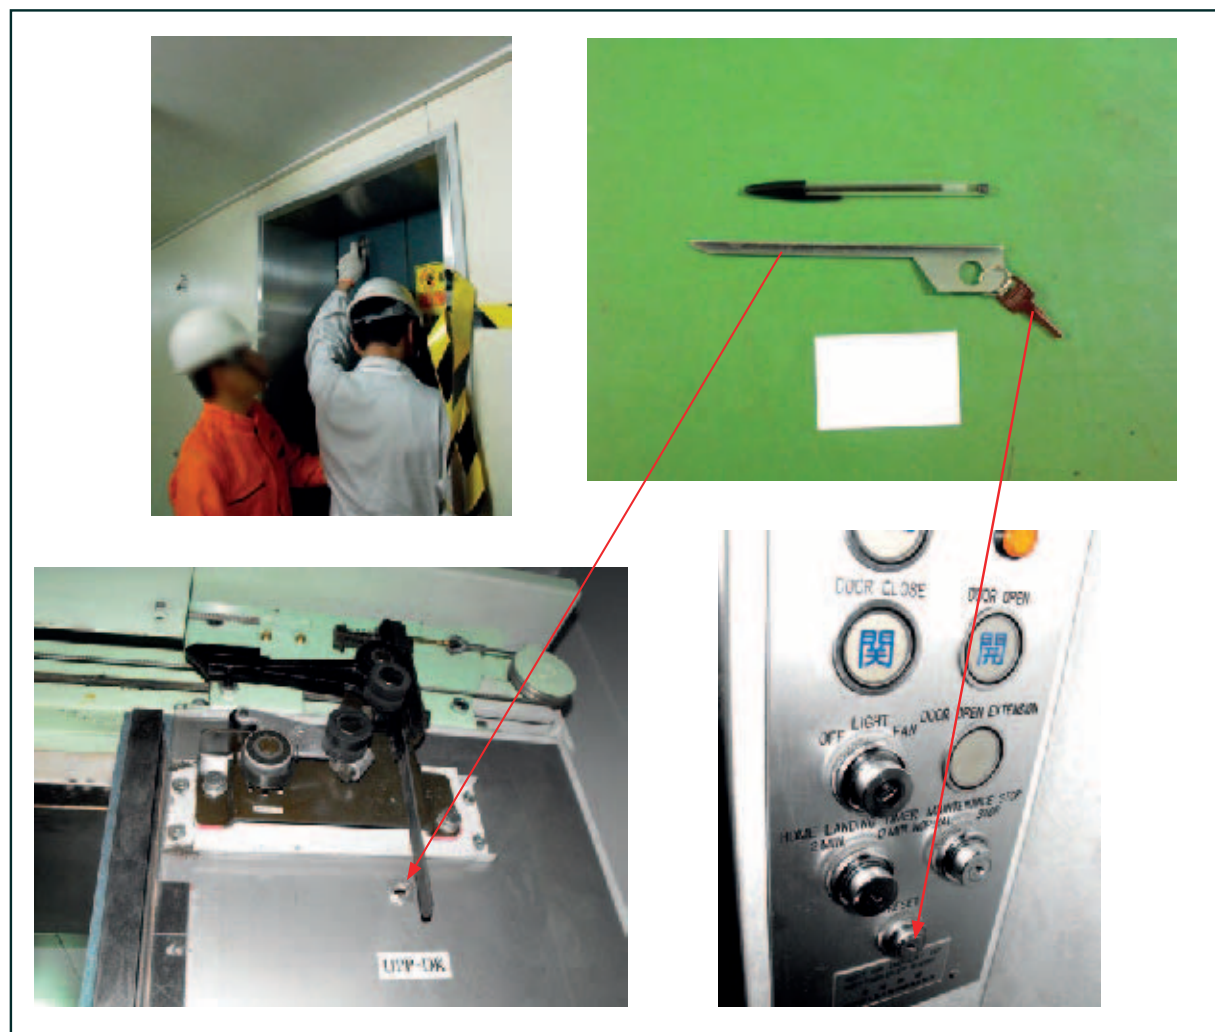
Figure 5: Door access

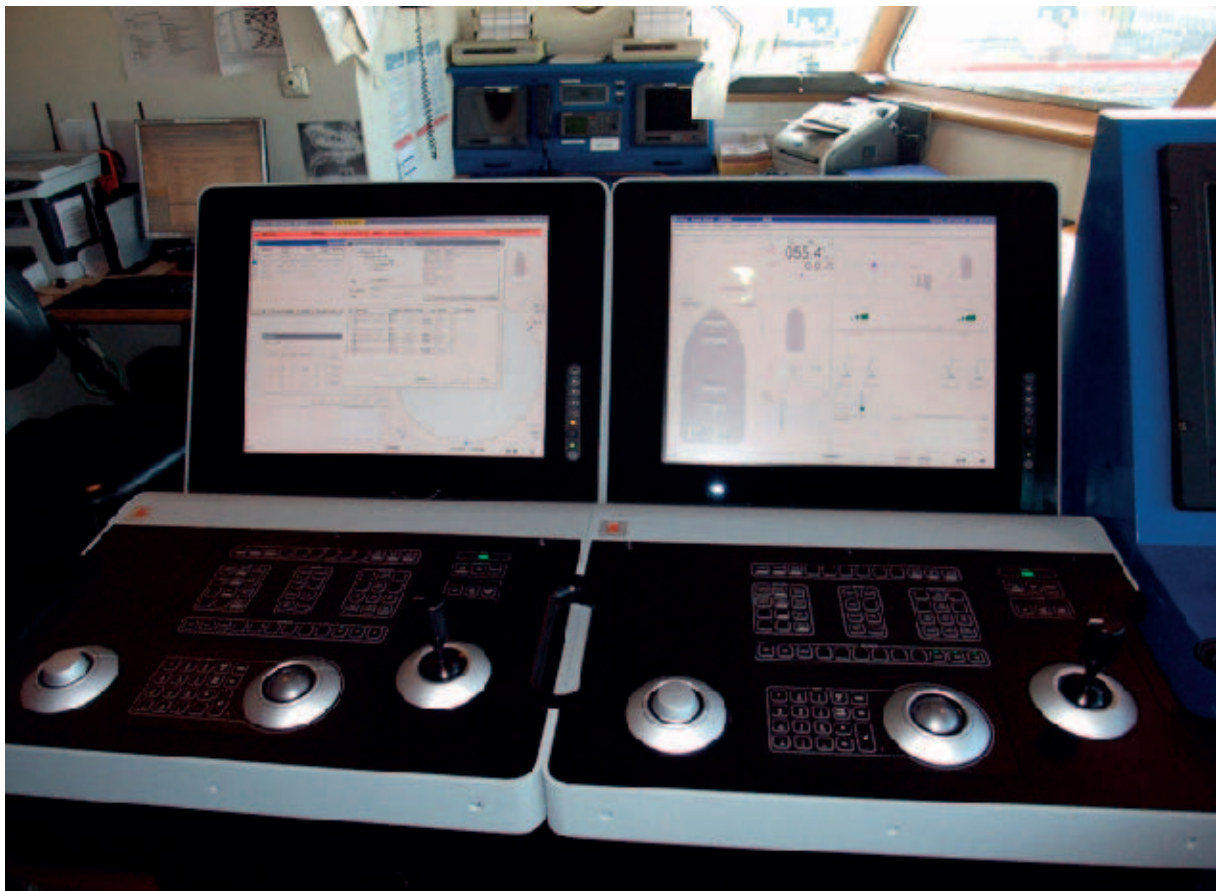
bridge (Figure 1) to the thrusters and CPPs to check their functionality. The chief officer and second officer were on the bridge as the tunnel thruster tests were carried out. These were successful and the technical superintendent then left the ship for personal reasons, leaving the technician in charge of the HAT.

Figure 1: DP operator station

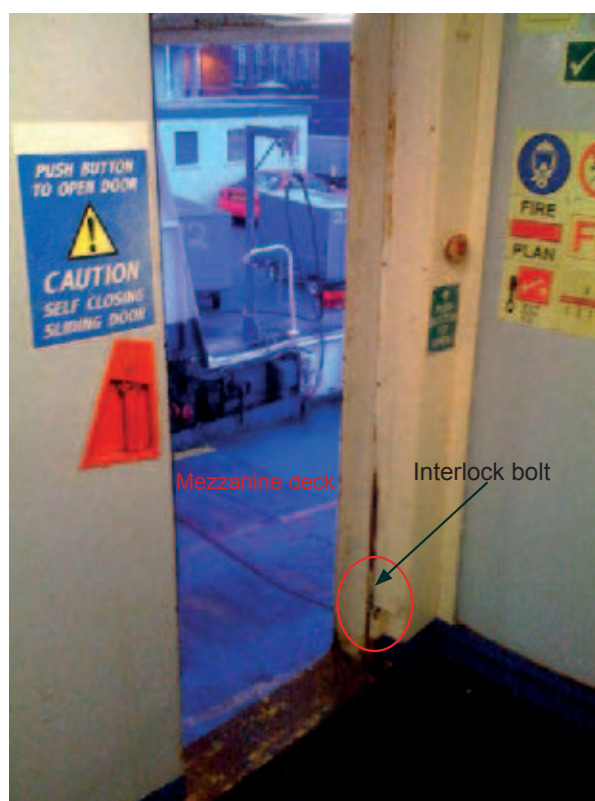
It was a pleasant journey, and as the ferry reached her destination the passengers went to retrieve their cars. Two of them proceeded to what they thought was the main vehicle deck entrance. In fact, they were both at the mezzanine deck level. One of the passengers depressed the port mezzanine deck door "open" button. The sliding door opened and the two passengers were just about to step through the door when, to their alarm, they found that there was no deck outside the door, but were instead confronted with a fall of 2.54 metres onto the main car deck below (Figure 2).

Figure 1: View of door from inside

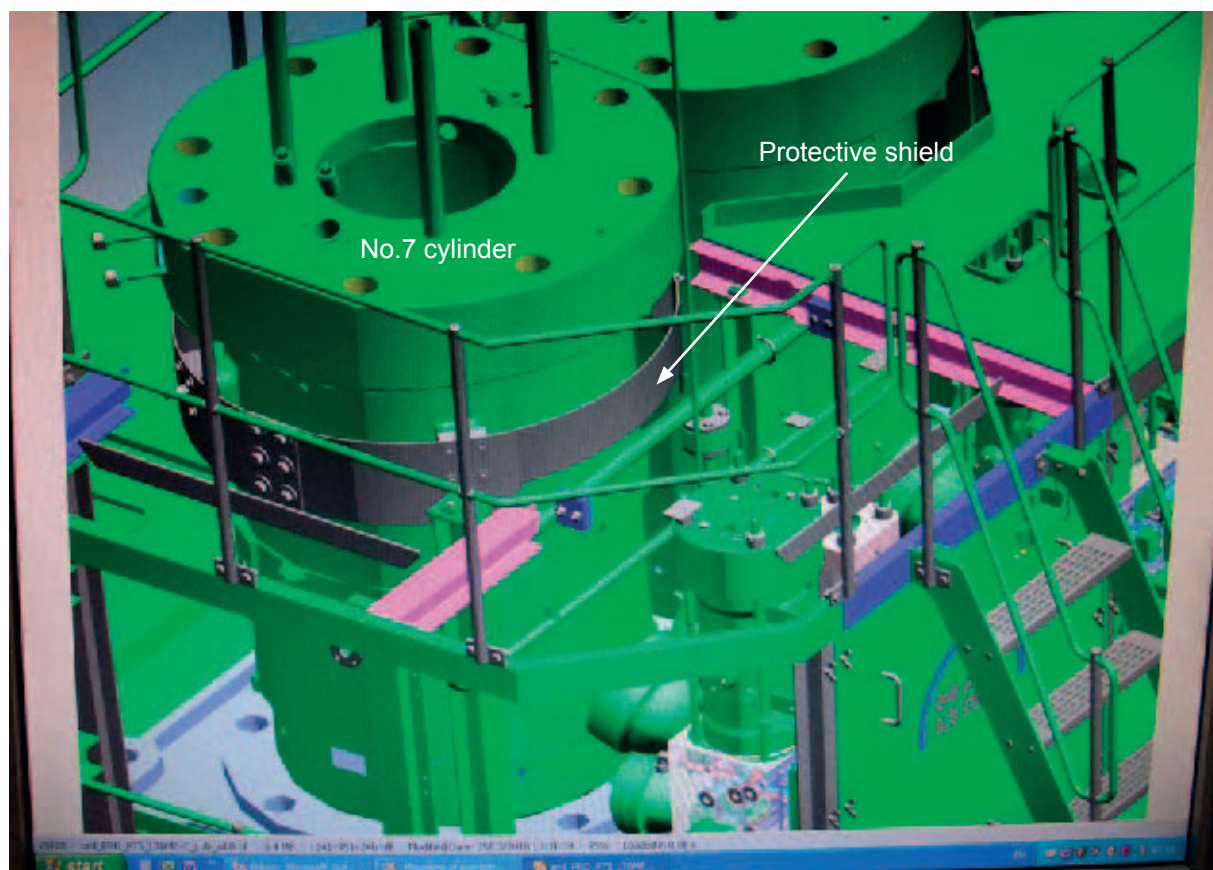
Figure 1: No.7 cylinder arrangement

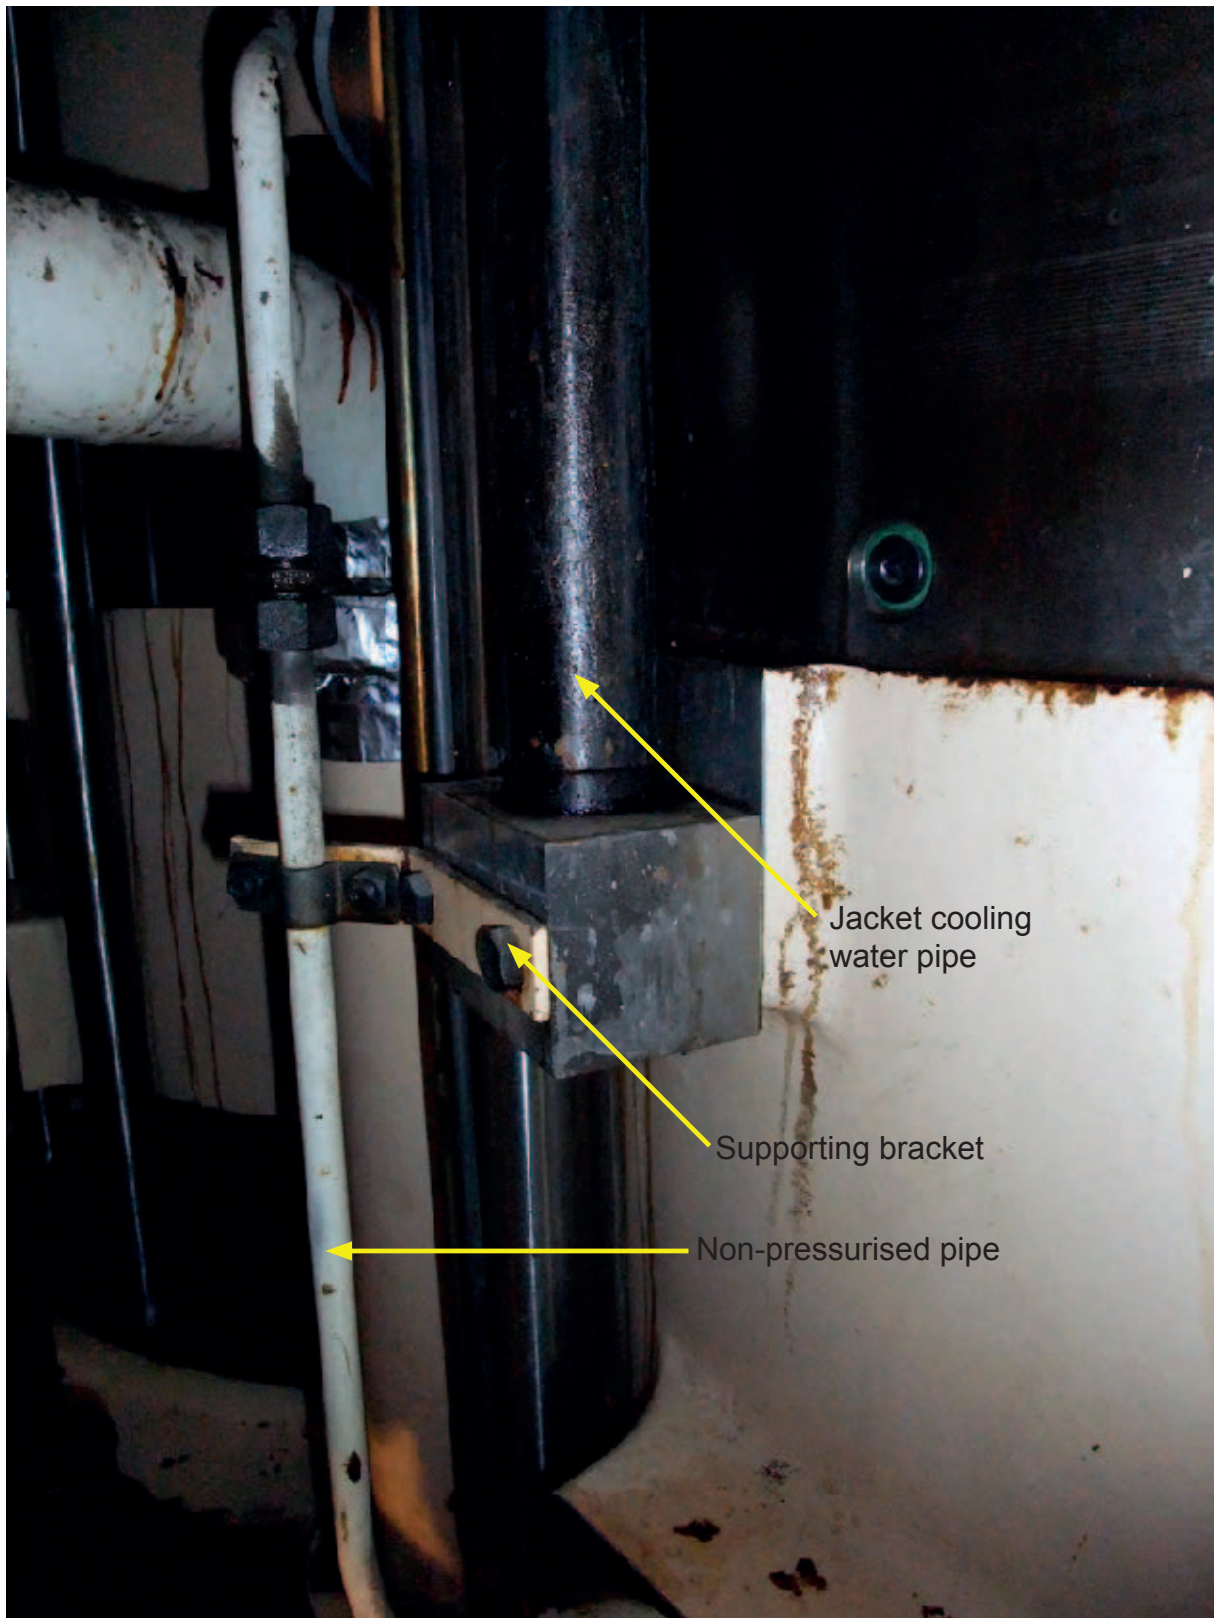
bracket. No attempt was made to re-evaluate the risks. Shortly after the pipe was removed (Figure 2), the second engineer left the area to respond to an alarm on the boiler. The third engineer then thought that the main bracket (Figure 2), which had supported the pipe, also needed to be dismantled, and removed the bolts which also secured the jacket cooling water pipe connection. As the third engineer and fitter attempted to manoeuvre the shield around the cylinder unit, it dislodged the cooling water pipe and resulted in the fitter becoming drenched with hot water (85° C) at 3.4 bar.

Figure 2: Pipe securing arrangement

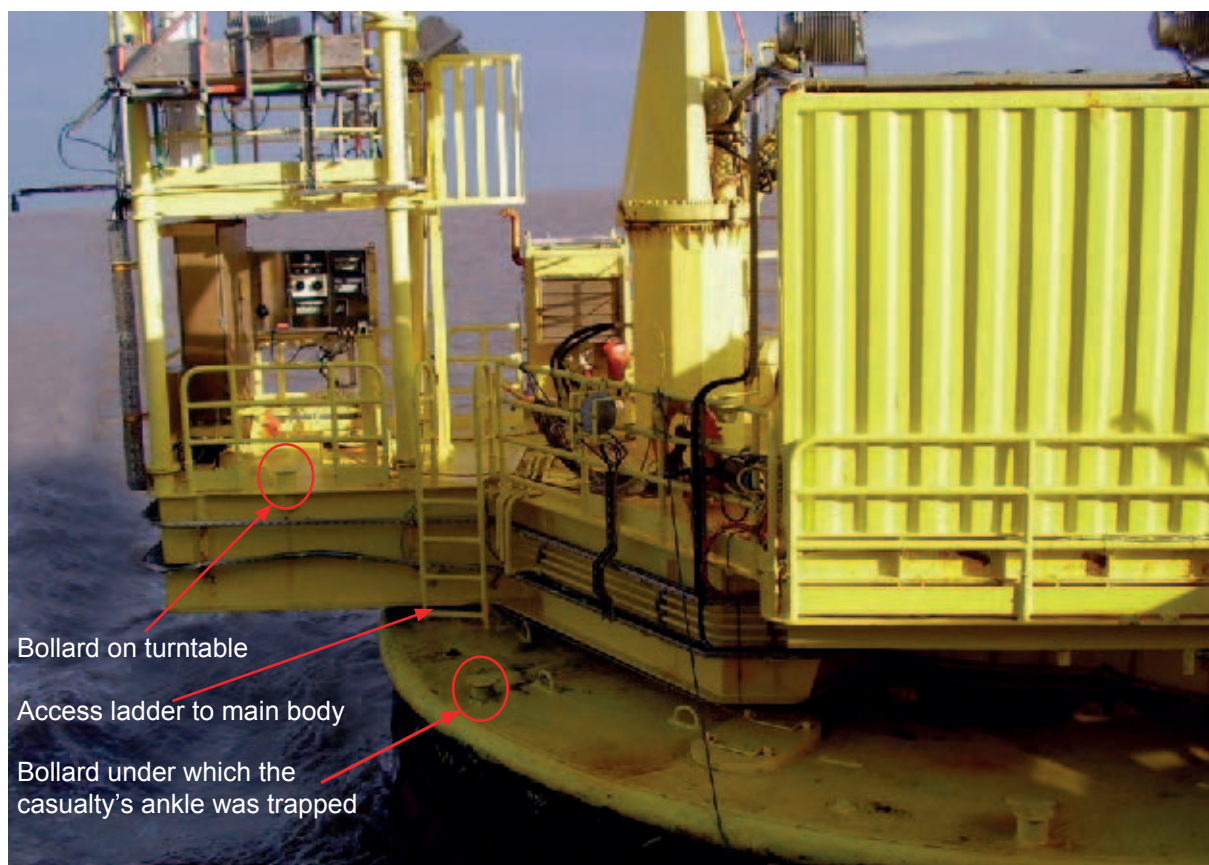
Figure 1: Monobuoy arrangement

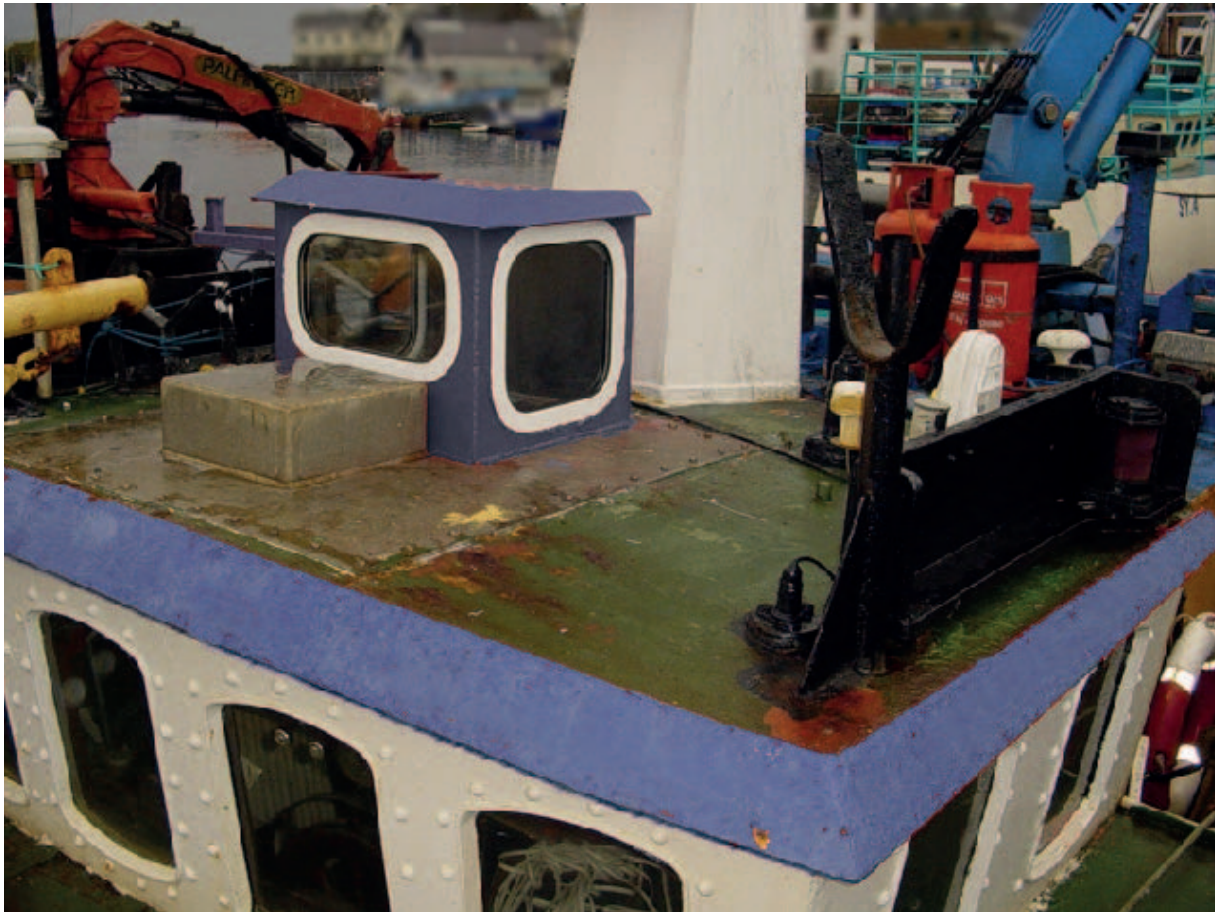
Following the collision, the skipper of Boat B improved the visibility from his wheelhouse by modifying the wheelhouse deckhead (figure).

View of the modified wheelhouse

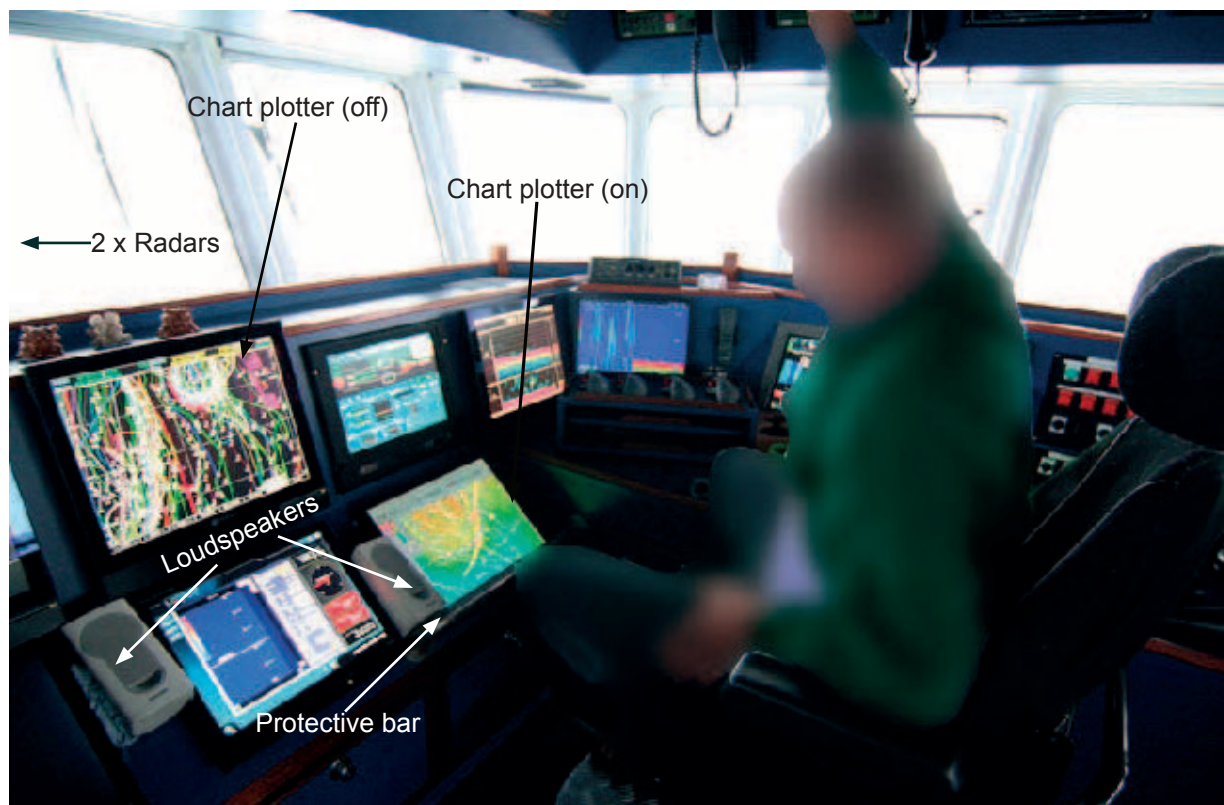
Figure 1: Wheelhouse looking forward to starboard

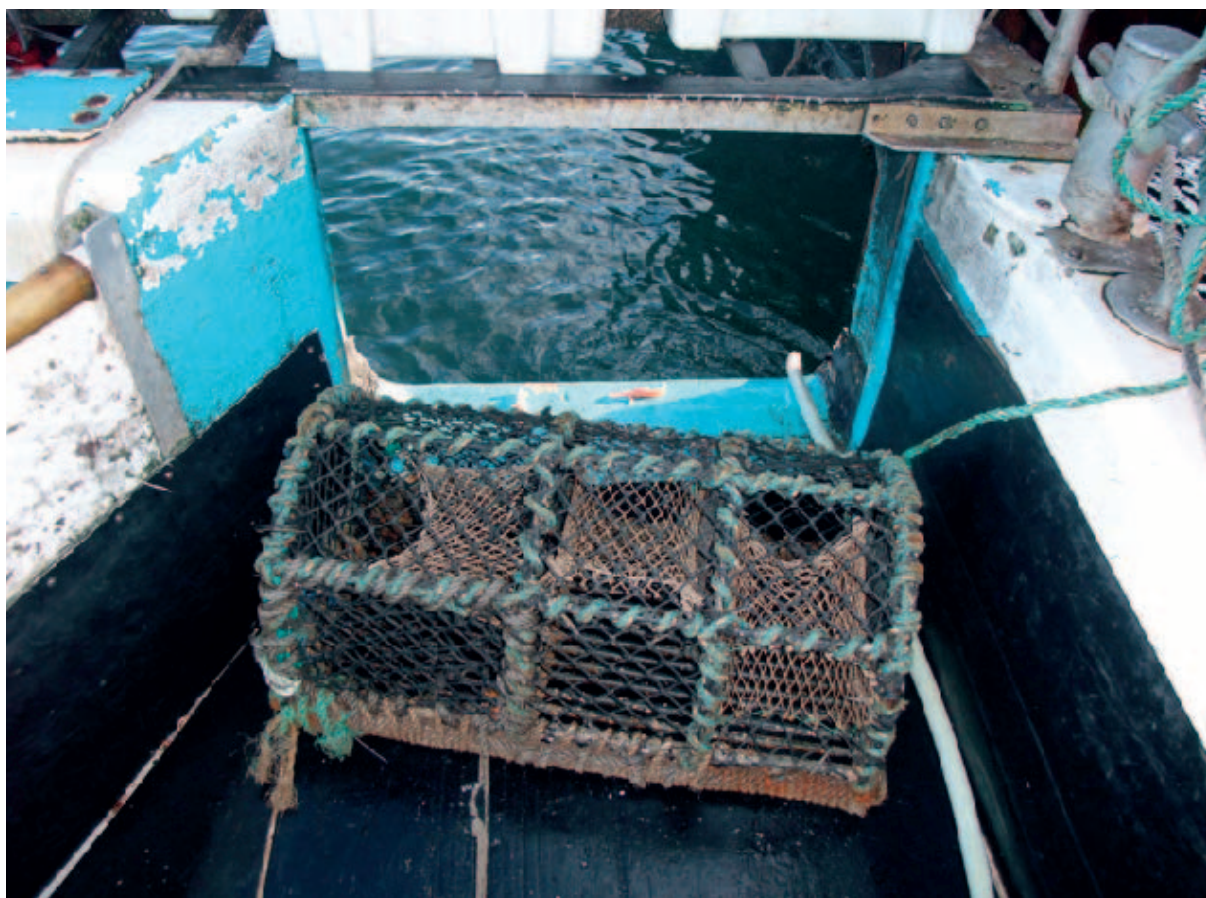
Figure 1: Creel and stern opening

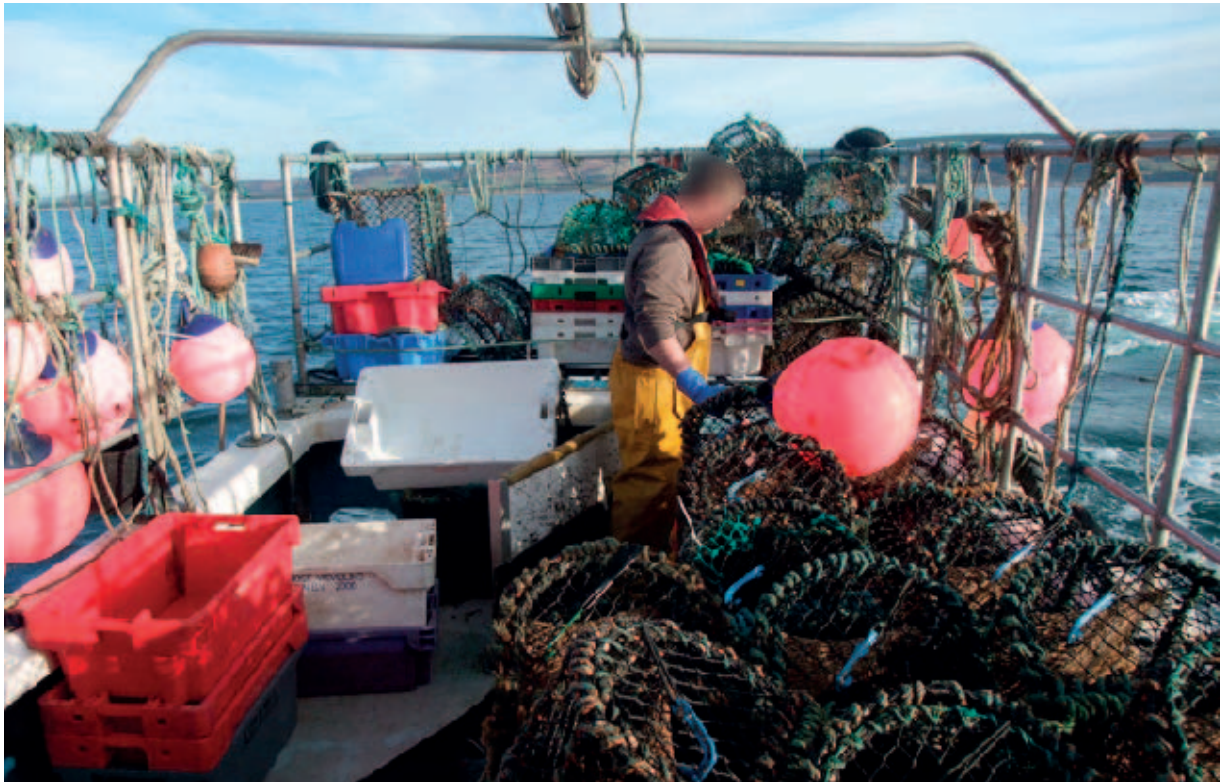
A fisherman working on a small creel boat had a lucky escape after his leg became caught in the back rope during shooting operations, dragging him overboard and down to a depth of up to 40 metres. It is unknown whether the fisherman had gone aft to help a fellow crewman who had also, momentarily, become caught in the back rope, or if he had gone aft to help clear a creel that was wedged in the stern shooting opening. Realising what had happened, the skipper of the boat stopped his engine, cut the back rope and steamed round to the marker buoy to haul in the fleet of creels and recover his colleague. The skipper also made a distress call straightaway to alert the coastguard, and he told them about the situation.

Figure 2: Working deck with a crewman standing in the position where the man was dragged overboard

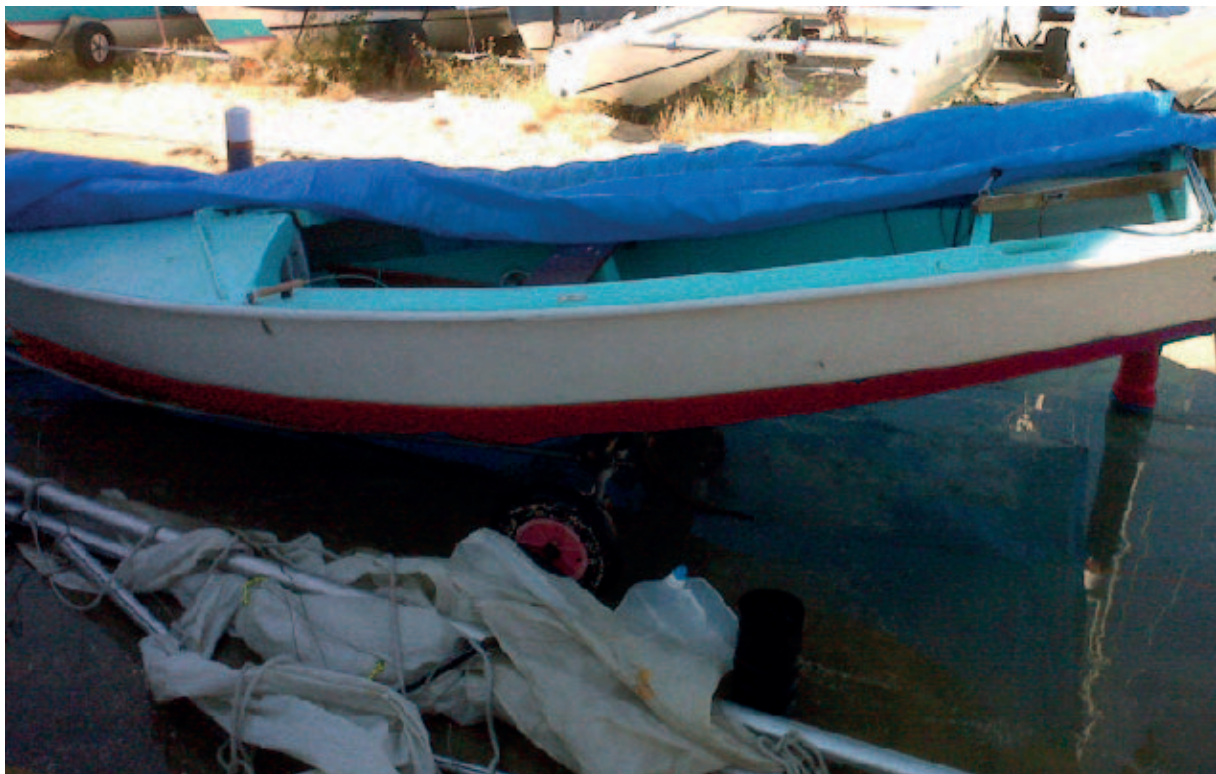
Figure 1: Dinghy involved in the accident

1. The helmsman had not expected to capsize in the light wind conditions of the day and had taken no precautions to secure equipment to the boat.
2. Had the helmsman and crewman informed someone of their plan, either at the yacht club or another person they would contact when they returned, their late arrival would have prompted a search for them.

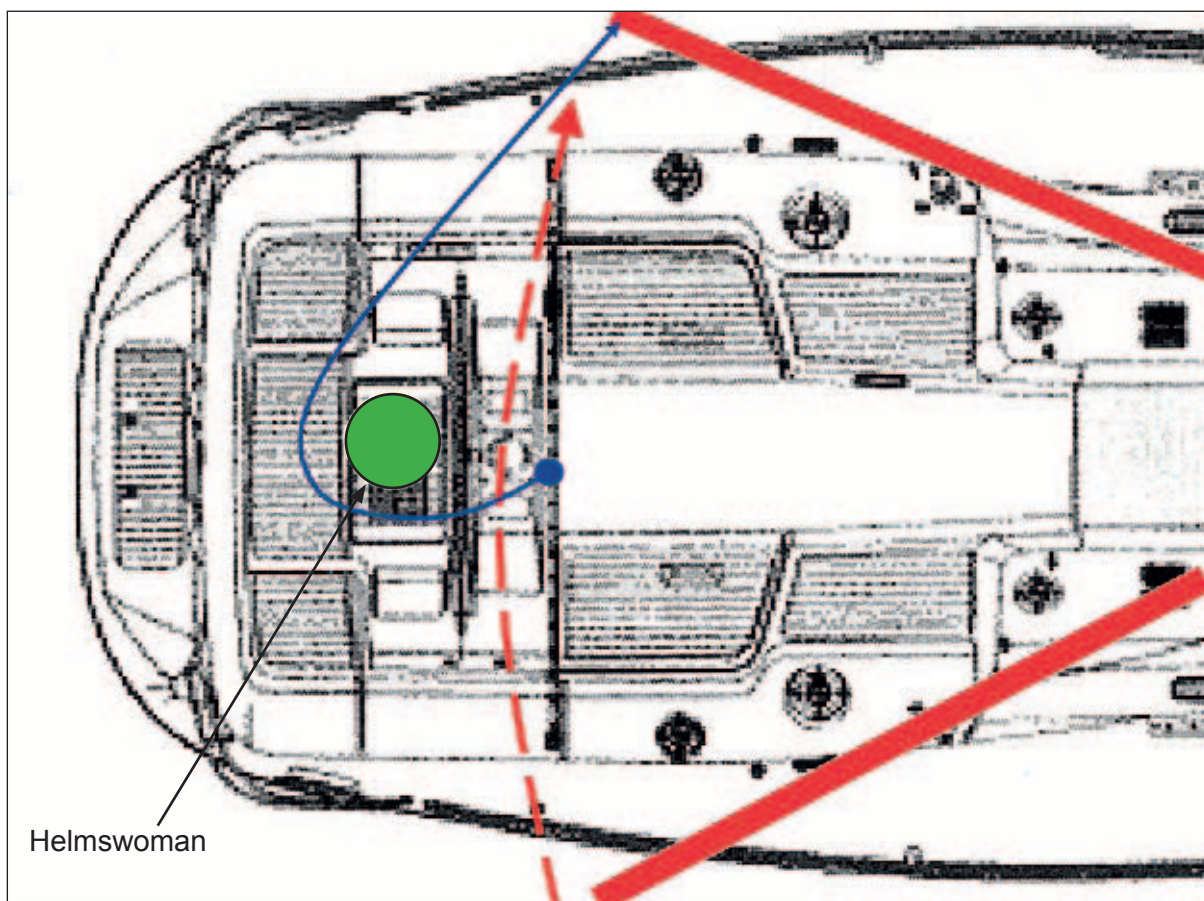
Uncertain of the skipper's instructions, the helmswoman put the helm to starboard. Without warning, the boat gybed and the boom and the mainsheet swung violently across the cockpit. The mainsheet struck the helmswoman, knocking her to the deck, unconscious.

Accidental gybe - movement of the boom and the mainsheet

1. Uncontrolled gybes are extremely hazardous and frequently lead to serious injury or worse. Usually, it is the fast-moving boom that causes head injuries, but it is clear that the mainsheet can be equally as hazardous.
2. Offshore racing is exciting and adventurous, but it can also be dangerous, particularly in adverse conditions when crews are inexperienced and tired. All skippers naturally want to do well, but, when race-
- training, the wellbeing and capabilities of even willing and eager crew need to be carefully judged and taken into account at all times.
3. The temptation for skippers to 'get stuck in' when something goes wrong is understandable. Indeed, on some occasions it will be absolutely necessary. However, in doing so, it is important they keep a broad view and do not lose sight of the overall objective: vessel safety.

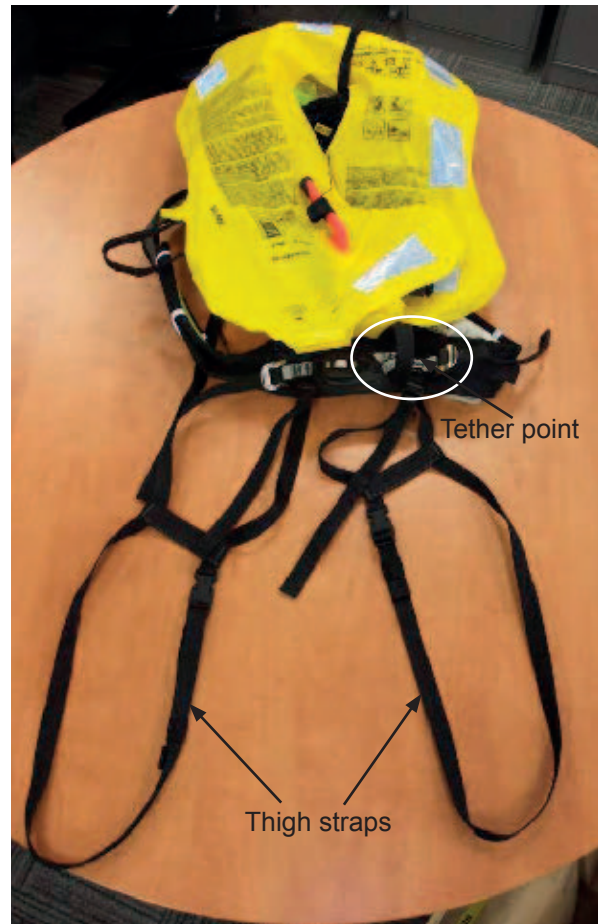
Figure 1: Lifejacket showing harness and thigh straps

Just as he was recovered to the deck, his lifejacket was pulled up his torso and over his head. The lifejacket waist strap was still fastened but the thigh straps side release buckles were undone.

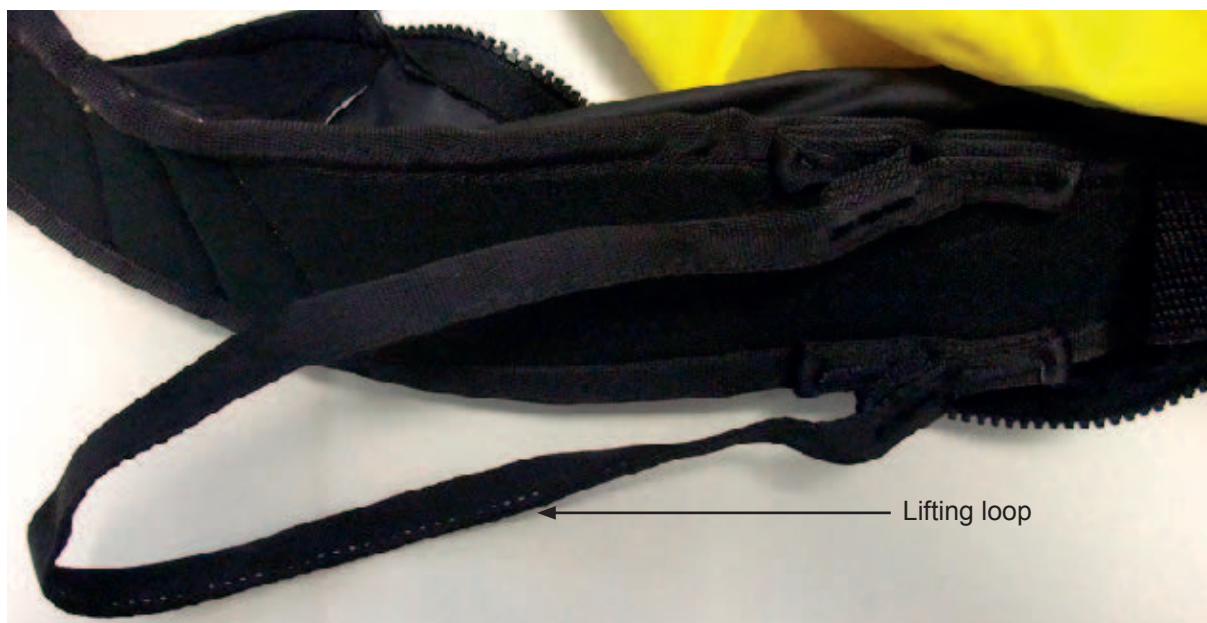
Figure 2: Lifting loop

Organization for Standardization (ISO) 12401 and 12402 requirements. Among other equipment, this meant that the lifejacket had the appropriate tether point at the front of the lifejacket's waist belt and was fitted with a lifting loop, although the latter was exposed only after the bladder had inflated. In this case, the lifting loop was black and was a little difficult to identify (Figures 1 and 2). Other brands of lifejacket are fitted with contrasting and brighter coloured lifting loops, which are sometimes annotated with "lift here" as shown in Figure 3.

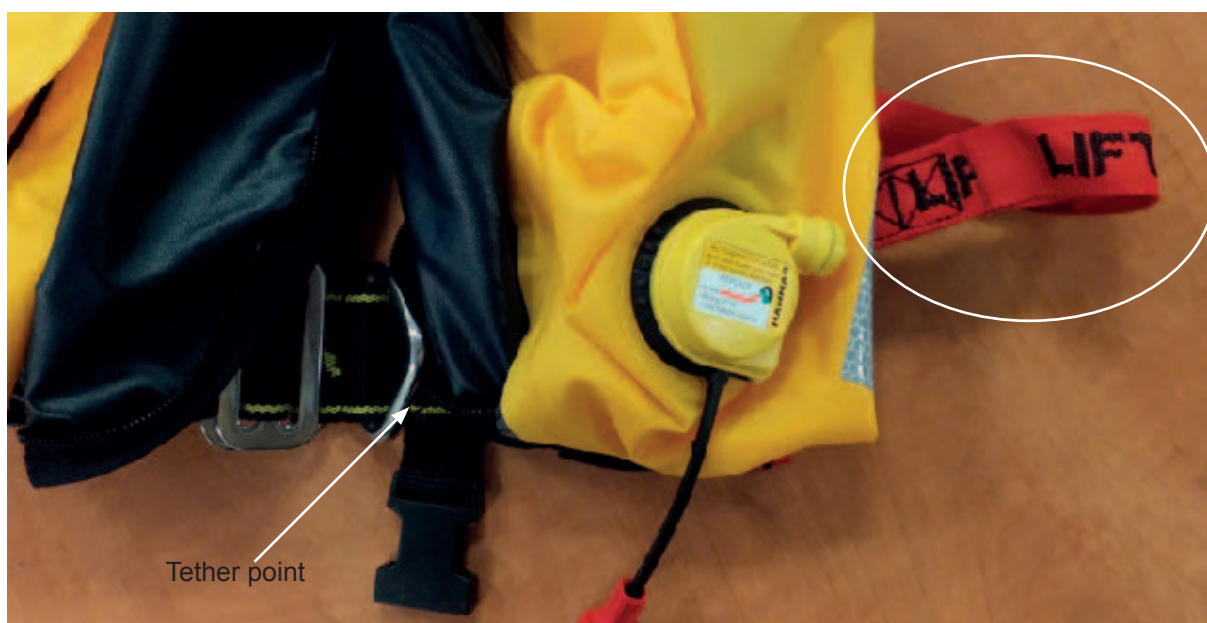
Figure 3: Contrasting coloured lifting loop
