MARINE ACCIDENT  
INVESTIGATION BRANCH

# SAFETY DIGEST

**Lessons from Marine  
Accident Reports  
2/2012**

**SAFETY DIGEST**  
**Lessons from Marine Accidents**  
**No 2/2012**

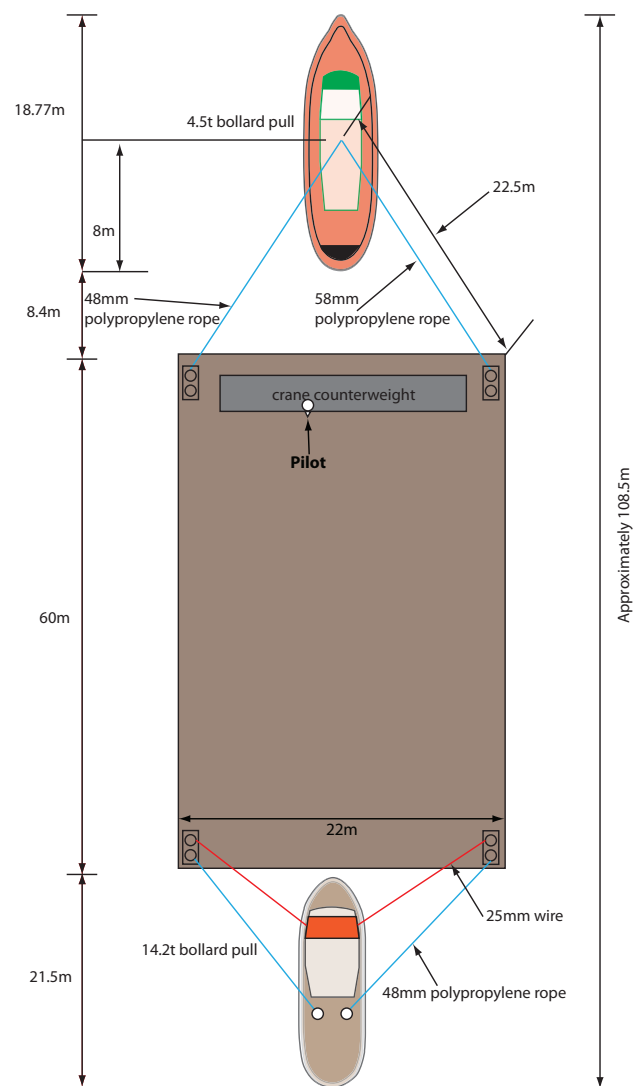
It was agreed that the pushing tug would be firmly connected directly to the stern of the barge with a combination of ropes and wires. This effectively made the tug and barge a composite unit in much the same way as a ship. The pulling tug was connected to the barge by a bridle made up of two short polypropylene ropes. The distance between the pulling tug and the barge was 8.4 metres. A schematic of the tow configuration is at Figure 1.

Figure 1: Tow configuration

3. Had a propulsion or steering failure occurred, the pulling tug would have been overrun because of the short towlines used. Do consider adjusting towline lengths to help prevent this.

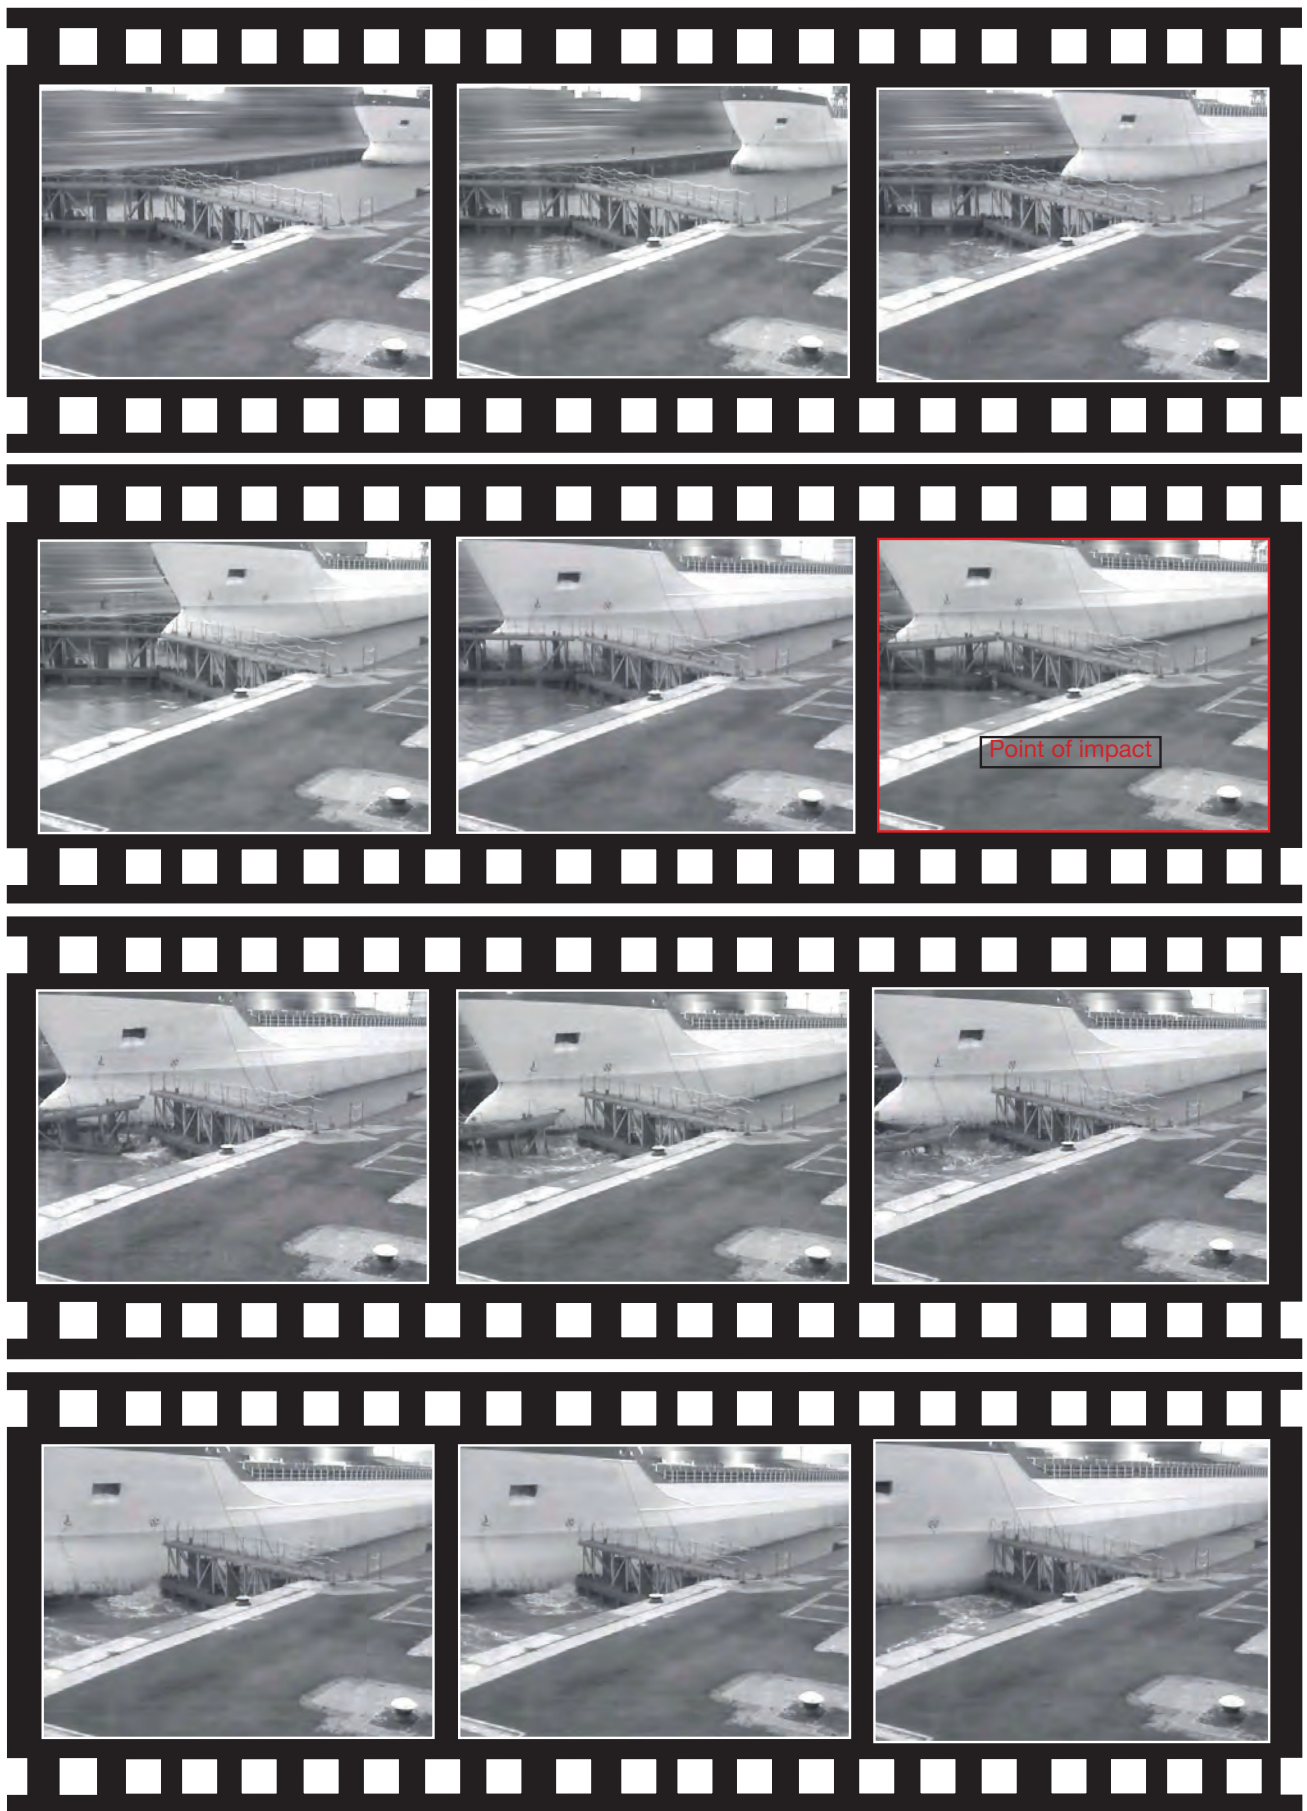
Despite these measures, the vessel impacted heavily with the outer lock gates at 3.7kts, just under 1½ minutes after the CPP control power failure alarm. One of the gates sustained major damage and subsequently sank (Figure 1), with the other outer gate suffering minor damage. The inner lock gates were immediately closed and they, too, sustained minor damage when the head of water in the dock caused them to slam shut. The vessel herself sustained only minor damage to her bulbous bow (Figure 2) and was later moved as a dead ship by two tugs back into the dock. There were no injuries or pollution.

Figure 3: CCTV footage of the accident before and after impact

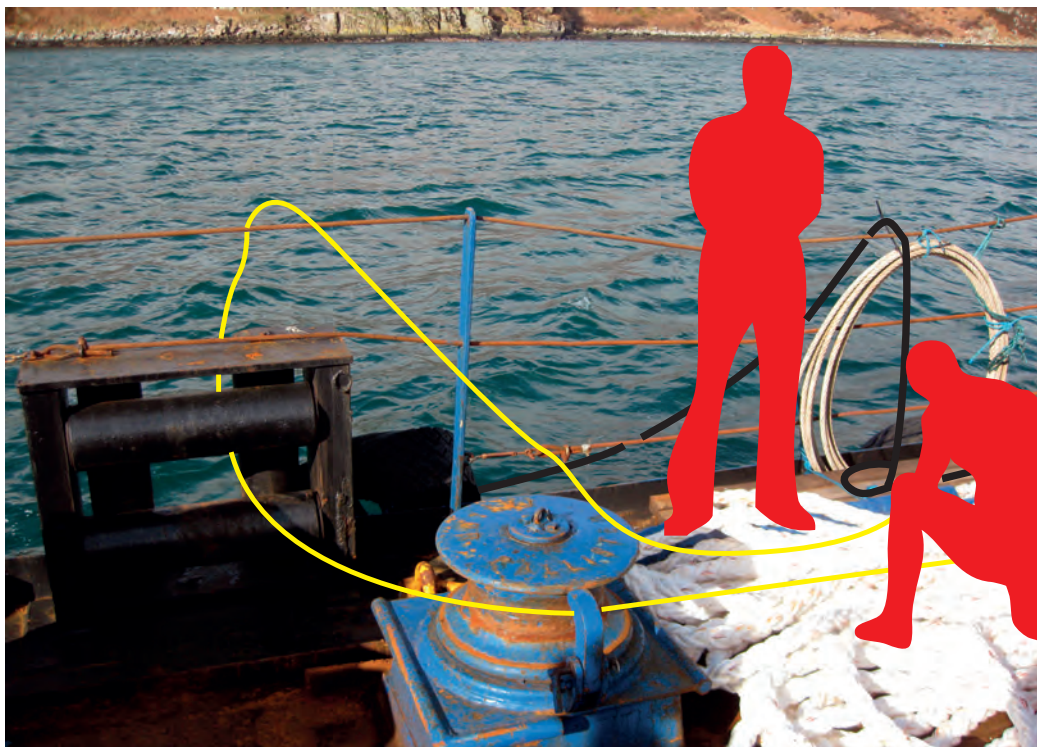
It was dark by the time it came to moor. The mate directed the master via VHF as planned, but once in position the mate put down the radio so he could prepare to make the connection. The only option available to the master was to hold station by monitoring his DGPS. The AB flaked out the winch wire on deck and fed it through a fairlead and back inboard over the ship's rail. He then used a boat hook to retrieve the floating mooring line and brought that inboard and handed it to the mate to shackle the two eyes together (Figure 1).

Figure 1: Able seaman standing in the bight

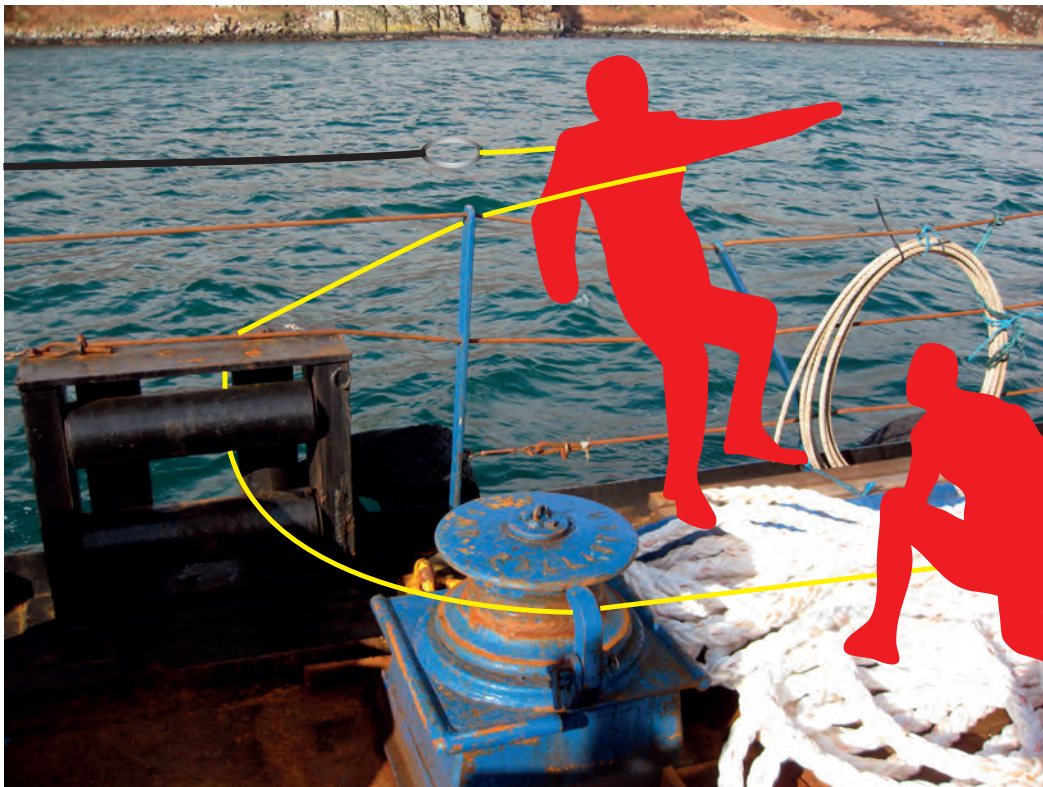
The AB was recovered with the assistance of the rescue boat crew from another company vessel. He was then transferred to the lifeboat and, soon afterwards, airlifted to hospital. Sadly, he died of his injuries - the postmortem report concluded that he had died from '*a blunt force chest injury*'.

Figure 2: The wire pinning the able seaman against the guardrail

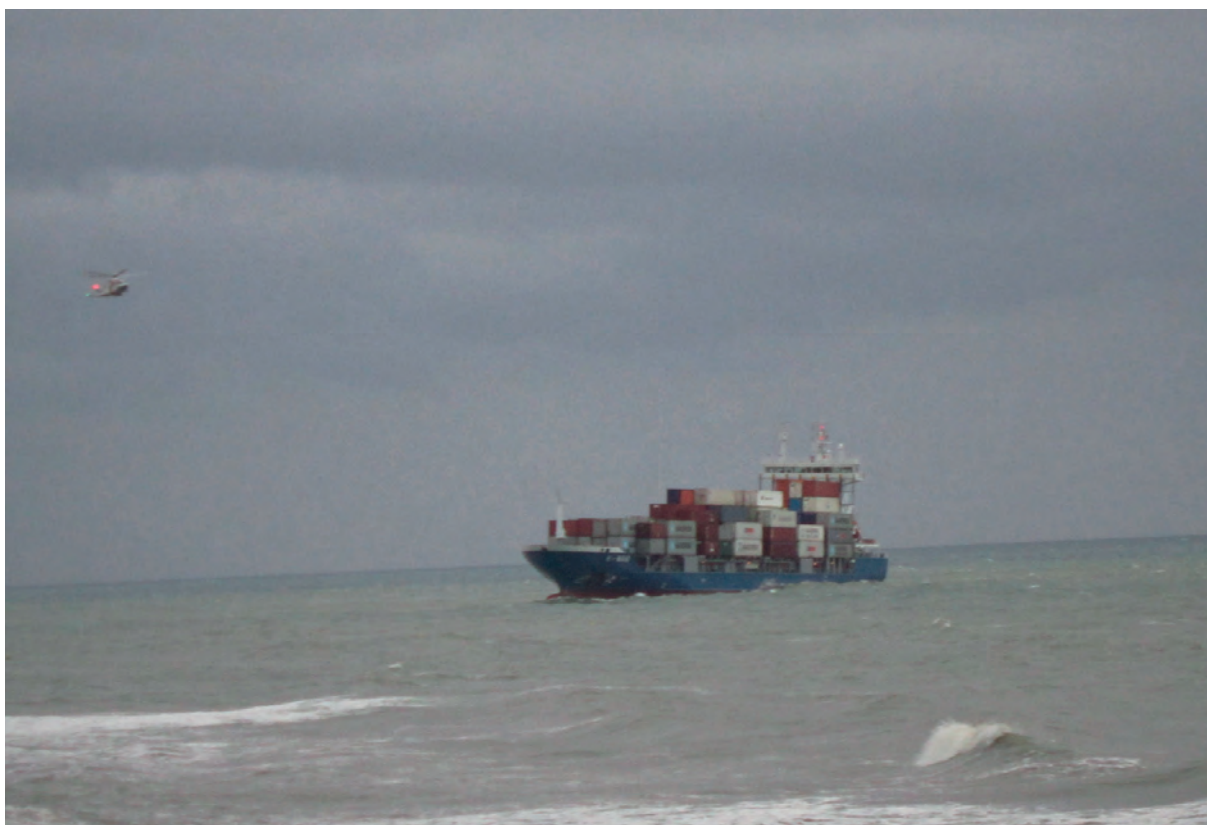
As a result, there was no one on the bridge as she crossed the tracks of other vessels in the area and steamed towards the shoreline. There, 3½ hours later, she grounded at full speed on a gently shelving, sandy shoreline. The vessel remained there, with her engine still running at full ahead, for a further 20 minutes before an officer finally came to the bridge. The master was then called and the propeller was stopped.

Vessel aground with rescue helicopter and lifeboat in attendance

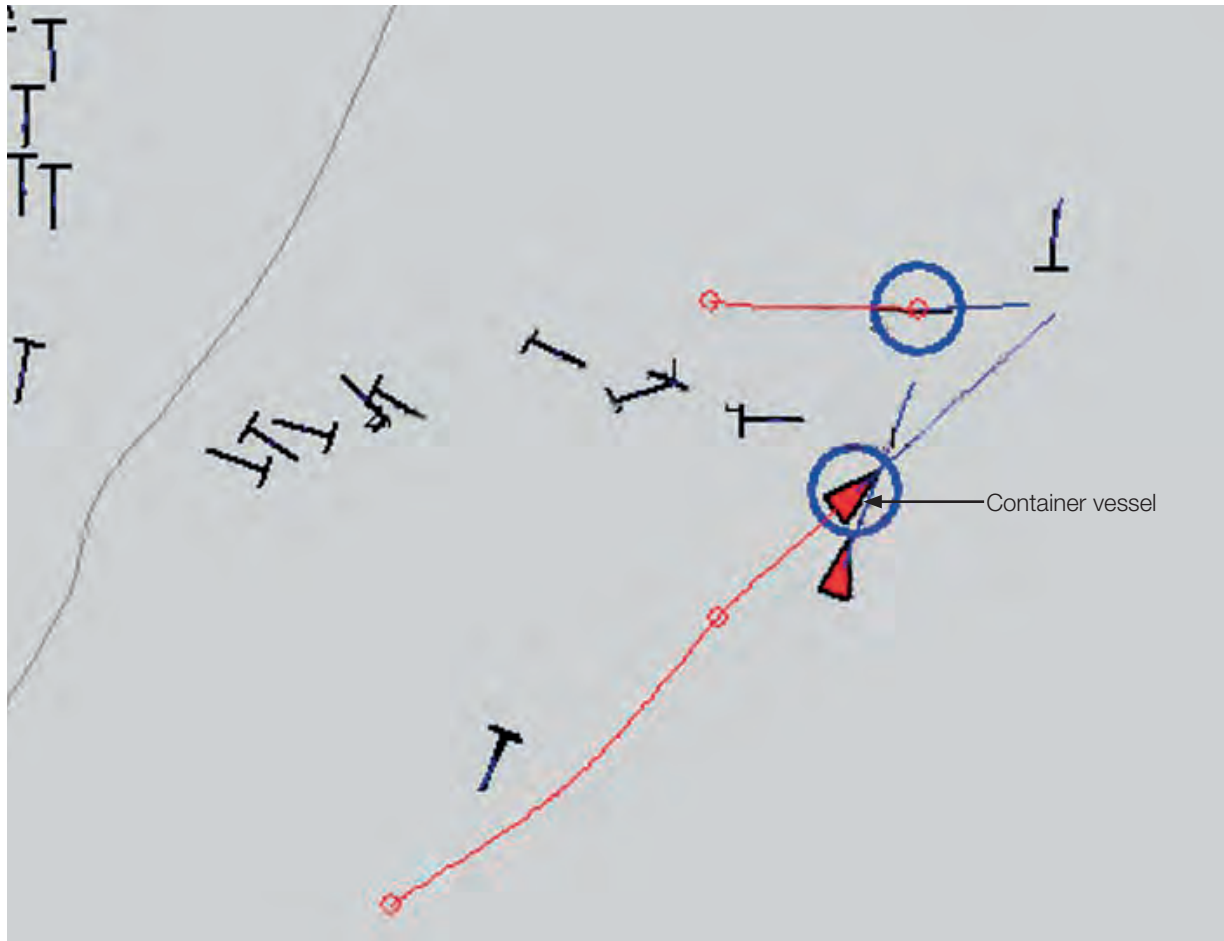
Figure 1: AIS screen shot of container vessel's course

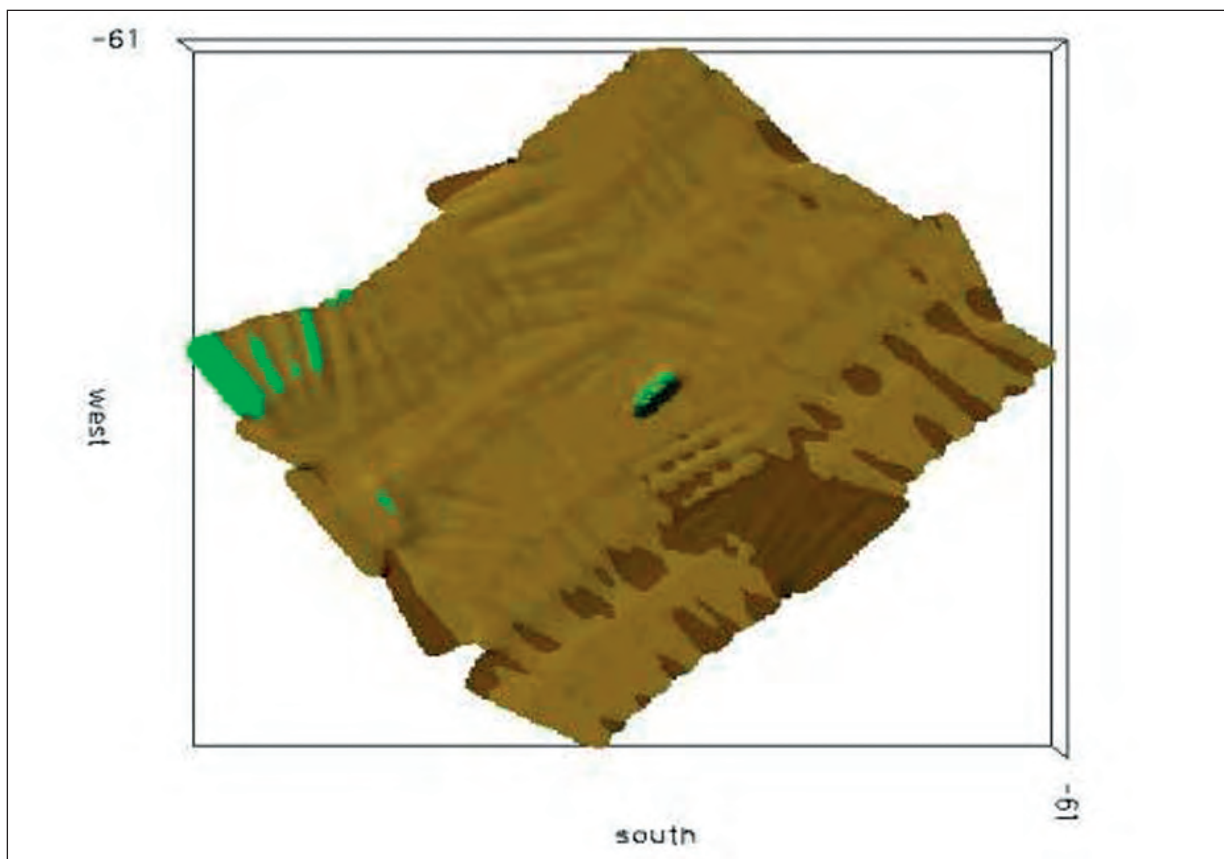
Eighteen hours after the collision, the coastal authorities were made aware that a fish transportation vessel was missing. An air and sea search was quickly commenced, and a review of AIS information indicated that the position and time of the missing vessel's final transmission coincided with the container ship's track. The wreck of the missing vessel was later located (Figure 2); all of her 11 crew were lost. She did not carry an EPIRB and the vessel's liferaft was never found. Anecdotal evidence suggests that it was customary to lash the raft to its cradle.

Figure 2: Side scan sonar image of the wreck

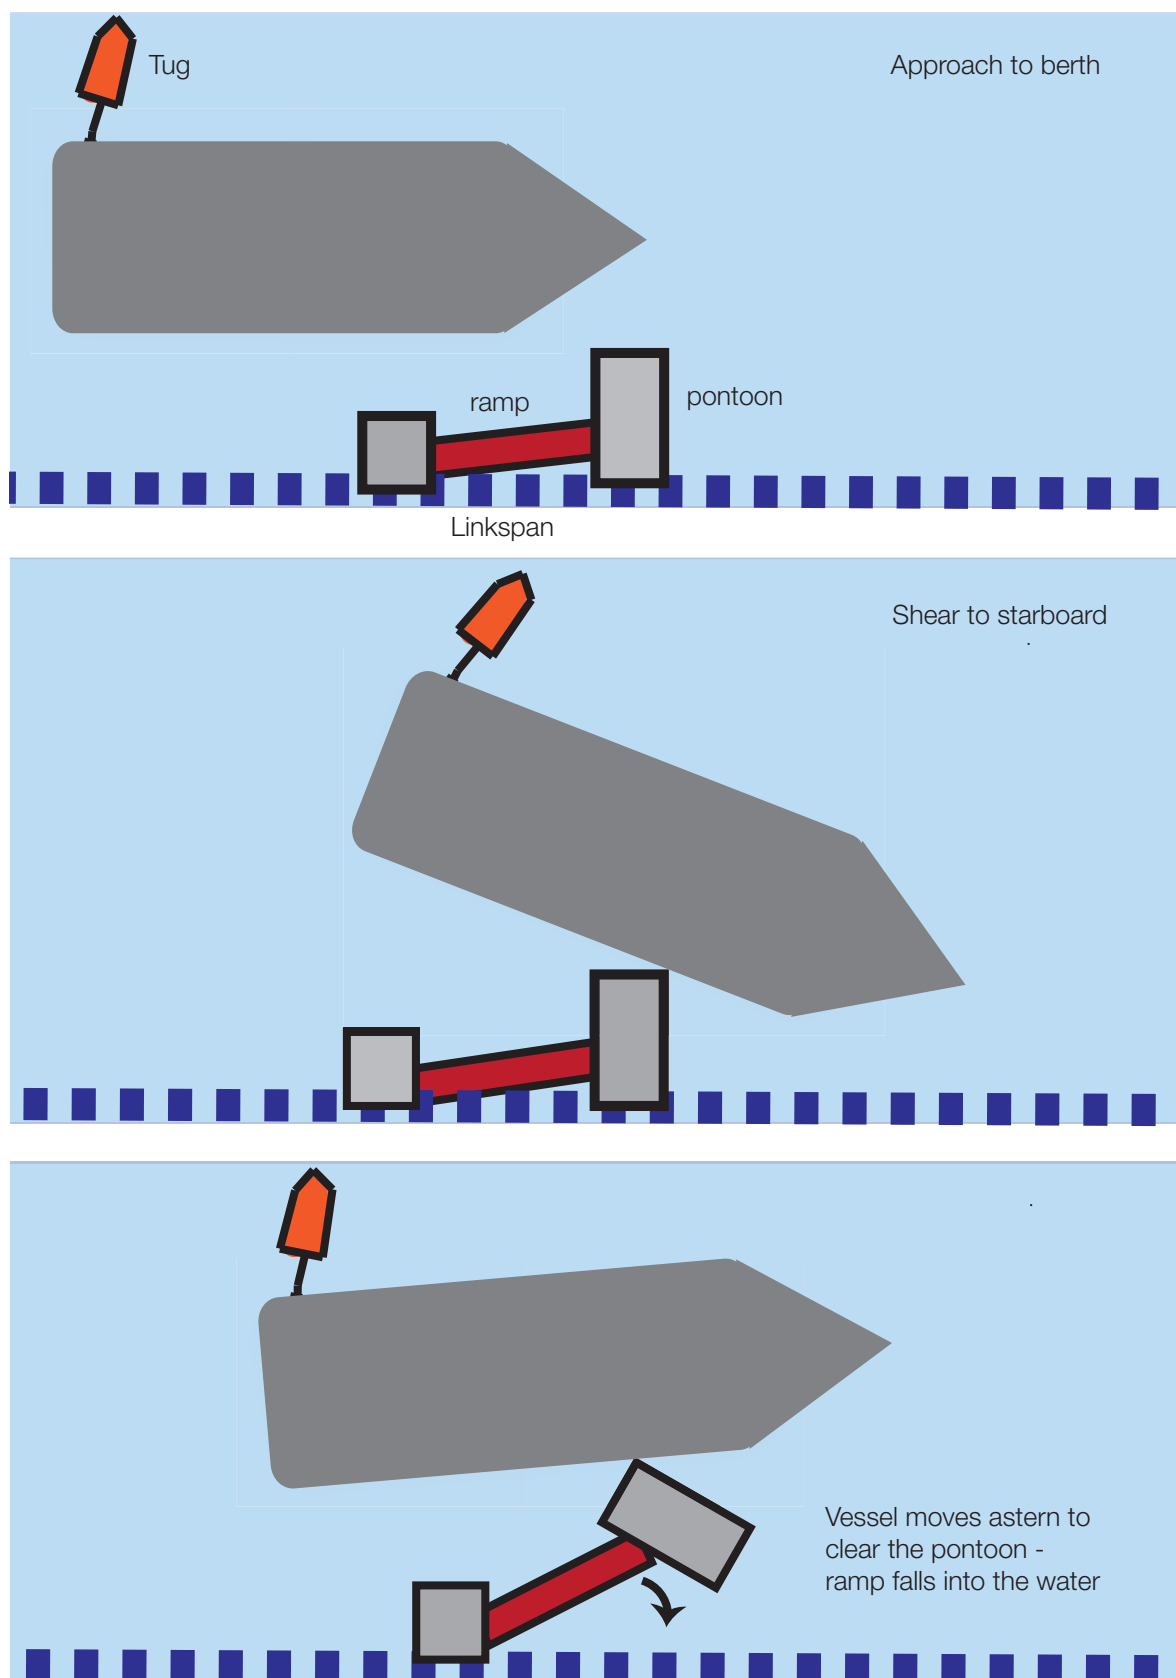
The corner of the pontoon pierced the hull. As the master put the engines astern to clear the linkspan, he dragged the pontoon away from the dockside. The ramp section of the linkspan could not be held without the support of the pontoon, and its fixings gave way, sending it to the seabed. The pilot quickly notified VTS of the situation and nearby tugs assisted the ship to get alongside an alternative berth and prevented the pontoon from drifting out and becoming a hazard to navigation.

Figure 1: Sequence of the approach

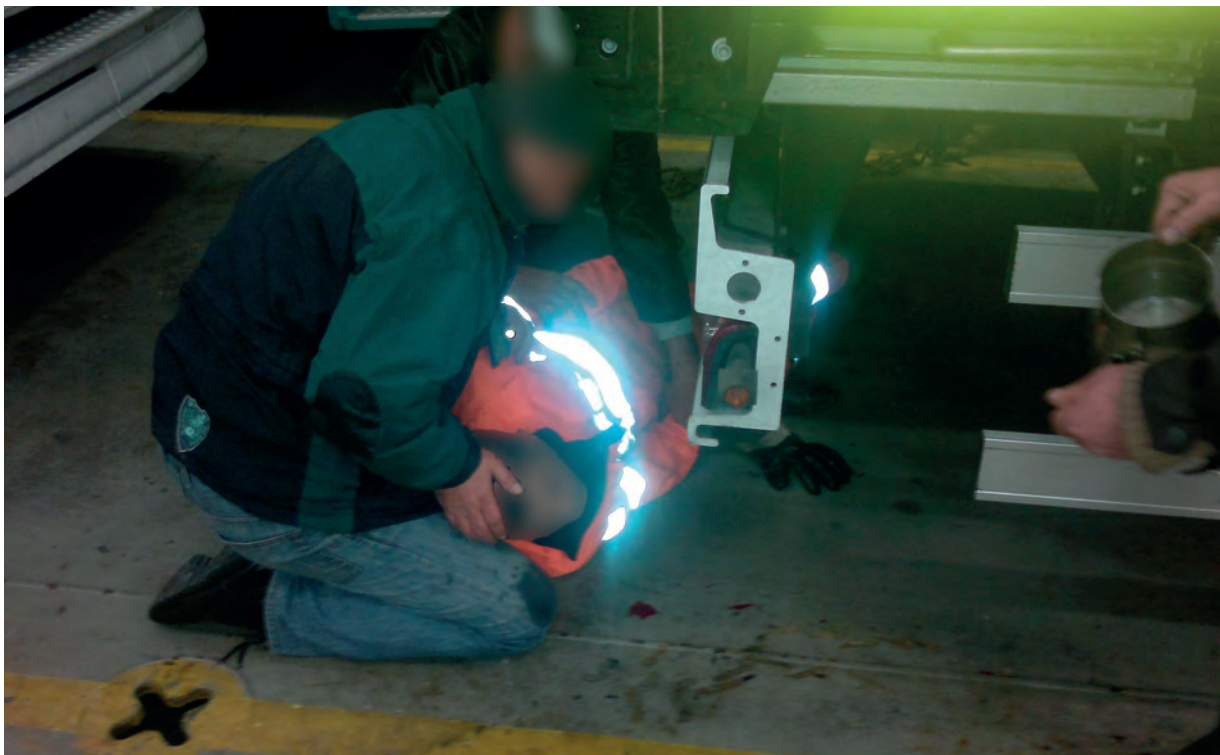
The lorry unit moved forward and crushed the stevedore, who was out of the driver's line of sight, against the cab of the vehicle ahead (Figure 1). Fortunately, the driver heard a shout and immediately stopped his vehicle. The injured stevedore was immediately attended to by one of the ship's crew who was directing the unloading and who was heading towards the section of nose-to-nose parked vehicles.

Position of the injured stevedore

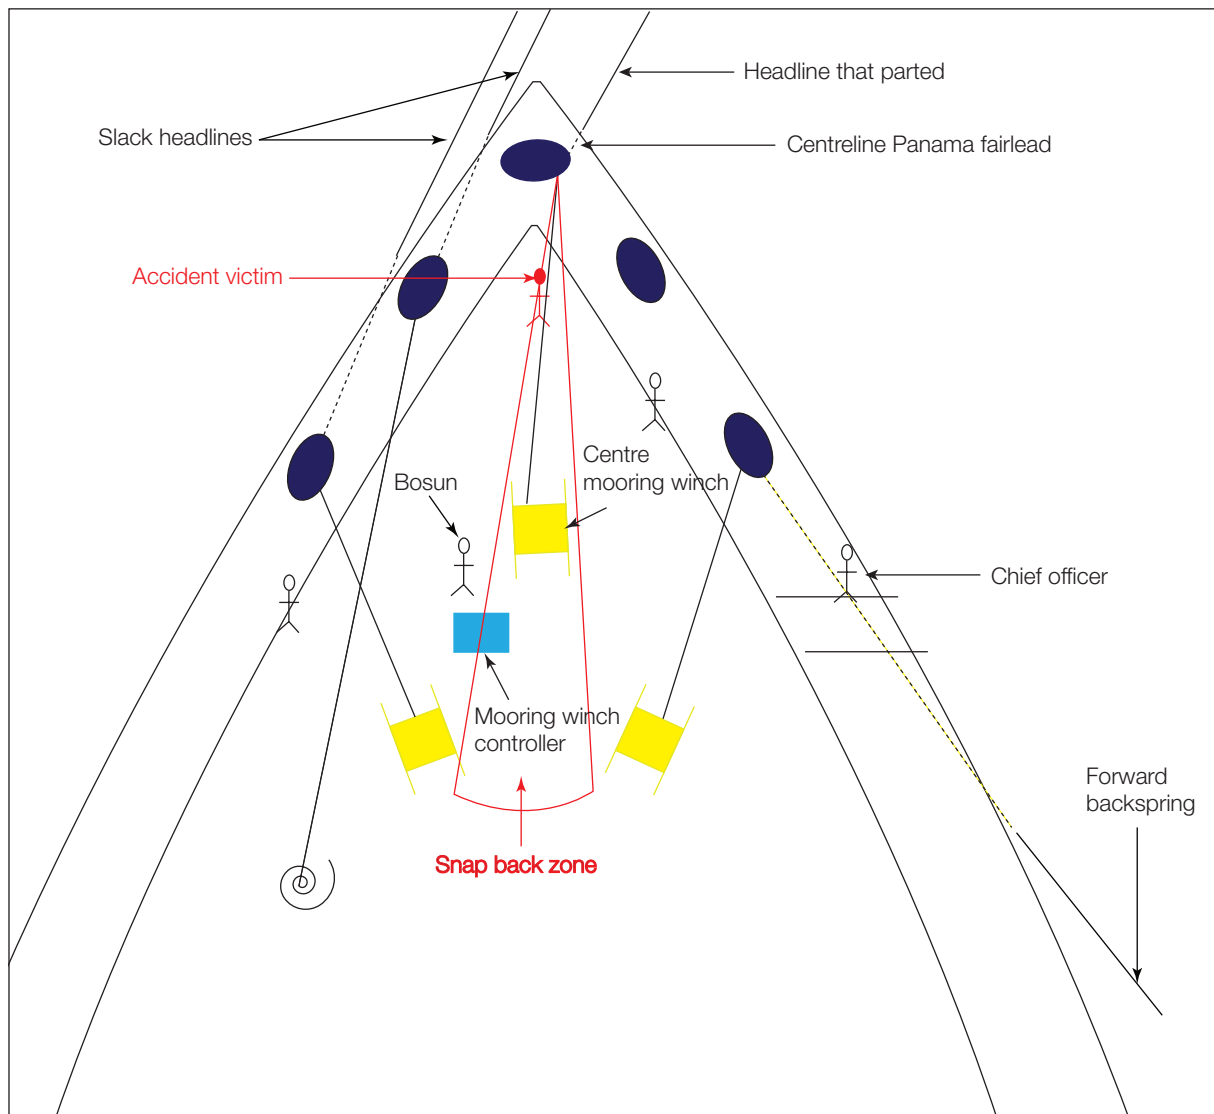
Figure 1: Forecastle deck arrangement

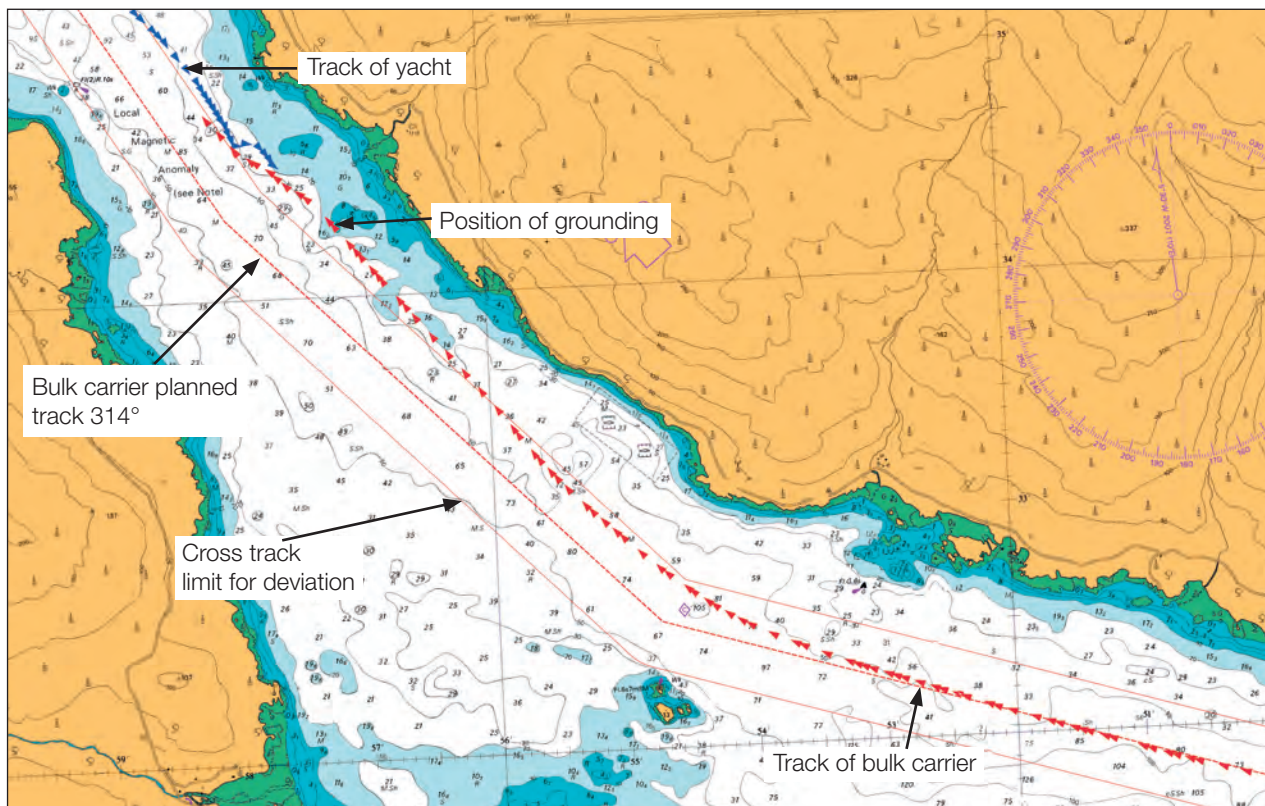
4. The bulk carrier required careful navigation in view of the restricted sea room and the likelihood of her encountering other traffic. The master was confident of the third officer's abilities and, on handing him the con, was content for him to navigate alone. However, his confidence was misplaced. The third officer lacked experience and, given the navigational demands of the passage, needed the support of the master, who should have avoided sending the routine departure messages until the vessel was clear of the sound.

Tracks of bulk carrier and yacht

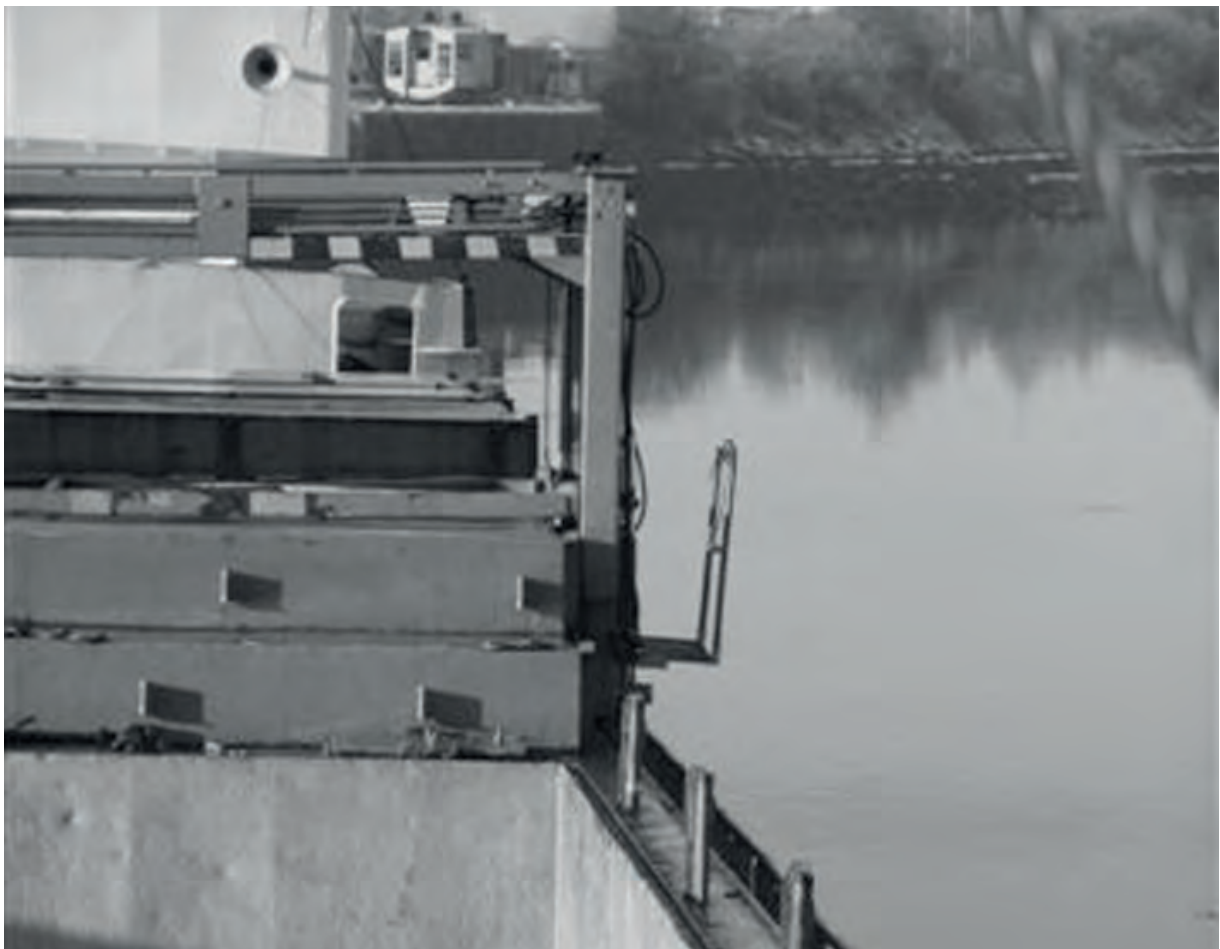
Figure 1: Straddle lift crane

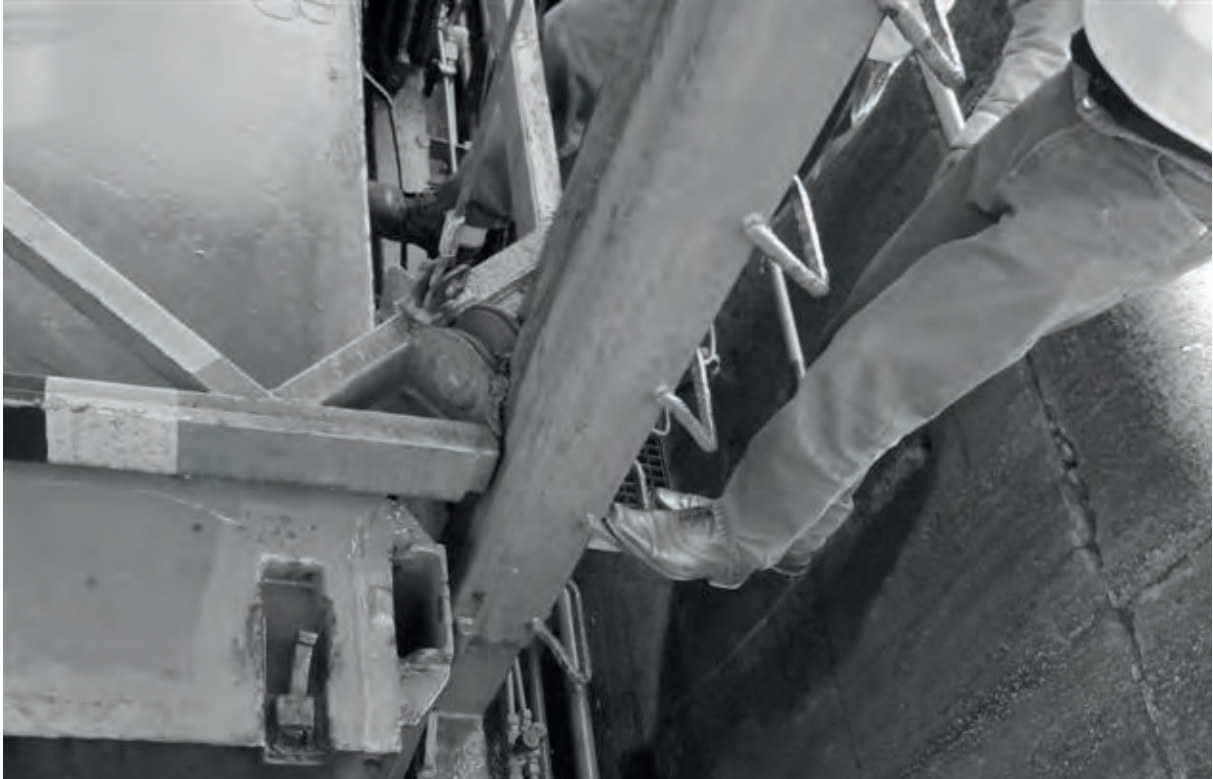
foot/hand-holds, neither the gloves nor the boots would have provided much grip. The postmortem examination of the deckhand showed that he was nearly 2.5 times over the alcohol limit allowed for professional seafarers in the UK.

Figure 2: Deck foot/hand-holds

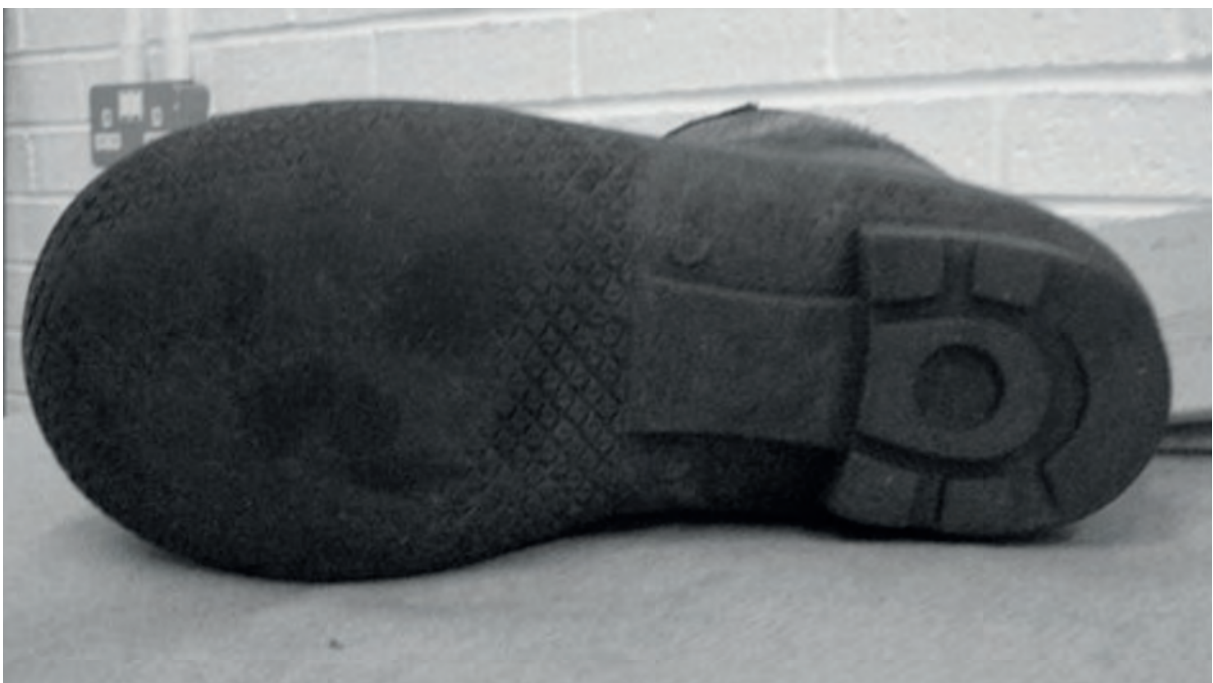
No one witnessed the accident. It is assumed that the deckhand slipped while he was climbing up to the platform. He had been wearing wellington boots that were almost entirely bare of tread (Figure 3), and his gloves had been worn smooth (Figure 4). On the wet or icy metal surfaces of the guardrails and

Figure 3: The wellington boots that were worn

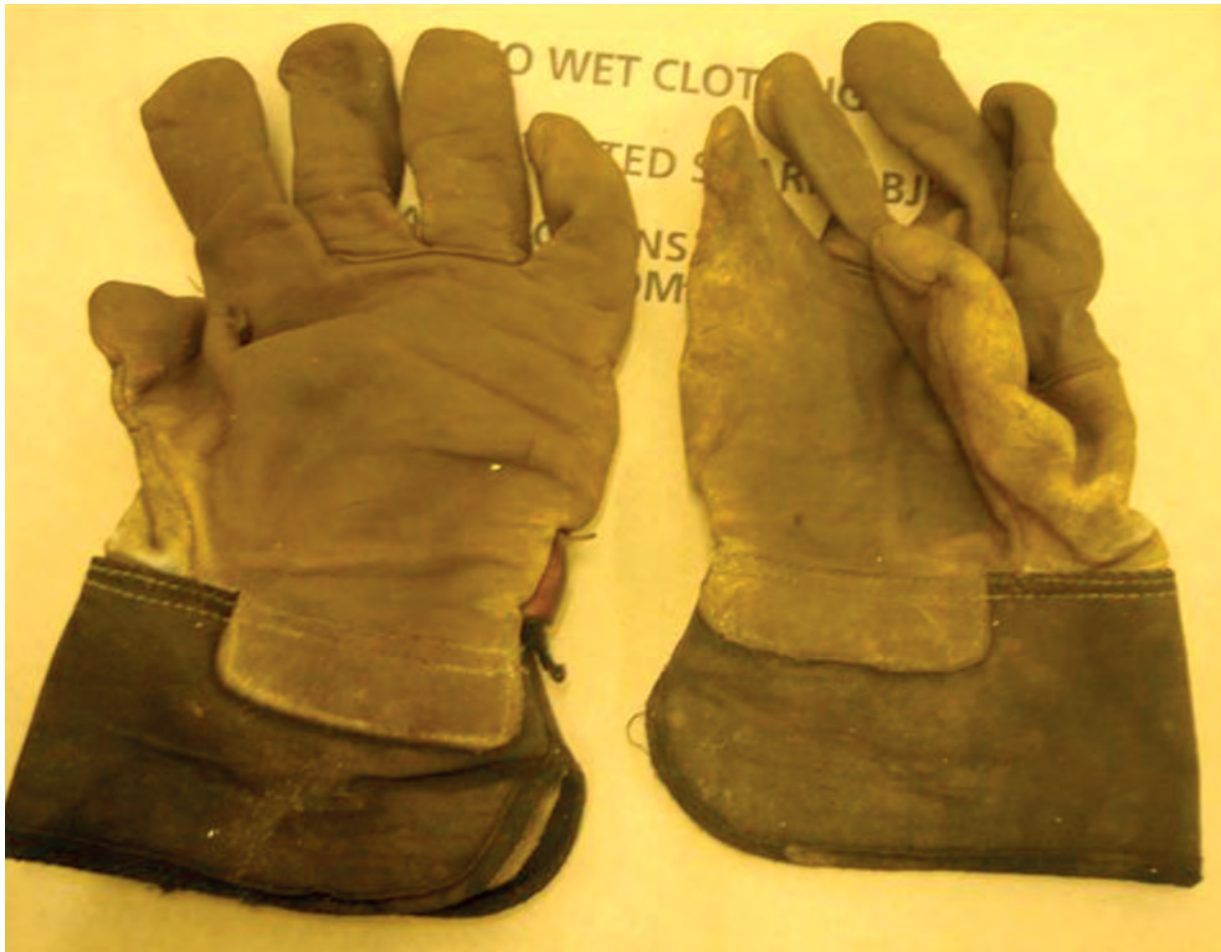
Figure 4: The gloves worn at the time of the accident

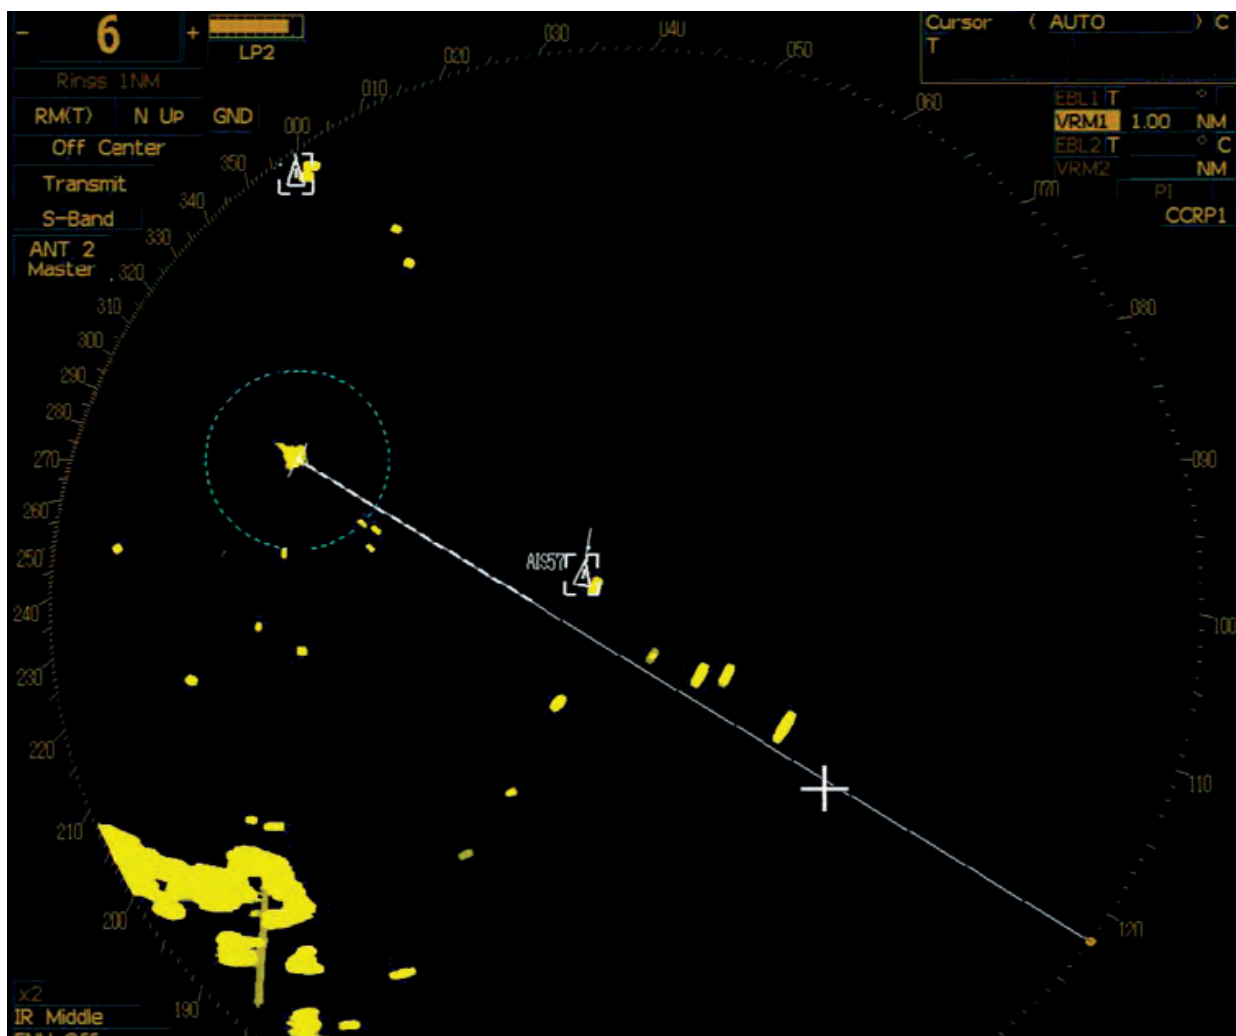
using the autopilot. He then interrogated an AIS target about 6.5 miles on the starboard bow and altered the vessel's course again, to 122° to increase the CPA with this vessel to about 1 mile. The second officer and AB on watch sighted three fishing vessels on the starboard bow. Their radar targets were not plotted and their bearings were otherwise not monitored. When the nearest fishing vessel was at about 1 mile range, the AB expressed his concern at what appeared to be a close-quarters situation with three crossing vessels (figure).

Radar display showing three fishing vessels on the starboard bow at 1 mile range

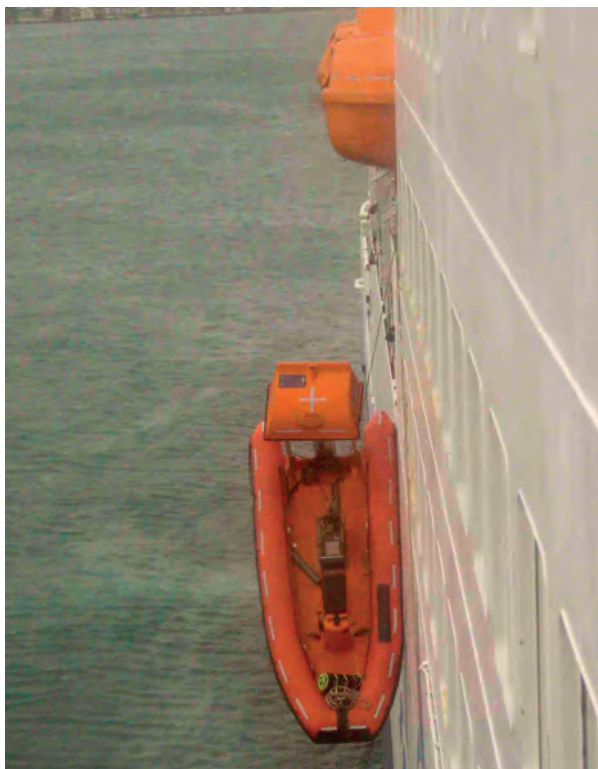
The second officer then assisted in pulling on the bowsing line to help move the FRC around the deck edge. At the same time, the assistant bosun got back into the FRC to help manoeuvre the FRC onto its stowage cradle. As the painter was tight, he decided to let it go and, in doing so, he also released the bowsing line, which became entangled around the control lever. As a result, the davit winch rapidly veered, and the winch wire became slack as the FRC slid from its precarious position on the edge of its stowage cradle. Luckily, the assistant bosun was able to jump back onto the ship's deck as the FRC slipped over the ship's side.

Figure 1: FRC in final position

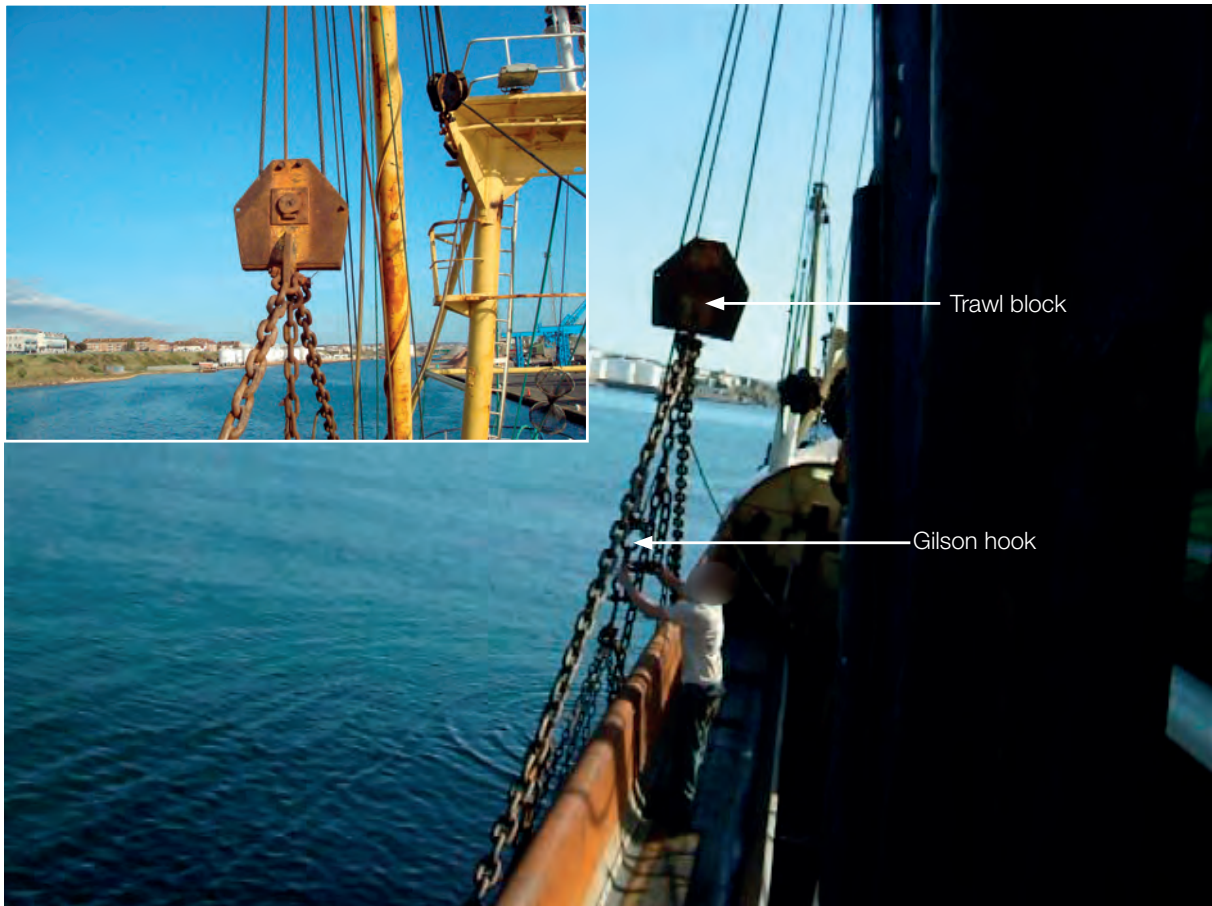
Crewman standing on catch bin attaching gilson wire

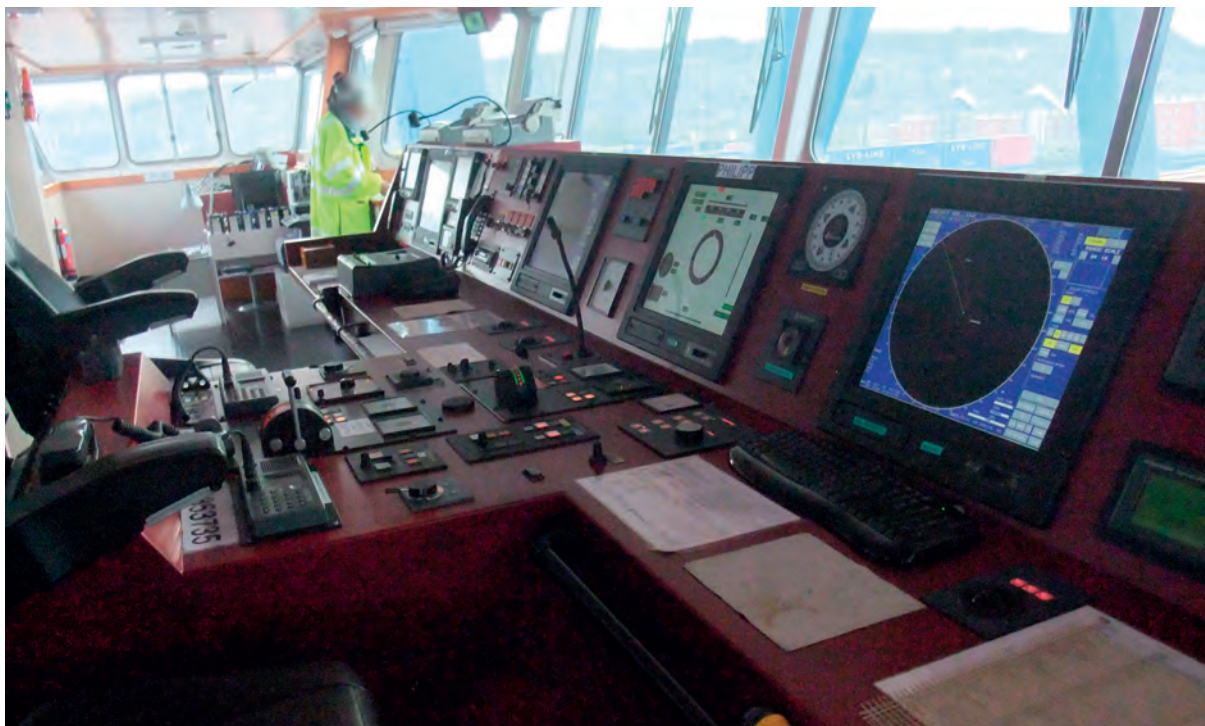
The deckhand on watch on board Boat A had seen the container ship and had initially assessed that she was passing clear. When he saw her closing rapidly from abaft the beam just before the impact, he tried to manoeuvre clear, but without success. Boat A suffered considerable damage to her bow and had to be towed back into harbour.

Bridge control station on container vessel
