MARINE ACCIDENT  
INVESTIGATION BRANCH

# SAFETY DIGEST

**Lessons from Marine  
Accident Reports  
2/2012**

**SAFETY DIGEST**  
**Lessons from Marine Accidents**  
**No 2/2012**

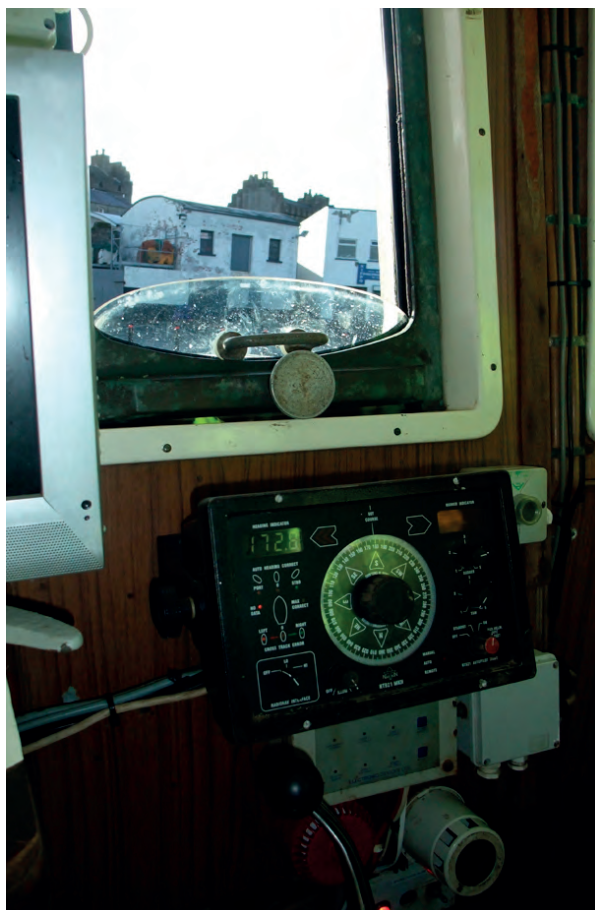
It did not seem to matter too much that two out of the three crew had no safety certificates, or that the written risk assessments were not supported by adequate control measures, including those for wheelhouse operations. And he was not concerned that the vessel was not fitted with a watch alarm because he would always be alert to the navigational situation - or would he?

Figure 1: Position of autopilot

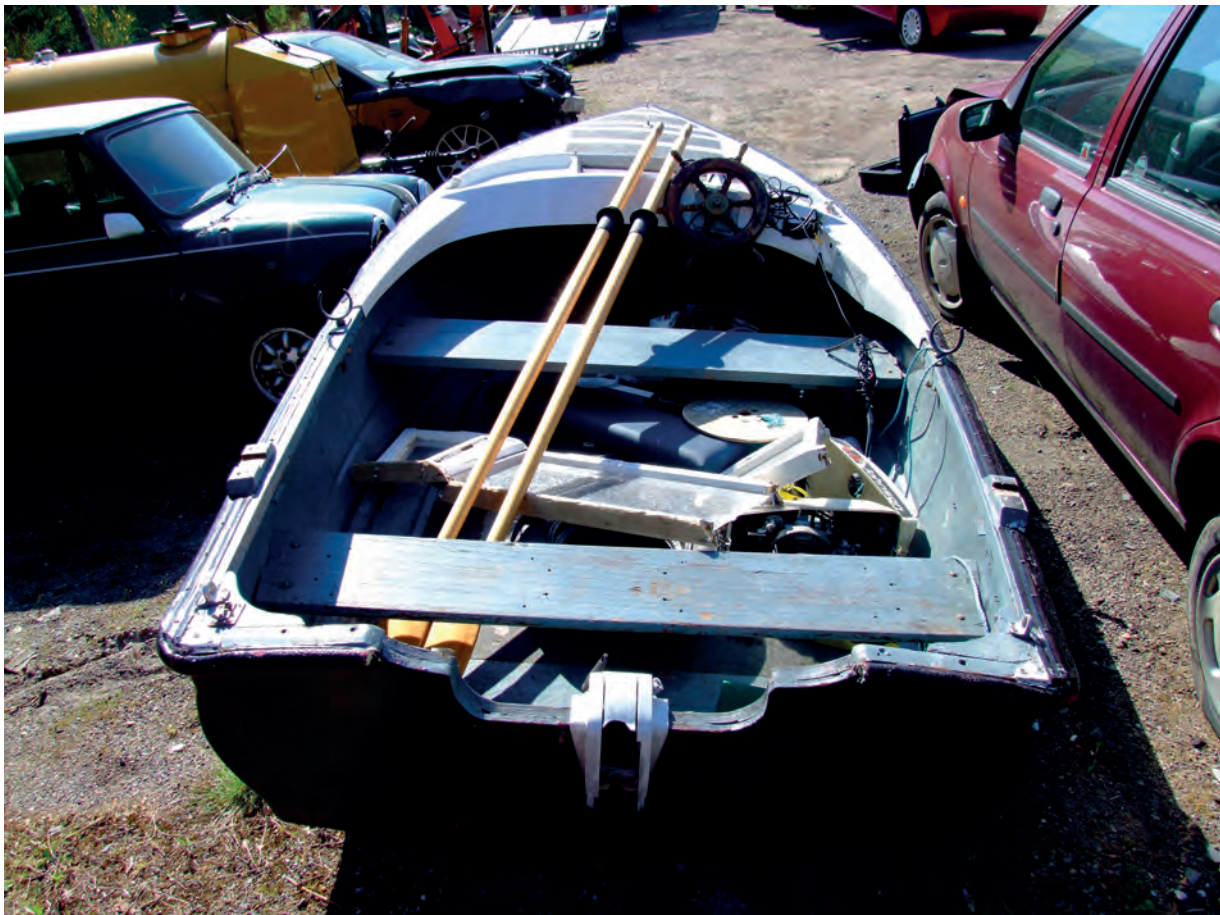
The open wooden boat

1. The fishing boat was not suitable for five men, particularly for the weather conditions on the day. Applying thought as to the boat they were about to use, and taking a considered look at the weather forecast, should have alerted them to the dangers.

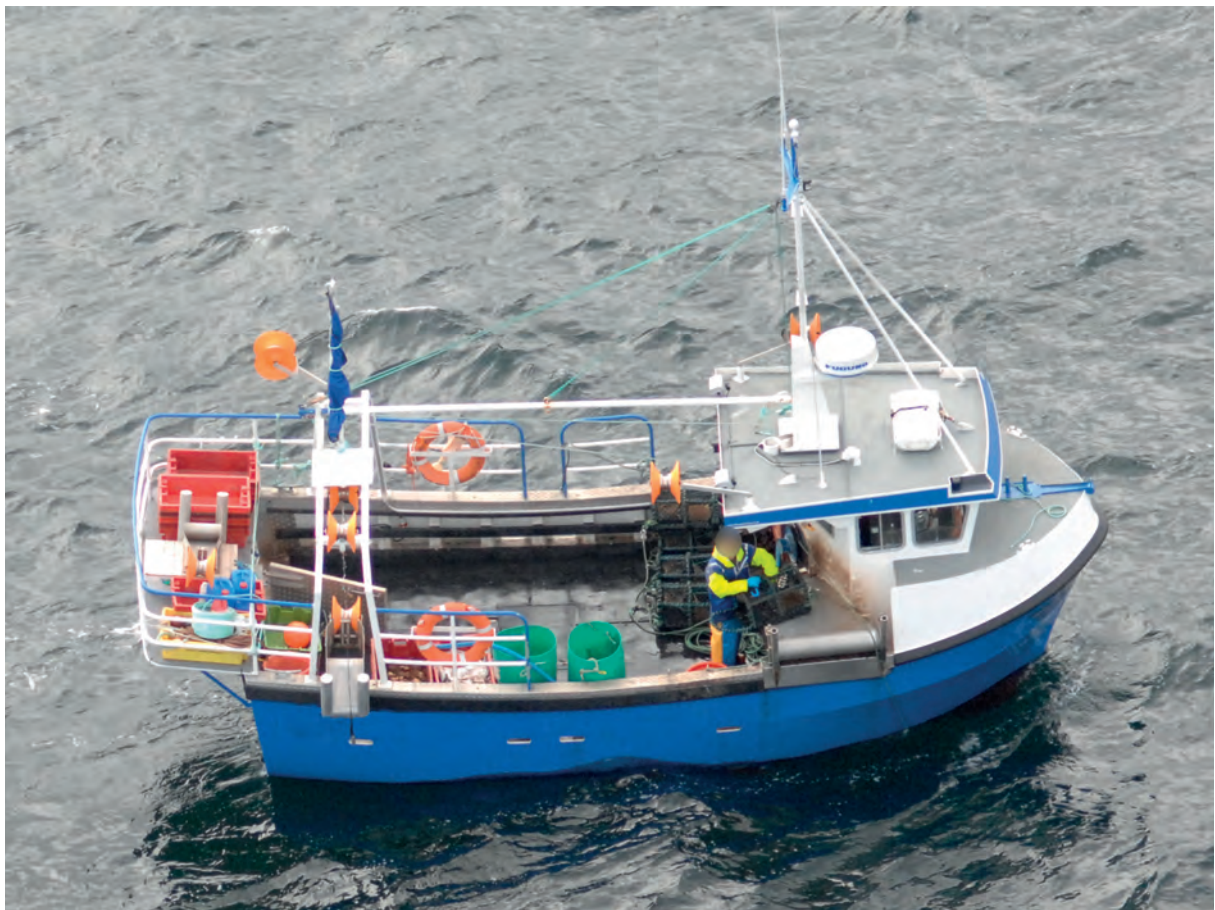
Figure 1: Potter showing potting roller - fishing single-handedly

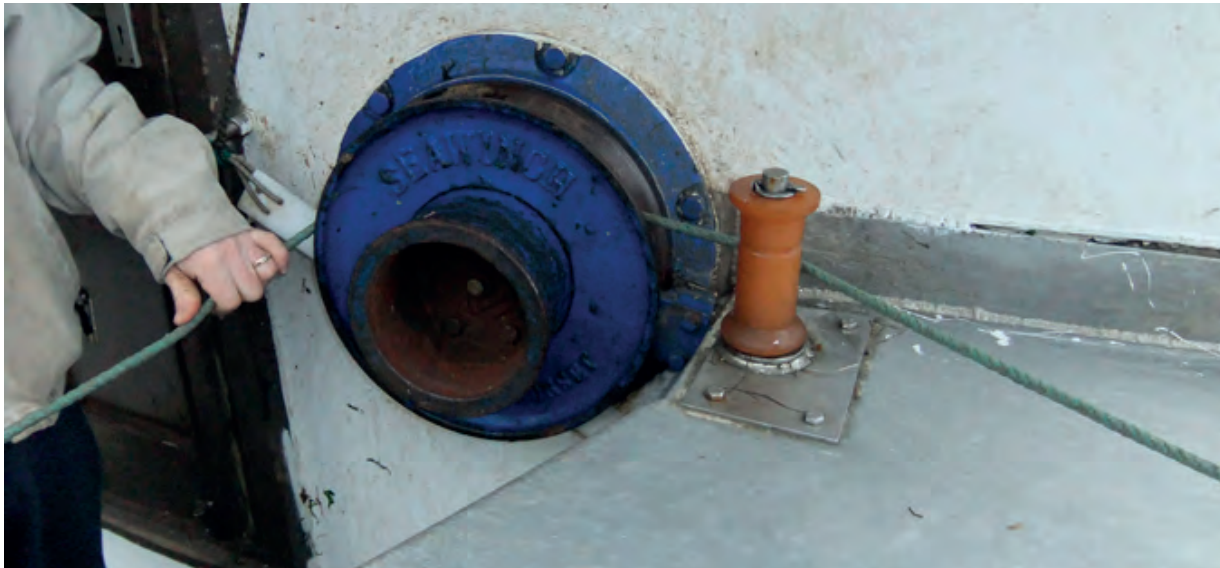
Figure 2: Additional vertical roller fitted close to the 'V' hauler

Careful boat handling is needed to make sure that the back rope leads onto the hauler correctly. This is best achieved by steering the boat so that the back rope leads from an angle forward of the beam. However, this is not always easy to achieve, particularly when working alone in demanding weather and tide conditions. If the back rope is allowed to lead from aft of the beam, there is a chance that it will ride out of the hauler, and the tension from the other creels still in the sea will quickly drag any creels that are on board back over the side. A modification to the system, such as the fitting of an additional vertical roller on the baiting table, can help prevent this from happening (Figure 2).

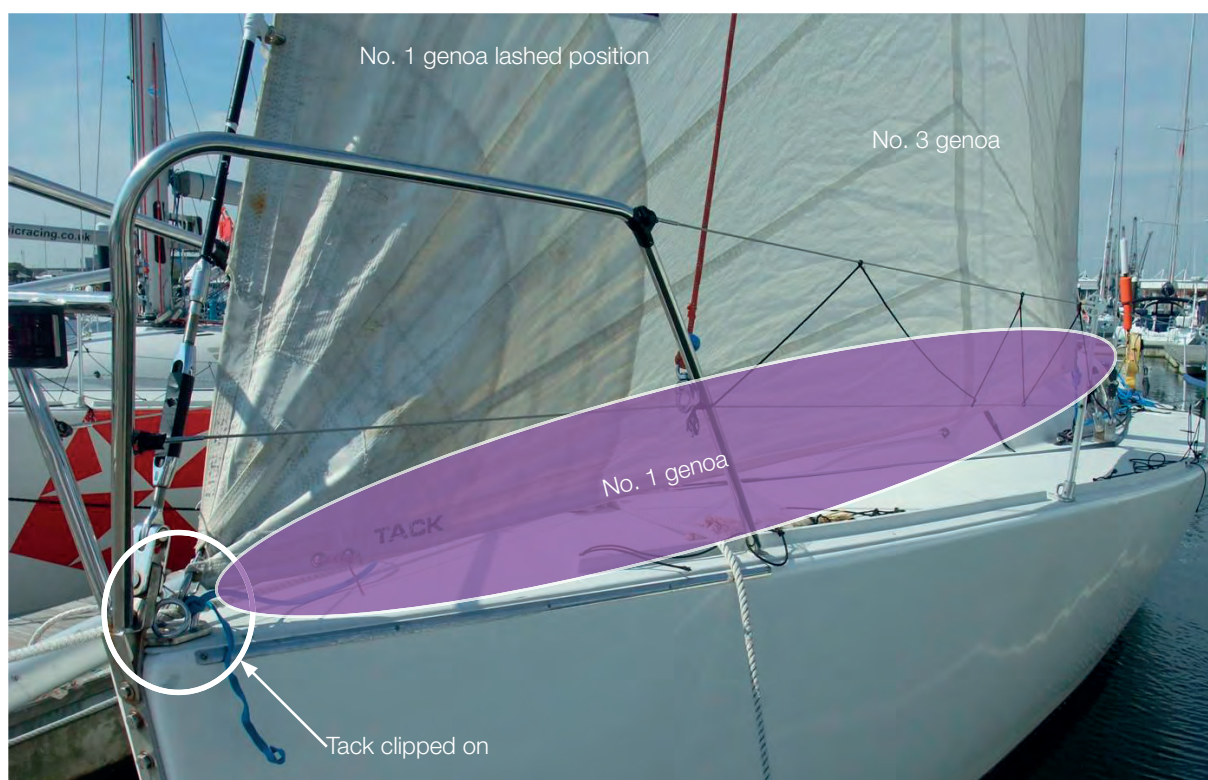
Just before midnight, as the wind gusted up to 38kts and the seas built to 3.5m, the skipper decided to replace the No. 1 genoa with a No. 3 genoa. Contrary to the skipper's normal practice, the No. 1 genoa was secured to the port forward stanchions and guard wires (Figure 1). Soon afterwards, the skipper and two crewmen went to the cabin for a short rest. Just after midnight, in poor visibility, the helmsman spotted that the No. 1 genoa had slipped into the water as the port toe rail dipped below the surface.

Figure 1: No.1 genoa lashed to the port forward stanchions and guard wires

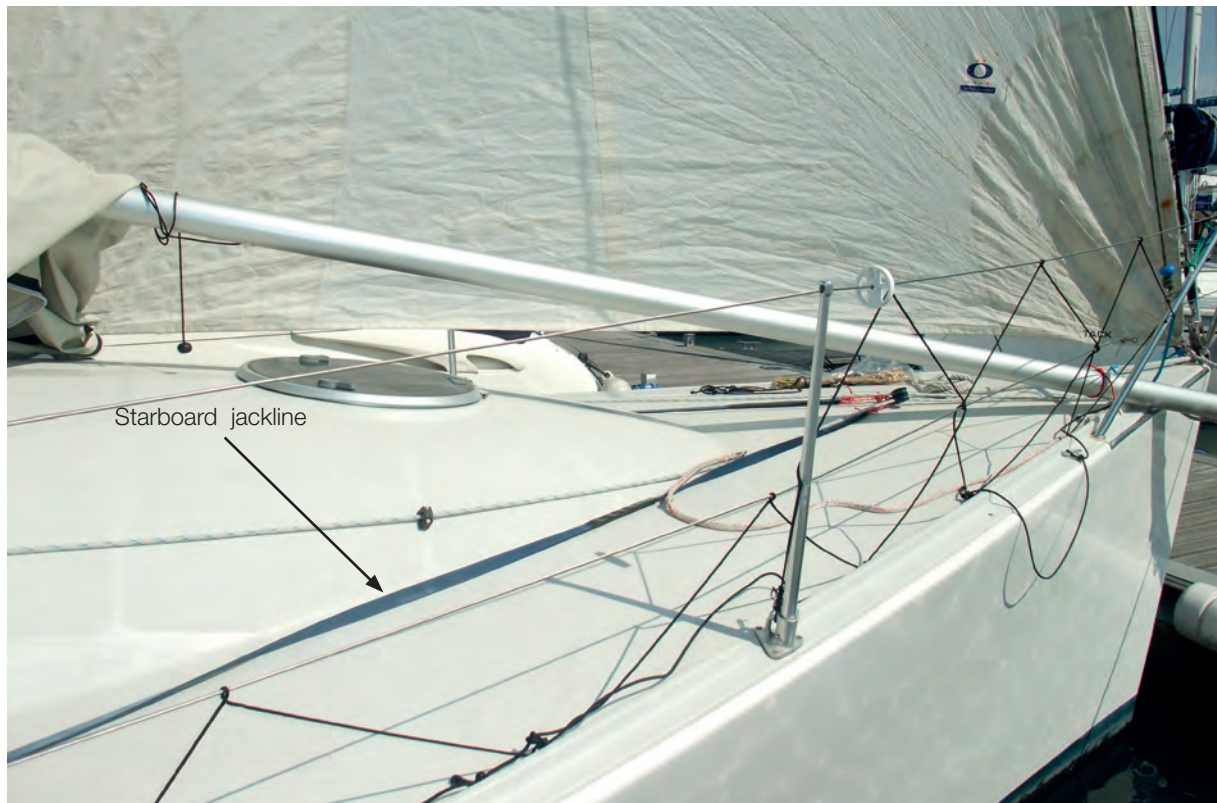
Figure 2: Tether connected to the starboard jackline

The skipper was roused, and he and two crewmen clipped onto the starboard jackline (Figure 2) with their 1.8 metre-long tethers, and made their way forward, on the high starboard side.

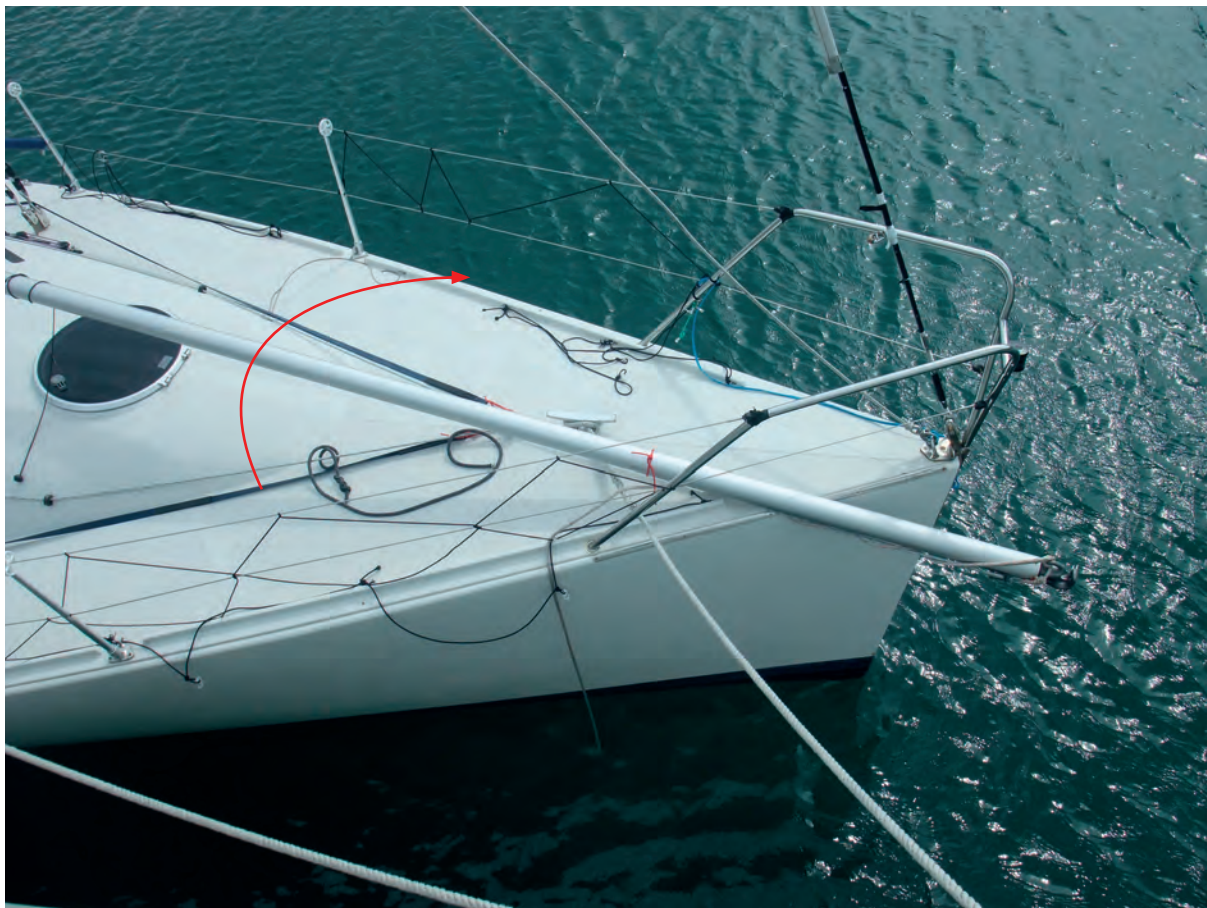
The skipper's tether was clipped to the starboard jackline. He had passed over the spinnaker pole and under the bottom guard wire (Figure 3). The skipper's inflated lifejacket bladder was partially covering his face, which made it difficult to check for signs of life. The situation was confused and was hampered by poor communications because no one was in overall control during the early stages of the accident as no one had been nominated to take over from the skipper.

Figure 3: Path of the skipper falling overboard

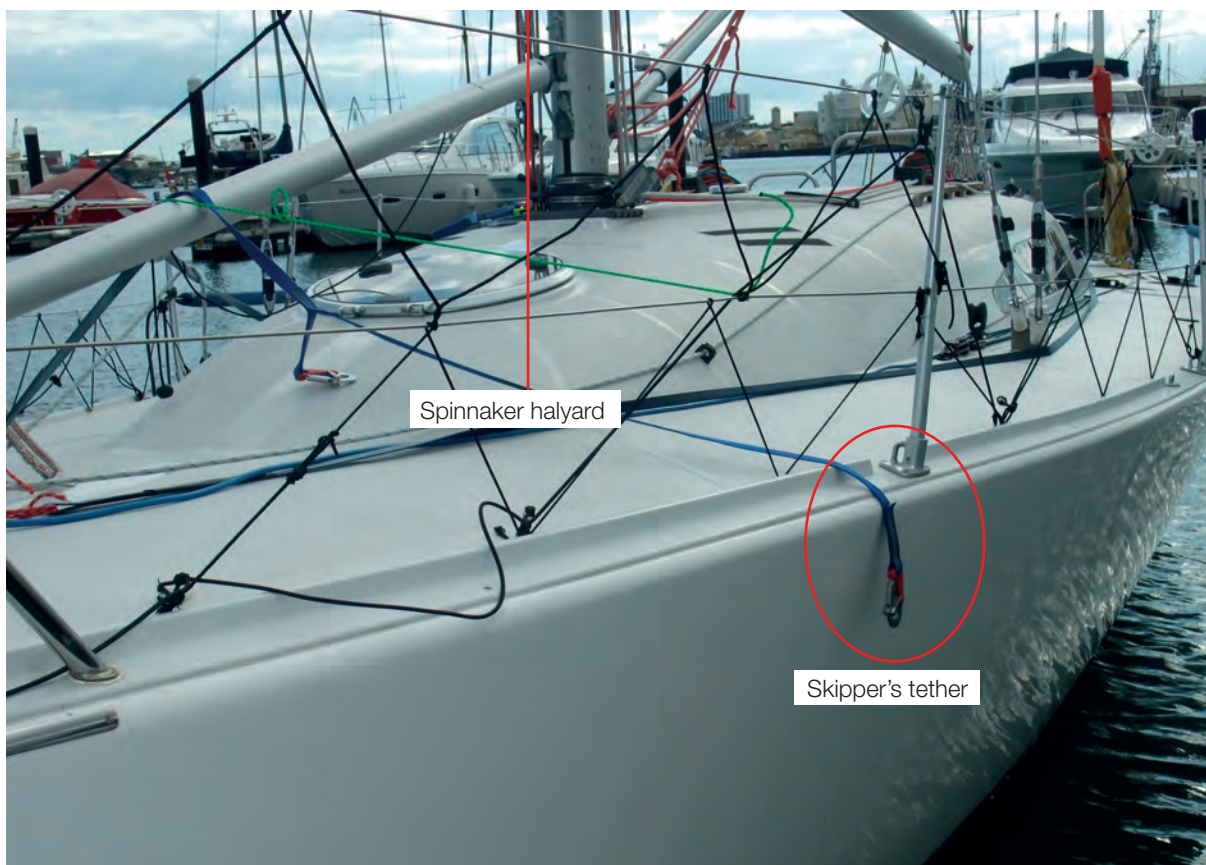
There was no response from the skipper as the crew fought hard to keep his head above water, but with limited success. After about 10 minutes of strenuous effort, a spinnaker halyard was connected to the skipper's tether and he was hauled clear of the water (Figure 4).

Figure 4: Spinnaker halyard connected to the skipper's tether

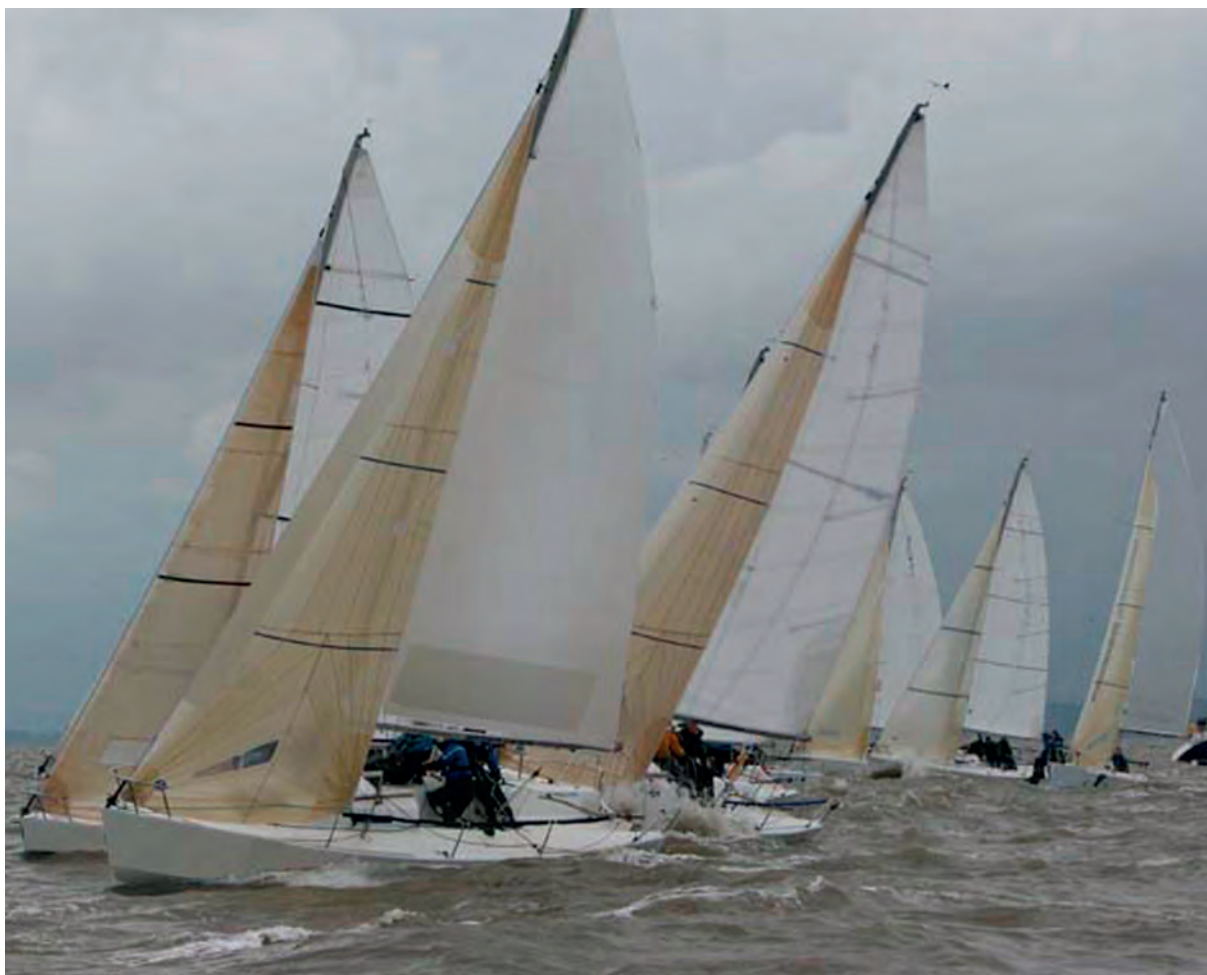
Although on the day of the race the weather was challenging, the crew were experienced and were very much looking forward to putting in a good performance. The race got underway and the crew and the yacht were doing well (Figure 1). Unfortunately things were about to take an unexpected turn.

Figure 1: J80 race
