# SAFETY DIGEST

**Lessons from Marine  
Accident Reports  
1/2013**

**SAFETY DIGEST**  
**Lessons from Marine Accidents**  
**No 1/2013**

April 2013

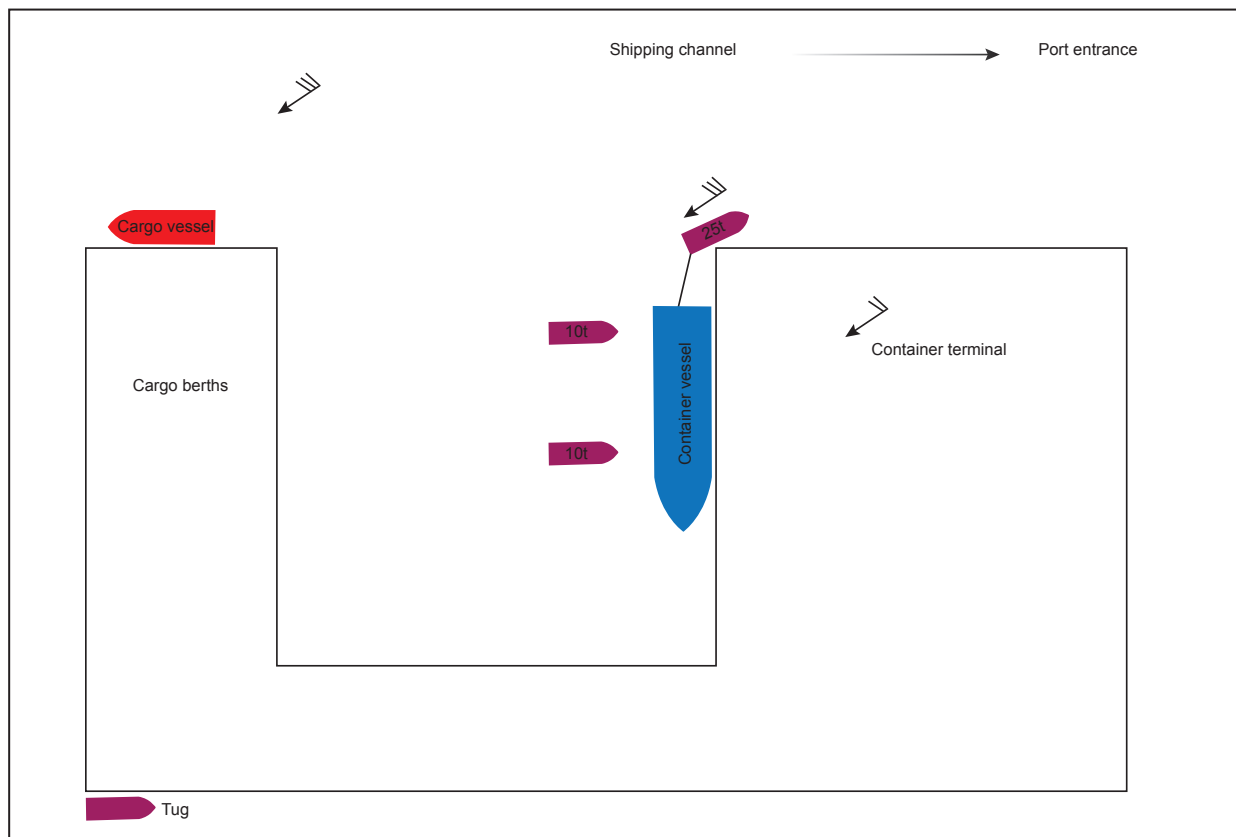
Once the vessel's mooring lines were let go she was quickly set off the berth by the wind (Figure 1) as she proceeded astern into the shipping channel. However, as the vessel moved astern into the main shipping channel, the force of the wind acting on her port beam was greater than the power the tugs could produce to hold the vessel against the wind. She was then rapidly set towards a cargo ship on an adjacent berth (Figure 2).

Figure 1: Vessel moves off berth and proceeds astern

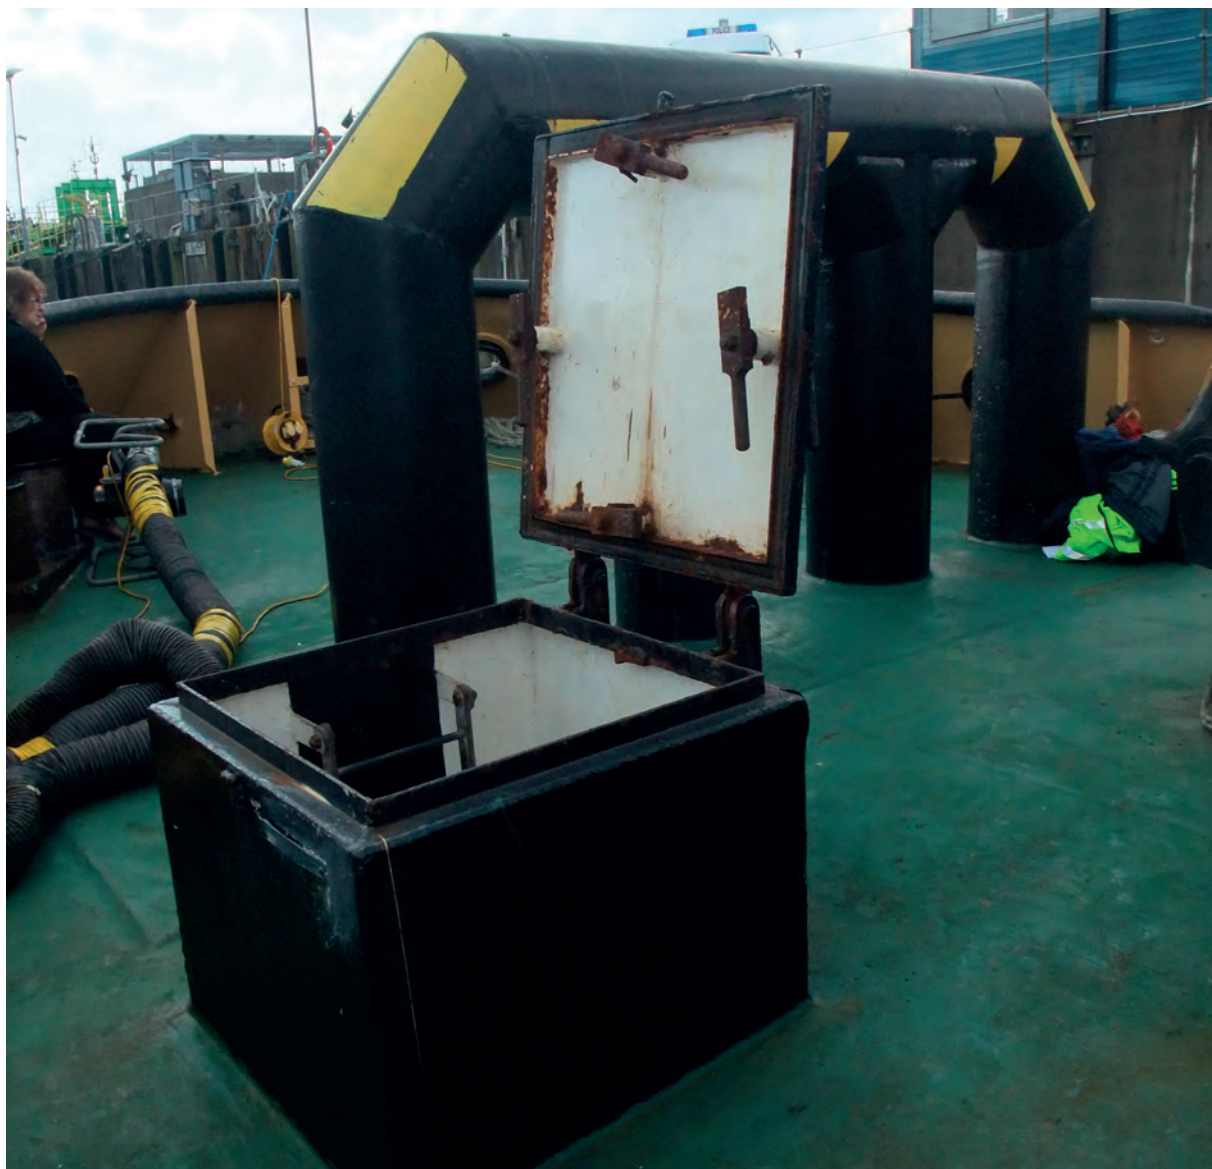
The senior engineer was directed to the CO<sub>2</sub> bottle room by an AB who was working on the aft deck, while the trainee prepared the release cabinet sited in the accommodation area. The AB opened the access hatch on the aft working deck (Figure 1) to enable the senior engineer to access the bottle room located in the hold below. The AB then continued with his work on the aft deck.

Figure 1: The hatch on the aft working deck

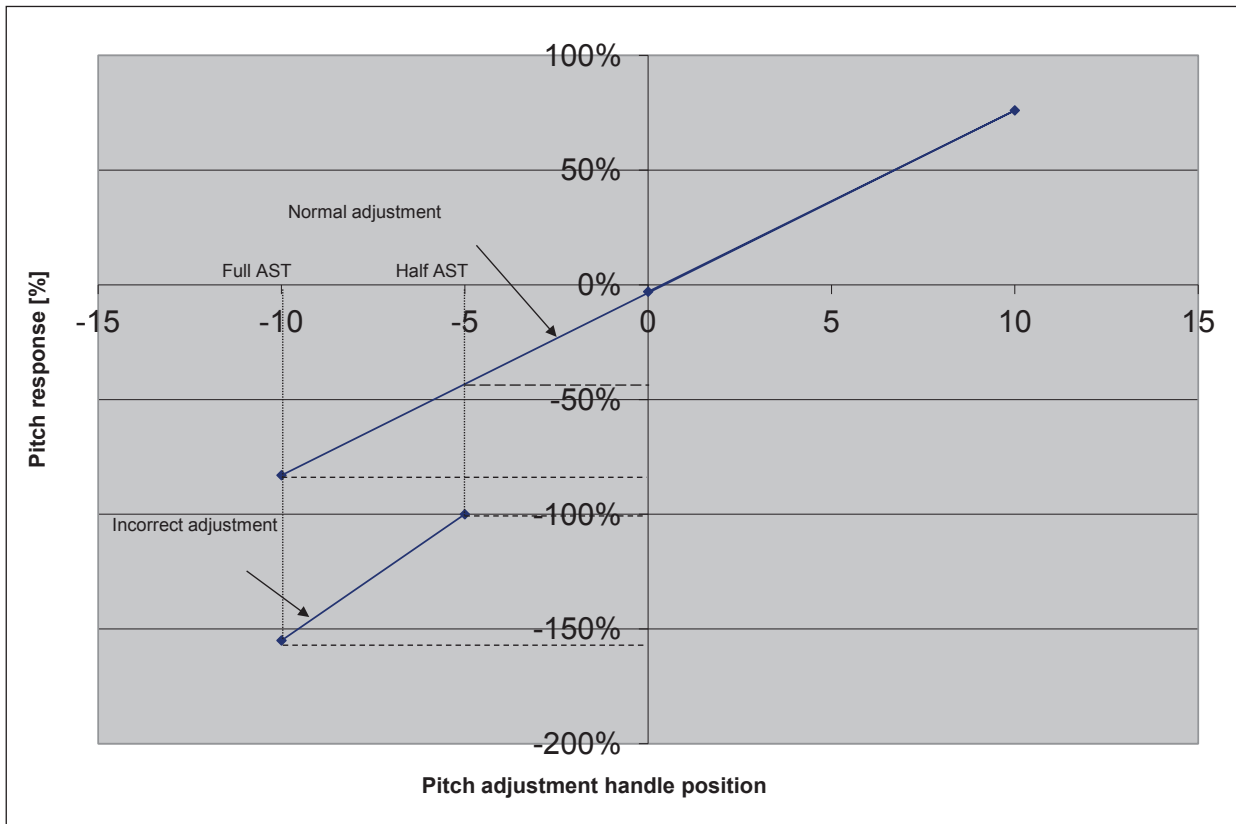
Figure 1: CPP behaviour with correct and incorrect adjustments

1. *Always carry out a full set of CPP tests, both ahead and astern.* Astern movements are not used as often as ahead movements. However, they are equally important. If the CPP system malfunctions in restricted waters, it is highly likely that it will result in an accident. Before every operation in restricted waters, carry out a complete set of engine tests in both ahead and astern directions.
2. *Familiarise yourself with the equipment you operate - in particular, understand what to do when it fails.* In an emergency situation, you will have very little time to think and reason. If you are not fully conversant with the failure modes of critical equipment, you may not be able to react quickly enough. Drills and exercises for main propulsion system failure should be regularly carried out.

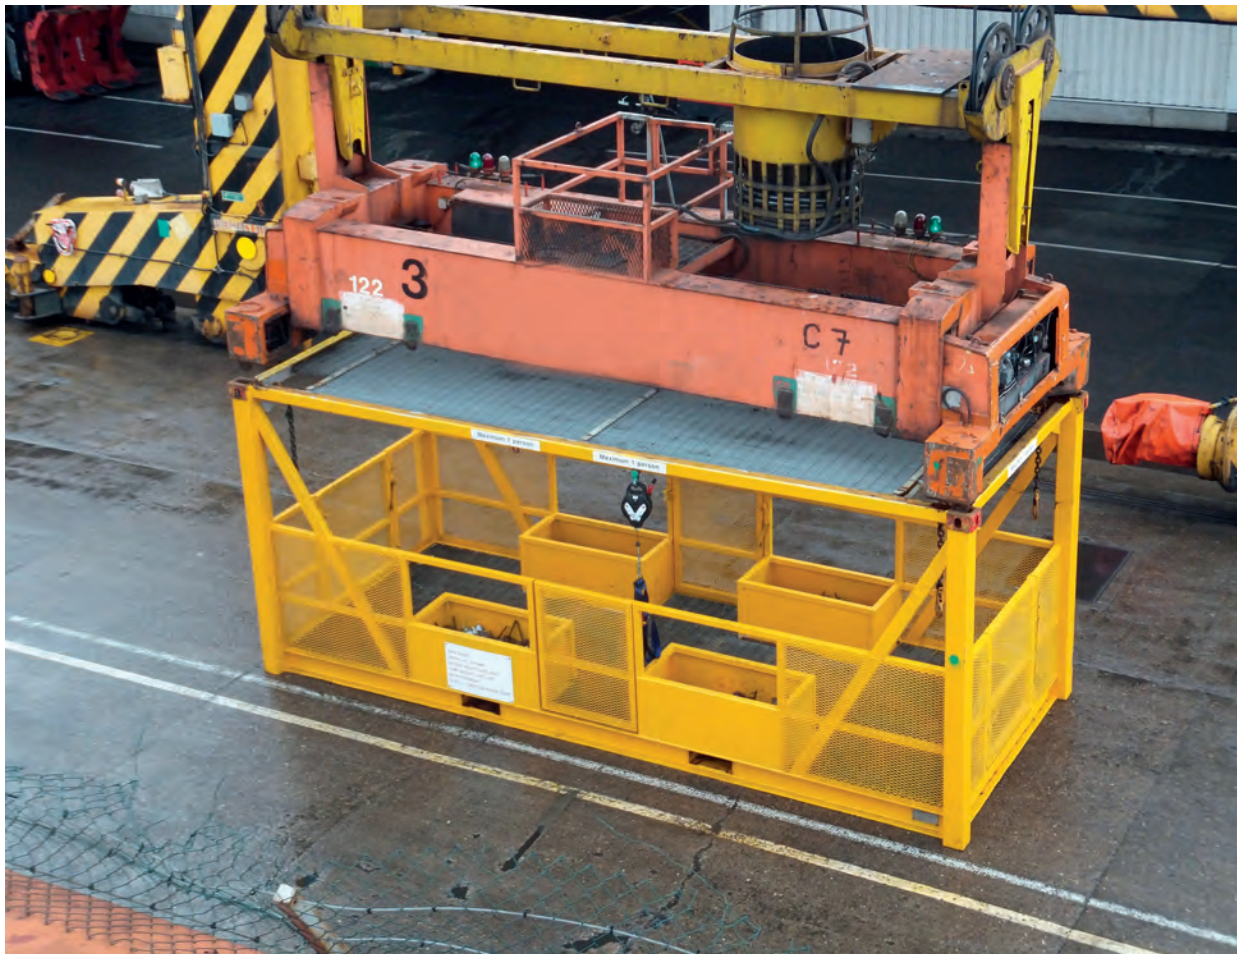
Figure 1: Man-basket

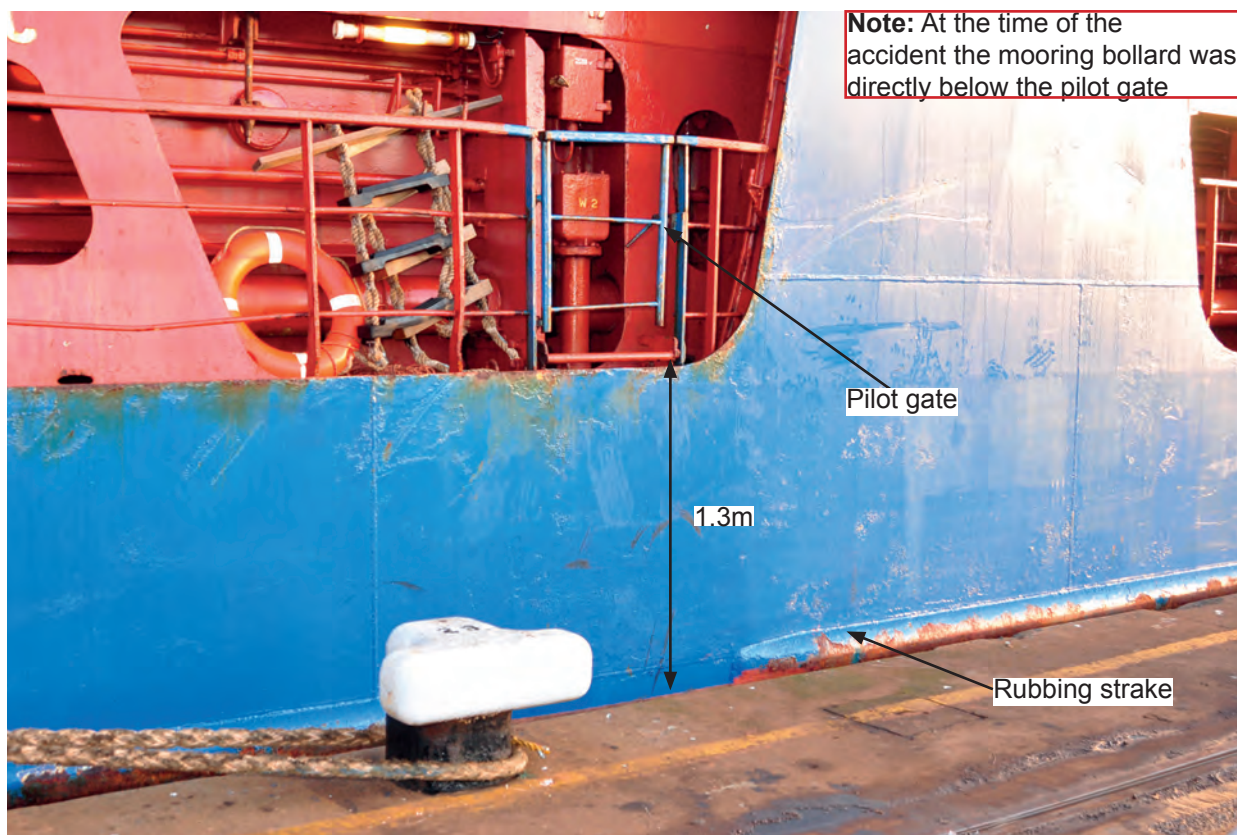
Shortly afterwards, the AB opening the hatch covers heard a scream. He immediately looked over the vessel's side and saw a safety helmet on the quay below the pilot gate sited in the guardrails (Figure 2). The AB quickly ran aft to the cargo room, where he found and alerted the second officer and the bosun. He then went to the aft deck to slacken the stern lines.

Figure 2: Pilot gate

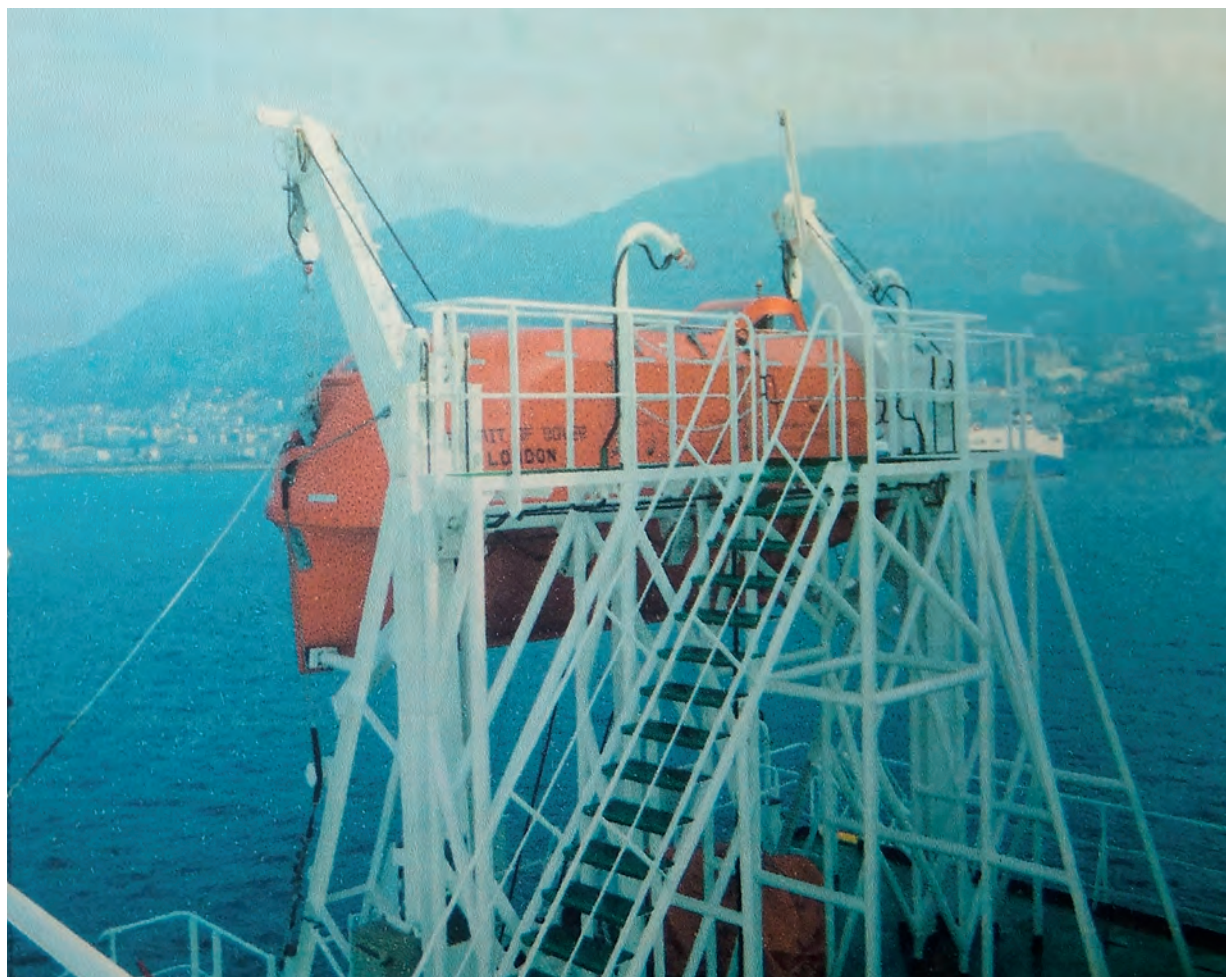
from a raised platform on the deck (Figure 1). The lifeboats were arranged for gravity lowering, in the conventional manner, from the deck, by manually controlling the brake. They could also be lowered from within the lifeboats by means of a control wire, which operated the brake control lever. The 4mm control wire was wound onto an auxiliary drum, which was connected to the main winch drum (Figure 2).

Figure 1: Lifeboat embarkation platform

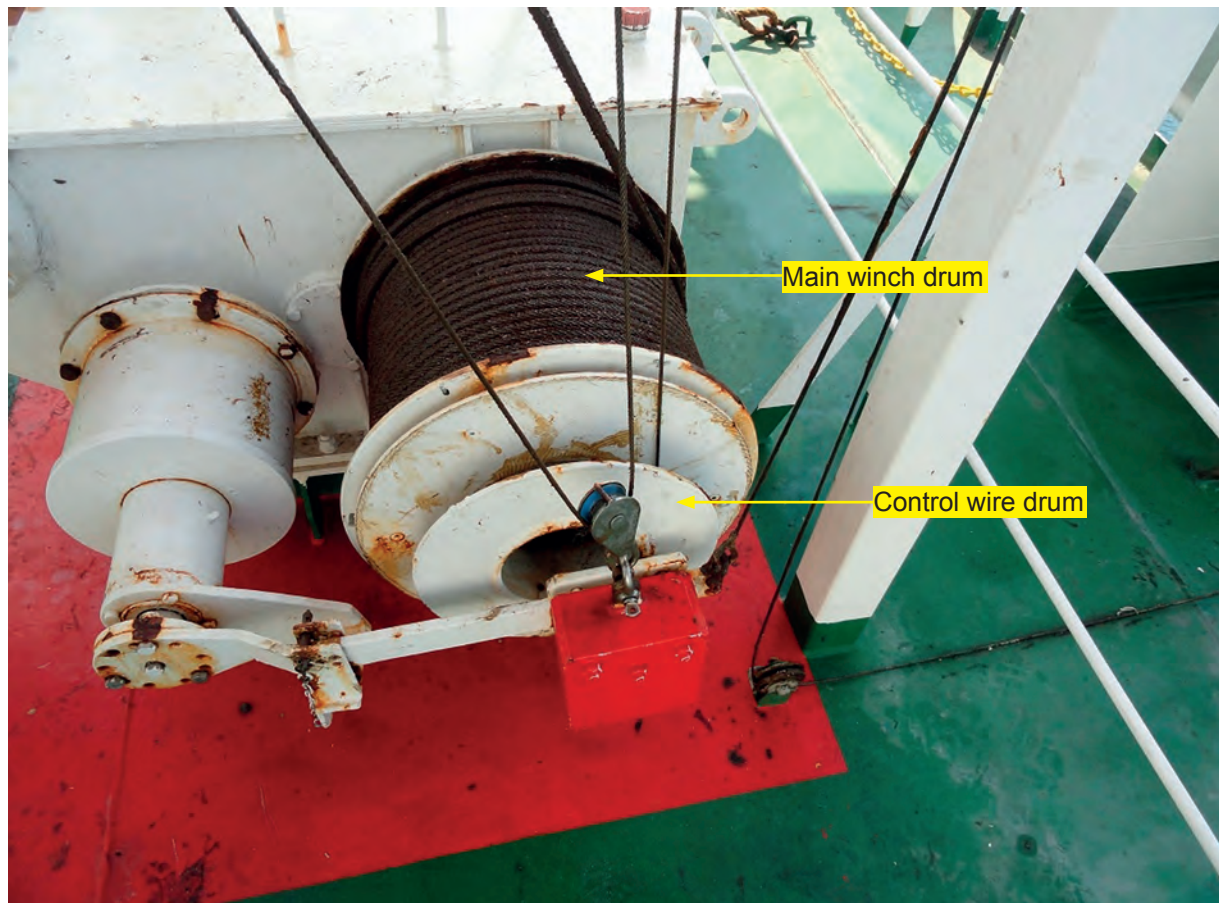
Figure 2: Main winch and control wire drums

Importantly, the instruction manual stated that, during hoisting, the operator should assist in evenly distributing the control wire on the drum to prevent “bunching”. The control wire also passed through four sheaves before finally passing through the lifeboat’s coach roof. Tension was maintained on the control wire by a 3kg counterweight which, according to the instruction manual, should be positioned approximately mid-way between the coach roof and the top sheave positioned at the davit head. This position provided sufficient clearance between the sheave and counterweight when the lifeboat was being hoisted and when fully stowed. The control wire and top sheave arrangements are at Figures 3 and 4 respectively.

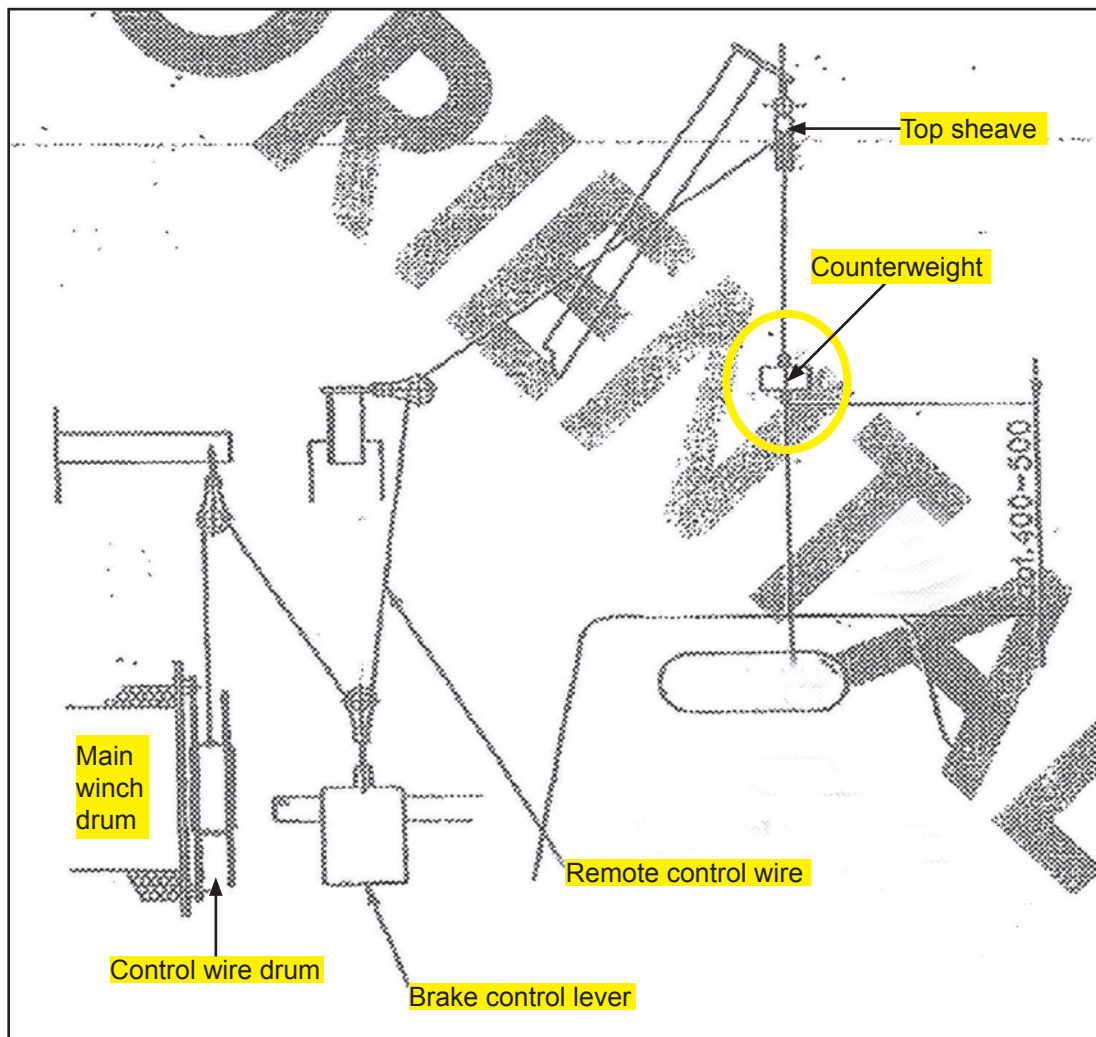
Figure 3: Control wire arrangement

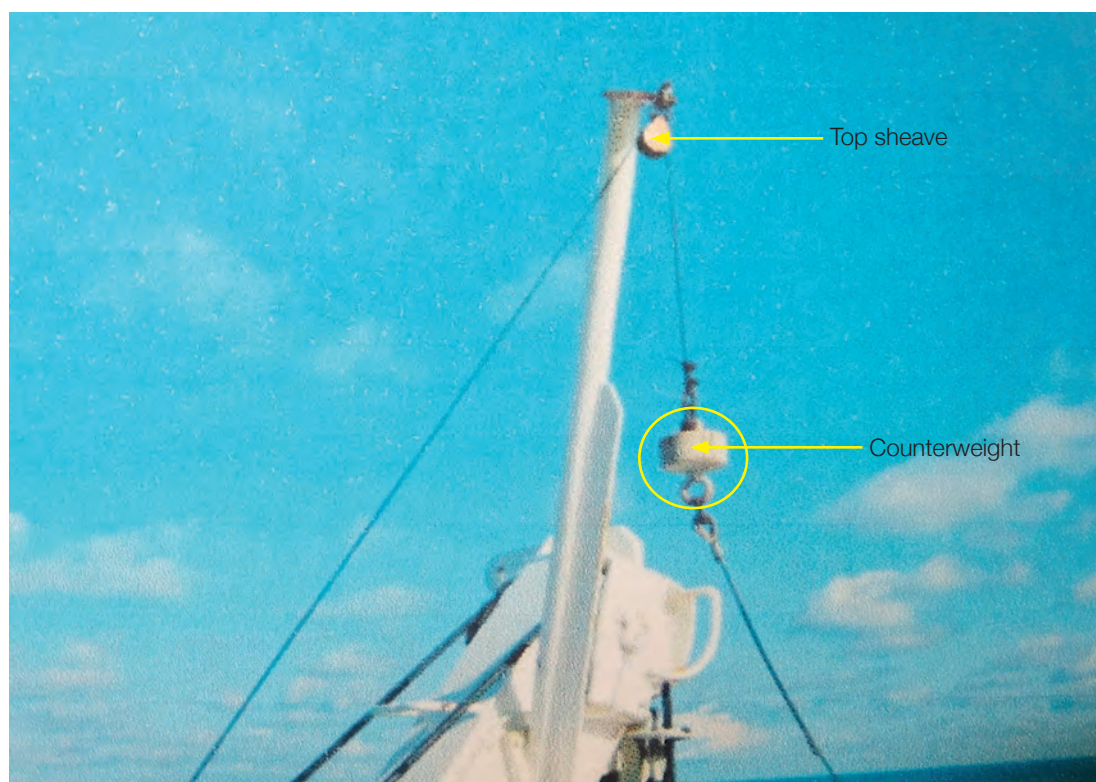
Figure 4: Control wire top sheave and counterweight

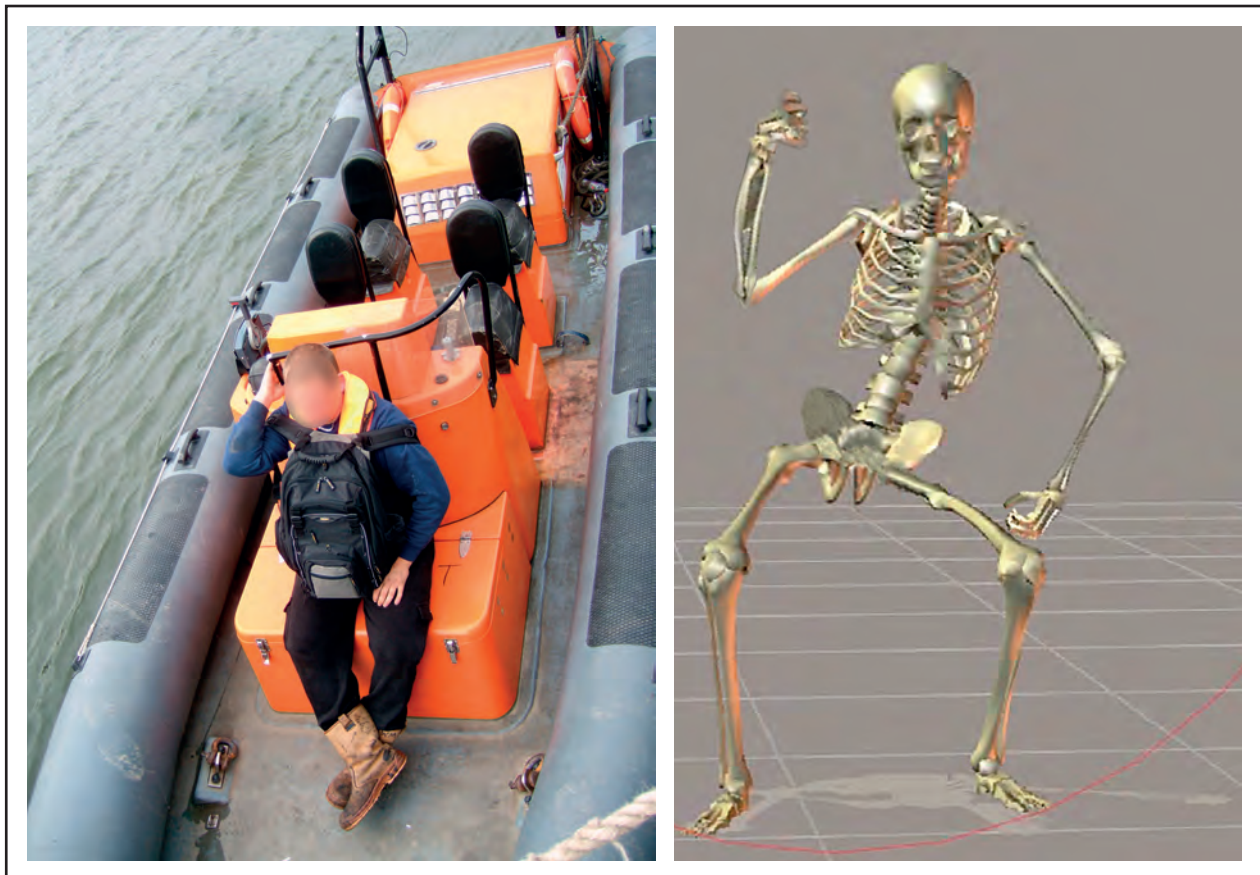
The driver reduced speed and diverted the RIB to a nearby pontoon landing place. There, ambulance personnel boarded and treated the injured person, who was then taken to hospital, where he was diagnosed with anterior wedge fractures of the first and third lumbar vertebrae of the spine.

Figure 1: Reconstruction of the injured person's position at time of accident with skeletal representation of probable spinal alignment

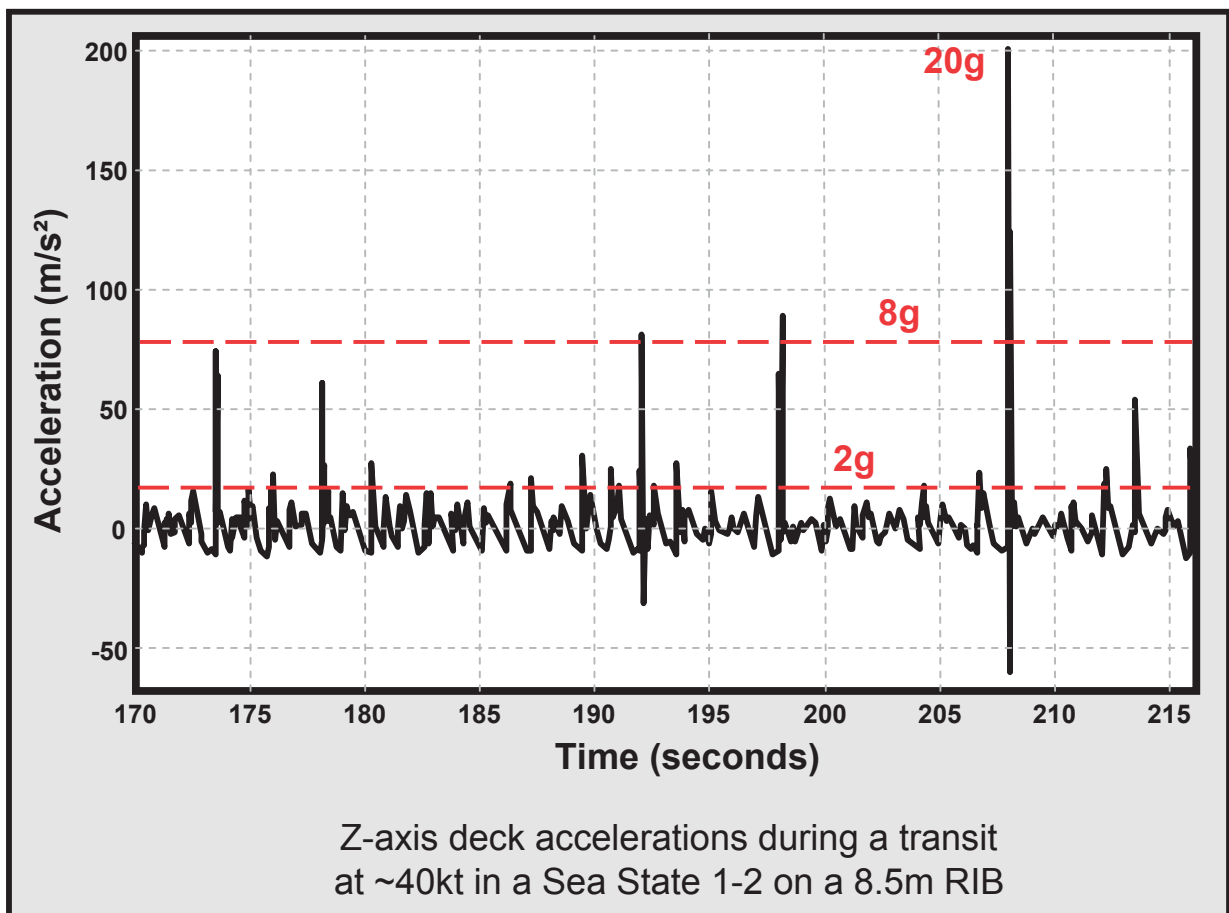
Data obtained during trials conducted on an 8.5m RIB during a high speed passage in calm conditions showed a constant force of  $2g^1$  acting through the deck of the RIB with intermittent shocks of between  $6g$  and  $10g$ . Occasional shocks of up to  $20g$  were recorded during the trials.

The magnitude of the repeated shocks experienced during a high speed passage in a small craft can be sufficient to cause impact injuries to both passengers and crew.

Figure 2: Magnitude and frequency measurements for repeated shocks recorded on an 8.5m RIB

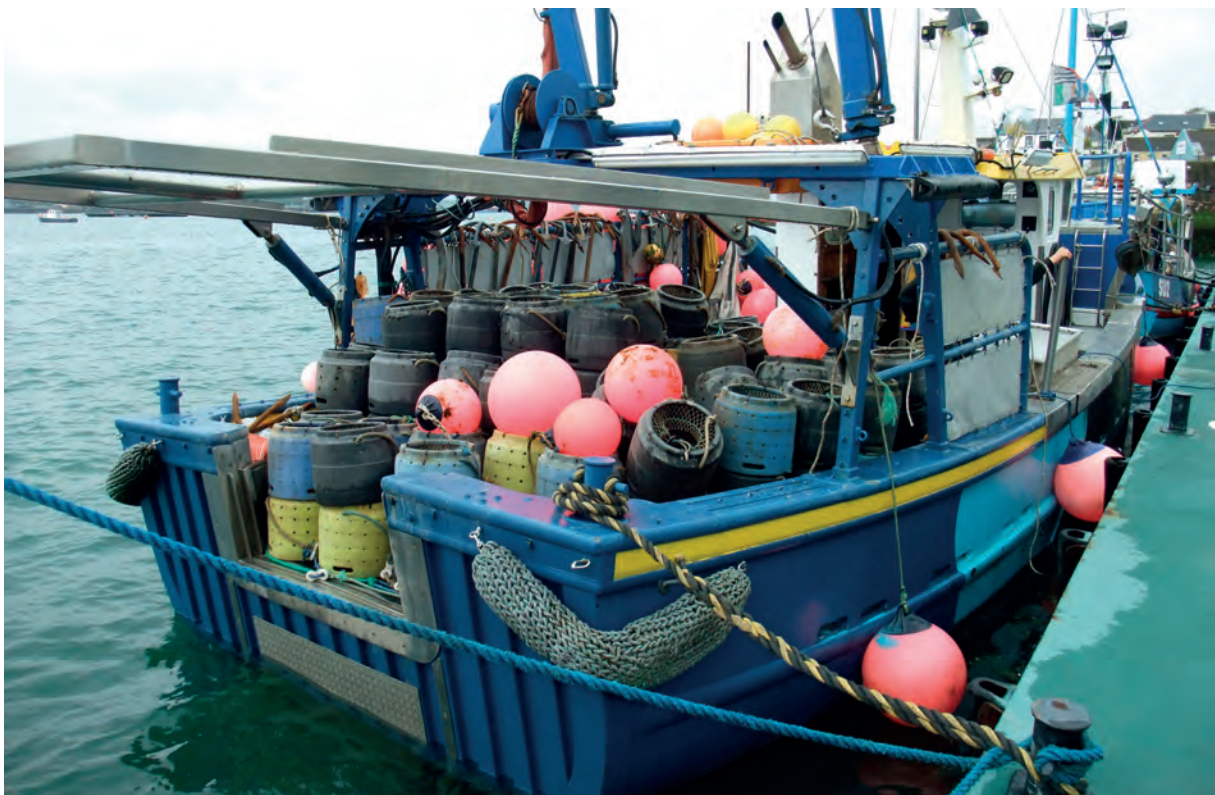
Figure 1: Pots stacked on the working deck

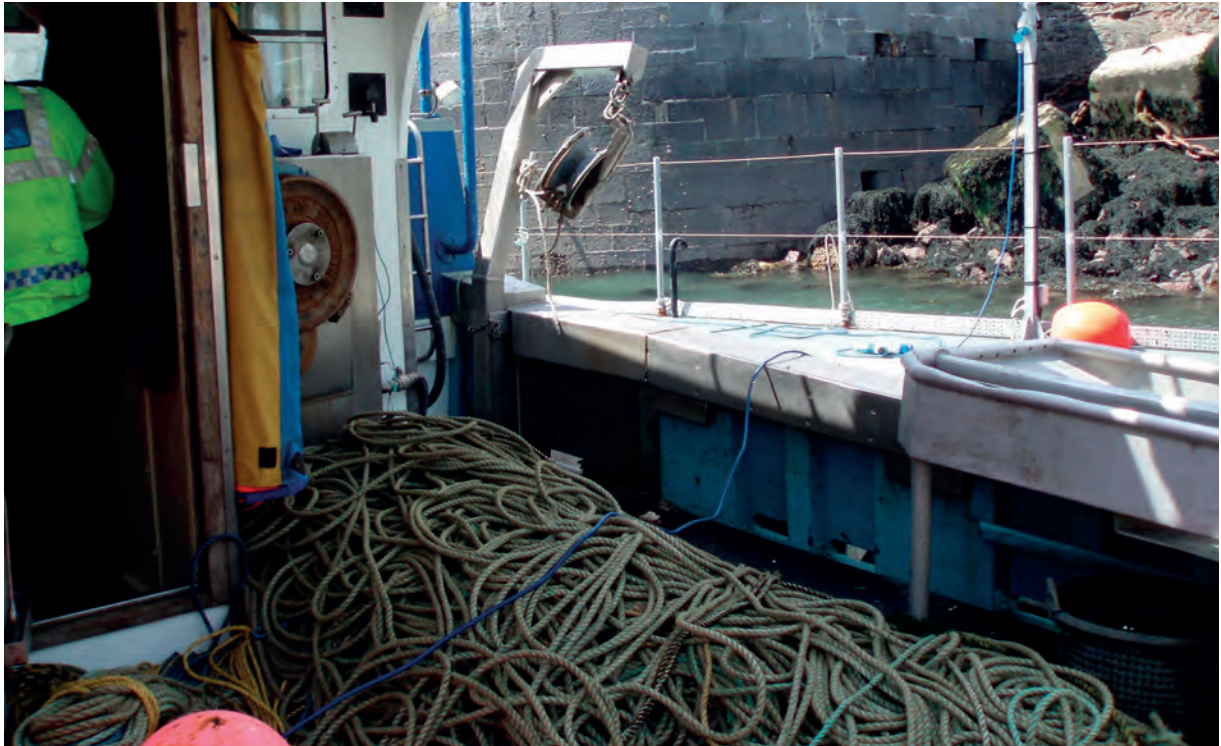
Figure 2: Back ropes and strops

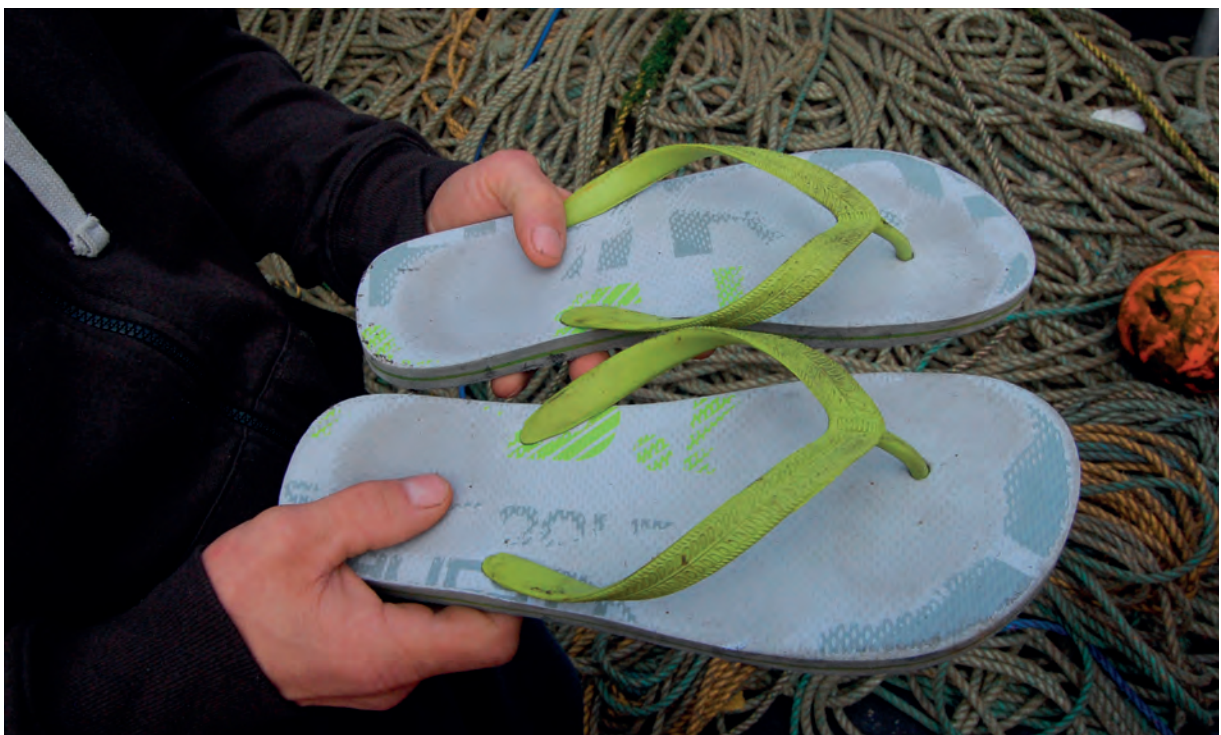
involving a large number of vessels and a helicopter, he was not found. He had been wearing a t-shirt, jogging bottoms and flip-flops, similar to those in Figure 3, but not a lifejacket.

Figure 3: Similar flip-flops to those that were worn by the crewman

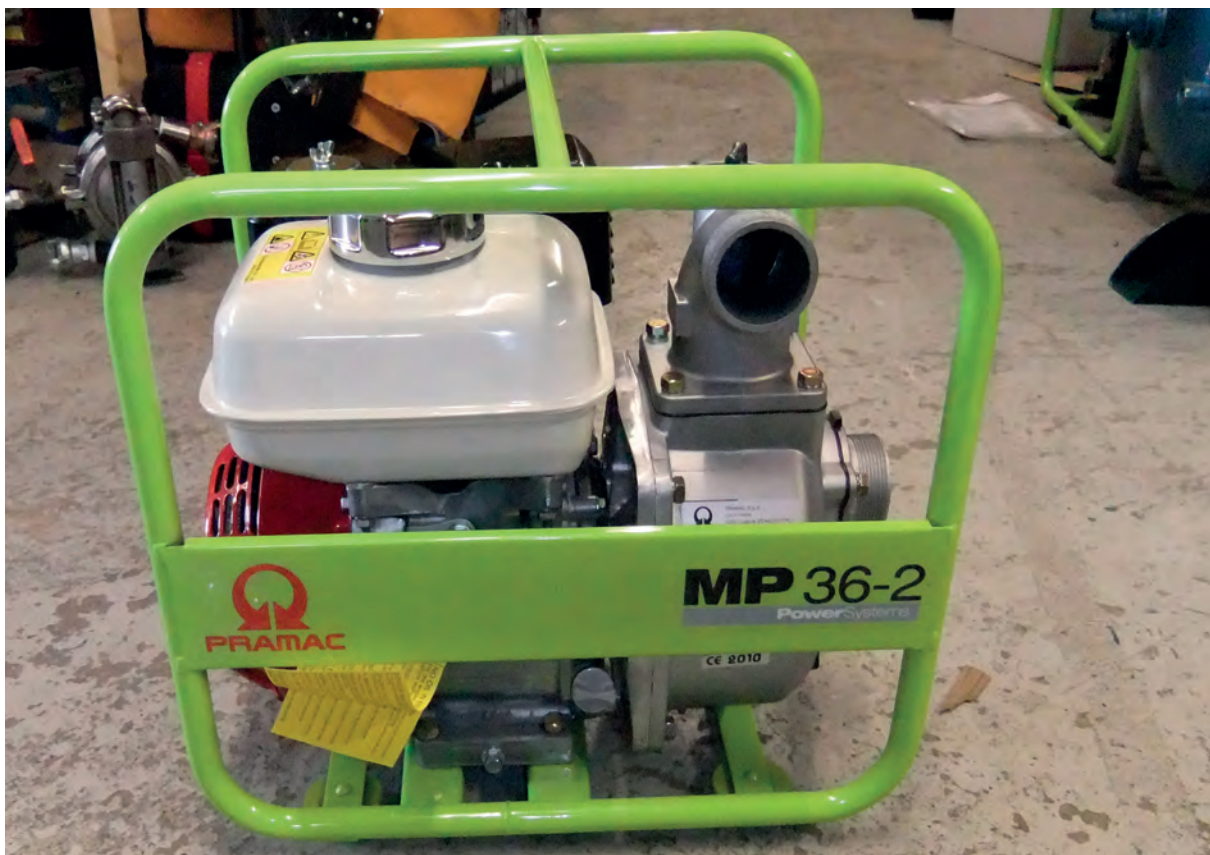
There was no gas monitor on board so the crew were not able to check whether the fish hold was safe to enter in order to rescue their collapsed colleague. Similarly, they were unable to enter the toxic atmosphere of the fish room safely as there was no breathing apparatus on board to allow this.

Figure 1: Pramac MP 36-2 petrol engine-powered pump

1. Do not use portable petrol or diesel engine-driven pumps in enclosed spaces, such as fish holds, unless the engine exhaust is vented to fresh air outside the space.
2. Ensure you are fully aware of the risks of carbon monoxide poisoning.
3. Think about the risks of operating portable pumps on board your boat, and where these should be best placed to avoid the risk of carbon monoxide poisoning.
4. The temptation to rescue a crewman from an enclosed space such as a fish hold can be overwhelming. However, no attempt should be made to enter the space, which may be hazardous, unless suitable rescue equipment, including breathing apparatus, is available and used. In most cases you should seek help from the emergency services or other vessels fitted with suitable rescue equipment.

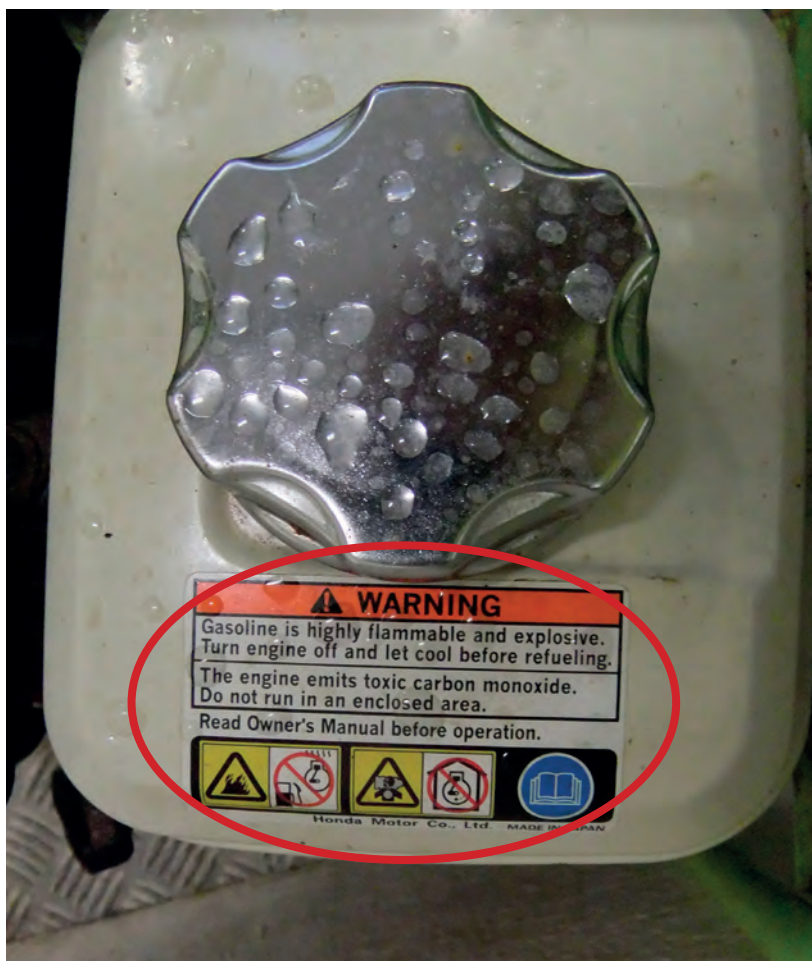
Figure 2: Warning notice on the petrol tank

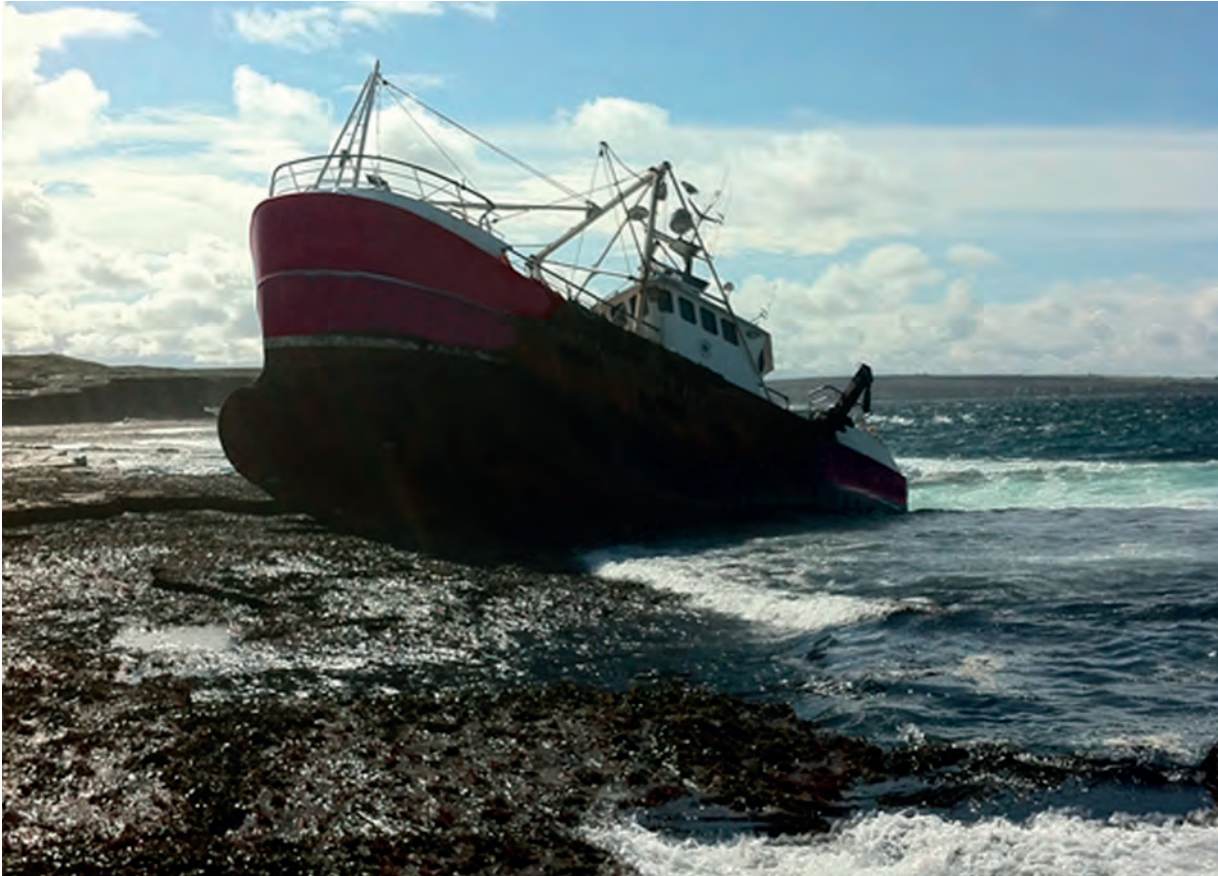
Vessel hard aground

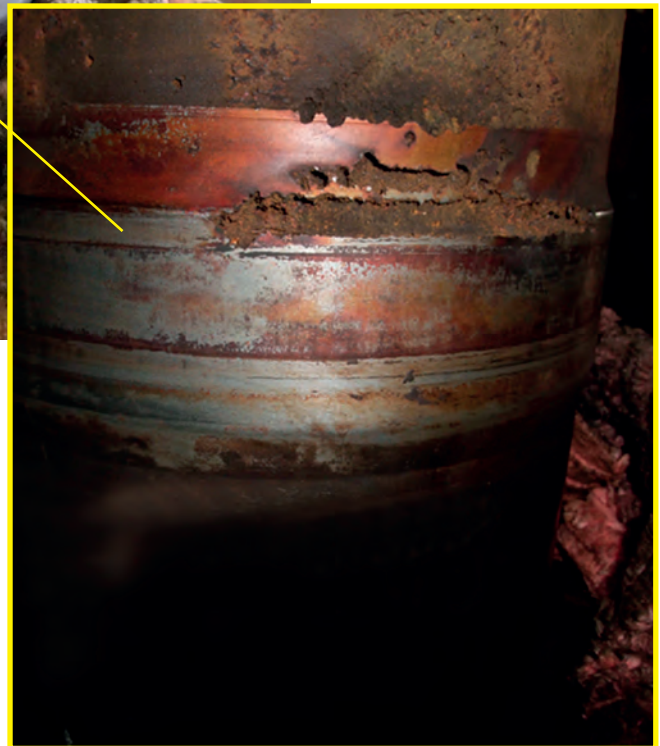
Electrolytic corrosion on vessel's cylinder liner

1. The source of water ingress was unknown, but probably resulted from the failure of a critical sea water fitting due to electrolytic corrosion. When such corrosion is found, always consider if anything else may be affected, and take action to inspect and replace damaged items.

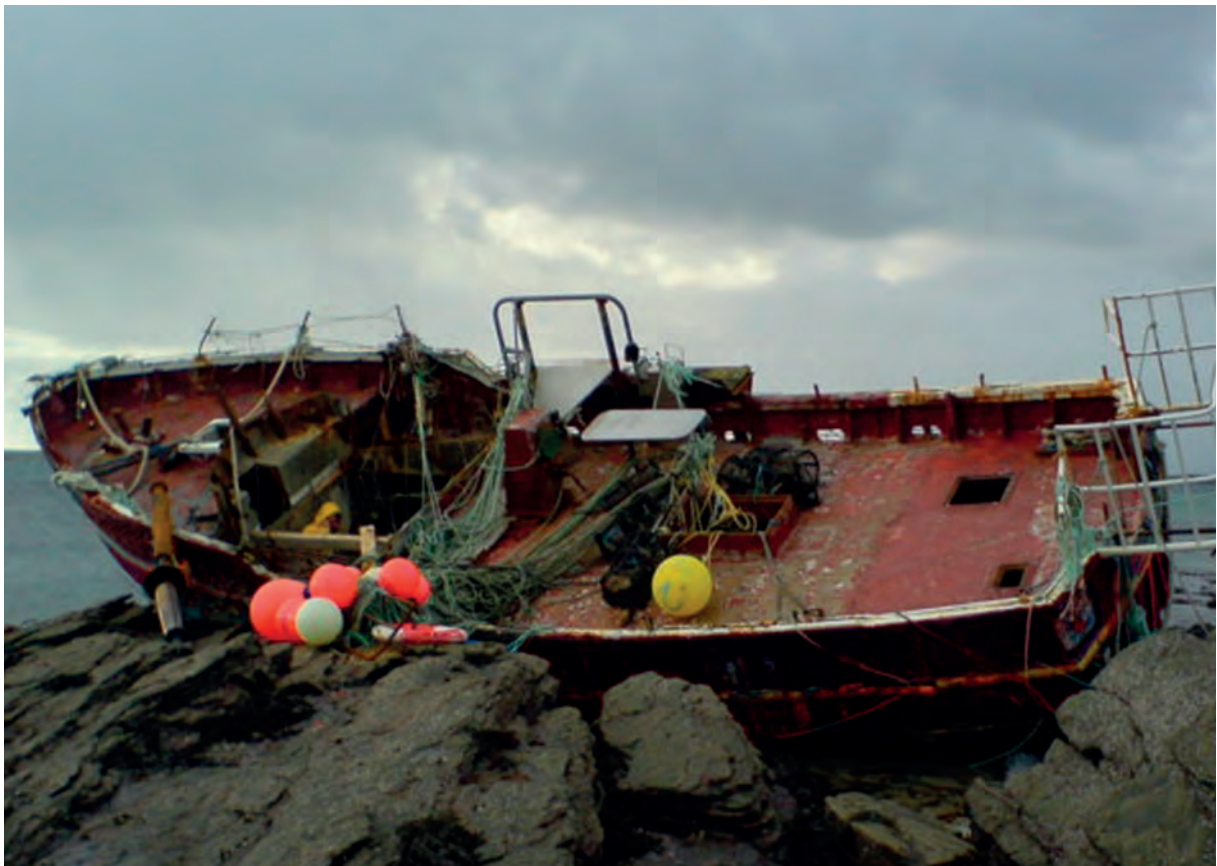
the vessel and the warm wheelhouse to create a sleepy atmosphere, and the deckhand soon fell asleep on a bench seat, knowing that his capable skipper was keeping a good watch. At some point after this the skipper also nodded off, to be awoken by the vessel grounding on a rocky foreshore.

Unfortunately, they were unable to get the vessel off the rocks immediately and were forced to abandon ship as the boat lay over dramatically in the ebbing tide. Neap tides and strong onshore winds in the following days resulted in the boat being completely destroyed before she could be salvaged.

Figure 1: The abandoned vessel

1. This was not an issue of fatigue; the crew were getting adequate sleep every night. This accident was caused by something that everyone has encountered at some time: a good meal, a warm atmosphere and lack of stimulation. All are ideal ingredients for nodding off. Counteract this sleepy feeling by: ensuring there is sufficient through ventilation (not just an open leeside window); getting off the seat and standing up to steer; drinking a cup of coffee; and switching on the radio, even if it does wake up your mate in the corner. And then, why not persuade him to take the wheel.
