# SAFETY DIGEST

**Lessons from Marine  
Accident Reports  
1/2013**

**SAFETY DIGEST**  
**Lessons from Marine Accidents**  
**No 1/2013**

April 2013

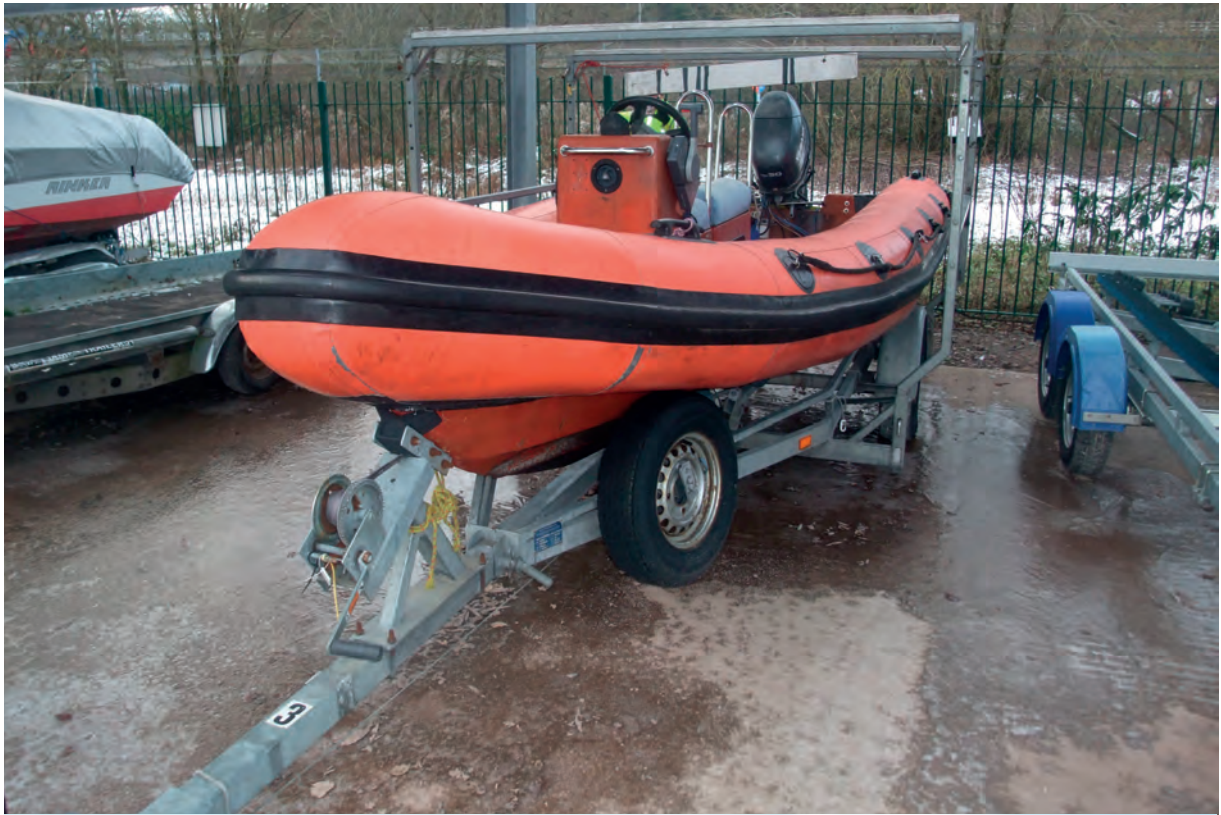
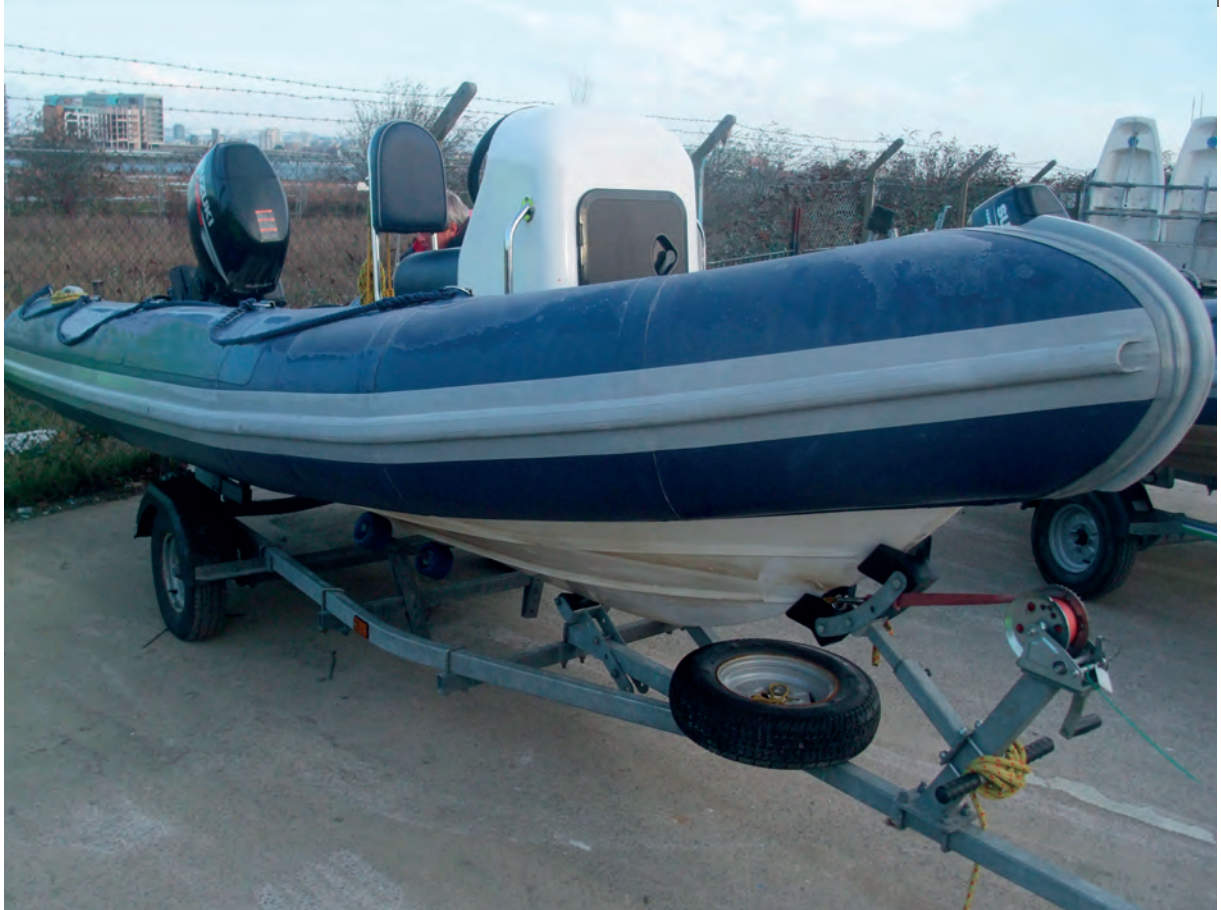
Although it was not initially evident that any of the group had been injured as a result of the collision, several of them later reported feeling unwell and they subsequently required extensive medical attention. One of those thrown overboard by the impact was later diagnosed with post-concussion syndrome, and experienced associated neurological problems which remained unresolved more than a year after the accident. Several of the other young sailors suffered whiplash and muscular injuries which also required prolonged medical treatment.

The RIBs involved in the collision

2. The club appointed two young persons to drive the two RIBs involved in the collision. While the drivers had been recently qualified to drive the RIBs during daylight hours, neither was trained nor experienced in night navigation. The fact that the boats involved in the collision were not carrying radios to communicate their predicament demonstrated the inadequate planning for the passage. Event organisers must ensure that the personnel used for any such transfer are suitably experienced, trained and qualified. They should also be provided with appropriate equipment to undertake such a task safely.

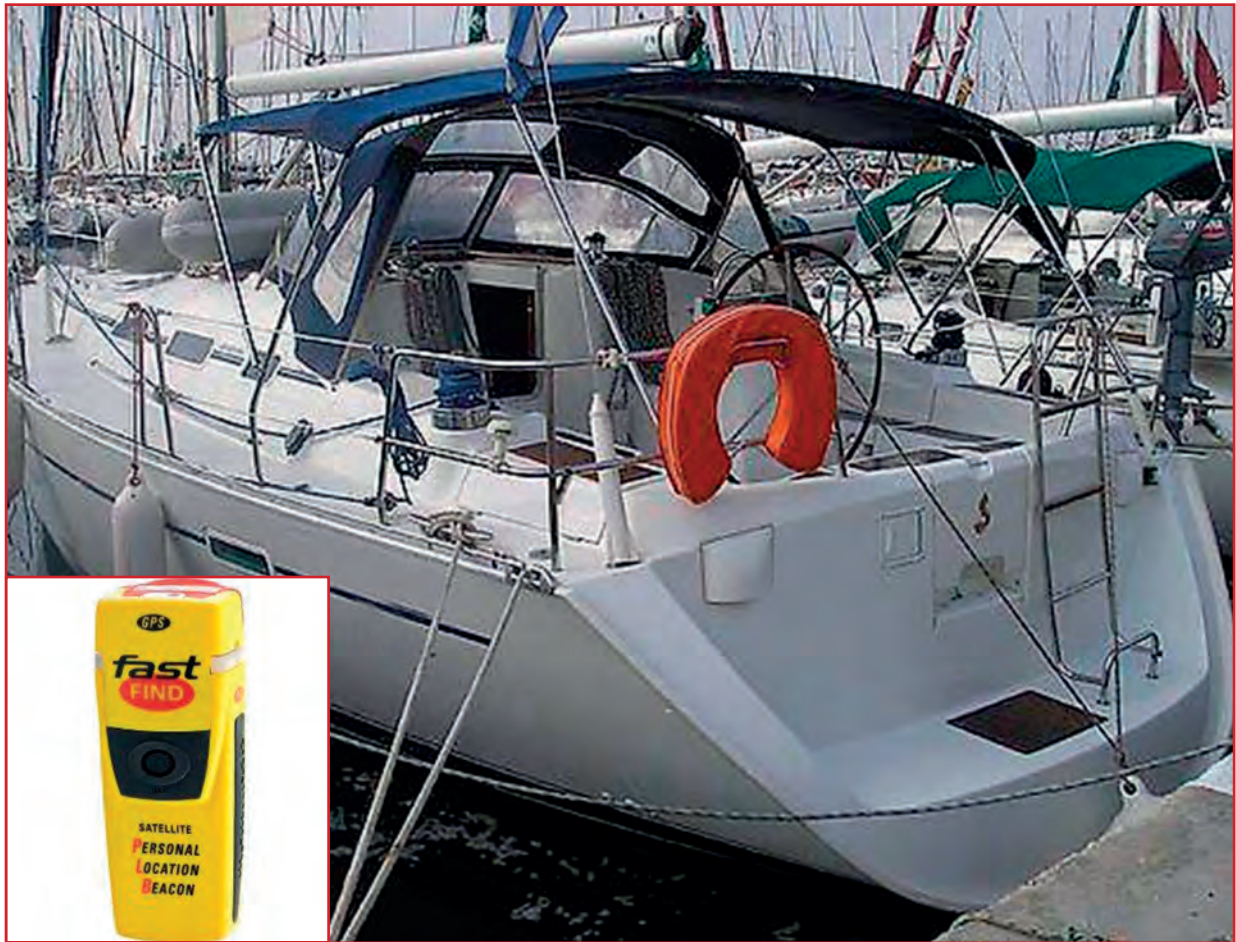
Wearing a lifejacket and harness, but without clipping on, the yachtsman went forward to try to sort out the mess. Seeing that this was not going to be possible he was starting to return to the cockpit when the yacht lurched and sent him over the port side.

The yachtsman was wearing several layers of clothing and a waterproof sailing jacket. Crucially, he carried a PLB, which he activated immediately. PLBs transmit on the same 406 MHz frequency as EPIRBs, so the alert was raised quickly. The yachtsman realised that being several miles offshore made it pointless for him to try to swim to shore, so he lay with his head to wind, his face sheltered by the cotton brimmed hat he was wearing.

The yacht and type of personal locator beacon involved in the accident

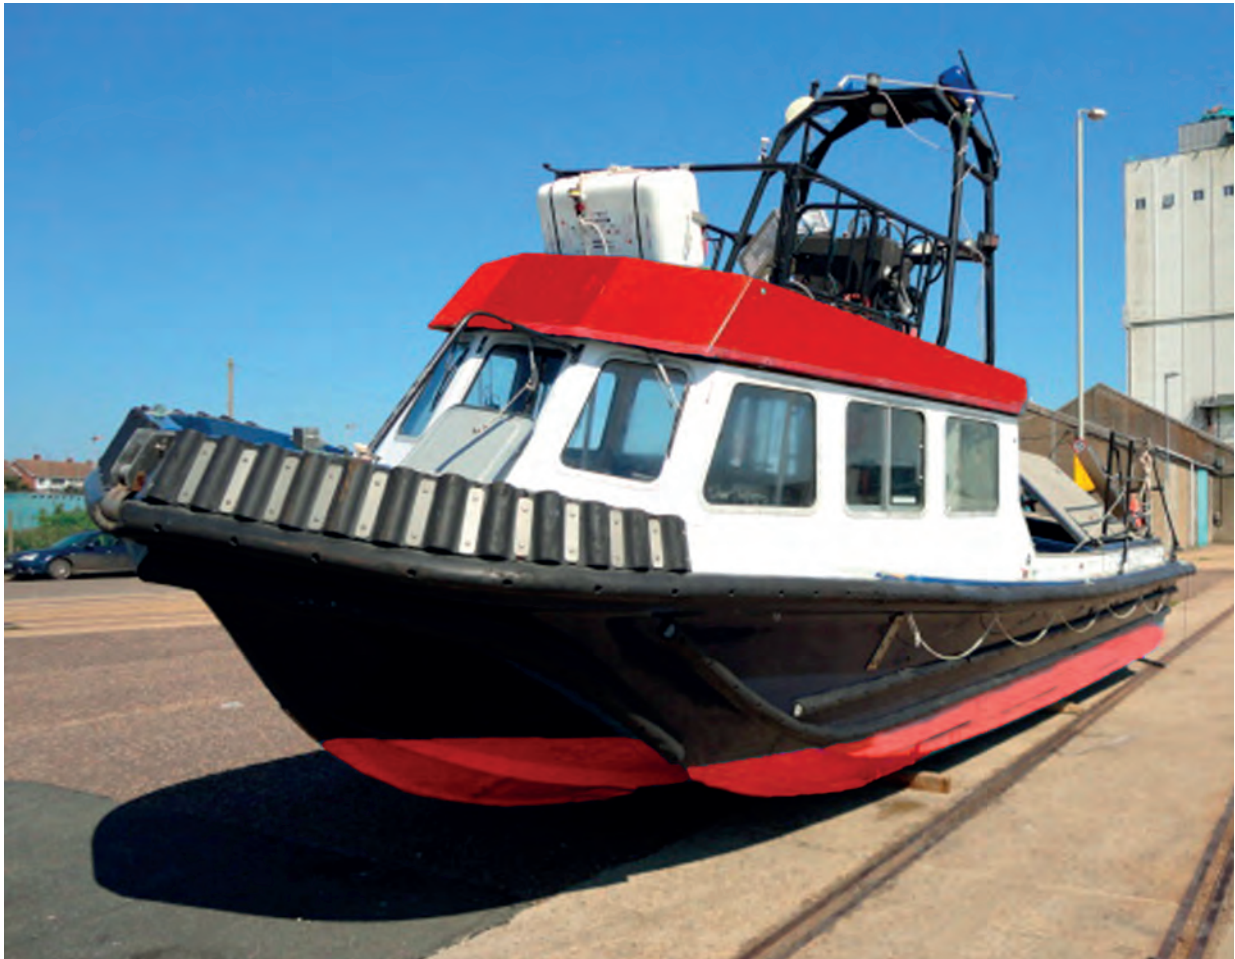
As the boat neared the harbour it slowed down to allow another vessel to enter first. A wave then swamped the stern of the boat. The bilge pump was running, but shortly afterwards two more waves swamped the stern. The crew started to hand out lifejackets, but didn't complete the task as the stern of the boat sunk beneath them.

The dive boat

2. This boat appears to have submerged by the stern relatively quickly. Donning lifejackets may not always be possible in rapidly deteriorating situations, but ensuring they are easily to hand and ready to use will maximise the opportunity of putting them on. In this case, it was highly fortunate a lifeboat was nearby to recover the persons from the water.
