# SAFETY DIGEST

**Lessons from Marine  
Accident Reports  
2/2013**

**SAFETY DIGEST**  
**Lessons from Marine Accidents**  
**No 2/2013**

October 2013

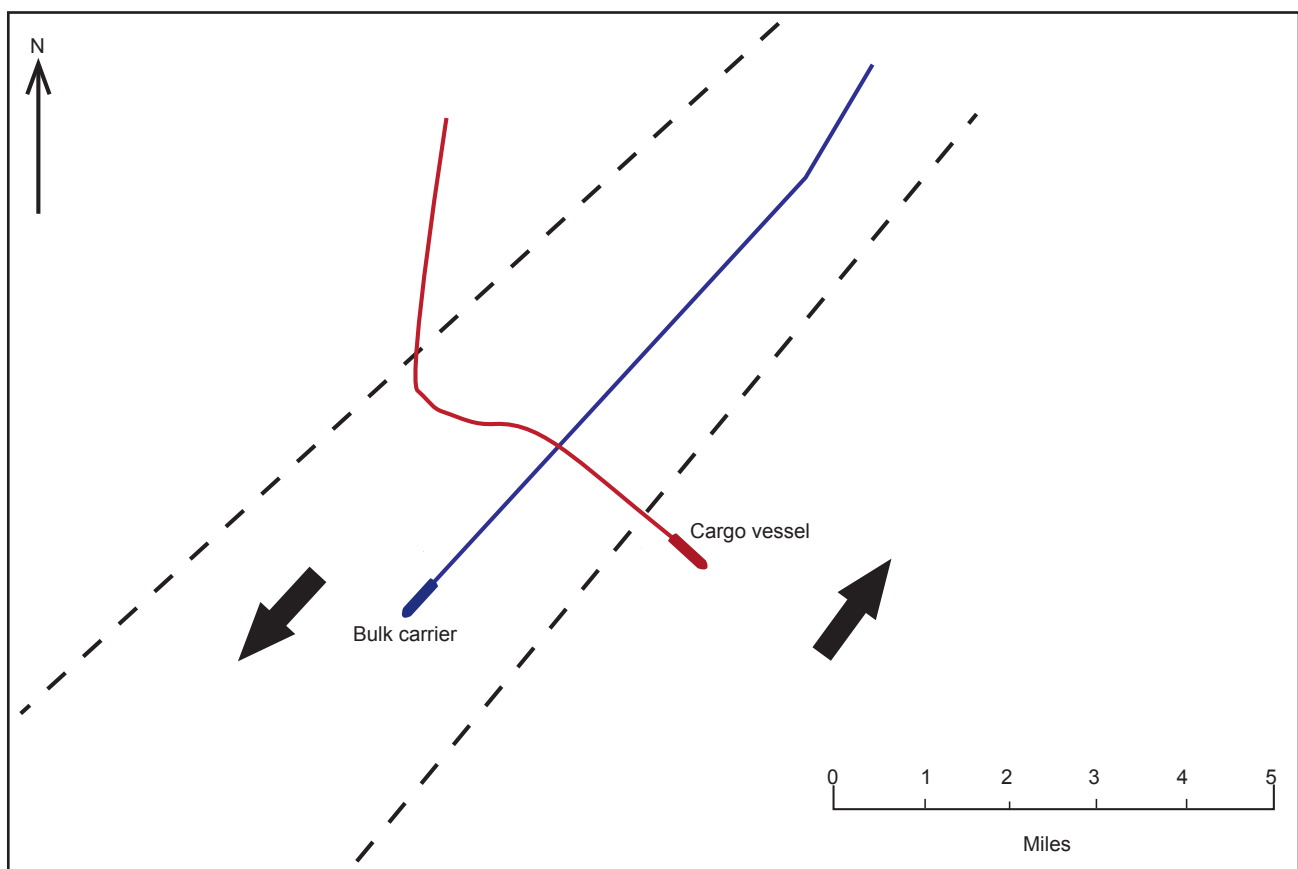
At the waypoint, the master ordered a slow alteration of course to port. During the turn, with the cargo vessel heading 125°(T) and the bulk carrier bearing 082°(T) at a range of 2.04 miles, the bulk carrier's OOW made several calls on VHF radio Channel 16 to clarify the cargo vessel's intentions. None was heard on board the cargo vessel.

The cargo vessel stopped turning on a heading of 093°(T) with the bulk carrier fine on her starboard bow at a range of 1.4 miles. She then slowly turned to starboard, keeping the bulk carrier on her starboard bow, and finally steadied on her planned course to cross the traffic lane.

Tracks of cargo vessel and bulk carrier

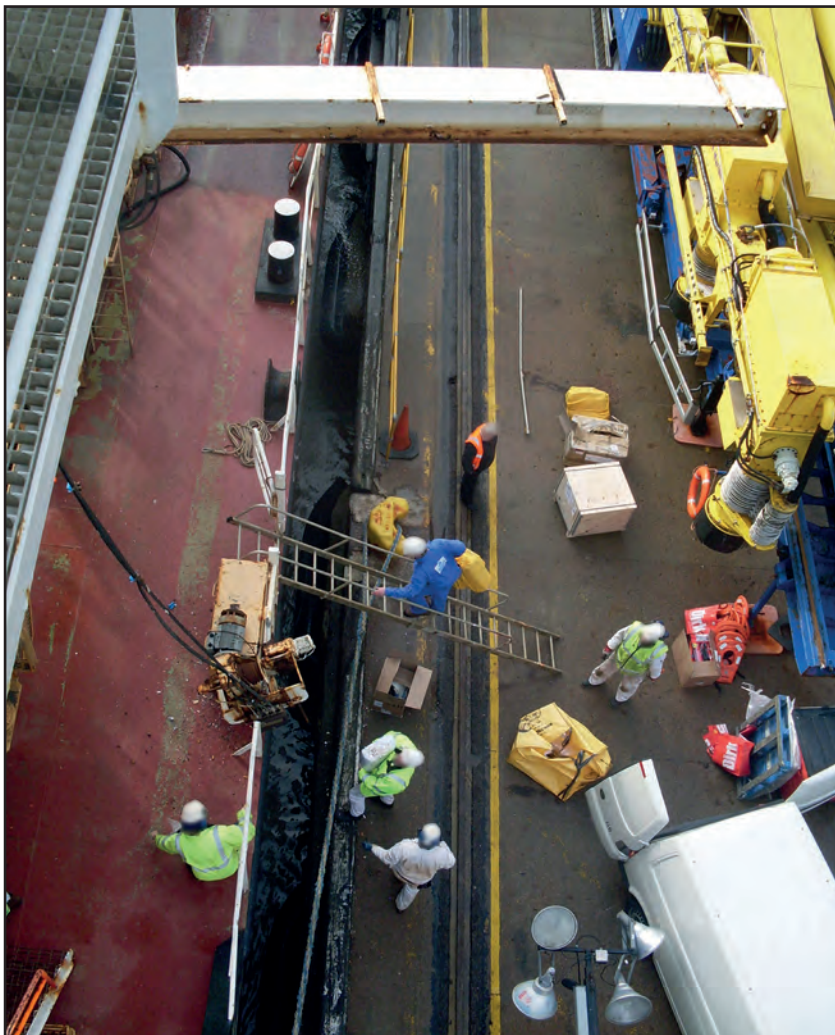
Figure 2: Main jetty shortly after the accident

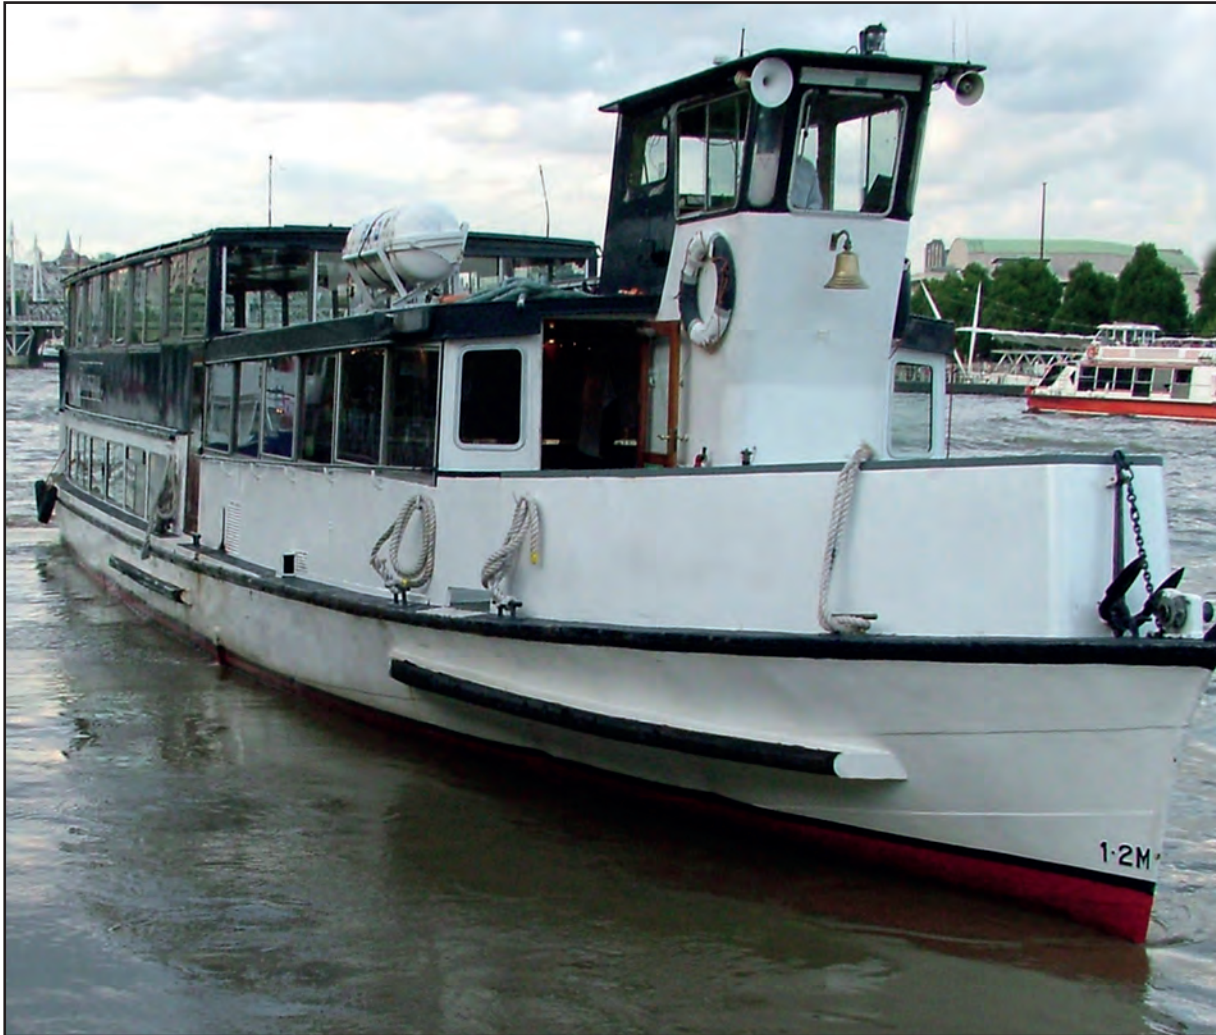
The passenger vessel

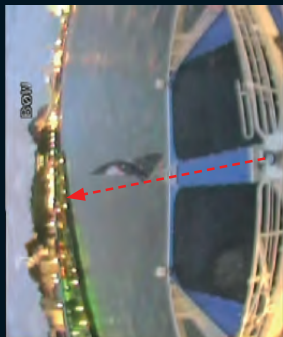
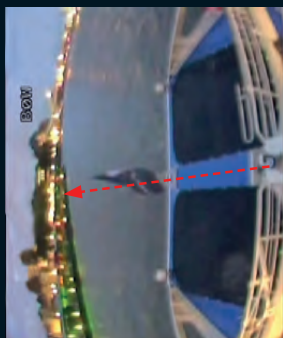
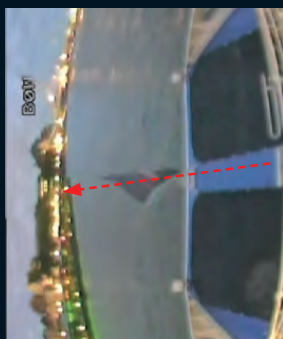
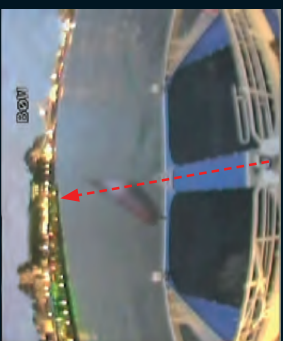
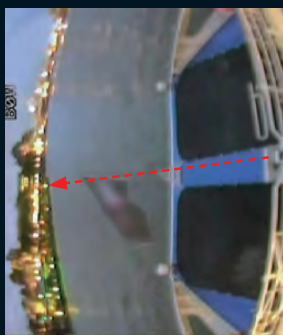
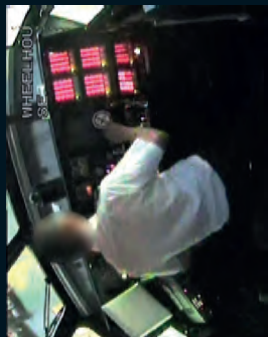
As the vessel left a pier on the opposite side of the river for one a short distance away, the master increased the vessel's speed to 12 knots, the maximum permitted for the area. The vessel was still making this speed when only 100m from the next pier. During the passage the master, who was alone in the wheelhouse, logged and entered the passenger figures into the data-link system, which resulted in him being distracted during a considerable part of the short passage (Figure 3).

19 seconds to contact:

The master was facing to starboard and was entering the passenger figures in paper log sheet. The vessel was making 12 knots over the ground and was heading for the far end of the pier.

Figure 3: Vessel's passage leading to contact with the pier

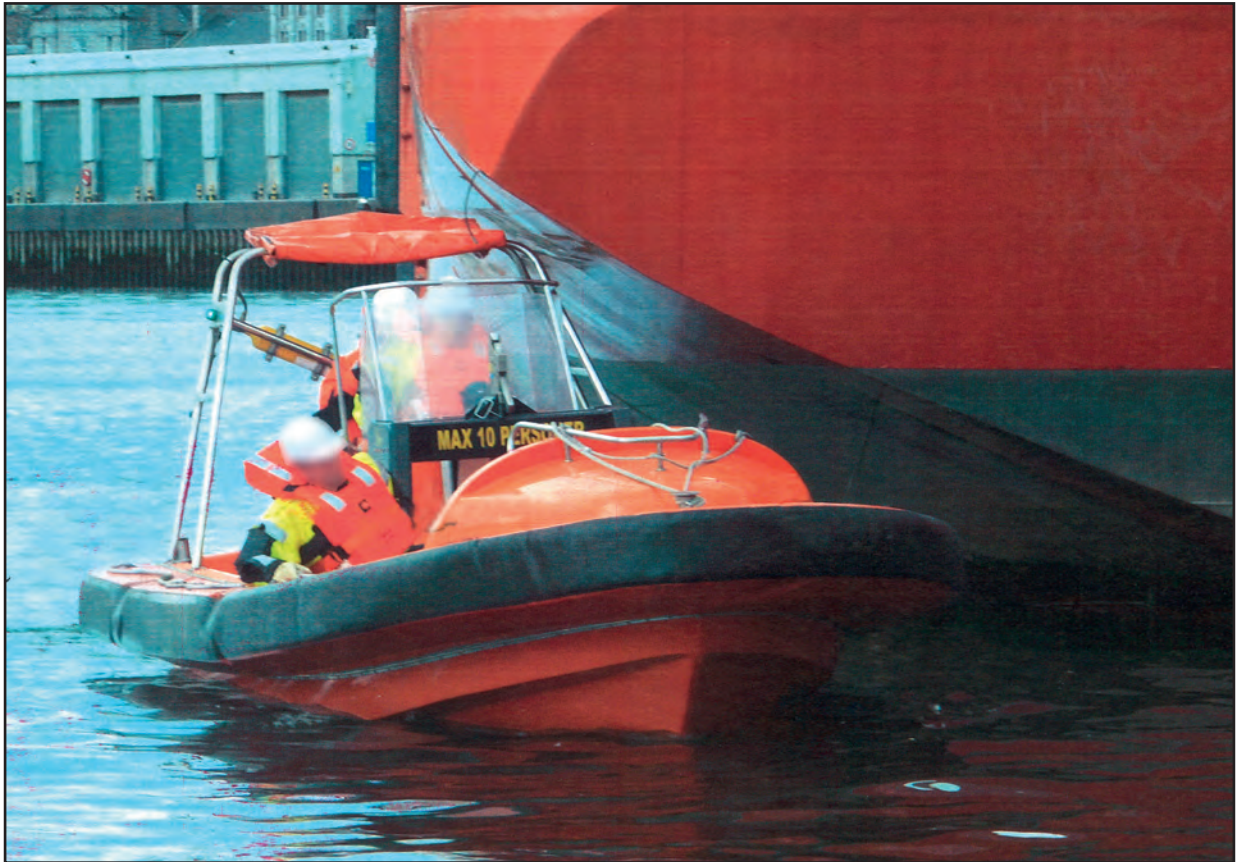
Moments later, the coxswain cried out in pain as he became trapped between the FRC's lifting frame and the supply vessel's hull. He soon fell to the deck. The chief officer quickly climbed down the ladder into the FRC and drove it under the port davit. The FRC was then hoisted back on deck. The coxswain was in pain but was conscious, and told his crew mates that he thought that he had cracked a rib. After looking at the International Medical Guide for Ships, the second officer gave the coxswain medication to ease the pain.

Fast rescue craft under the vessel's cutaway on the port quarter

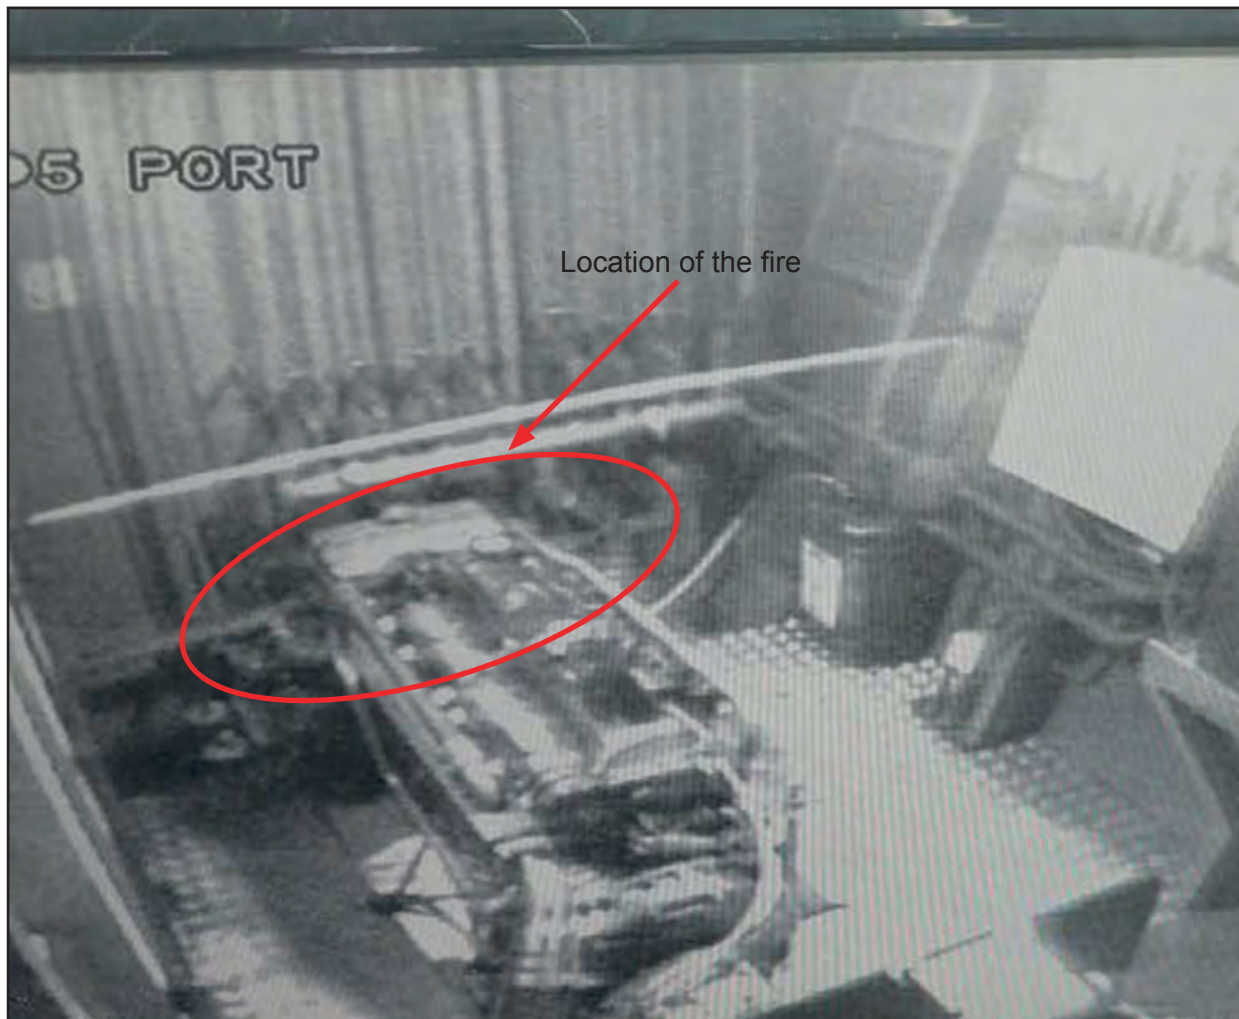
The engine rooms had not been re-visited by the time the ferry neared her berth on the return leg of the crossing at 0700. Suddenly the port main engine high temperature alarm sounded. The master looked at the port engine room camera monitor situated in the wheel-house (Figure 1) and saw black smoke rapidly developing at the forward end of the engine room, although the fire alarm had not sounded. He immediately stopped the port engine and notified his nearby shore office.

Figure 1: Port engine room camera monitor

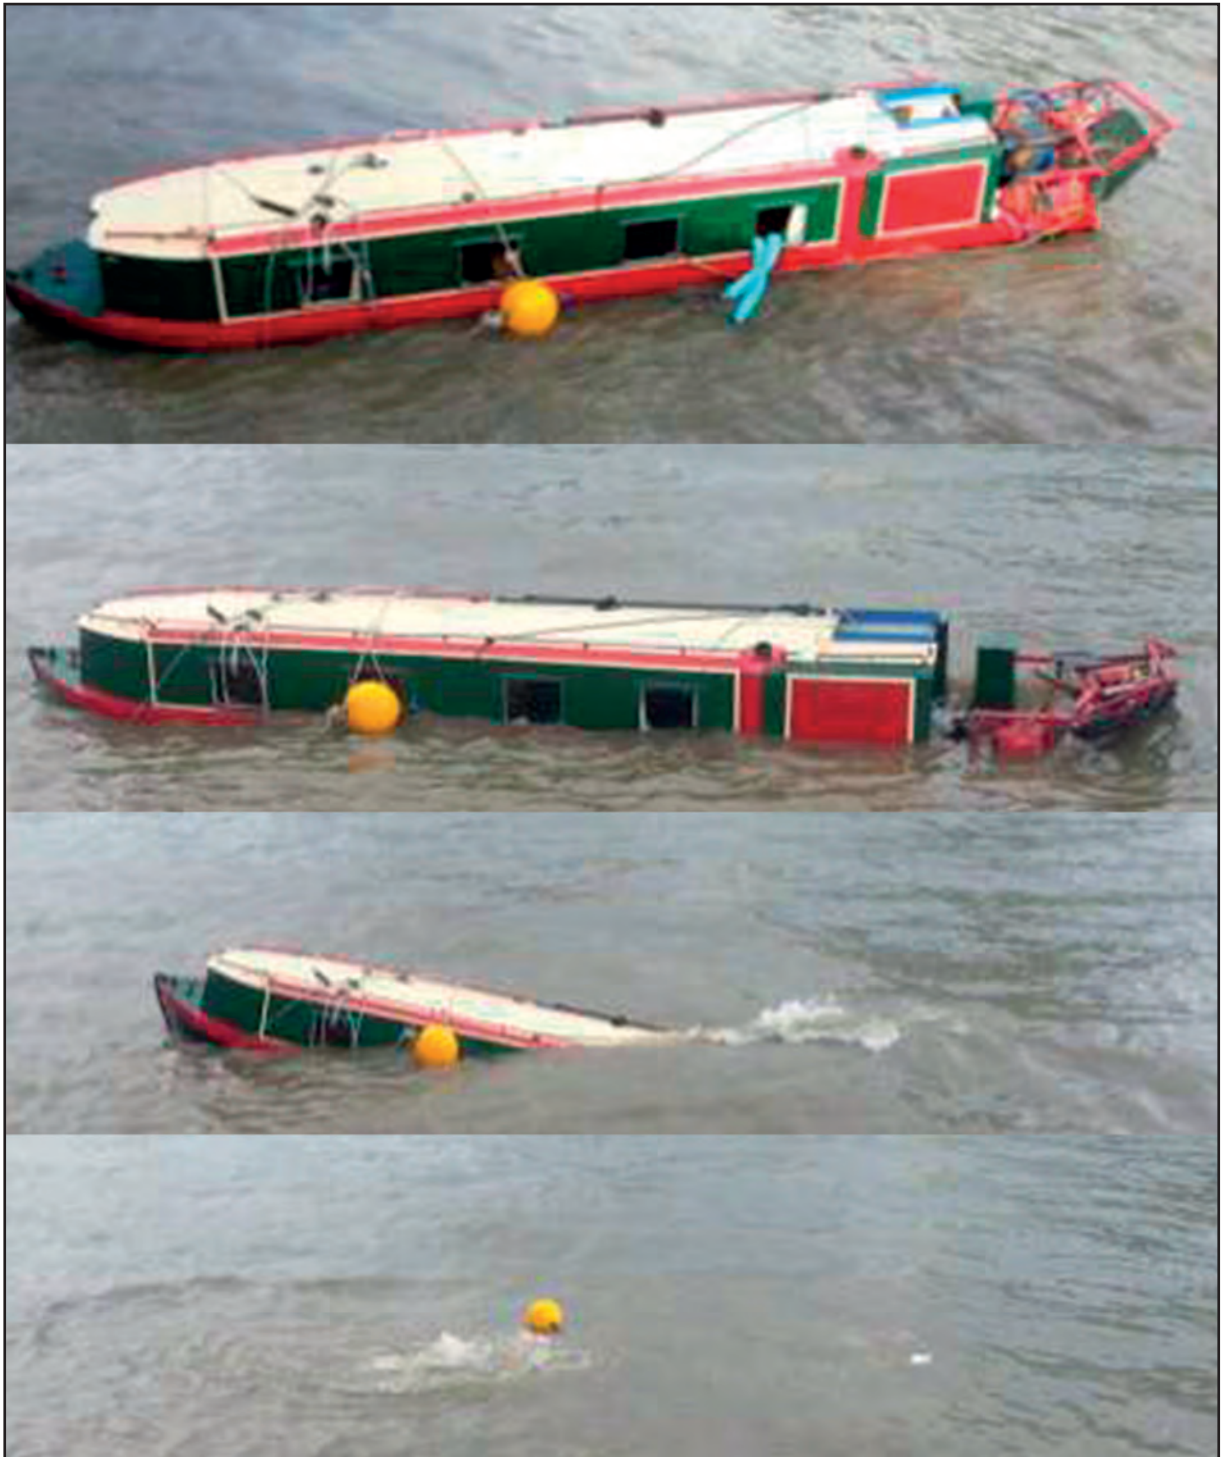
An investigation of the boat showed that the hull had not been breached. The engine was air-cooled and the air passed through a substantial vent on the side of the hull. Over the years the boat had become heavier as steel was replaced and accessories were added. This meant that the vent got closer and closer to the waterline.

In the choppy waters of the river, it was possible for waves to lap over the lower edge of the vent. With three adults standing aft, the rate of flooding increased until the inevitable sinking happened.

Figure 1: The narrow boat during the sinking

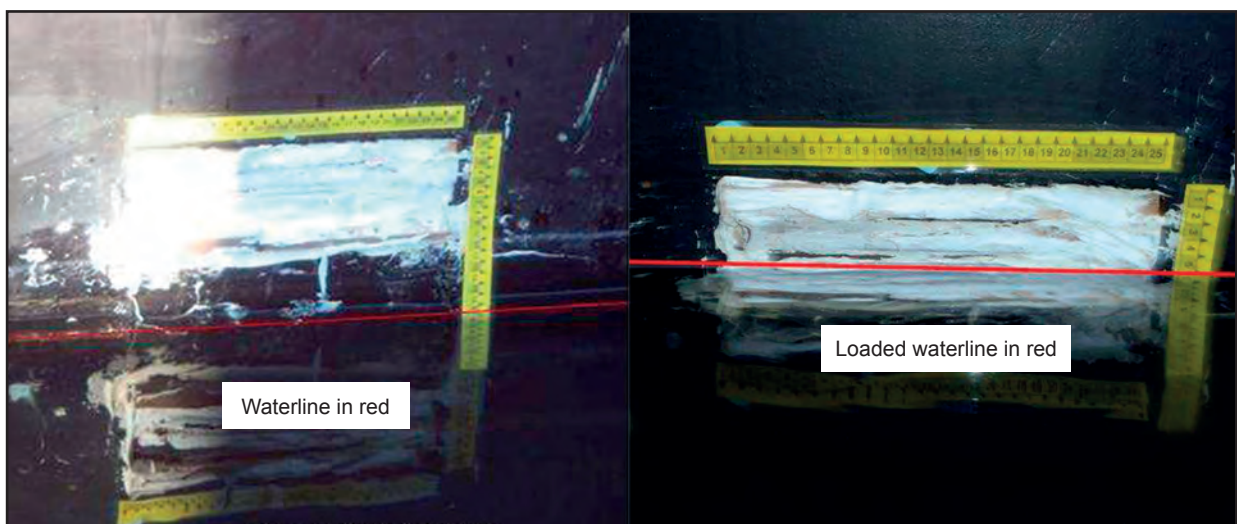
Figure 3: Position of the engine room air intake when the boat was refloated

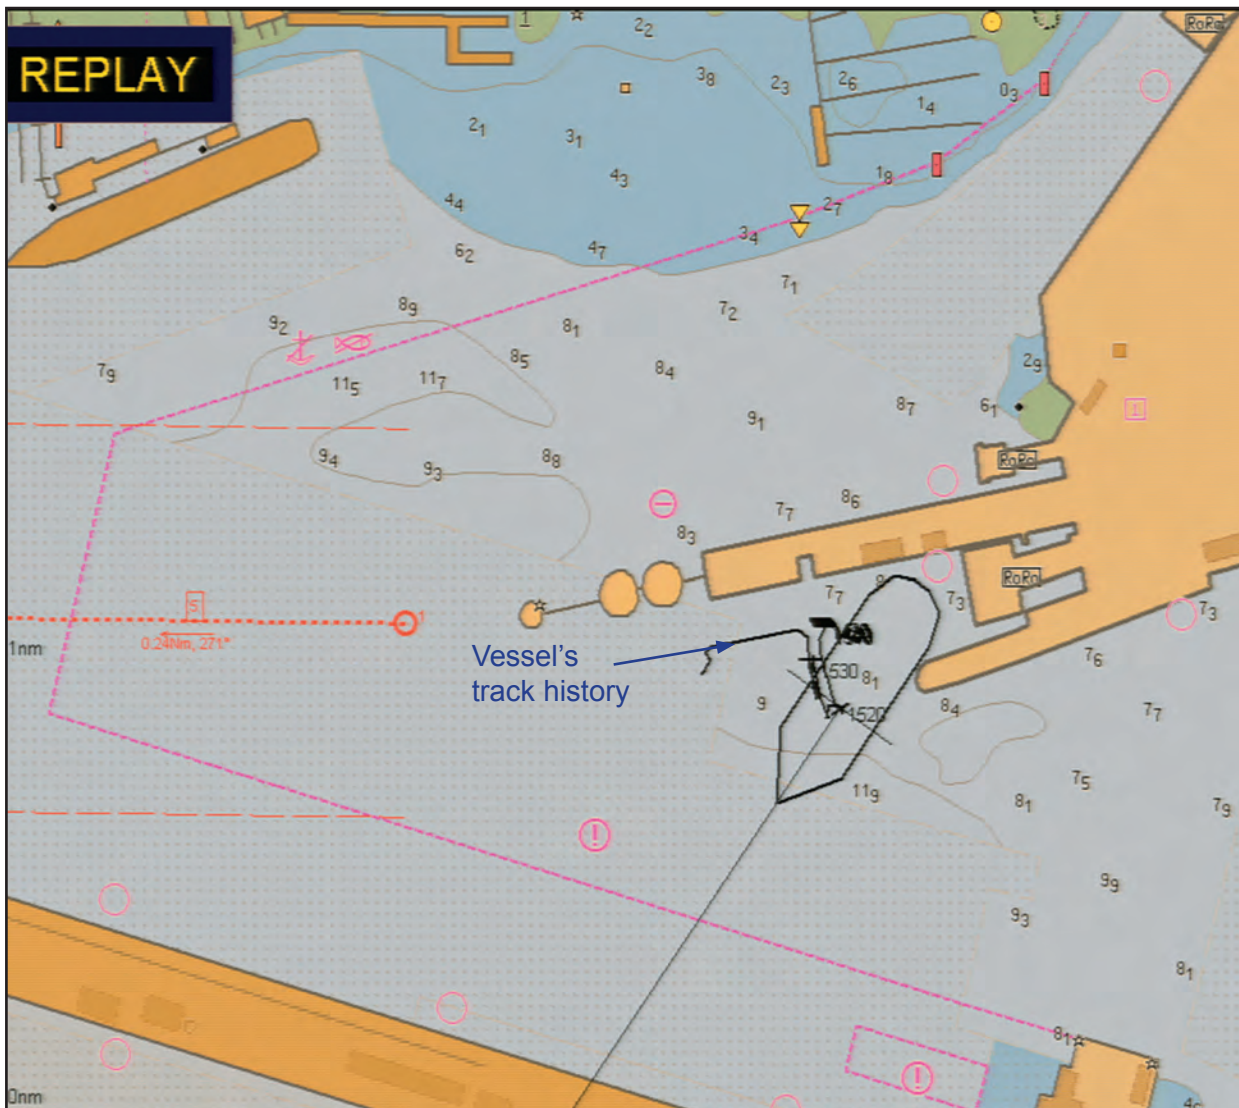
The master was at the aft-facing manoeuvring station in the centre of the bridge, from where his view of the area immediately around the vessel was limited. As the lines were let go, the wind increased and began to blow the vessel's bow to the south. In an attempt to keep the vessel parallel to the berth, the master adjusted its water jets, but was unable to prevent the vessel from being blown towards a finger jetty several meters off the vessel's port side. The HSC landed heavily on the end of the jetty (see Figure 1).

Figure 1: Vessel on finger jetty, heading 217°

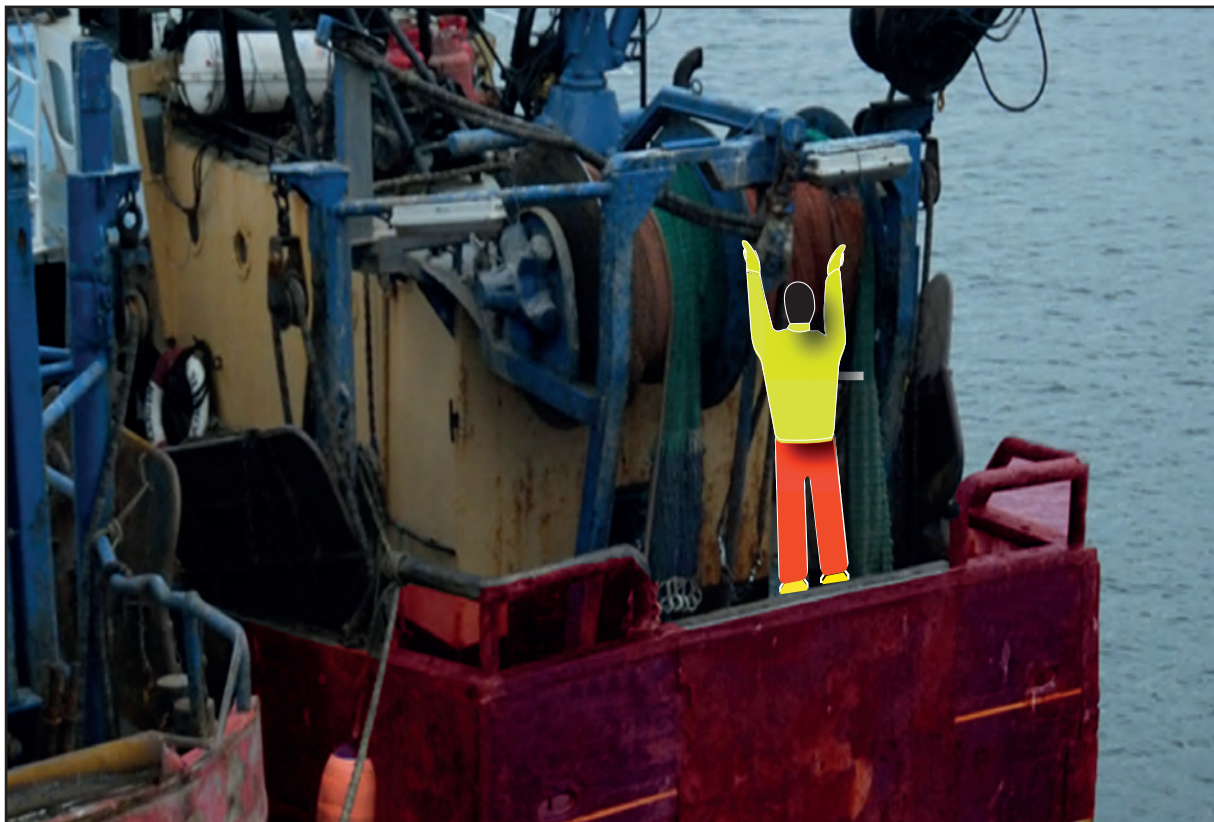
Figure 1: Position of casualty at time of being swept overboard

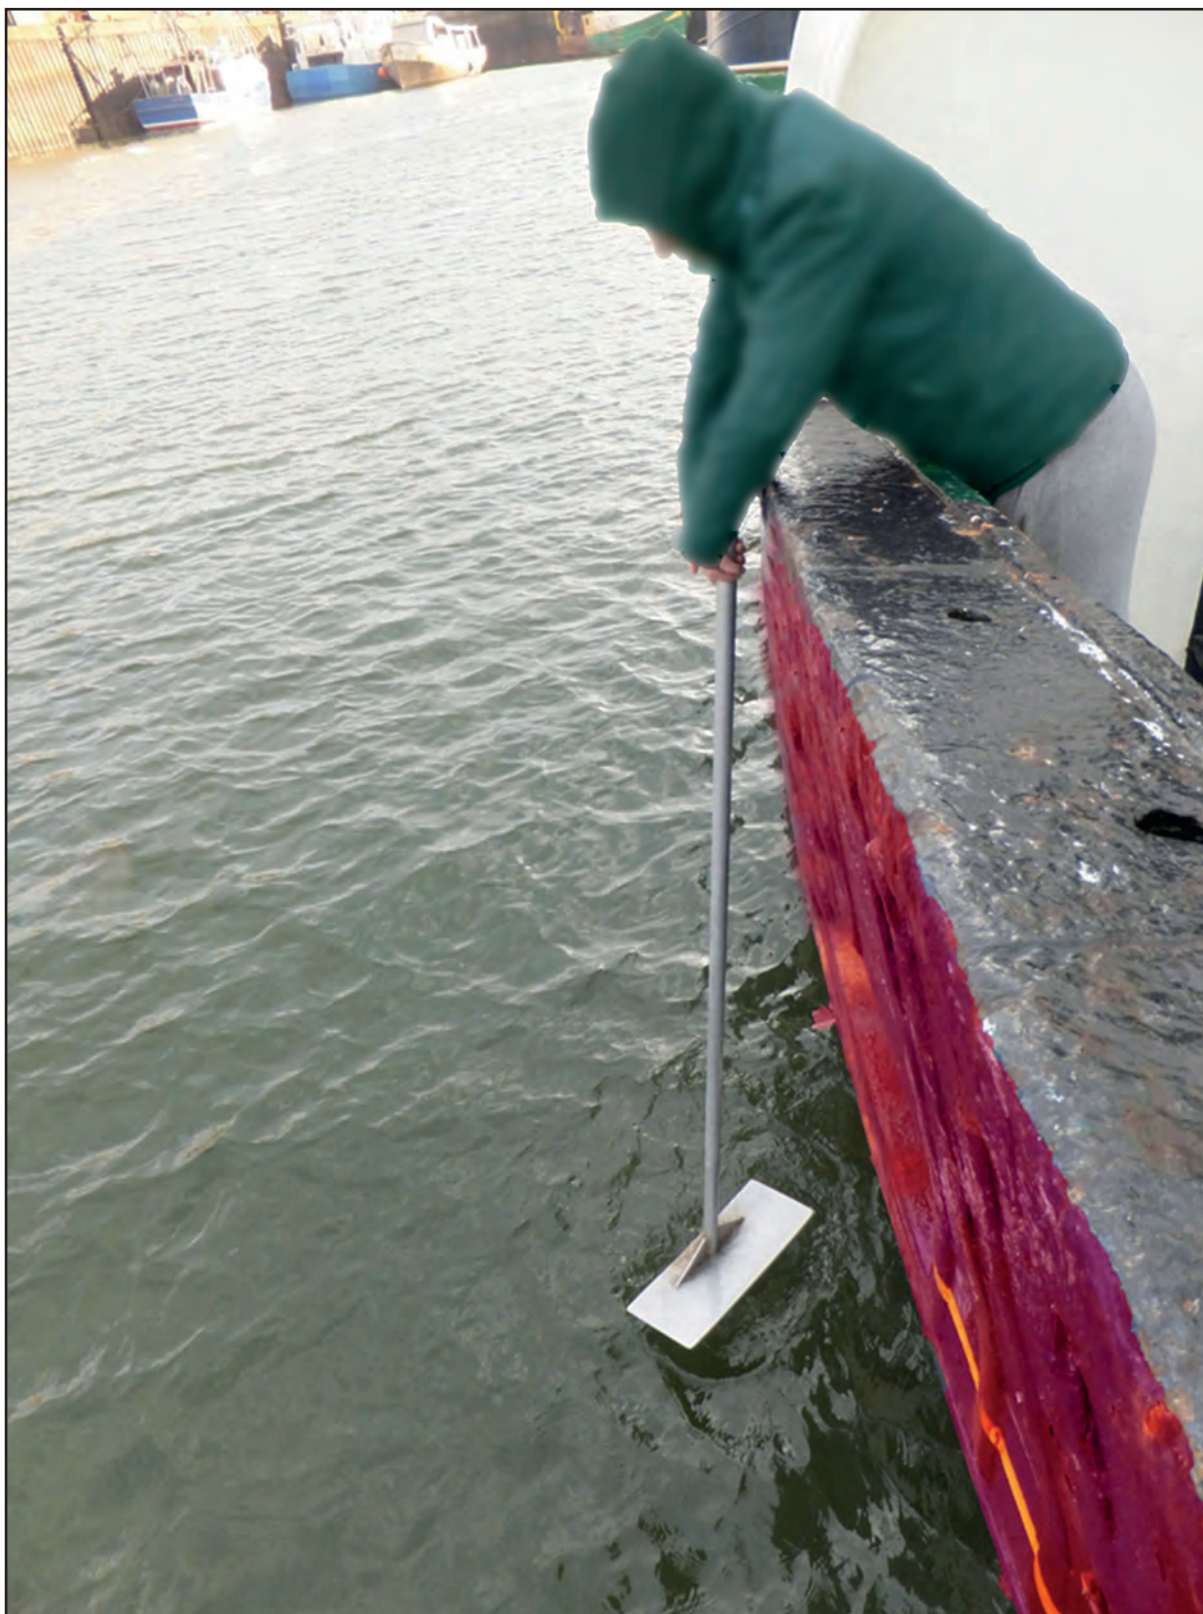
The skipper skilfully manoeuvred the trawler (with the nets streaming behind) around to the casualty, where his colleagues reached out to him with a prawn rake (Figure 2) (they had no boat hook on board) and shouted to him to grasp it. He showed no signs of understanding their commands, so they manoeuvred the blade of the rake under his arm to help support him. As they did this, his arm lifted into the air and he slipped below the surface.

Figure 2: Prawn rake used for attempted retrieval; no substitute for a boat hook

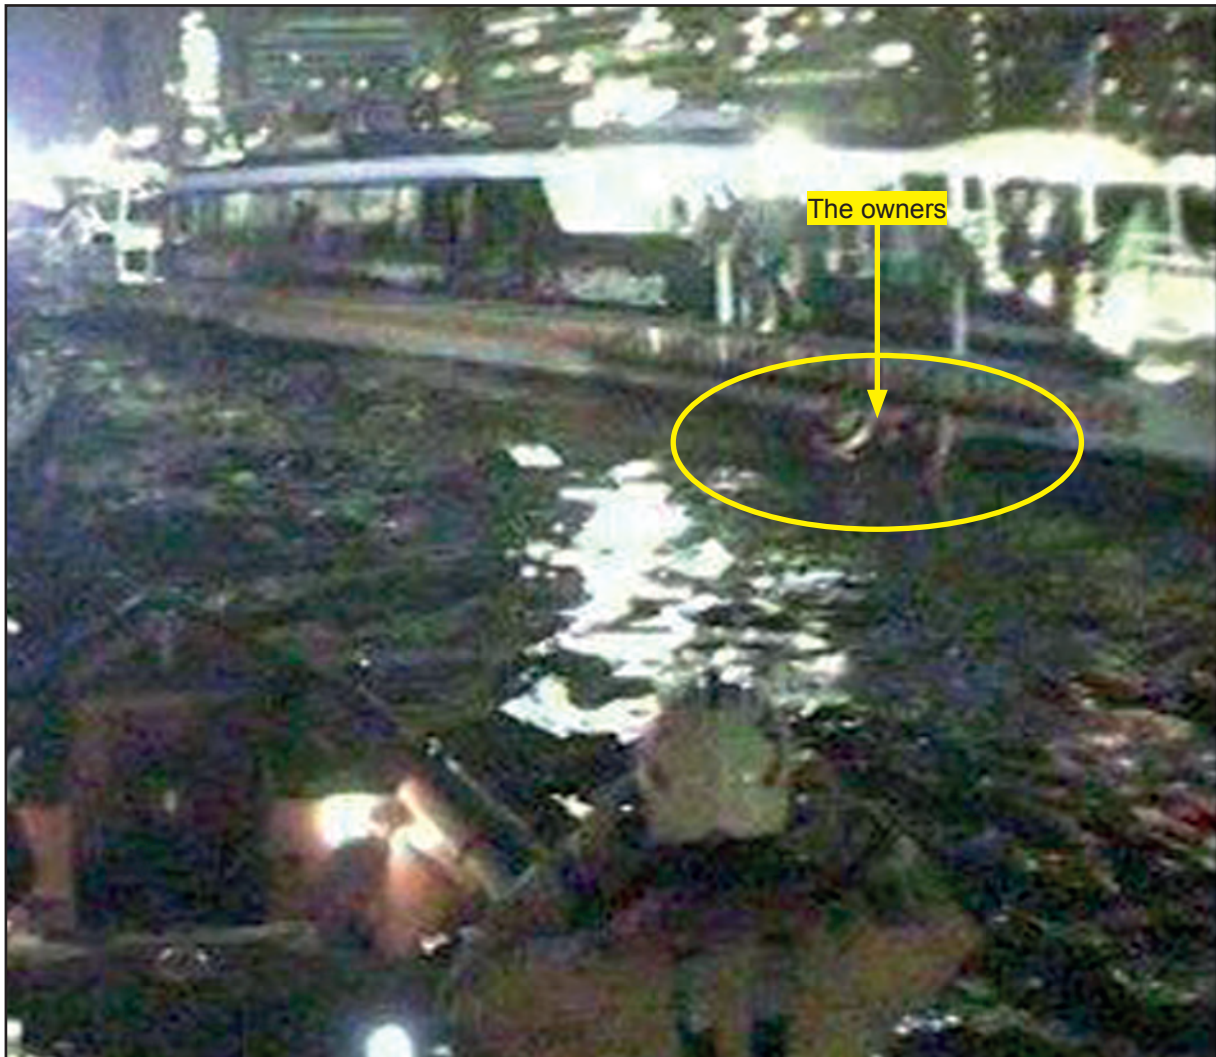
Both of the RIB's owners smelled of alcohol; the driver failed an alcohol breath test shortly afterwards.

CCTV still - owners being approached by nearby vessel

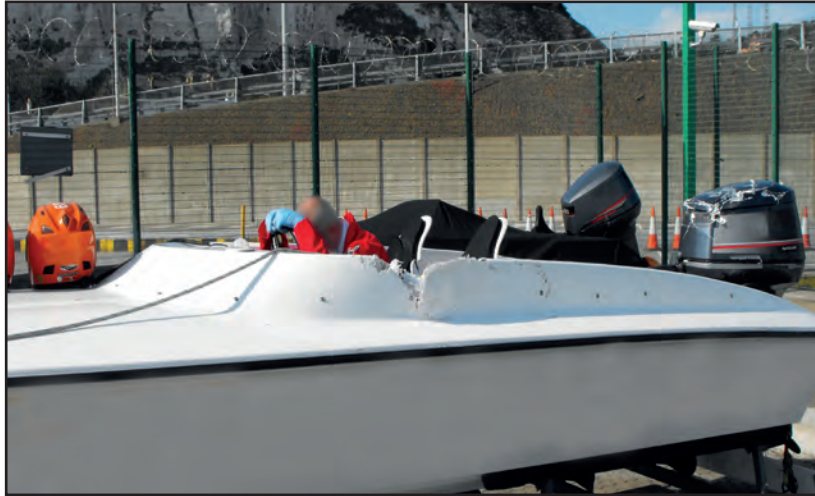
View looking at point of impact and showing 'driver' leaning forward

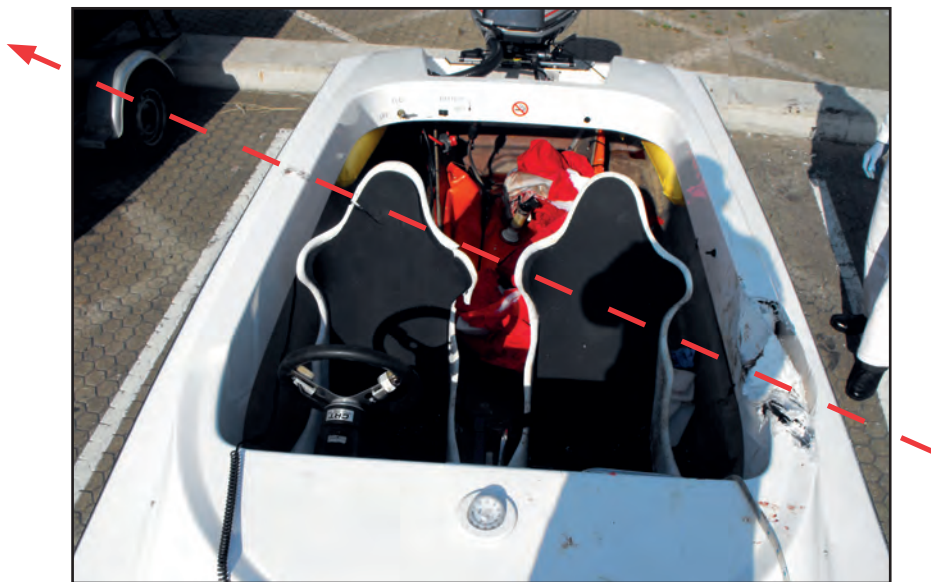
Approximate direction of travel of other boat as it crossed the casualty's boat

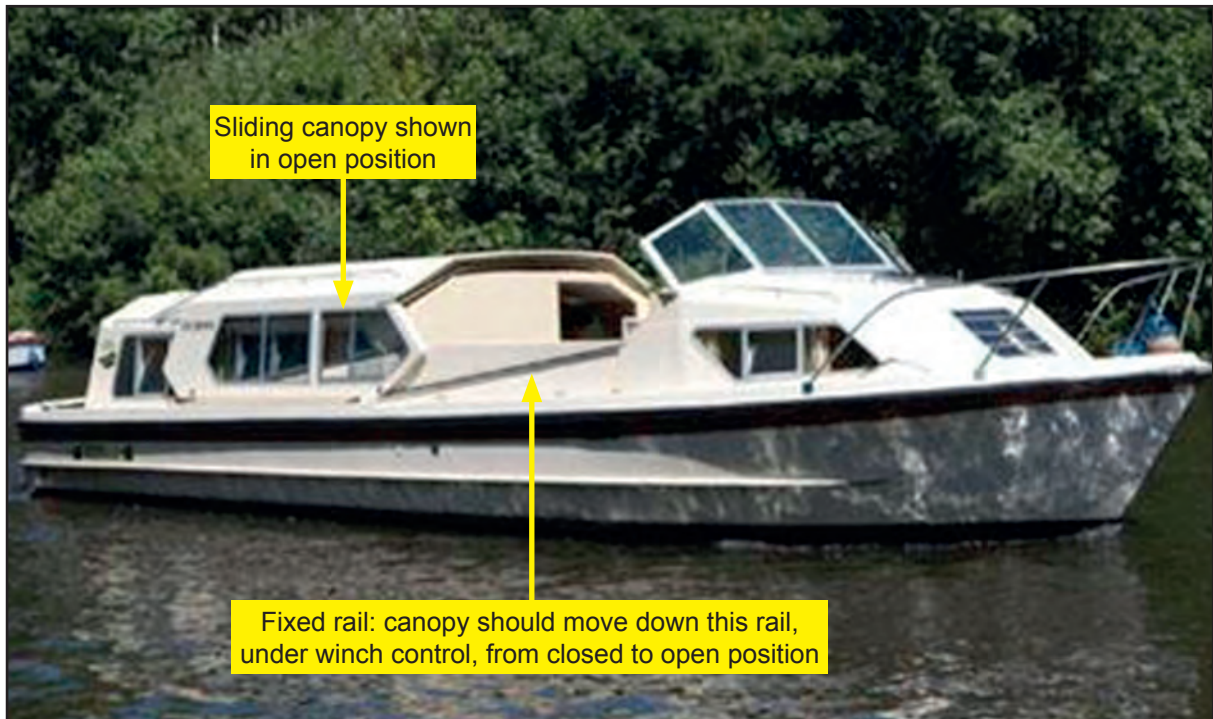
A boat hirer received head and neck injuries when he was struck by the sliding canopy roof of an inland waterway hire boat, which suddenly slid open.

Figure 1: The vessel

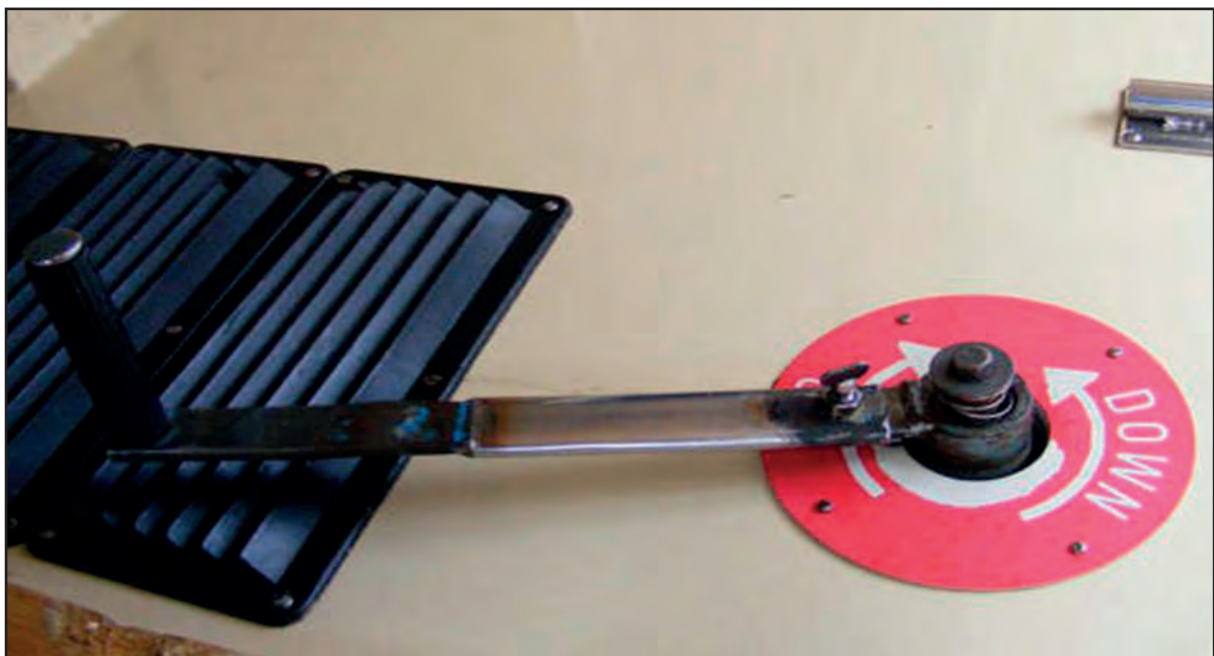
The canopy had been in the closed position, forming the roof of the craft's cockpit, and the man had attempted to open the canopy by winding the winch operating handle in the downward direction. But the canopy remained closed.

Figure 2: Winch operating handle

Investigation of the accident revealed that the winch handle had been modified, contrary to the manufacturer's recommendations, and it was concluded that this might have adversely affected the operation of the winch which held the wire used to raise and lower the canopy.

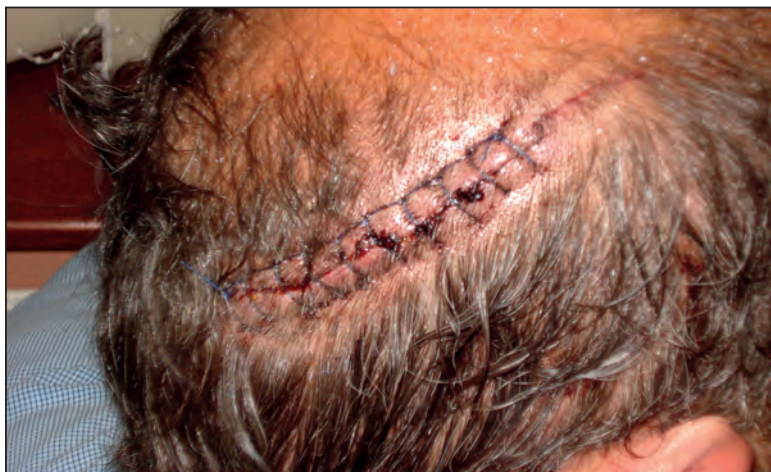
The man left the winch handle slack and was facing aft when the canopy suddenly and rapidly slid open. As it did so, a light fitting on the underside of the canopy struck him on the back of his head. He was then lifted off his feet as his head and shoulders became trapped between the canopy roof and the aft bulkhead of the cockpit.

Figure 4: The injured person suffered lacerations to the head and shoulders when struck by the light fitting and then trapped by the canopy

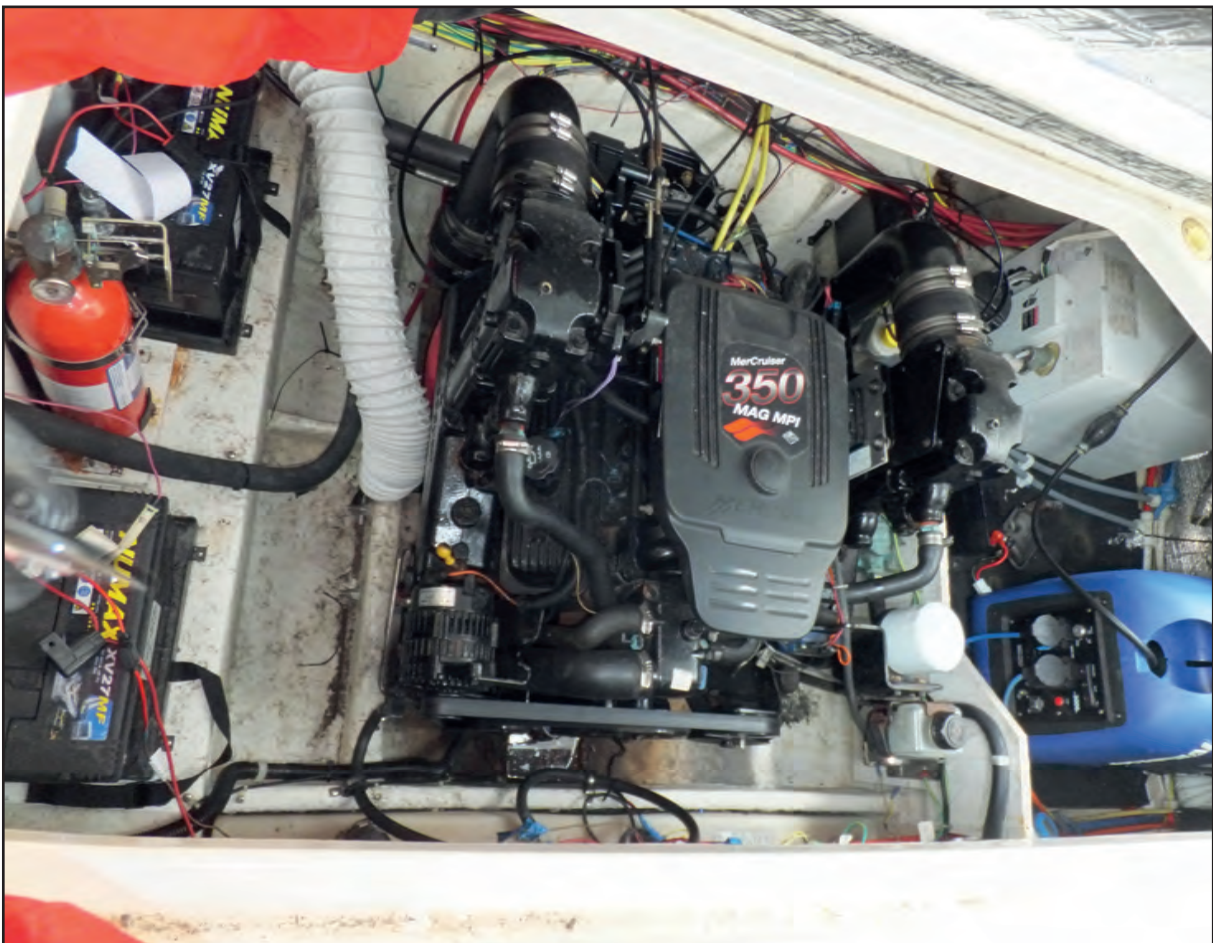
Figure 1

A “suitcase” type portable petrol-driven generator (Figure 1) had been installed in the motor cruiser’s engine bay to supply the boat with 240v power. The generator had been fitted with an improvised exhaust and silencer system which had become detached from both the generator and the outlet on the vessel’s side (Figures 2 and 3). As a result, the generator’s exhaust fumes filled the engine bay and spread through gaps in an internal bulkhead into the aft cabin where the mother and daughter were asleep. When the owner of the boat awoke in the boat’s forward cabin, he was suffering from carbon monoxide poisoning but was able to raise the alarm. The mother and daughter could not be revived.
