SAFETY DIGEST

**Lessons from Marine
Accident Reports
2/2014**

SAFETY DIGEST
Lessons from Marine Accidents
No 2/2014

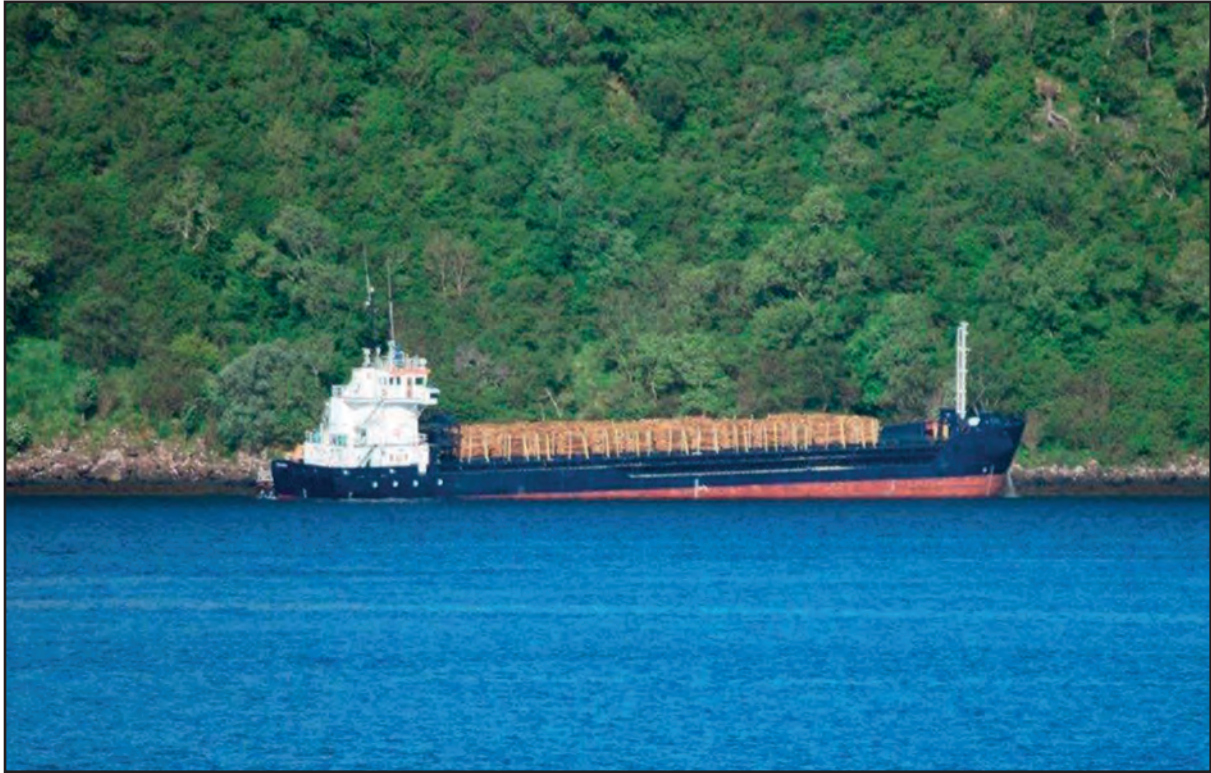
Vessel aground

Shortly after 0300 a dry cargo vessel ran aground on a rocky coastline at almost 12kts. All the off duty crew were awakened by the impact, but when the master arrived on the bridge he found the chief mate asleep on the bridge chair and the vessel still in gear and driving ahead.

Fortunately it was quickly established that the hull was not holed and, although sitting on rocks, because of the fine weather the vessel was not pounding. The vessel was refloated 9 hours later when it was discovered that substantial plate and frame buckling had occurred, requiring almost 50 tonnes of steelwork to be replaced.

The chief mate fell asleep probably due to lack of stimulation compounded by fatigue induced by a change to his work/rest pattern the day before. These issues can affect all seafarers at some point, and are not unusual. Therefore all the more reason to take precautions to guard against them. The fact that the chief mate did not radio the pilot is indicative of his weariness at the time, while sleeping through the grounding impact gives some indication of how deeply he was sleeping.

3. If attacked by weariness while on watch, do the sensible thing: walk about the bridge, open windows, drink some coffee or call another watchkeeper. Whatever you do, react positively to the signs of fatigue and do not close your eyes for even a few moments as these moments can so easily become minutes, or even hours.

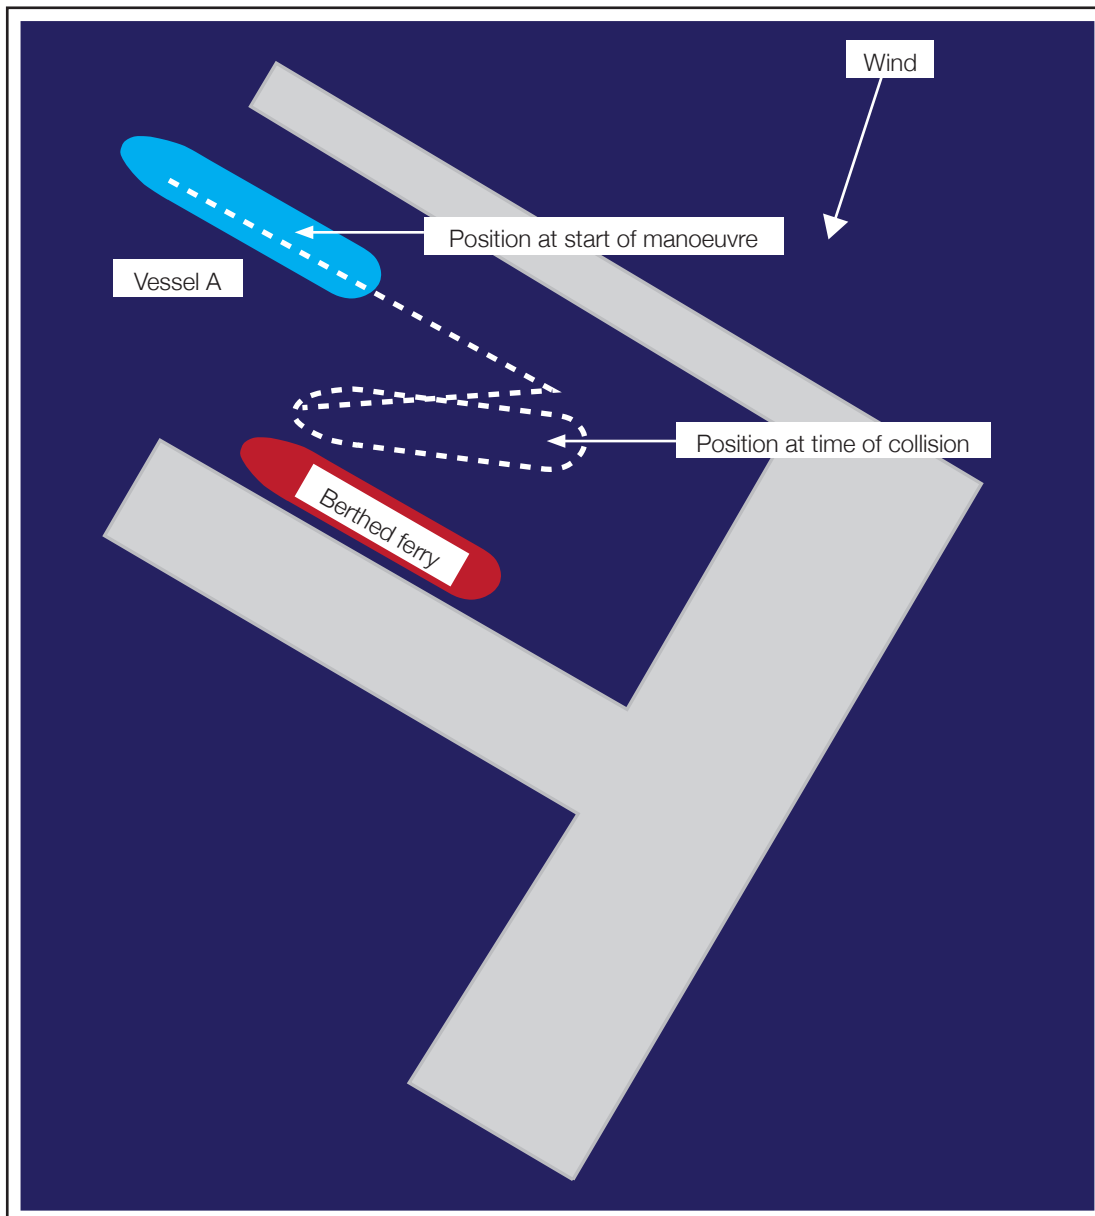
Figure 1: Movement of Vessel A

The master acted in accordance with the management company's standard operating procedures in employing a tug on the port quarter in the prevailing wind direction and speed. However, he had limited experience of manoeuvring the vessel with a tug and had not previously carried out the manoeuvre in similar wind conditions.

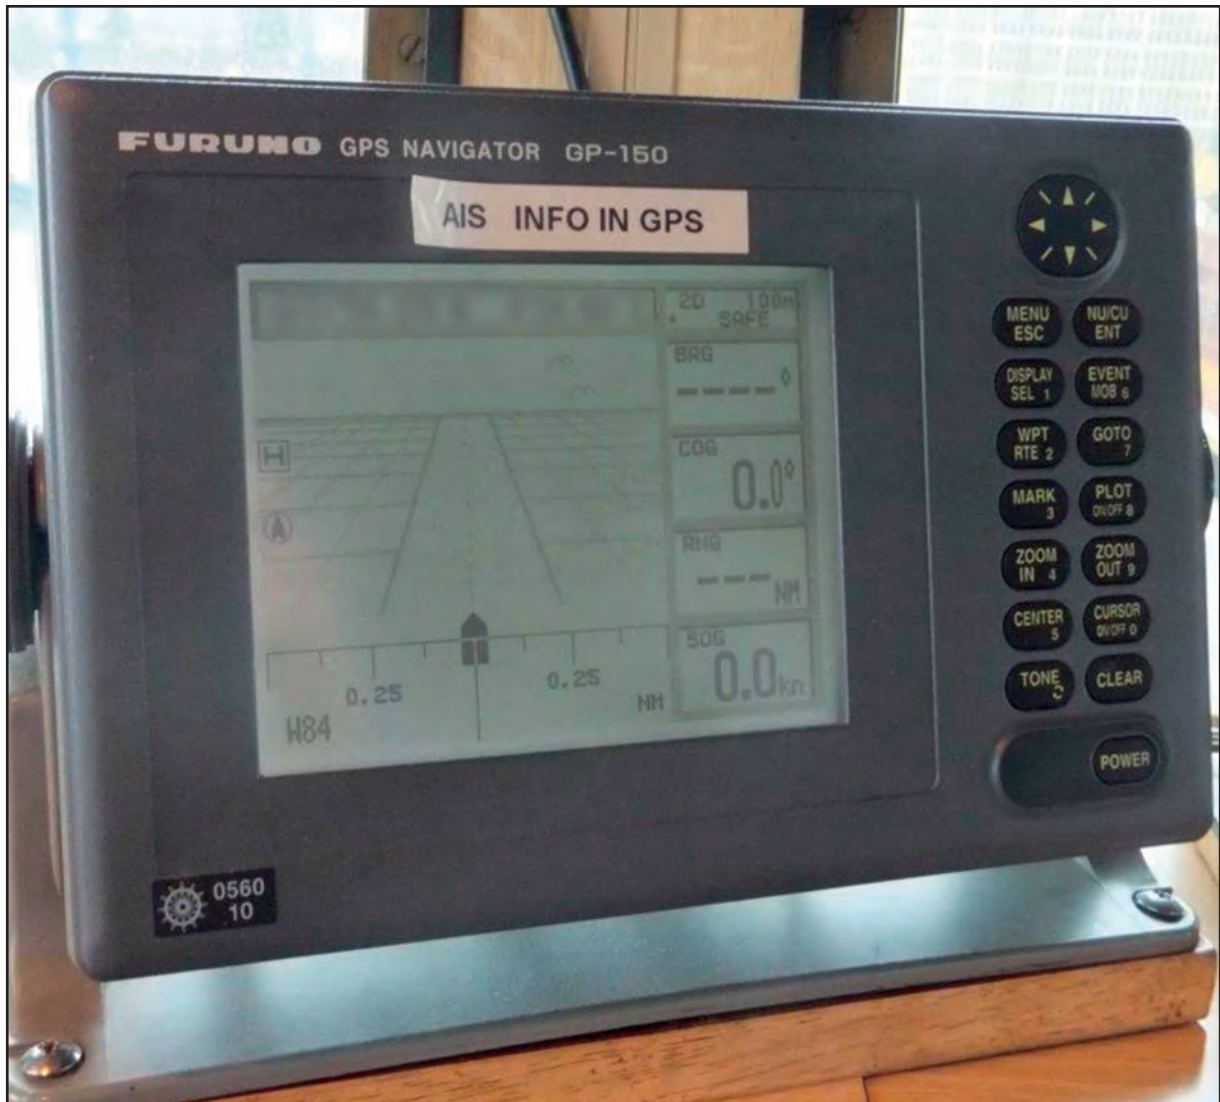
Figure 1: GPS receiver

The master soon arrived on the bridge and saw that the vessel was not moving, and he put the engine telegraph to 'stop'. He also switched on the echo sounder and plotted the vessel's position on the paper chart. The master saw that his ship was well off the planned route. The waypoint displayed as the next destination waypoint in the GPS was also not as he expected; the vessel had been heading towards the wrong waypoint.

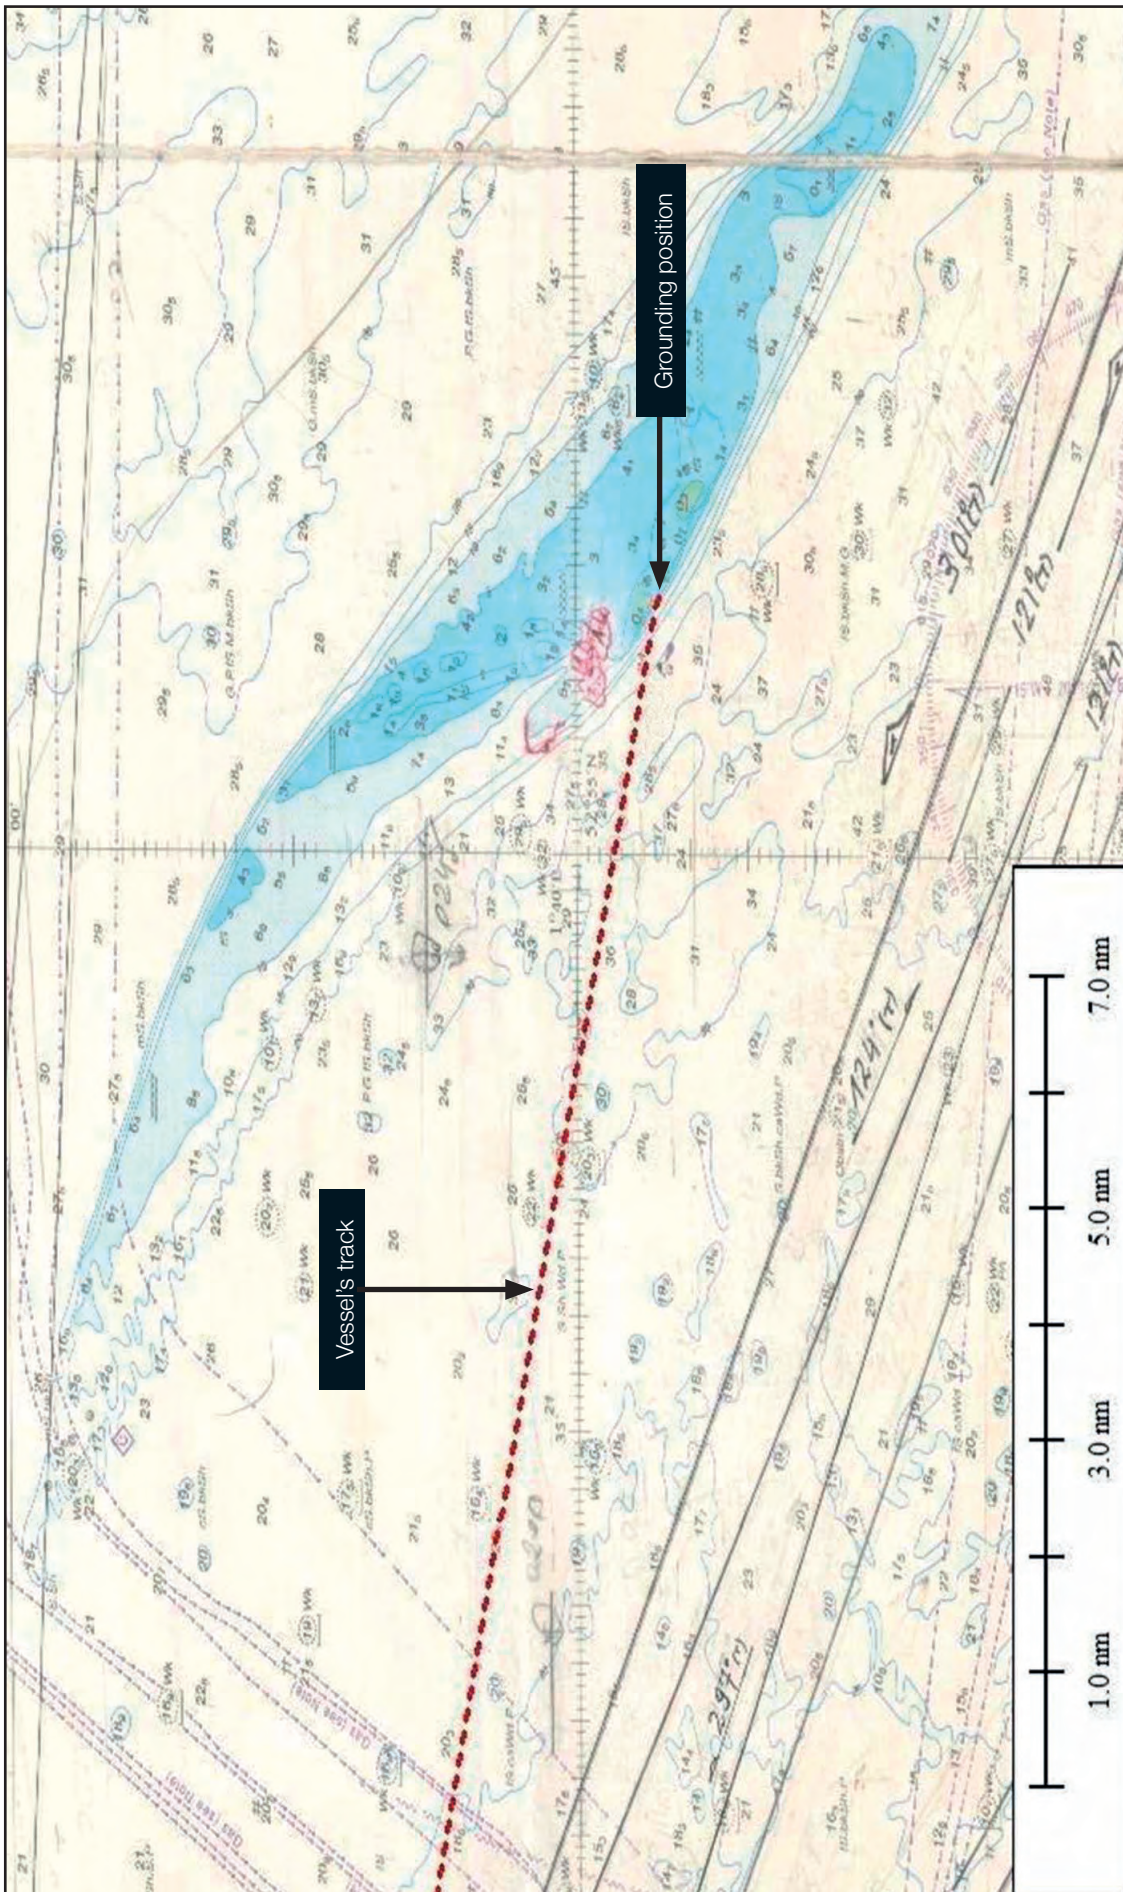
Figure 2: Vessel's track to grounding positions with extract from chart in use

To try and move the vessel clear of the bank, the master manoeuvred its engines between 'full ahead' and 'full astern'. The vessel eventually re-floated after about 1 hour on the rising tide. However, it would not respond to the helm so the master ordered the anchor to be let go. Soon afterwards, the master reported to the coastguard that the cargo ship had anchored due to steering difficulties; he did not mention the grounding. Subsequent inspection identified that the vessel had lost its rudder (Figure 3). The vessel had to be towed to port for repair.

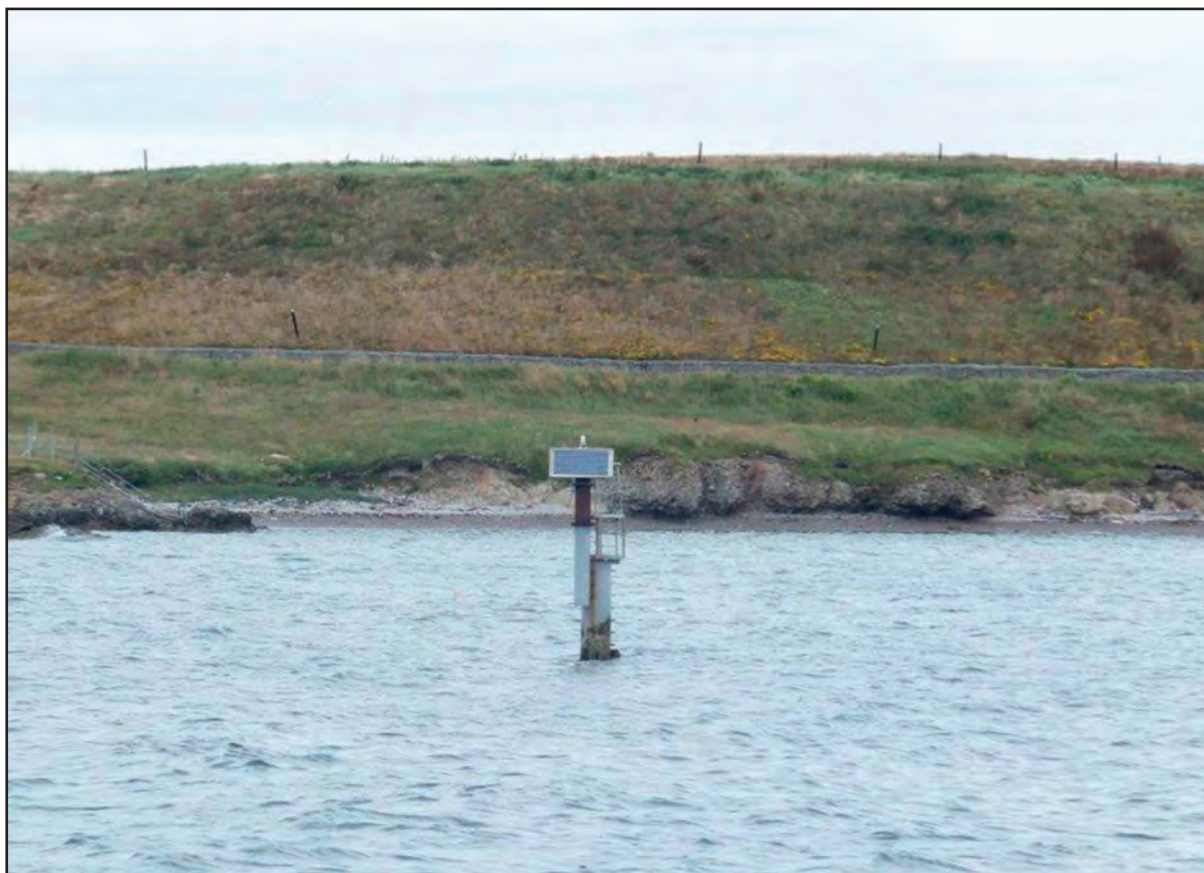
Figure 1: Beacon marking the rocky outcrop

The tug and ALB arrived a short time later. Additional salvage pumps were supplied, but despite a total pumping capacity of about 200 tonnes/hour the water ingress could not be stemmed. At 2040, the vessel floated free of the rocks on the rising tide. It was decided that the ALB would tow the vessel away from the main channel, assisted by the port's tug. With the fishing vessel crew now on board the ALB, the vessel was taken under tow. However, it adopted an angle of loll and the towline was cut. The tug gently pushed the vessel towards the shore but it foundered in 15 metres of water (Figure 3) a short time later.

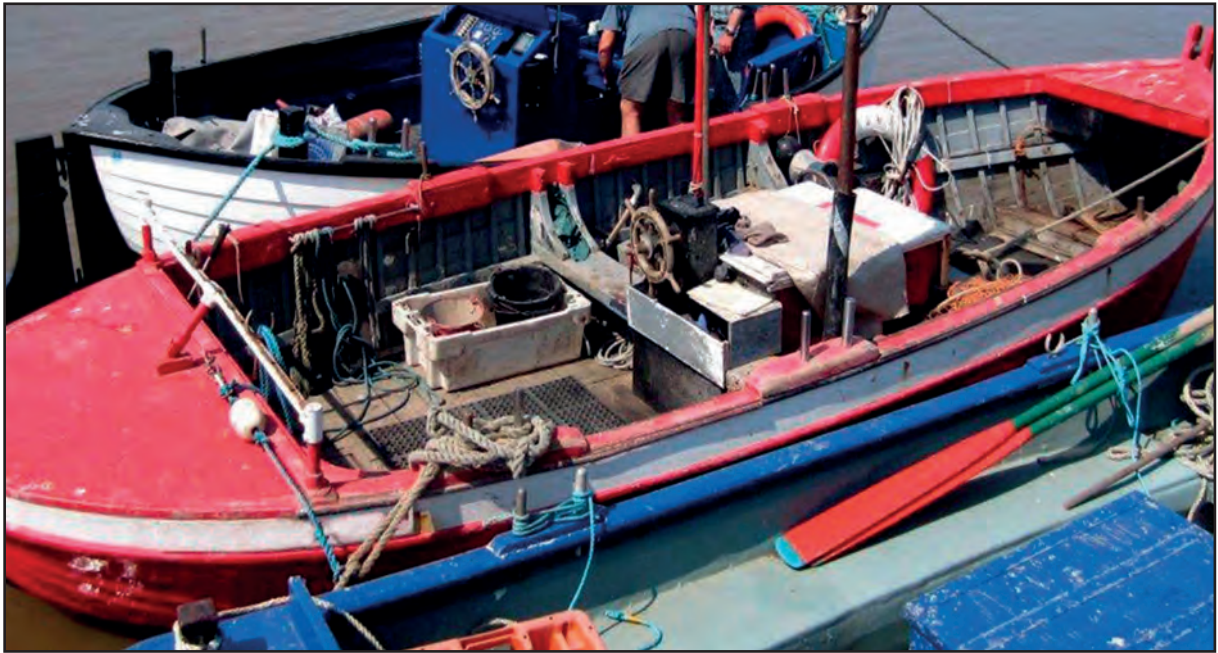
Figure 1: Deck layout of the open-decked fishing boat

As the boat was on a steady heading at about 2.5kts and the gear was towing nicely, he decided to lift the deck boards and clean the bilge pump suction strum box, which he suspected was probably blocked with the mud he had washed into the bilge. As he put his hand into the bilge, the slightly ragged sleeve of his smock (Figure 2) became caught around the unprotected propeller shaft (Figure 3).

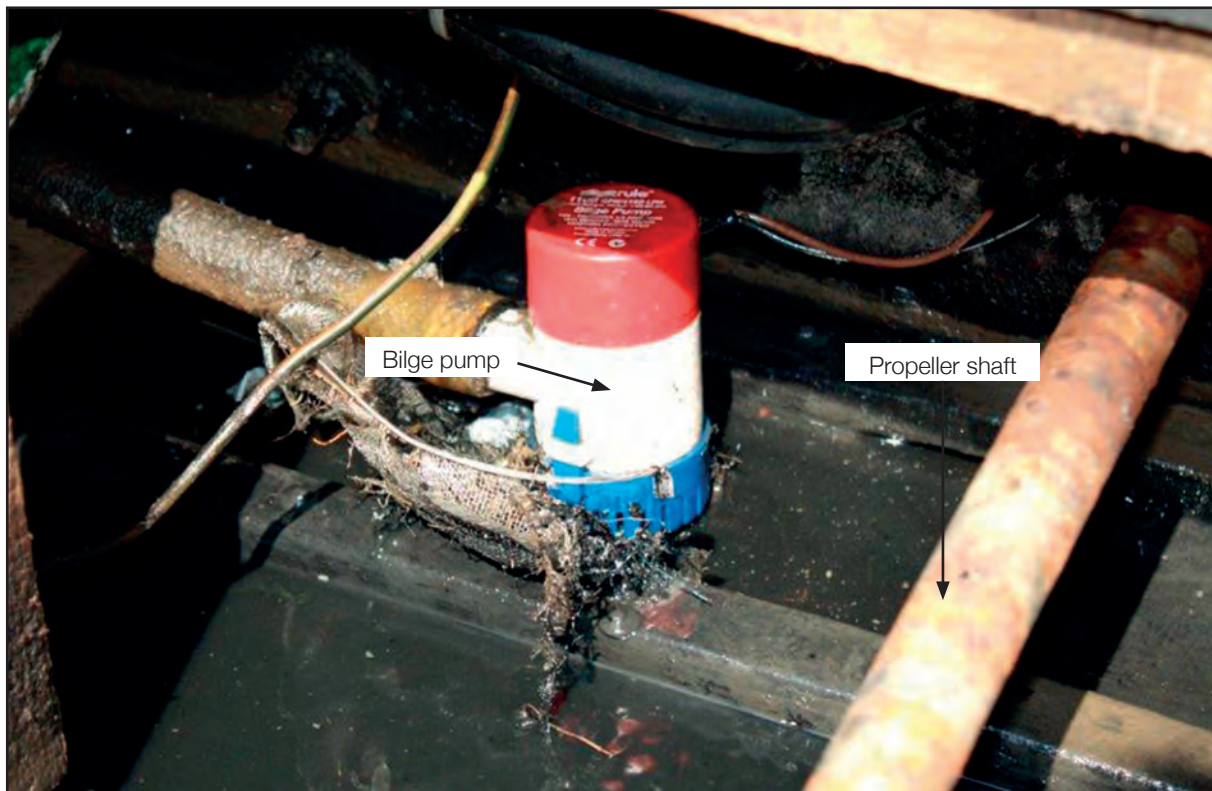
Figure 3: Propeller shaft and bilge pump

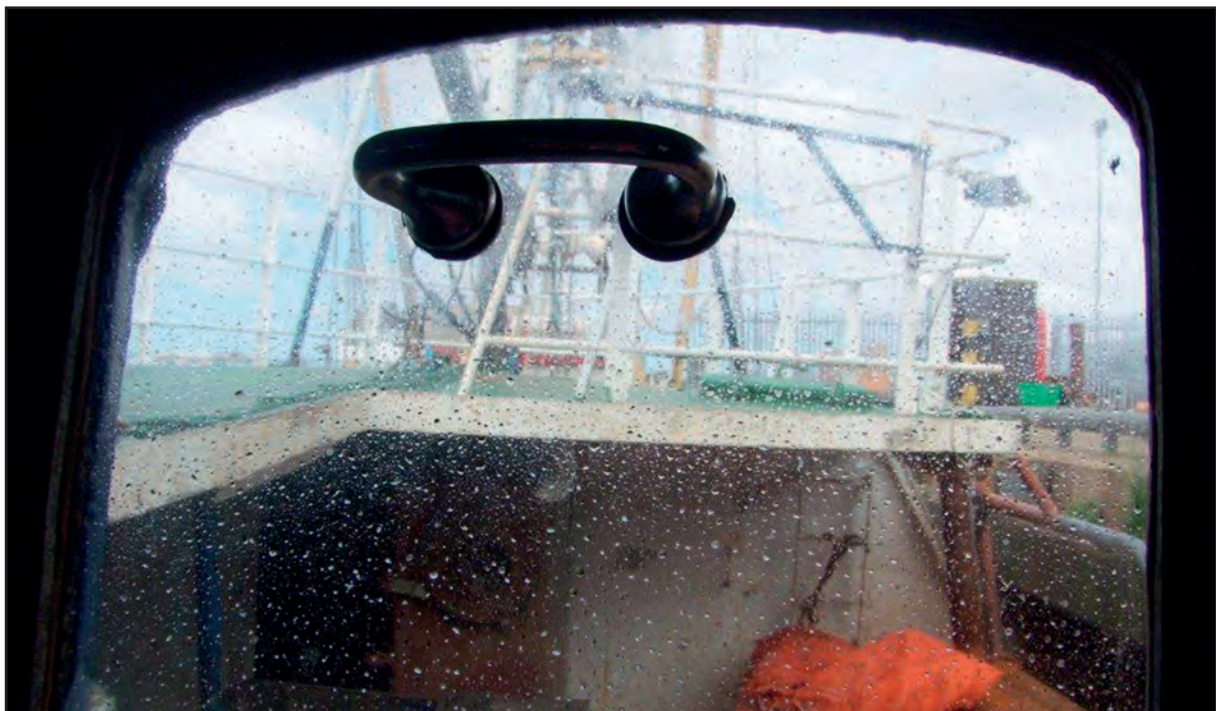
The sole occupant of the pleasure craft, which had no radar reflector, had seen the fishing vessel approaching and had managed to jump clear before the impact. He had been wearing a lifejacket with an attached portable VHF radio, which he now used to call the coastguard. Having heard and seen the man overboard, the fishing vessel skipper summoned his crew on deck and manoeuvred his vessel towards him. He was pulled from the water and then transferred ashore by lifeboat, with some bruising but, fortunately, no lasting ill-effects.

Figure 1: Restricted visibility from the wheelhouse

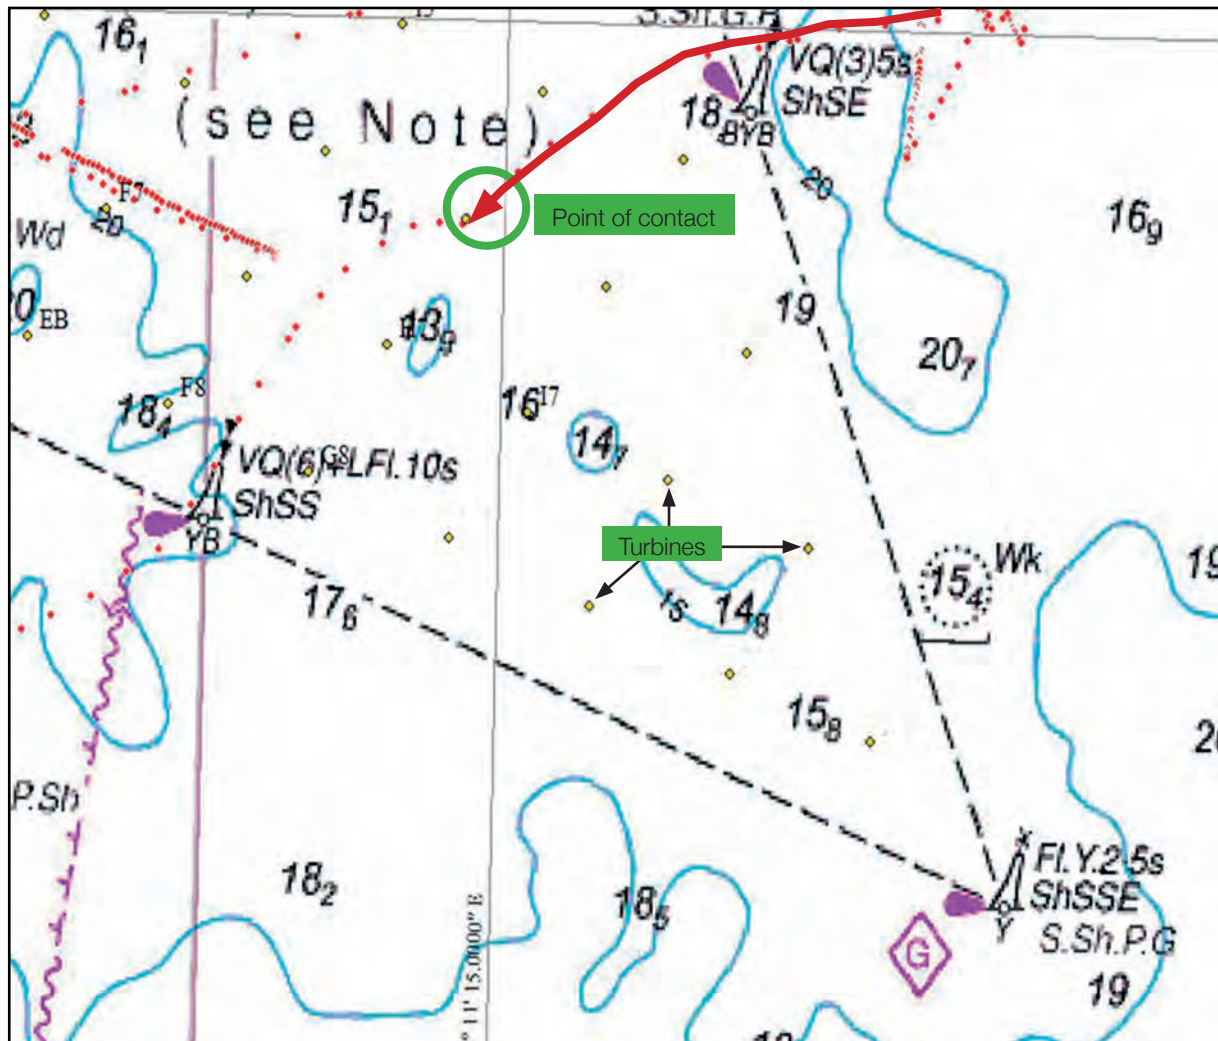
AIS track of vessel

Fortunately the only hull damage was above the waterline. Other nearby support vessels were asked to stand-by and the wind farm marine control room was informed. Contact with the coastguard was eventually established half an hour after the accident.

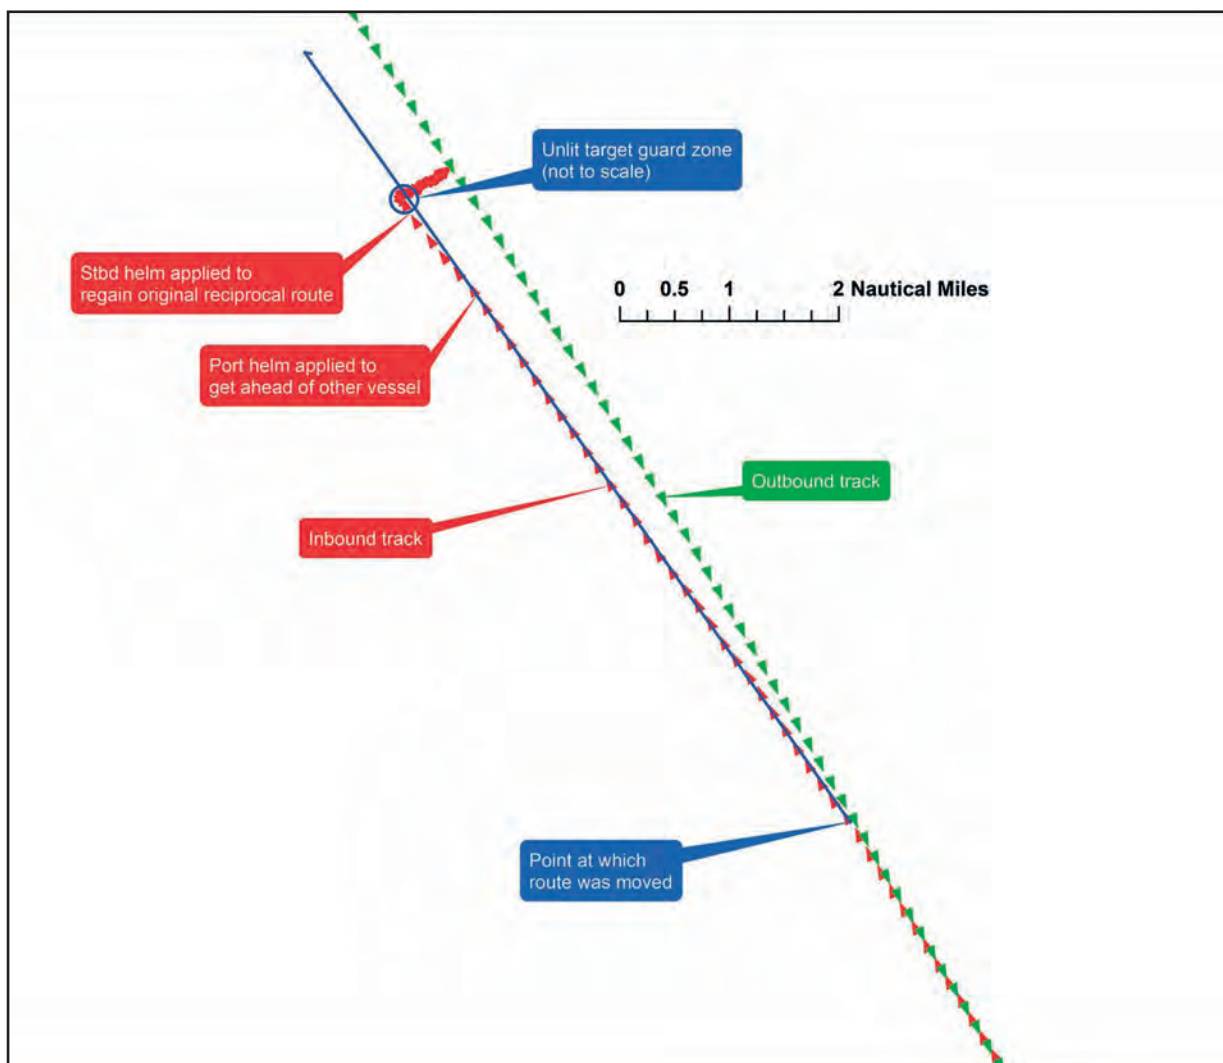
Figure 1: AIS tracks

With the vessel listed but stable the crew and passengers transferred to another vessel that came to assist. The damaged vessel was subsequently taken under tow to her home port for repairs.

Fortunately there were no injuries, but the vessel suffered extensive penetrations to the port hull shell plating (Figure 2). The port skeg was removed, the port propeller shaft was bent and the port propeller blades were badly damaged (Figure 3). The target also suffered extensive damage.

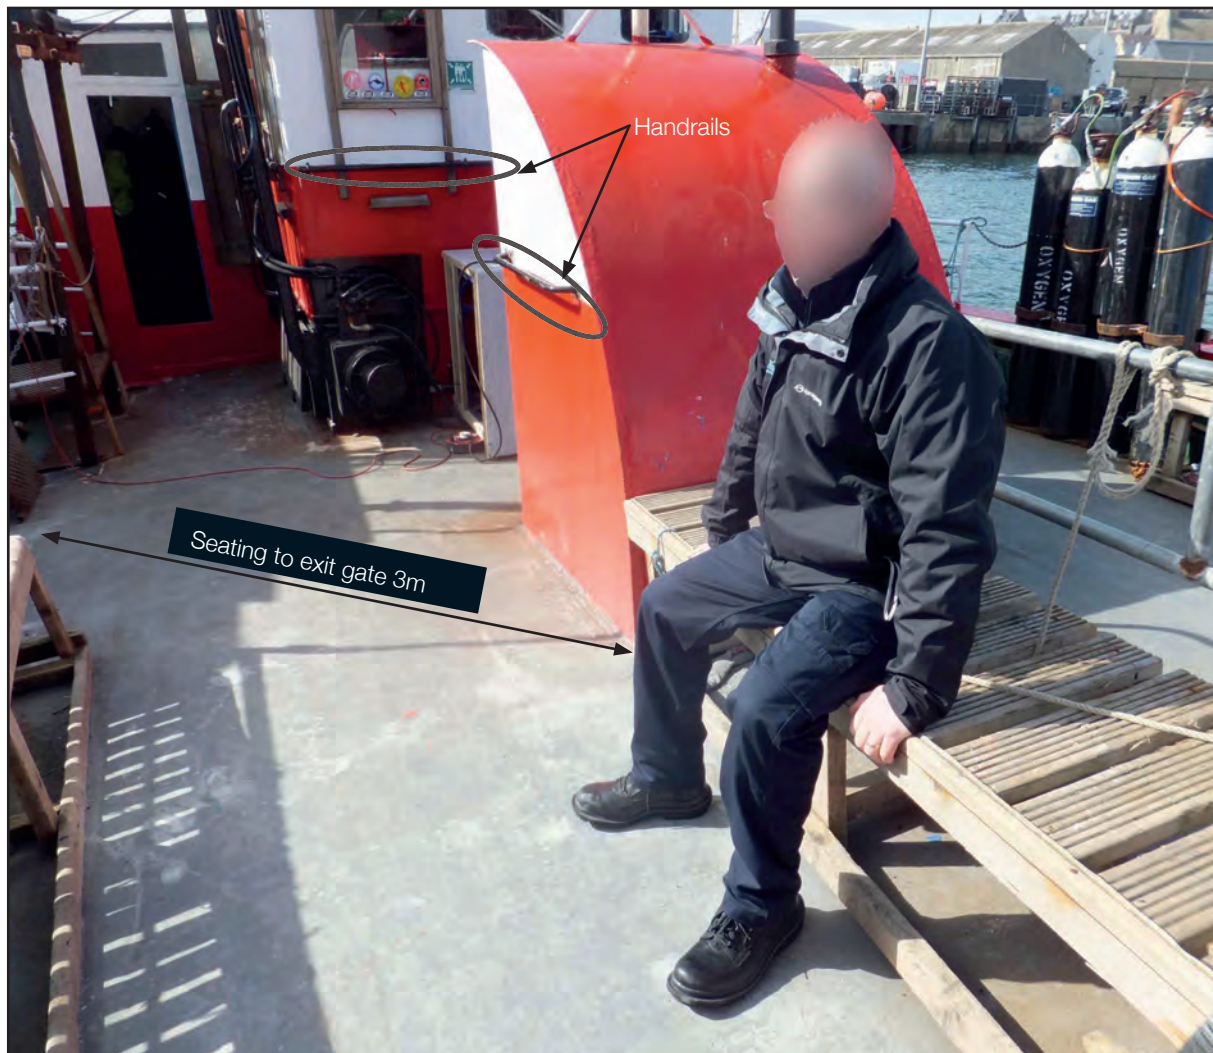
As the sixth diver tried to walk forwards unaided, he stumbled and fell heavily onto the deck. Although it was not immediately apparent, it was likely that the diving gear impacted into the diver's abdomen during the fall and caused significant internal injuries.

Diver's dressing position

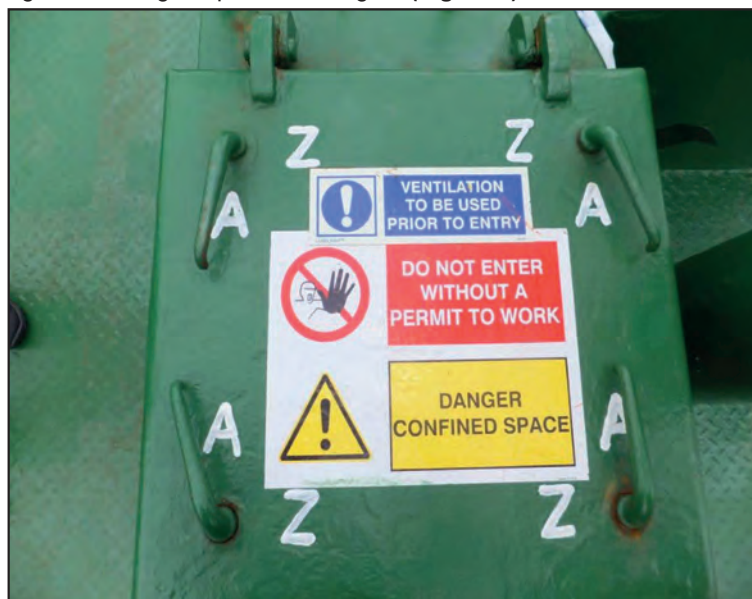
Figure 1

With a timber cargo loaded in the hold and the hatch covers closed, access to the compartment was subject to a permit-to-work and confined space entry procedures. The lid of the hatch into the compartment had signs indicating the potential dangers (**Figure 1**).

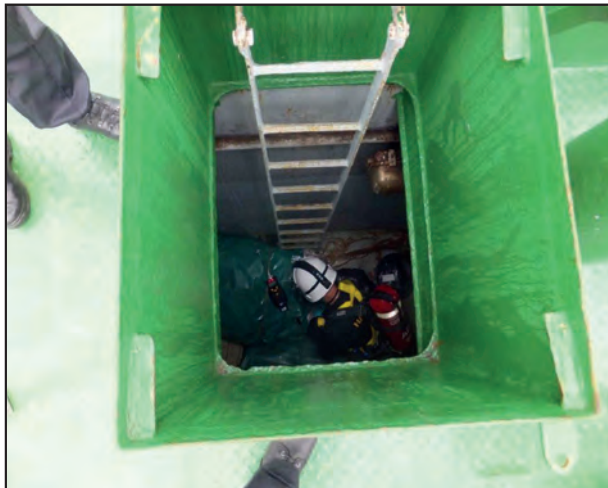
Figure 2

The Fire and Rescue Service analysis of the atmosphere after the accident showed normal readings (20.9%) of oxygen content at the access hatch; the readings reduced to 10% just below main deck level inside the hatch opening and to between 5% and 6% at the bottom of the ladder into the compartment (**Figure 2**). Such low levels of oxygen cannot support life. Anyone exposed to such levels will faint almost immediately, followed by convulsions, coma and respiratory seizure within a few minutes. It is likely that the timber cargo caused the deprivation of oxygen in the cargo hold and access compartments.
