SAFETY DIGEST

**Lessons from Marine
Accident Reports
1/2015**

SAFETY DIGEST
Lessons from Marine Accidents
No 1/2015

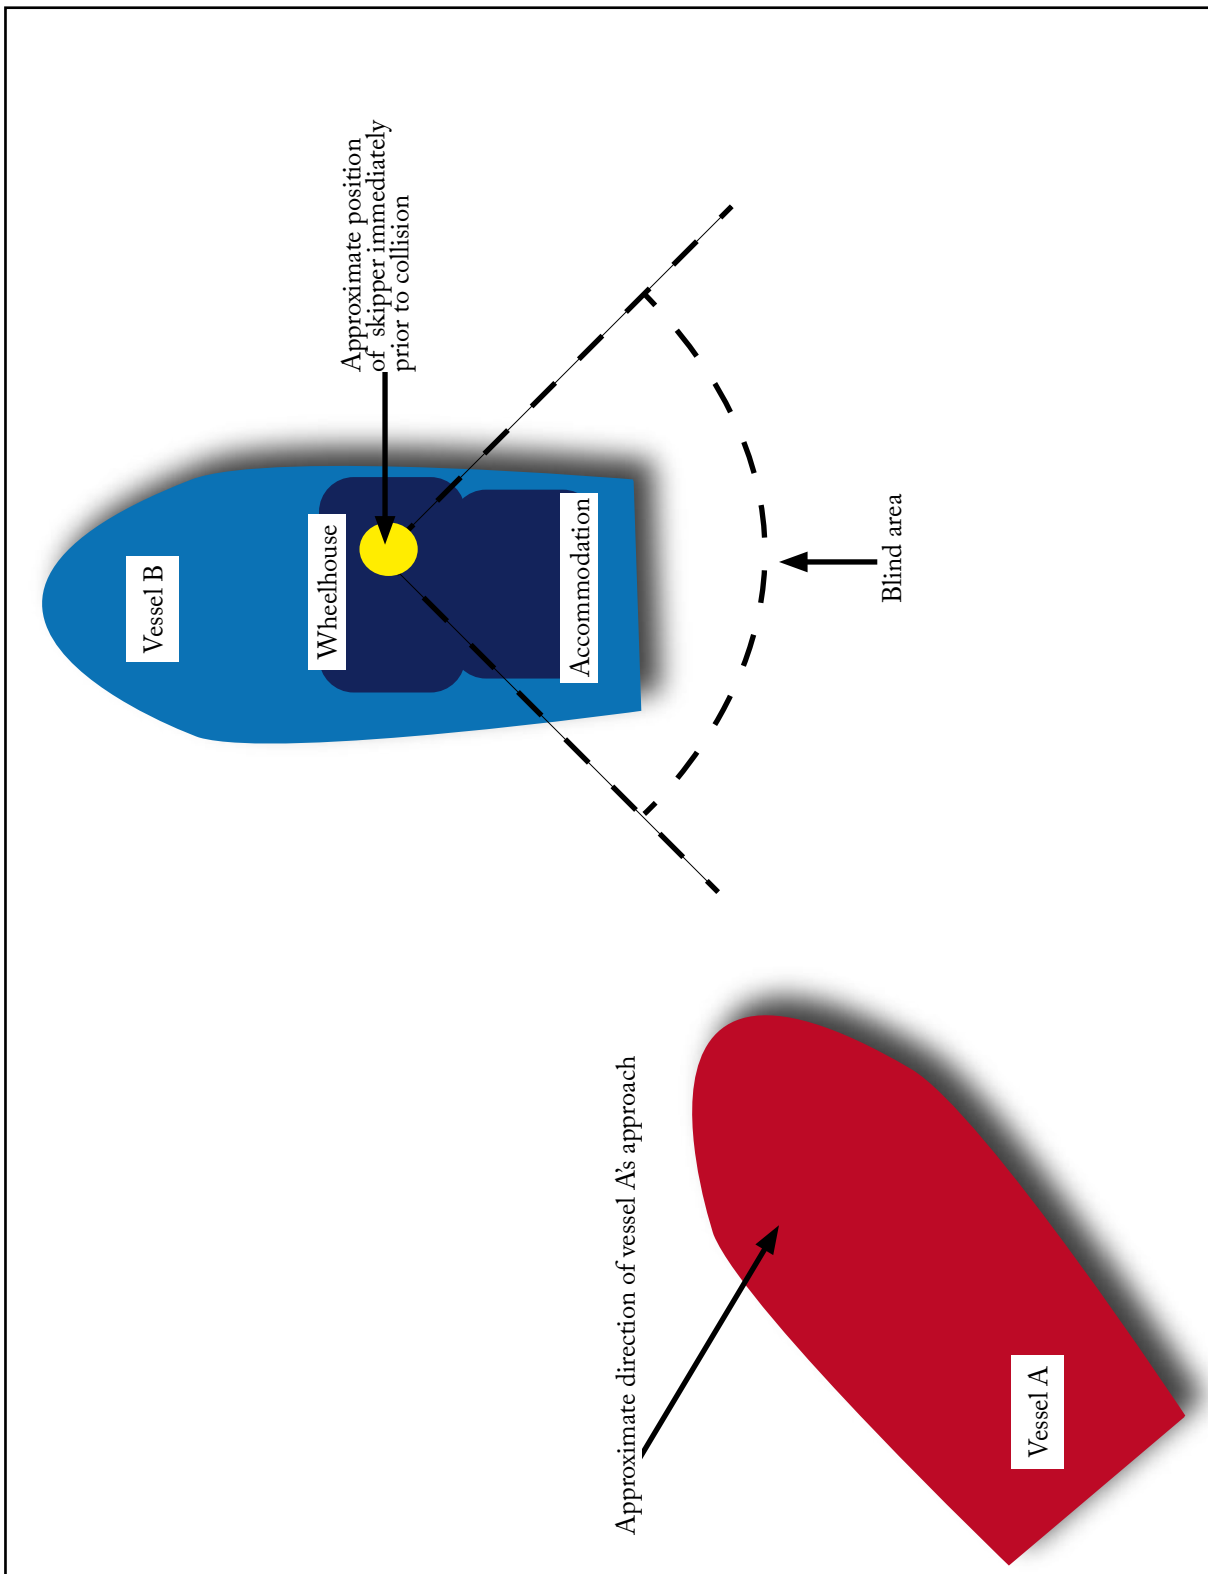
Relative positions of Vessel A and B, and Vessel B's blind area when standing at the chart plotter

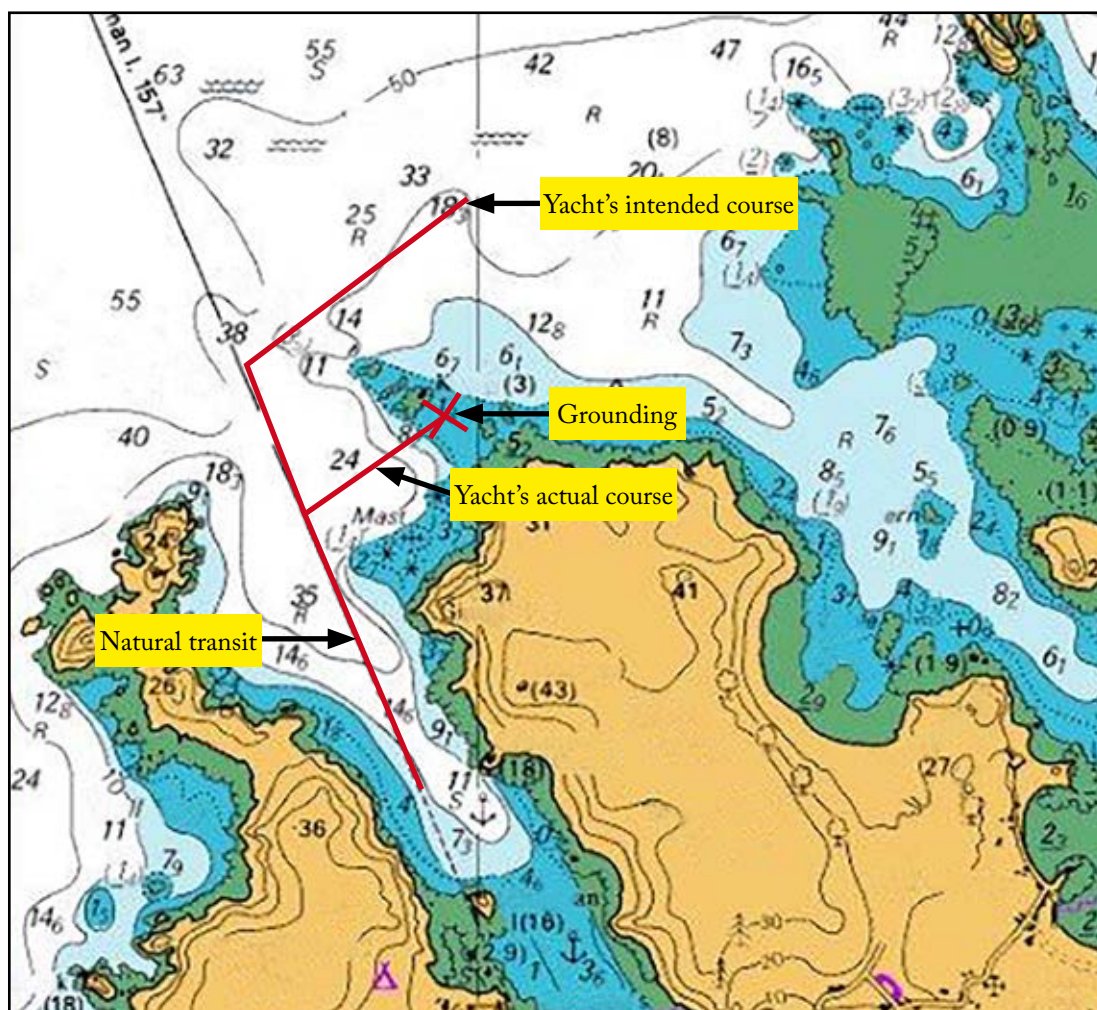
Chartlet showing yacht's intended and actual course before grounding

1. Planning passages from berth to berth can sometimes seem to be an unnecessary burden, but the consequences of not doing so may be disastrous. Therefore, plan your passages thoroughly and, if the conditions or your situation change, don't rush. Slow down, stop or even anchor and revise your plan before proceeding.
2. Get in the habit of plotting your position at regular intervals and check your vessel's position by alternative means. Remember that if you are guessing where you are, then you really don't know where you are.
3. If a situation appears untoward or dangerous, don't be shy about coming forward and letting people know. The person in charge might appear to be in control of the situation, but appearances can sometimes be deceptive.
4. Communication is a key factor – always ensure that all instructions and information are received and understood.

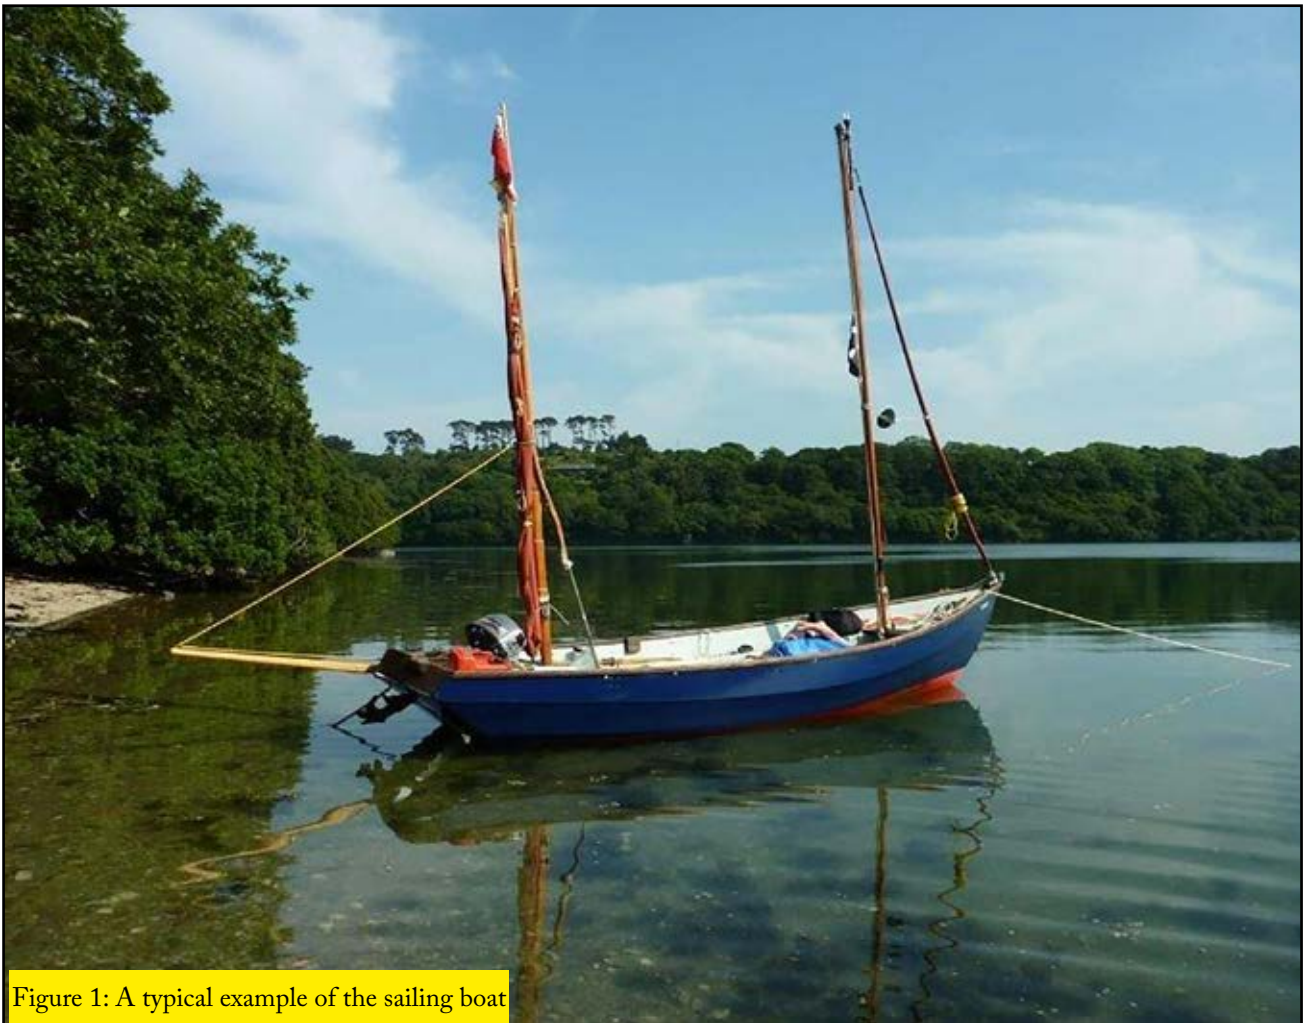
Figure 1: A typical example of the sailing boat

1. Things can and do go wrong so don't put more people in the boat than absolutely necessary. It's not a fun ride.
2. Towing hitches wear over time, causing trailers to uncouple without warning. It is therefore important that the hitches are routinely inspected and maintained

and that safety chains or breakaway devices remain fixed every time a trailer is attached. Help and advice on towing boat trailers and towing hitches are available at www.gov.uk.

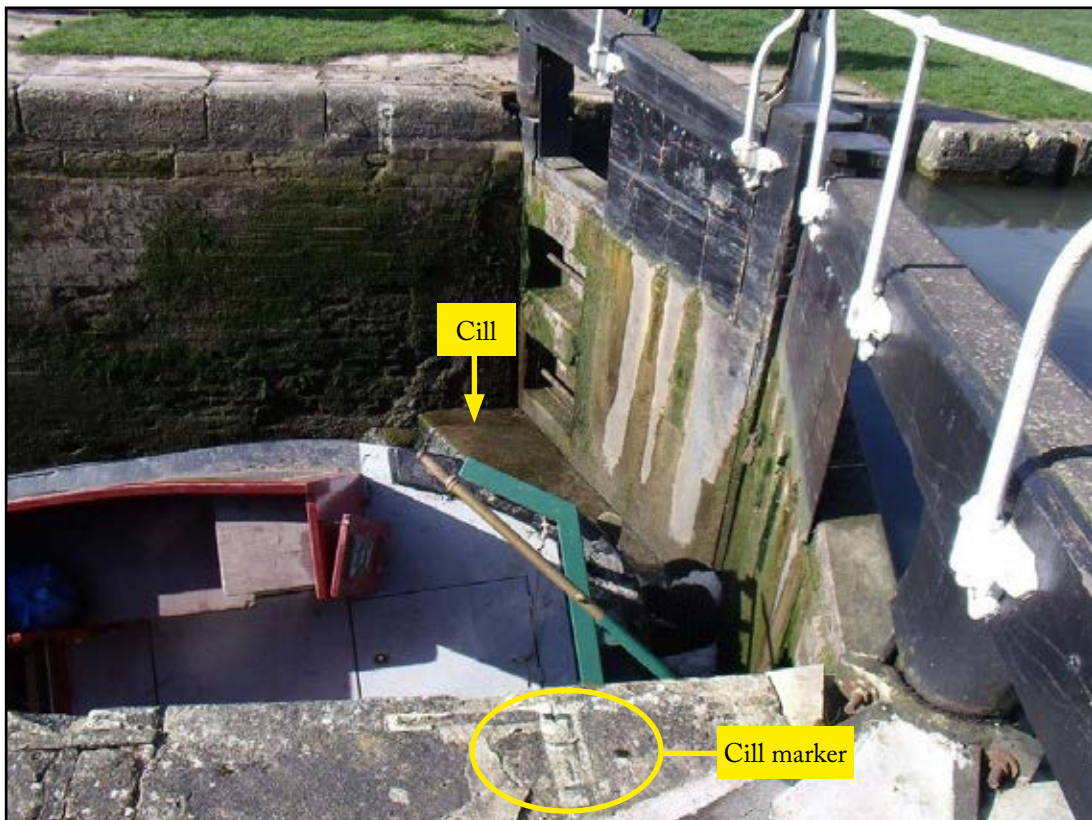
Both narrow boats sailed early the following morning. The smaller of the two, with the group of three on board, made better progress in navigating the locks and so soon left the larger boat behind. The least experienced group member was on the tiller as the vessel entered a lock. The gearbox was in neutral and the engine at idle as the lock gates were closed and the vessel remained stationary, above the lock's cill, which was clearly indicated on the lock's side coping stone (Figure 1).

Figure 1: Showing cill and marking
