**Lessons from Marine
Accident Reports
2/2015**

SAFETY DIGEST
Lessons from Marine Accidents
No 2/2015

October 2015

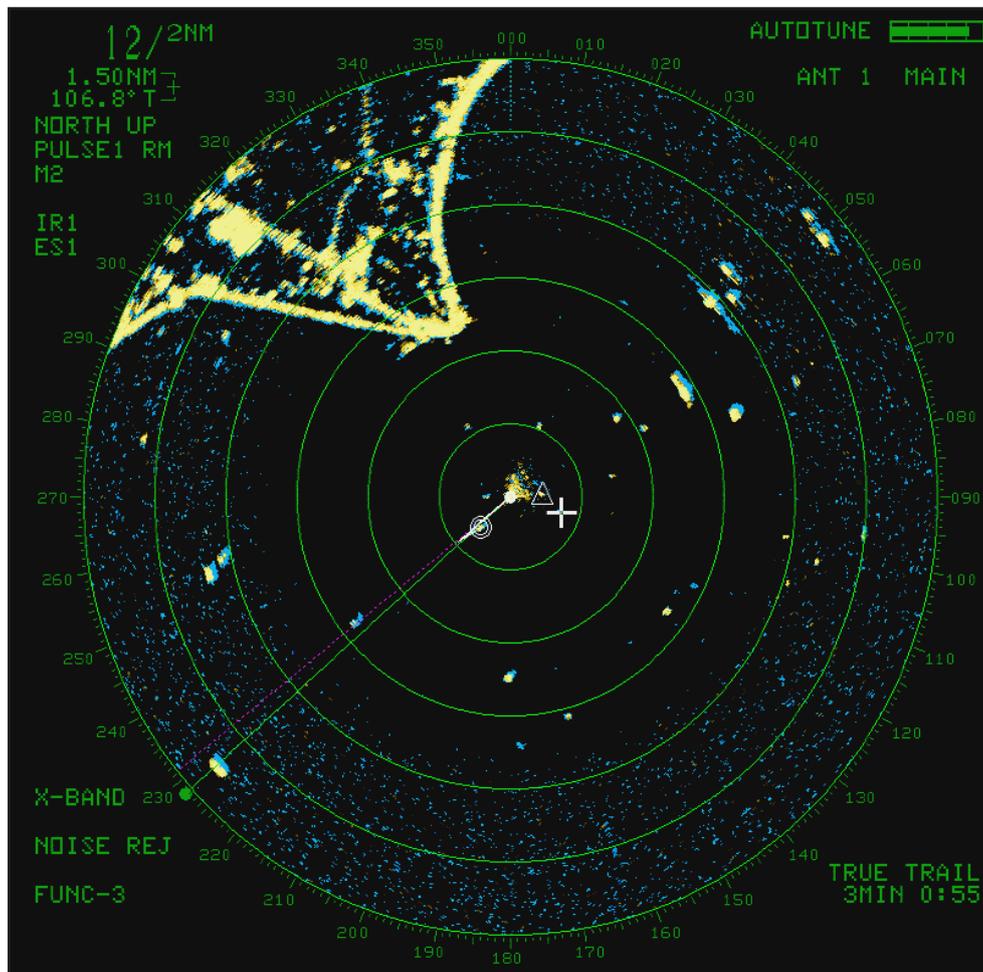
Figure 3: General cargo vessel - ARPA radar display at 1007

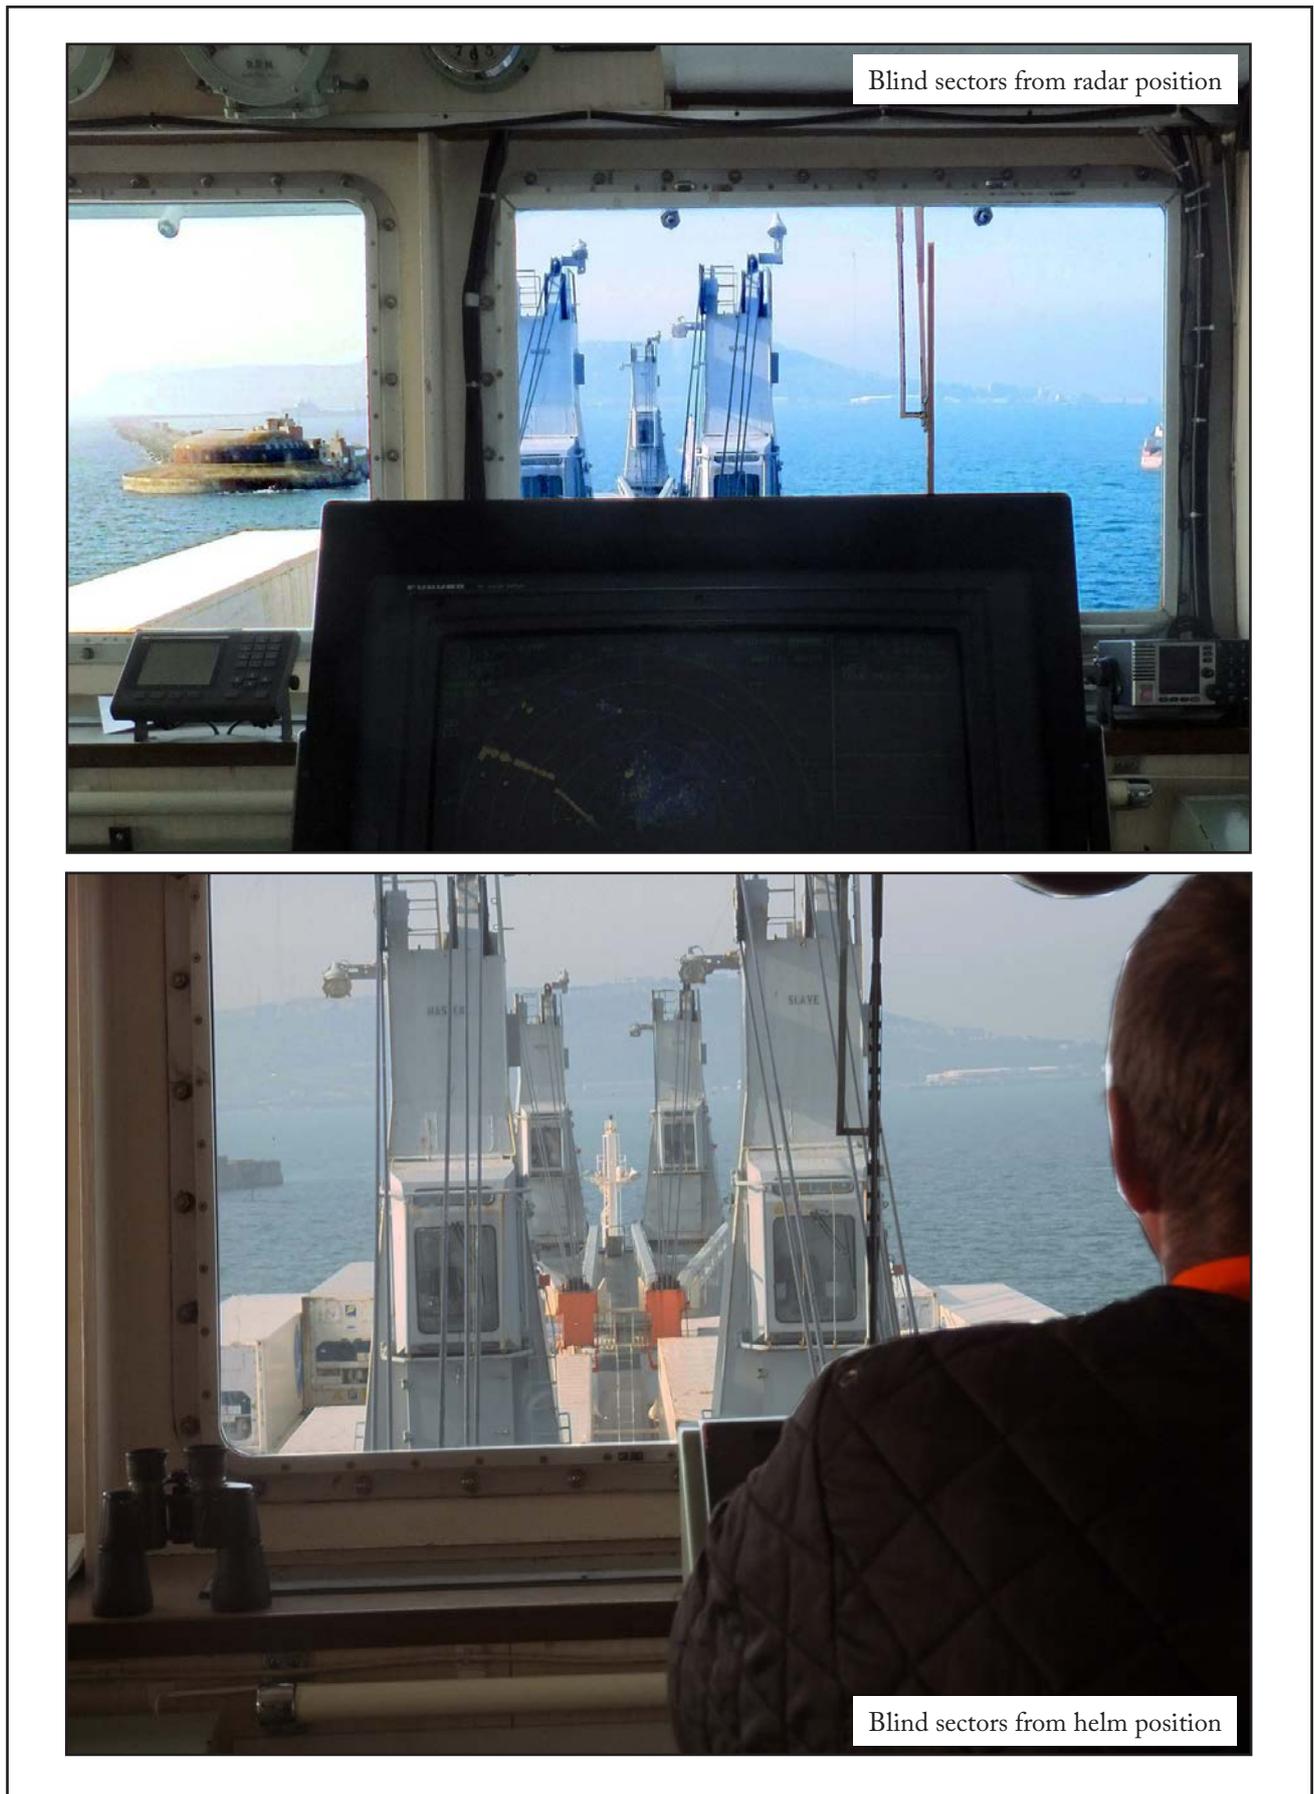
4. By failing to move around the bridge periodically, the master of the cargo vessel did not see the tanker visually until it was too late to avoid collision because of blind sectors ahead created by deck cranes. Always move around the bridge when keeping watch to ensure that target vessels are not hidden in blind sectors. Moving around the bridge will also keep you stimulated and alert!

Figure 4: General cargo vessel bridge showing blind sectors from radar and helm positions

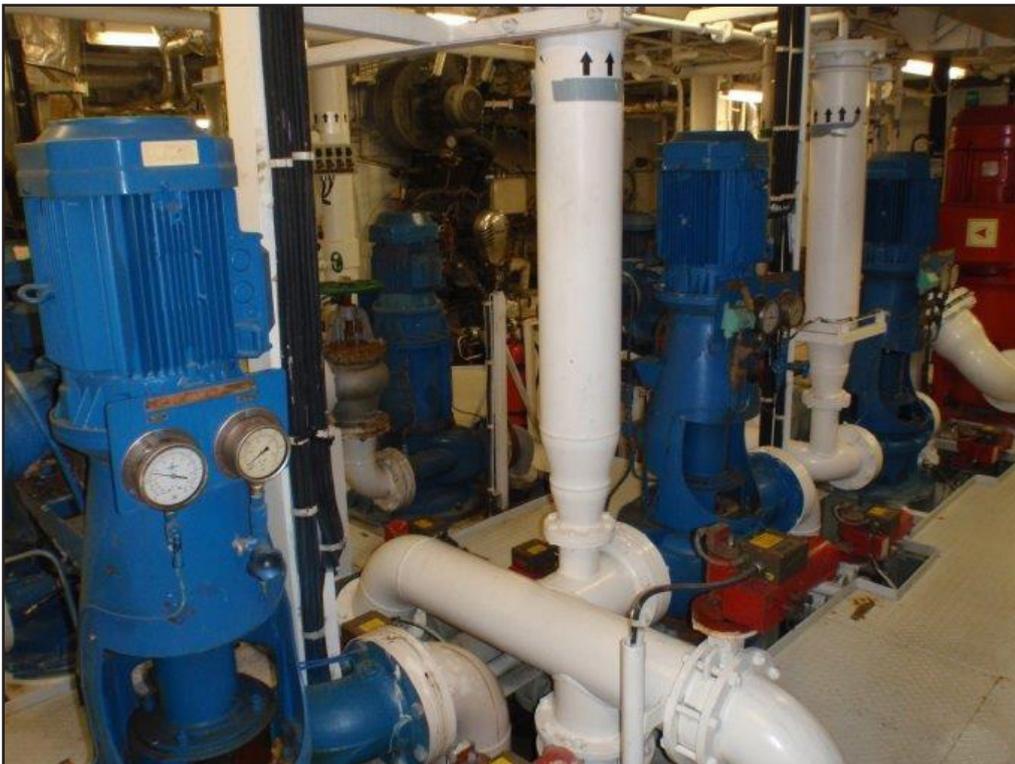
To configure the ballast system, the second officer accessed the ballast system screen on the PMS. This showed all the ballast pumps and ballast valves, but it did not show the cross-over valve connecting the ballast system with the bilge system. This valve was only shown on the bilge system screen, which was not selected for viewing. Using the PMS, the second officer opened the required ballast system valves and started a ballast pump. The transfer of ballast water commenced.

Figure 1: Bilge and ballast pumps and valves

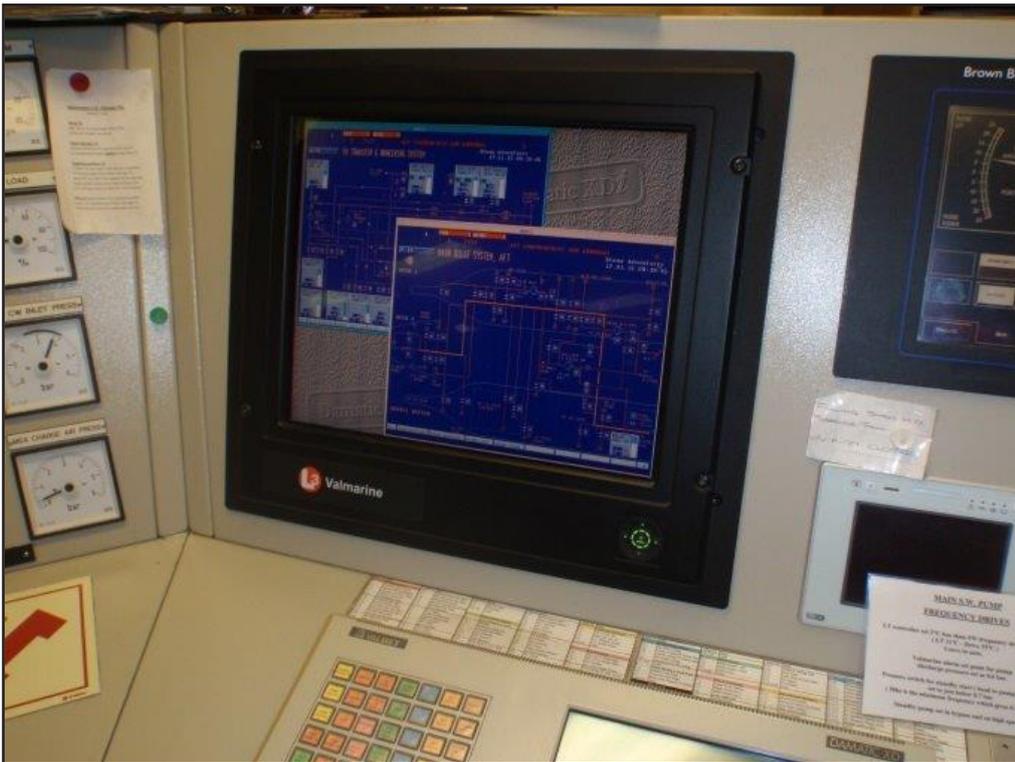
Figure 2:
PMS control station

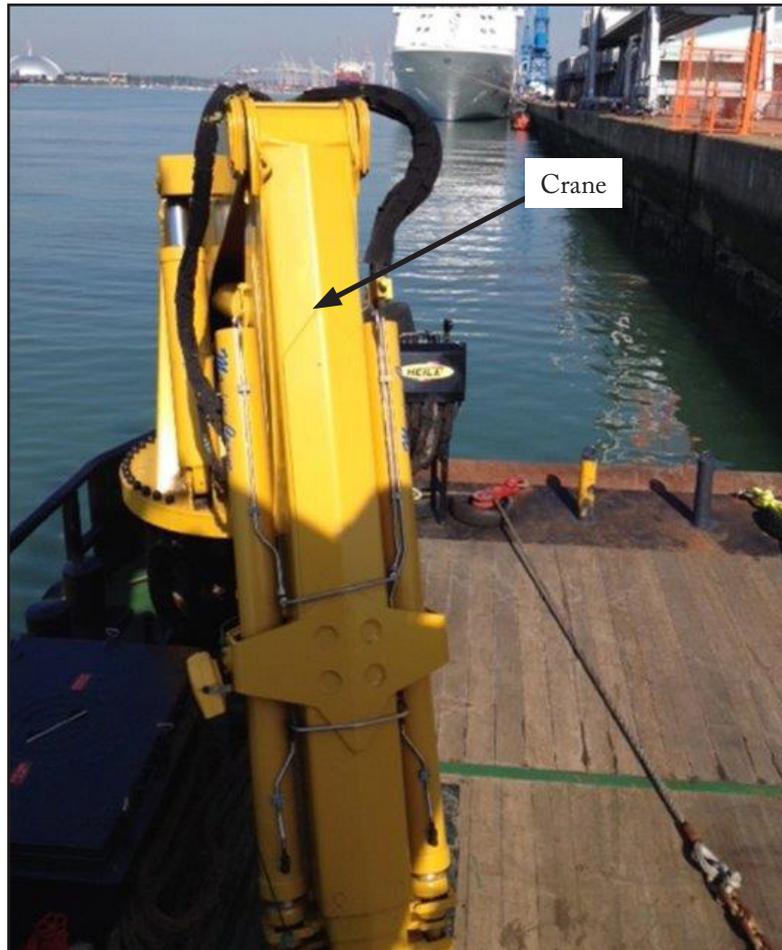
Figure 1: View forward

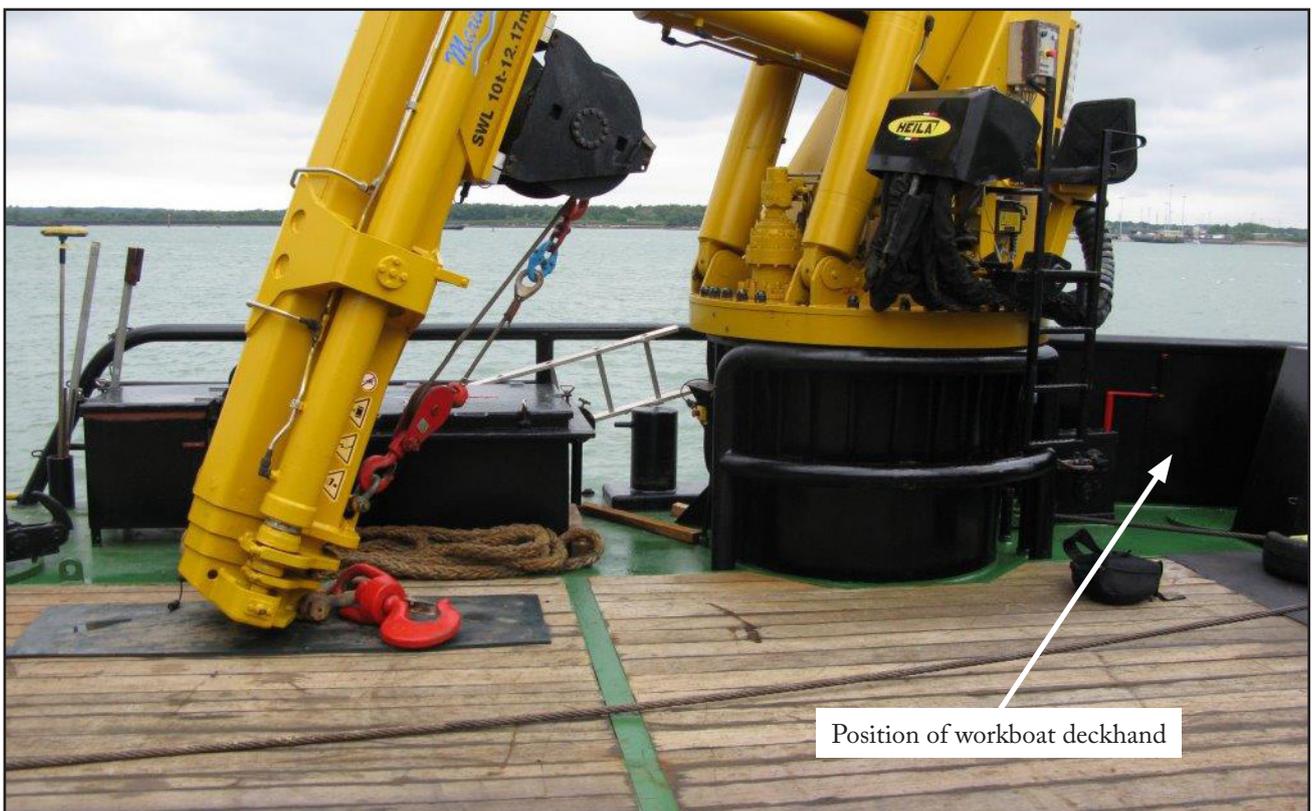
Figure 2: View towards port side

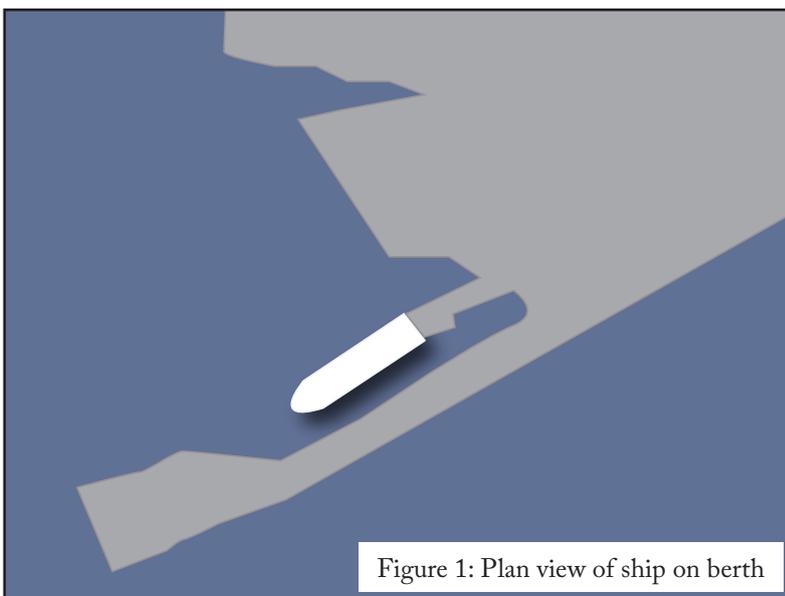
Figure 1: Plan view of ship on berth

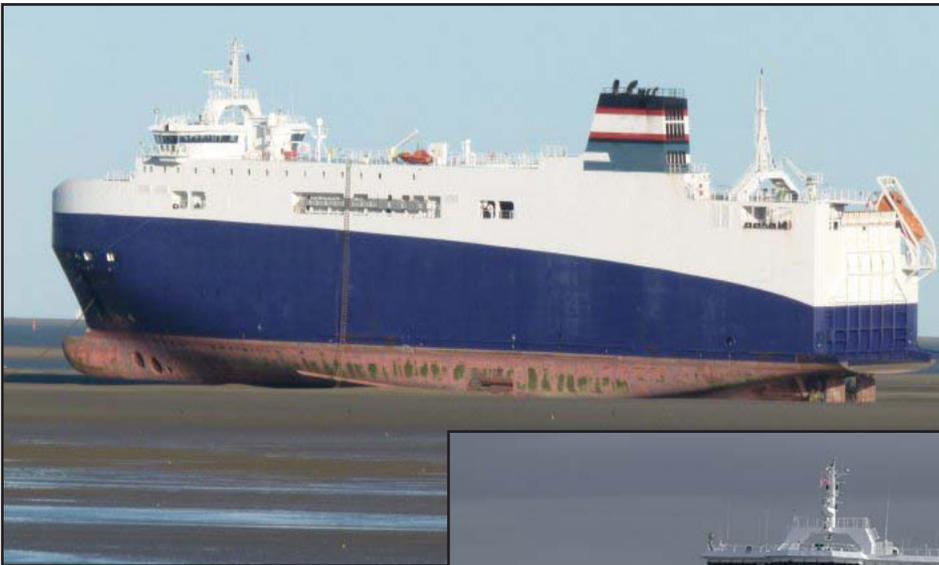
As the vessel was blown out of the dredged area of the port towards shallow water, a port pilot embarked to assist the master and they agreed that, due to the high winds, it was no longer possible to sail into open water. The master, helped by the pilot, spent the next 50 minutes trying to reduce the vessel's exposure to the wind and to keep the vessel in deep water. However, the vessel ultimately grounded on sand and mud 45 minutes after high tide (Figures 2a and b).

Figures 2a and b: Vessel aground

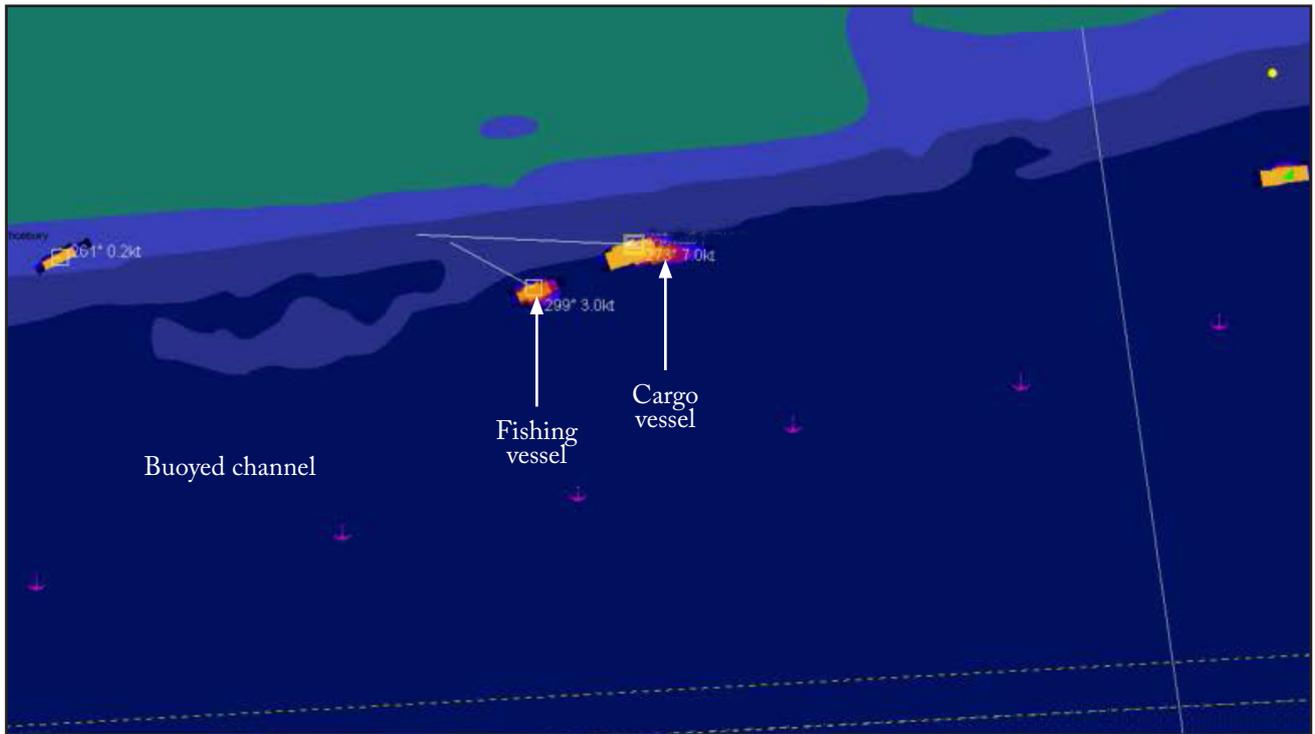
The cargo ship was only 0.2nm away and the vessels were now heading for a collision (Figure 3). In response, the cargo ship's deckhand turned the cargo ship further to the north, reduced its speed and sounded the general alarm. However, the vessels collided soon after (Figure 4); the trawler's bow struck the cargo ship's port side. The cargo ship then ran aground in shallow water outside the channel.

Figure 3: Snapshot 3

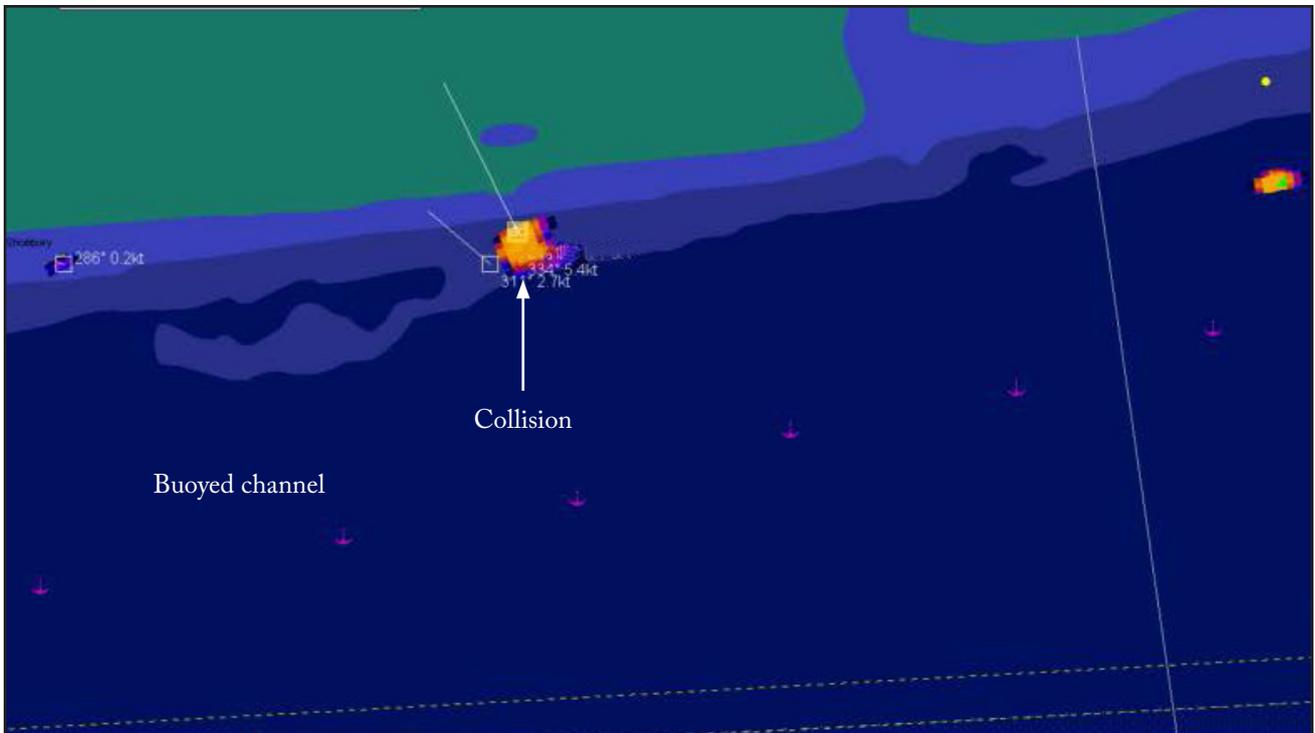
Figure 4: Snapshot 4

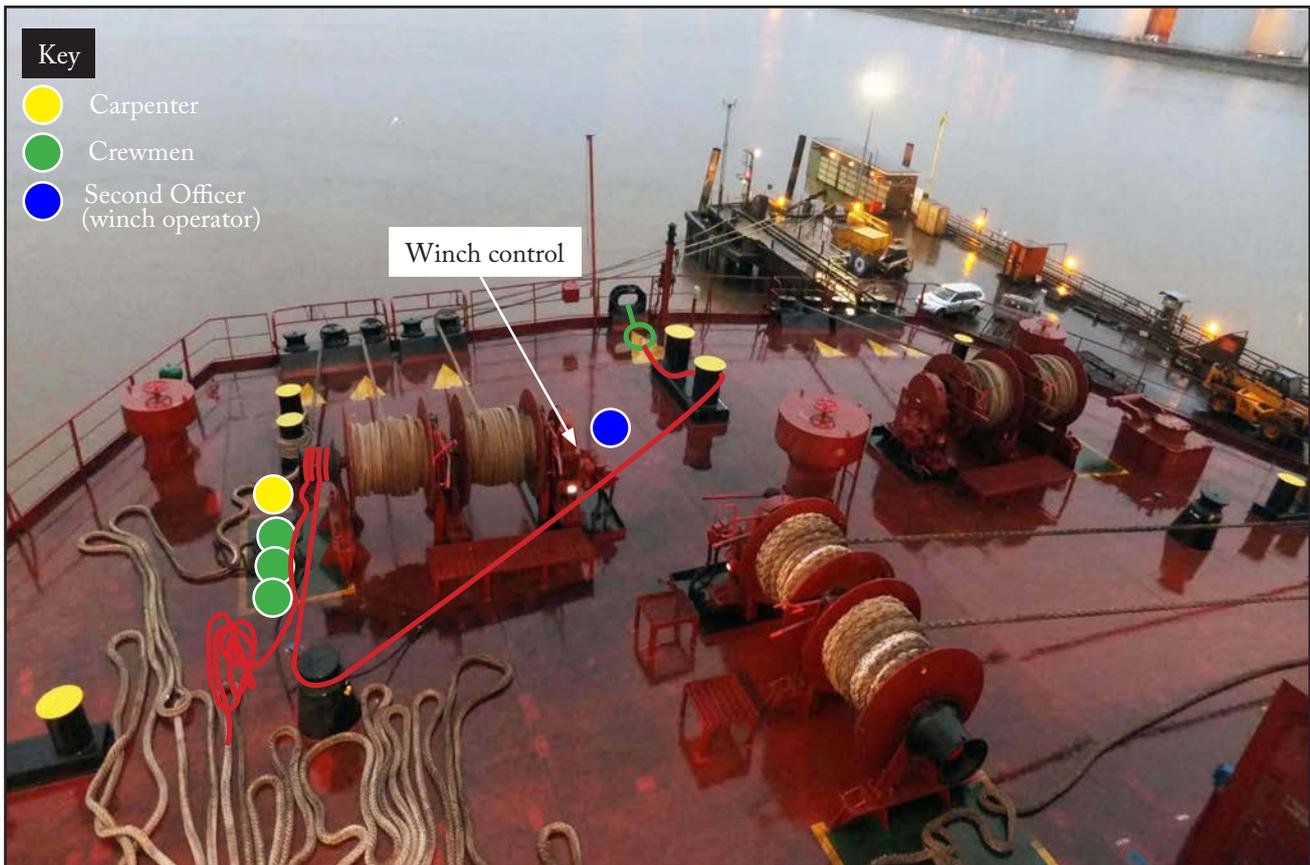
It was established that a section of the tensioned messenger line slipped off the end of the warping drum and struck the carpenter on his neck.

Layout of mooring equipment and messenger line routing at the time of the accident

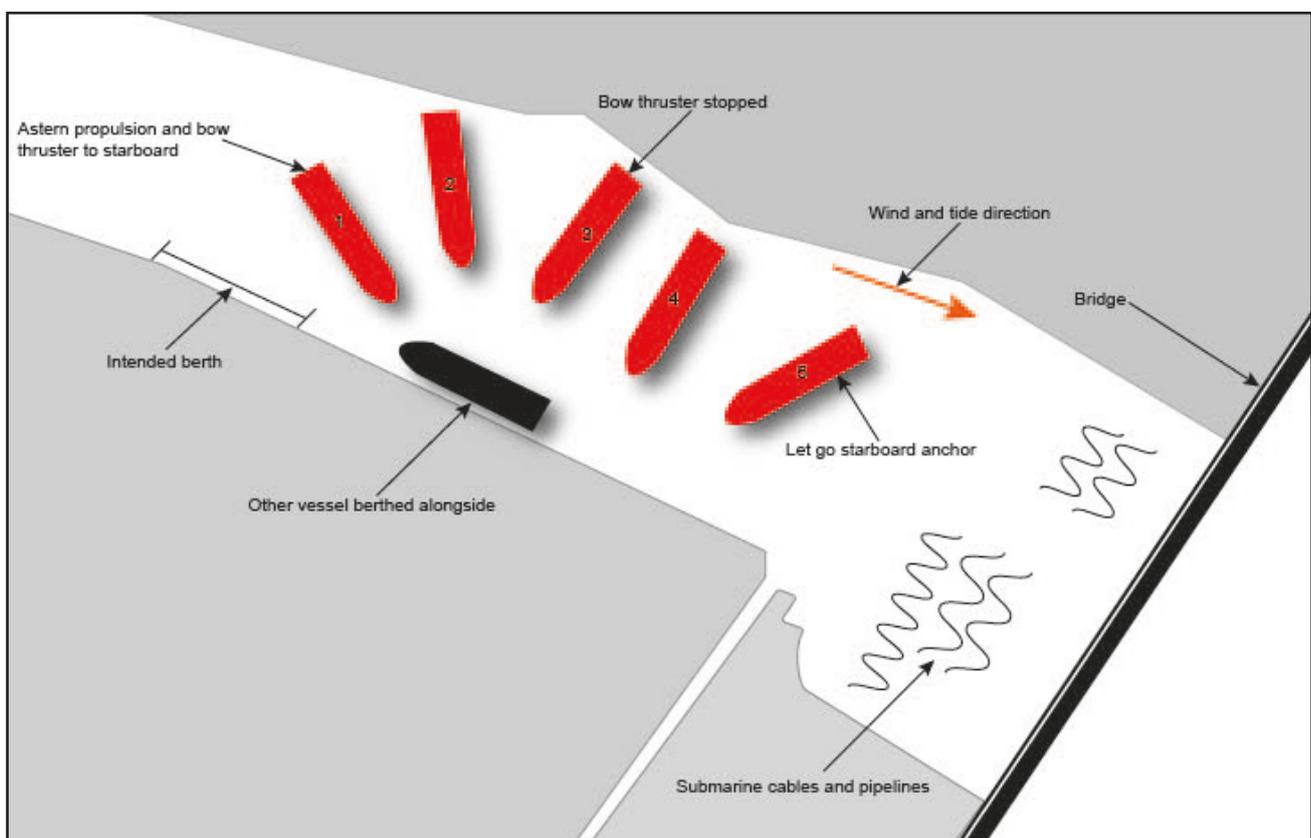
The pilot ordered astern propulsion and bow thruster to starboard. Halfway into the turn, the bow thruster stopped. Aware that the vessel was being set towards a bridge that spanned the waterway, and that he would be unable to complete the turn using only helm and propulsion, the pilot ordered the starboard anchor, and then the port anchor, to be let go. Although this had the effect of assisting the turn, the vessel was too close to the bridge to prevent its stern impacting with it.

Following the accident, both anchors were weighed and the vessel was manoeuvred port side alongside its intended berth. Substantial damage had been caused to the vessel's port quarter and lifeboat davit. The bridge, which accommodated road and rail traffic, was subsequently closed to rail traffic until resulting damage to its tracks was repaired some days later.

Sequence of events leading up to the accident

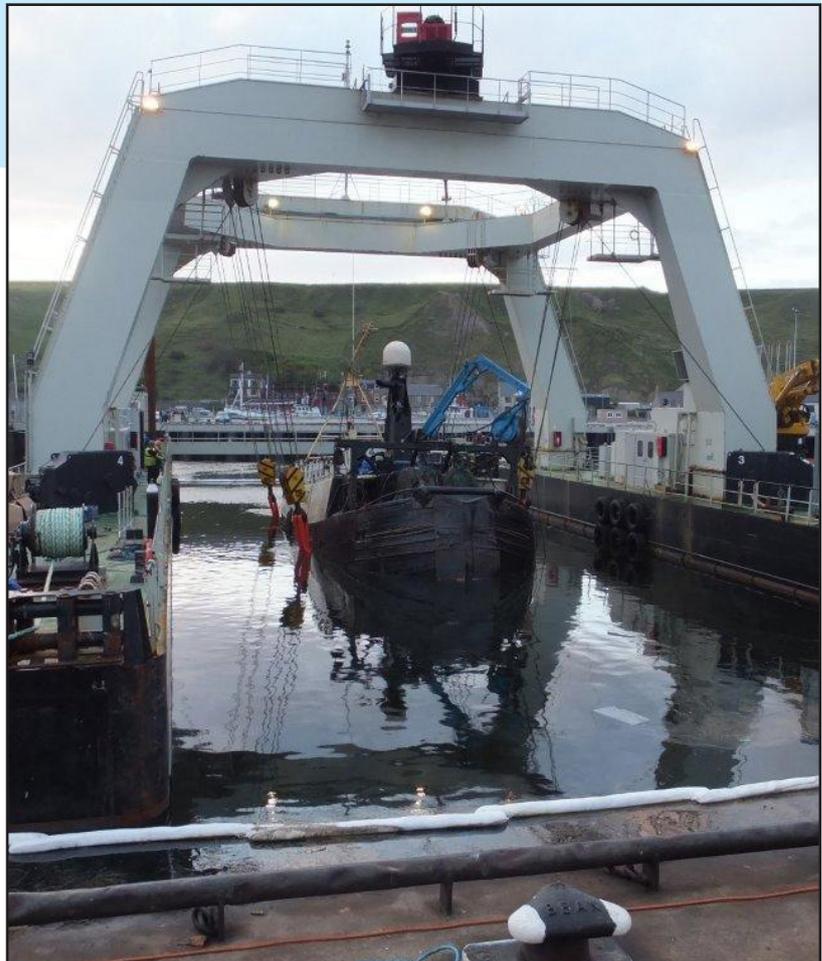
The trawler was eventually re-floated (Figure 2) and an investigation discovered that the loss of control was due to a clamp, used to secure the Morse cable between the control lever in the wheelhouse and the engine and gearbox, detaching from supporting framework (Figure 3). The clamp had been secured with one rather than two screws as intended (Figure 3 inset) and the lone screw had worked loose and had fallen out.

Figure 2: Salvage

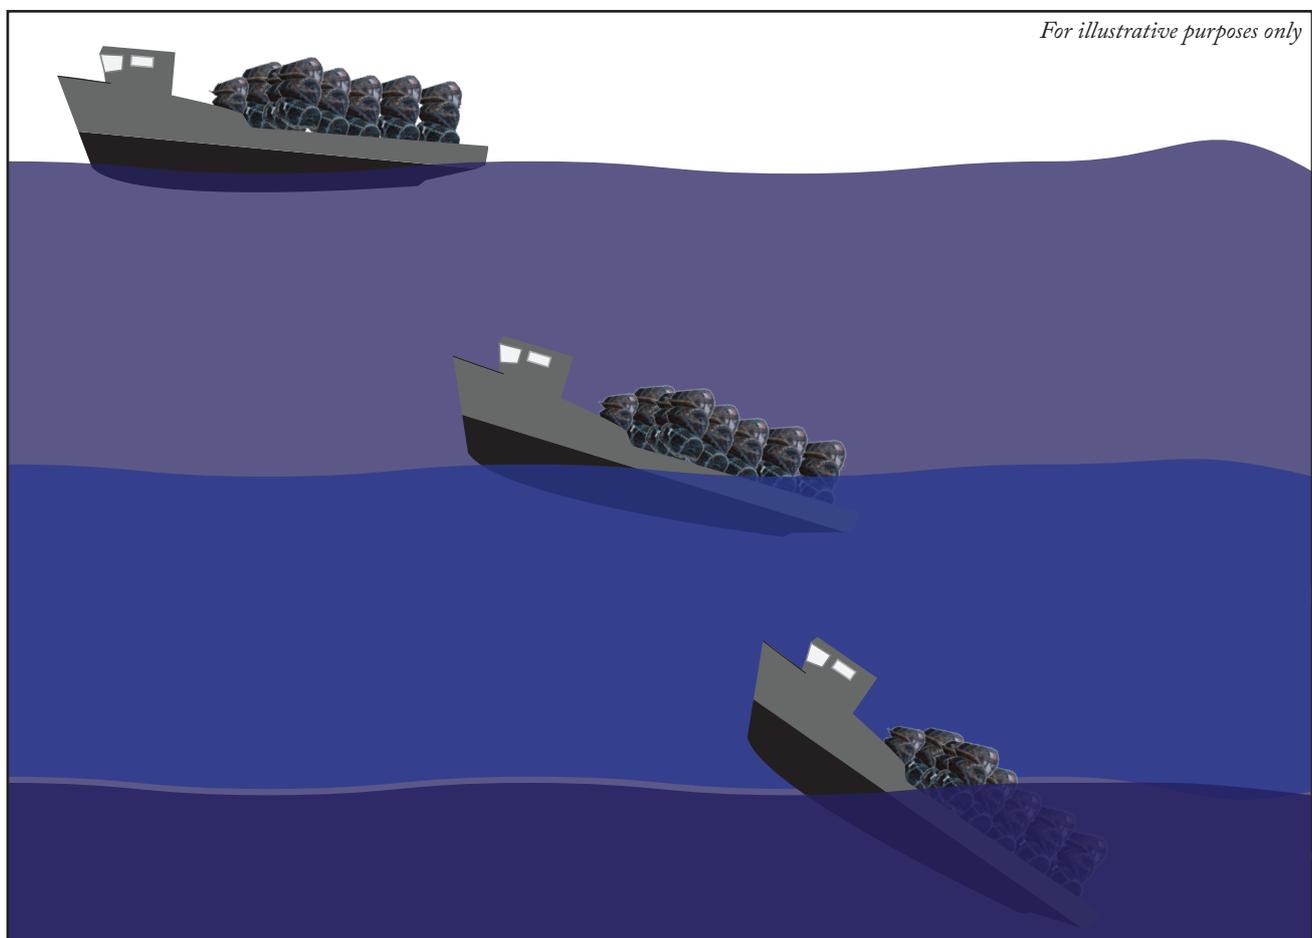
The skipper had previously disconnected the fish hold bilge alarm, relying solely on the engine room bilge alarm, which had been tested a week before the accident.

Behaviour of fishing vessel with heavy stern trim during flooding

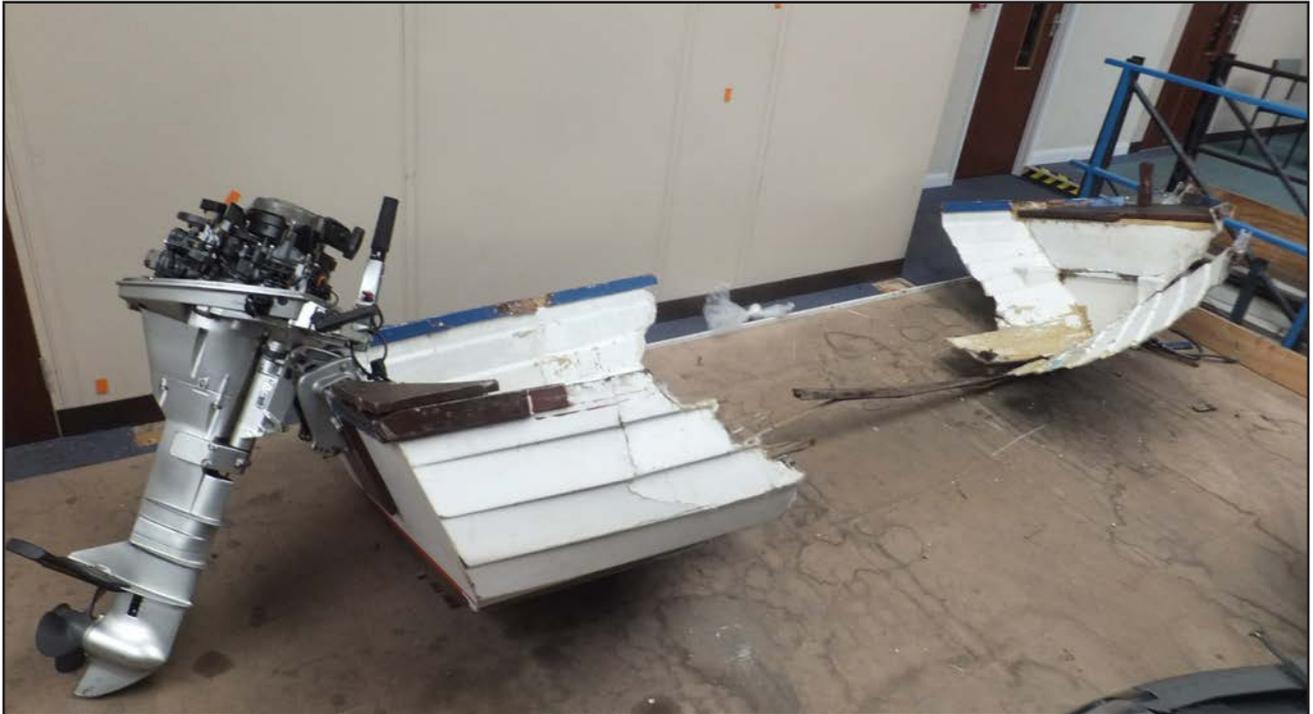
Four days later, two sections of the boat were found close together 35 miles east of the fisherman's location (Figure 1). It was concluded that he had not been wearing his kill cord (Figure 2) when he fell overboard and the boat's engine had continued to run with the propeller in gear. His boat was probably struck by a ship several days later.

Figure 1: Fishing vessel recovered sections

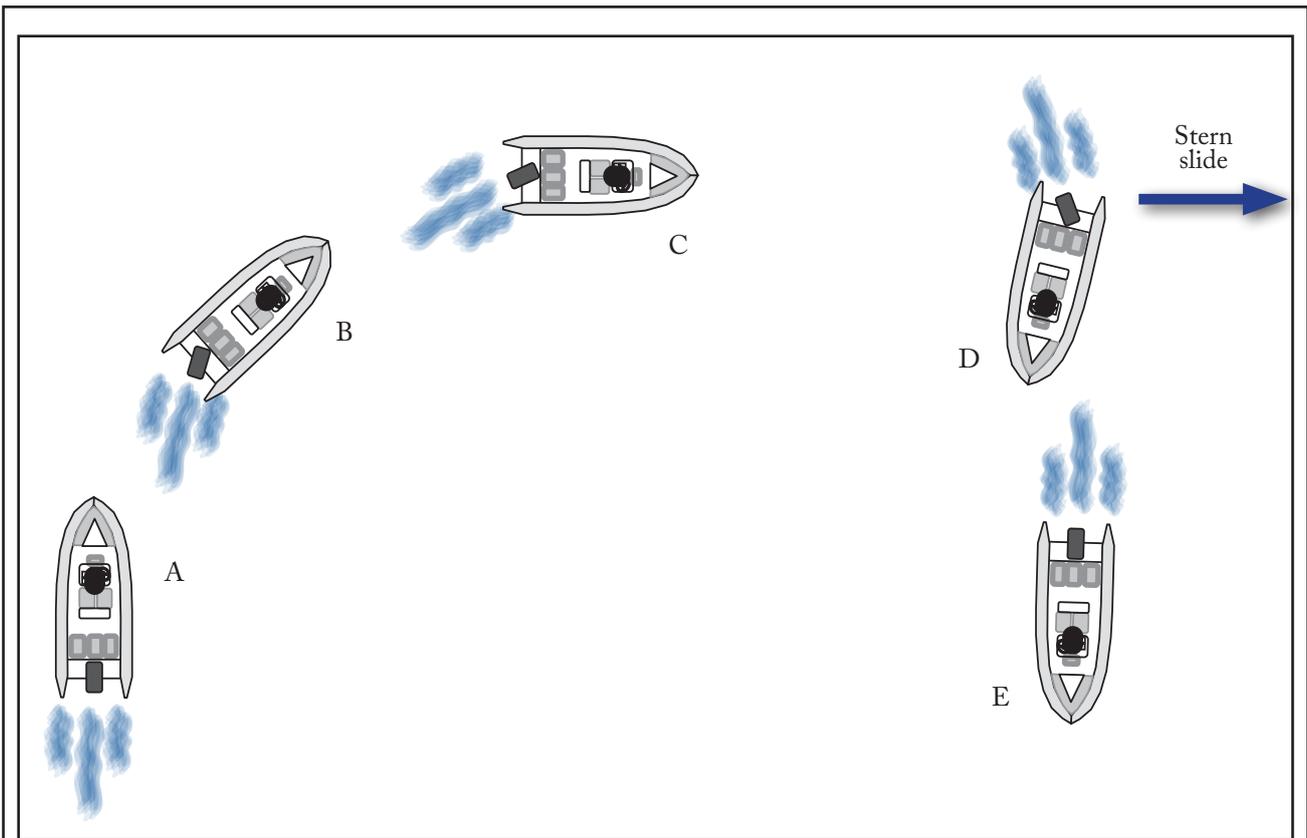
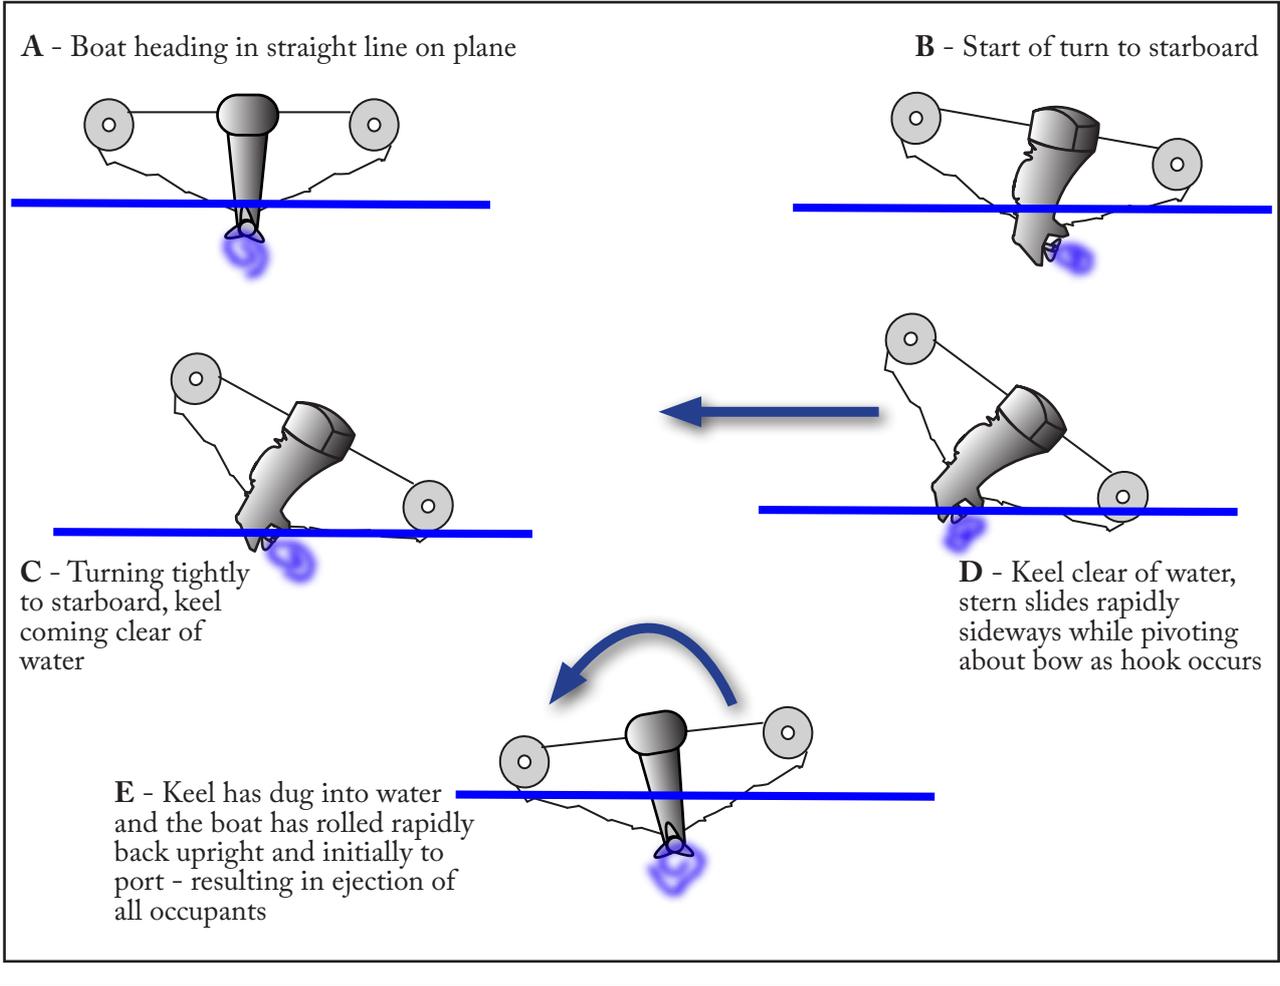
Figure 2: Diagram showing a hook during a turn

2. The adults did not have a good understanding of how the boat would perform in a high powered turn and were not prepared for the forces exerted when the boat 'hooked'. Entry level powerboat training courses may not be sufficient preparation for the safe operation of boats with powerful engines. Always ensure you are sufficiently well trained to safely handle your boat.

3. At the time the family were ejected from the boat, the children were all in the bow area and some of them were standing. The adults were not aware that the magnitude of impact and movement on small high speed craft is greater at the bow and reduces towards the stern. Drivers should consider the potential effect of these forces on those on board when deciding where each passenger will sit.

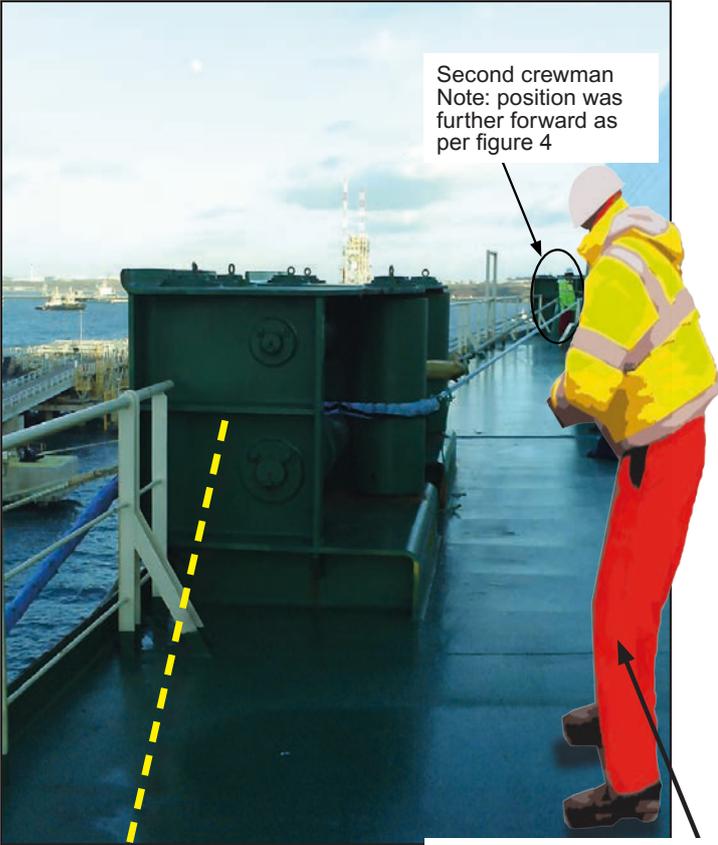
Figure 3: Forward mooring party OIC at port-shoulder roller fairlead

The OIC positioned himself aft of the forward springs' port-shoulder roller fairlead (**Figures 2 and 3**), and positioned a second crewman forward of him in order to relay his orders to the winch operator. As the winch operator attempted to heave in on the springs, the winch repeatedly stalled and rendered¹. After about 10 minutes, one of the spring lines began to rattle and creak, and then suddenly parted (**Figure 4**). The section of the line between the break and the port-shoulder roller fairlead struck the OIC on his head as it whipped back before going overboard through the fairlead.

OIC forward mooring party
