MARINE ACCIDENT
INVESTIGATION BRANCH

SAFETY DIGEST

**Lessons from Marine
Accident Reports
1/2019**

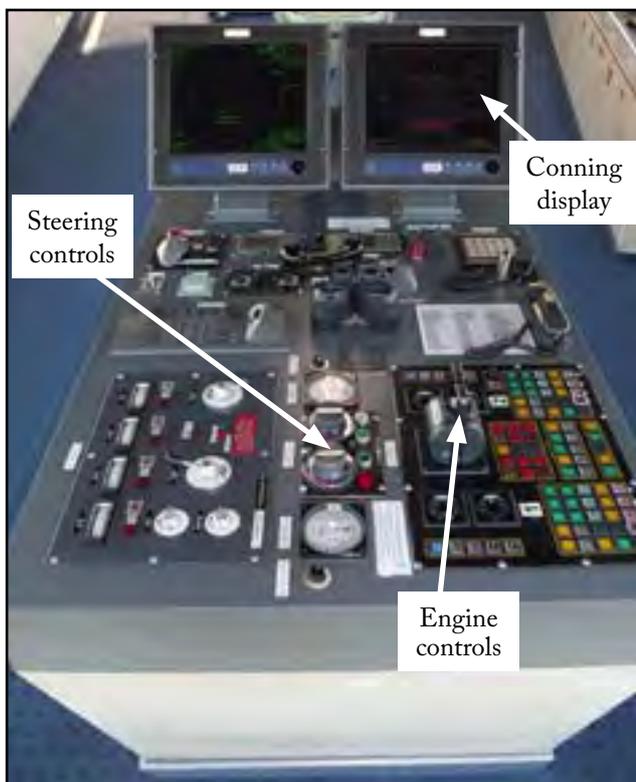
Figure 1: Port bridge wing console

A ro-ro passenger ferry left its berth with 320 passengers, 72 crew and several cars and trucks on board. The planned manoeuvre was to clear the berth, increase speed, and steer a curved track, using port helm, to pass between the two breakwaters at the port's entrance. The master controlled the engine, thrusters and steering from the console on the port bridge wing (Figure 1).

The ferry cleared the berth on schedule in light winds on a hazy morning. About halfway into its turn towards the breakwater entrance the computerised steering mode changed unexpectedly from the port console to the trackpilot system. Immediately, the trackpilot applied starboard helm to arrest the swing and steer the course it was on when it activated. This was not immediately noticed by the bridge team.

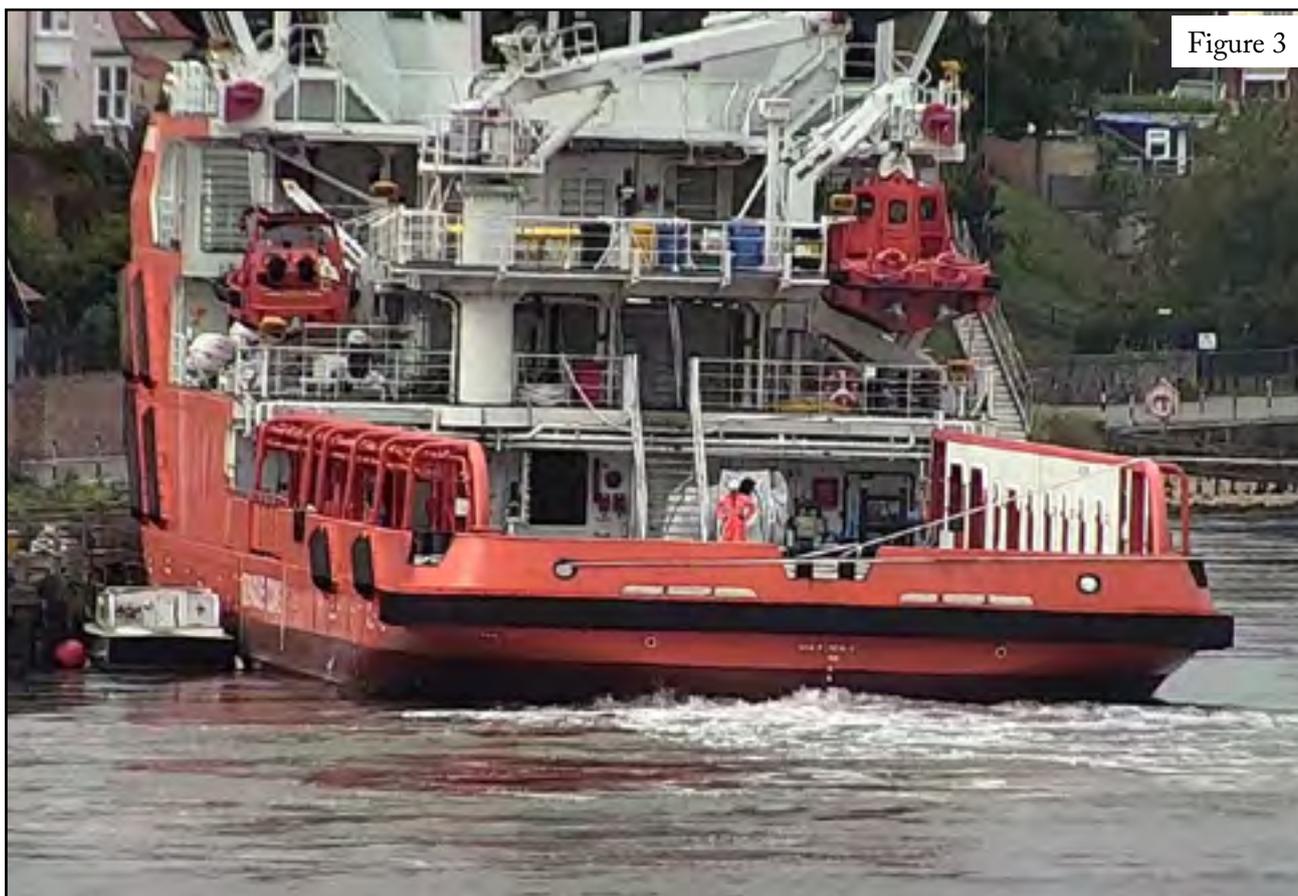
Figure 3

Meanwhile, the shore linesmen managed to let go the aft spring. Although the deck crew tried to recover the spring inboard, there was a lot of line in the water and they could not prevent it from fouling the starboard propeller. By that time, the supply vessel was very close to berths on the opposite bank and, although stern lines remained connected, the master had managed to keep the vessel head-to-stream. However, he could not prevent it from colliding with two small moored boats (Figure 3). Soon after,

the thrusters were started and the master was able to manoeuvre the supply vessel back alongside its original berth. The two small boats sank.

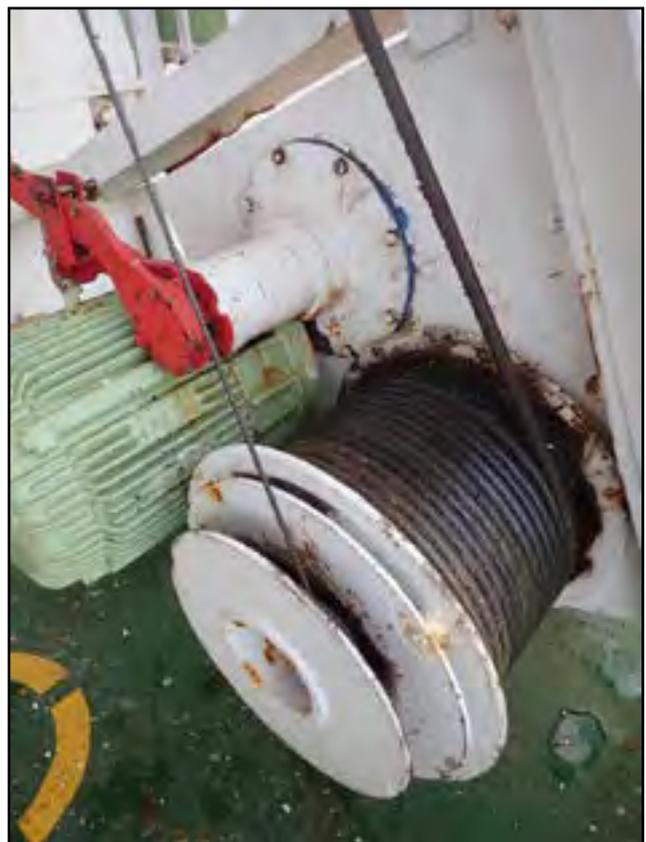
Figure 1: Winch drum

Once the lifeboat was ready, the chief officer gave the order and the bosun started to hoist the lifeboat using the electric motor. Unnoticed by the bosun, the cadet stepped forward to grease the fall wire by letting it run through his hand close to the winch drum (Figure 1) as the boat was being heaved up. Without warning the cadet's hand became stuck to the wire and his fingers became trapped under it as it was being wound onto the drum. Because his hand was so close to the drum, his warning shouts did not give the bosun enough time to stop the hoist motor before his fingers were trapped and traumatically amputated (Figure 2) between the wire and the drum.

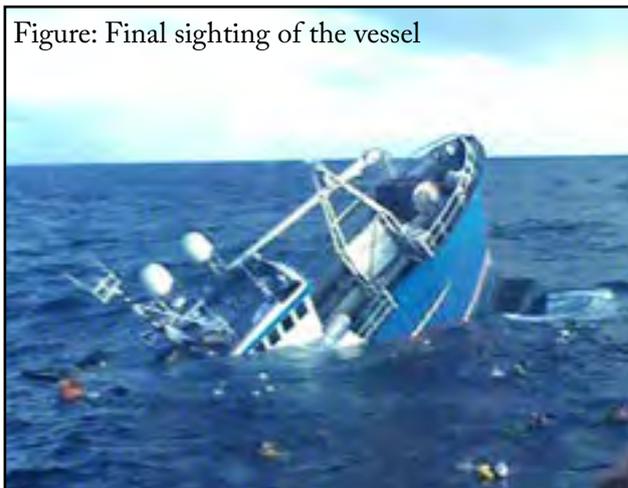
Figure: Final sighting of the vessel

as the flood took hold and a bow up trim was adopted. The portable pumps were also susceptible to blockages by debris. As a result, the flood could not be brought under control and the vessel was lost when the escape hatch submerged, causing overwhelming flooding.

All of the vessel's four crew members and two lifeboat crew members, who had embarked to assist with the pumping effort, ended up in the sea as the vessel sank (see figure), but fortunately all were rescued safely onto the lifeboat.

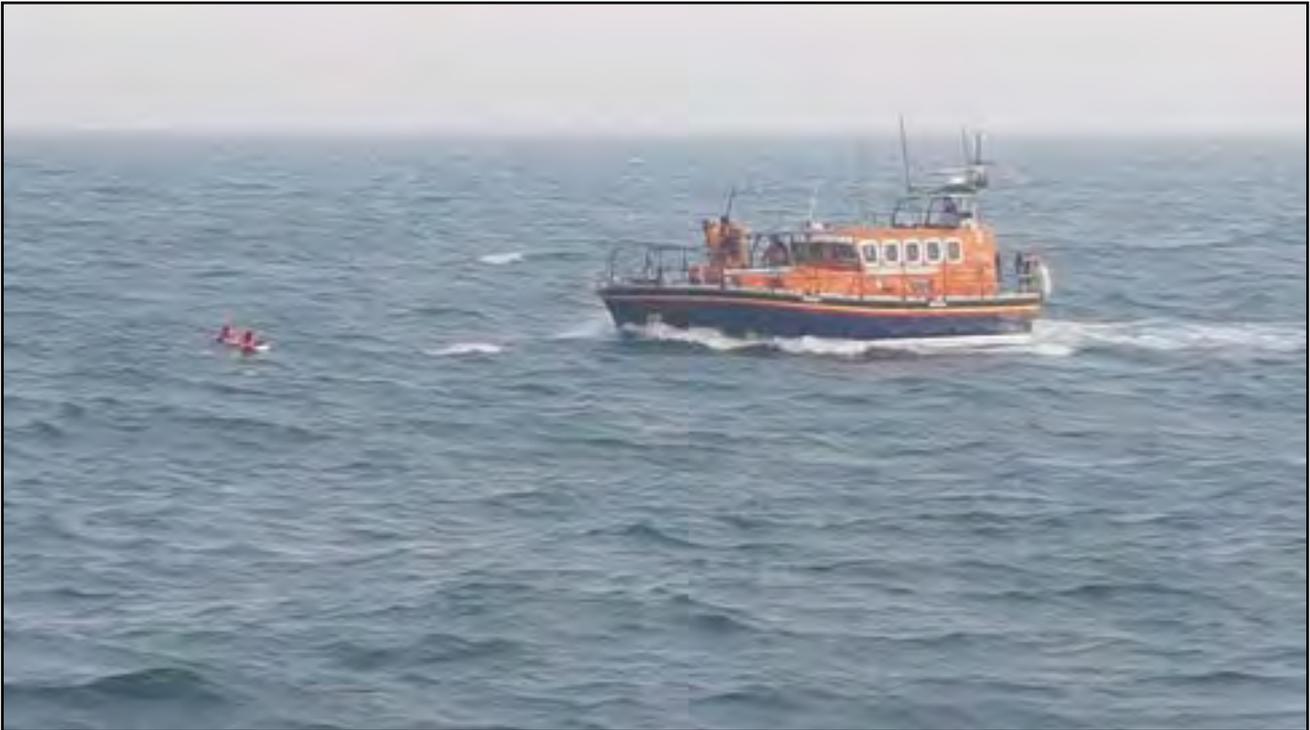
Figure 2: RNLI rescue

The boat settled on its side and both crew managed to scramble onto the side of the wheelhouse. The skipper raised the alarm by calling 999 on his mobile phone and getting through to the coastguard. Although the skipper was not able to pass a precise position, the information he gave was sufficient for a successful search and rescue mission. The fishing boat sank prior to the arrival of the lifeboat, leaving both men in the water clinging to a lifebuoy (Figure 2).

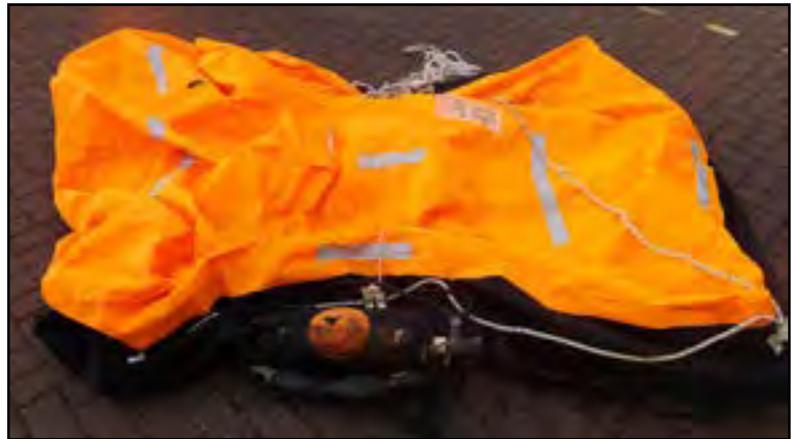
Figure: The uninflated liferaft

The skipper and crew were able to escape out of the accommodation and don foam-filled lifejackets. They activated the EPIRB and prepared to launch the liferaft but, despite their efforts, it would not inflate. To give the liferaft some buoyancy, the crew put fishing marker buoys inside the canopy before lowering it into the water (see figure).

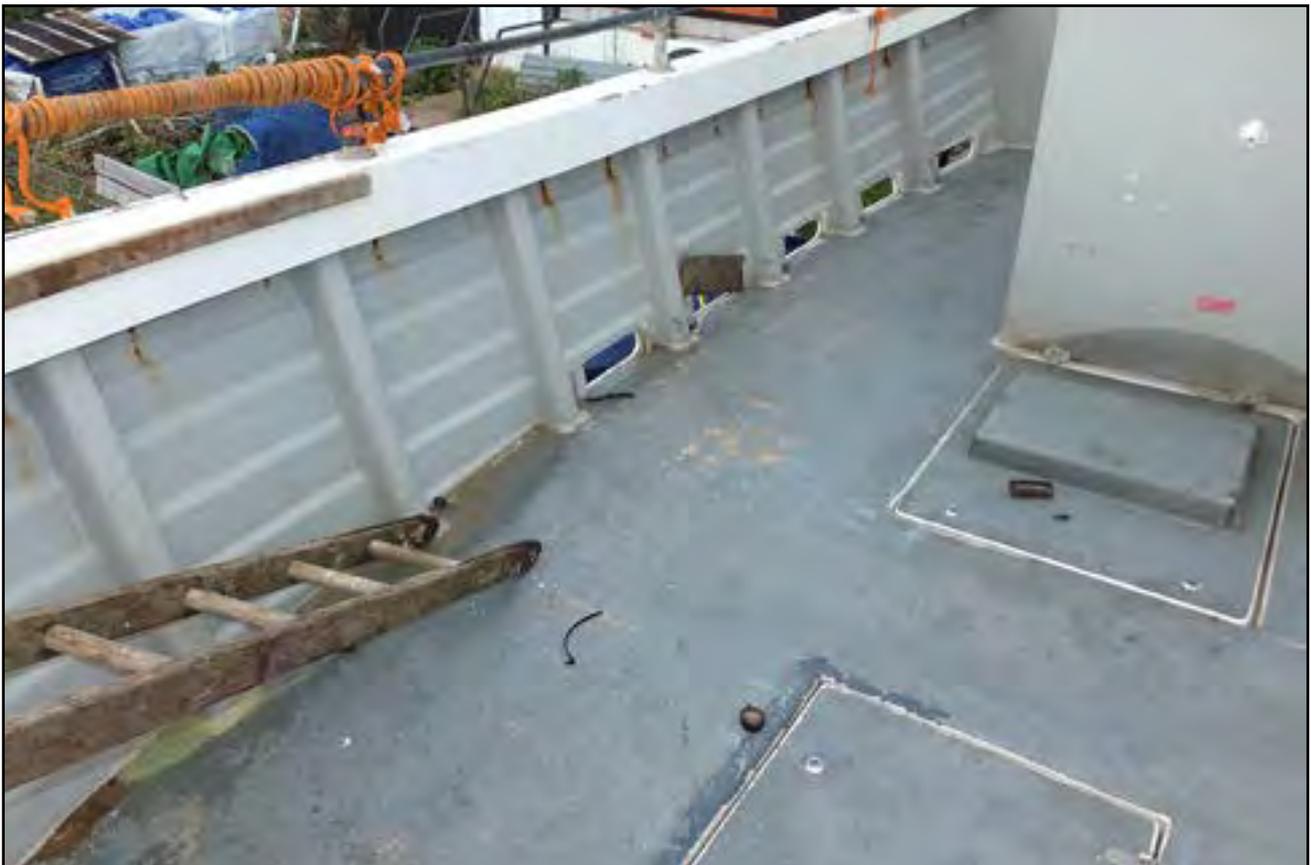
Figure 1: Freeing ports

The boat arrived at the static nets, which were about 3nm offshore, and the men set about retrieving them with the hauler and stowing them in net bins forward. As the net bins filled, the boat started to trim by the head. Neither the skipper nor his crewmen noticed sea water starting to come through the freeing ports onto the deck and over the flush deck hatches.

The three fishermen were shocked when they saw that the boat's deck was awash. By then, the boat had started to sink rapidly beneath

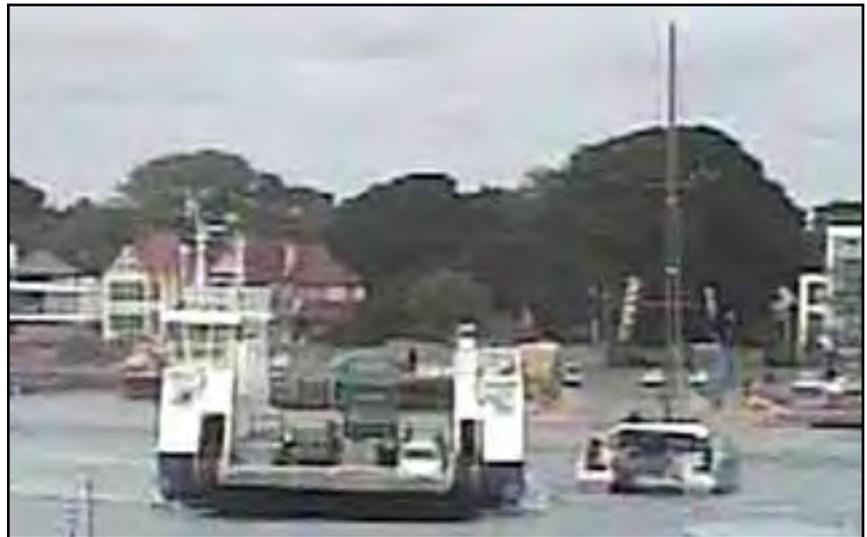
Figure 1: CCTV imagery of the catamaran being swept onto the chain ferry just before the collision

When attempting to hold position using astern power, control of the catamaran was lost and it was swept sideways towards the crossing ferry by the strong tidal stream. Realising that the situation was deteriorating the skipper transferred throttle control to the starboard

side console then applied full power ahead on the port engine and maximum starboard rudder in an attempt to steer away from the chain ferry (Figure 1). However, this was unsuccessful and the catamaran's port side made heavy contact with the ferry.

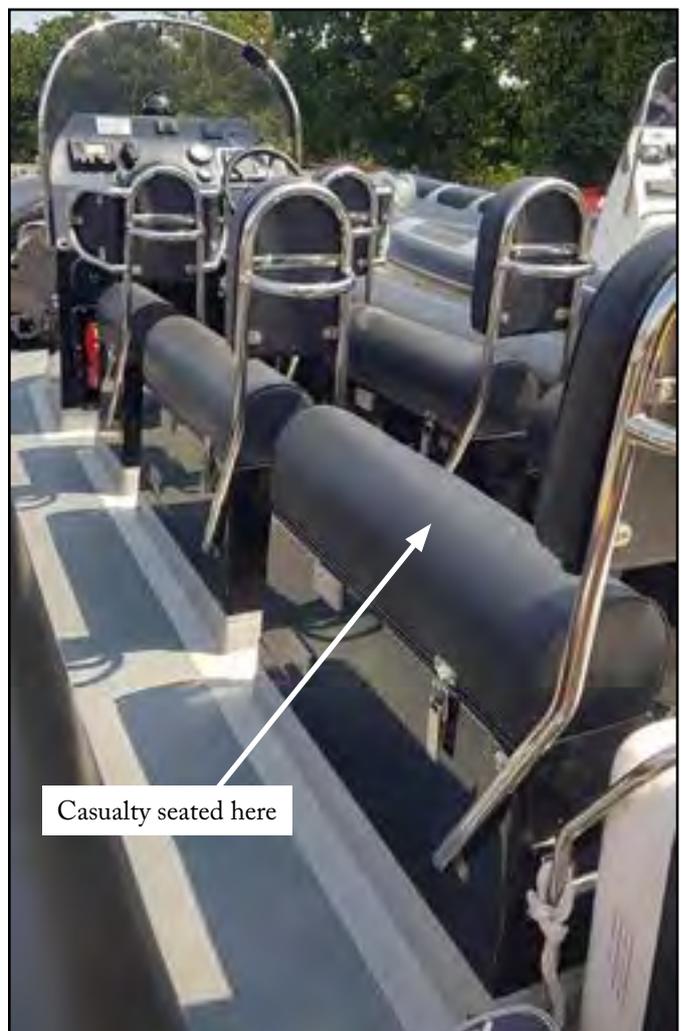
Figure 1: Jockey seats behind skipper's helm position

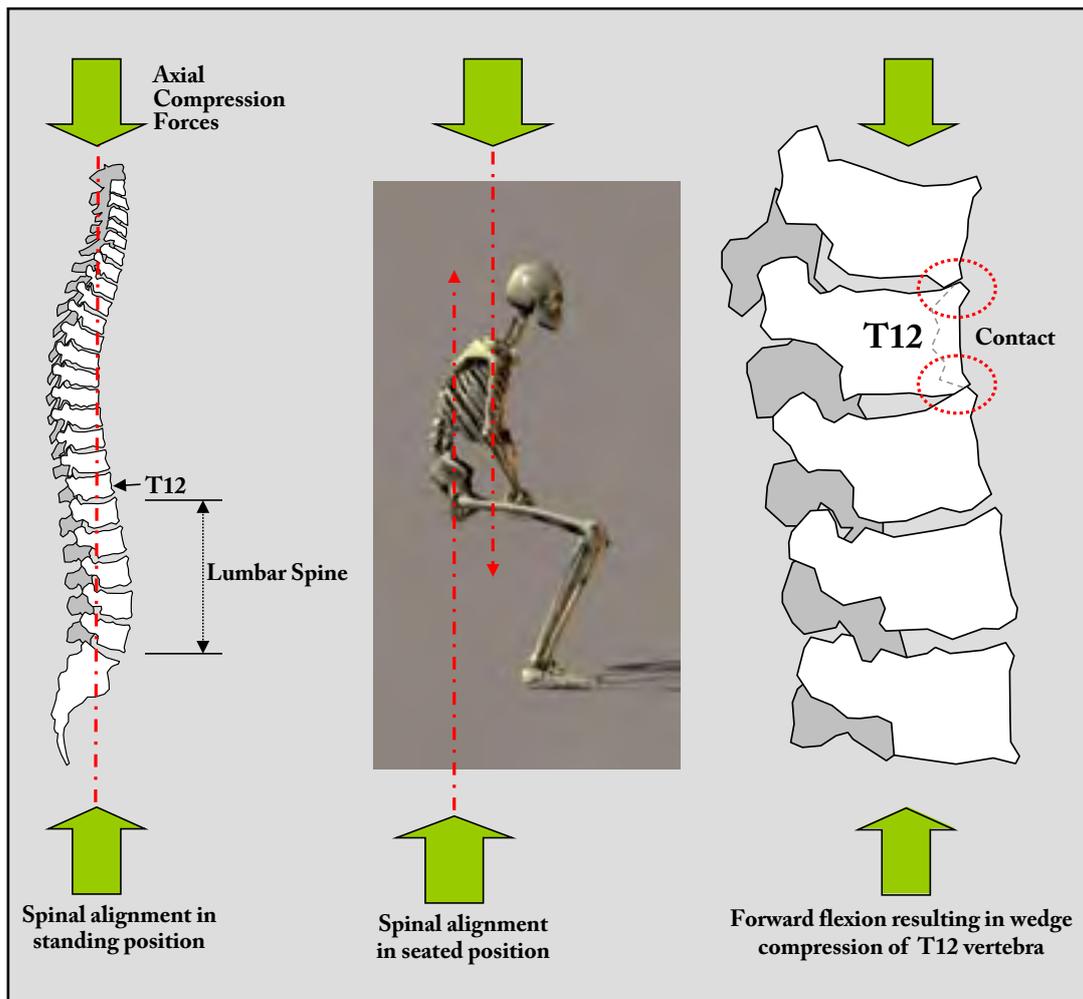
Two telephone calls were made to the local ambulance service requesting that it attend the casualty at the marina. But the ambulance failed to turn up. The injured passenger was assisted off the boat and taken to the local hospital by her husband for diagnosis and treatment. She remained in hospital for a few days while being treated for a compression fracture of her T12 vertebra (Figure 2).

Figure 2: Spinal alignment and wedge compression effect when boat slams into the water

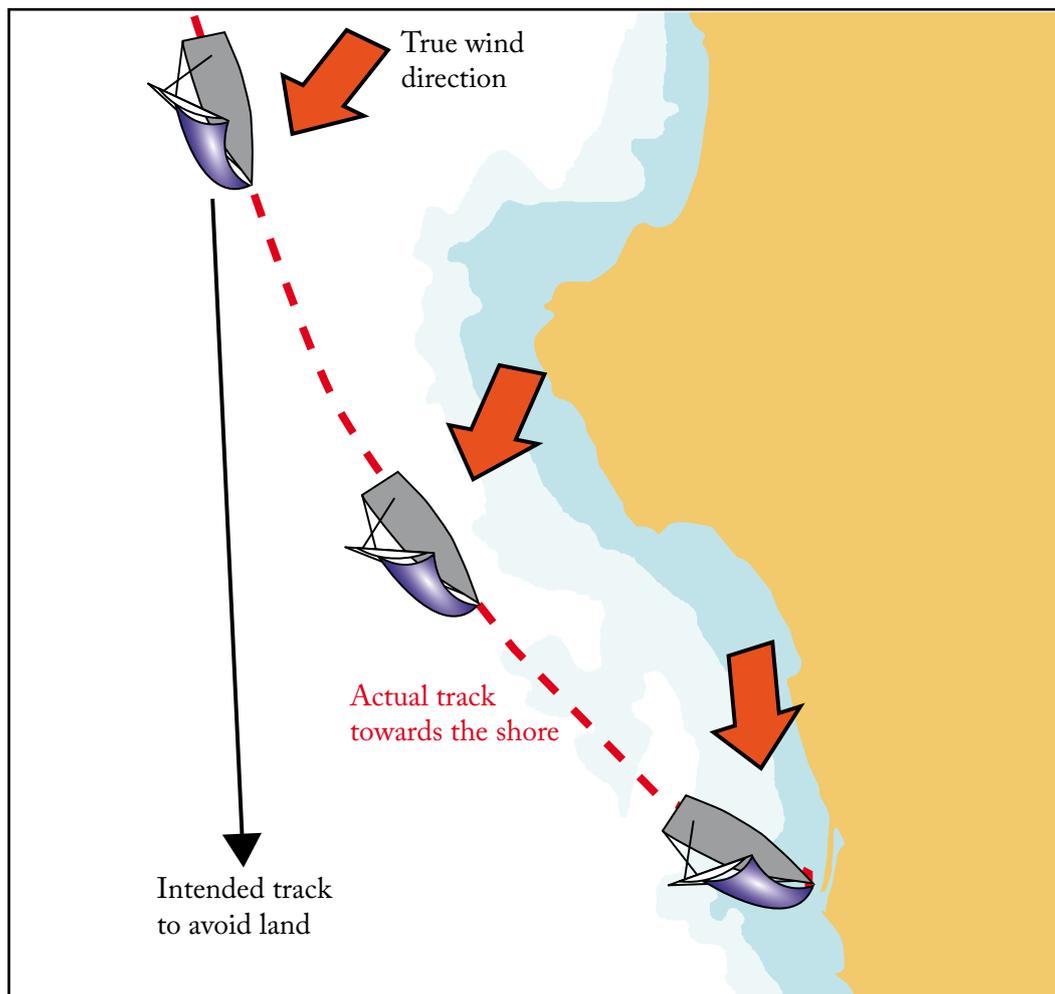
a potentially dangerous accidental gybe, the crew made a succession of small alterations of course to port. These course changes had the effect of driving the yacht unintentionally close inshore (Figure 1).

Figure 1: The intended and actual tracks of the yacht

1. Every vessel, whatever its size or purpose, needs a passage plan that has identified all potential hazards for the voyage ahead. In this case, the skipper had intended to head away from land after the race start so was not planning to sail close to the shore. This meant that there was little expectation of having to manage coastal navigation. Nevertheless, the requirement to pass the headland meant that the passage plan should have assessed the risks of operating in shallow water.

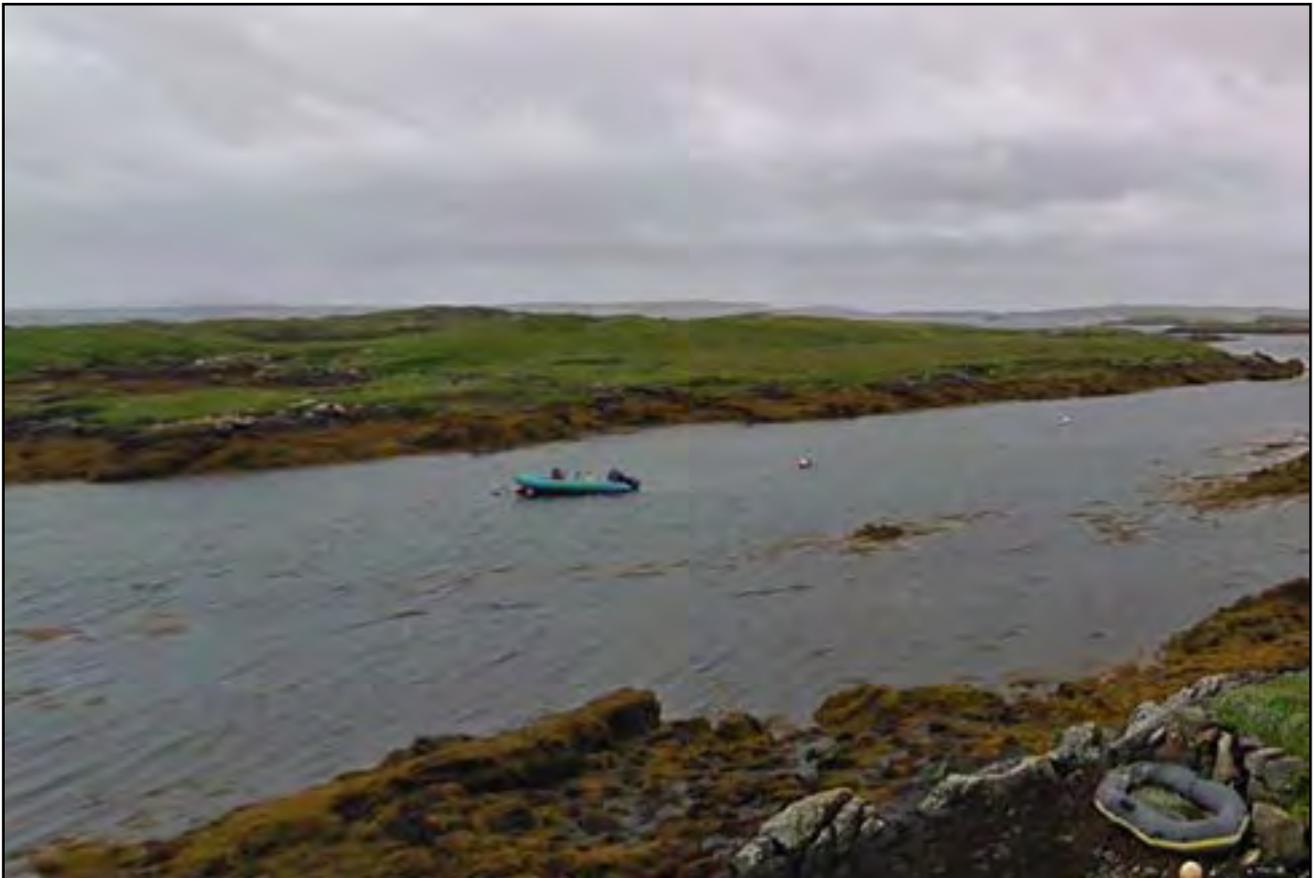
The owner of a RHIB and a friend rowed a small inflatable dinghy out to the moored RHIB to bail out rain water (Figure 1). It was a blustery afternoon so both men were wearing warm clothing, waterproof jackets and wellington boots; neither man was wearing a lifejacket or buoyancy aid.

Figure 1: The RHIB and the dinghy

1. The difficulty of trying to swim in cold sea water without the support of a buoyancy aid or lifejacket cannot be over emphasised. The owner and his friend routinely wore lifejackets when they took the RHIB to sea but did not wear them when rowing to the mooring to bail the boat. The risk of falling overboard when transferring from boat to boat is high and therefore it is essential that buoyancy aids and lifejackets are always worn.

2. Stepping between boats is always hazardous. In this case the owner's friend attempted to step from one boat to the other, across both flotation tubes, wearing wellington boots. Had the friend lowered his centre of gravity by sitting on the RHIB's side tube, holding on to a lifeline, swinging first his legs and then his body into the dinghy (Figure 2), he would have remained in control of his movement throughout, significantly reducing the risk of his falling overboard. Similarly, had suitable non-slip footwear been worn, the risk of slipping would have been reduced.

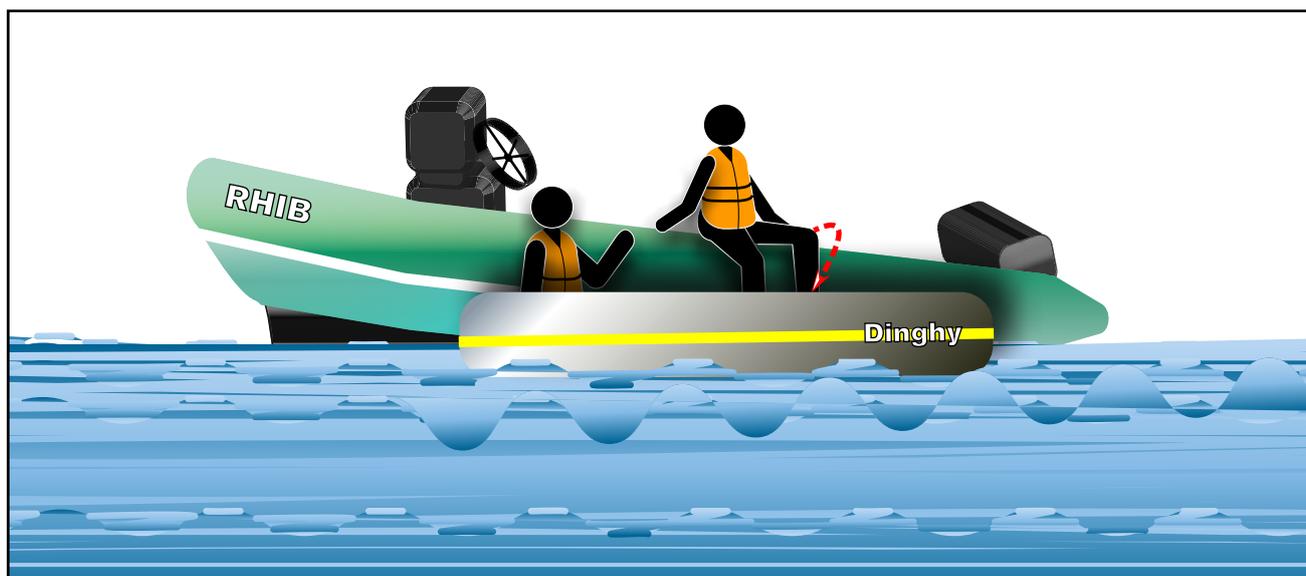
Figure 2: Safe transfer - sitting on the RHIB's side tube to safely transfer to the dinghy and wearing appropriate safety gear (illustrative purposes only: not to scale)

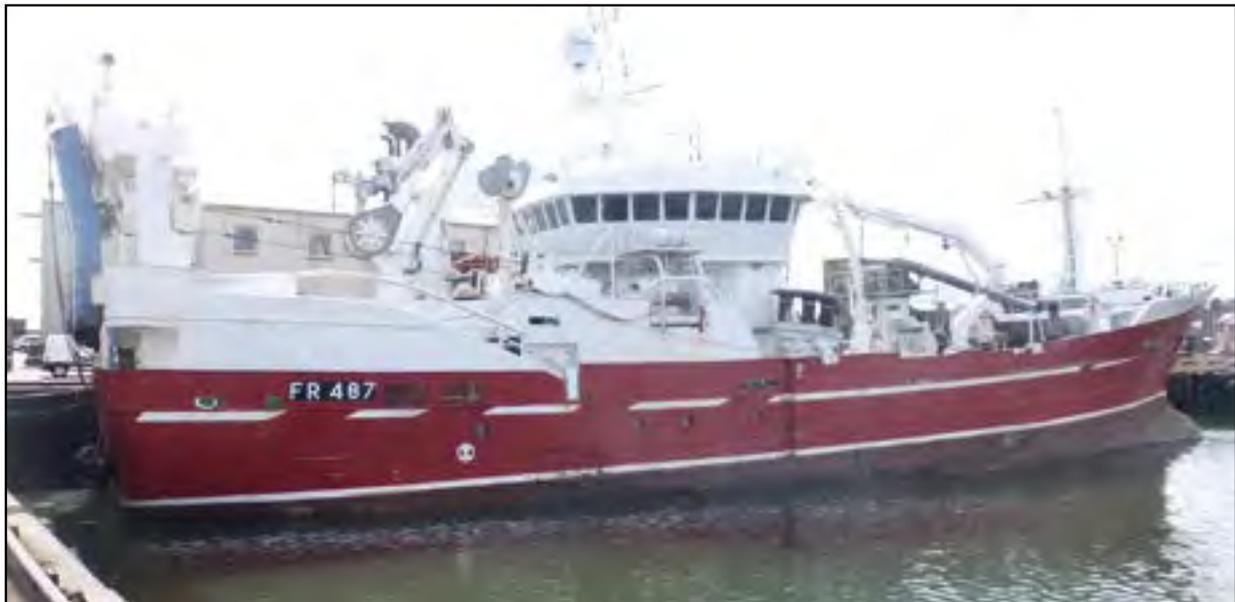
Sunbeam (**Figure 1**) was a 56m UK registered pelagic trawler. Its home port was Fraserburgh, Scotland, and it was typically manned by a crew of eleven. In the weeks prior to the accident, it had been fishing for herring in the North Sea and landing its catch in Lerwick, Shetland. The vessel had nine refrigerated salt water (RSW) tanks for storing its catch.

Figure 1: FV *Sunbeam*

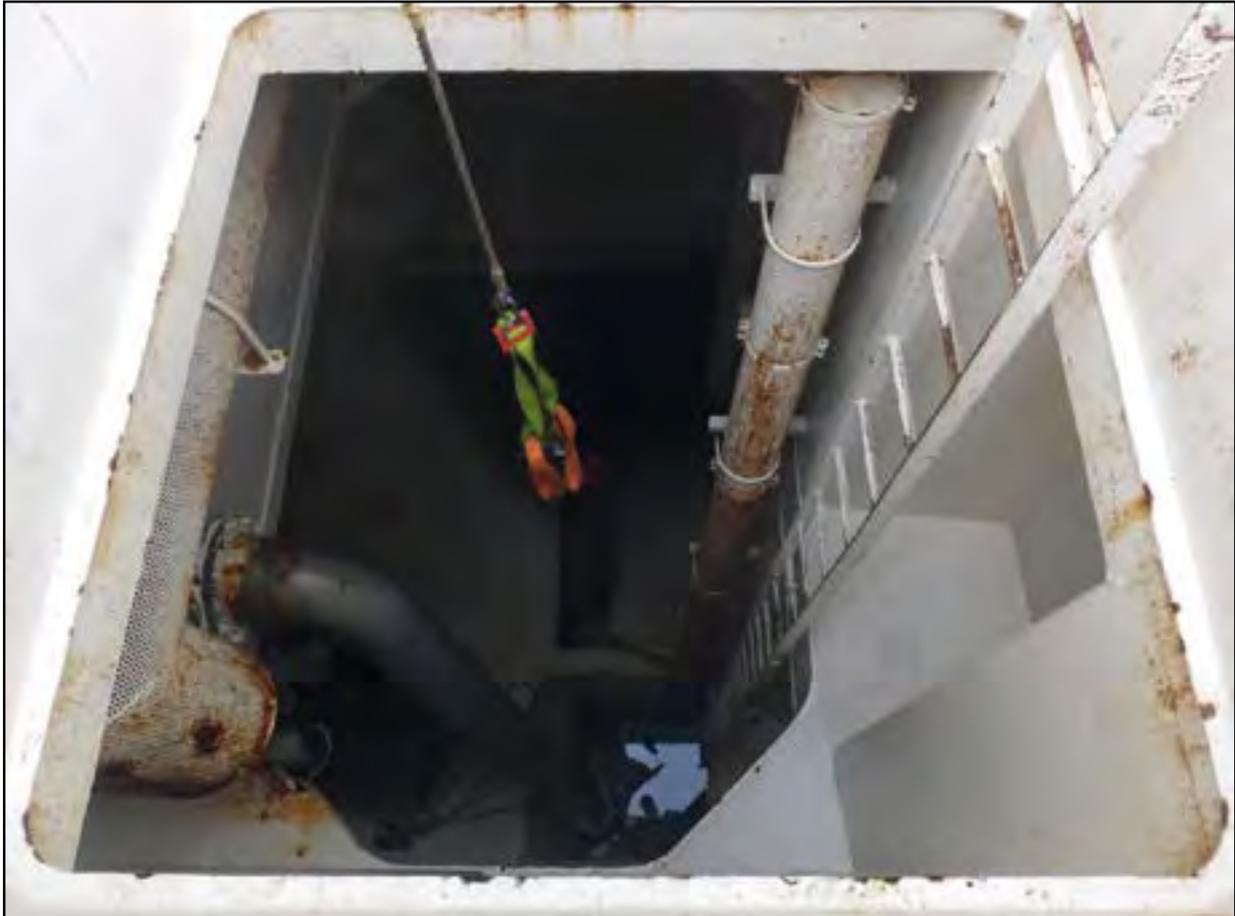
It is unclear when and why the second engineer entered the tank. However, evidence indicated that his intention was to sweep the residual seawater that had settled at the aft end of the tank forward in to the tank's bilge well. No safety procedures for entering or working in RSW tanks had been completed before he entered the tank.

Figure 2: Aft centre RSW tank

Tests of the atmosphere in the tank following the accident showed that the level of oxygen at the bottom was less than 6% (normal level should be 20.9%). Further tests of both the tank atmosphere and residual water samples showed the presence of Freon R22, the refrigerant gas used in the RSW tank's refrigeration plant.
