This *Safety Digest* draws the attention of the marine community to some of the lessons arising from investigations into recent accidents.

MARINE ACCIDENT INVESTIGATION BRANCH

Chief Inspector's Foreword	4
1 Check Your Lifejacket	6
2 Incorrect Use of Trawl Blocks Leads to Fatal Accident	8
3 Skipper Killed by Lifting Gear Failure While Alongside	10
4 The Tragic Outcome of Overloading	11
5 Cook's Crash Diet	12
6 Rude Awakening!	13
7 Steering Fault and Poor Lookout Cause Pair Trawlers to Collide	14
8 Quay Ladders Always Require Care	16
9 Heavy Weather Fishing – Fatal Accident!	18
10 Lookout! – Unfortunately Not	20
11 Lookout! – Unfortunately Not	21
12 Perished in the Darkness	22
13 NUC or Not?	23
14 Near Miss Leads to Grounding	24
15 Loss of Fisherman Within Harbour Breakwater	25
16 Can You See/Hear Your Bilge Alarm?	26
17 Bilge Alarm Success Stories	28
18 Back Rope Bights Back	30
19 The Price of Coronation Street	32

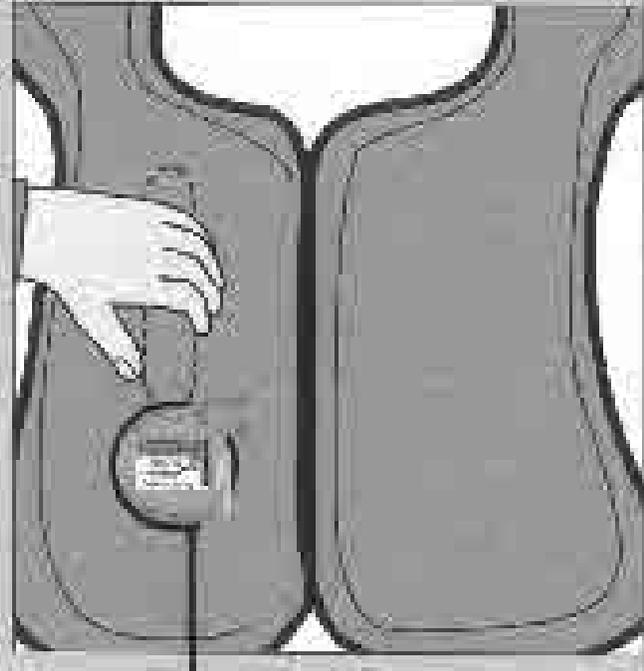
**WARNING AND REMINDER!
PLEASE CHECK YOUR LIFEJACKET
— YOUR LIFE MAY DEPEND ON IT!**

We remind you of the necessity to follow the instructions attached to every lifejacket equipped with the Hommar Standard/Automatic as well as the Hommar Manual Lifejacket Inflator.

Check that the gas cylinder is firmly tightened by holding it through the lifejacket fabric.

The tests revealed that the lifejackets which had failed to inflate, had probably done so because the gas cylinders had become detached from the Hammar release units.

As usual we recommend you to service your lifejacket regularly at a professional and qualified service station, at least on a yearly basis. The lifejacket is a friend that may one day help to save your life.

1 Fishermen and mariners who routinely wear inflatable lifejackets should ensure that the gas cylinders are firmly tightened into the release units. Owners of lifejackets fitted with Hammar release units are particularly urged to make this check, and should also carry out the safety checks listed in the booklet issued with every lifejacket:

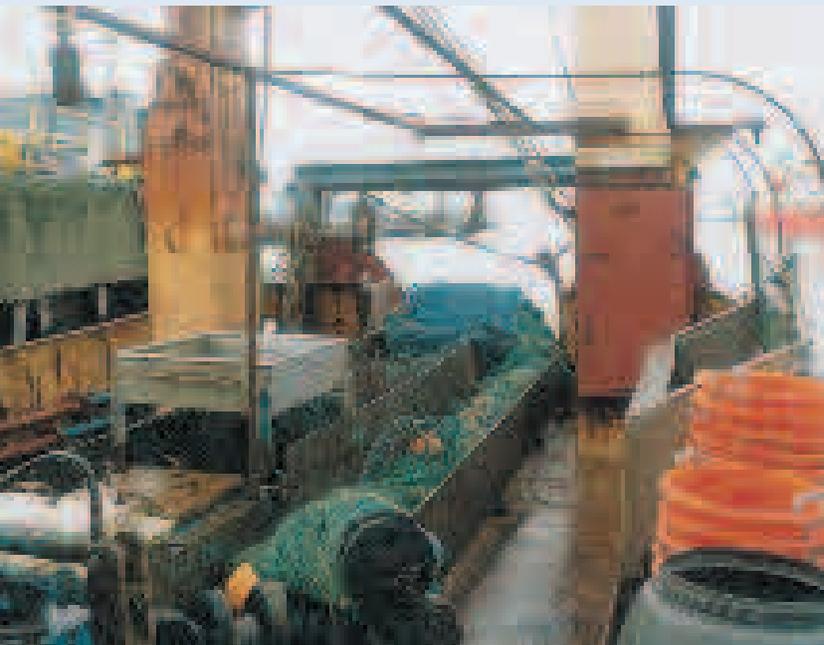
Incorrect use of blocks leads

While fishing off the east coast of England, a crew member from a 15.8m stern trawler was killed after being crushed by a trawl wire. The following is an account of how snatch blocks, if operated incorrectly, can lead to tragedy.

The snatch blocks being used on the aft gantry to lead the trawl wires over the stern, were being used in the open condition. Because of the general condition of the blocks, and the lack of any locking pins, they were unable to be used in the correct manner anyway.

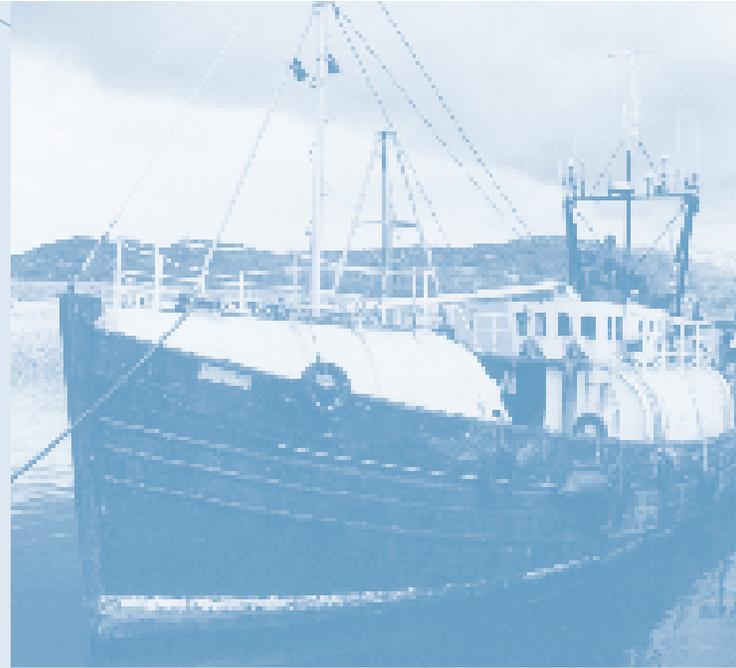
skipper could join his colleagues in the rest room for a bite to eat. Several minutes later, a loud crash was heard. The skipper hurriedly returned to the wheelhouse. The vessel had collided with a 21m twin-rig trawler heading in a south-south-westerly direction. Neither the skipper, nor the

watchkeeper of the trawler, had detected the purse-seiner by sight or by radar.

The trawler suffered damage to her shelter deck and gunwale area. The purse-seiner escaped with just minor scrape marks to her paintwork. Fortunately, nobody was hurt.

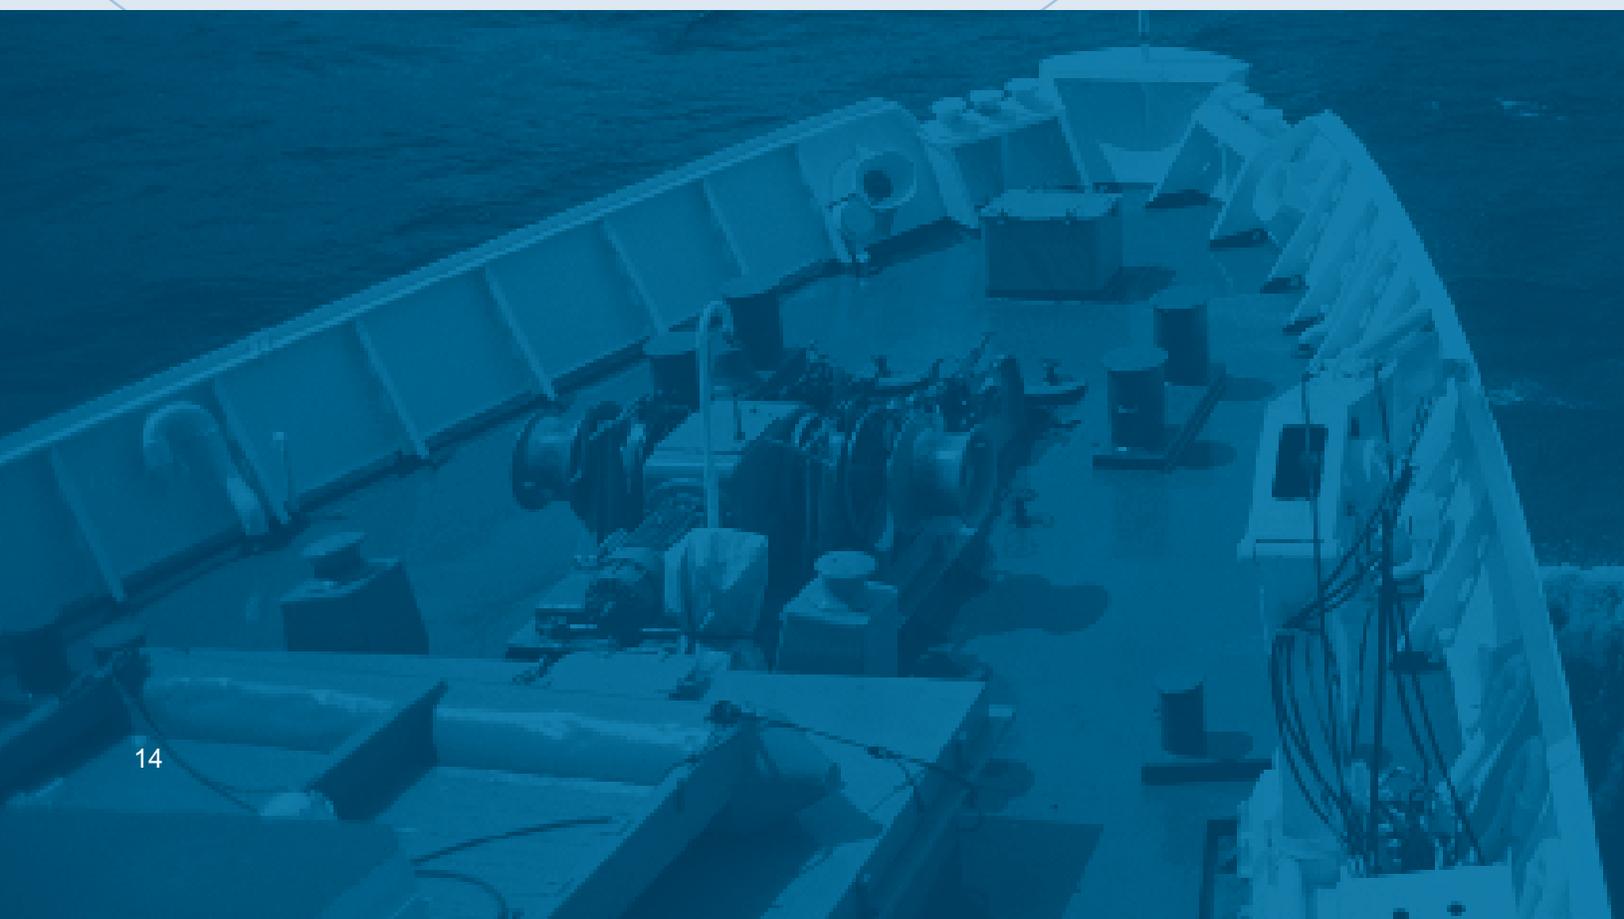
Steering fault and lookout cause to collide

The collision caused above-water damage to Vessel B's hull and shelter, and sprung planks below the water level on Vessel A. Despite attempts to control the flow of water using pumps, Vessel A began to trim by the head. A bilge alarm fitted in the fish hold gave timely warning that progressive

As Vessel A foundered after the collision, it has not been possible to discover, with certainty, the cause of the steering problem. It might have been the contacts, as the skipper believed, or perhaps another previously undetected fault with the system.

1 When two vessels are steaming only 300m apart, an unexpected event can cause a dangerous situation to develop in a very short time. Skippers should be aware of this and, in accordance with good seamanship, should make appropriate allowances for any eventuality.
