# Fishing 2005 Safety Digest

MARINE ACCIDENT INVESTIGATION BRANCH

This *Safety Digest* draws the attention of the marine community to some of the lessons arising from investigations into recent accidents.

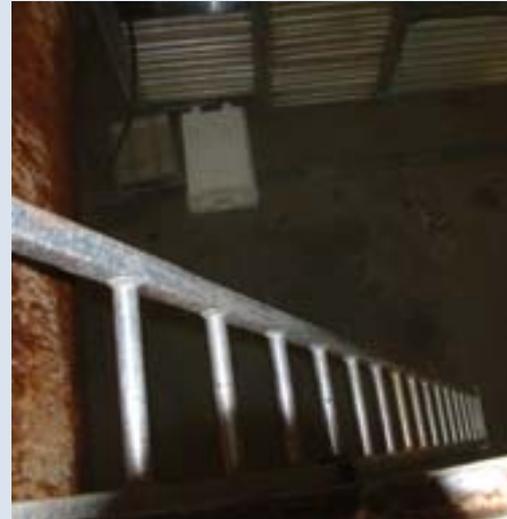
*Views into and out of the fish hold indicating the distance the casualty fell*

A 34m vessel was trawling when one of her crew fell down into the fish room through the open hatch from the deck above.
