Fishing 2009 Safety Digest

MAIB

This *Safety Digest* draws the attention of the marine community to some of the lessons arising from investigations into recent accidents.

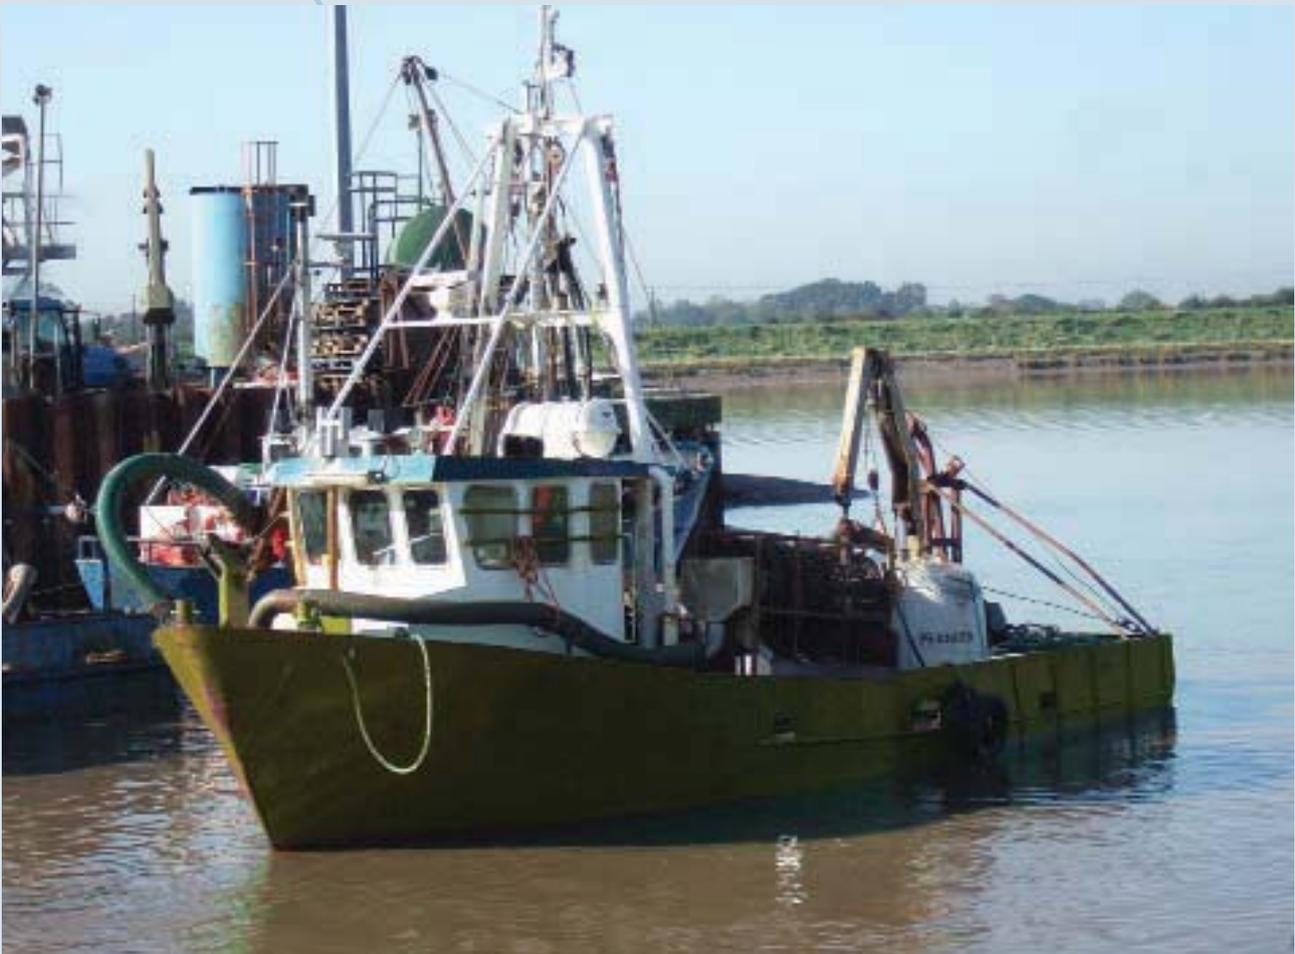
Figure 1

The skipper of a 14m purpose-built, shell fishing vessel (**Figure 1**) took on a 17 year school leaver to assist with the busy cockle dredging season. The young man joined on a trial basis to see if he would like the job. The skipper told the new crewman what his job entailed, and issued him with wet weather gear and gloves.

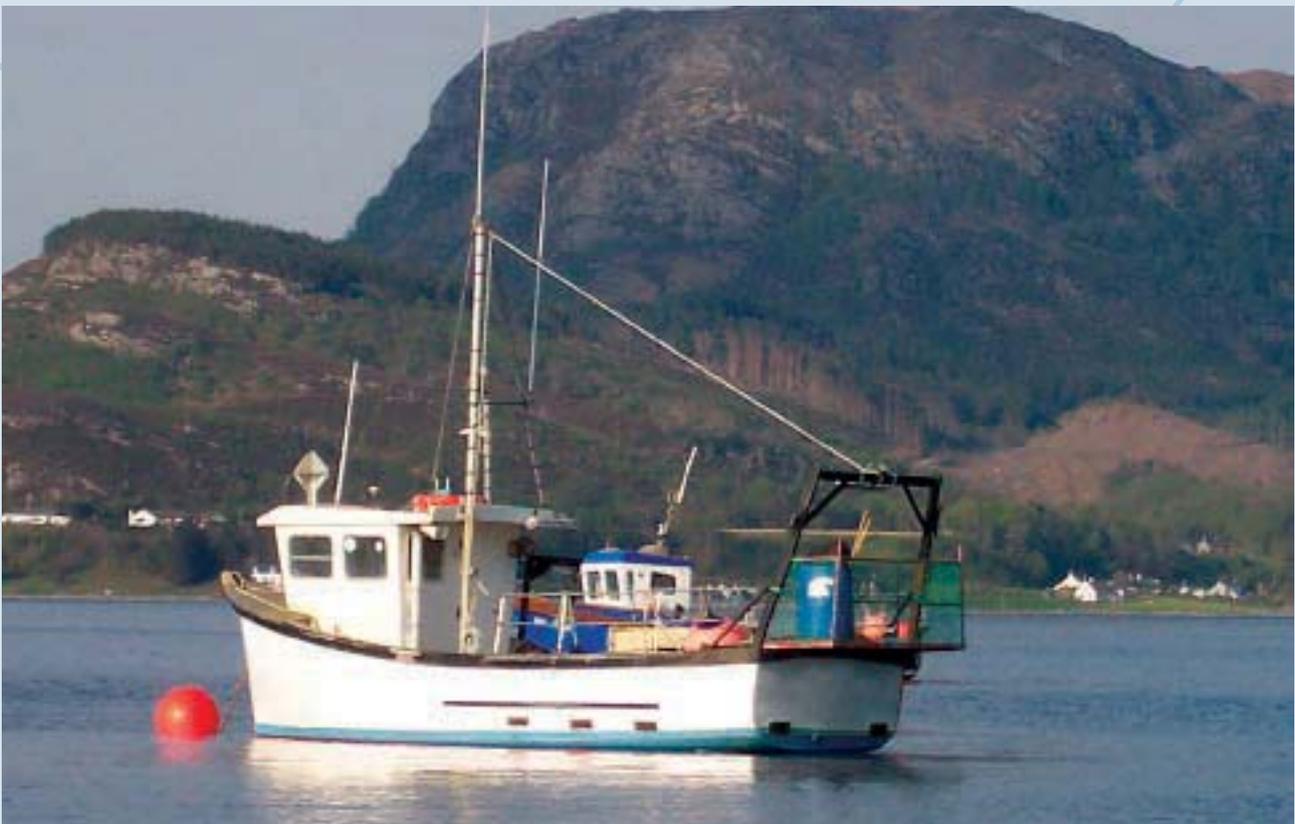
Figure 1

In the morning, the skipper and his crew tried to locate the boat, but were unable to do so. They believed that it was probably dragged out to sea by the tides and had sunk. However, they continued to search the inlets and eventually found it at low tide resting on rocks. The wheelhouse, deck and most of the hull had been consumed by the fire.

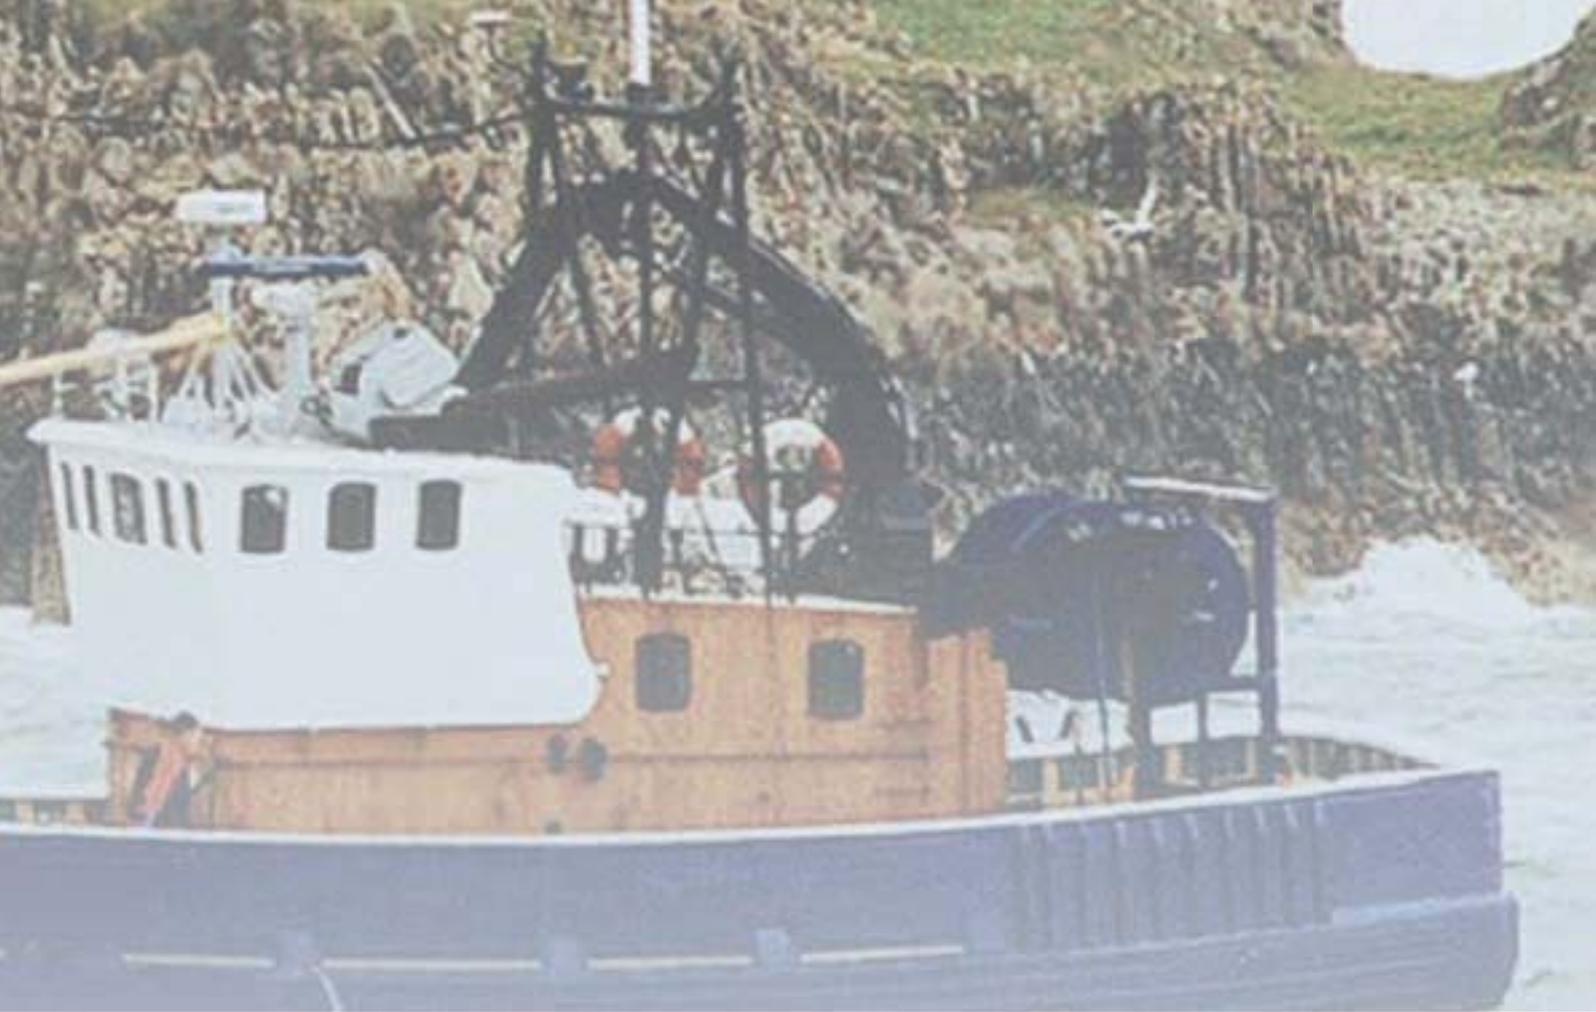
An underwater survey of the wreck showed that the vessel was badly holed below the waterline on her bow.

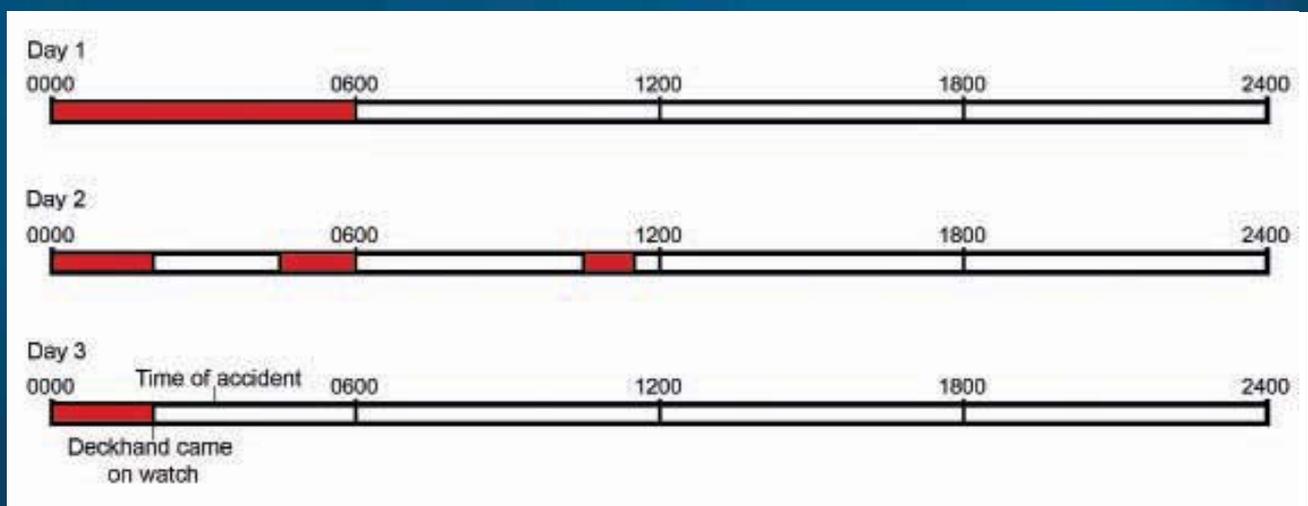
Deckhand's sleep patterns prior to the accident

1 The vessel did not turn as expected. This might have been as a result of environmental influences and the vessel's slow speed. Alternatively, it is likely that the deckhand's performance was affected by fatigue, and he might have either not altered course at all, or dialled an incorrect course into the automatic helm.

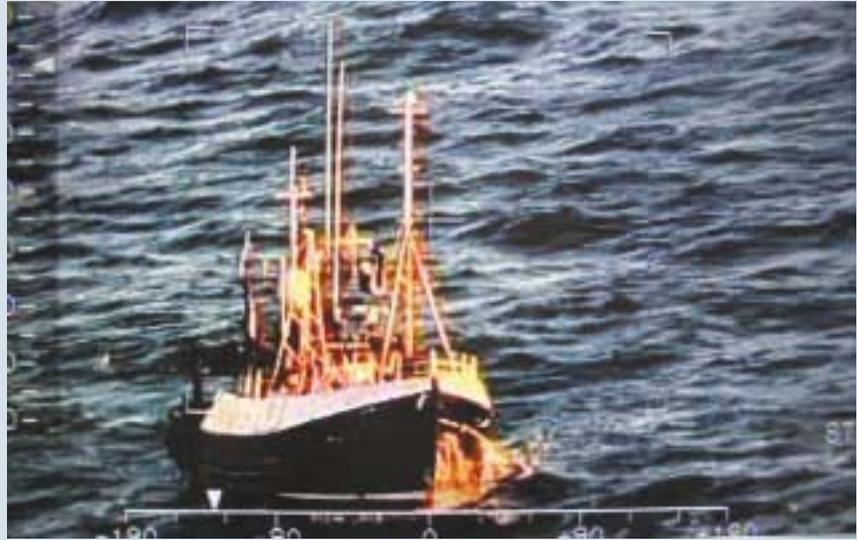
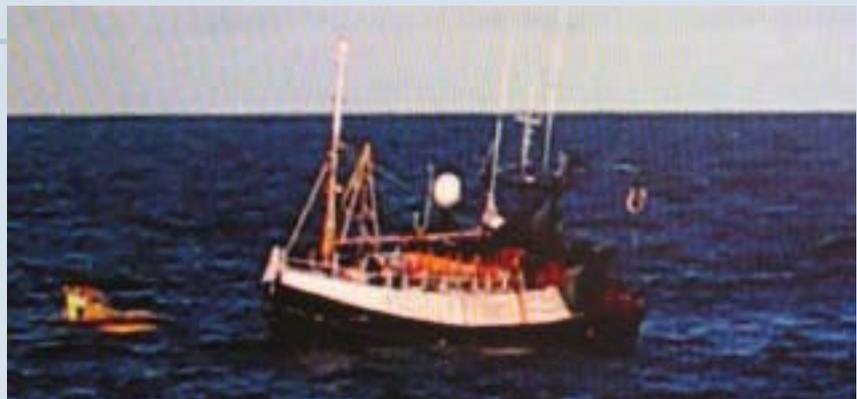
Images courtesy of RAF rescue helicopter footage

point that the skipper went to the fish hold. The water was now about 10cm above the level of the well, and could be seen running from forward through a redundant cable gland opening in the forward bulkhead.
