Rail Accident Investigation Branch

# Rail Accident Report

**Train collision with material washed out from a cutting slope at Corby, Northamptonshire  
13 June 2019**

Report 04/2020  
May 2020

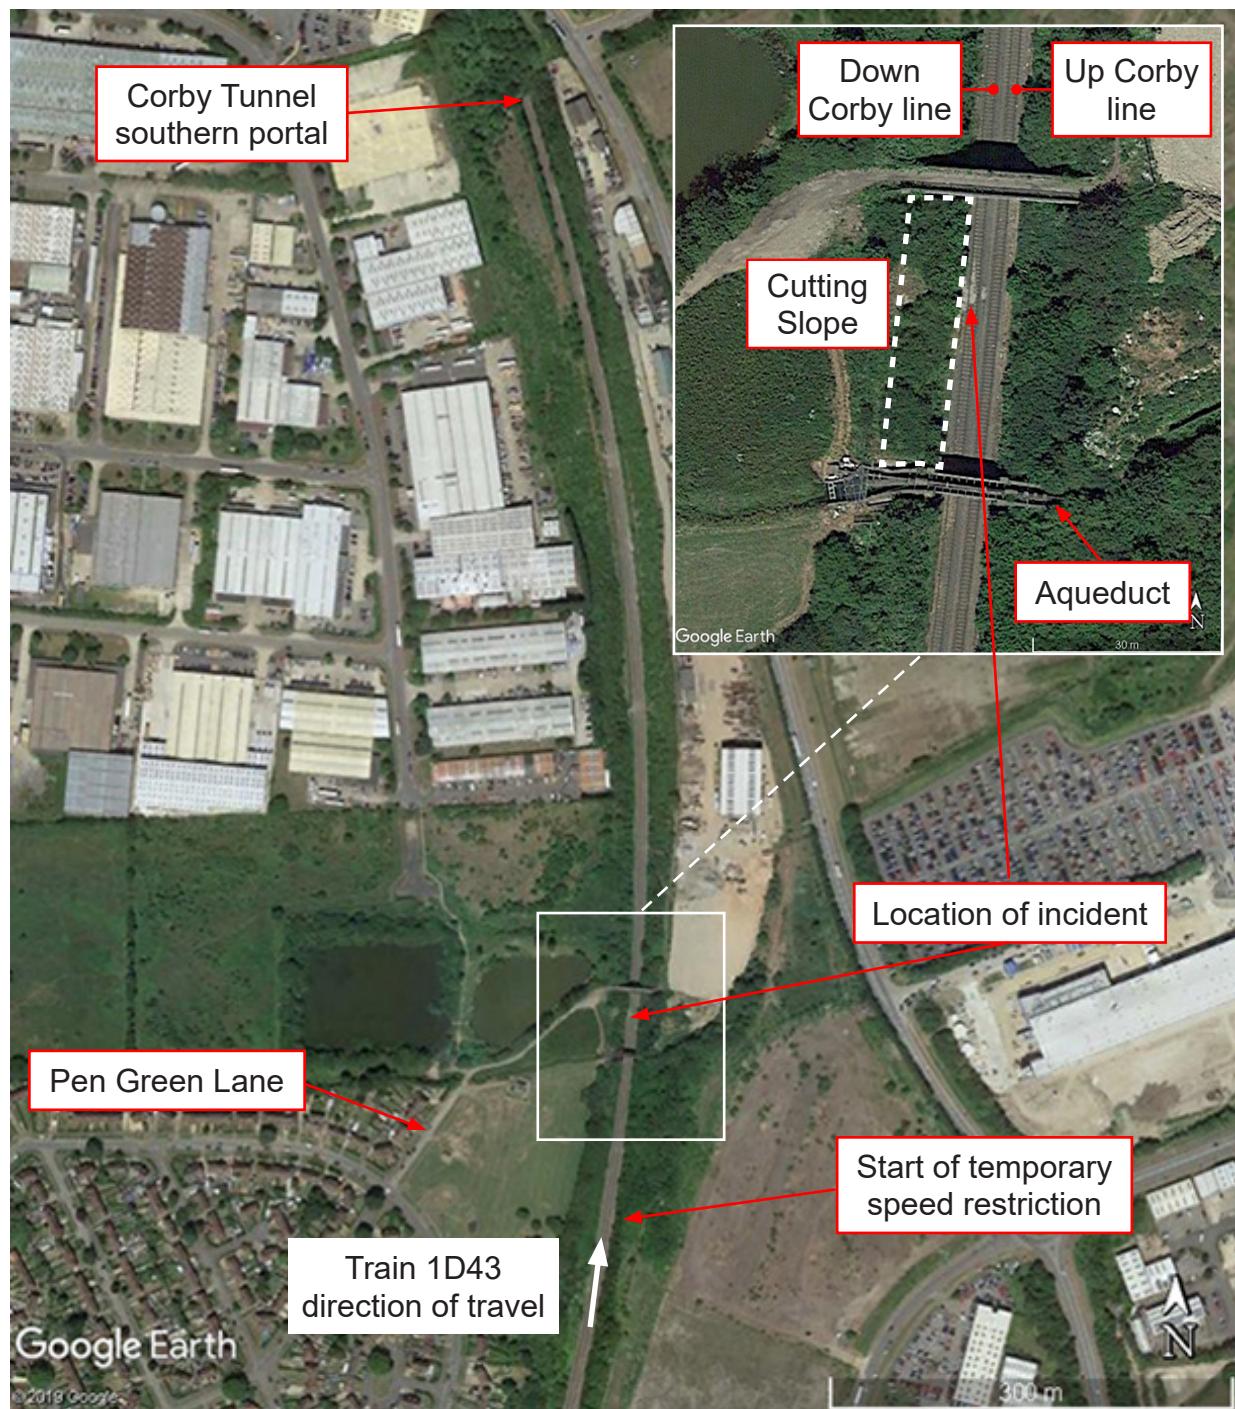
- 4 At about 15:53 hrs on Thursday 13 June 2019, a northbound passenger train, travelling at 40 mph (64 km/h), collided with debris around one mile (1.6 km) north of Corby station (figure 1). The debris comprised sandy gravel and soil which had been washed onto the track from the adjacent cutting slope (figure 2) by flood water. The train did not derail. The driver brought the train to a stand and contacted the signaller to report the landslip and flooding.

Figure 2: Google Earth image showing overview of incident site

- 7 The collision happened on the down Corby line (figure 2) at 80 miles 39 chains<sup>1</sup> (from a zero reference at London St Pancras), between Corby and Manton Junction, which is part of Network Rail's East Midlands Route<sup>2</sup> within its Eastern Region.<sup>3</sup> Here the railway passes through a cutting, on a left-hand curve (in the northbound direction of travel) with a radius of about 2000 metres (figure 2).

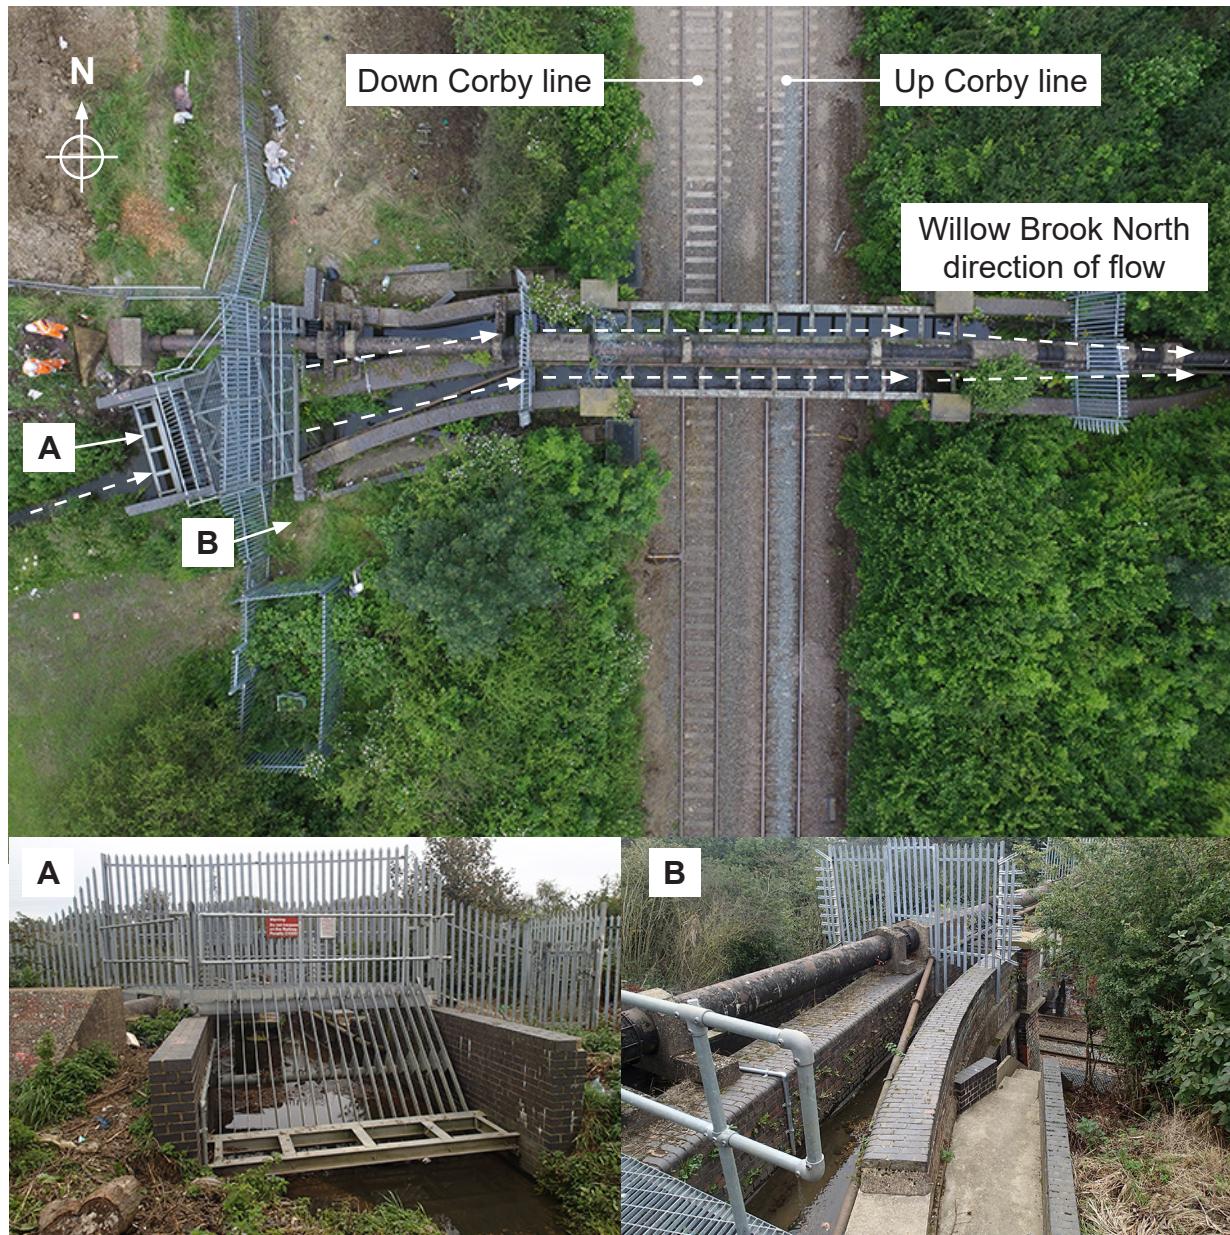
- 8 At this location, known as the Pen Green Lane area, the two-track railway comprises the up Corby and down Corby lines. The permitted speed for trains on both lines is 60 mph (97 km/h). However, northbound trains were travelling slower than this as a temporary speed restriction of 40 mph (64 km/h) was in place on the down Corby line, starting 9 chains (181 metres) to the south. This speed restriction was due to the condition of the track in Corby Tunnel. Just south of the incident location, at 80 miles 38 chains, an aqueduct carries a watercourse called Willow Brook North, over the railway (figures 2 and 4).

Figure 4: The aqueduct over the railway

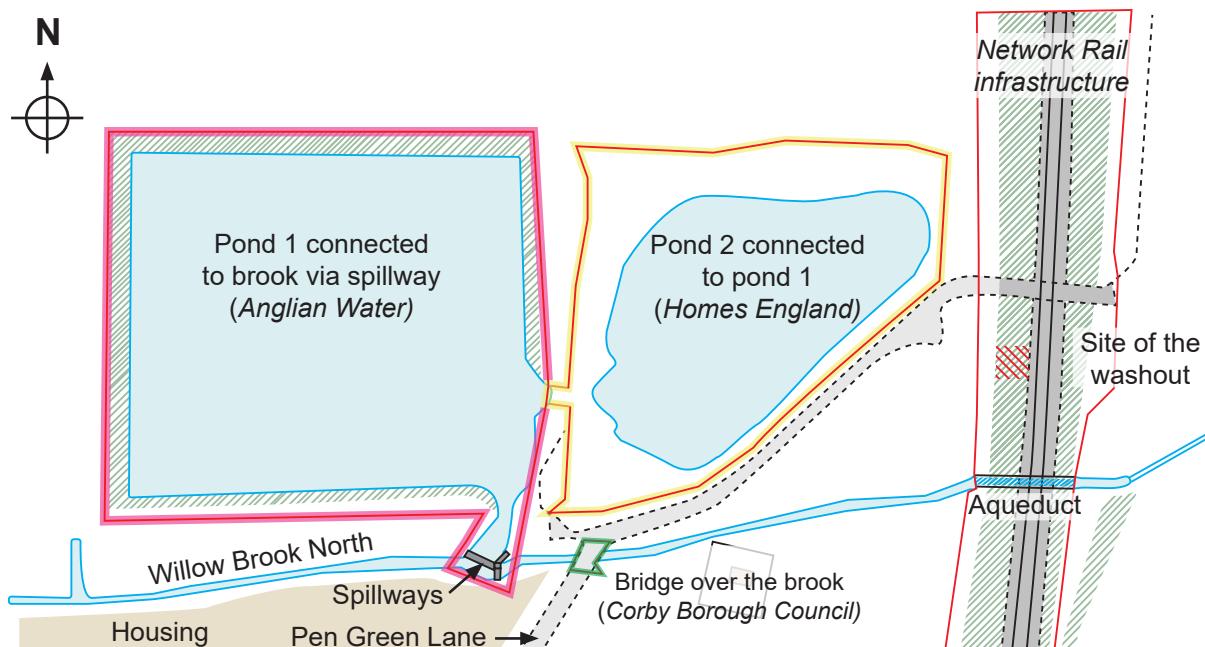
- 12 Figure 5 shows the assets relevant to flooding in the Pen Green Lane area and the organisations responsible for them. The watercourse, Willow Brook North, is designated as a main river.<sup>5</sup> This means the Environment Agency has permissive powers under the Flood and Water Management Act 2010 to maintain the watercourse as necessary for flood risk management purposes. Network Rail is responsible for the aqueduct that carries Willow Brook North over the railway, and the trash screen at its entrance. Anglian Water is the owner of the Pen Green Lane flood storage reservoir (from now on referred to as pond 1) and is responsible for the structure and trash screens that connect it to Willow Brook North. Homes England is the owner of the Pen Green Lane balancing pond (from now on referred to as pond 2) and is responsible for the culvert and trash screens that connect it to pond 1. Corby Borough Council is responsible for the bridge that carries Pen Green Lane over Willow Brook North. Northamptonshire County Council is the Lead Local Flood Authority, and is responsible for preparing and maintaining a strategy for managing the risk of flooding in the Corby area.

Figure 5: The assets relevant to the flooding in the Pen Green Lane area

- 60 The water flowing in Willow Brook North was restricted by debris that had collected at the entrance to the bridge carrying Pen Green Lane over it (figure 5). This caused water in the brook to back up to the spillways located about 25 metres upstream of the bridge (figure 5). The spillways control the flow of water between Willow Brook North and the flood storage ponds as described in figure 10. When the water backed up, it raised the water level in the brook, which in turn diverted more water over the service spillway and into the ponds.

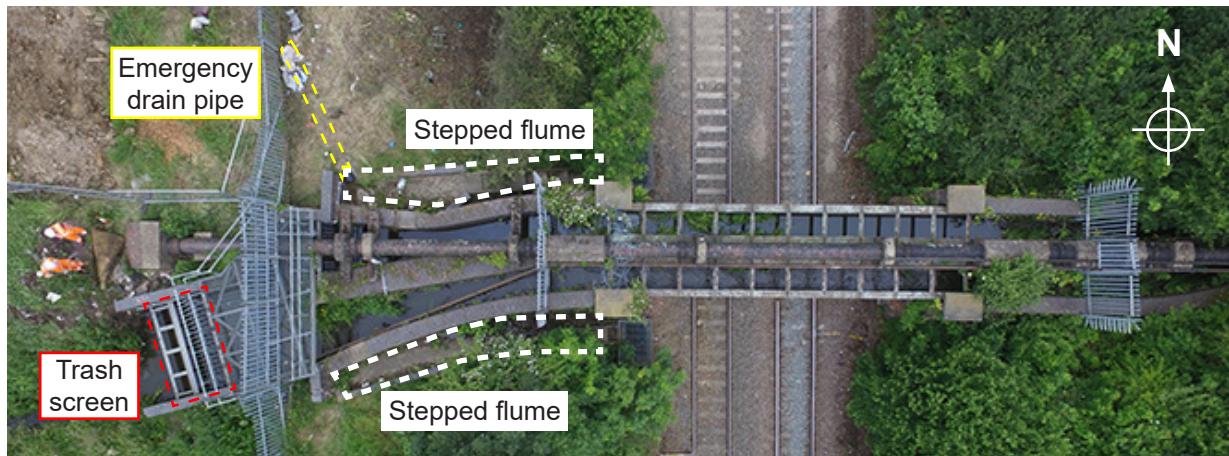
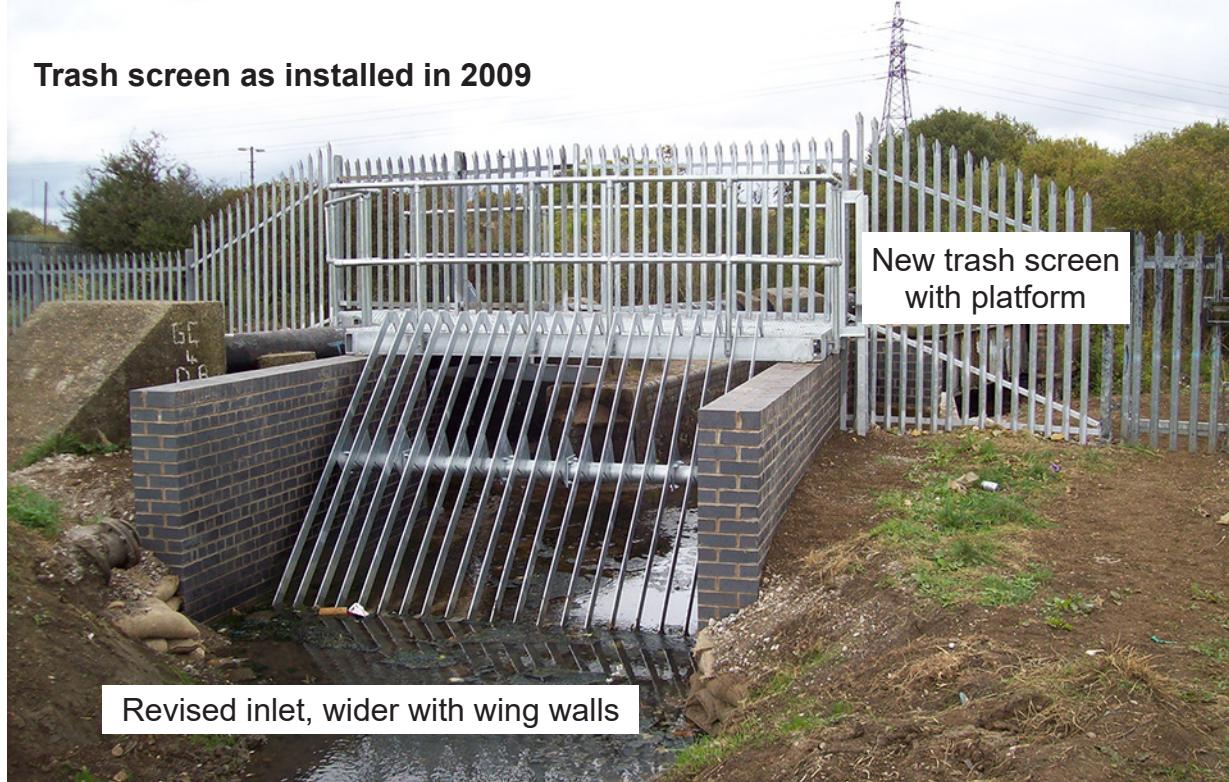
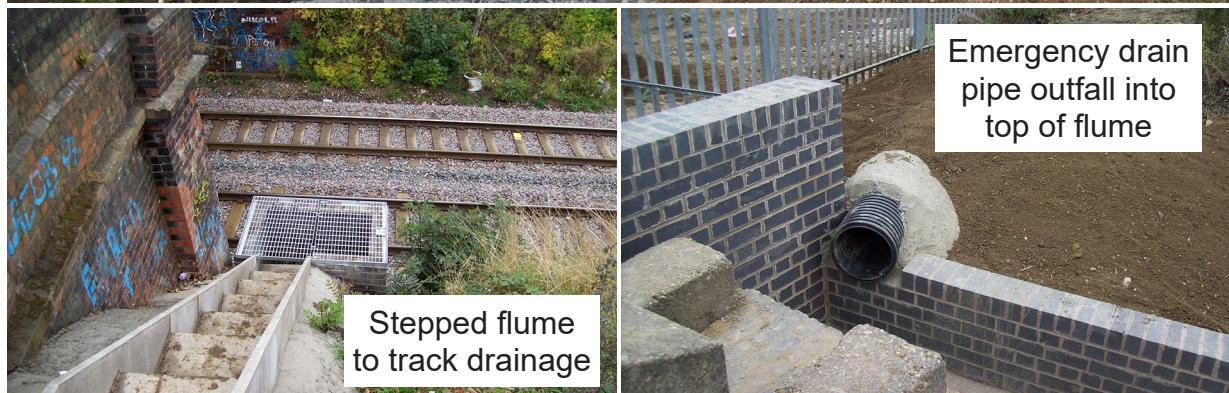
**Trash screen as installed in 2009**

- 83 The 2006 site visit report had also identified the source of the water for the washout failure as coming from the entrance to the aqueduct when it became blocked. Water from the brook then flooded the land surrounding the entrance and flowed to a low spot at the top of the cutting slope, where the washout in 1999 had occurred. To better manage flooding at the entrance to the aqueduct, Network Rail scoped, designed, obtained planning permission and made changes at the aqueduct's entrance between 2007 and 2009. This included modifications to the inlet of the aqueduct, installation of a new trash screen with a platform for clearing debris, replacement of the flumes either side of the aqueduct with stepped flumes to better manage any overflow, and modifications to the cess drain chambers to receive the overflow water (figure 18). Network Rail also installed an emergency drain pipe, with its inlet at the boundary fence line of the adjacent field. Its outlet discharged into the flume on the northern side of the aqueduct.

- 84 Network Rail completed these changes to the aqueduct's entrance in 2009, at the same time that the earthwork was repaired. It believed that these changes would protect the adjacent cutting slope from flood water, so the repair to the cutting slope did not include any specific measures to deal with a large volume of water at the crest. This meant that when water from pond 2 flooded the field at the crest of the cutting slope prior to this incident, the cutting suffered a washout failure.

*Figure 18: The changes made at the aqueduct's entrance, 2007-2009 (images courtesy of Network Rail)*

- 107 The next significant flood event occurred in 2016. Network Rail staff and an earthwork examiner attended a reported landslip. They found a washout had occurred with water ponding in the field above the cutting slope. They reported that the water had come from the flood storage pond which had overtopped, as well as from the entrance to the aqueduct. They also noted that the emergency drain pipe that should allow water to drain from the field at the cutting slope's crest was blocked (figure 18).

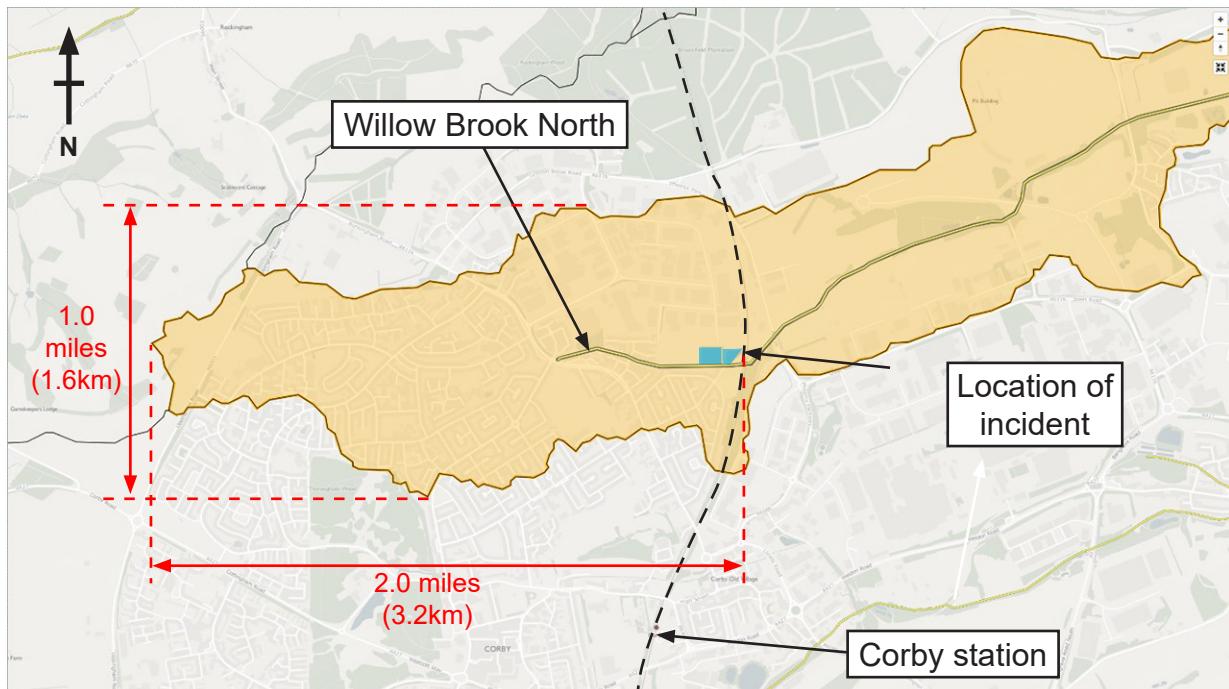
- 96 Flooding has been happening on the railway at Pen Green Lane for a long time (paragraphs 36 to 49). Rainfall radar data for the Willow Brook North surface water catchment area (figure 21) recorded between 9 June and 13 June 2019 indicated the rainfall was not exceptional. It was less than a 1 in 1 year<sup>12</sup> rainfall event over the five-day period, in terms of both intensity and volume. Figure 21 also shows that the size of the water catchment area is not large, covering about two square miles (five square kilometres). However, the flood management system at this location could not cope with the volume of surface water that was discharged into the brook during that period. This was primarily due to three factors:

Figure 21: The catchment area for Willow Brook North as defined by the Environment Agency (image courtesy of the Environment Agency, see <https://environment.data.gov.uk/catchment-planning/WaterBody/GB105032045590>)

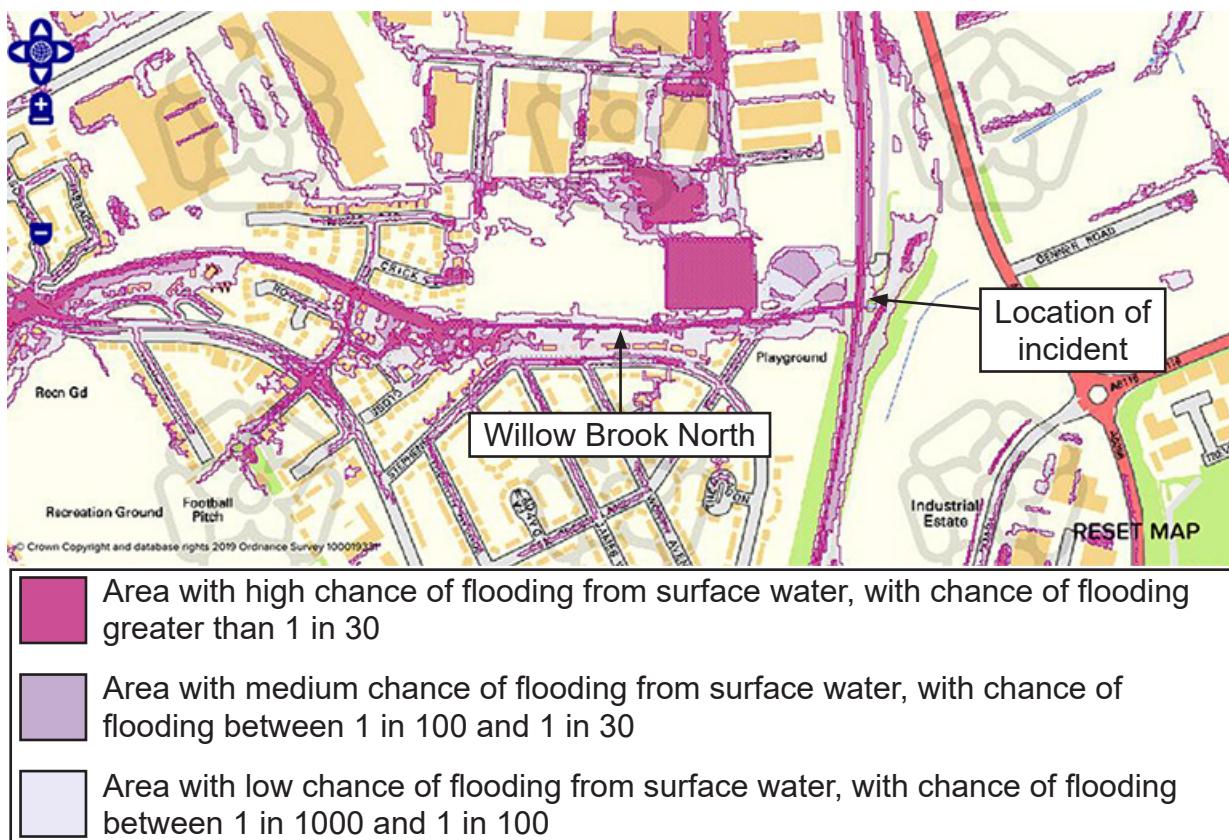
- 98 As the Lead Local Flood Authority, Northamptonshire County Council also provided a publicly available web-based toolkit to understand the risk of flooding at locations within its area of responsibility. The toolkit showed the Pen Green Lane area as being at risk from surface water flooding (figure 22). Northamptonshire County Council had no plans to carry out any flood mitigation work at this location as it considered fluvial flooding<sup>13</sup> to be the greatest risk at Pen Green Lane, so under the Flood and Water Management Act 2010, it believed that management of this risk rested with the Environment Agency.

Figure 22: Northamptonshire County Council flood risk toolkit results for risk of surface water flooding in the Pen Green Lane area

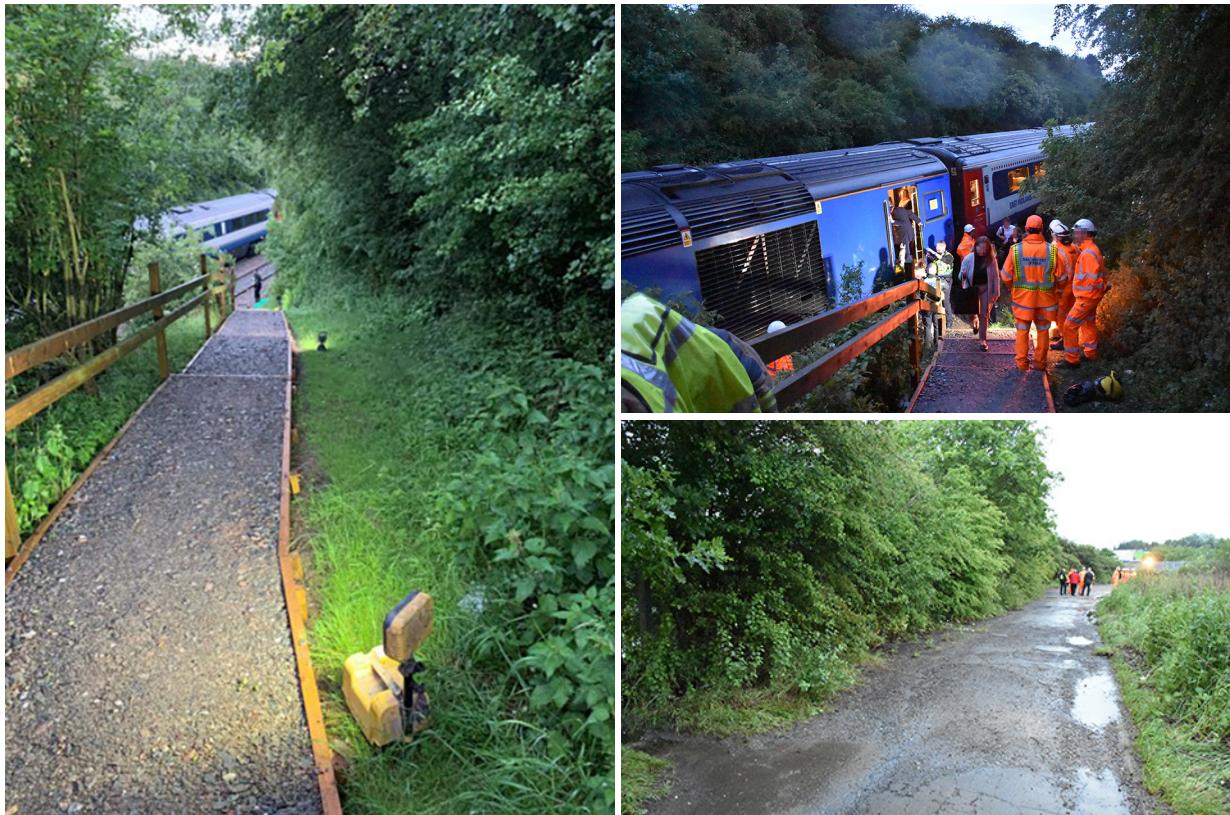
Figure 25: The access point and pathway (left image courtesy of CML)

133 Train 1C52 was moved so that the sliding door on its front power car was close to the ramp for the access point (figure 25) and the evacuation began (paragraph 33), one passenger at a time. As this was taking a long time, staff from East Midlands Trains, Network Rail and the fire and rescue service began assisting able-bodied passengers down onto the track from a second door towards the rear of the train. These passengers needed to be able-bodied as they were required to walk a short distance along the track to the access point. Just over seven hours after train 1D43 had stopped, the transfer of about 450 to 550 passengers off the railway was completed without any further incidents or injuries being reported.
