Rail Accident Investigation Branch

# Rail Accident Report

## Loss of brake control on a sleeper train approaching Edinburgh 1 August 2019

Report 05/2020  
May 2020

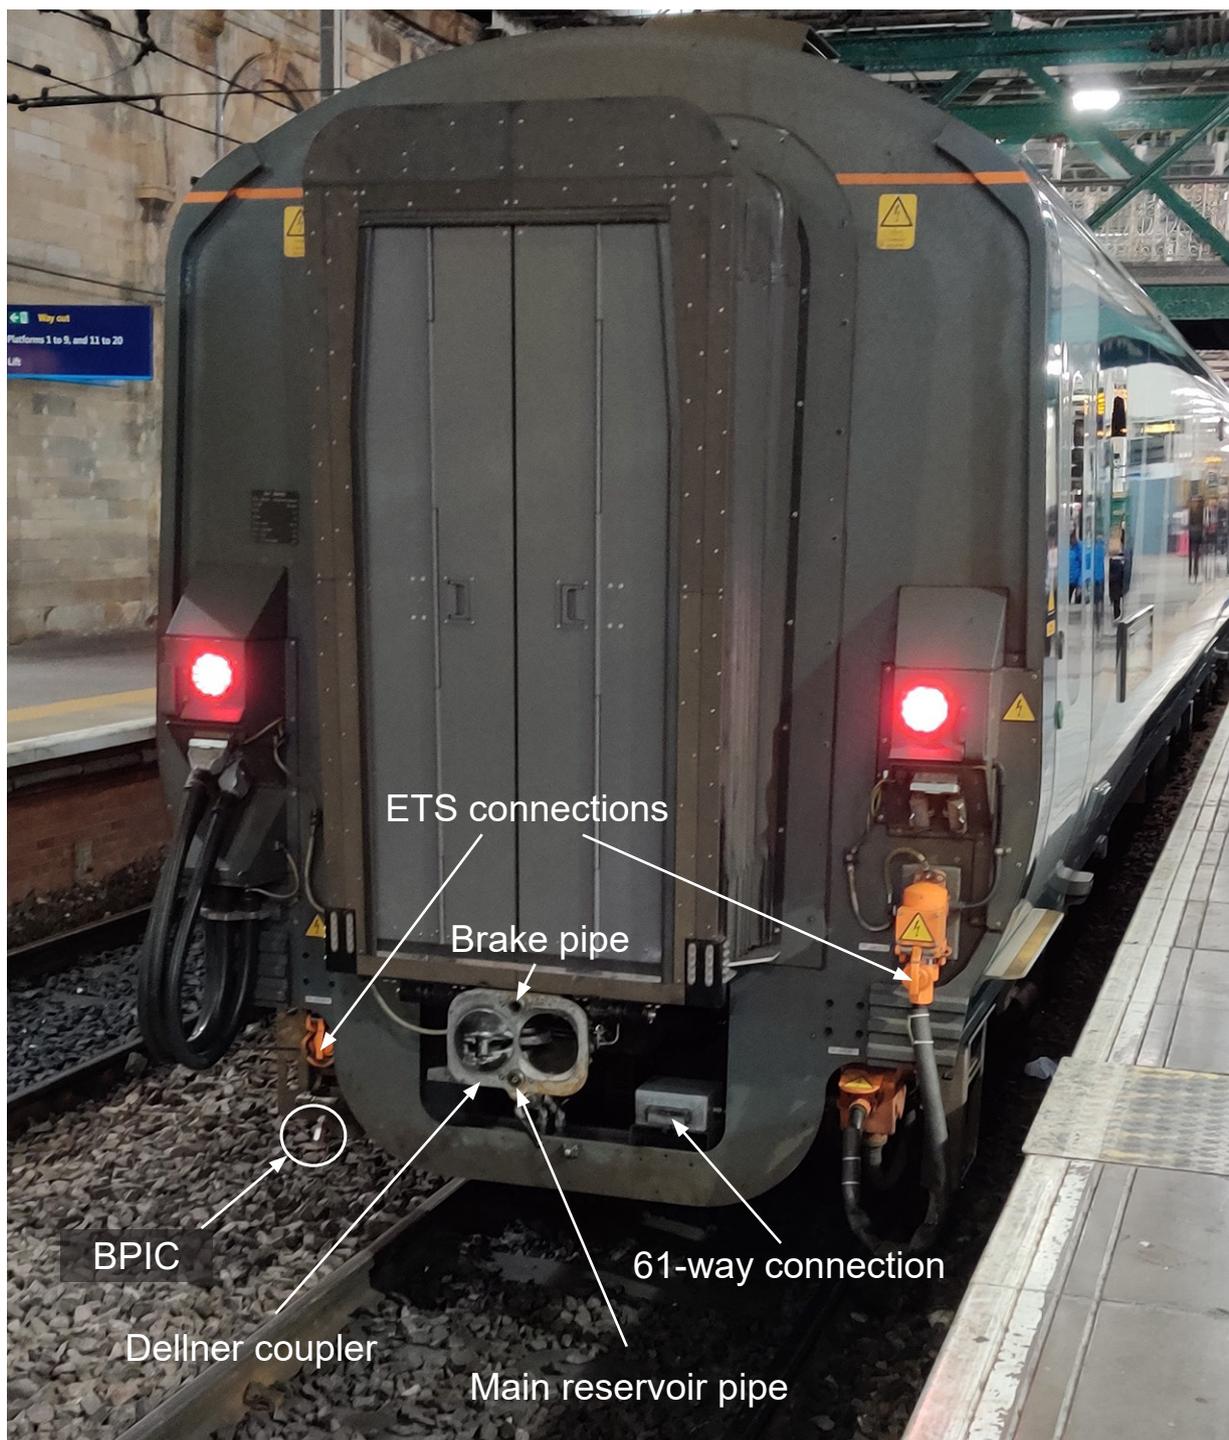
Figure 5: Mark 5 sleeper coach end, showing Dellner coupler and other connections

- 99 In October 2016 the BPIC was repositioned on the end of the coach underframe, due to the manufacturer's concerns about the possibility that the complexity of the brake pipe layout would result in excessive brake propagation<sup>8</sup> times along a 16-coach train. The repositioned Mk5 BPIC was installed below the ETS socket (figures 5, 12 and 13). This change also required staff to access the track during coupling and uncoupling.
