**CONTENTS****SPECIAL BULLETINS / INTERIM REPORTS**

**AAIB FIELD INVESTIGATIONS****COMMERCIAL AIR TRANSPORT****FIXED WING**

Airbus A320-216	EC-KLT	26-Aug-19	3
ERJ 190-200 LR (Embraer 195)	G-FBEJ	28-Feb-19	11

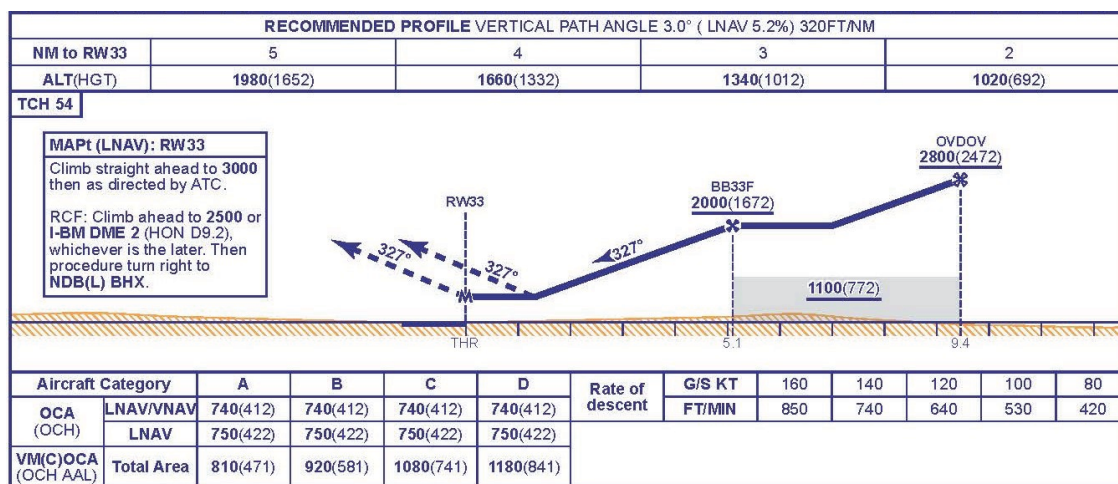
**Figure 1**

The aircraft was at 4,000 ft approximately 11 nm south of the airport when ATC cleared it to descend to 2,000 ft and carry out the RNAV approach (Figure 1). The pilots read back the clearance correctly but, thirty seconds later, the aircraft had not changed altitude and they contacted ATC to request descent. ATC again cleared the aircraft to descend to 2,000 ft and to carry out the approach. The aircraft was 10.5 nm from the runway when it started descending. At 9.4 nm it was at 3,800 ft, 1,000 ft above the correct profile.

Vertical profile of RNAV approach to Runway 33 at Birmingham Airport  
(Extract from UK Aeronautical Information Publication)

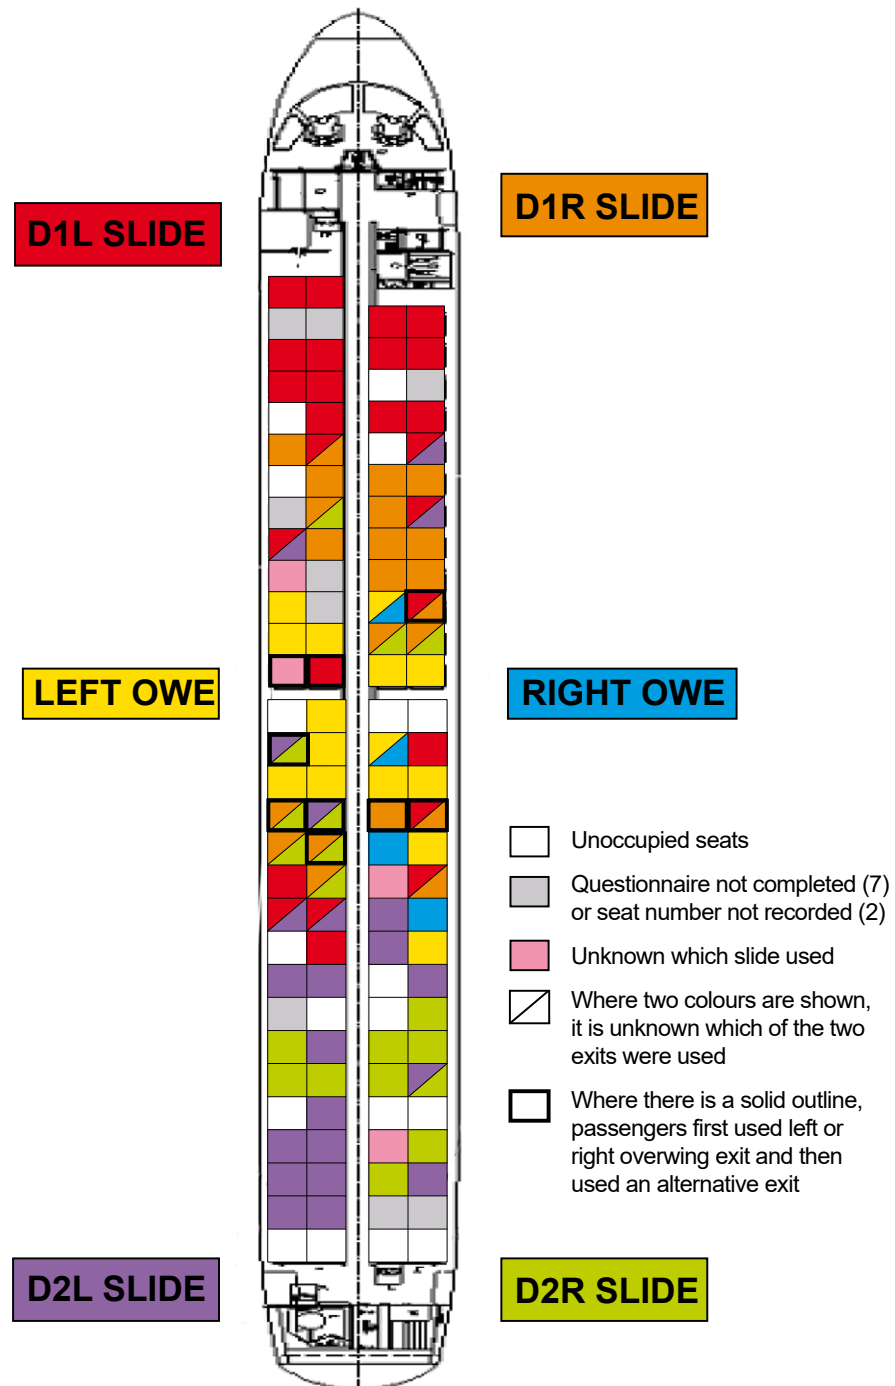
**Figure 2**

On completing the emergency evacuation checklist, the commander left the flight deck and confirmed with the SCSM that all the passengers and other cabin crew members had evacuated. They were joined by the co-pilot and all three left the aircraft via the forward left slide. Out of the 100 passengers on board G-FBEJ, 93 completed AAIB questionnaires regarding the evacuation. Figure 2 illustrates the exits used by the passengers, correlated by seat position.

## Evacuation Routes Used

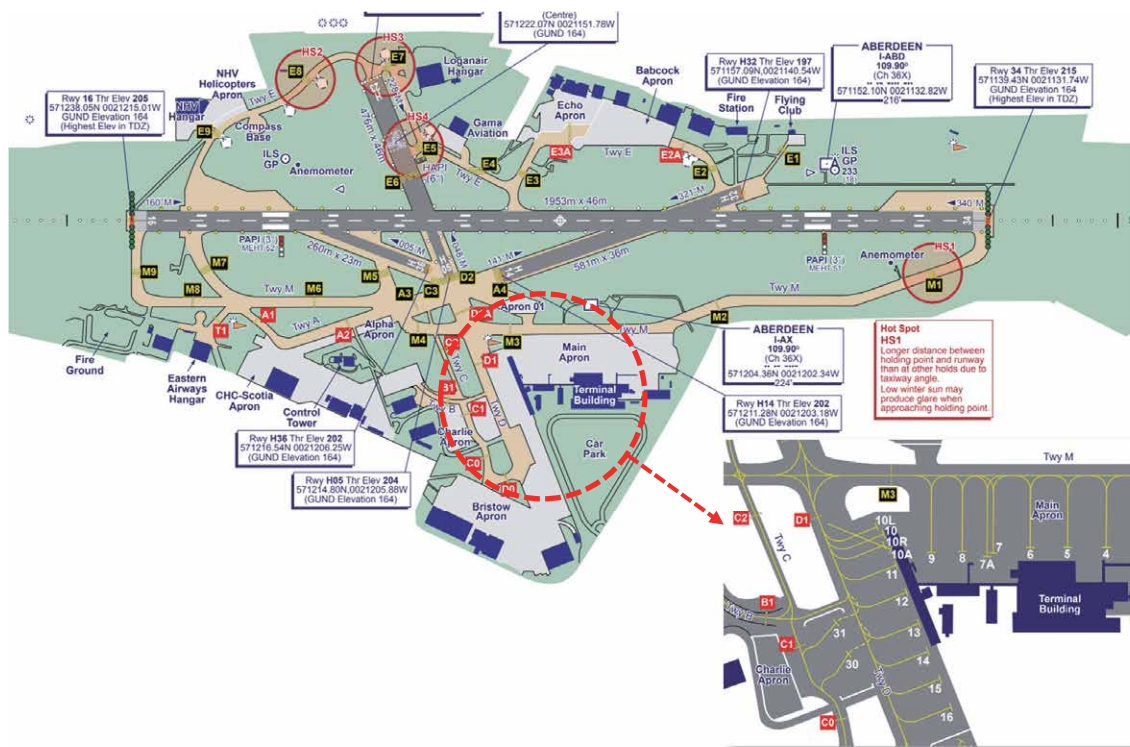
**Figure 1**  
Aberdeen Airport (Stands 31 and 11 shown in inset)

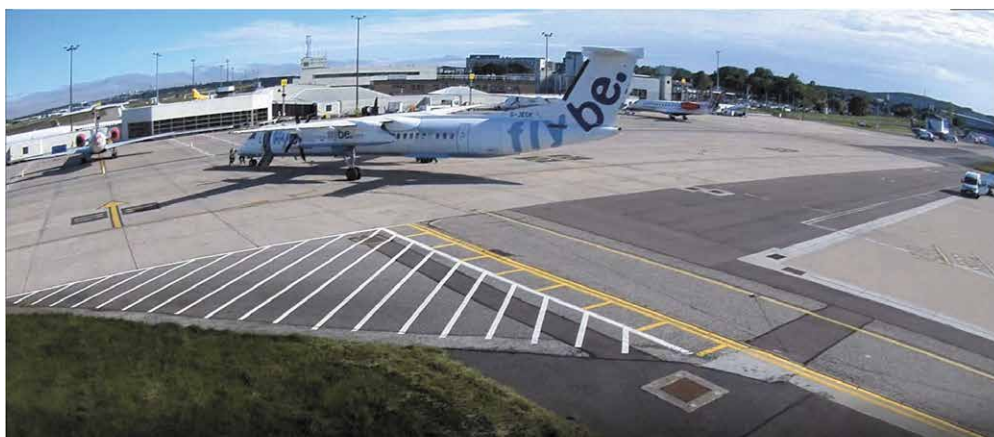
The recordings showed that at 1639 hrs a Sikorsky S92 helicopter had taxied past G-JECK, whilst a refuelling vehicle also manoeuvred nearby (Figure 6). At 1644:30 hrs, G-JECK started rolling forward. The aircraft's ground speed gradually started to increase and by 1645:23 hrs it had travelled about halfway across Taxiway D (Figure 7). At 1645:35 hrs, G-JECK struck G-SAJS (Figure 8) whilst travelling at a ground speed of about 5 kt.

**Figure 7**  
G-JECK as it rolled across Taxiway D

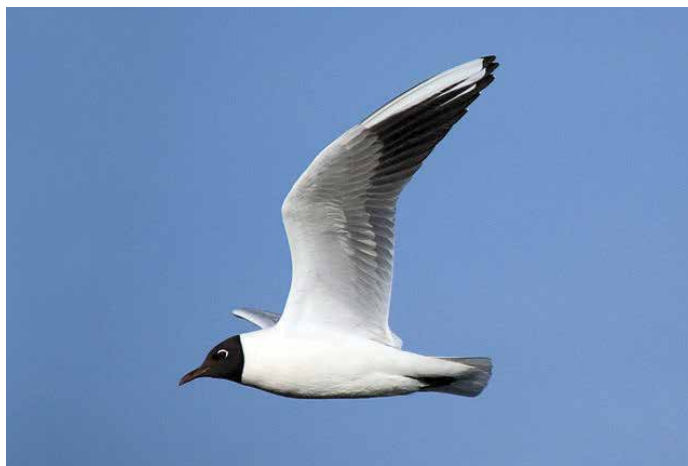
The pilot had previously operated the UAS in coastal and onshore locations where gulls were present, and had been cautious while operating in their areas, especially in the nesting season. He had not experienced this level of aggression before and noted that it was one of the black-headed gulls in the area which had attacked the UAS. The distinctive appearance of the Black Headed Gull is shown at Figure 1.

**Figure 1**  
Black Headed Gull
